**REPORT NUMBER: NCAPSIDE-TRC-2007-004**

**NEW CAR ASSESSMENT PROGRAM  
SIDE IMPACT TEST**

**MITSUBISHI MOTORS CORPORATION  
2008 MITSUBISHI OUTLANDER MPV  
NHTSA NUMBER: M85603**

**FINAL REPORT**

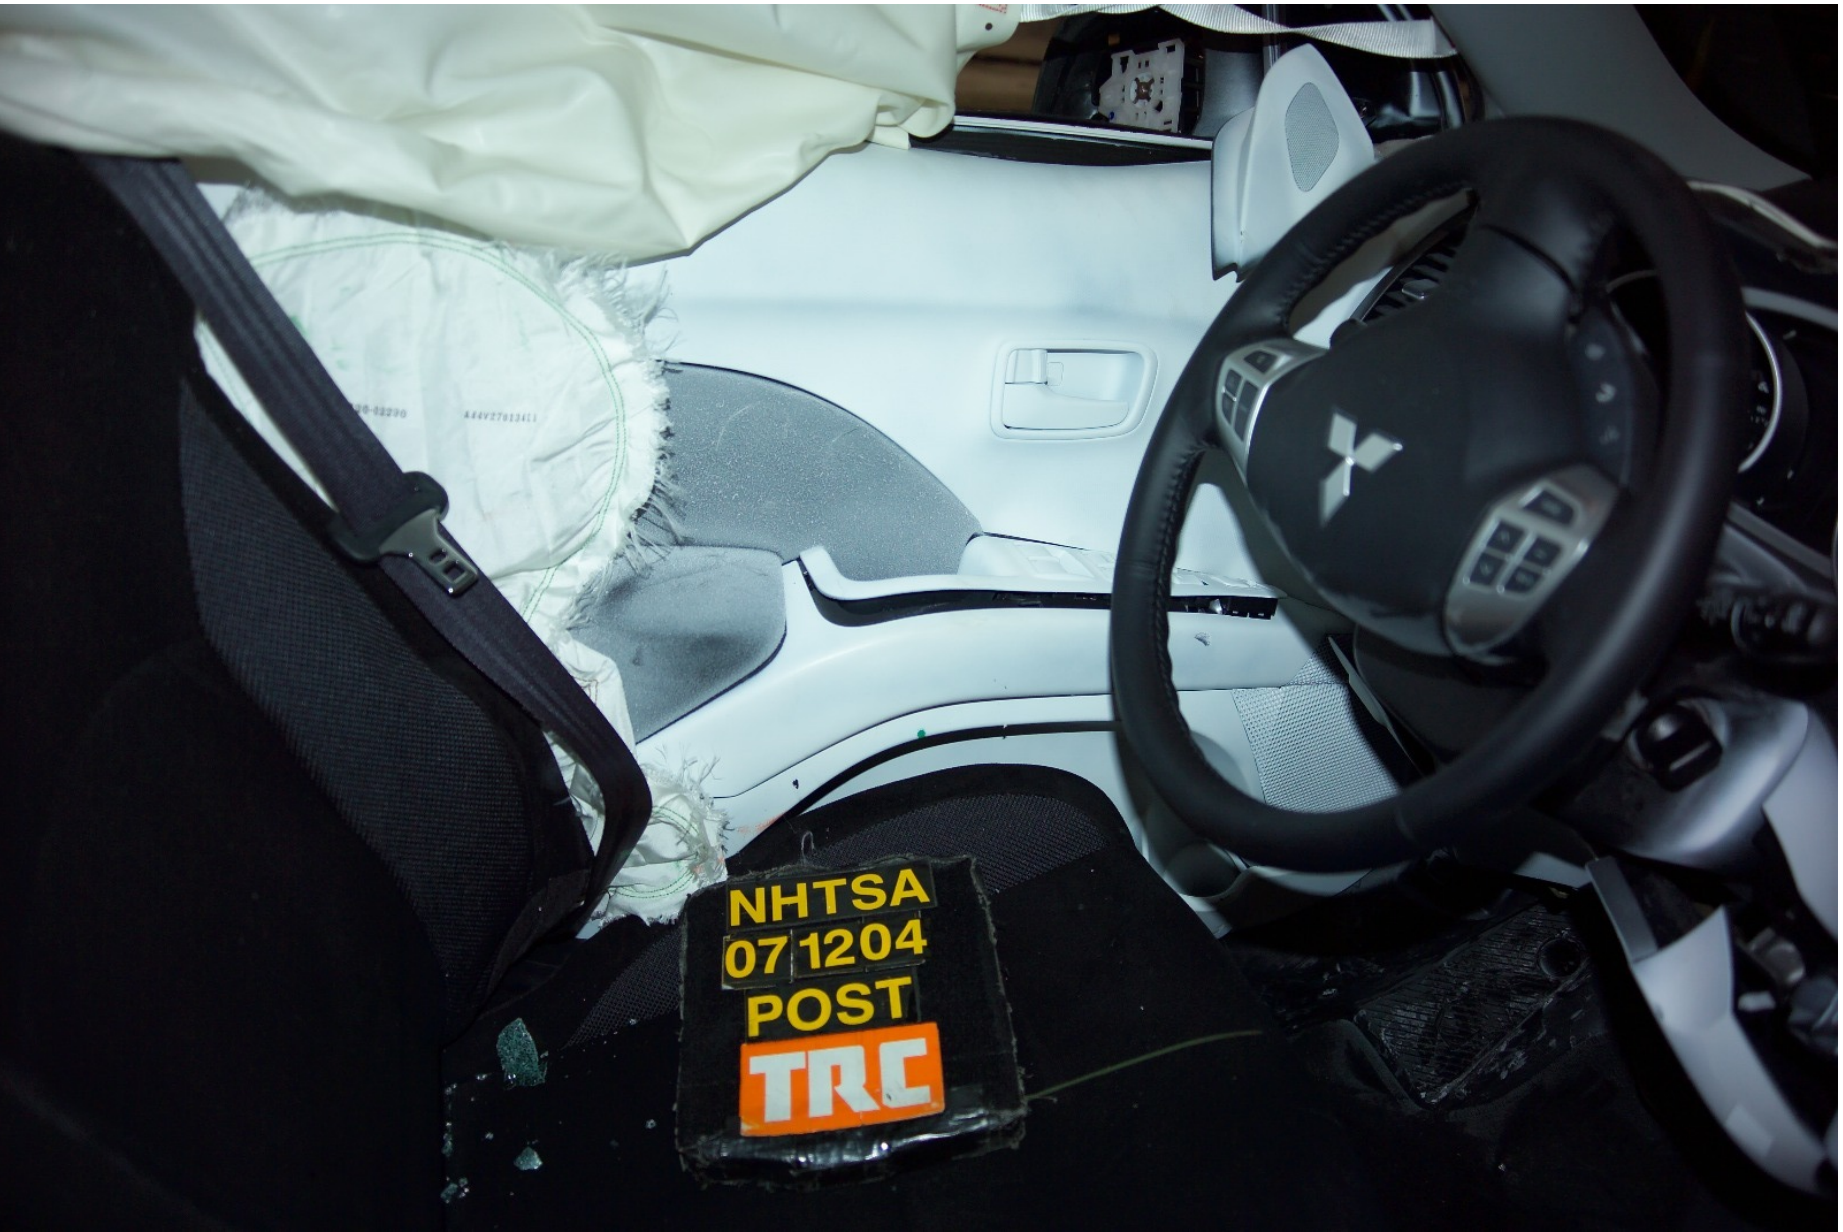
Figure A-60 Post-Test Interior of Front Door Showing SID Impact Locations

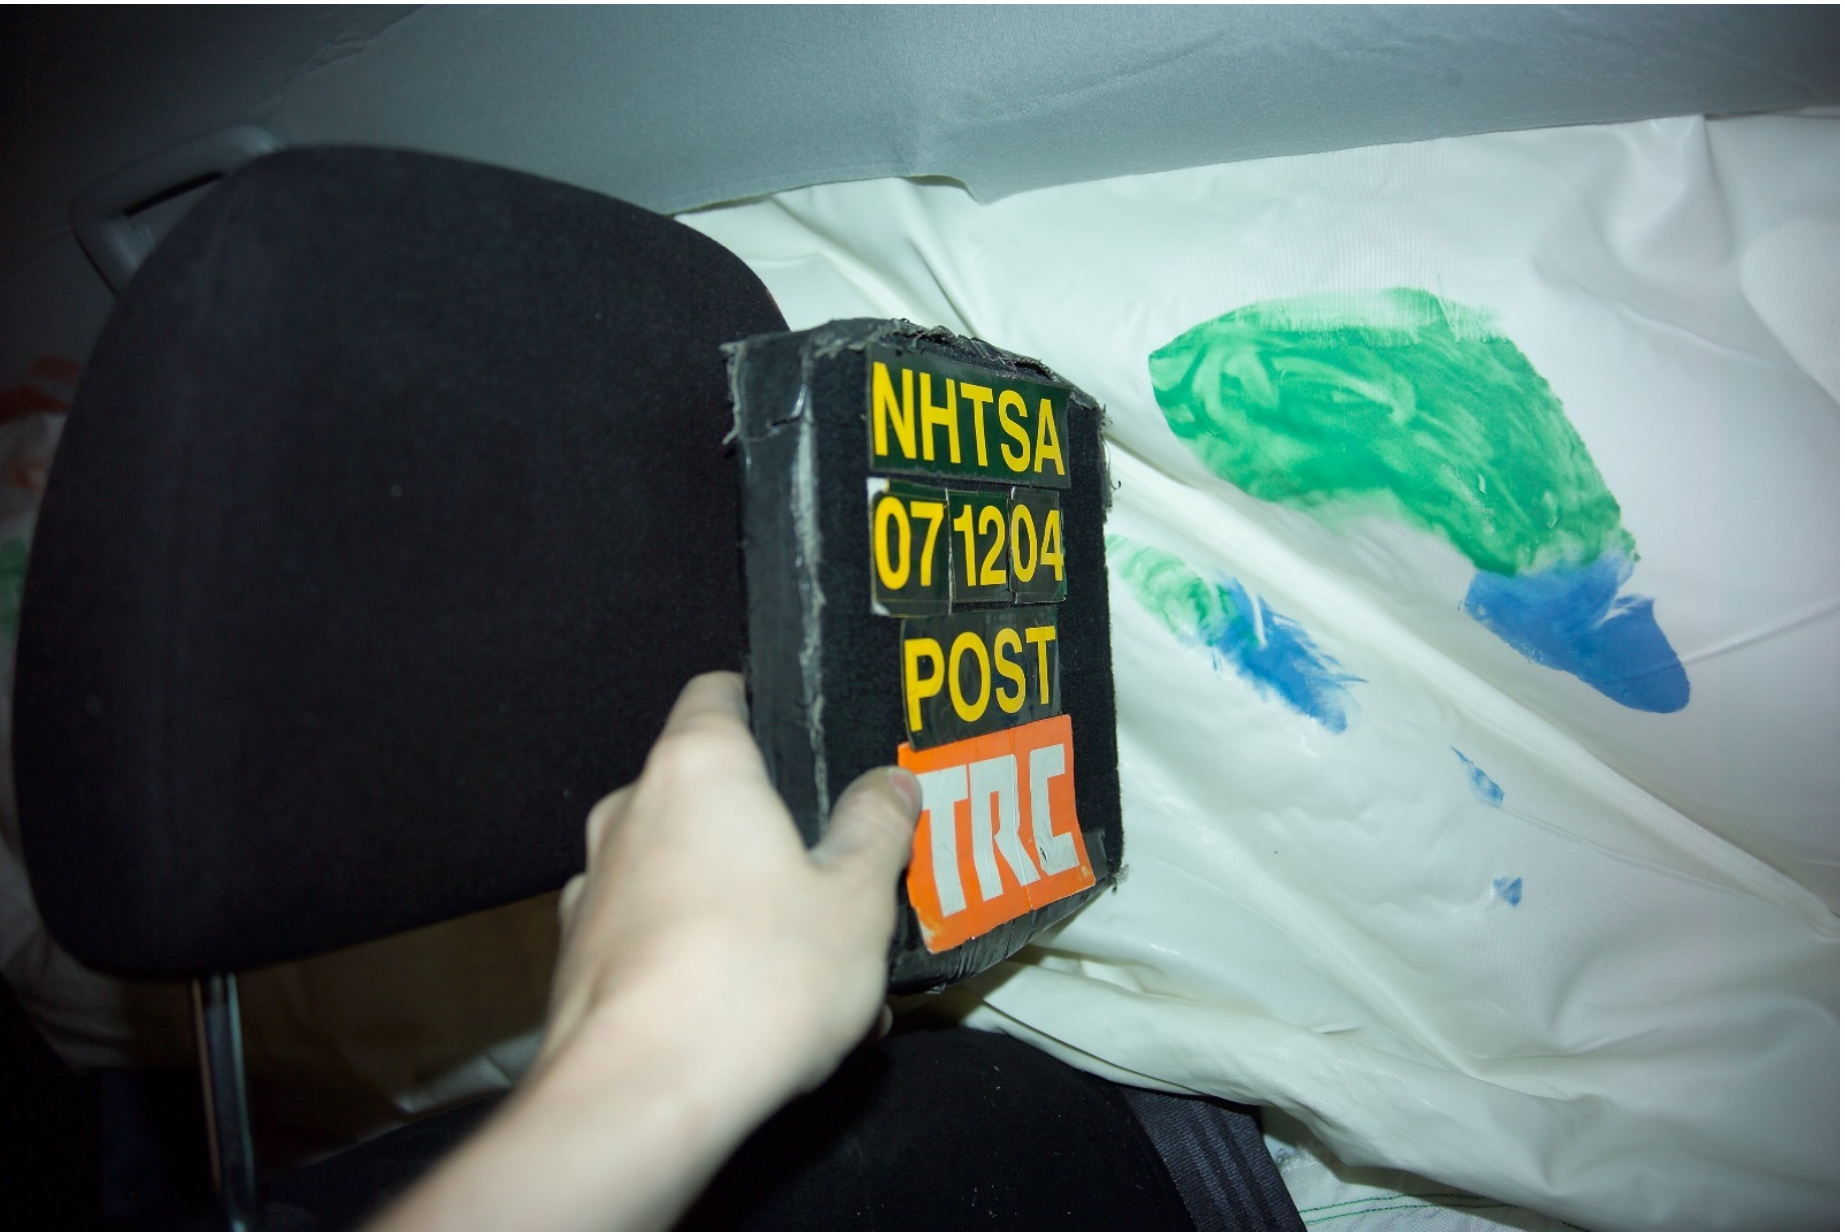
Figure A-61 Post-Test Front SID Contact - View 1

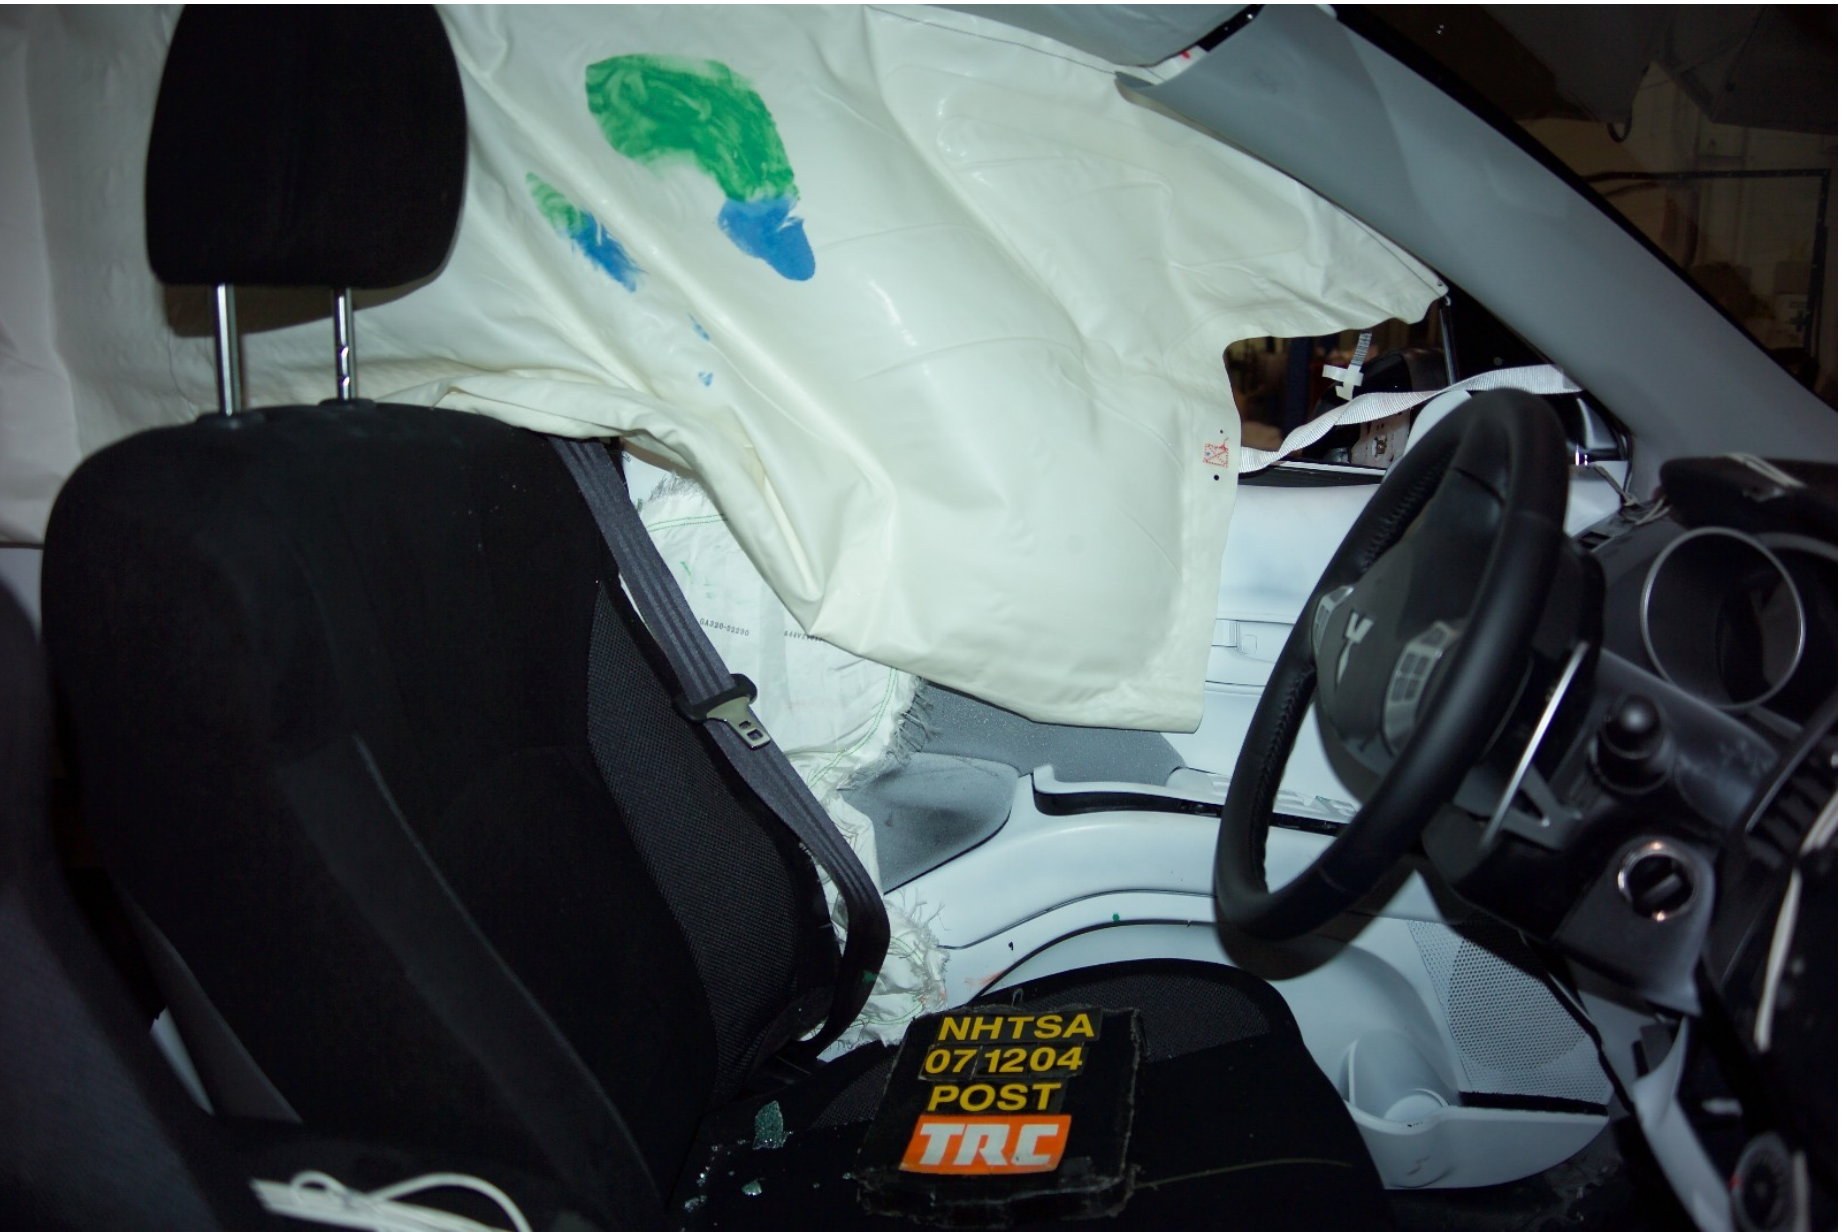
Figure A-62 Post-Test Front SID Contact - View 2

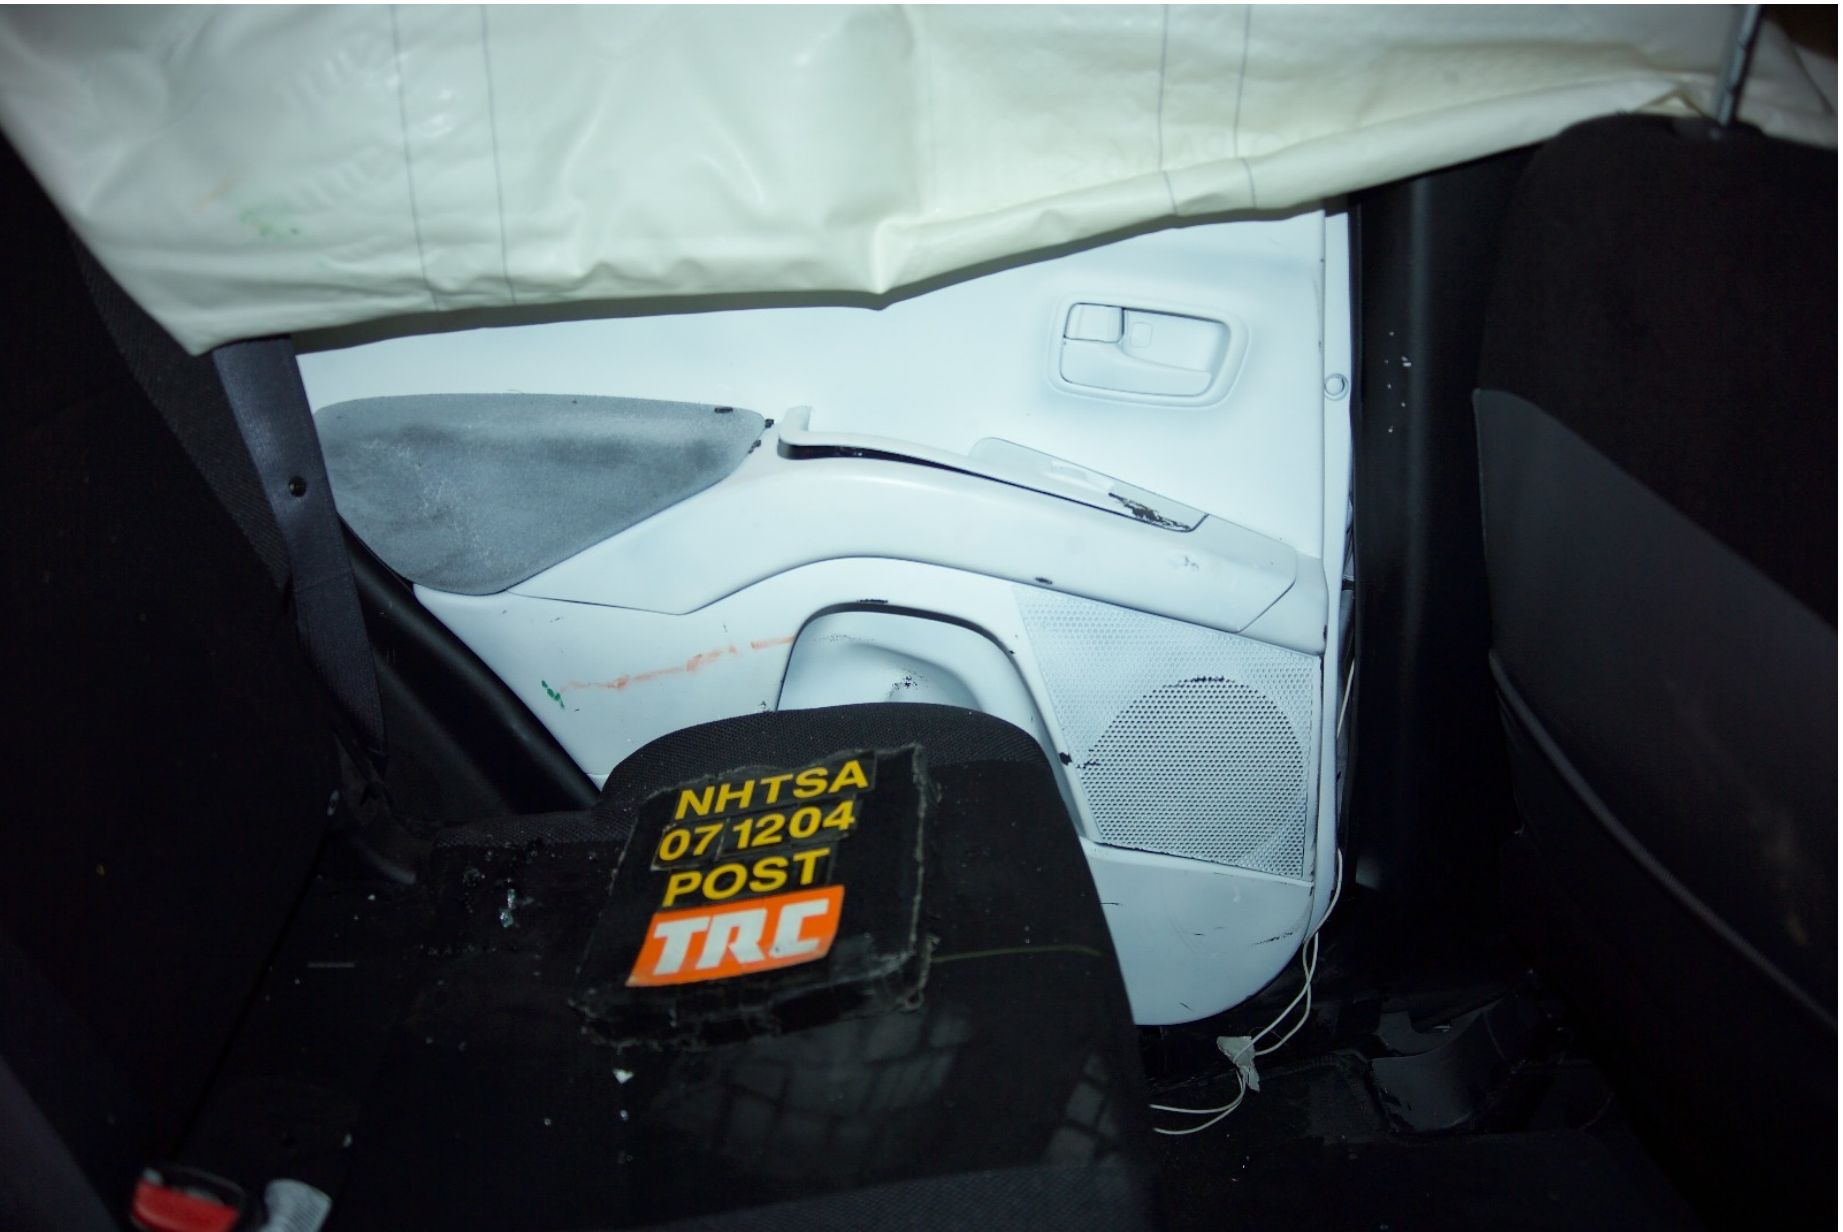
Figure A-64 Post-Test Interior of Rear Door Showing SID Impact Locations

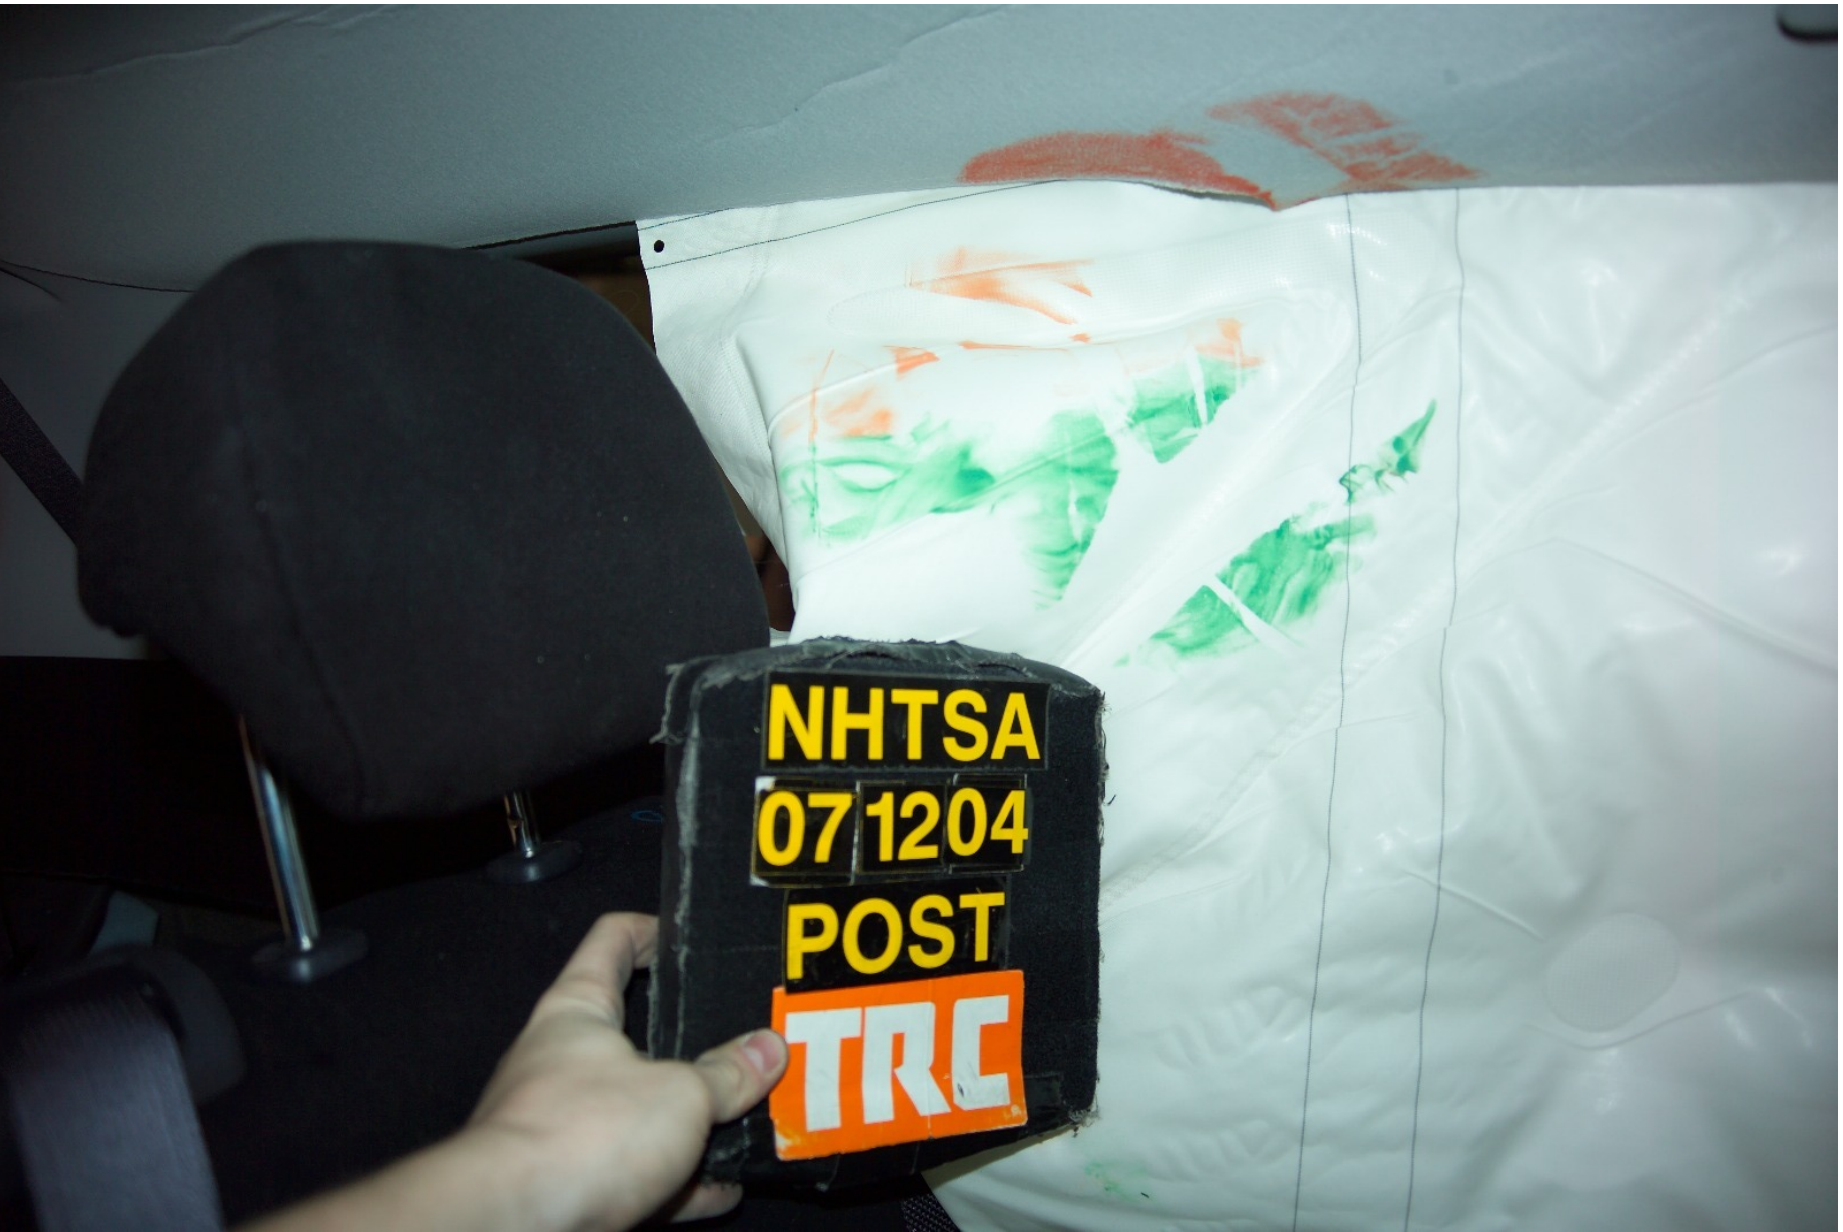
Figure A-65 Post-Test Rear SID Contact - View 1

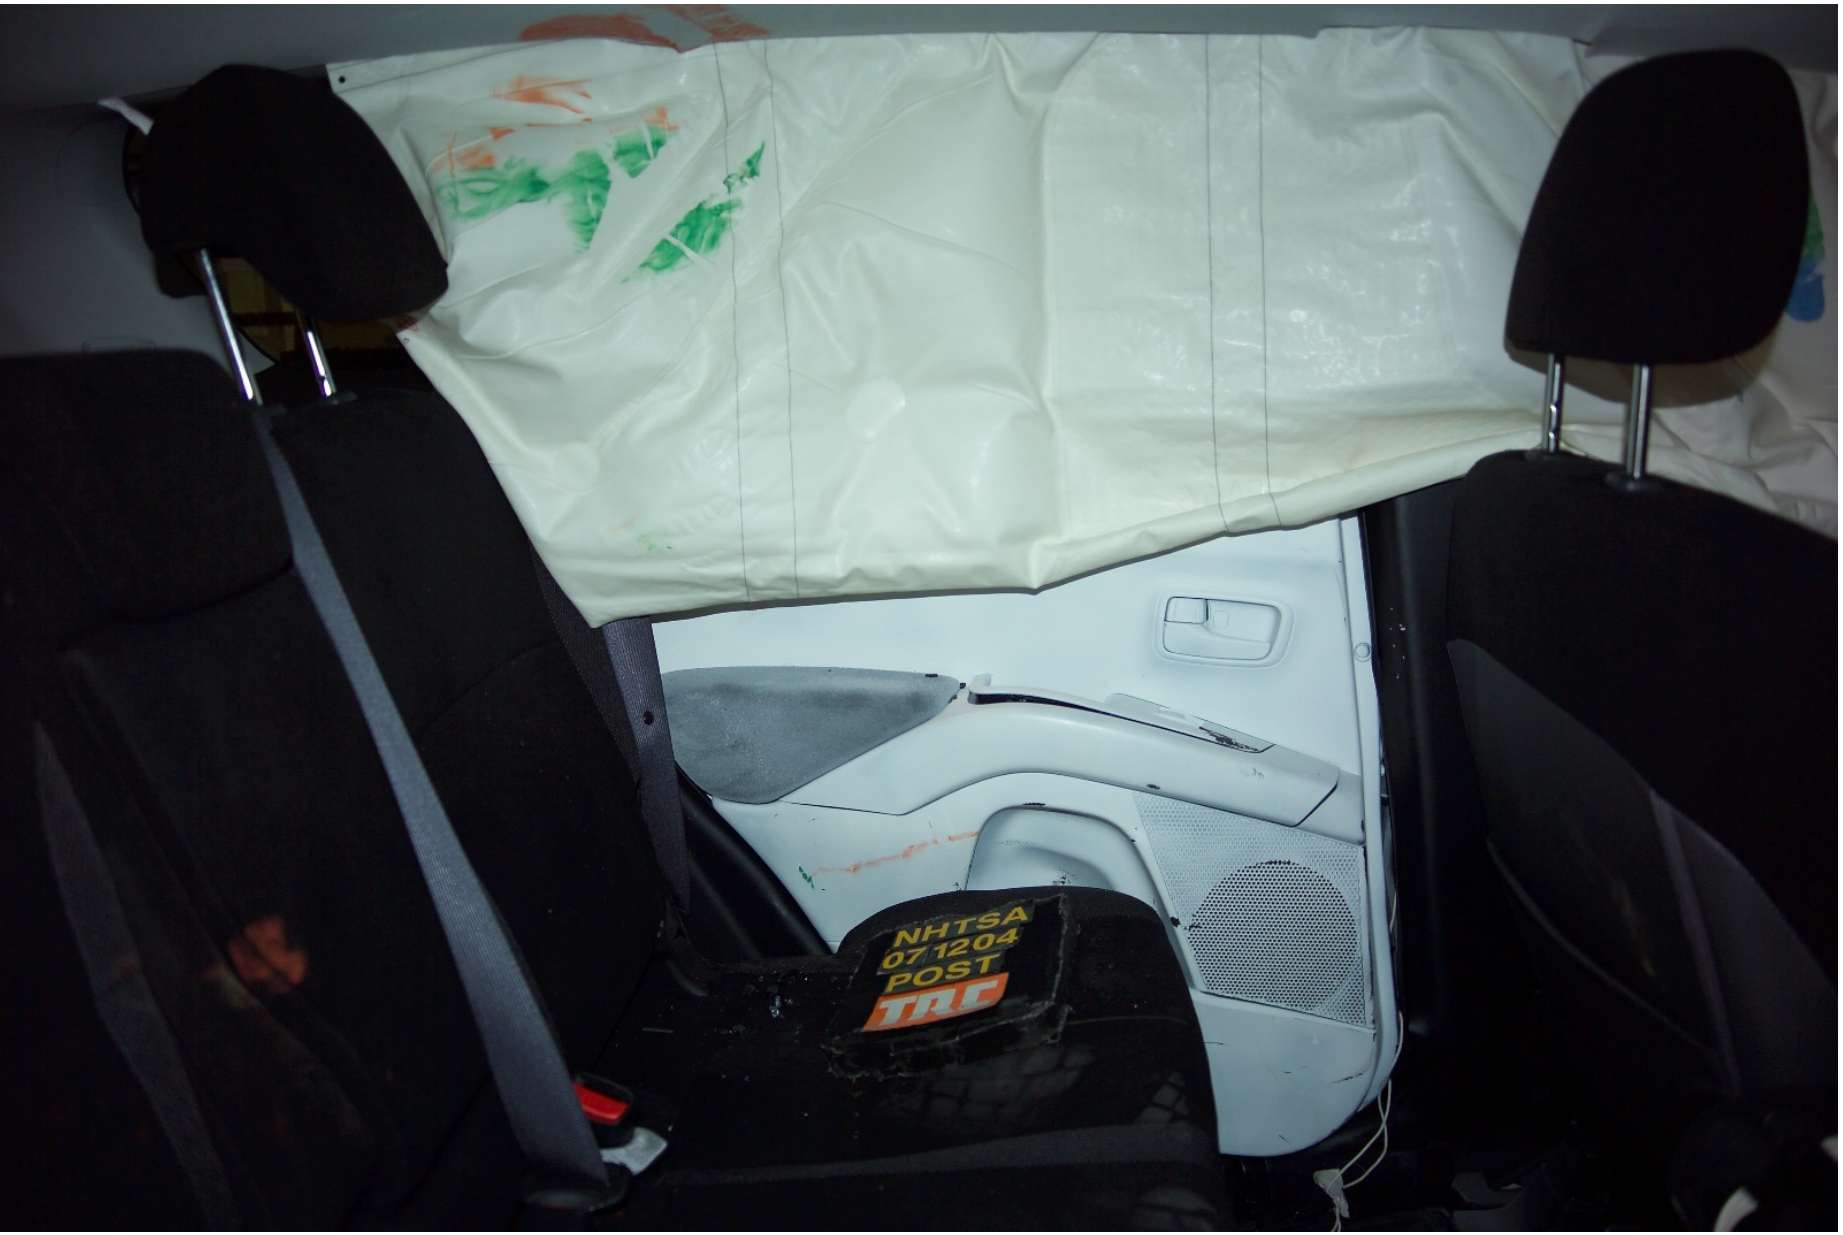
Figure A-66 Post-Test Rear SID Contact - View 2

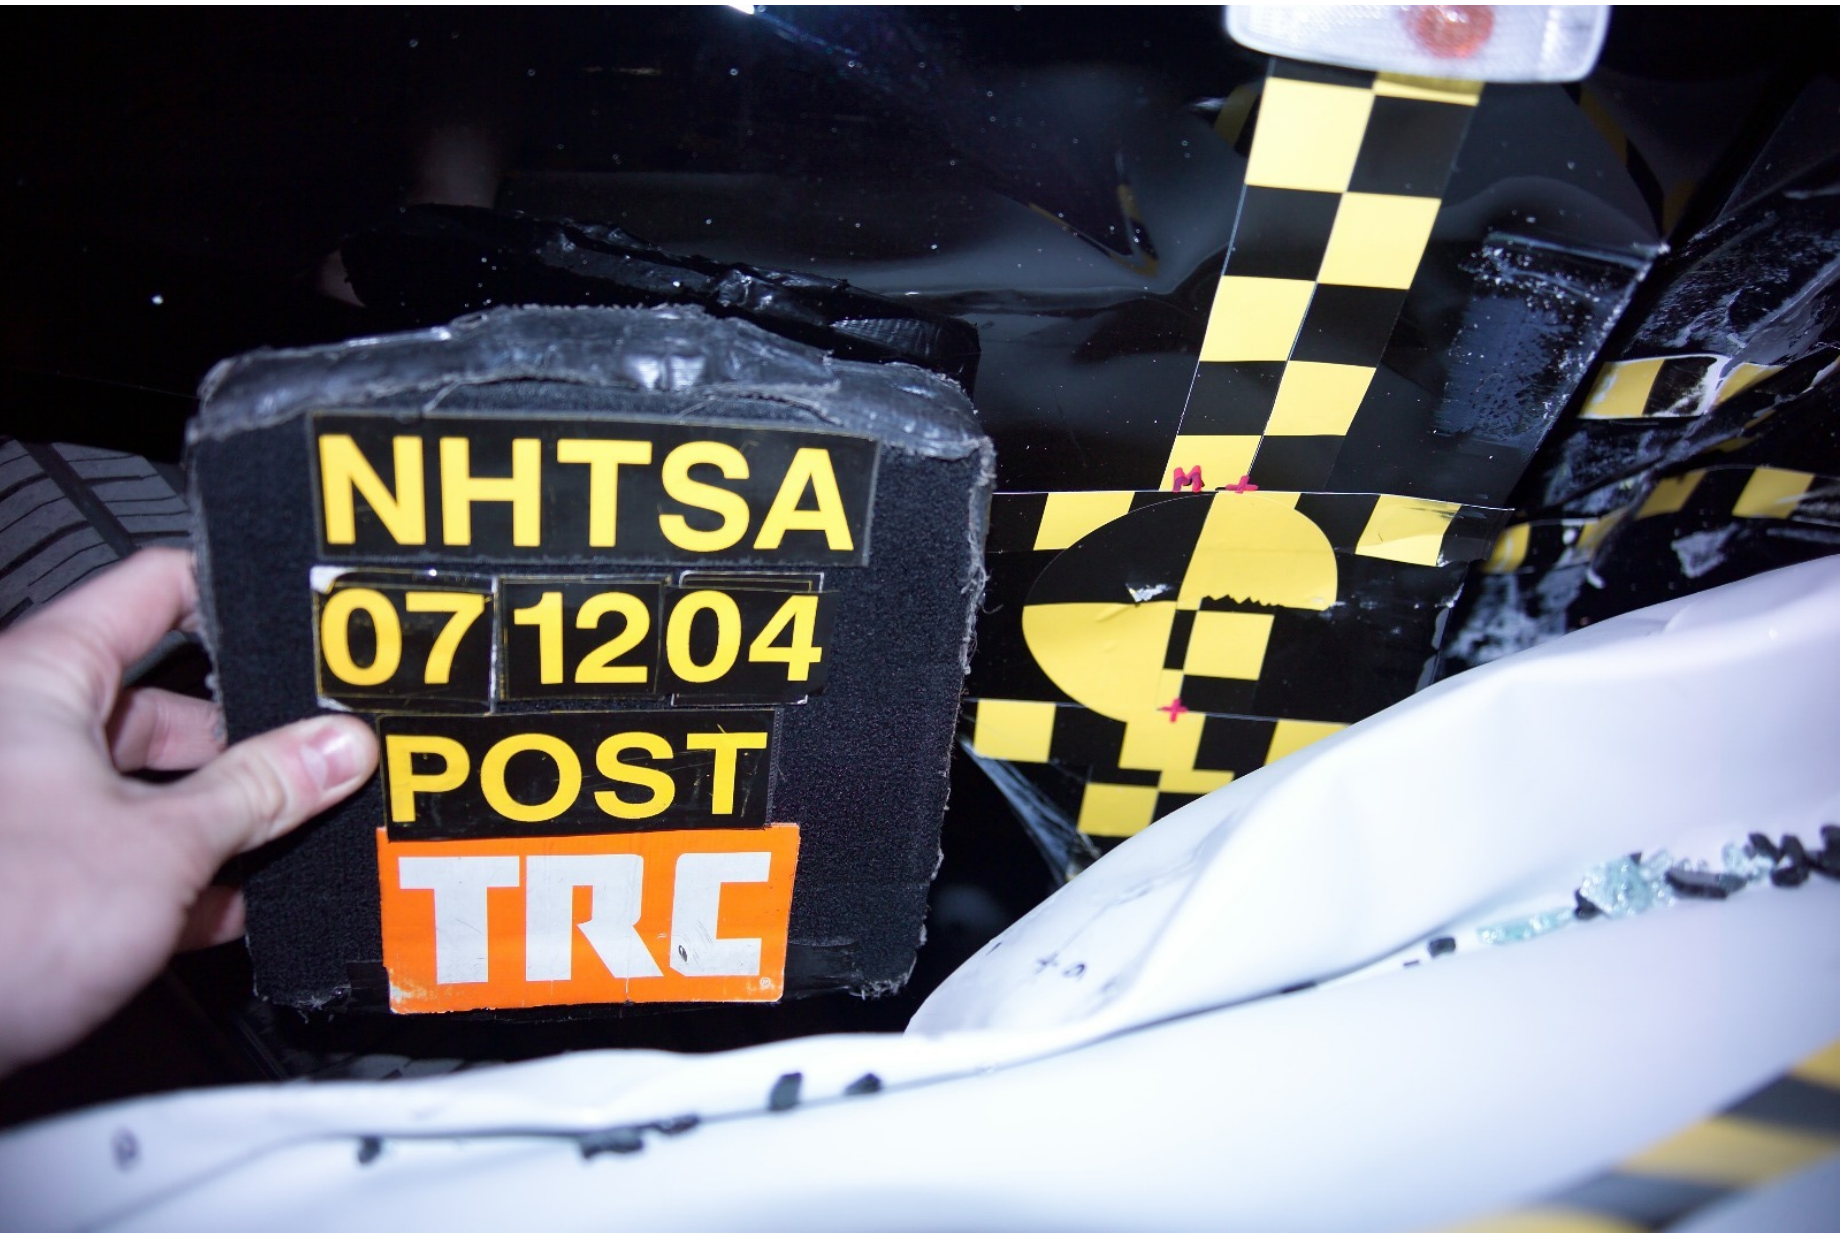
Figure A-70 Post-Test Primary Impact Point View

The test vehicle sustained a maximum static crush of 214 mm at level 3, 750 mm rearward of the left impact point. The driver SID/HIII, Serial No. 066, and left rear passenger SID/HIII, Serial No. 059, were calibrated prior to this test.
