**REPORT NUMBER TR-P28001-14-NC**

**NEW CAR ASSESMENT PROGRAM  
FRONTAL BARRIER IMPACT TEST**

**GENERAL MOTORS CORP.  
2008 CHEVROLET MALIBU LS  
4-DOOR SEDAN**

**NHTSA NUMBER: M80102**

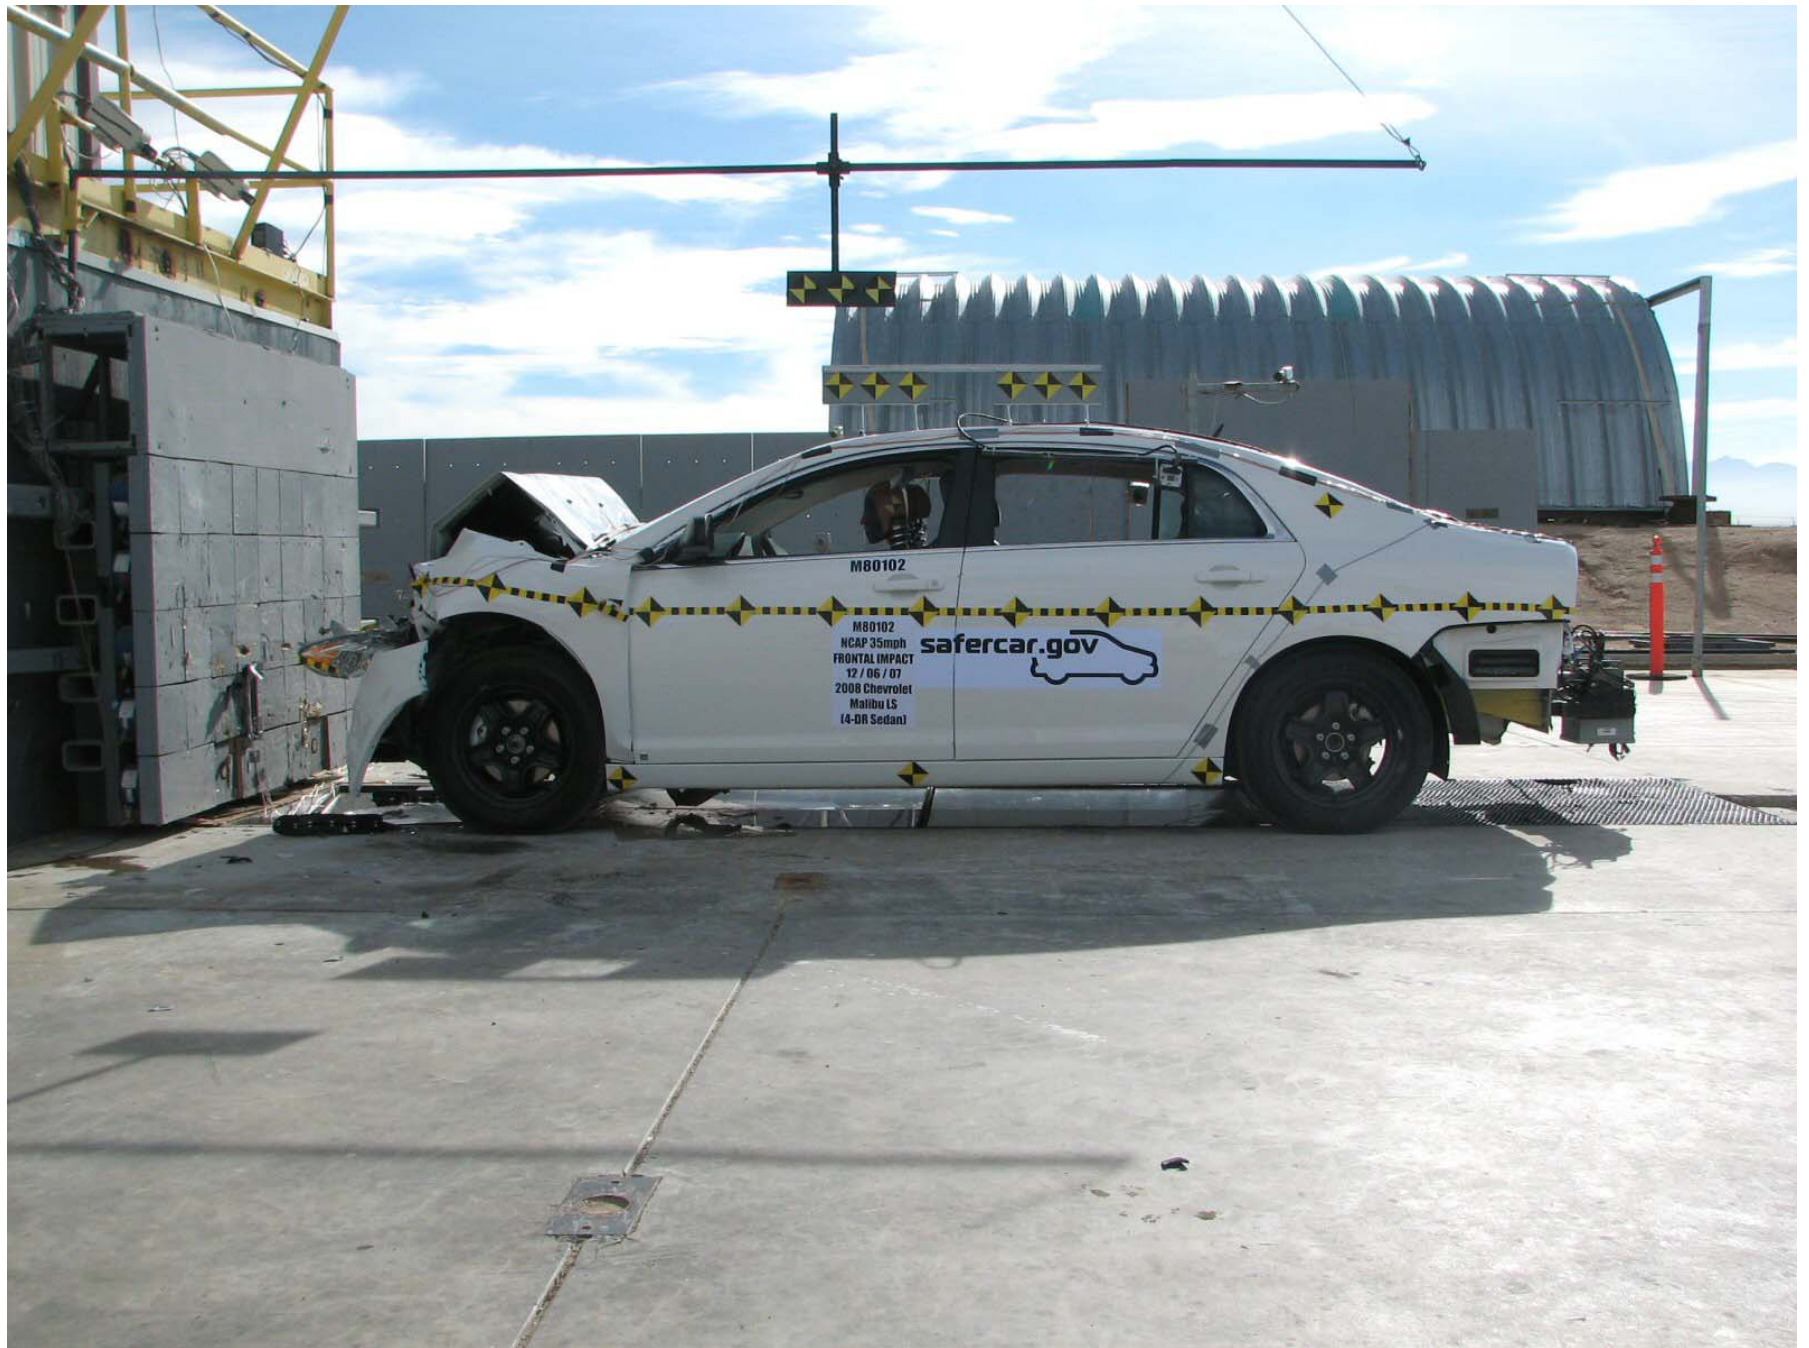
Figure A-9: Post-Test Left Side View

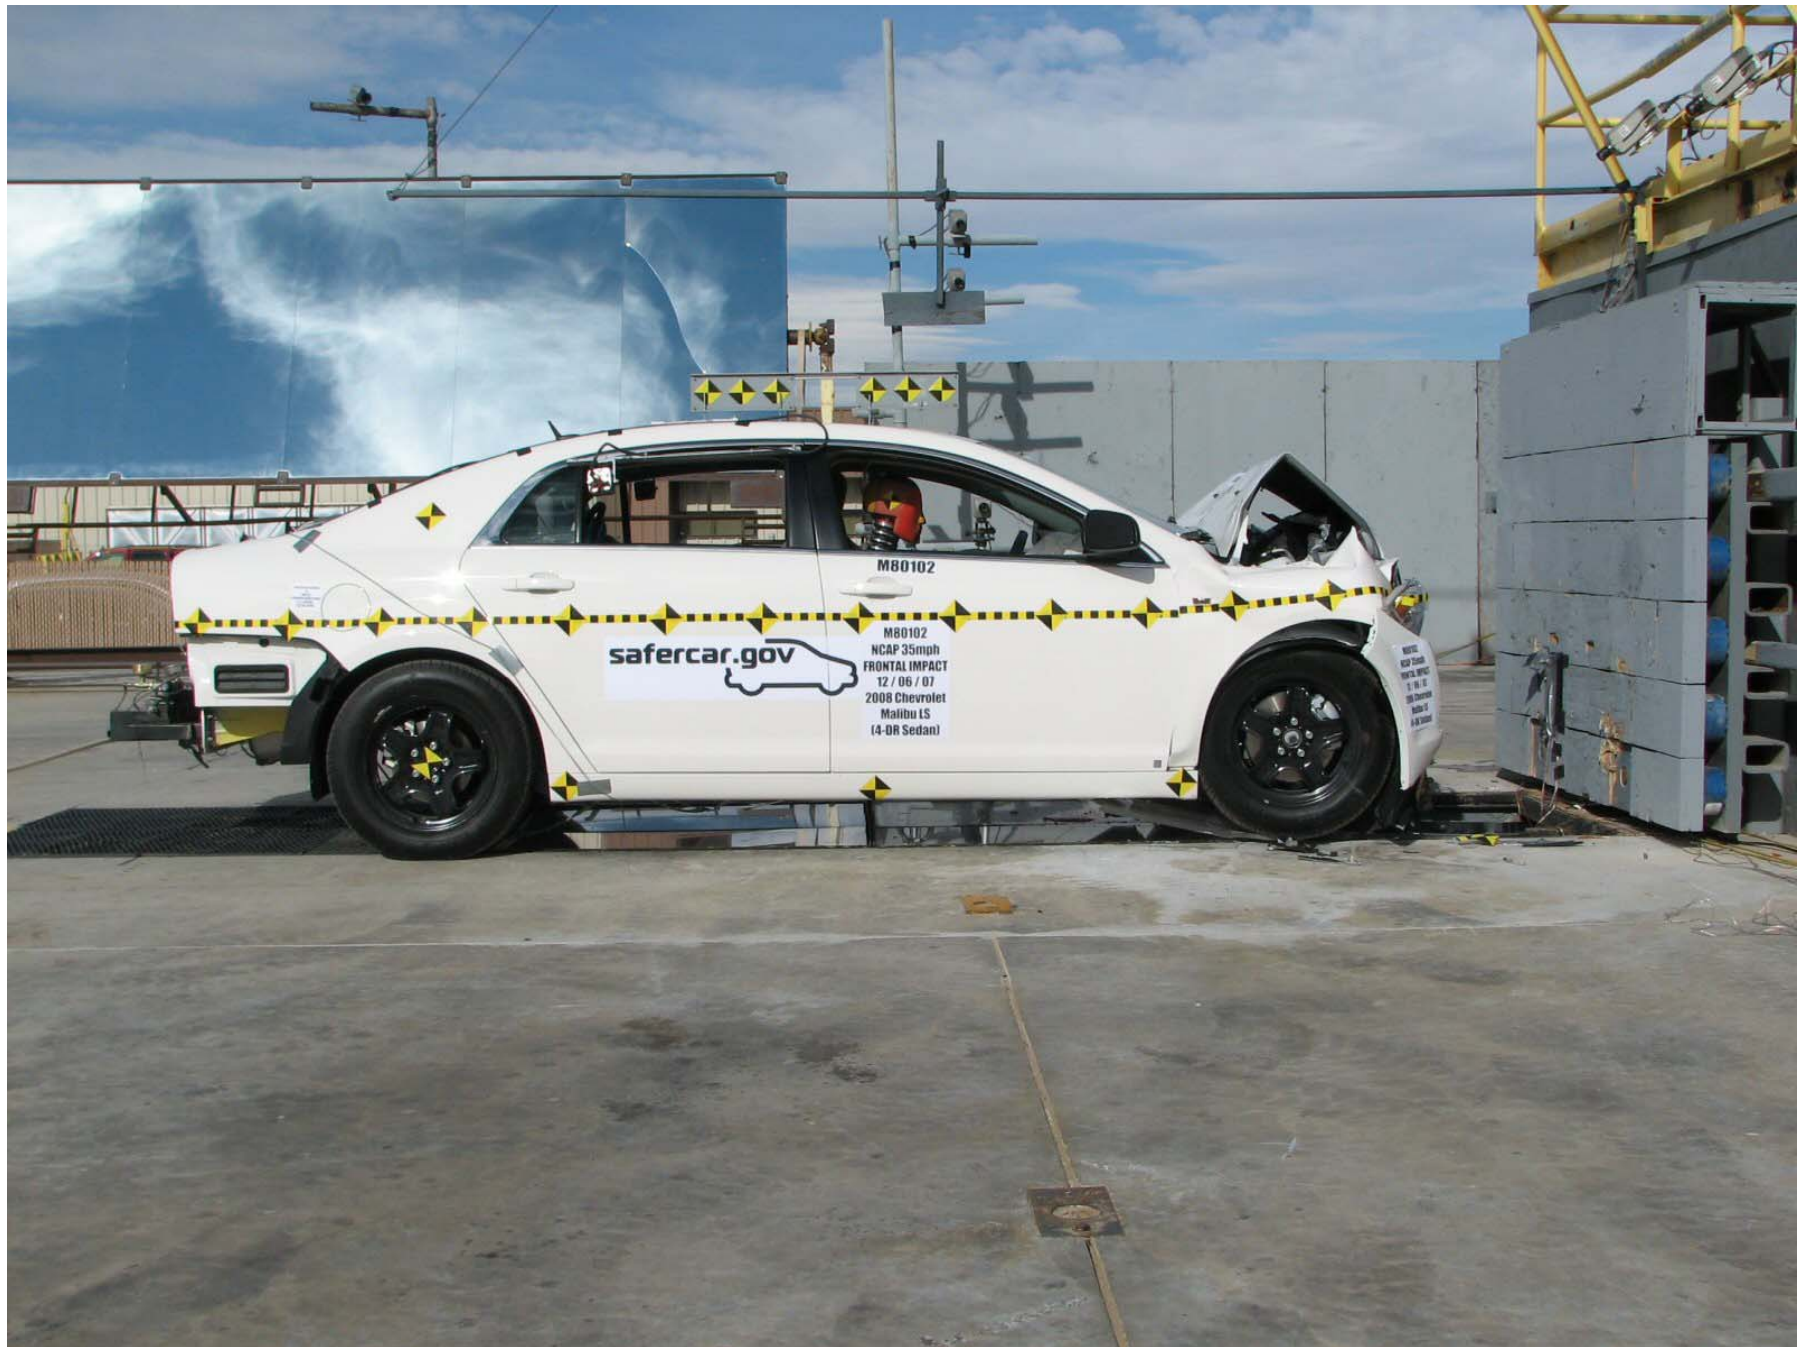
Figure A-11: Post-Test Right Side View

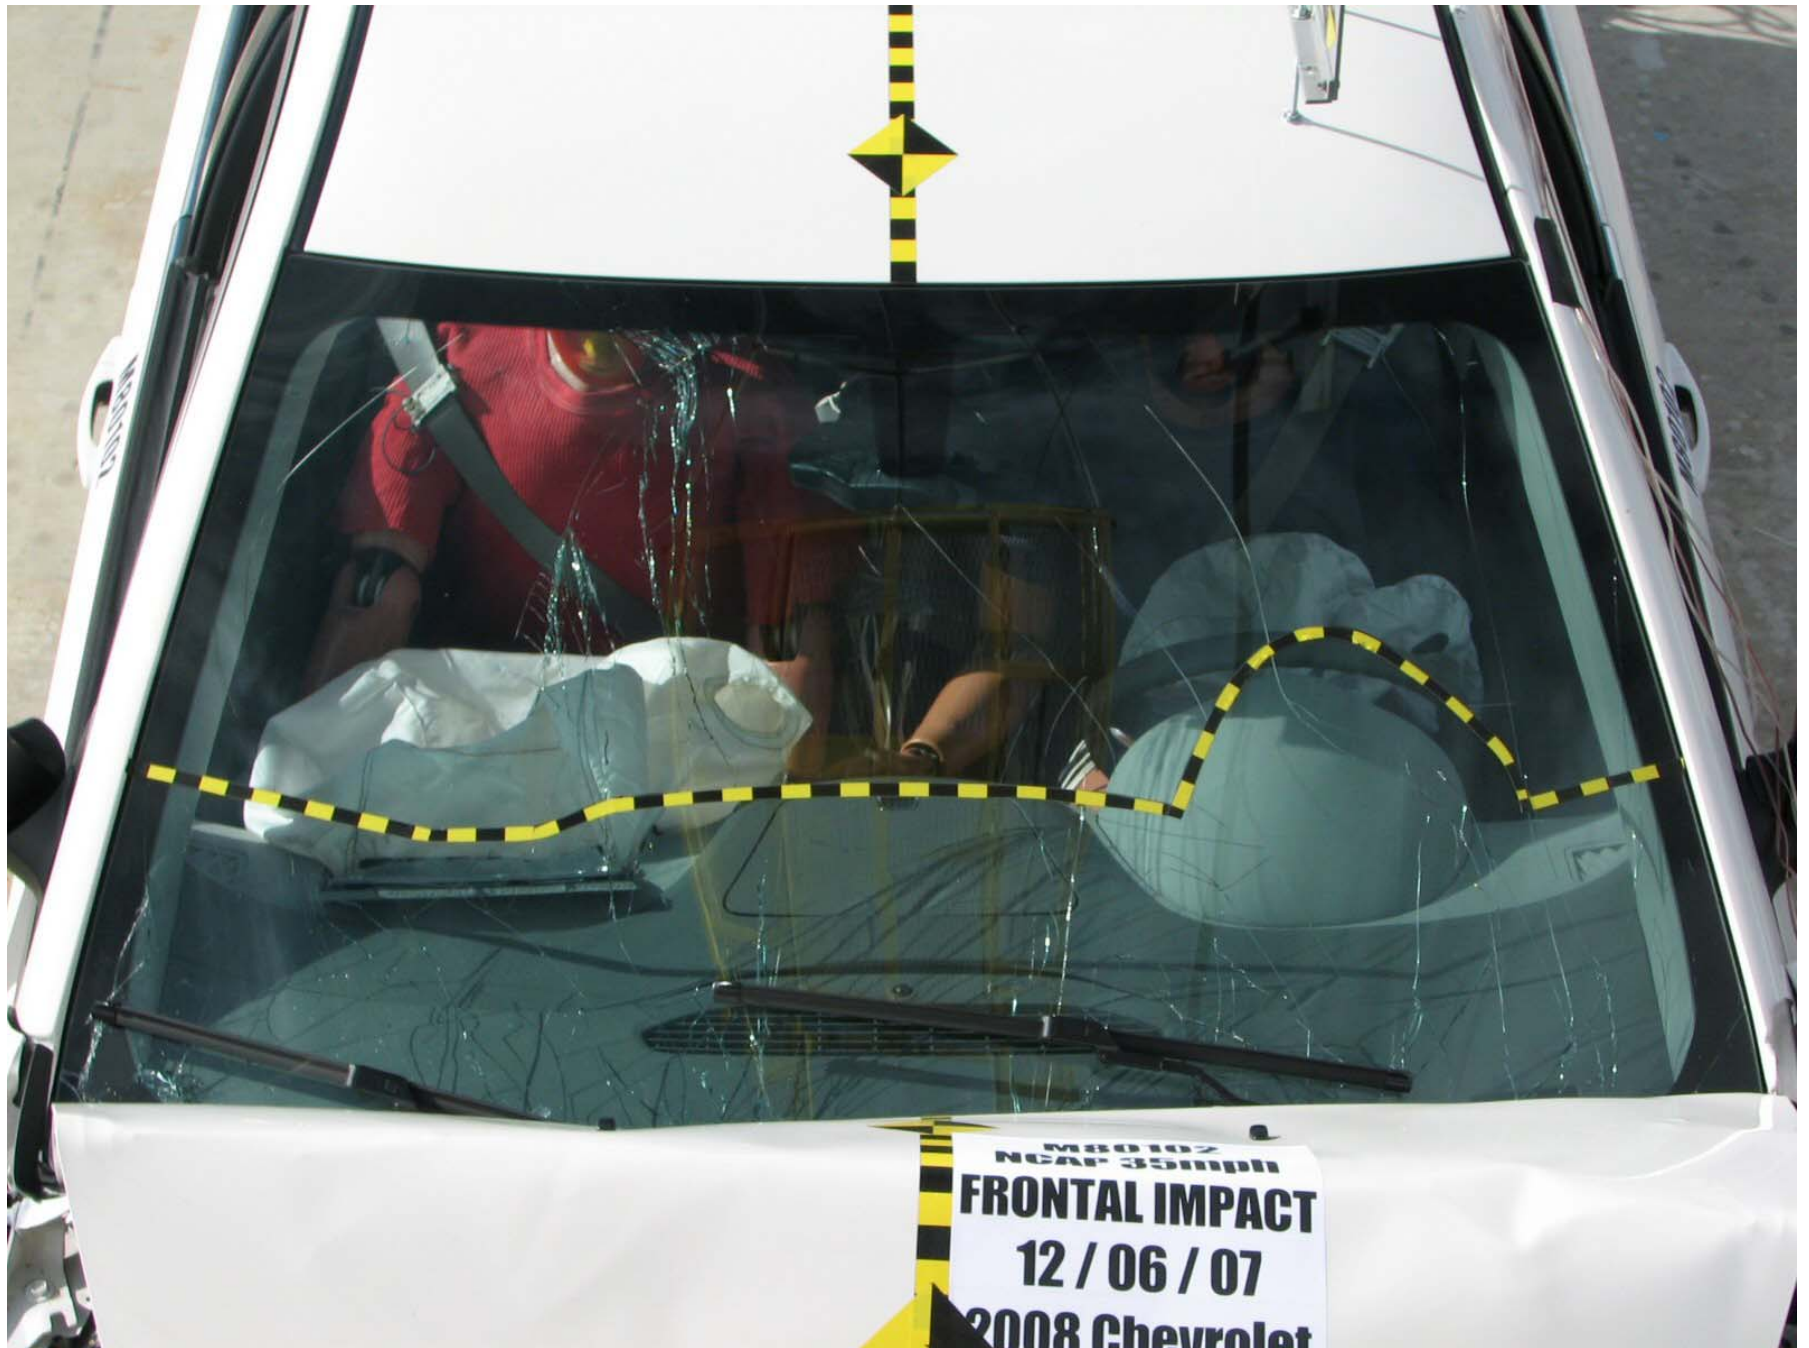
Figure A-19: Post-Test Windshield

There was 100% windshield retention and no intrusion into the protected zone of the windshield during impact. There was no Stoddard solvent leakage after the event, or during any phase of the static rollover.

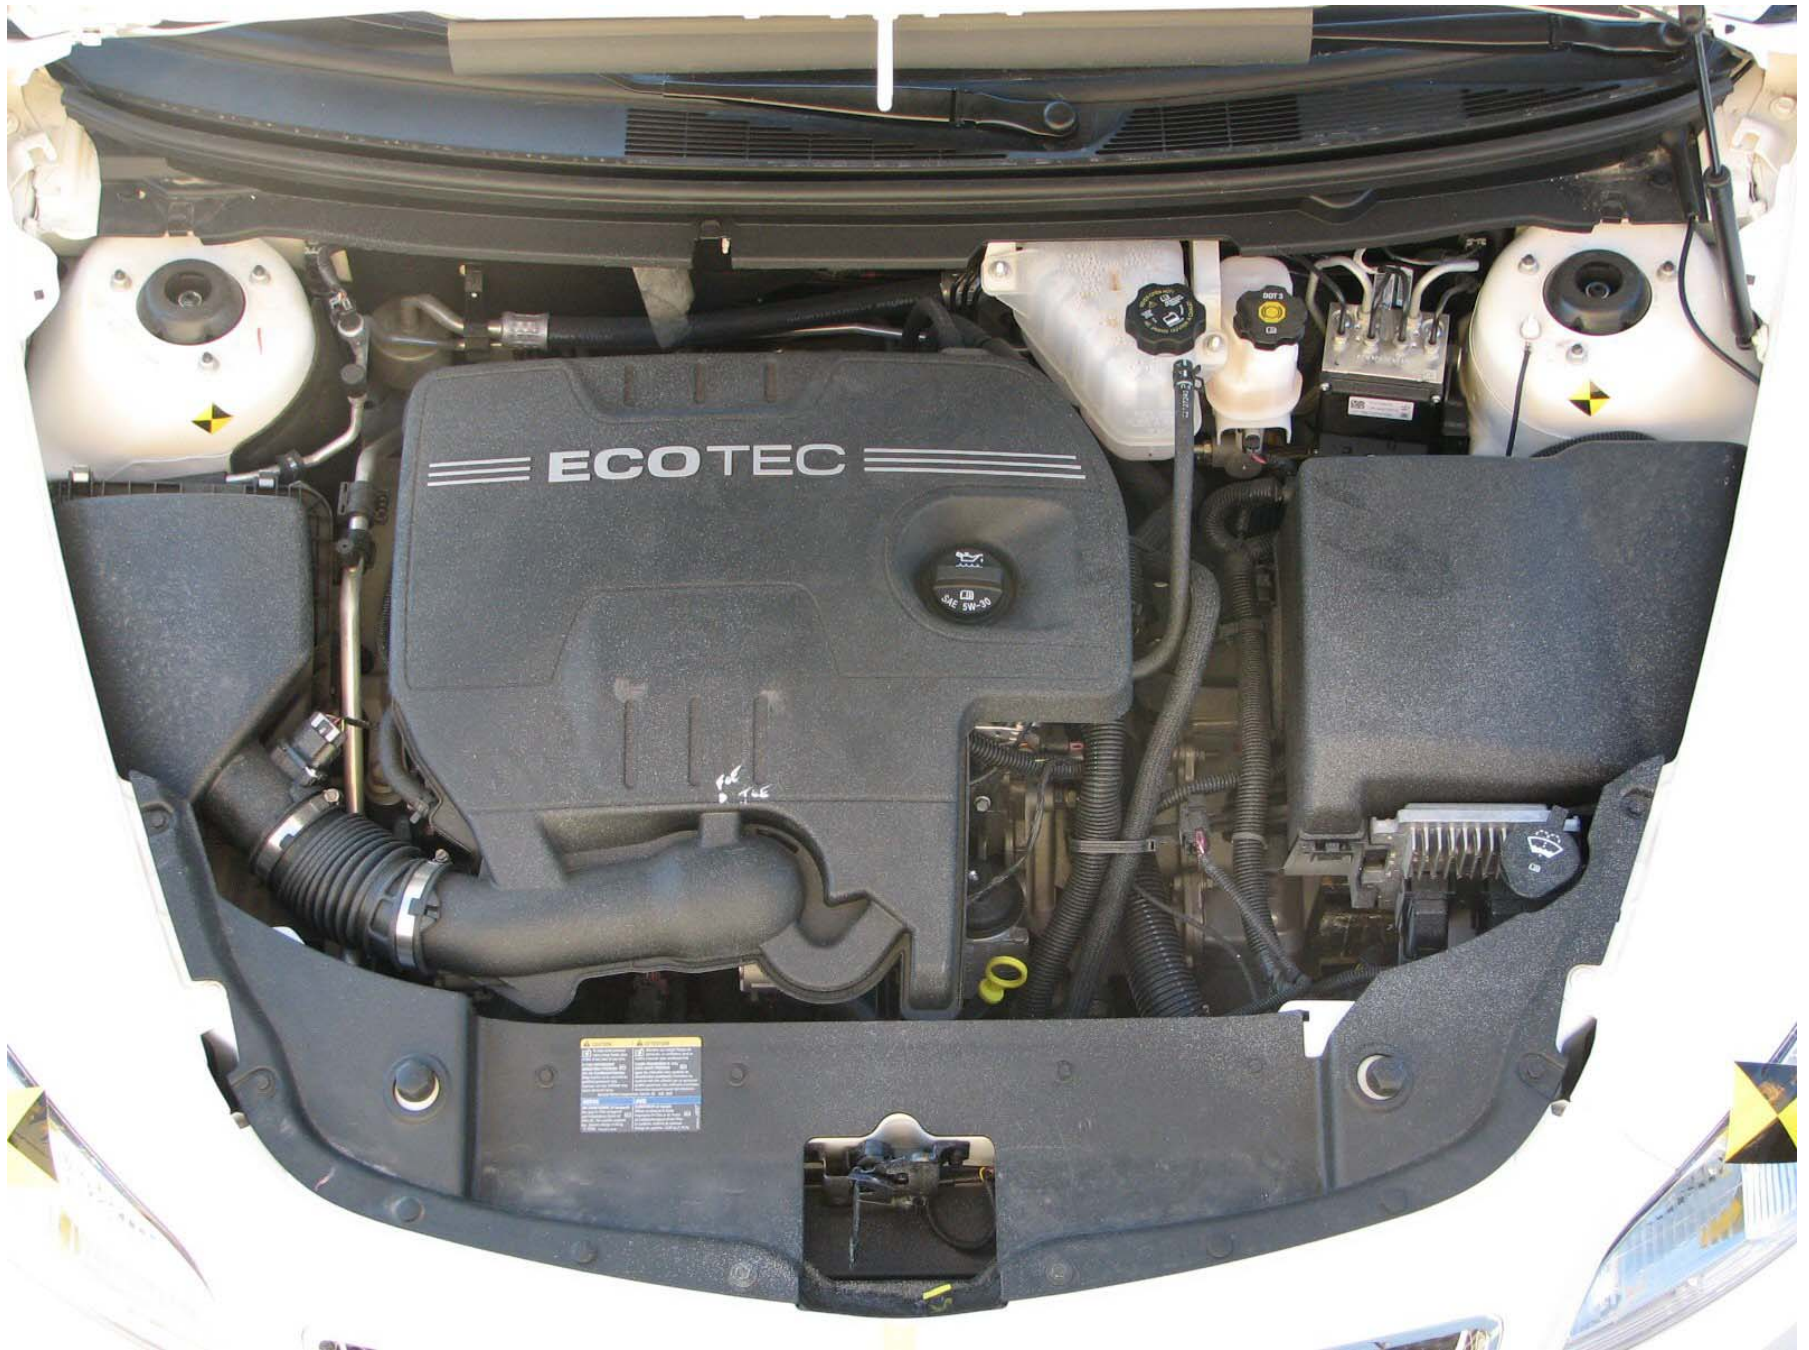
Figure A-20: Pre-Test Engine Compartment

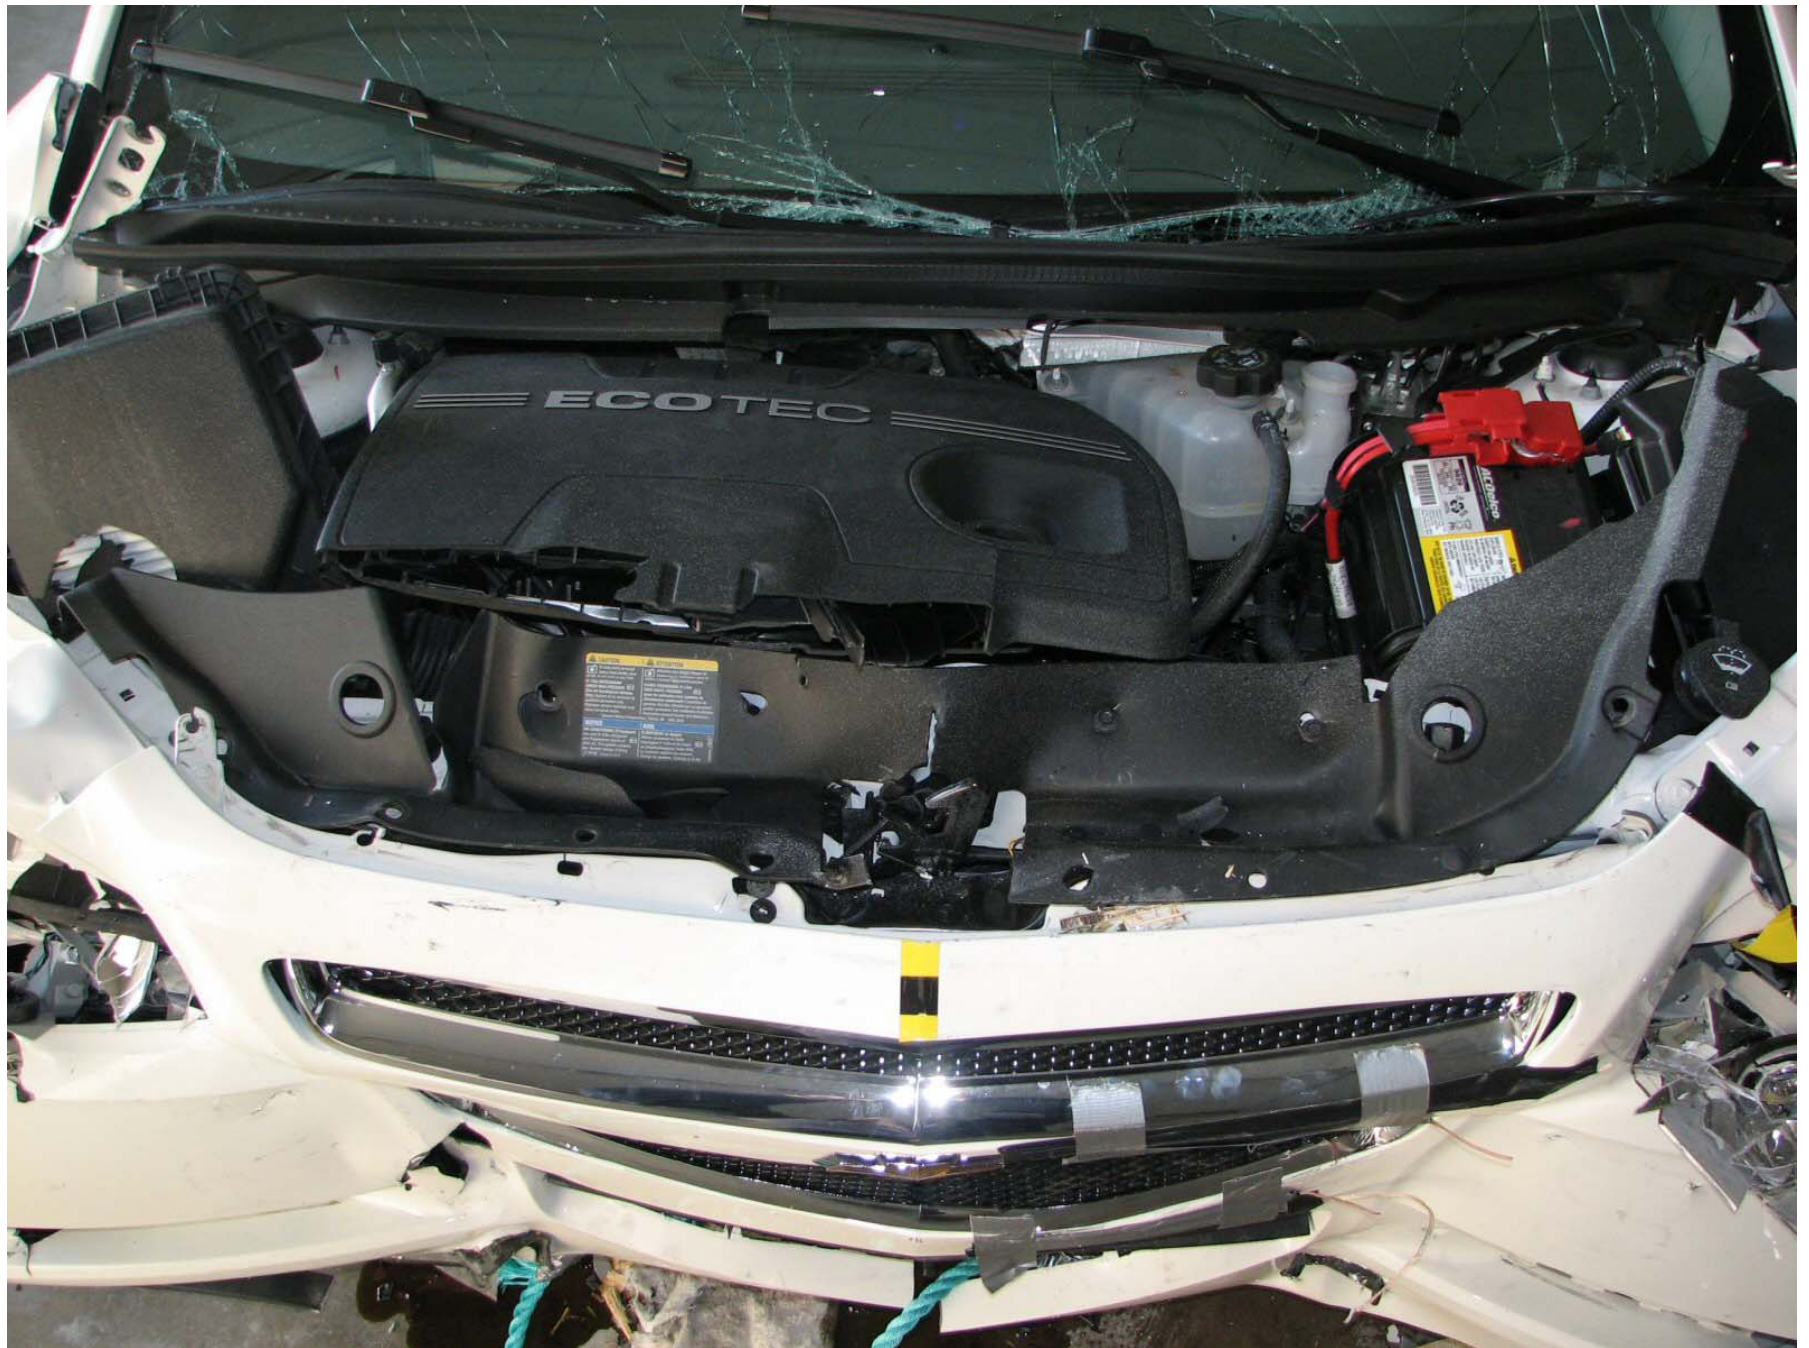
Figure A-21: Post-Test Engine Compartment (Vehicle Moved)

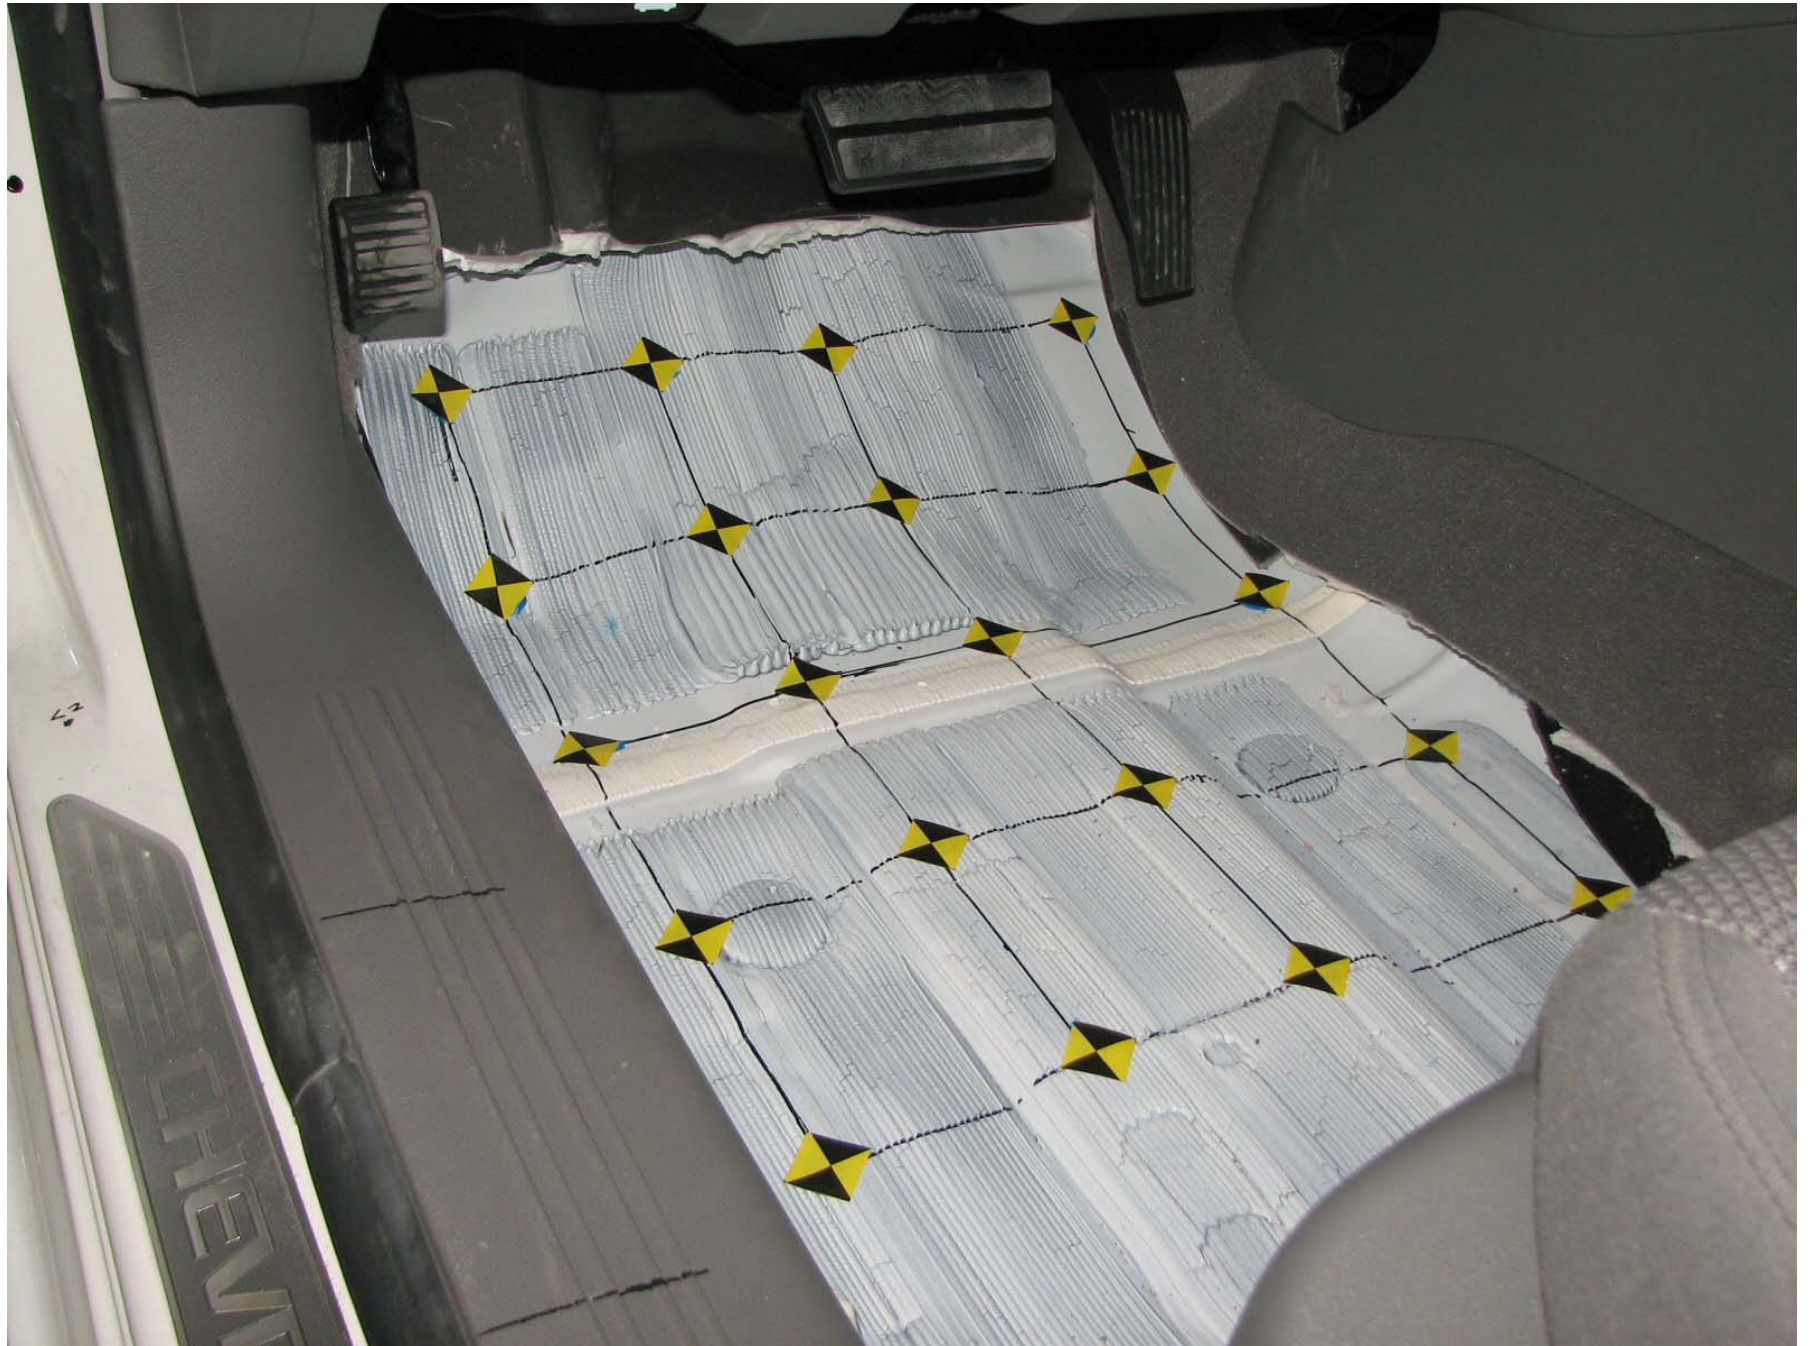
Figure A-40: Pre-Test Driver Side Floor Pan

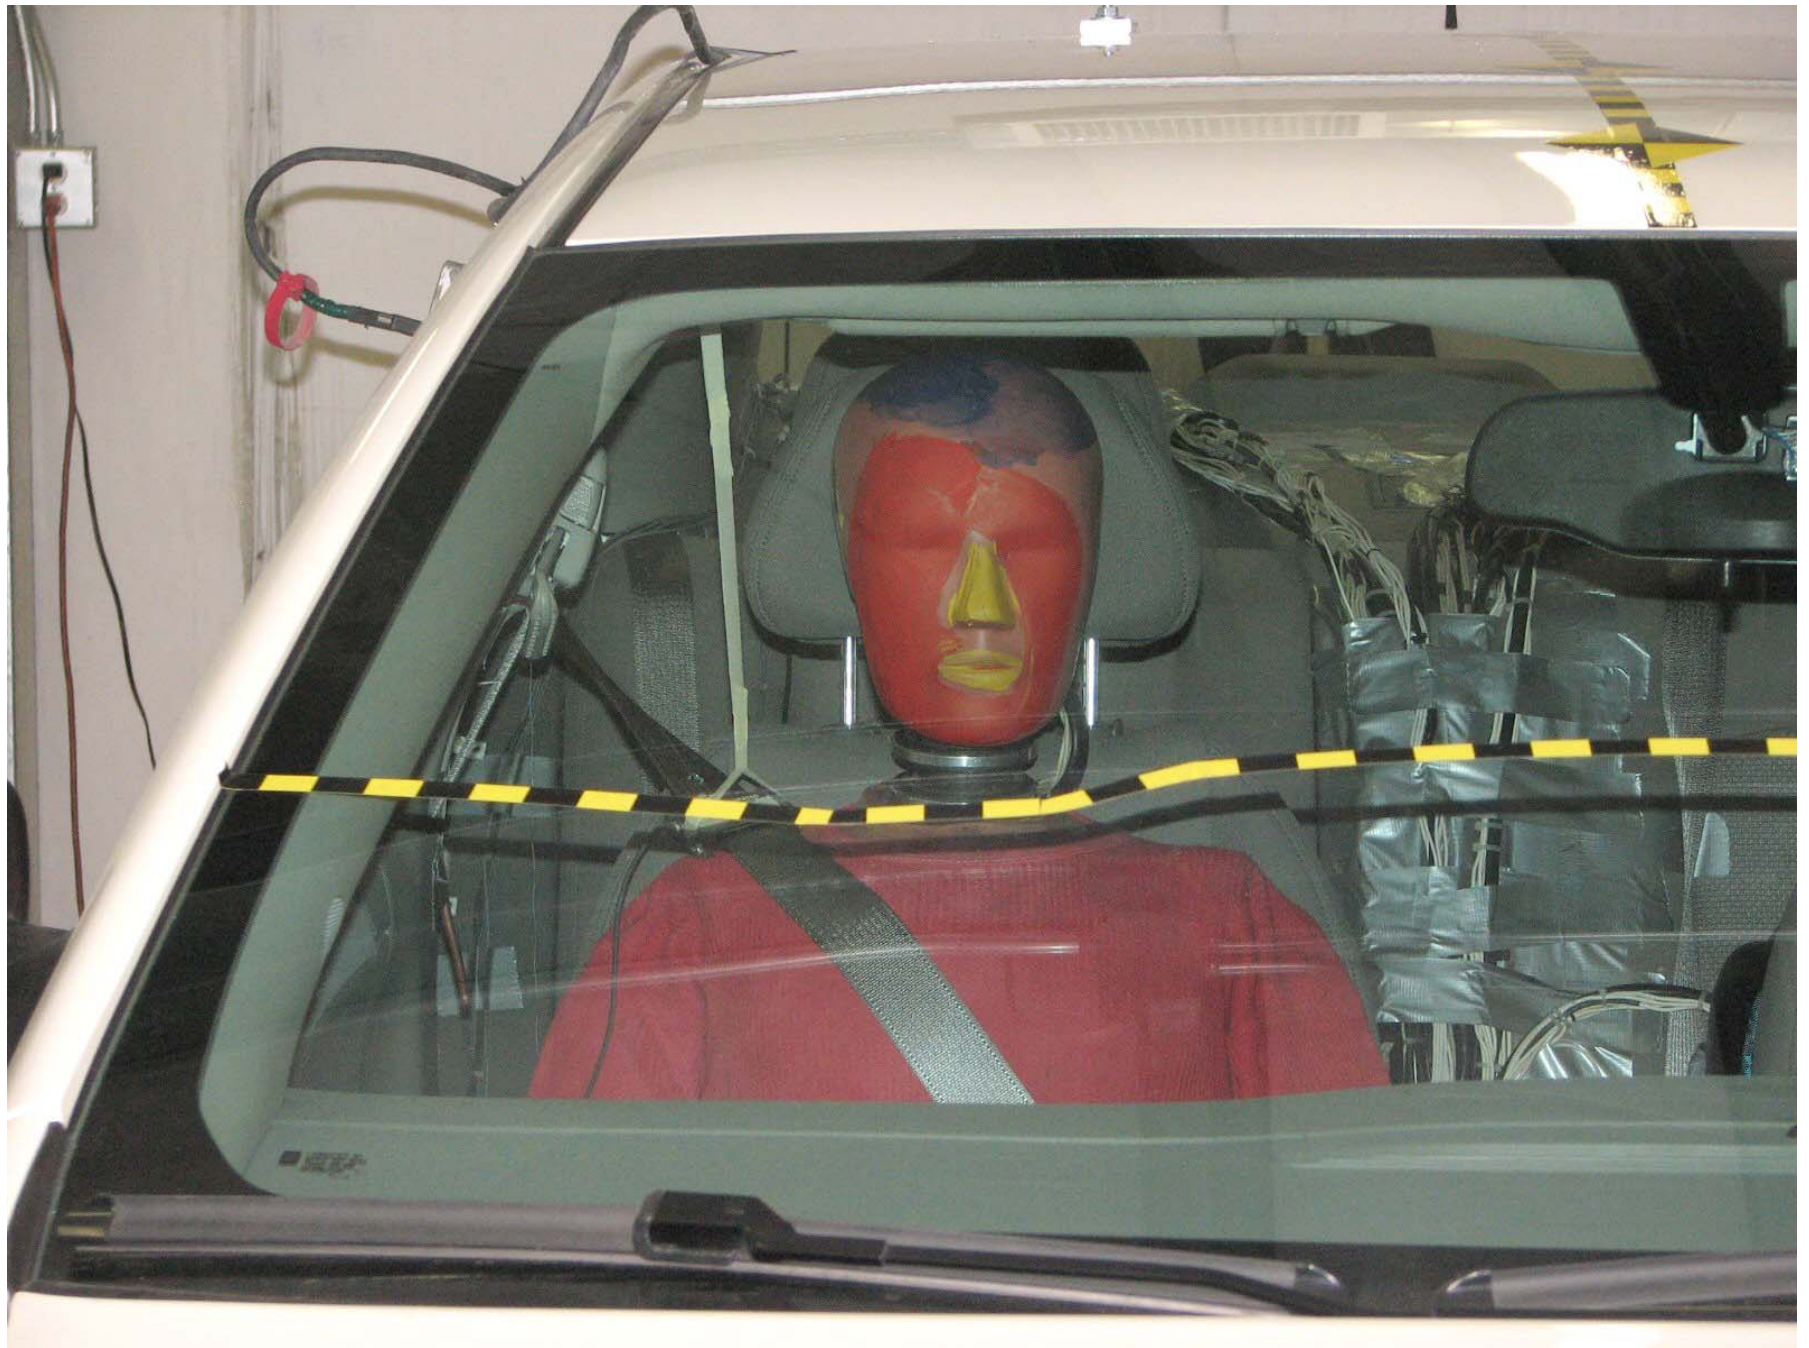
Figure A-44: Pre-Test Passenger Dummy Front View (Head Position)

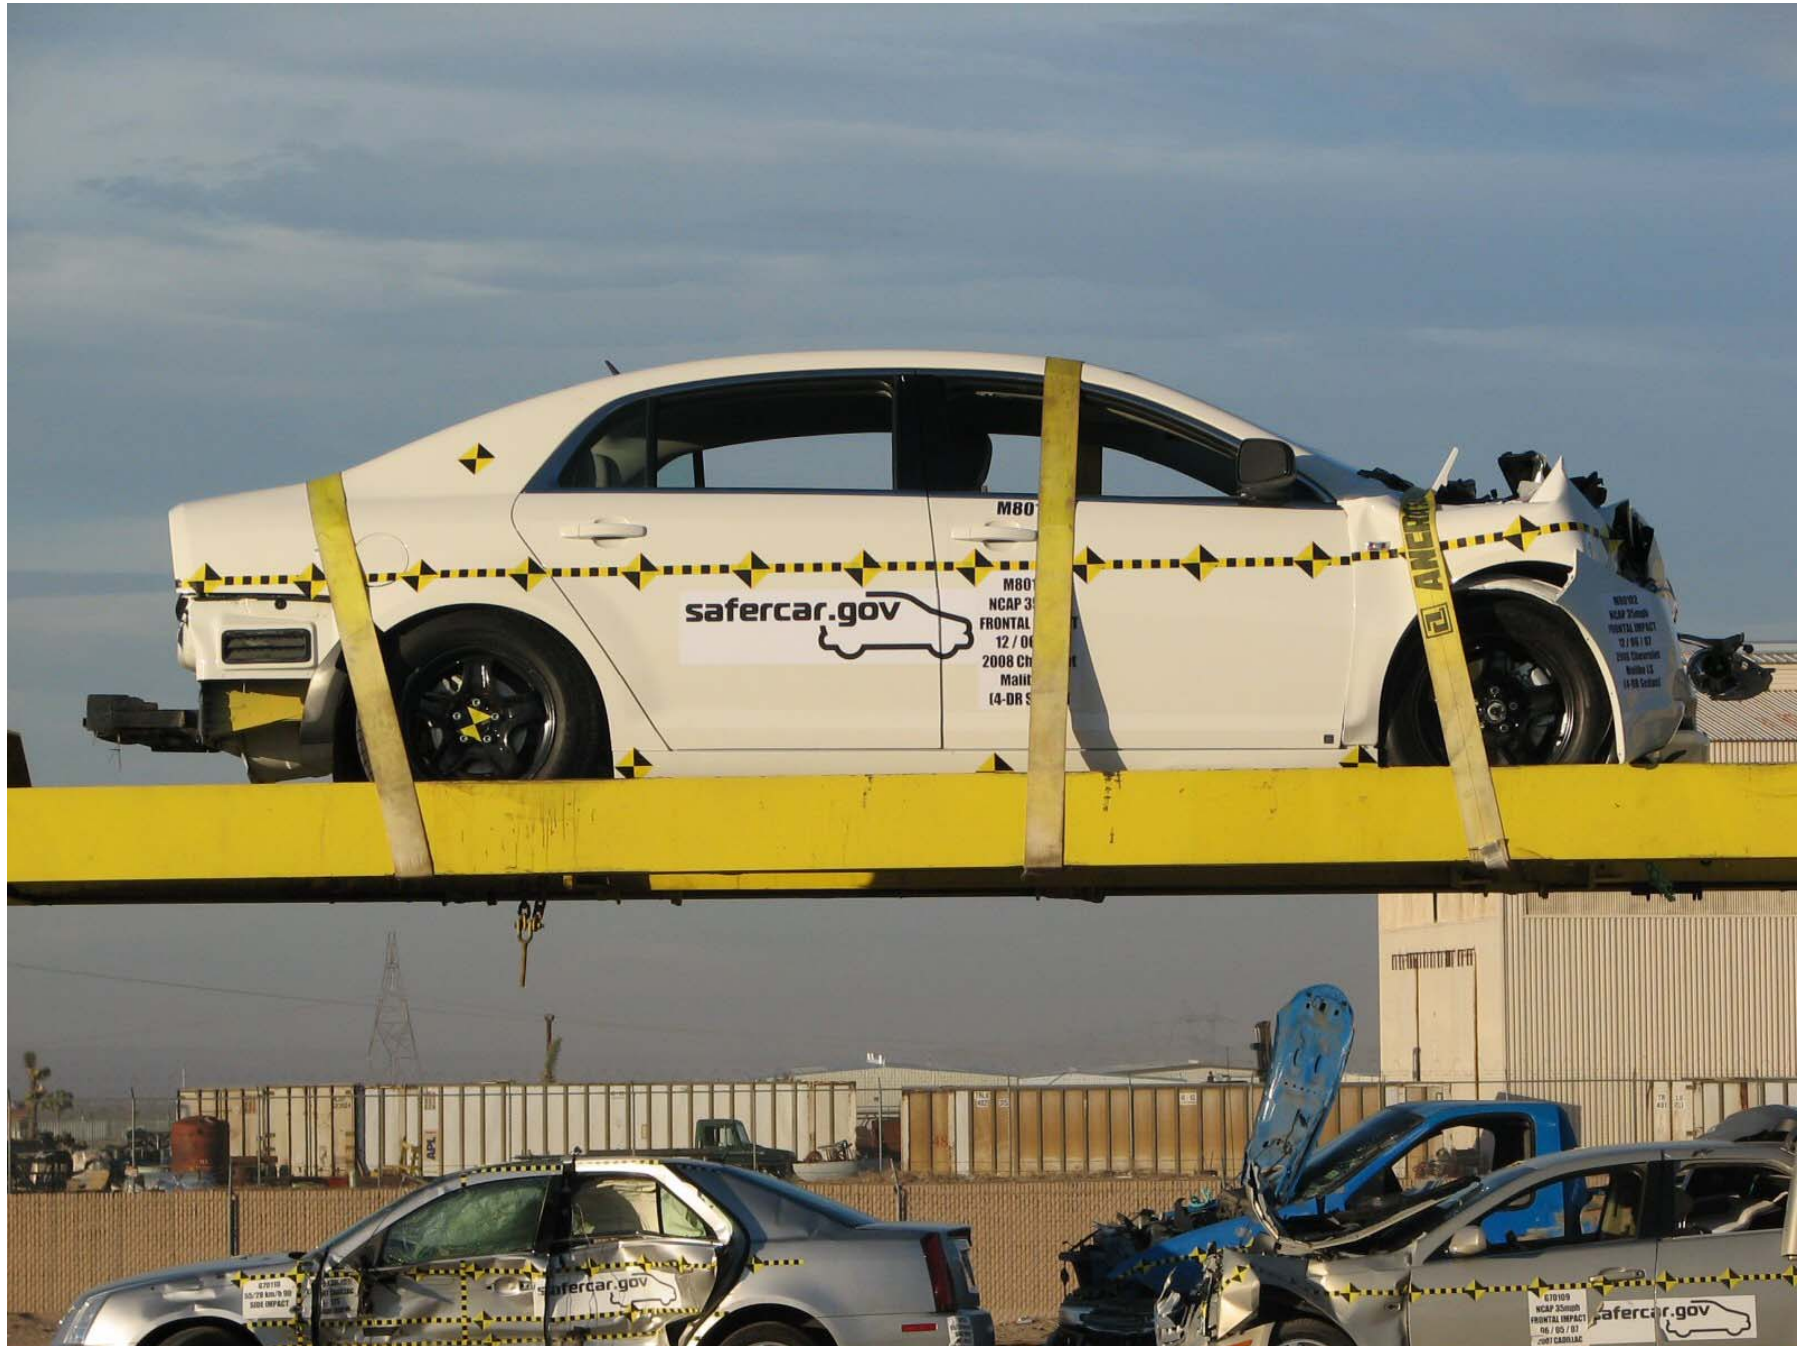
Figure A-58: Vehicle on Rollover Device (0°)

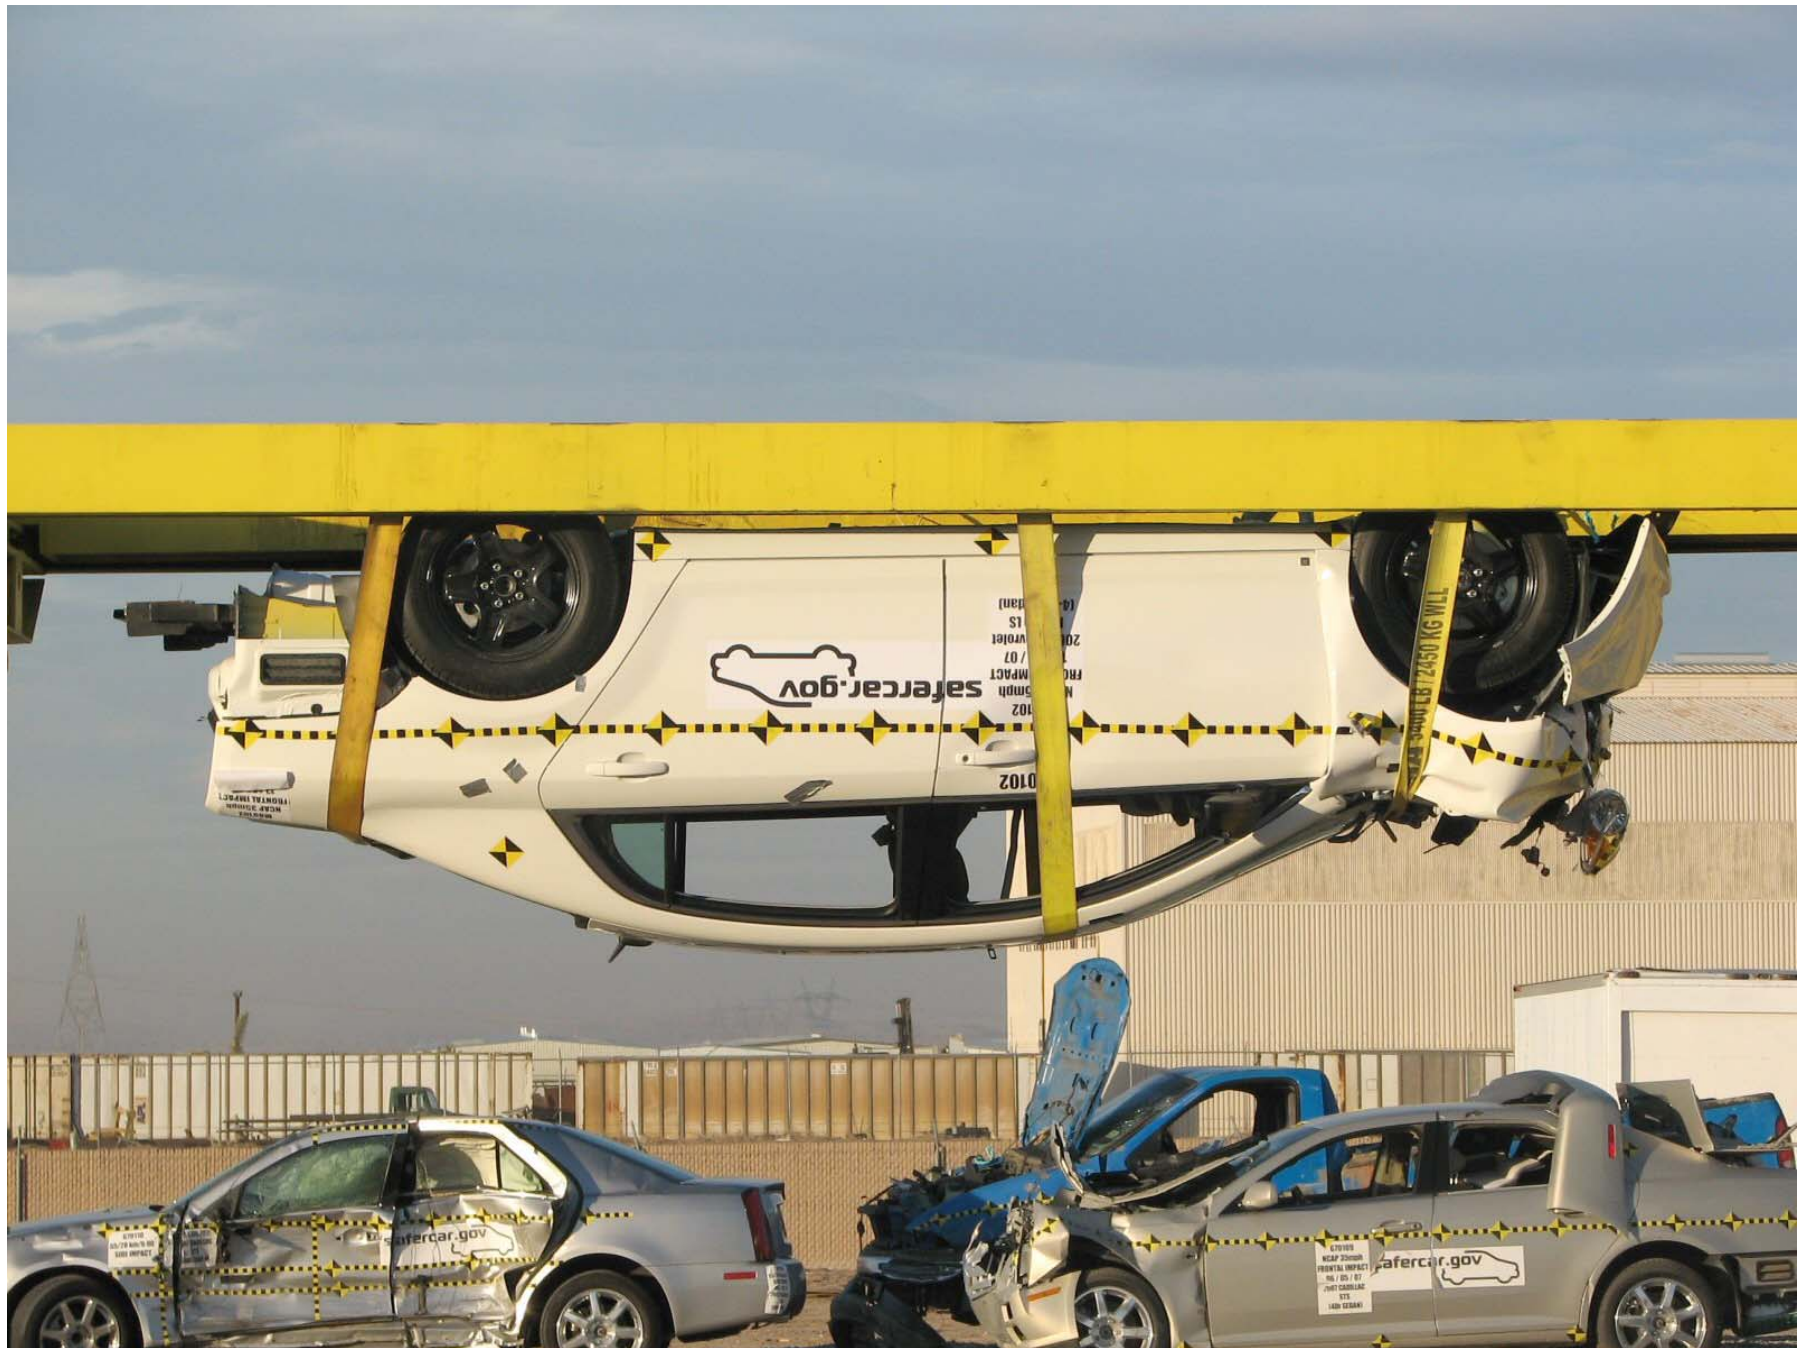
Figure A-60: Vehicle on Rollover Device (180°)
