**REPORT NUMBER: SNCAP-CAL-07-12**

**NEW CAR ASSESSMENT PROGRAM  
SIDE IMPACT TEST**

**FORD MOTOR CO.  
2008 FORD FOCUS  
FOUR DOOR SEDAN**

**NHTSA NUMBER: M80210**

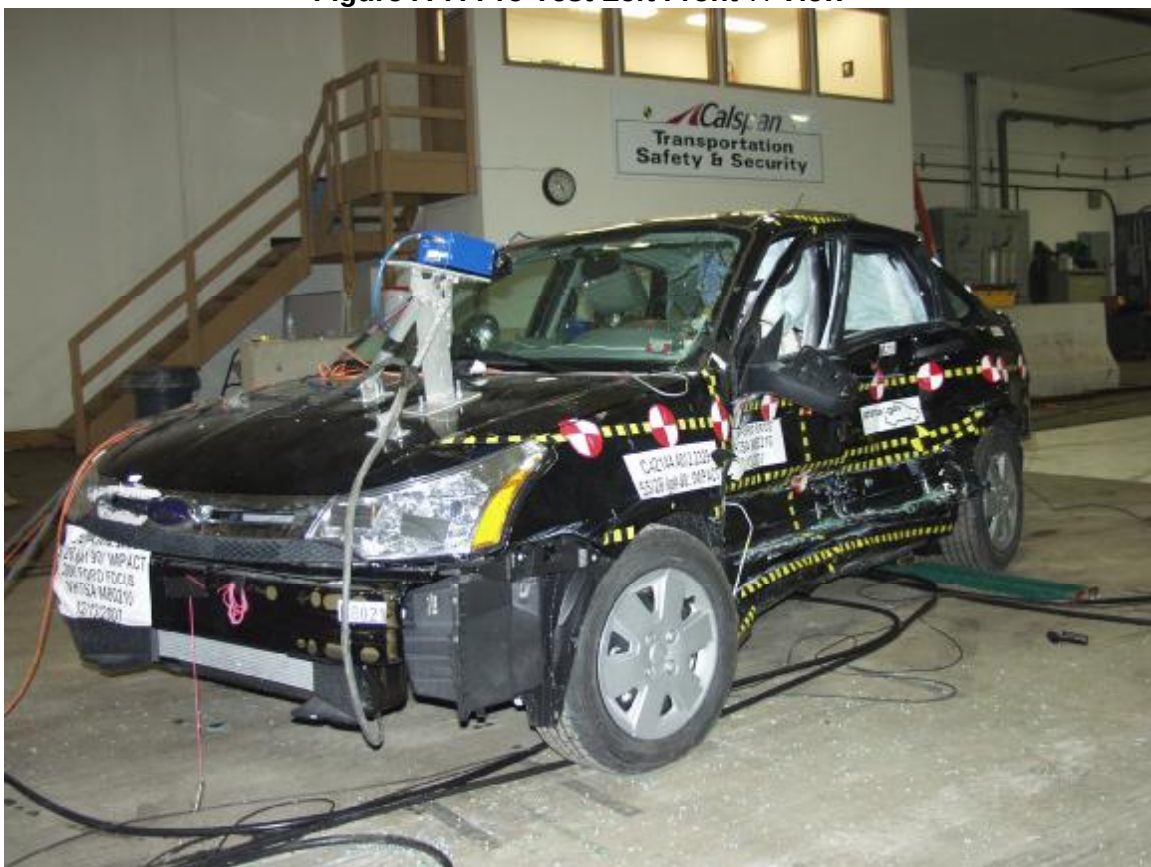
**Figure A-8: Post-Test Left Front  $\frac{3}{4}$  View**

The test vehicle sustained a maximum static crush of 288 mm at level 2, 900 mm rearward of the left vertical impact point. The driver and passenger SID/HII's, Serial Nos. 905 and 906 respectively, were calibrated just prior to this test.

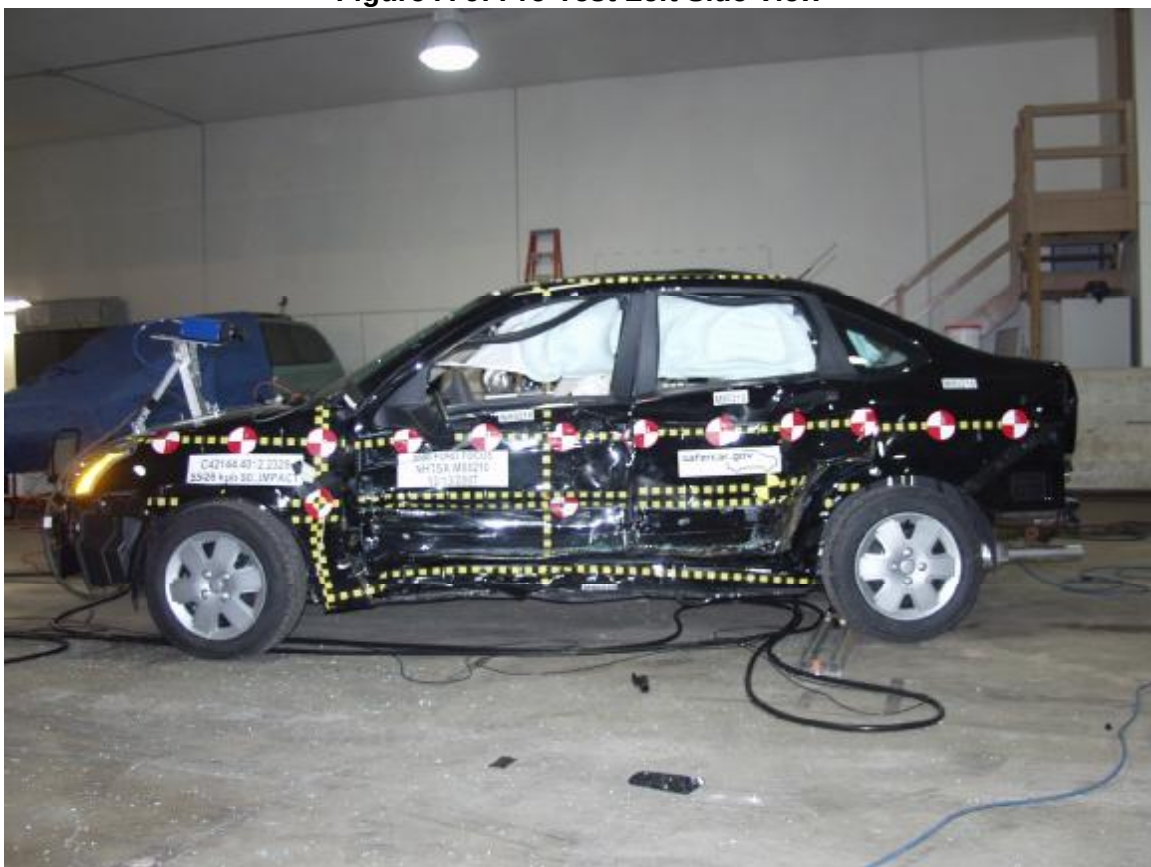
**Figure A-10: Post-Test Left Side View**

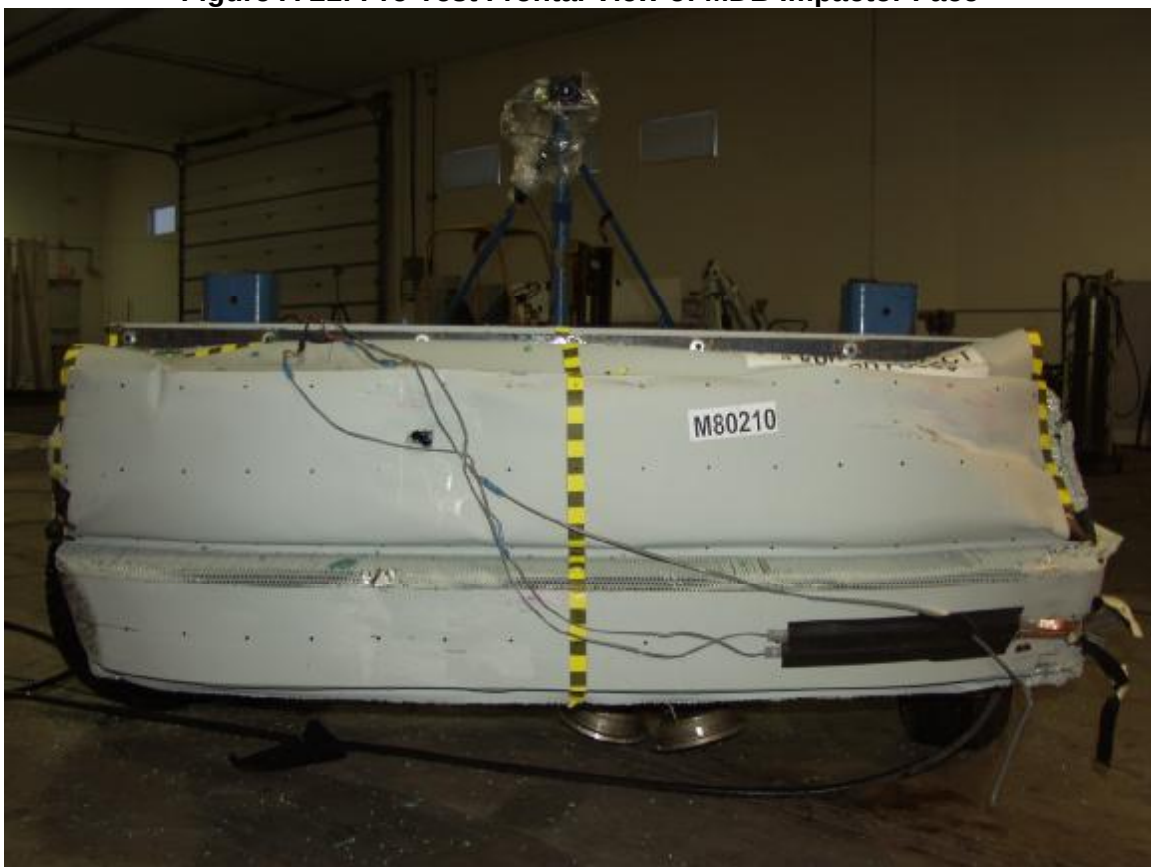
**Figure A-22: Post-Test Frontal View of MDB Impactor Face**

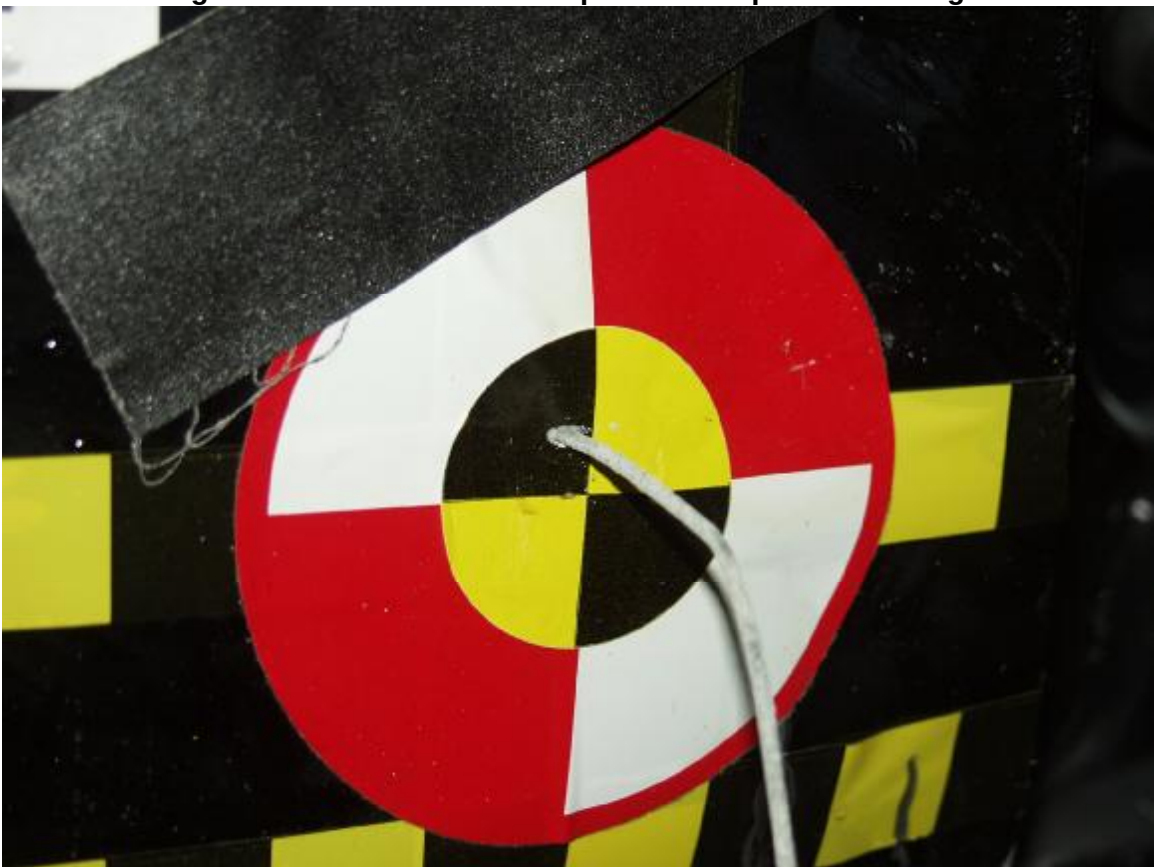
**Figure A-34: Post-Test Close-Up View of Impact Point Target**

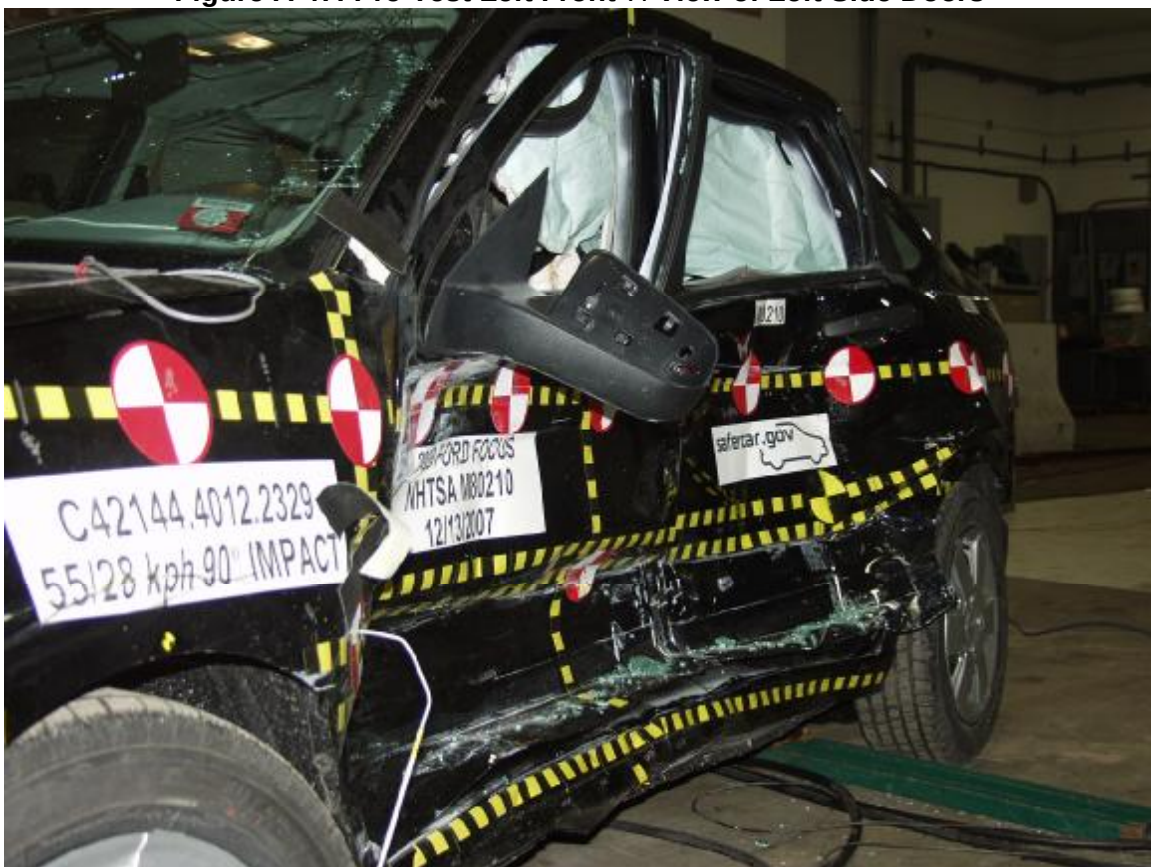
**Figure A-48: Post-Test Left Front ¾ View of Left Side Doors**

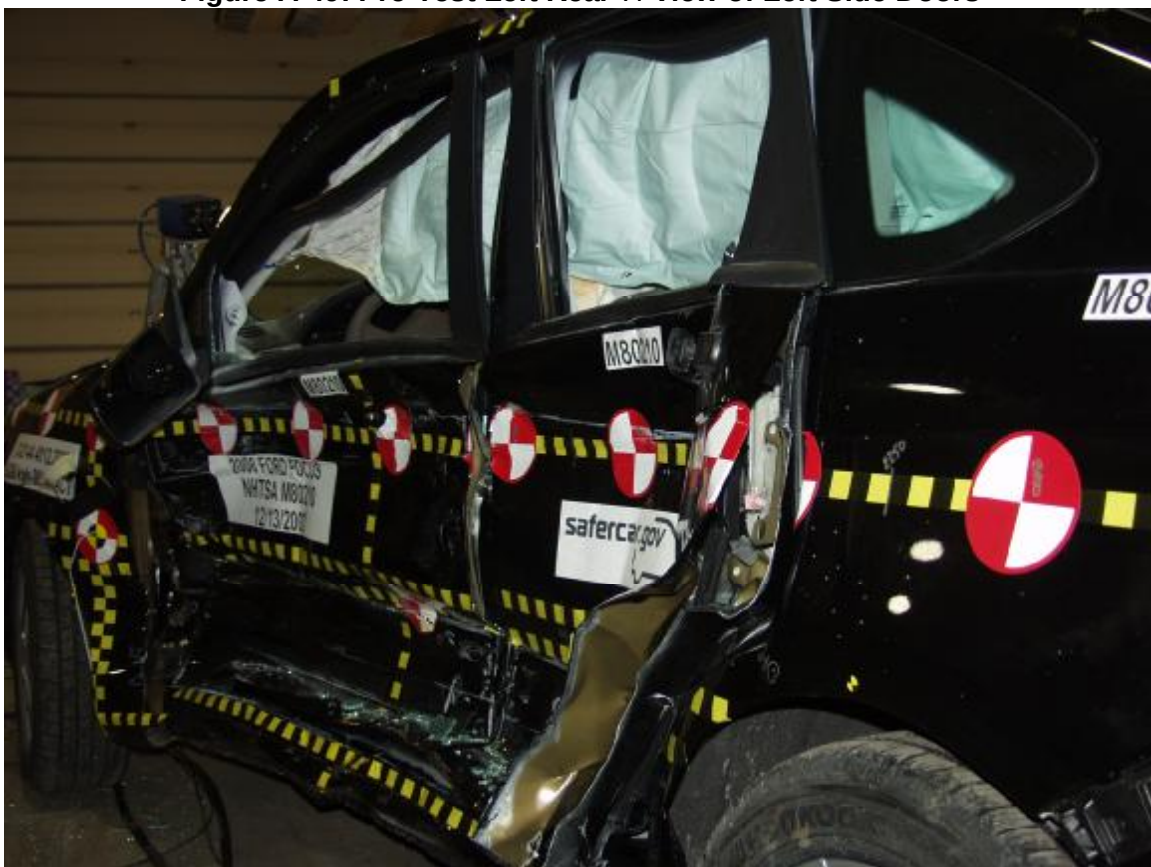
**Figure A-50: Post-Test Left Rear  $\frac{3}{4}$  View of Left Side Doors**
