**REPORT NUMBER: NCAPSIDE-MGA-2008-010**

**NEW CAR ASSESSMENT PROGRAM  
SIDE IMPACT TEST**

**FORD MOTOR COMPANY  
2008 FORD FOCUS 2-DOOR COUPE  
NHTSA NUMBER: M80209**

**PREPARED BY:  
MGA RESEARCH CORPORATION  
5000 WARREN ROAD  
BURLINGTON, WI 53105**

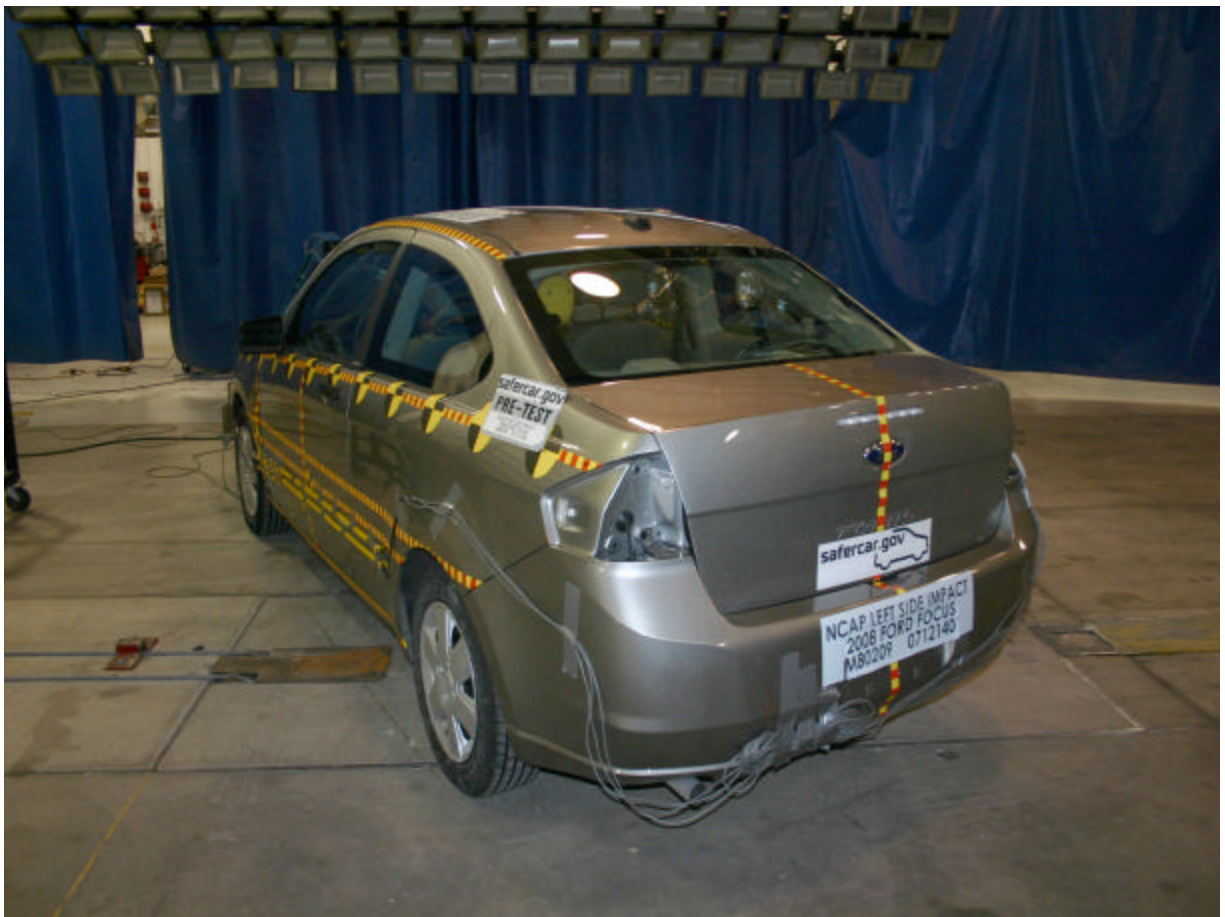
Post-Test Left Side View

The test vehicle sustained a maximum static crush of 331 mm at level 2, 1500 mm rearward of the vertical impact point. The driver and passenger SID/HIIIs, Serial Nos. 904 and 271 respectively, were calibrated just prior to this test.

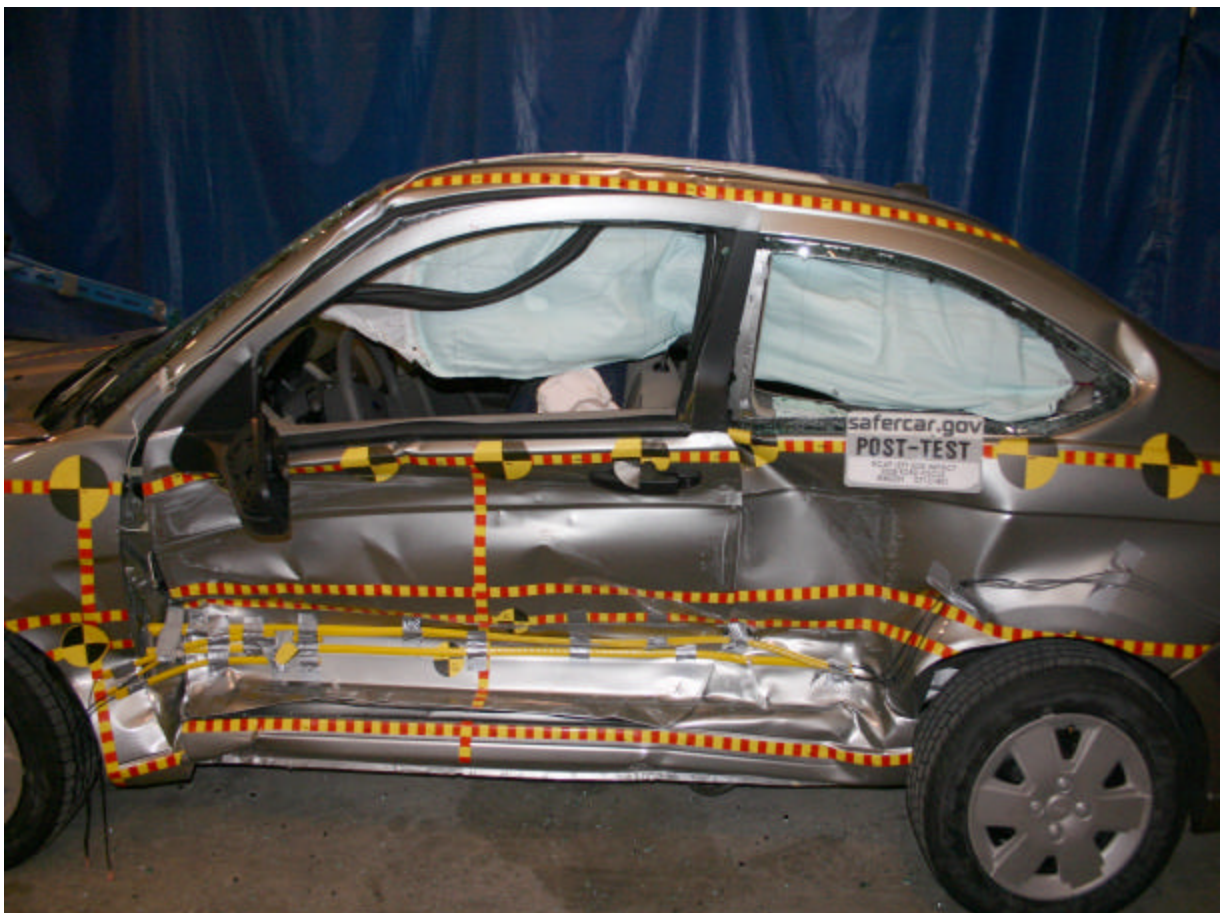
Post-Test Left Side Impact Close-up

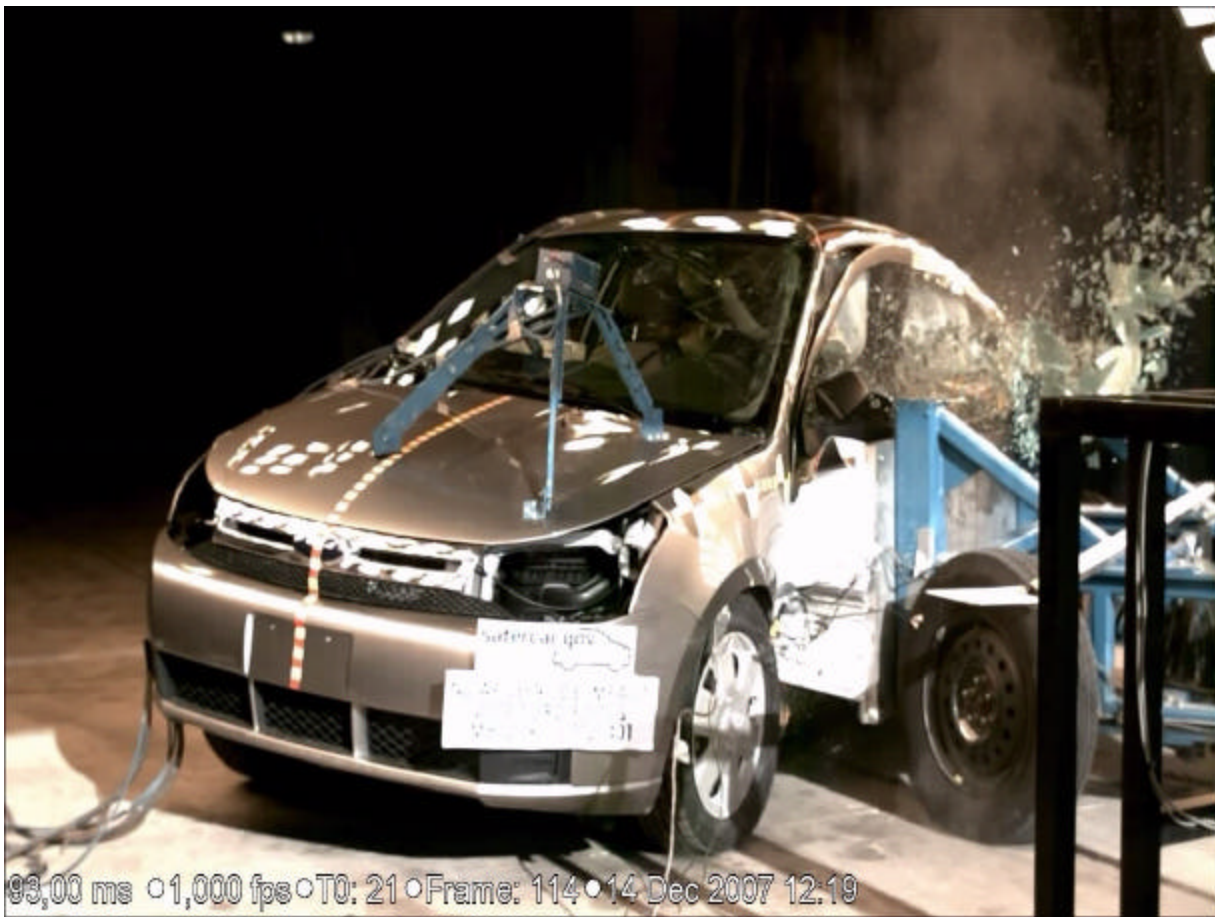
Vehicle Impact

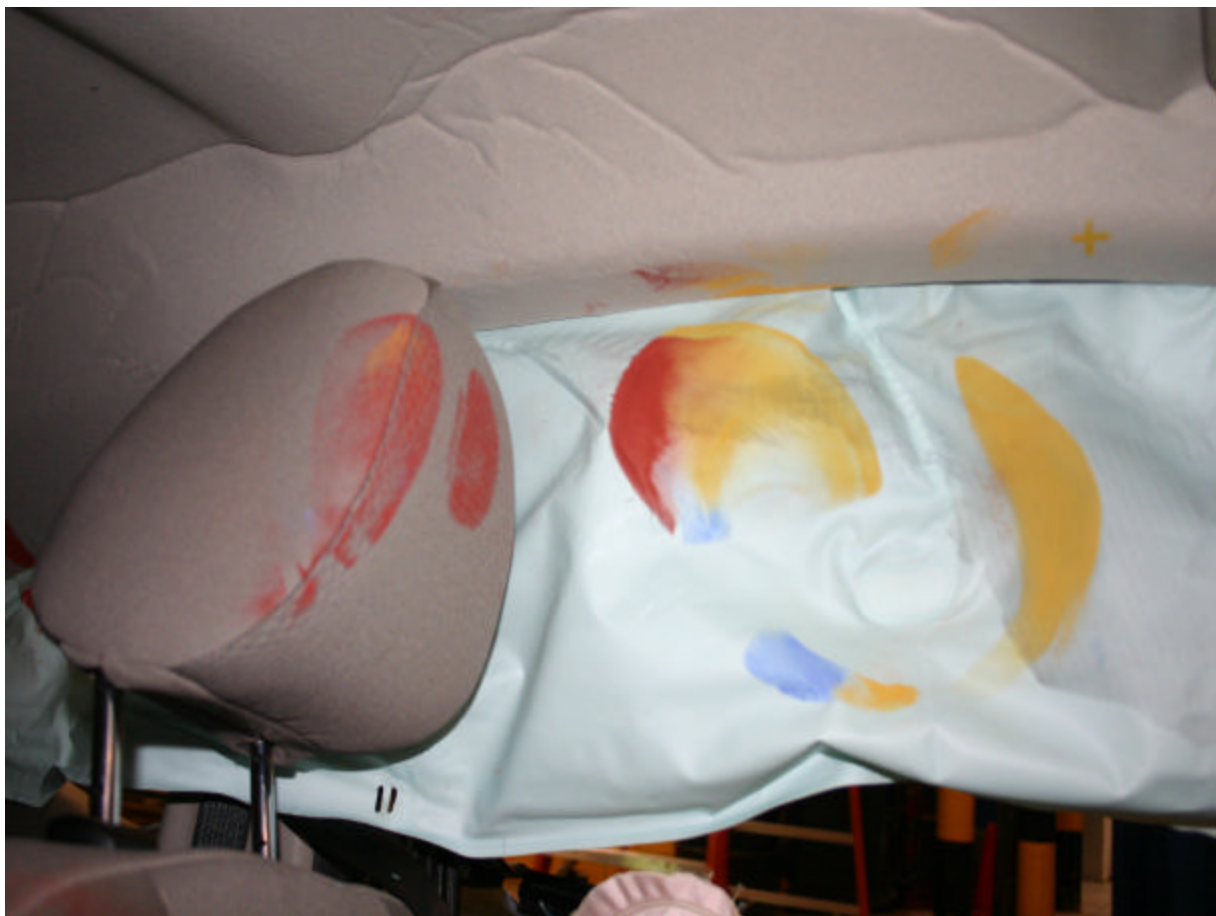
Post-Test Driver Dummy Head Contact

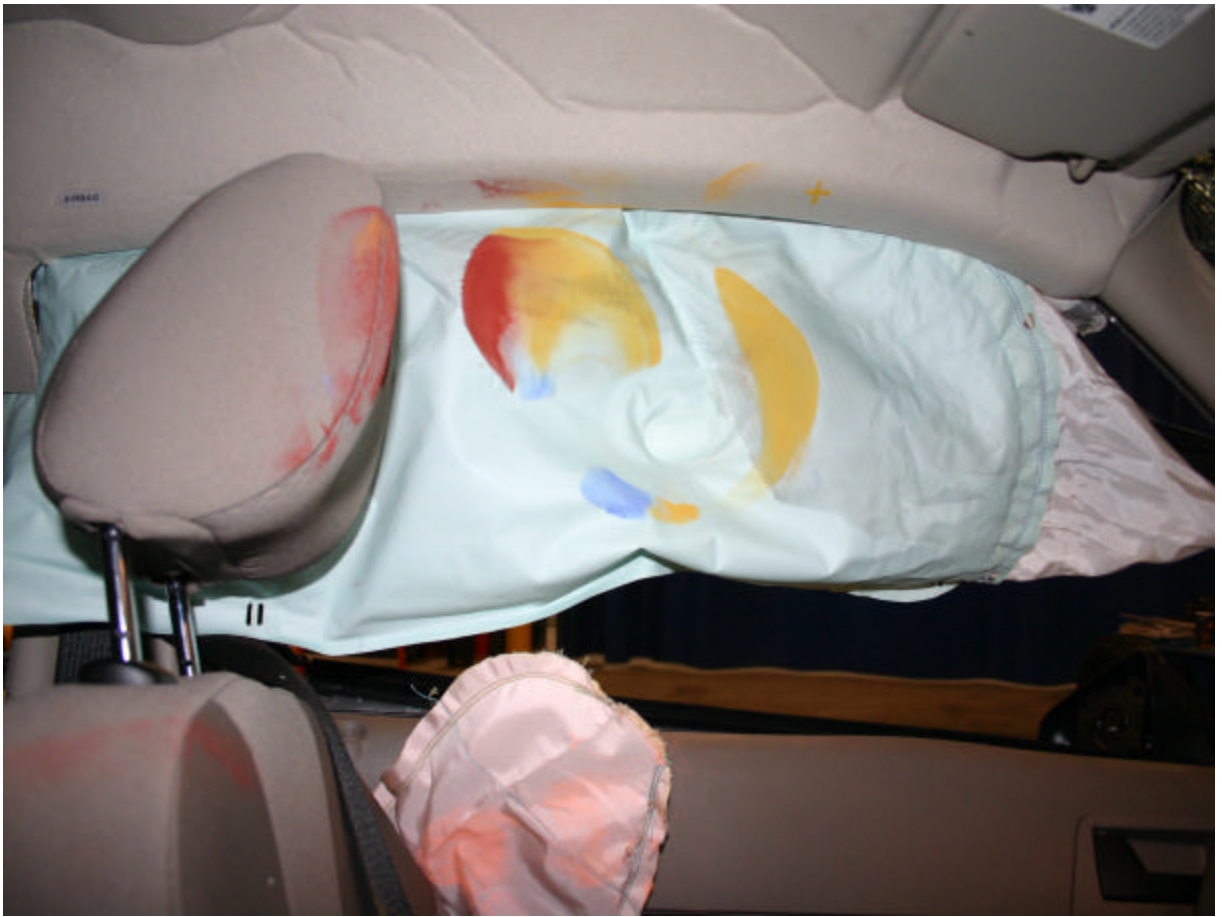
Post-Test Driver Dummy Upper Torso Contact

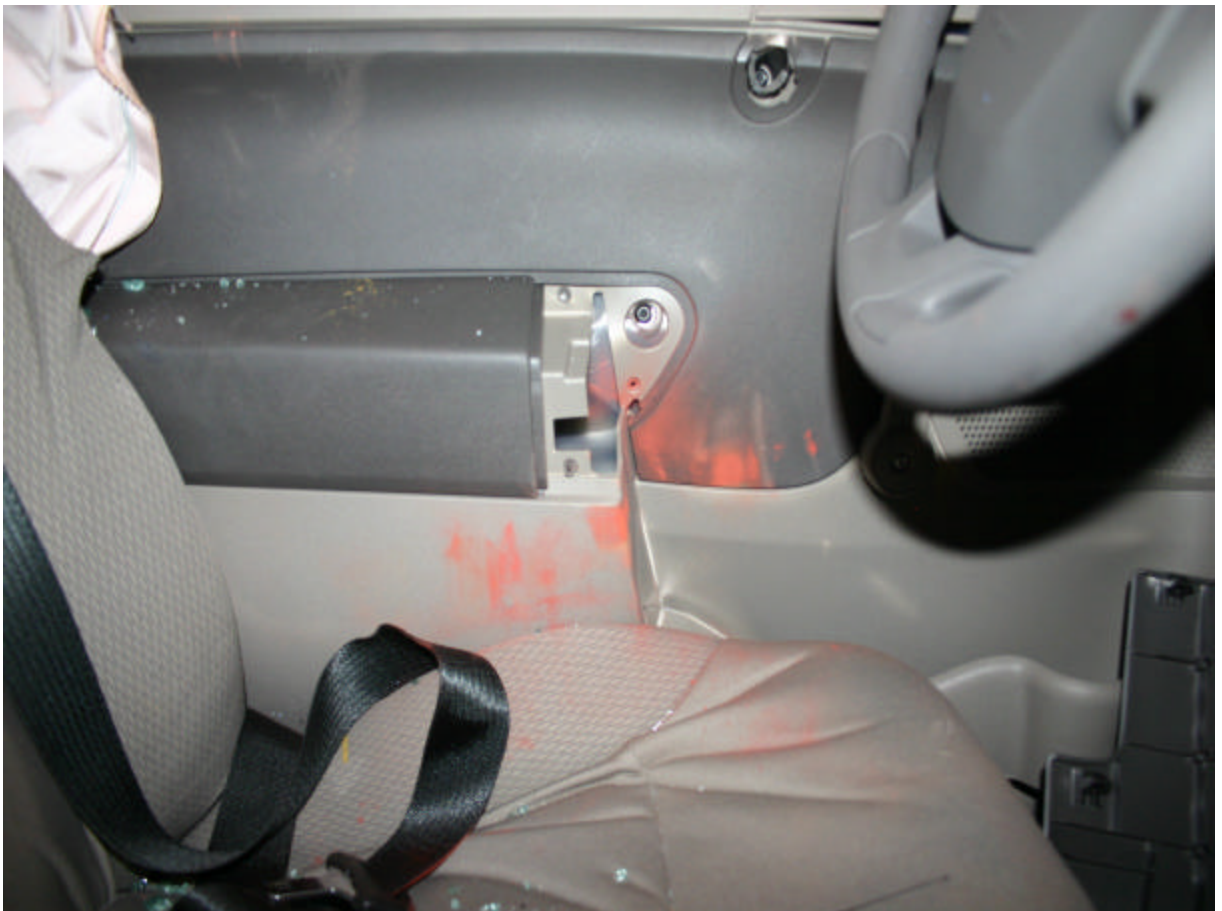
Post-Test Driver Dummy Lower Torso Contact
