REPORT NUMBER TR-P28001-15-NC

**NEW CAR ASSESMENT PROGRAM
FRONTAL BARRIER IMPACT TEST**

**GENERAL MOTORS CORP.
2008 CADILLAC CTS
4-DOOR SEDAN**

NHTSA NUMBER: M80105

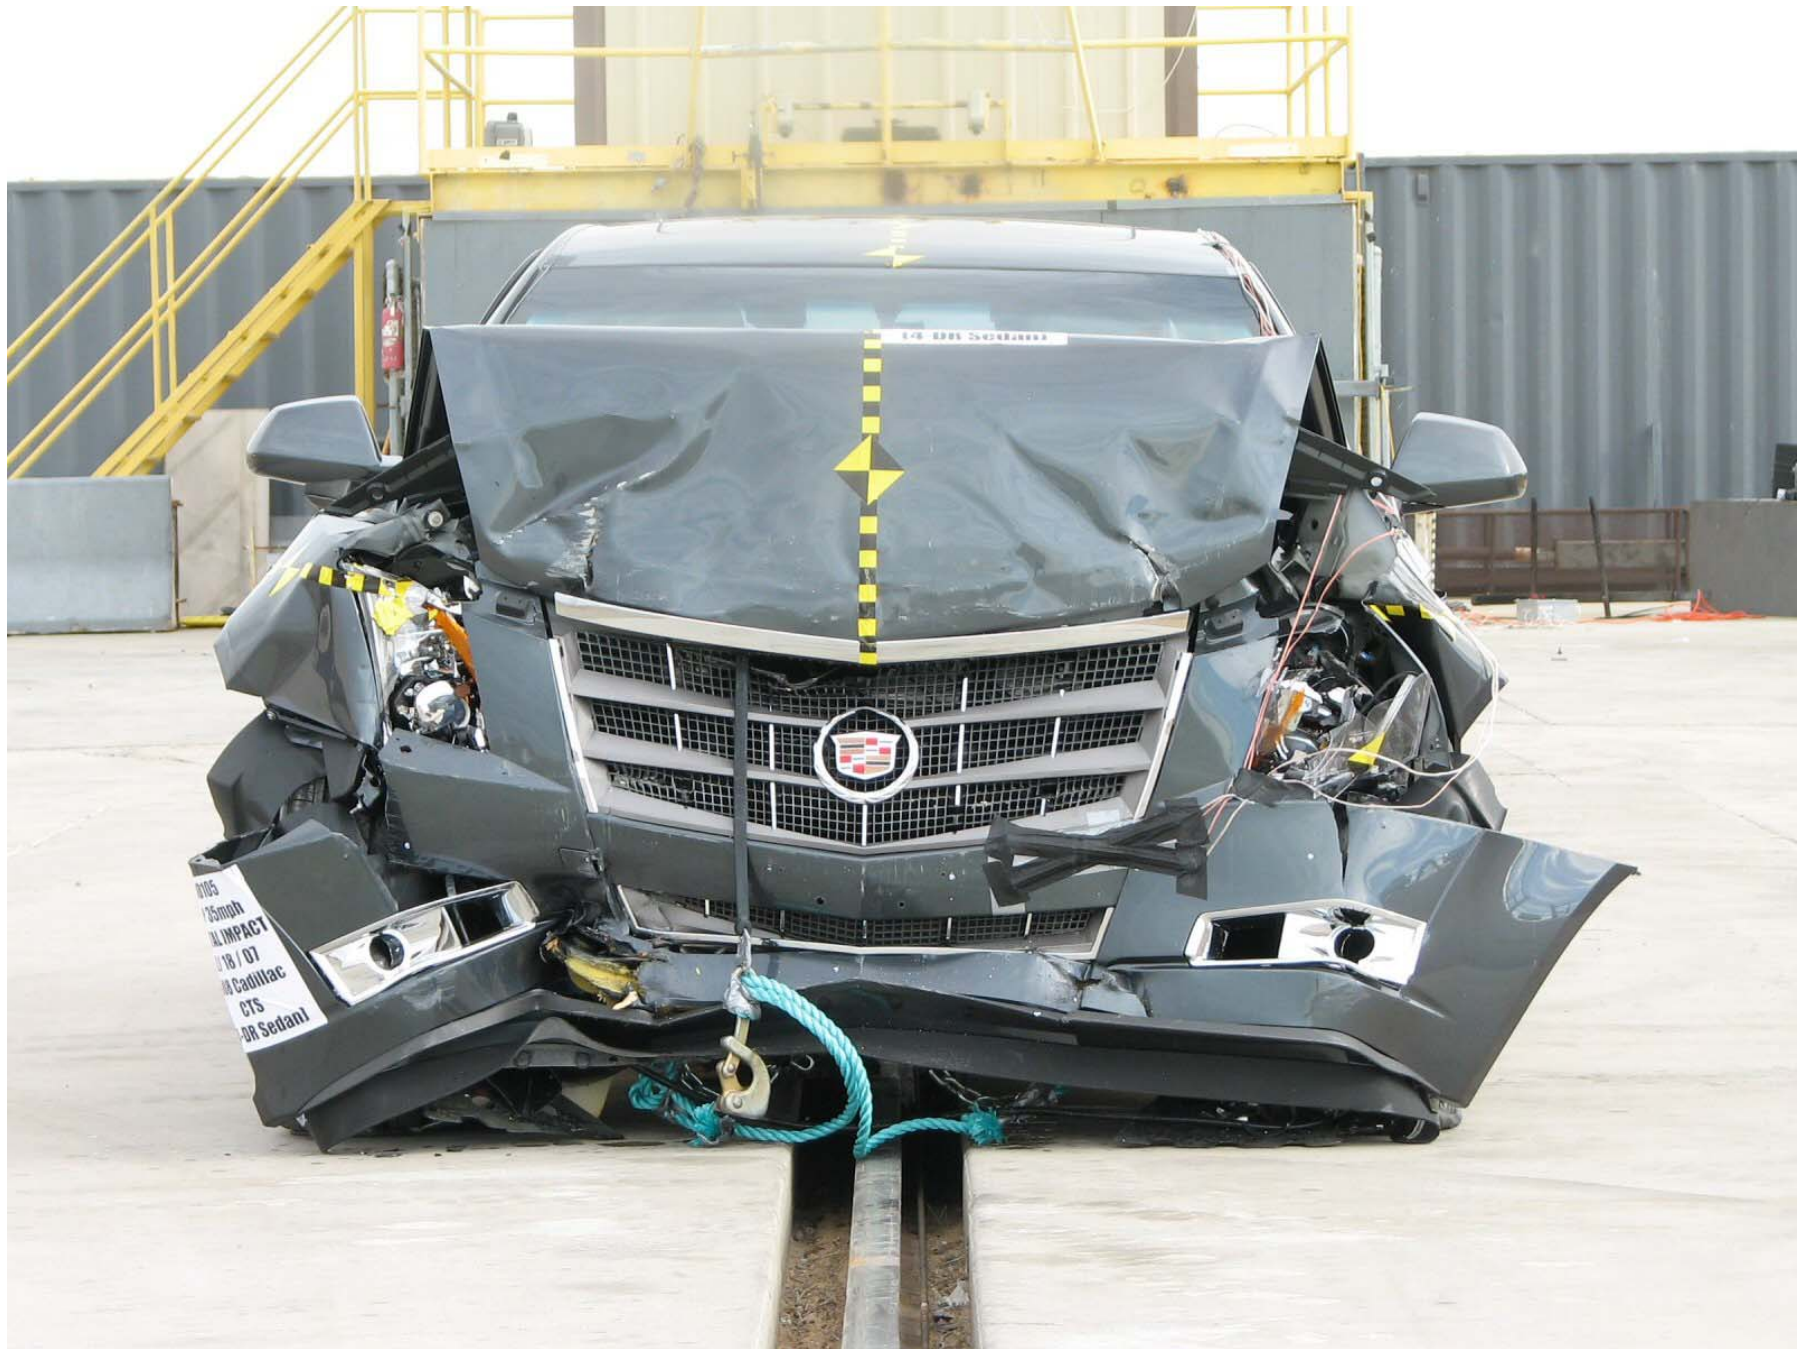
Figure A-7: Post-Test Front View (Vehicle Moved)

The maximum static crush of the vehicle was 477 mm at DPD 5, to the right of the vehicle's centerline. Both the driver and passenger side doors remained closed and latched during the impact event, and were operable after the impact.

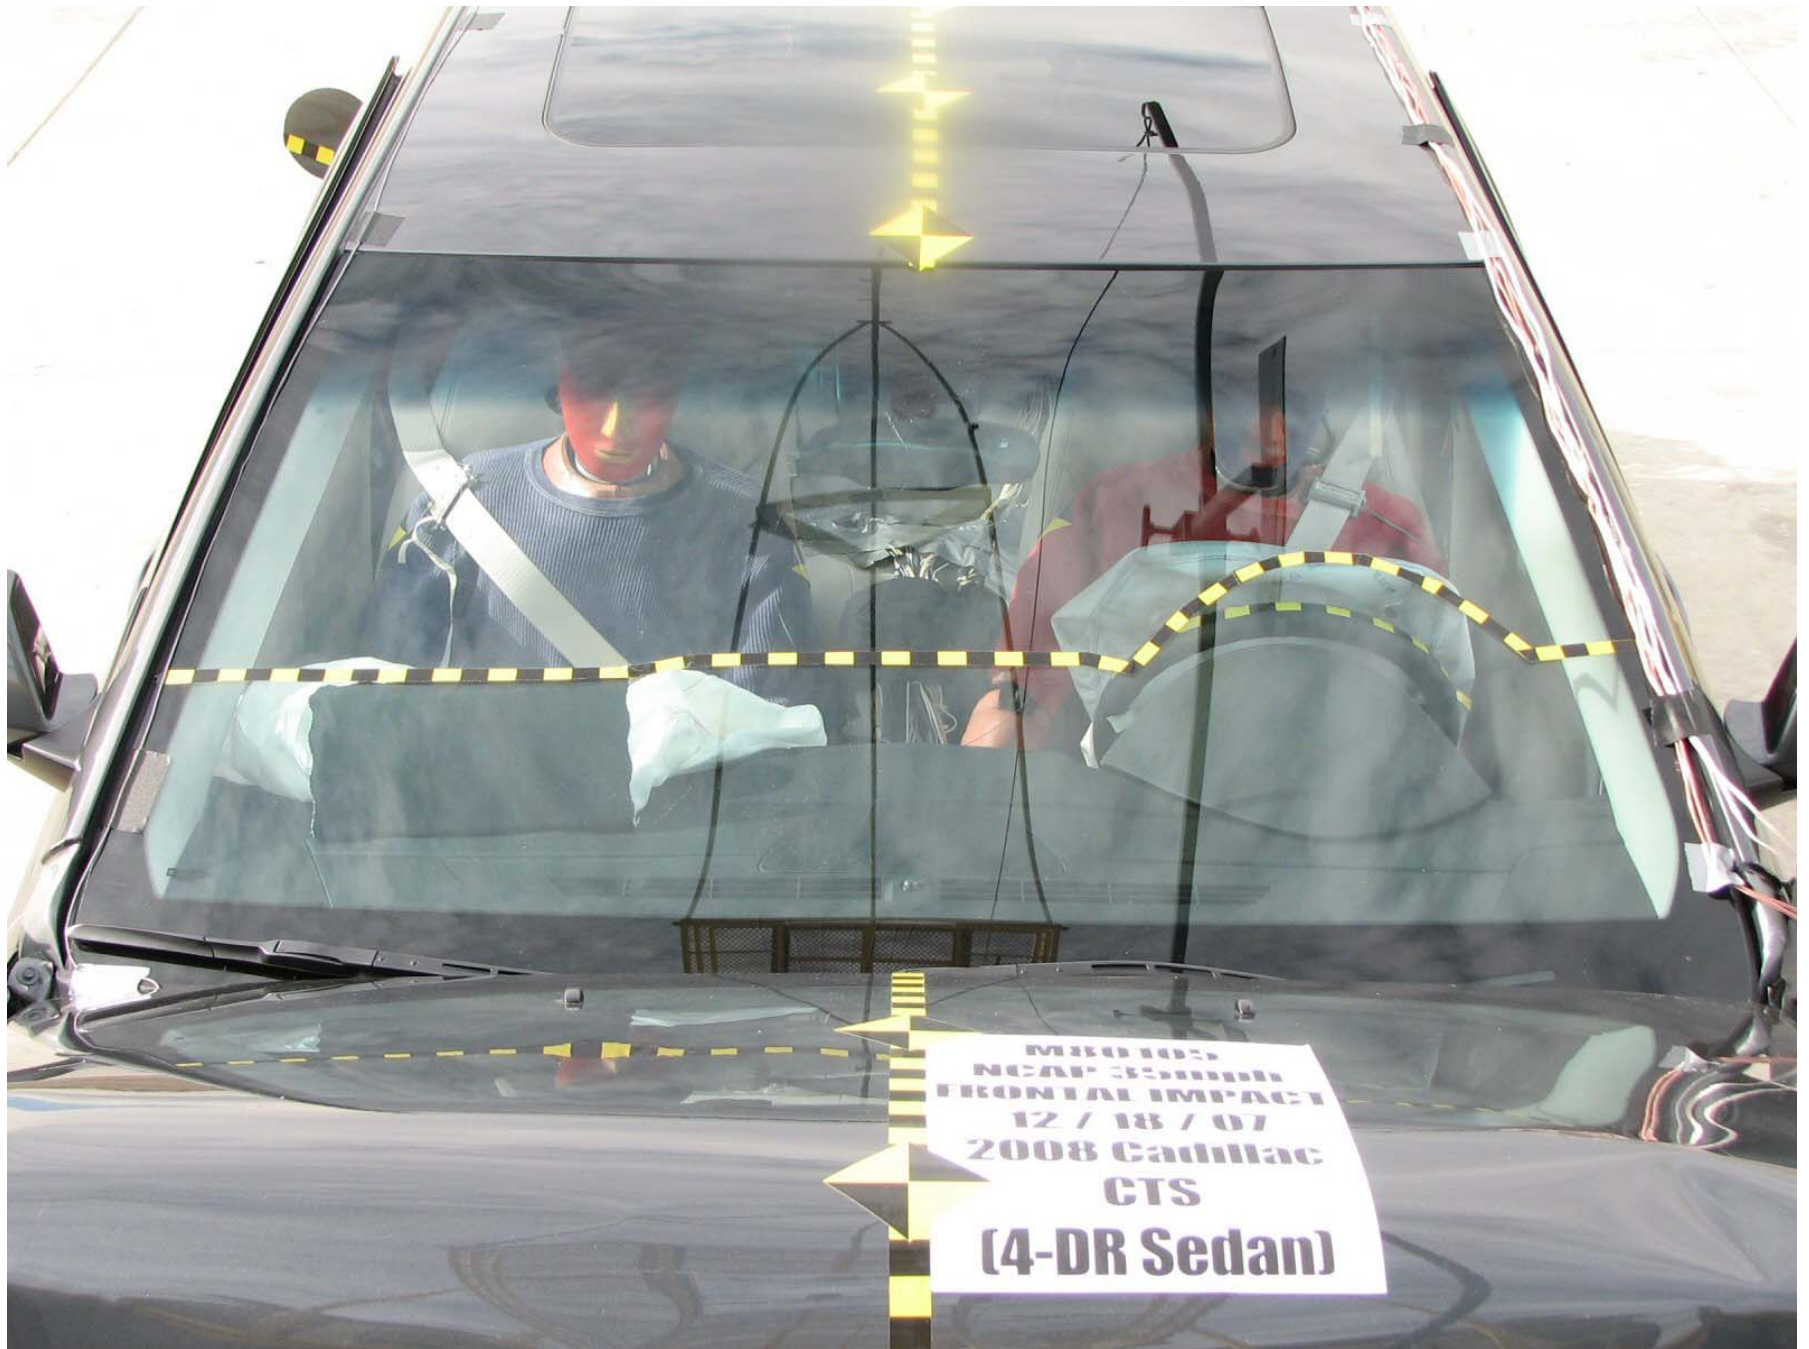
Figure A-19: Post-Test Windshield

There was 100% windshield retention and no intrusion into the protected zone of the windshield during impact.. There was no Stoddard solvent leakage after the event, or during any phase of the static rollover.

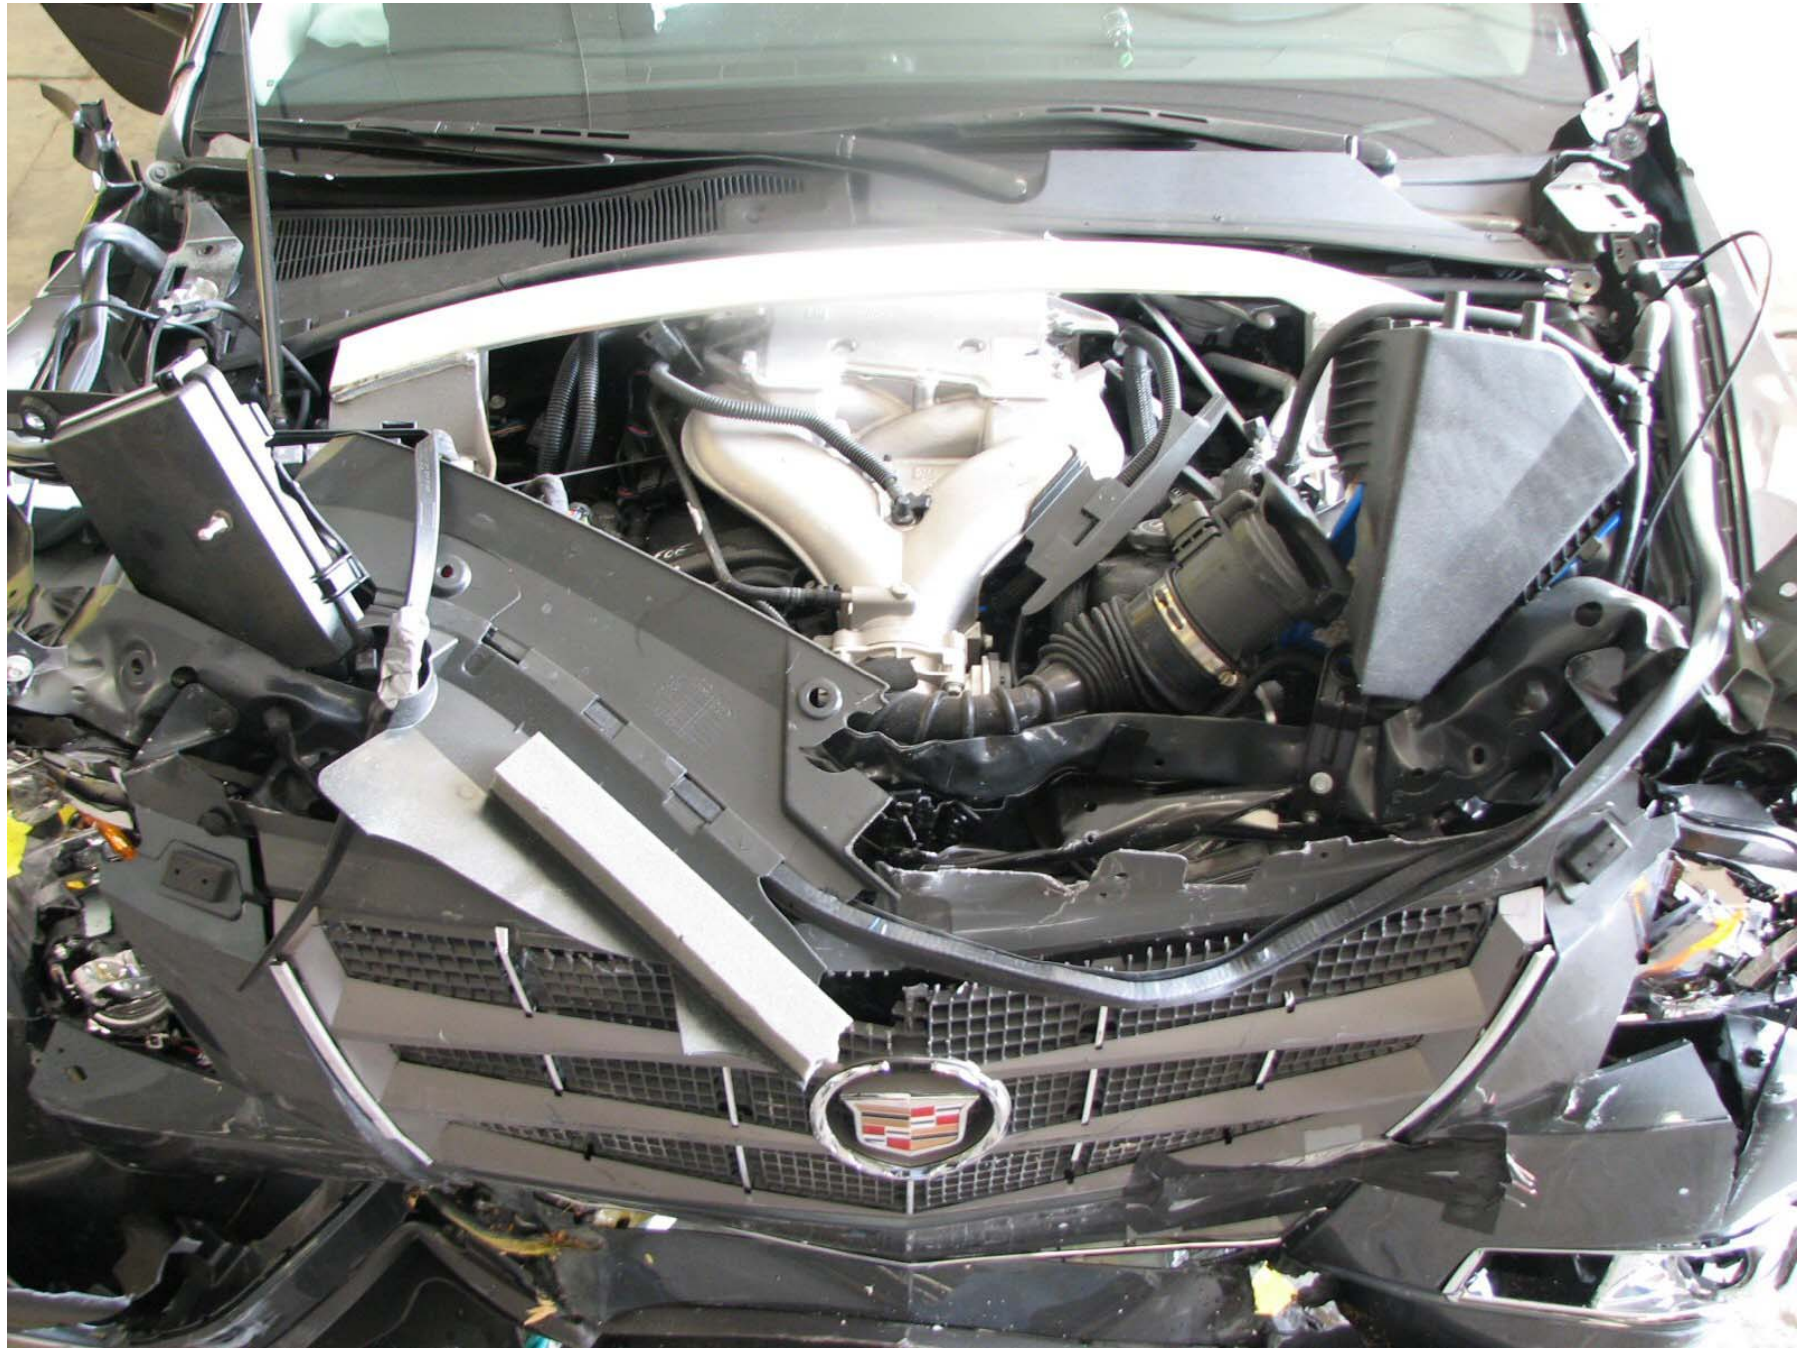
Figure A-21: Post-Test Engine Compartment (Vehicle Moved)

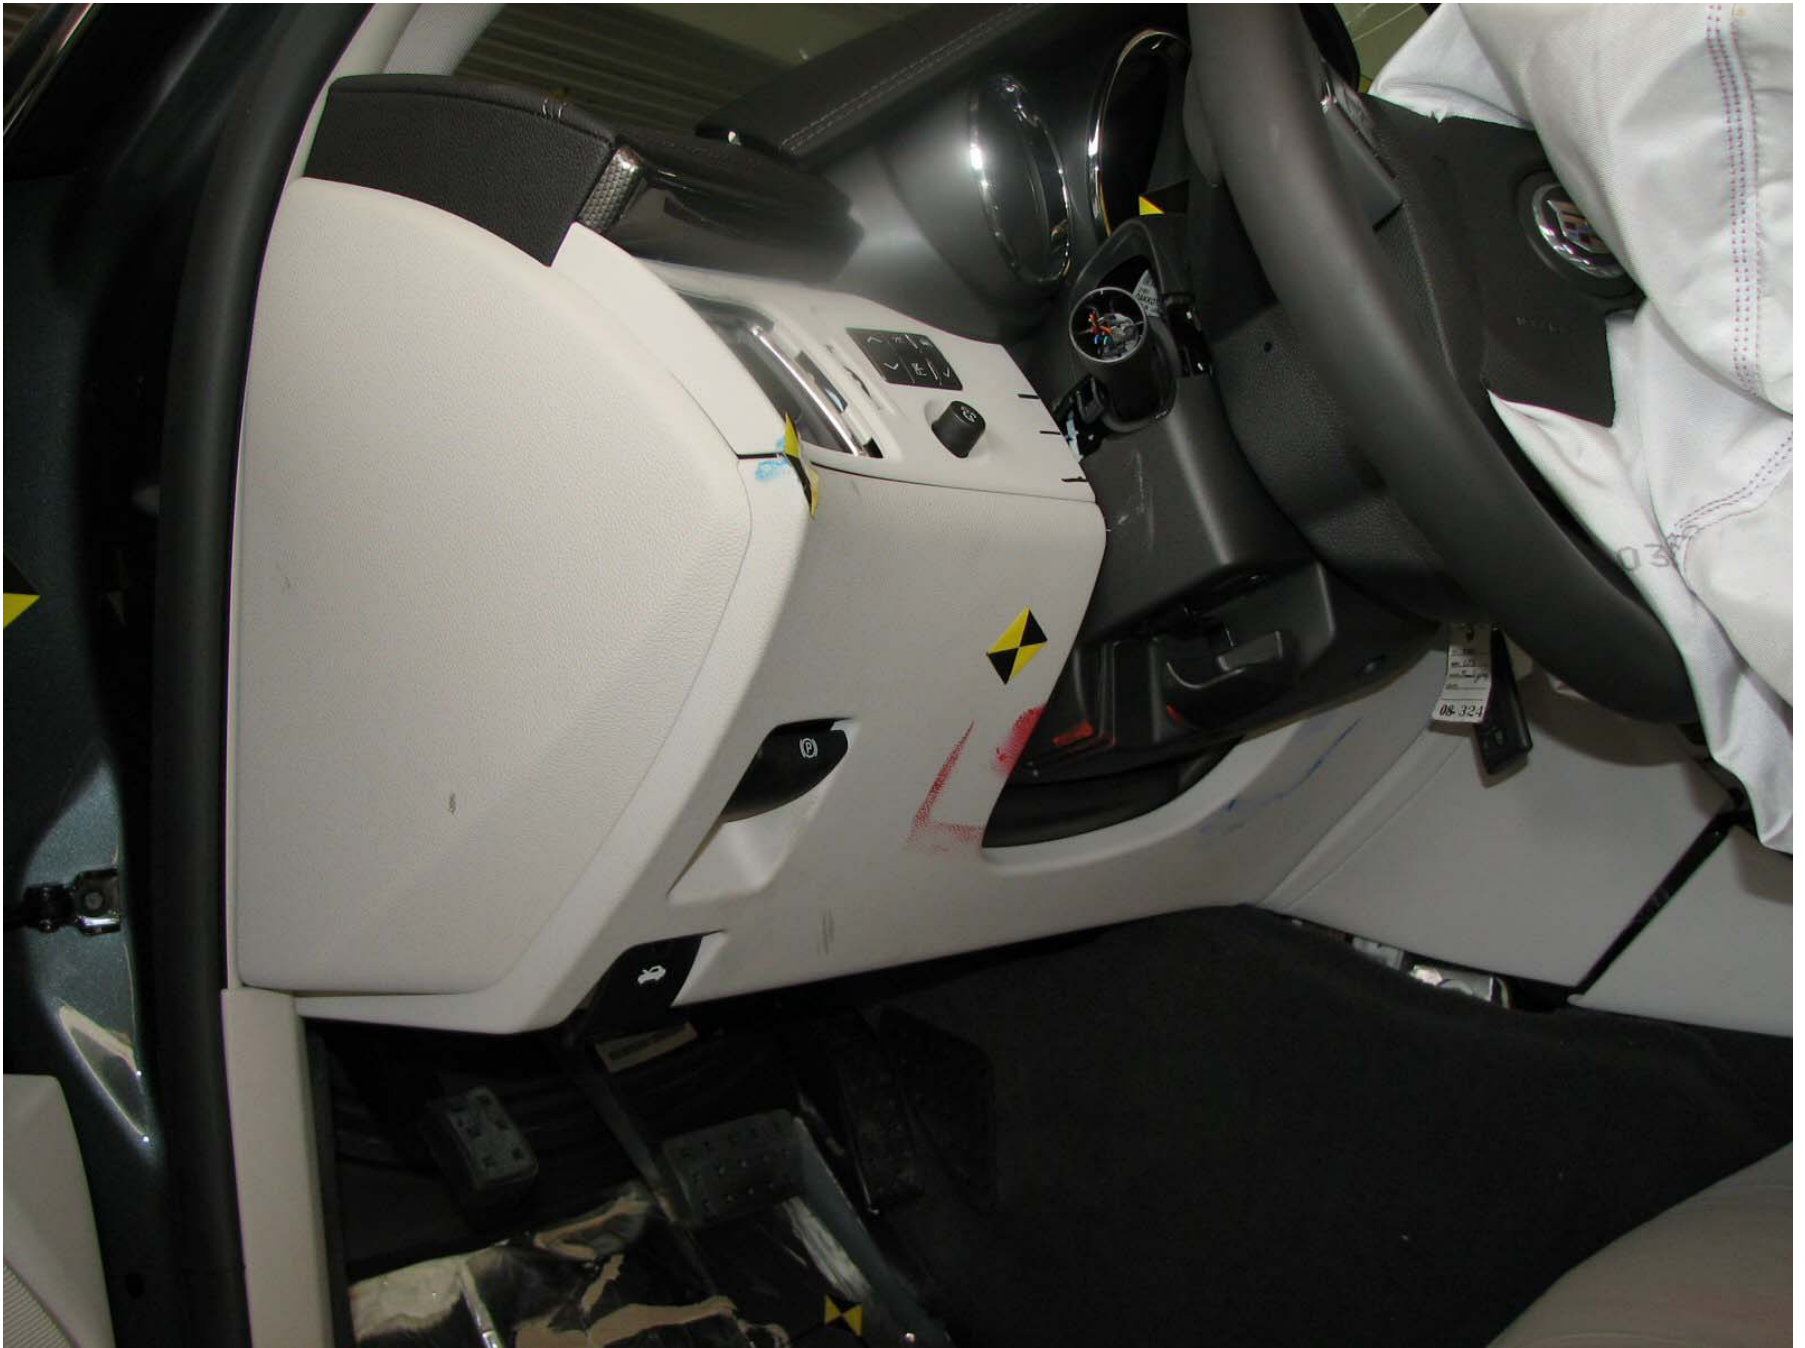
The driver's visible contact points were as follows: The driver ATD's head, chest, and abdomen contacted the airbag. The head also contacted the headrest. Both knees contacted the bolster.

Figure A-39: Post-Test Driver Side Knee Bolster

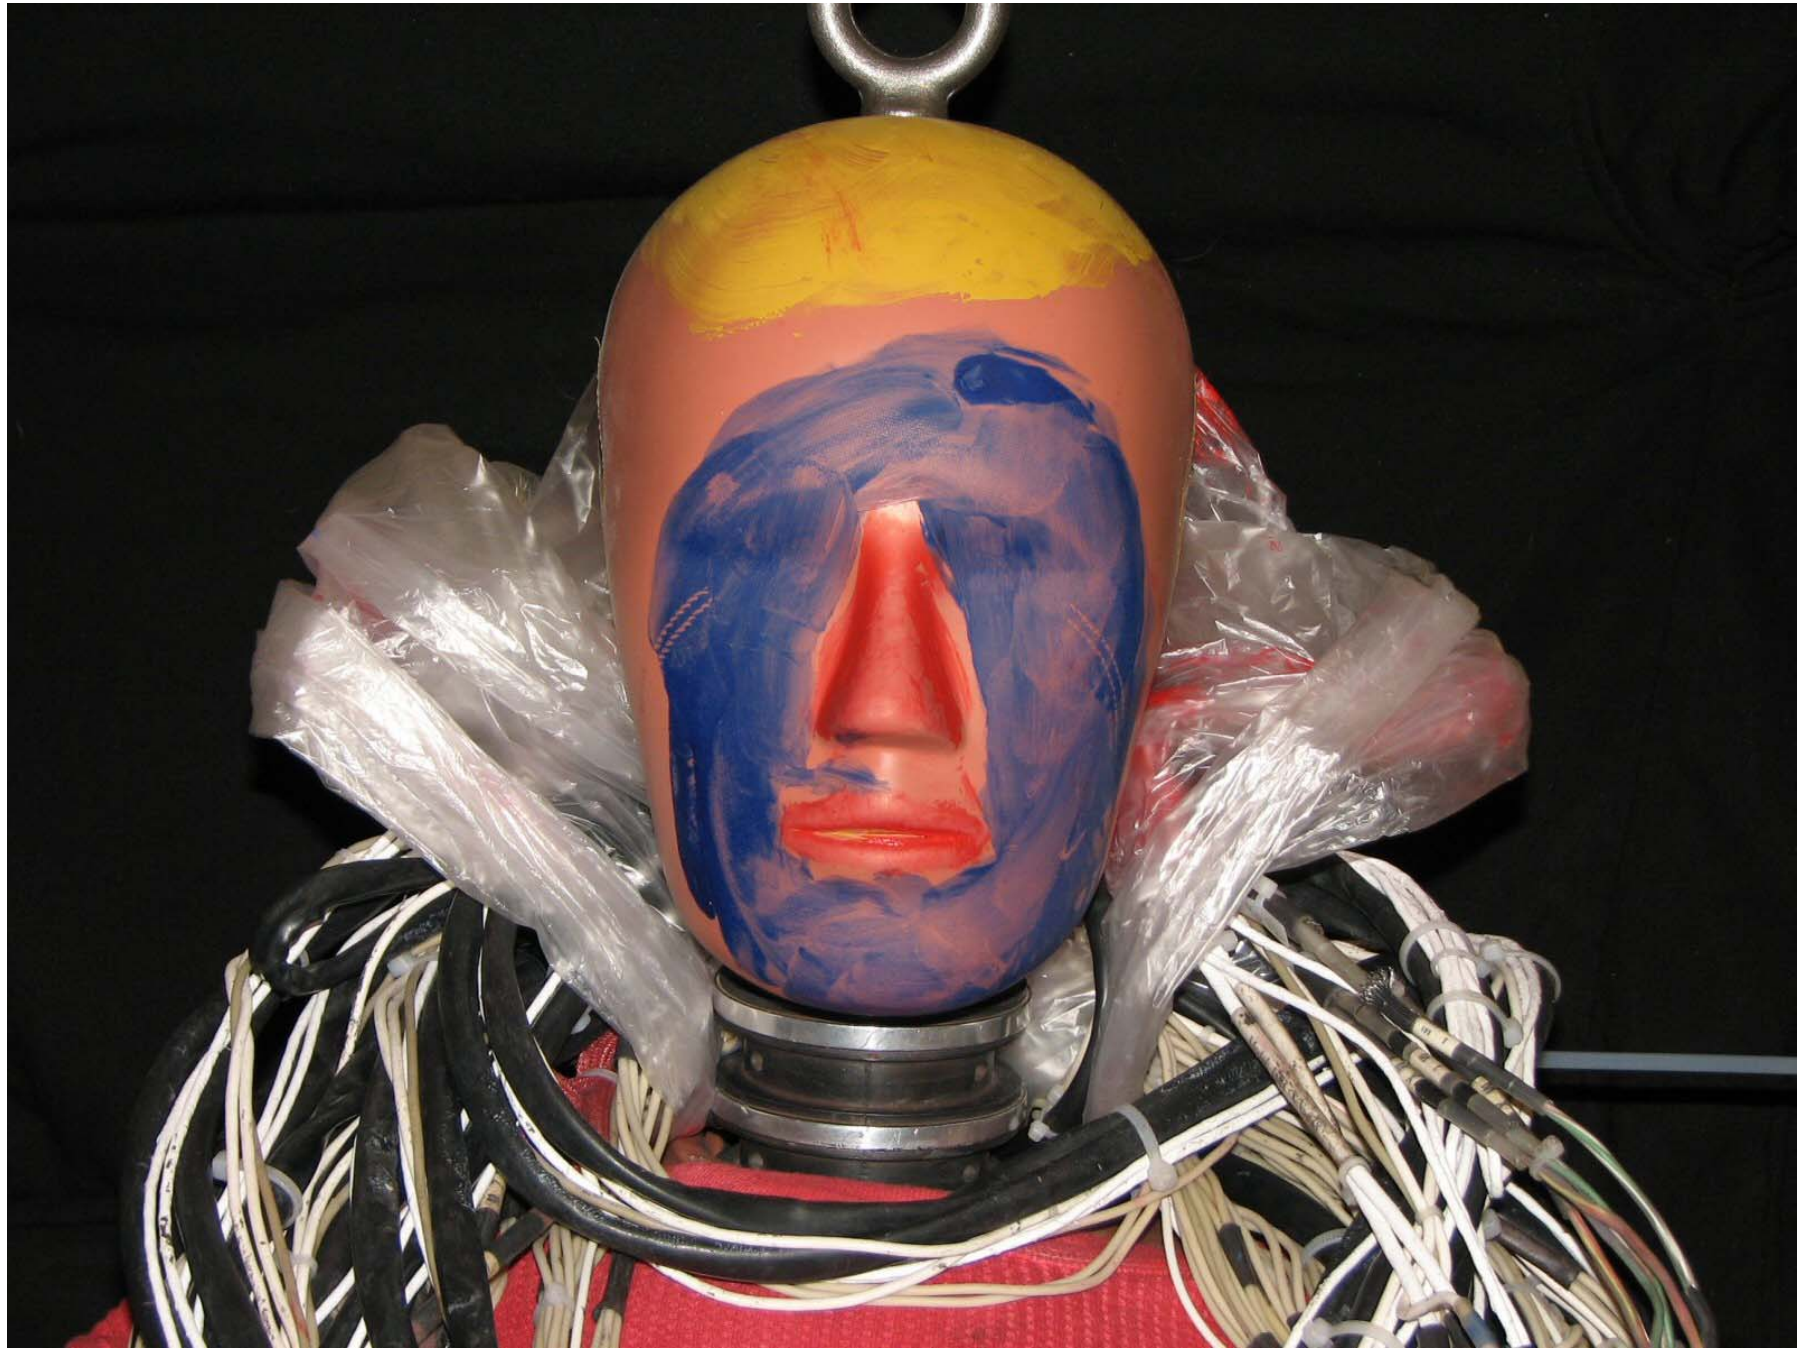
Figure A-42: Post-Test Driver Dummy Head

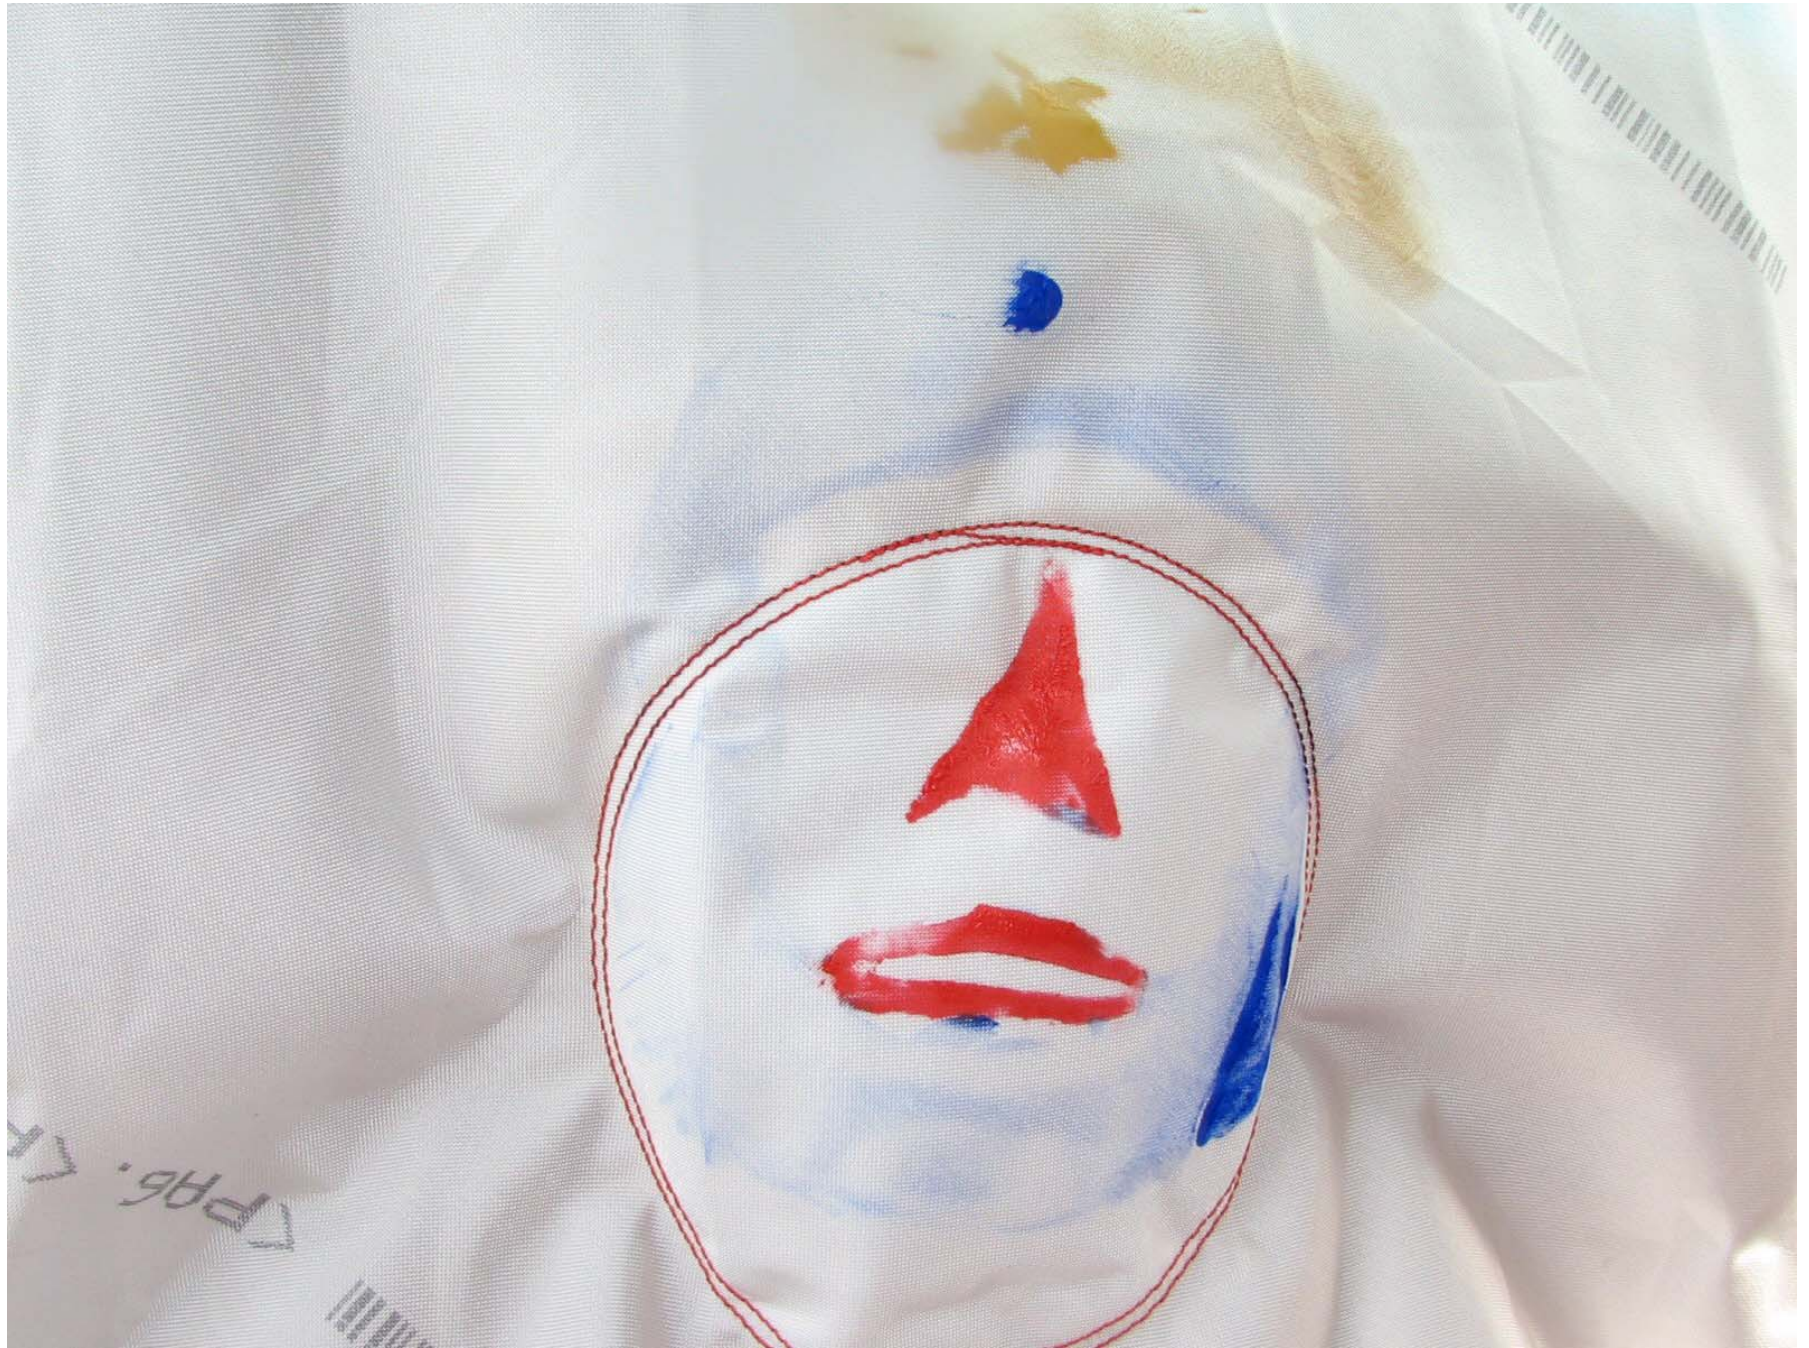
Figure A-43: Post-Test Driver Dummy Airbag Contact

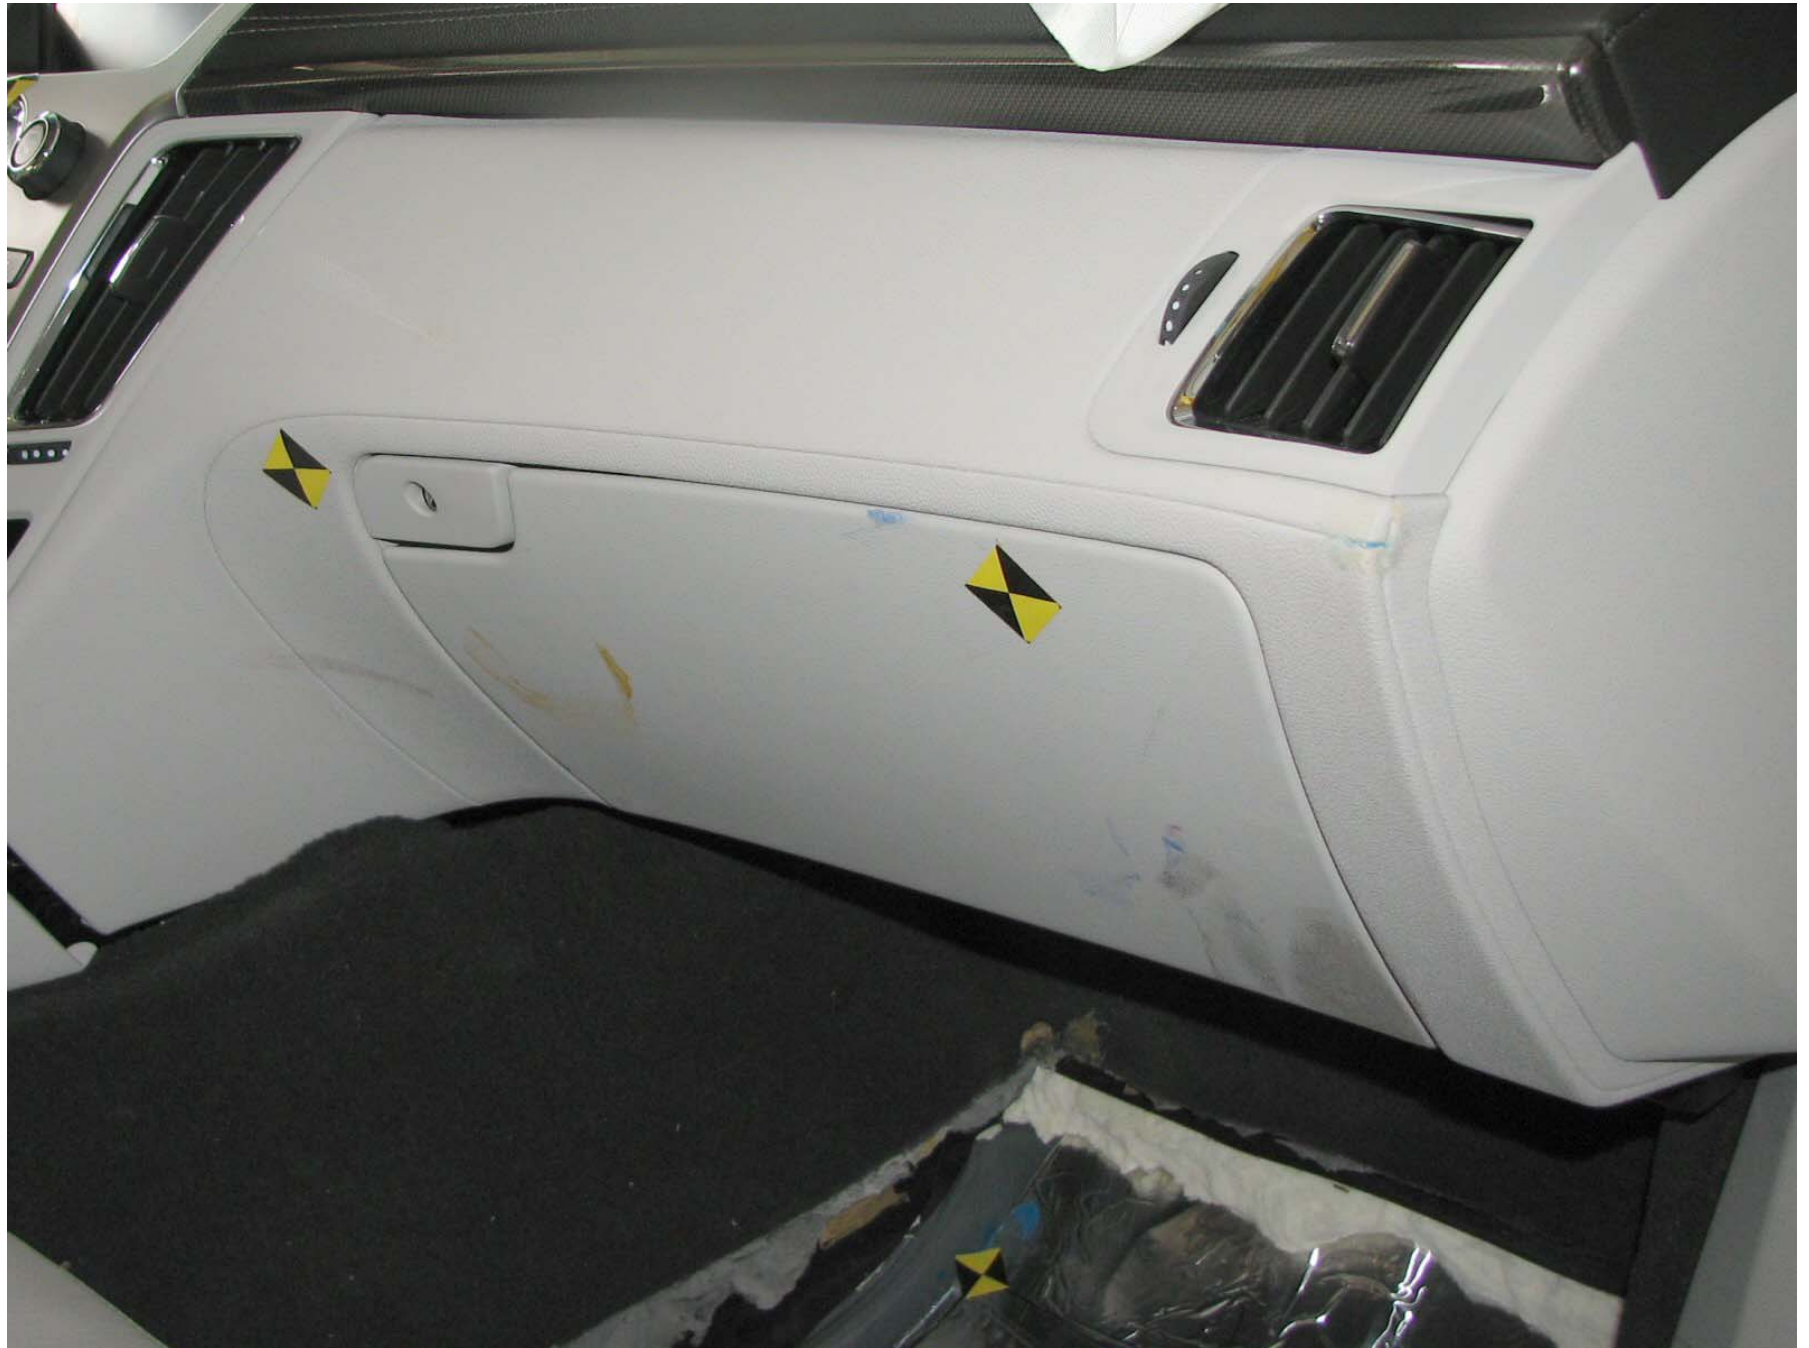
The passenger's visible contact points were as follows: The passenger ATD's head, chest, and abdomen contacted the airbag. Both knees contacted the glovebox.

Figure A-53: Post-Test Passenger Side Glove Box

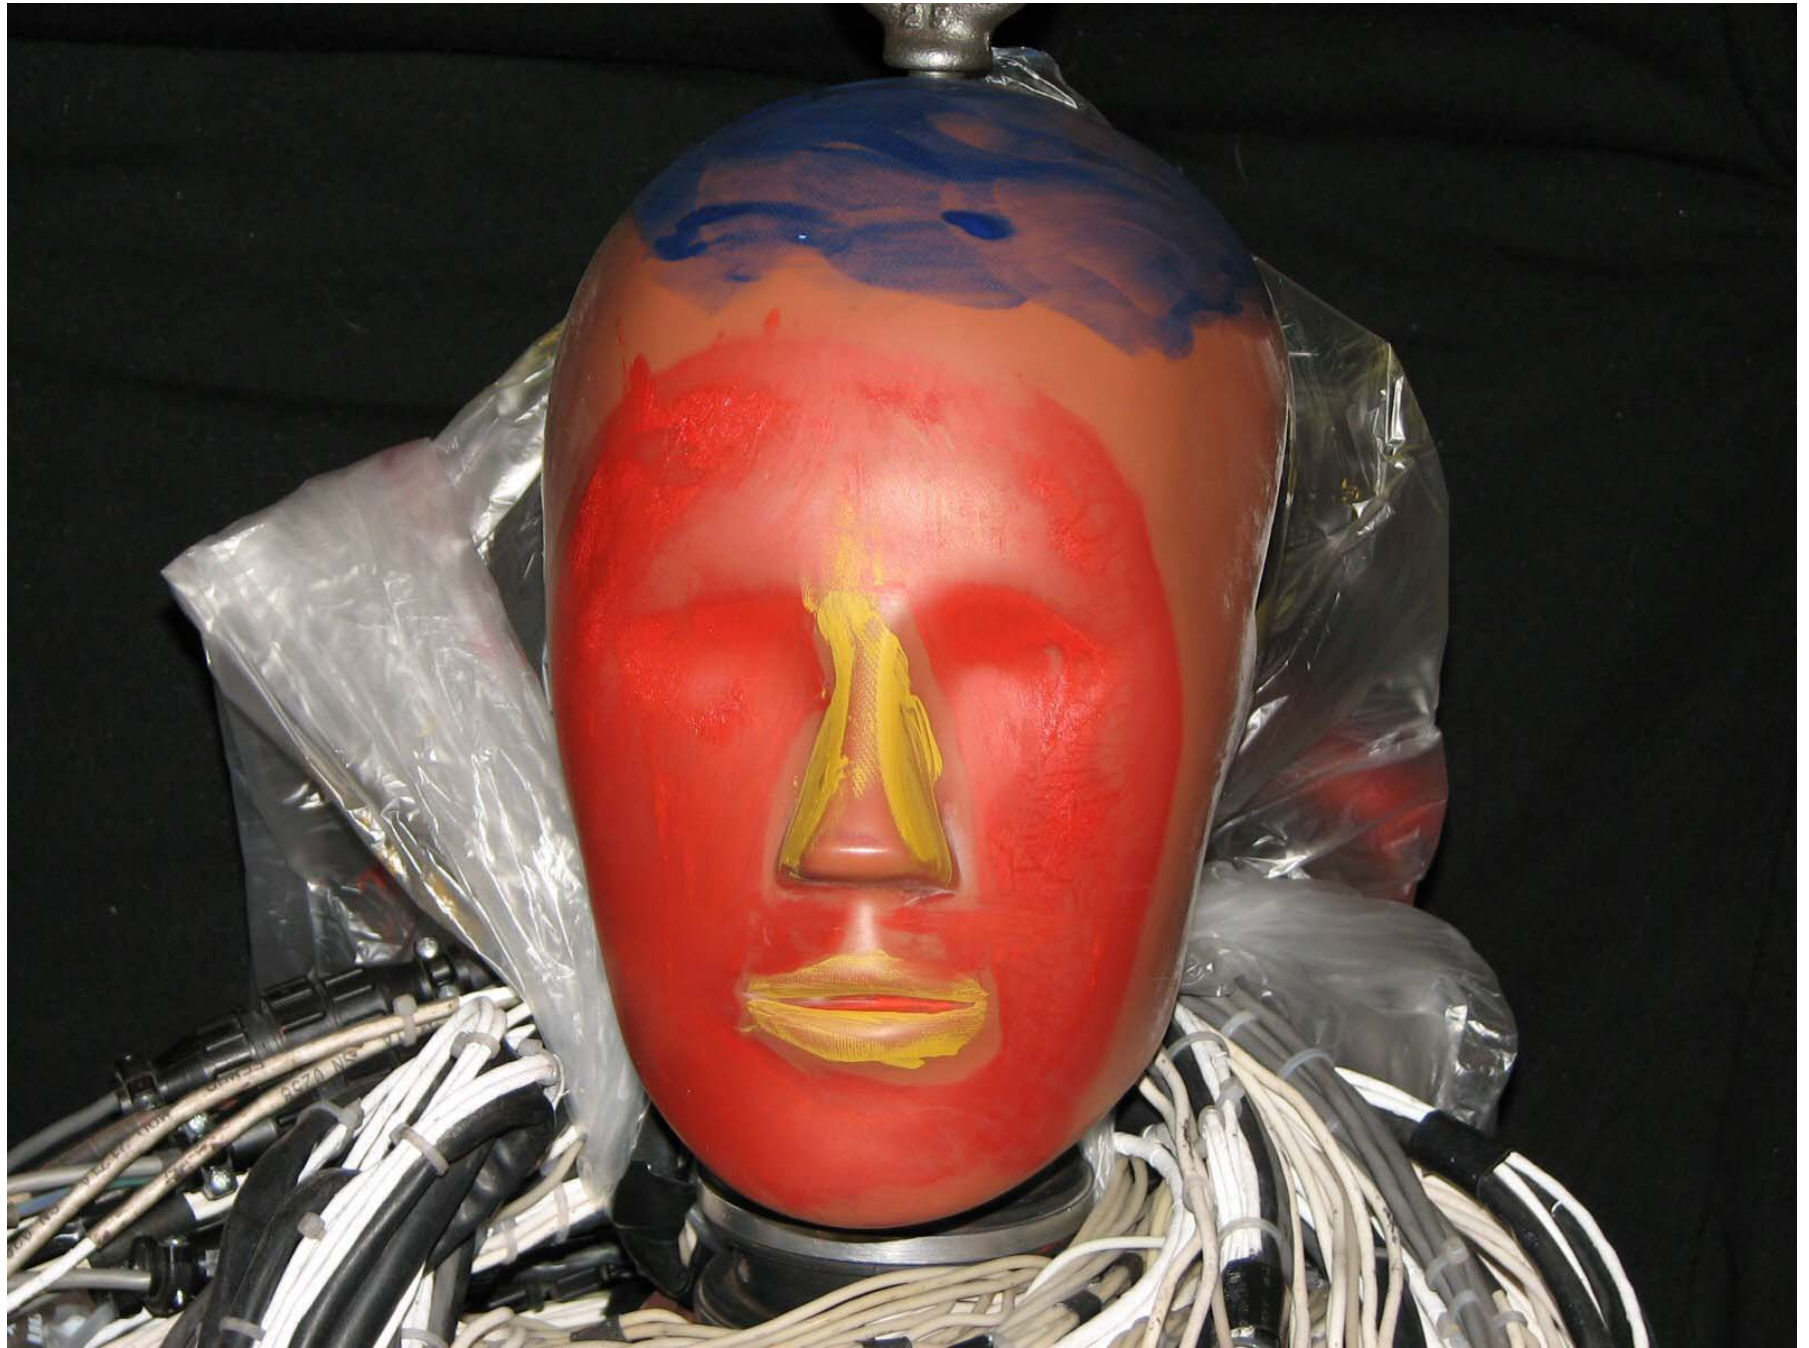
Figure A-56: Post-Test Passenger Dummy Head

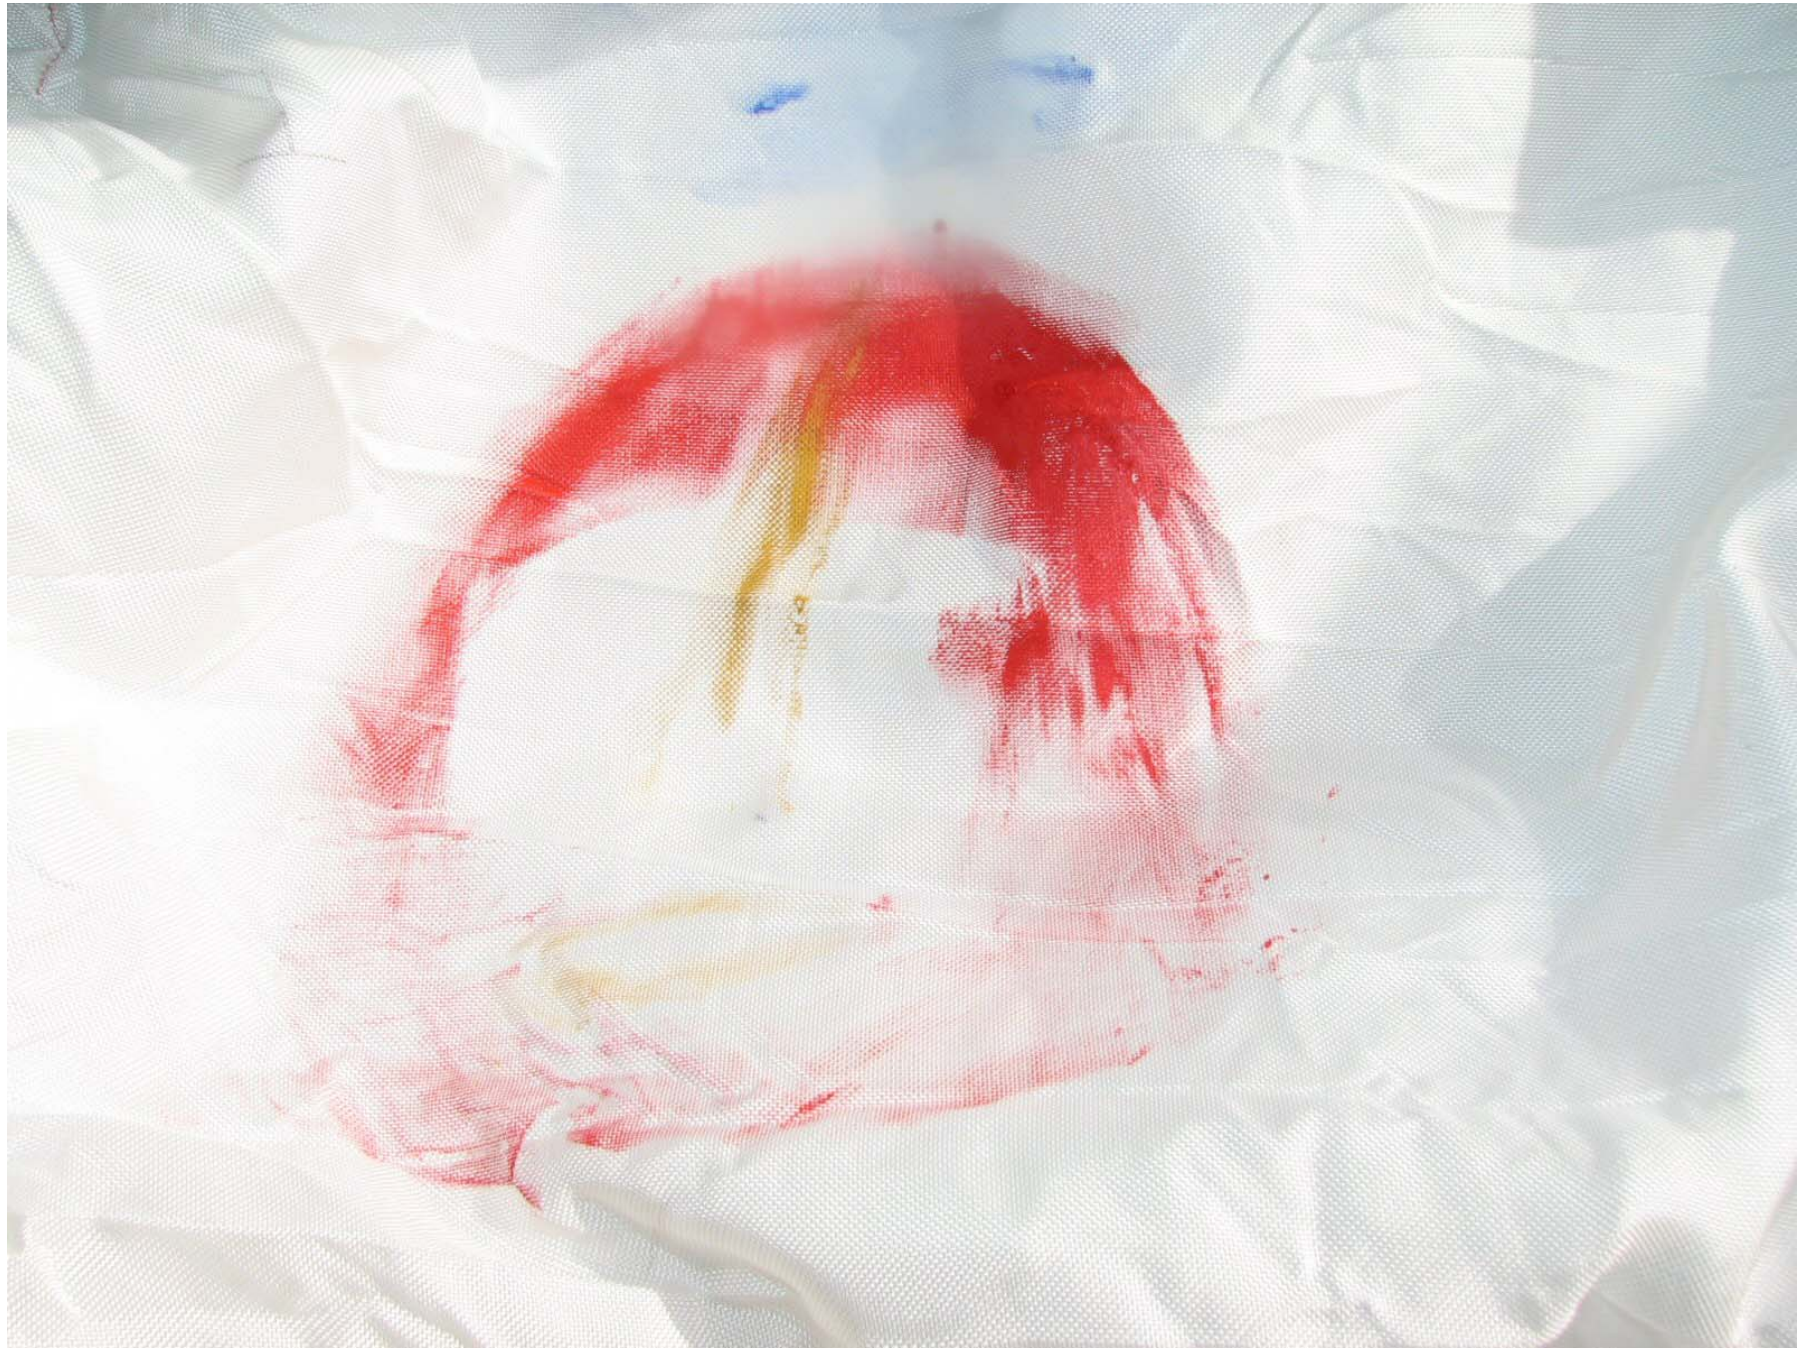
Figure A-57: Post-Test Passenger Dummy Airbag Contact
