REPORT NUMBER TR-P28001-15-NC

**NEW CAR ASSESMENT PROGRAM
FRONTAL BARRIER IMPACT TEST**

**GENERAL MOTORS CORP.
2008 CADILLAC CTS
4-DOOR SEDAN**

NHTSA NUMBER: M80105

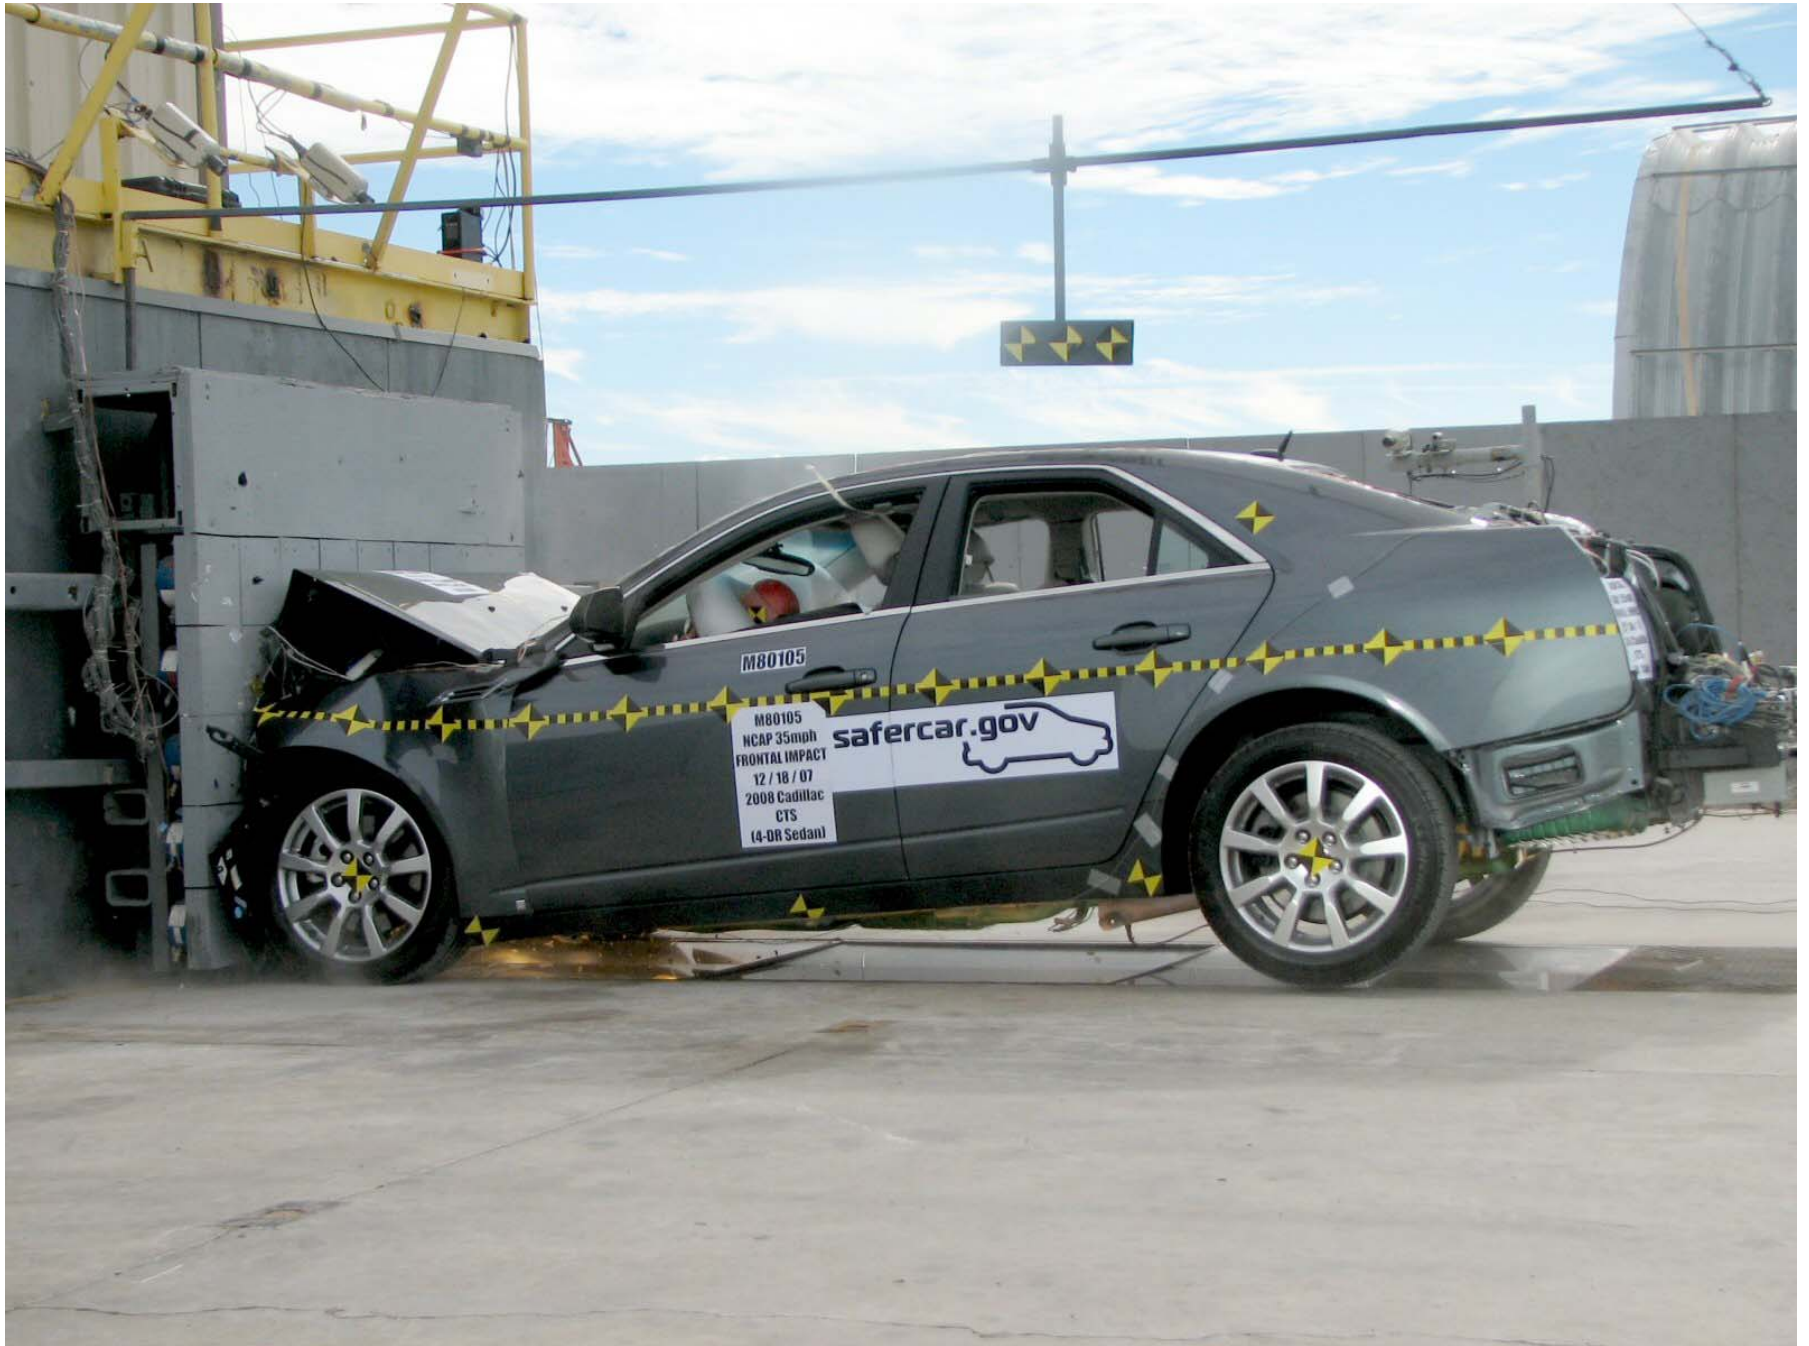
A load cell barrier consisting of 36 load cells was impacted by a 2008 Cadillac CTS 4-Door Sedan at a velocity of 56.04 km/h. The test was performed at KARCO Engineering, LLC on December 18, 2007

Figure A-62: Vehicle Impact
