REPORT NUMBER: NCAPSIDE-MGA-2008-012

**NEW CAR ASSESSMENT PROGRAM
SIDE IMPACT TEST
RESEARCH PROJECT**

**DAIMLERCHRYSLER CORPORATION
2008 DODGE GRAND CARAVAN SE
NHTSA NUMBER: M80311**

**PREPARED BY:
MGA RESEARCH CORPORATION
5000 WARREN ROAD
BURLINGTON, WI 53105**

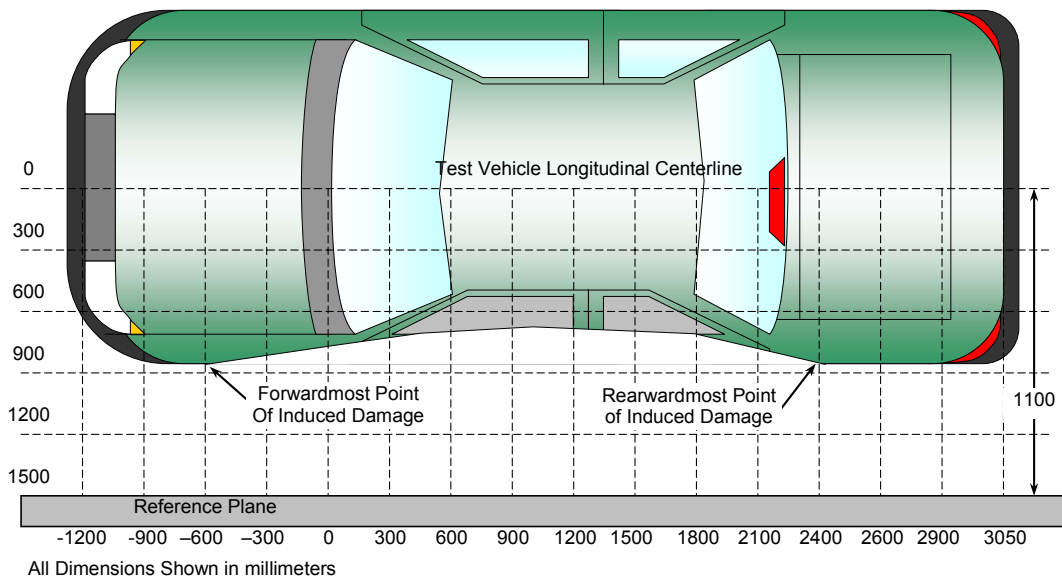
TOP VIEW

DAMAGE PROFILE DISTANCES

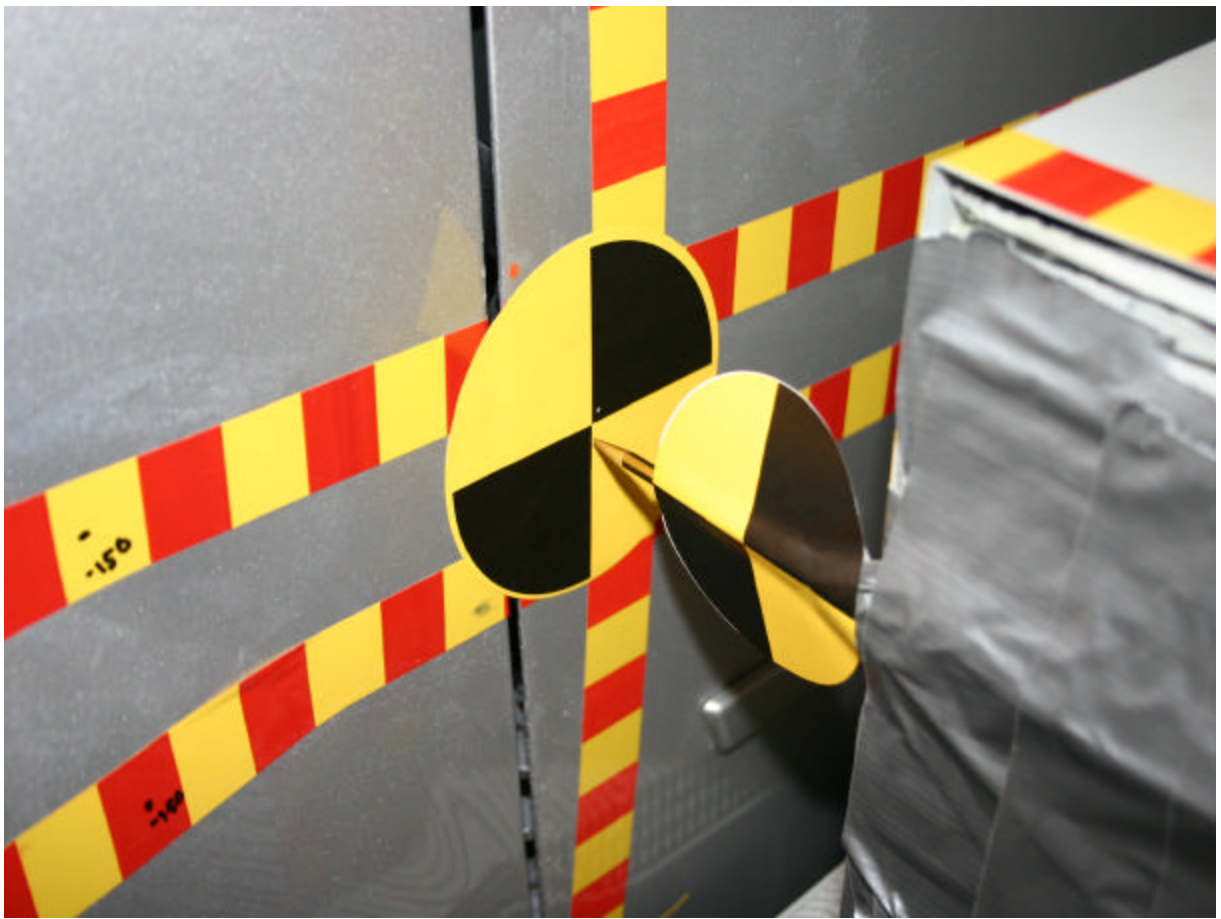
Pre-Test Left Impact Point

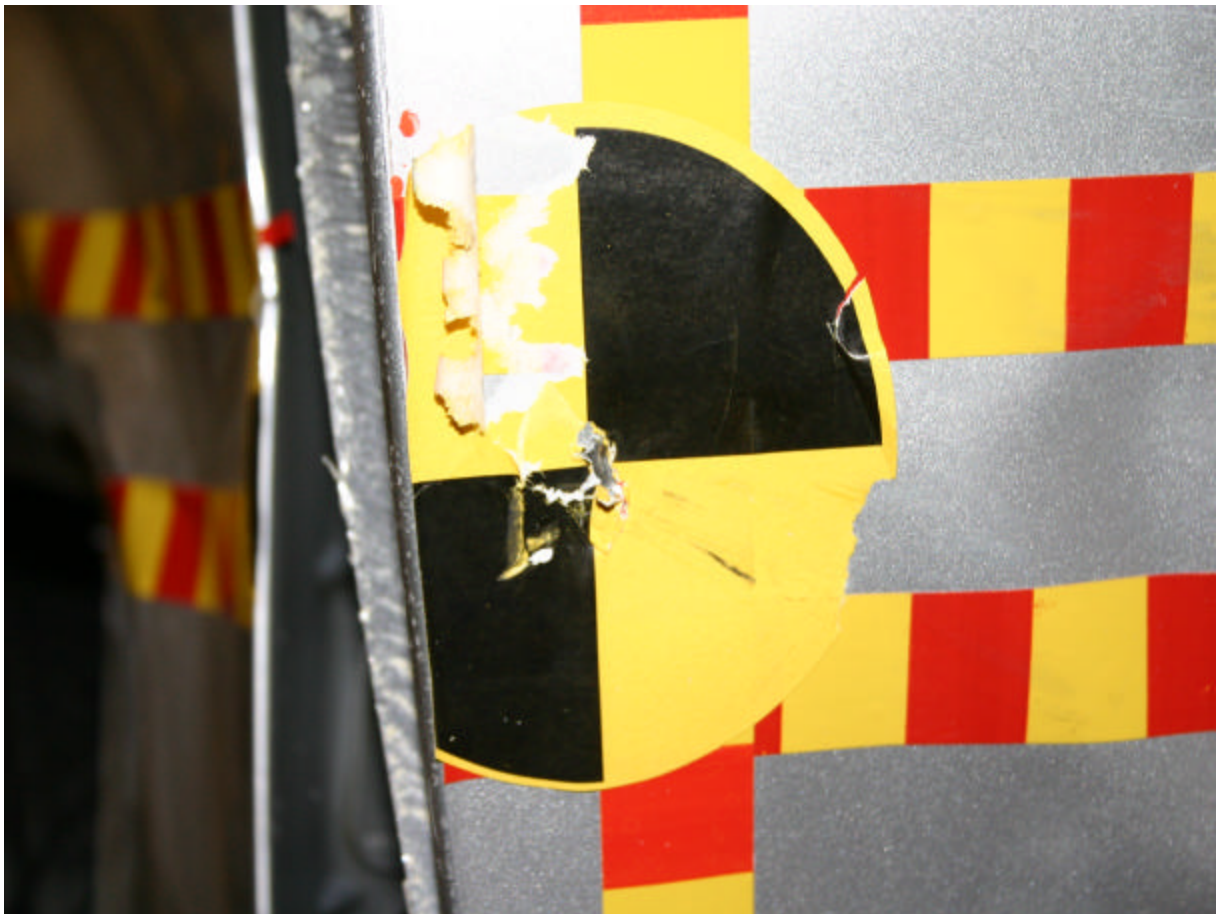
Post-Test Left Impact Point

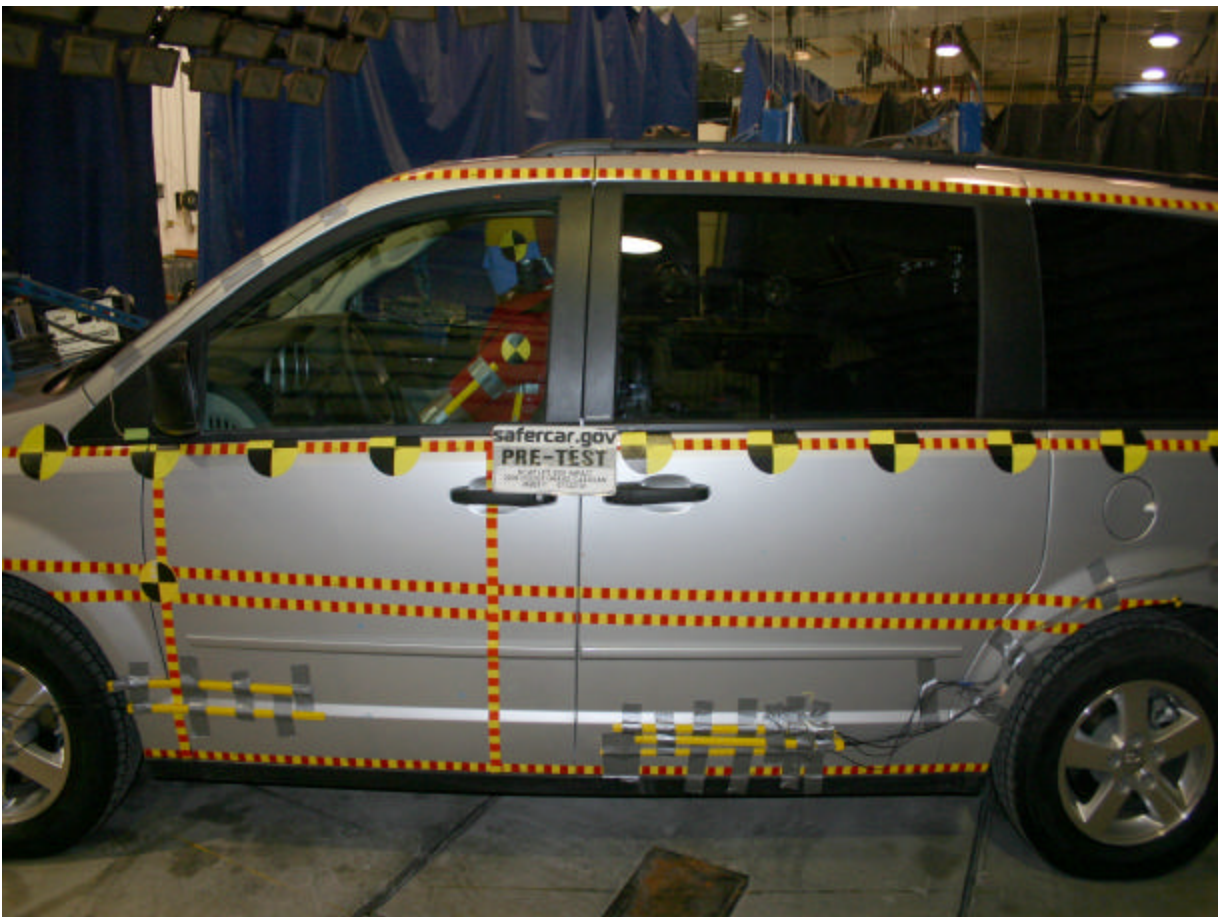
Pre-Test Left Side Impact Close-up

Post-Test Left Side Impact Close-up

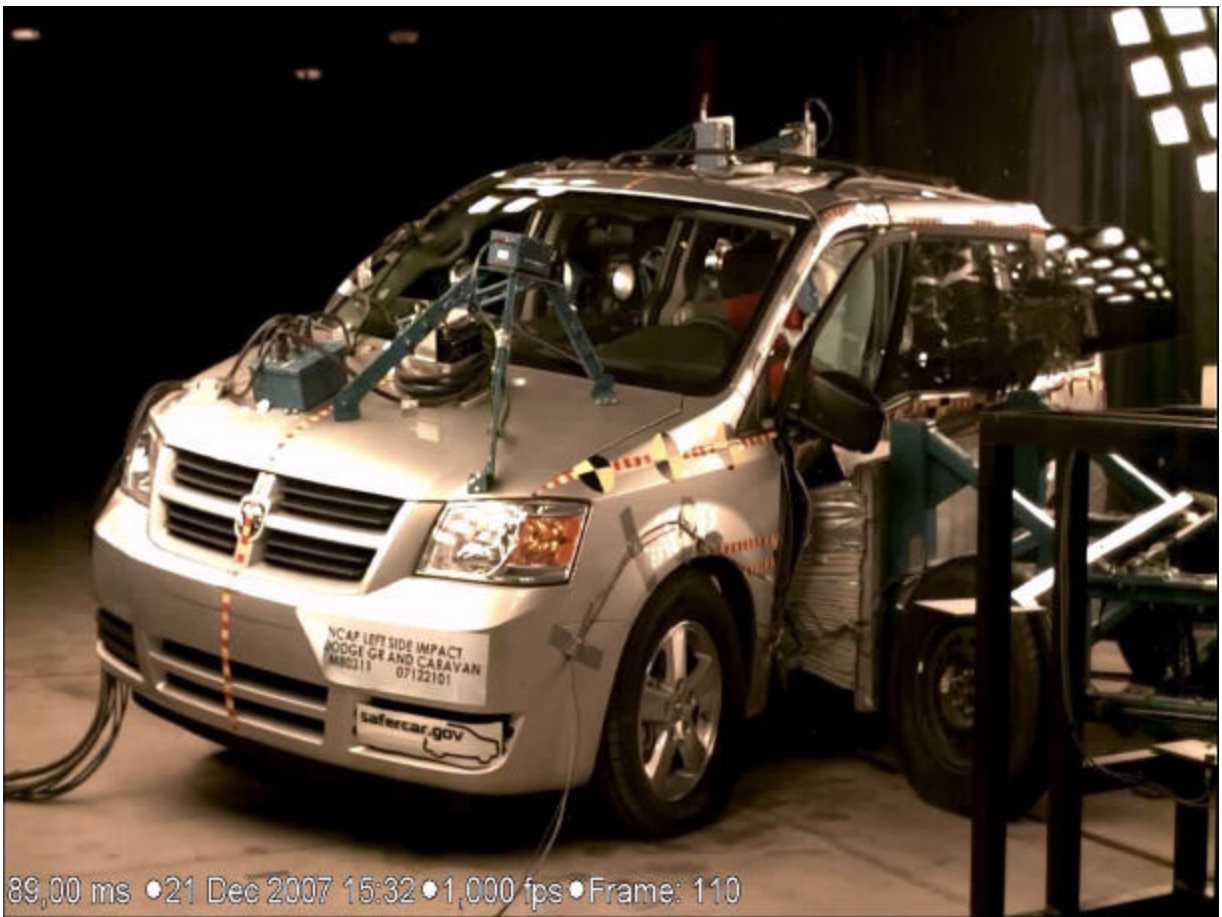
89,00 ms • 21 Dec 2007 15:32 • 1,000 fps • Frame: 110

Vehicle Impact

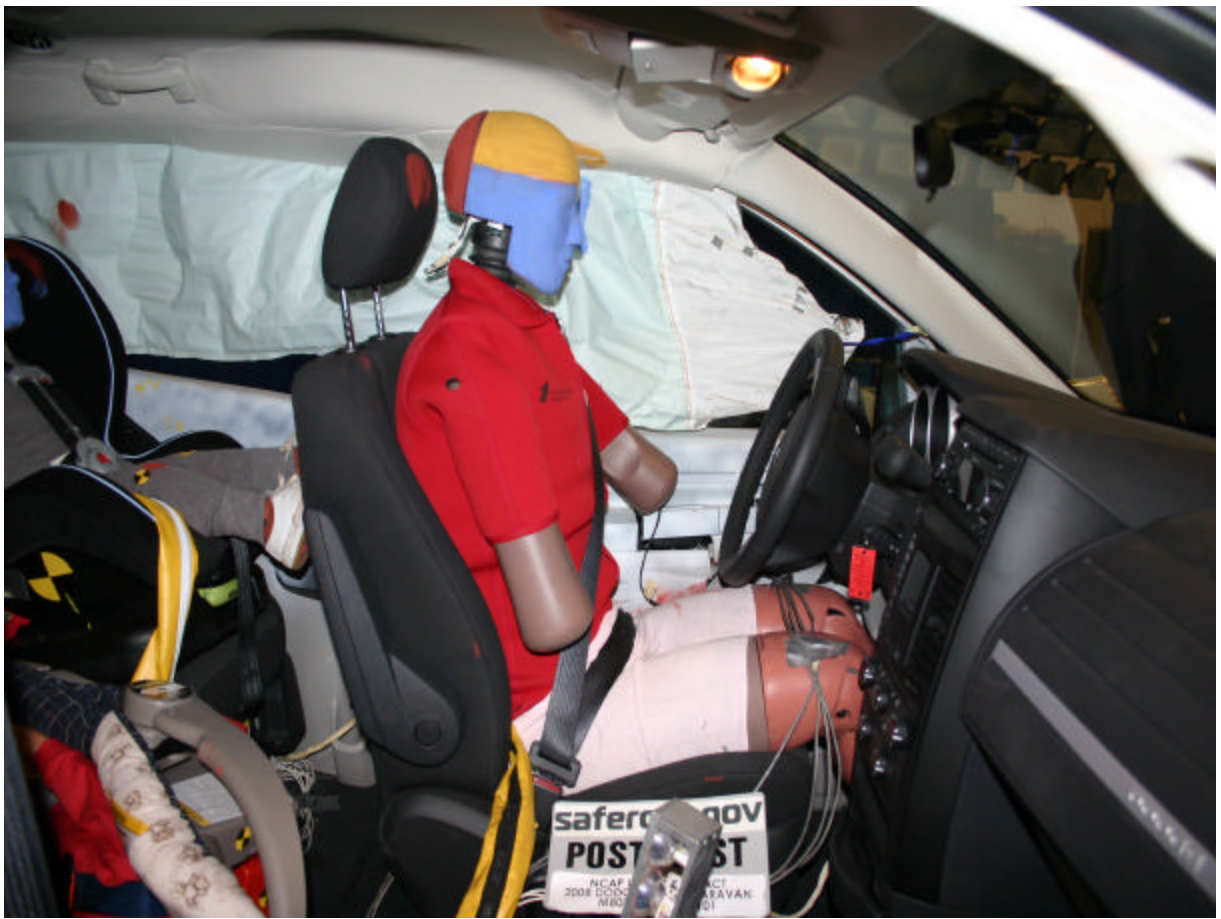
Post-Test Driver Dummy Contact

Post-Test Driver Dummy Head Contact

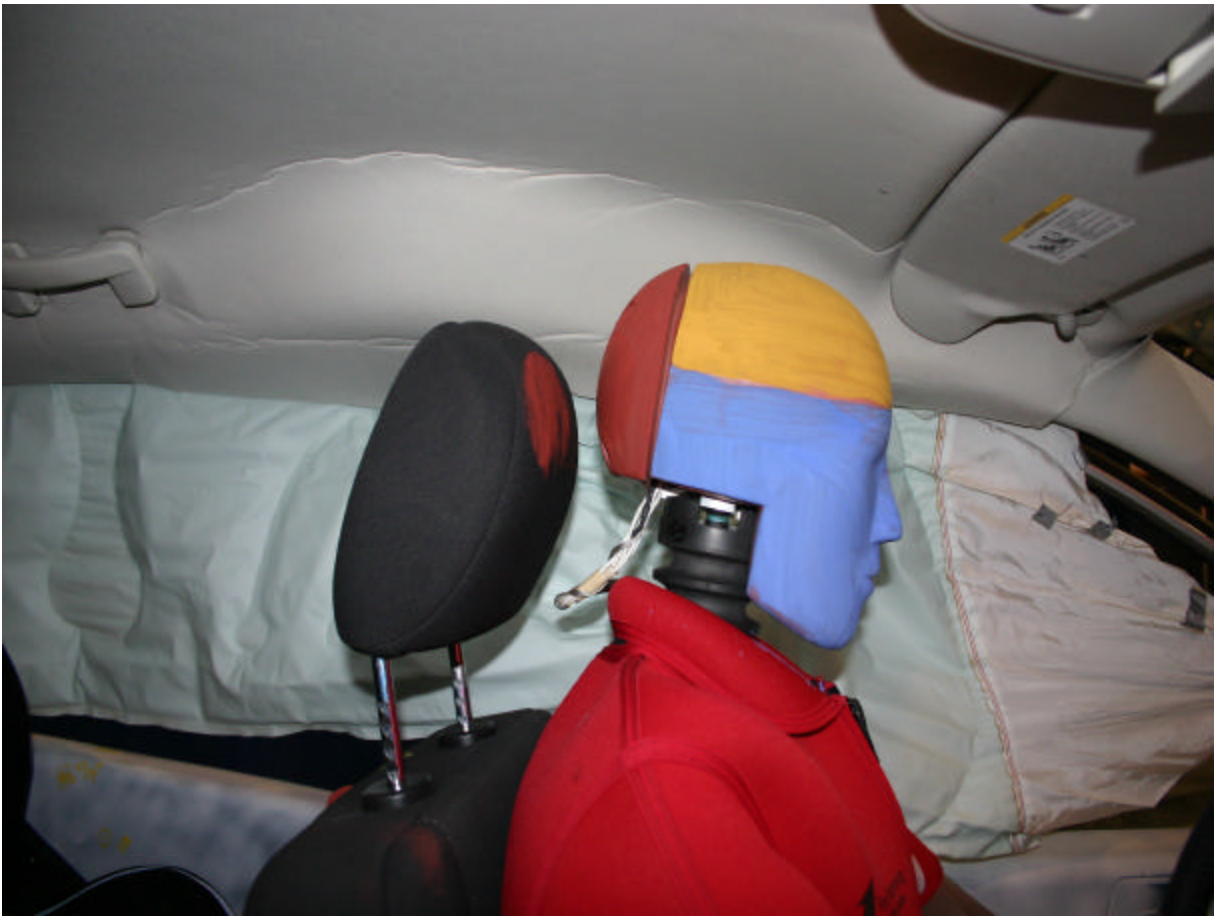
Post-Test Driver Dummy Head Contact

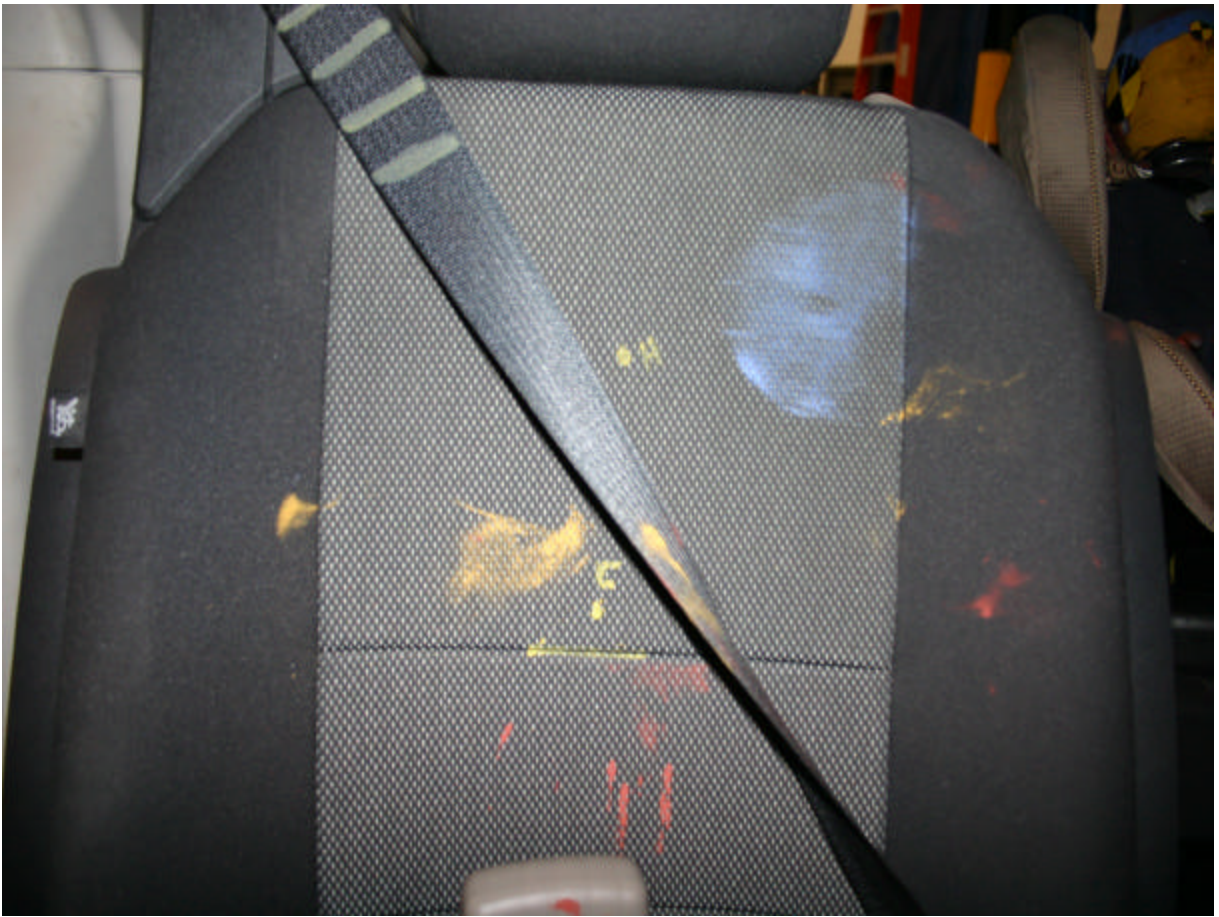
Post-Test Position 3 Head and Feet Contact

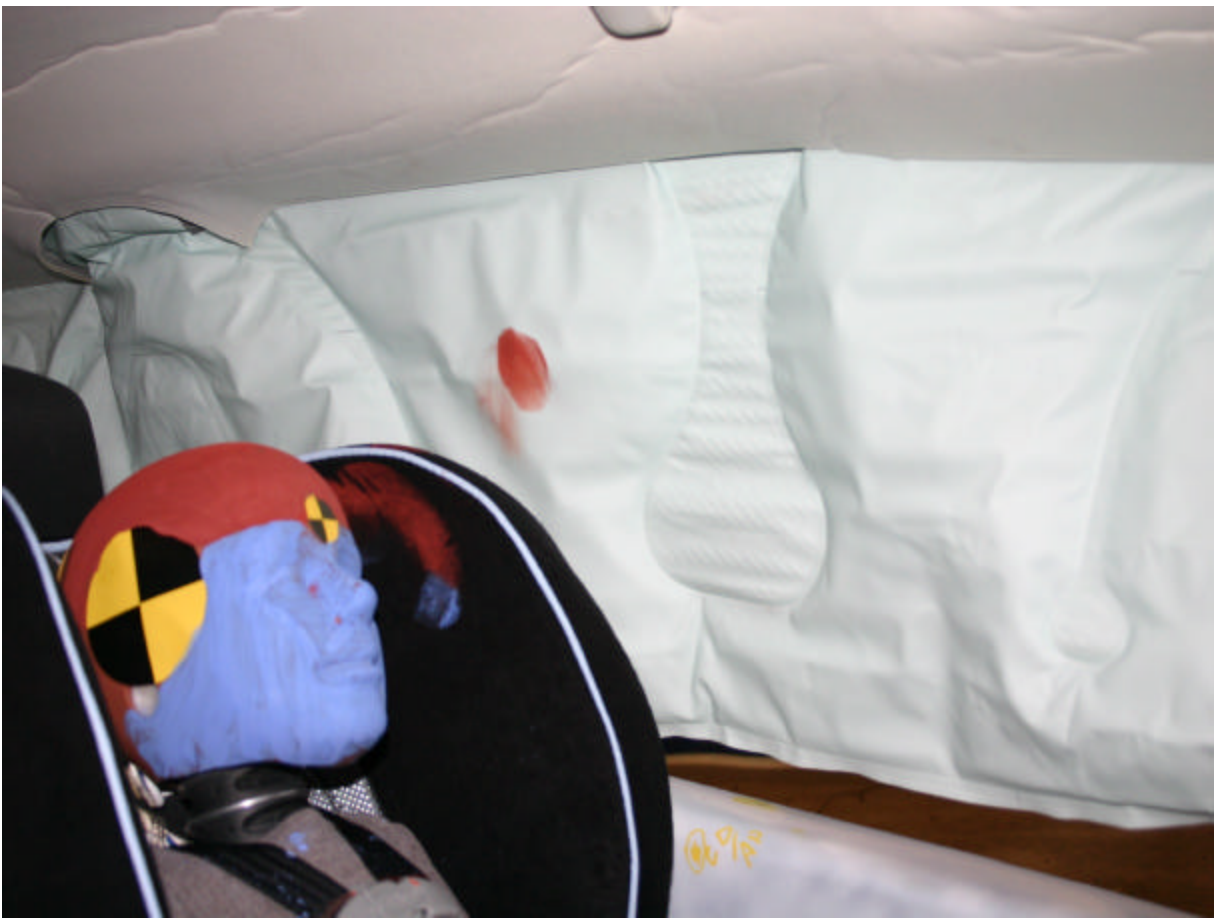
Post-Test Position 4 Head Contact

Post-Test Position 4 Feet Contact

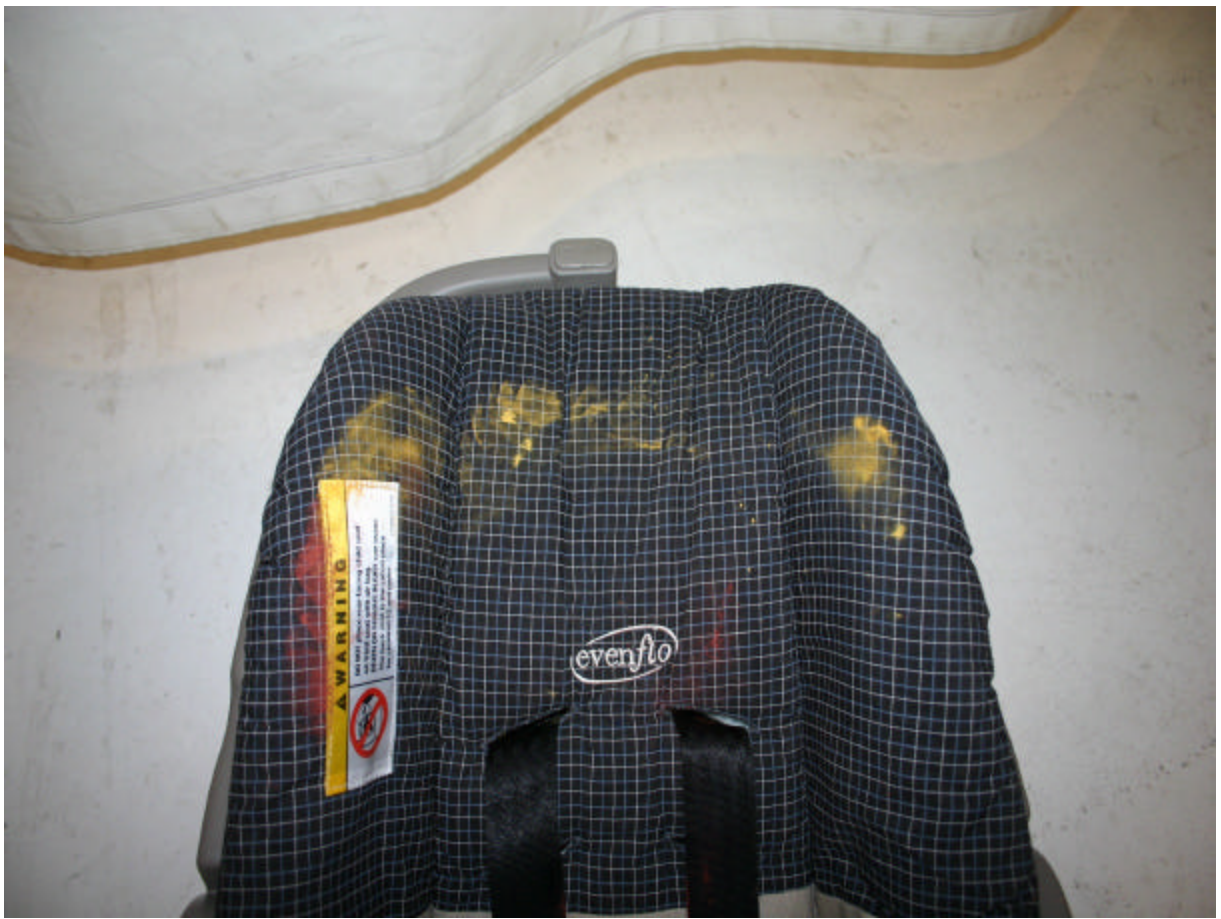
Post-Test Position 5 Head Contact

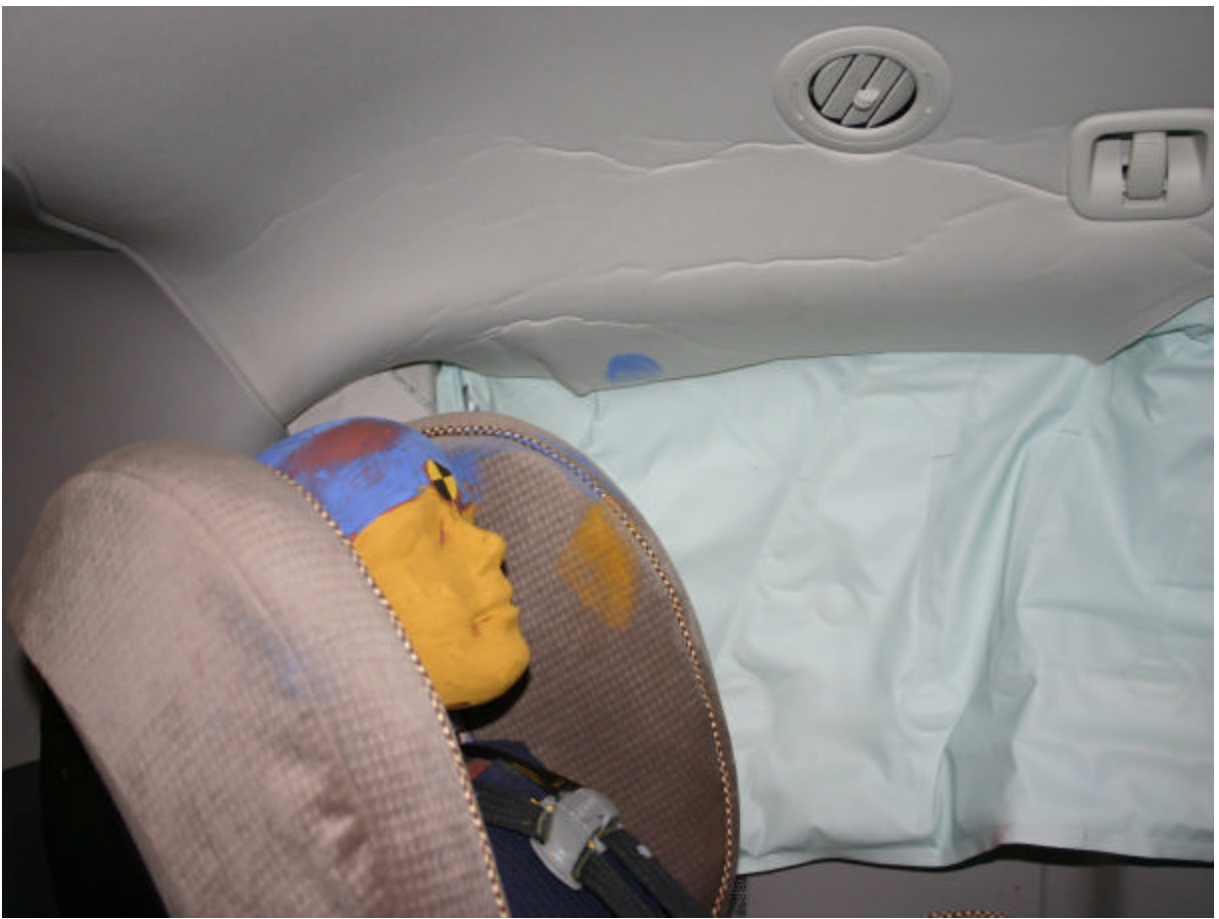
Post-Test Position 6 Head Contact
