REPORT NUMBER: 214-CAL-08-03

**SAFETY COMPLIANCE TESTING FOR FMVSS 214
SIDE IMPACT PROTECTION
INDICANT**

**NISSAN MOTOR COMPANY
2008 NISSAN 350Z ROASTER
2-DOOR Convertible**

NHTSA NUMBER: C85203

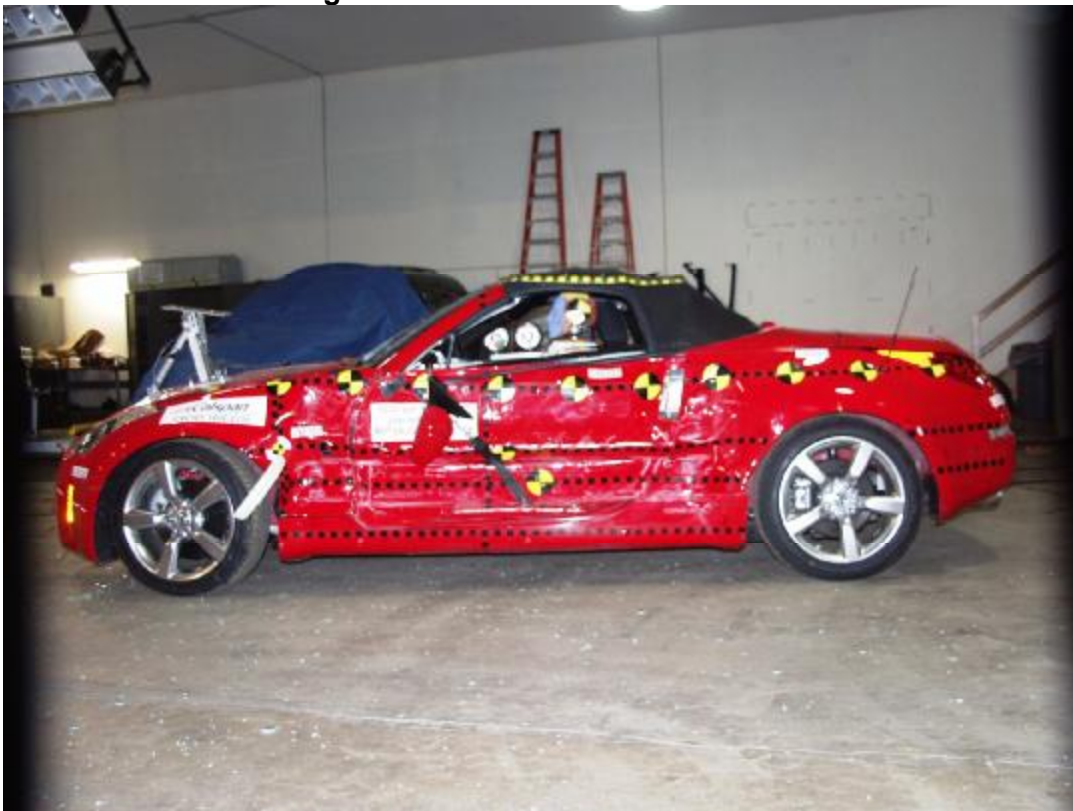
Figure A-10: Post-Test Left Side View

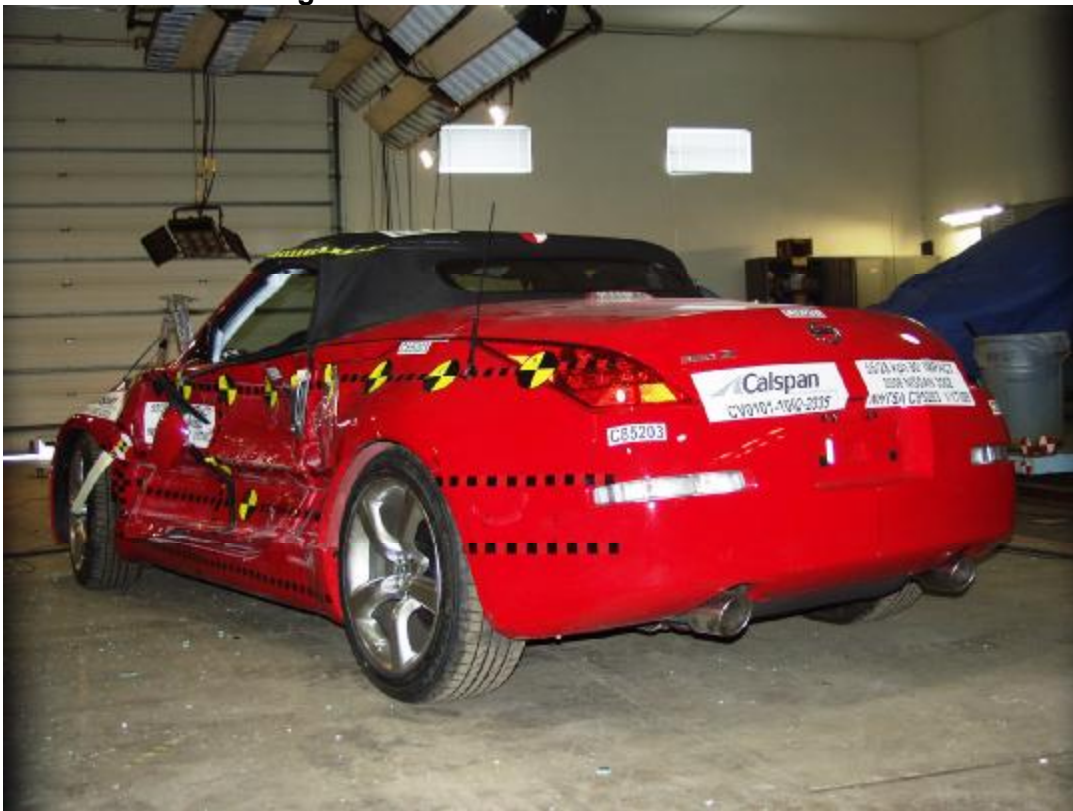
Figure A-12: Post-Test Left Rear $\frac{3}{4}$ View

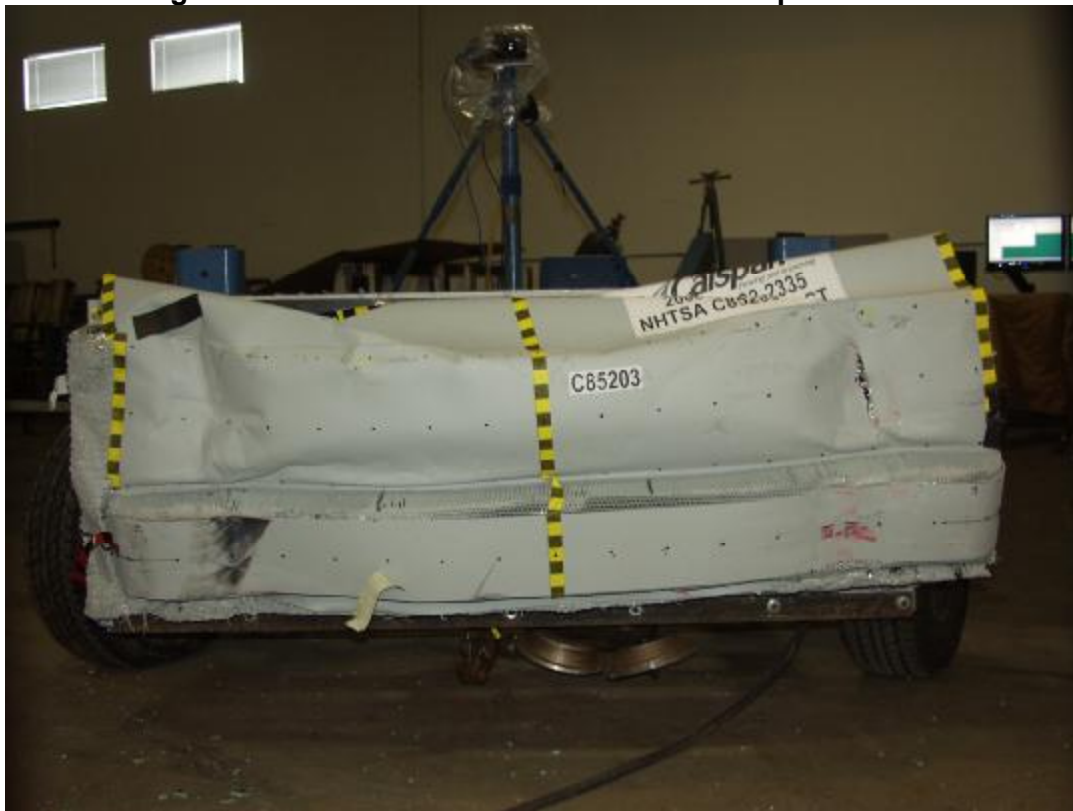
Figure A-22: Post-Test Frontal View of MDB Impactor Face

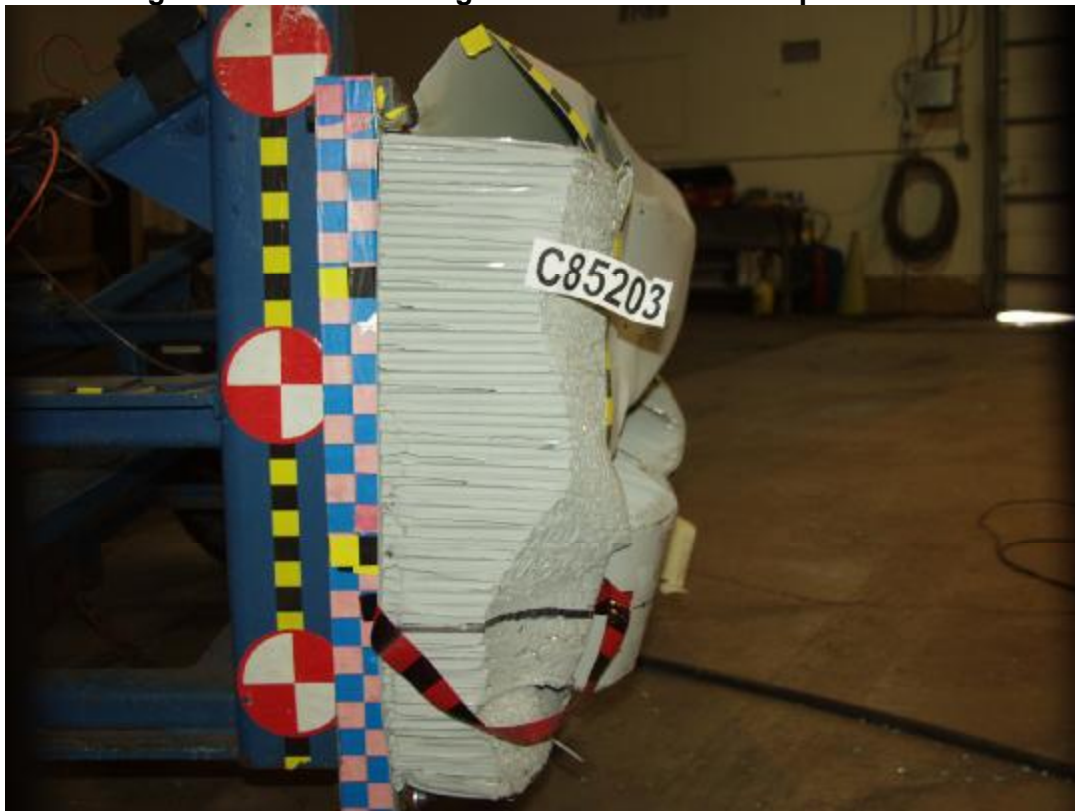
Figure A-26: Post-Test Right Side View of MDB Impactor Face

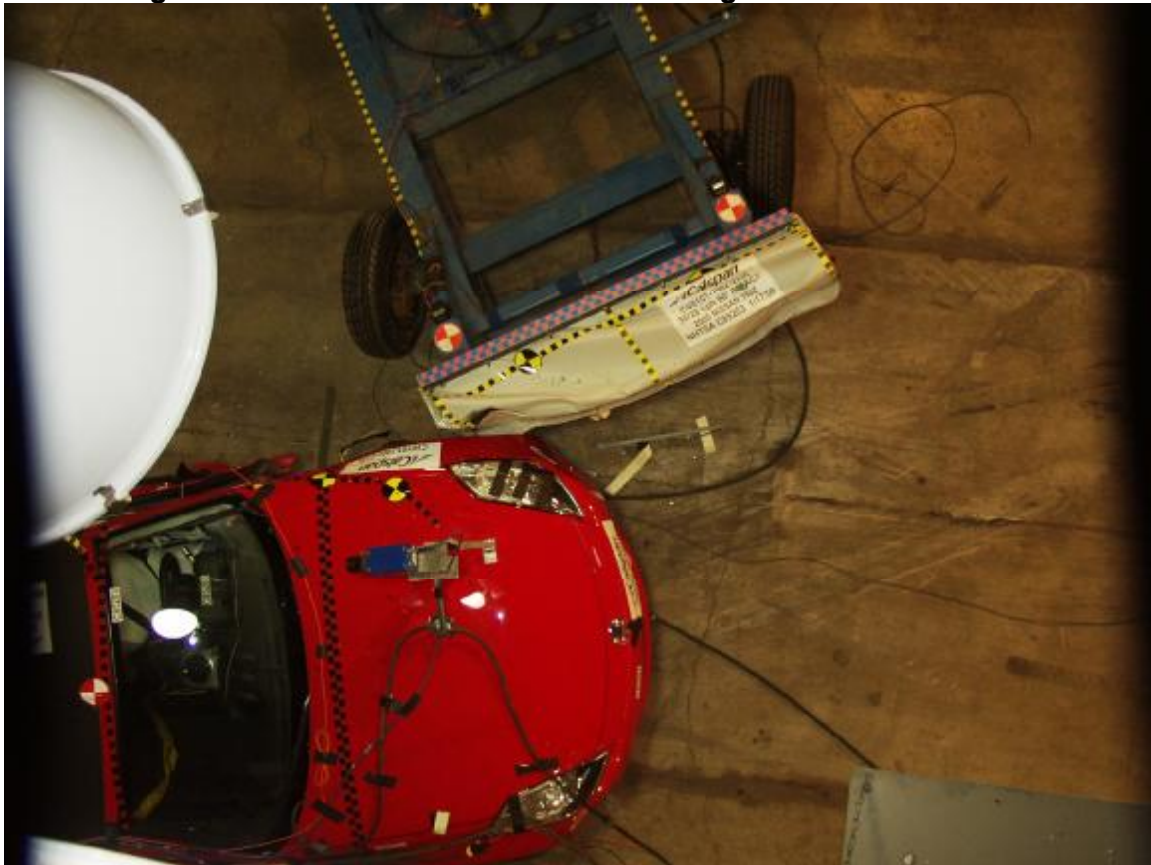
Figure A-32: Post-Test Overhead View of MDB and Vehicle

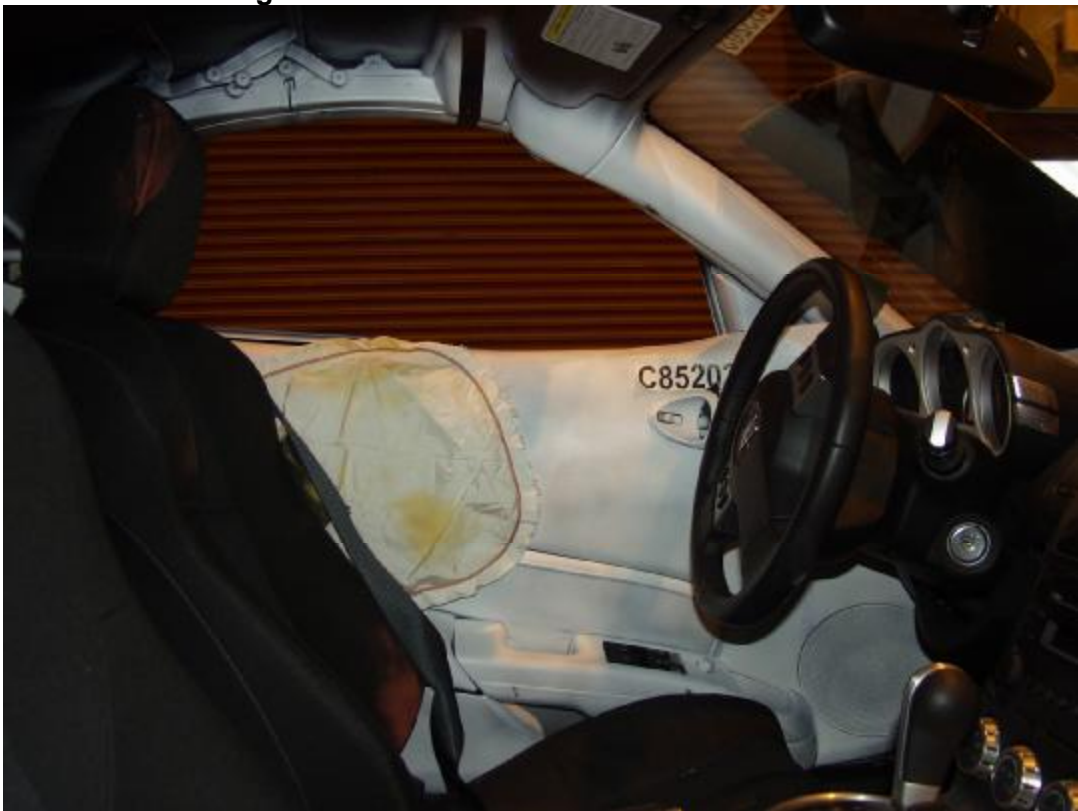
Figure A-40: Post-Test Left Front Interior Trim

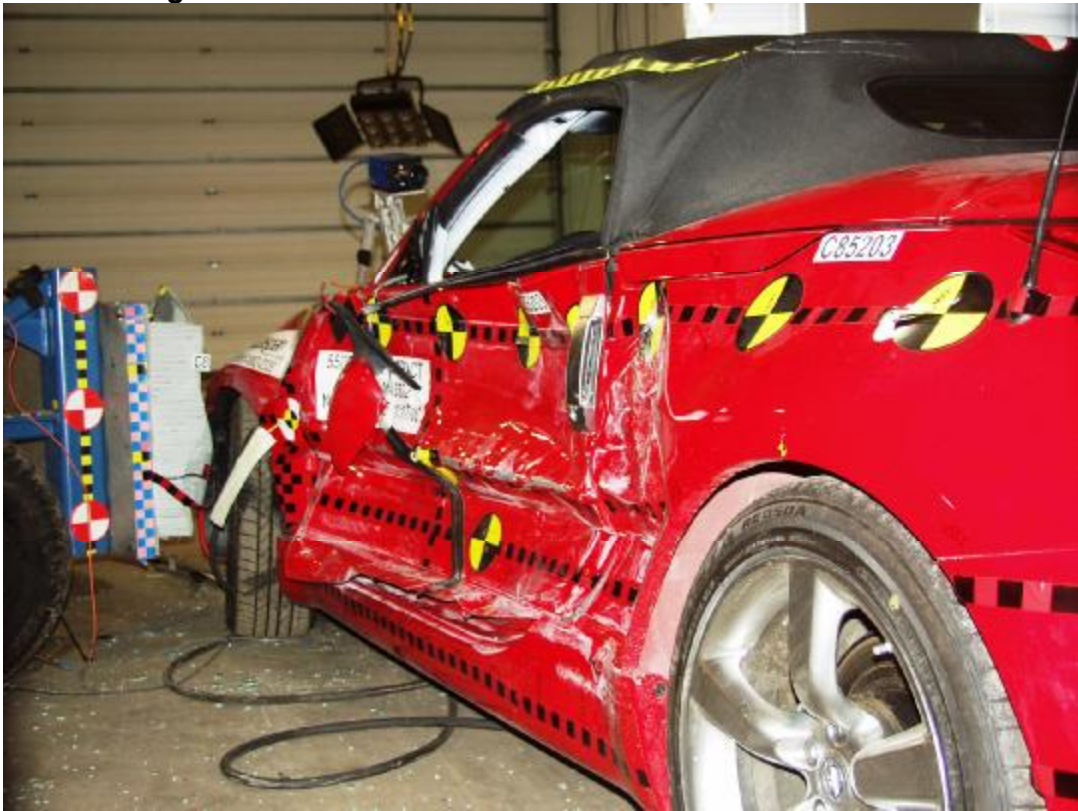
Figure A-44: Post-Test Left Rear $\frac{3}{4}$ View of Left Side Doors

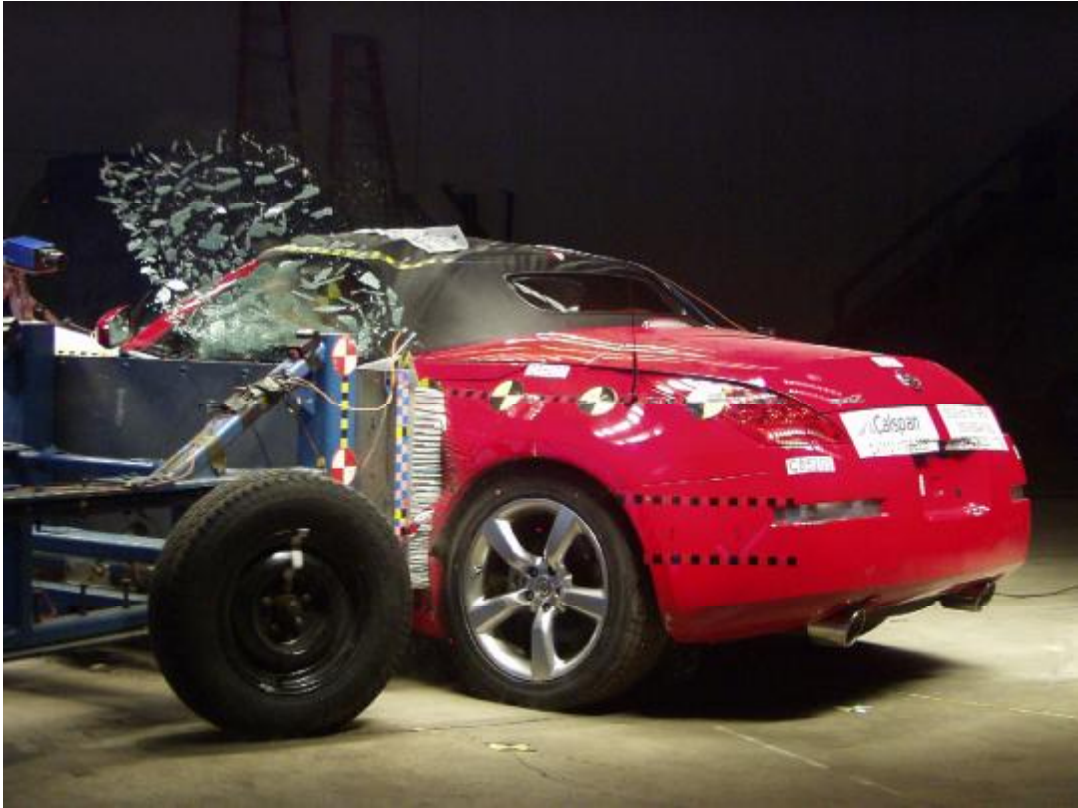
Figure A-49: Impact Photo
