**REPORT NUMBER: NCAP-MGA-2008-012**

**NEW CAR ASSESSMENT PROGRAM  
FRONTAL BARRIER IMPACT TEST**

**NISSAN MOTOR COMPANY, LTD.  
2008 INFINITI EX35 AWD JOURNEY  
NHTSA NUMBER: M85212**

**PREPARED BY:  
MGA RESEARCH CORPORATION  
5000 WARREN ROAD  
BURLINGTON, WI 53105**

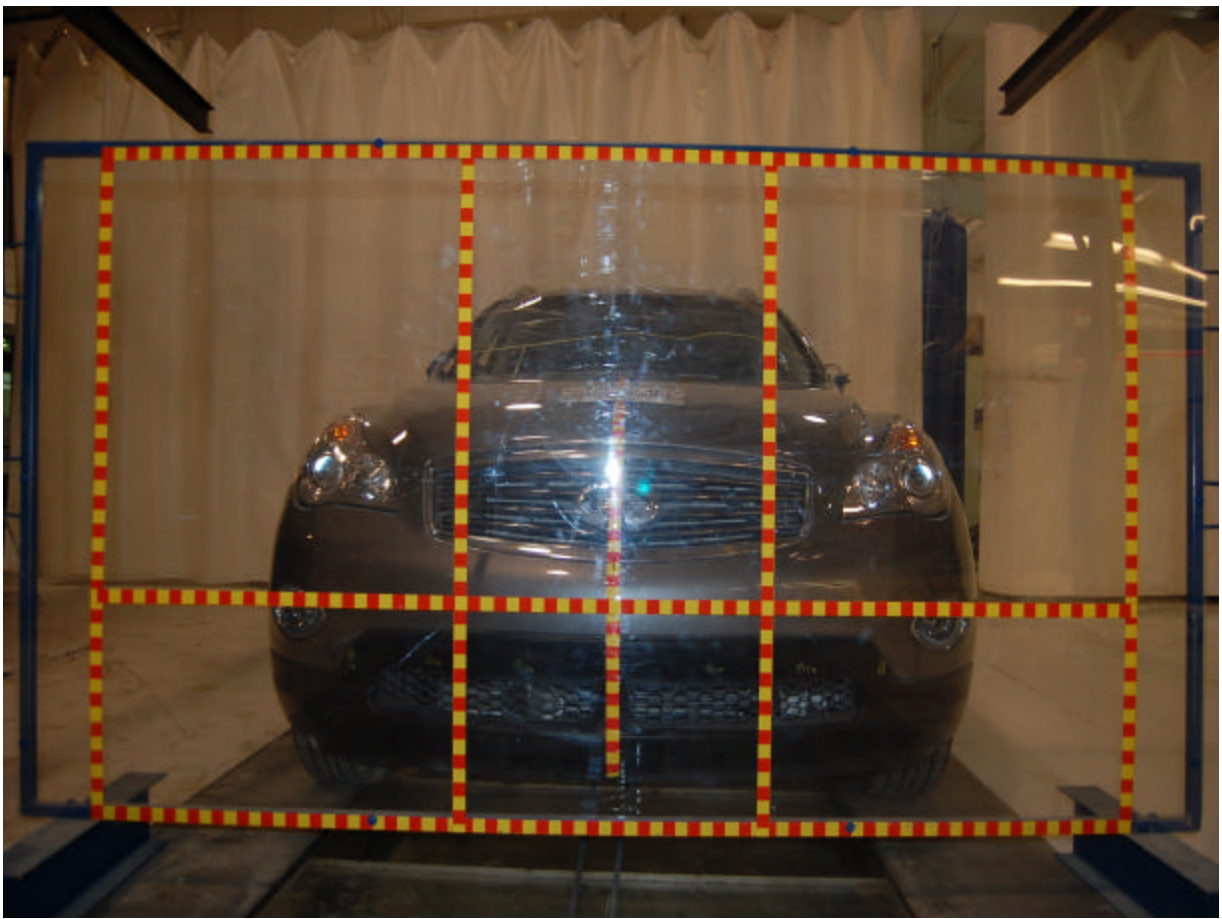
Load Cell Location

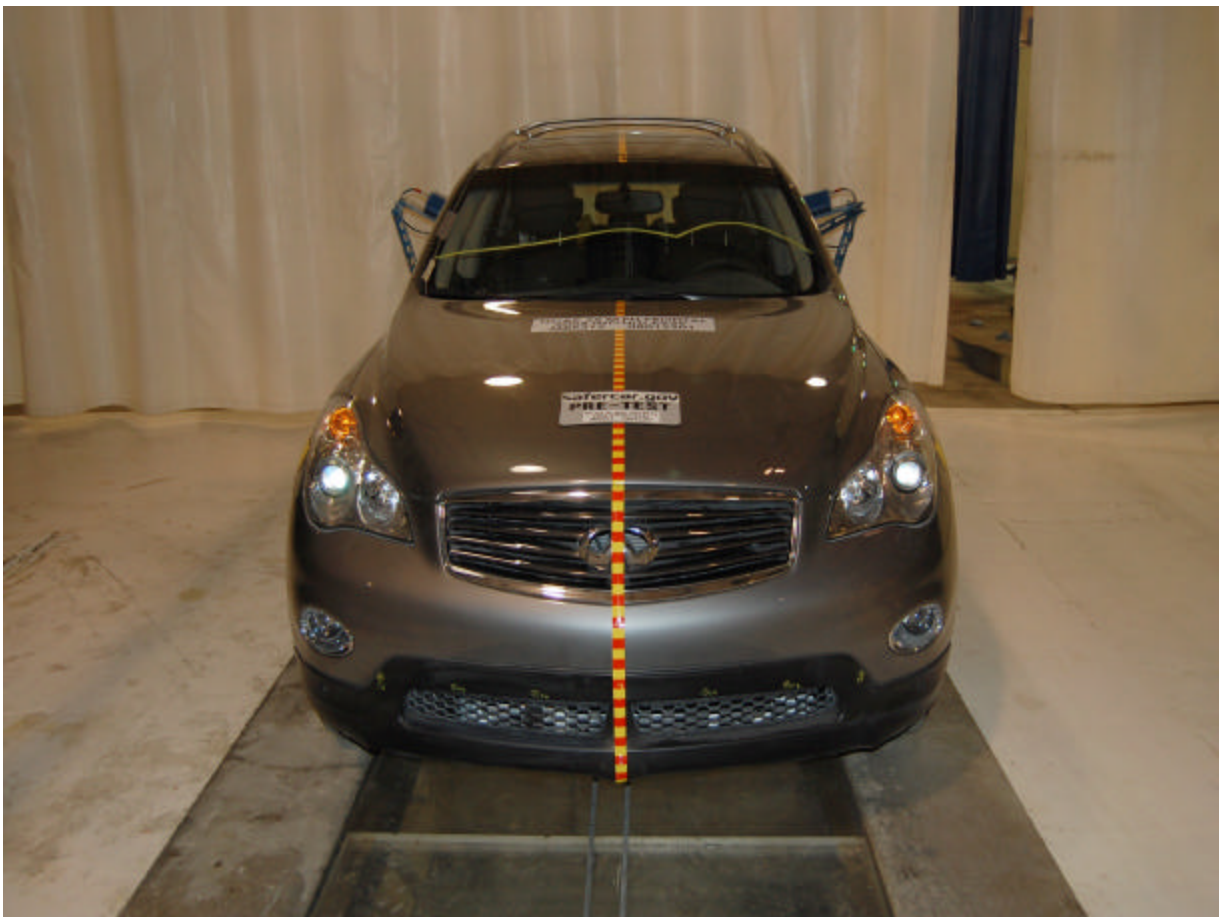
Pre-Test Front View

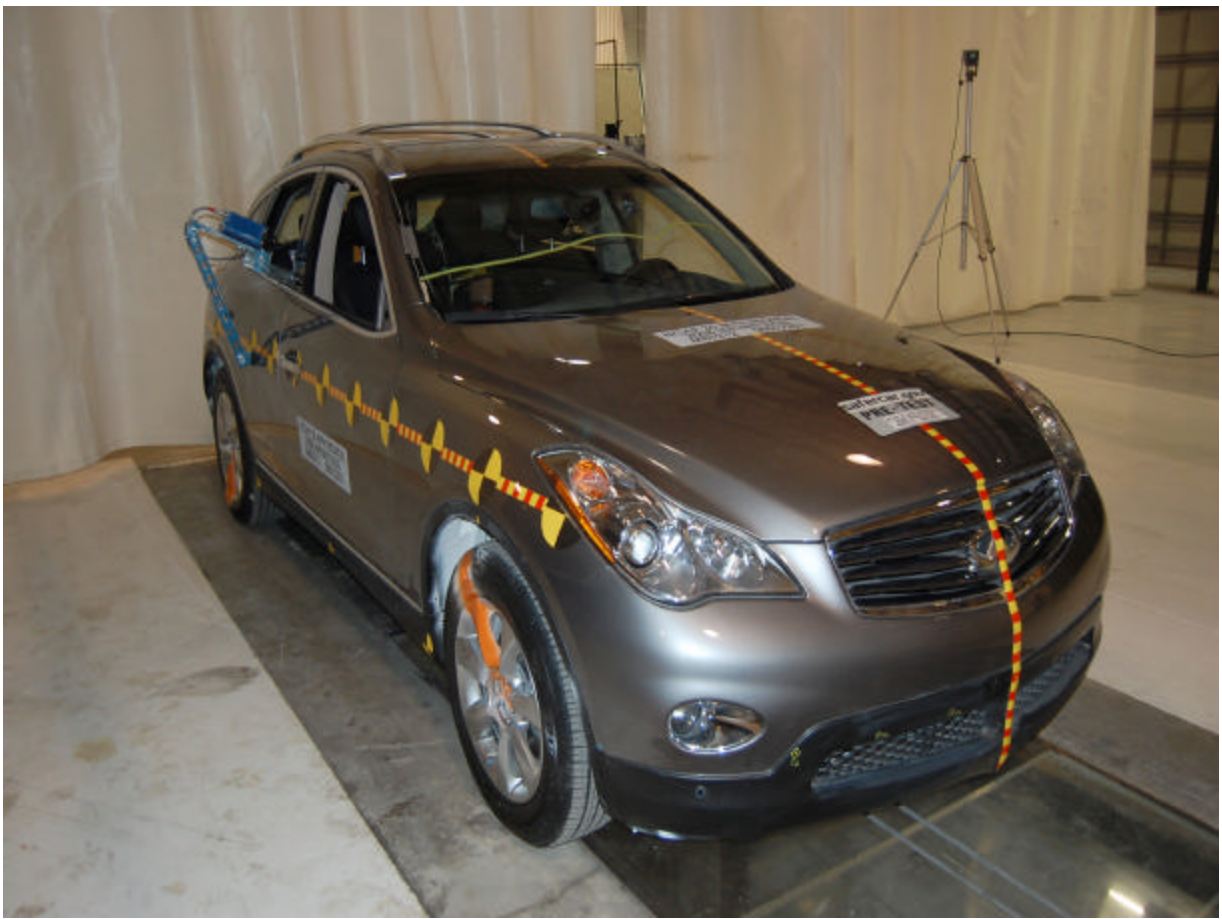
Pre-Test Right Front ¾ View

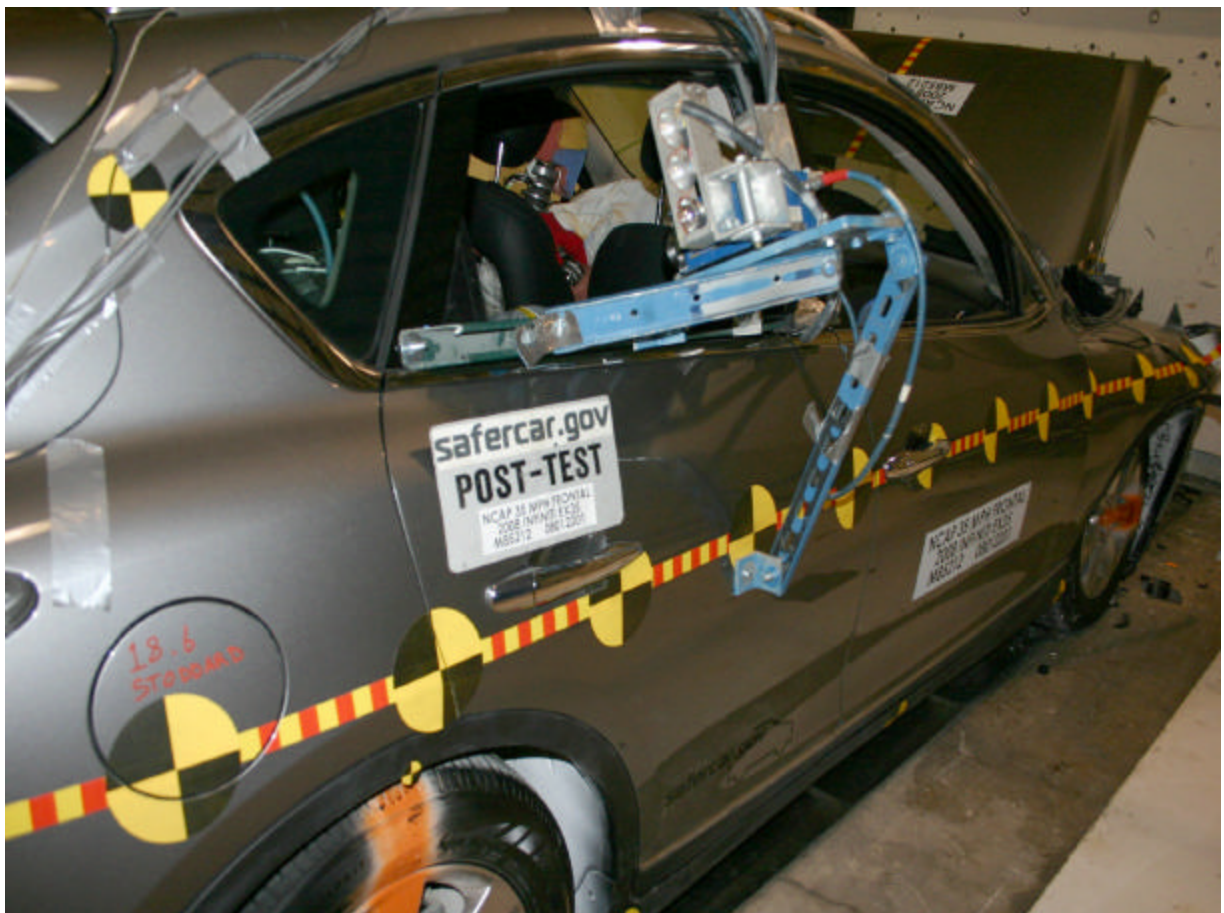
Post-Test Right Side 3/4 View of Doors After Impact

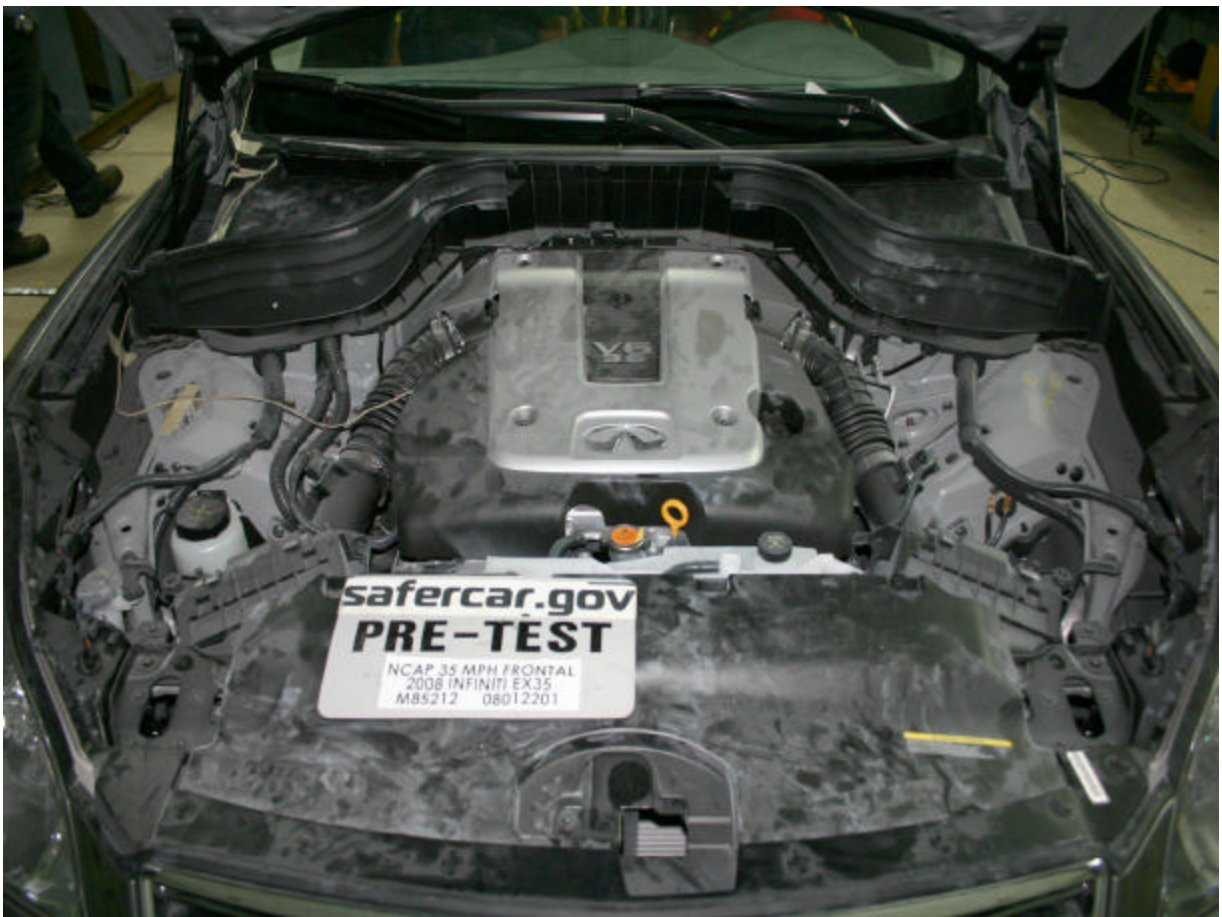
Pre-Test Engine Compartment View

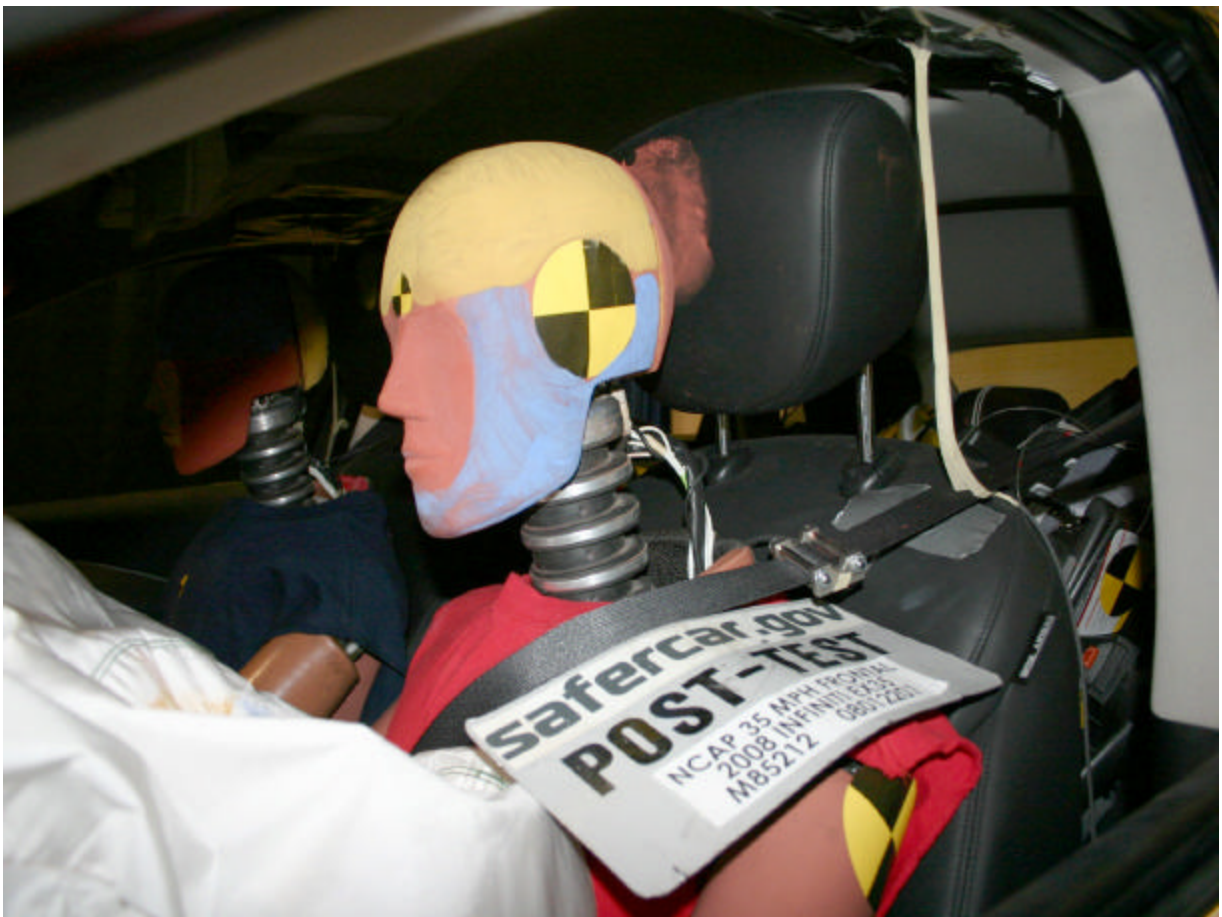
The driver's head and chest contacted the airbag. The driver's head also contacted the headrest. The driver's knees contacted the knee bolster. The passenger's head contacted the visor, headliner, dash, and headrest. The passenger's knees contacted the glove box.

Post-Test Driver Dummy Head Contact (Headrest)

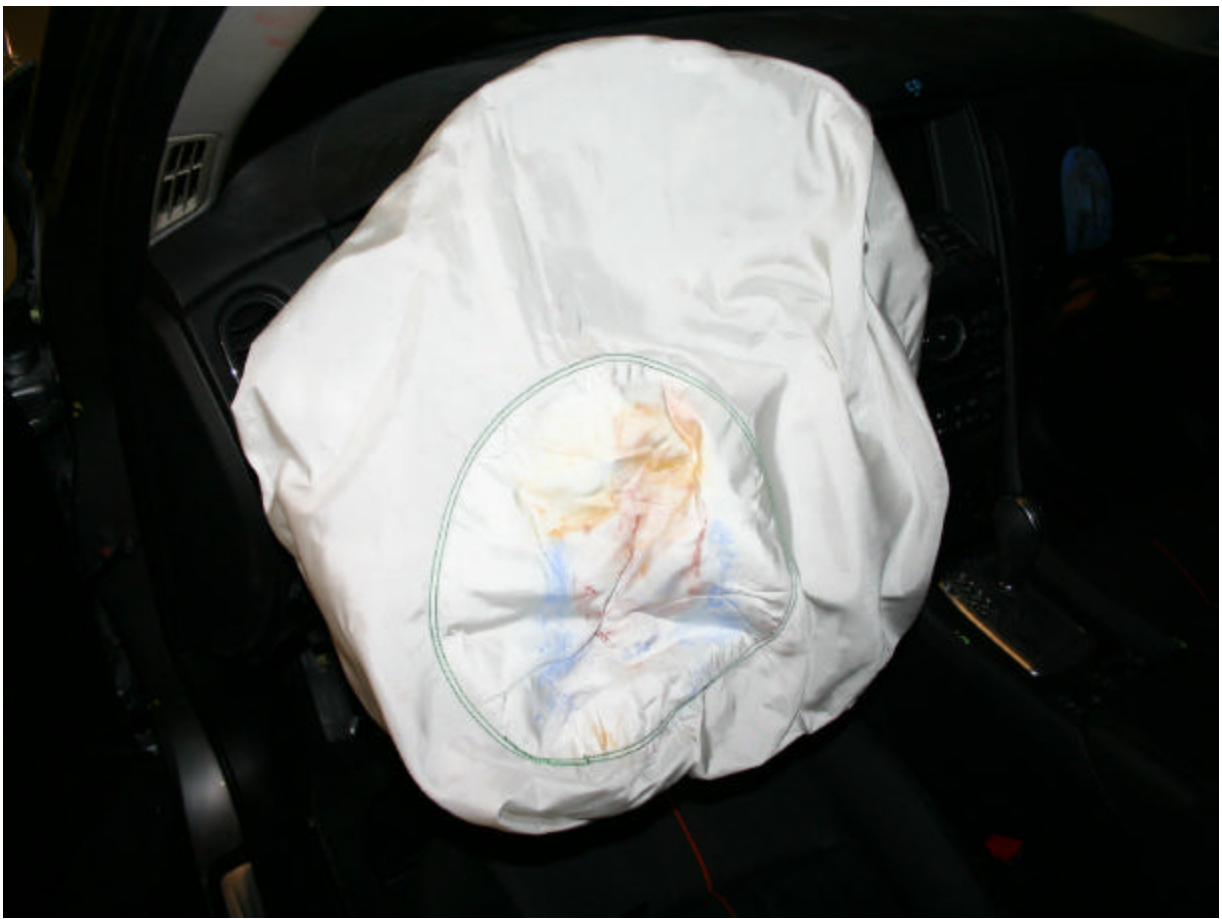
Post-Test Driver Dummy Airbag Contact

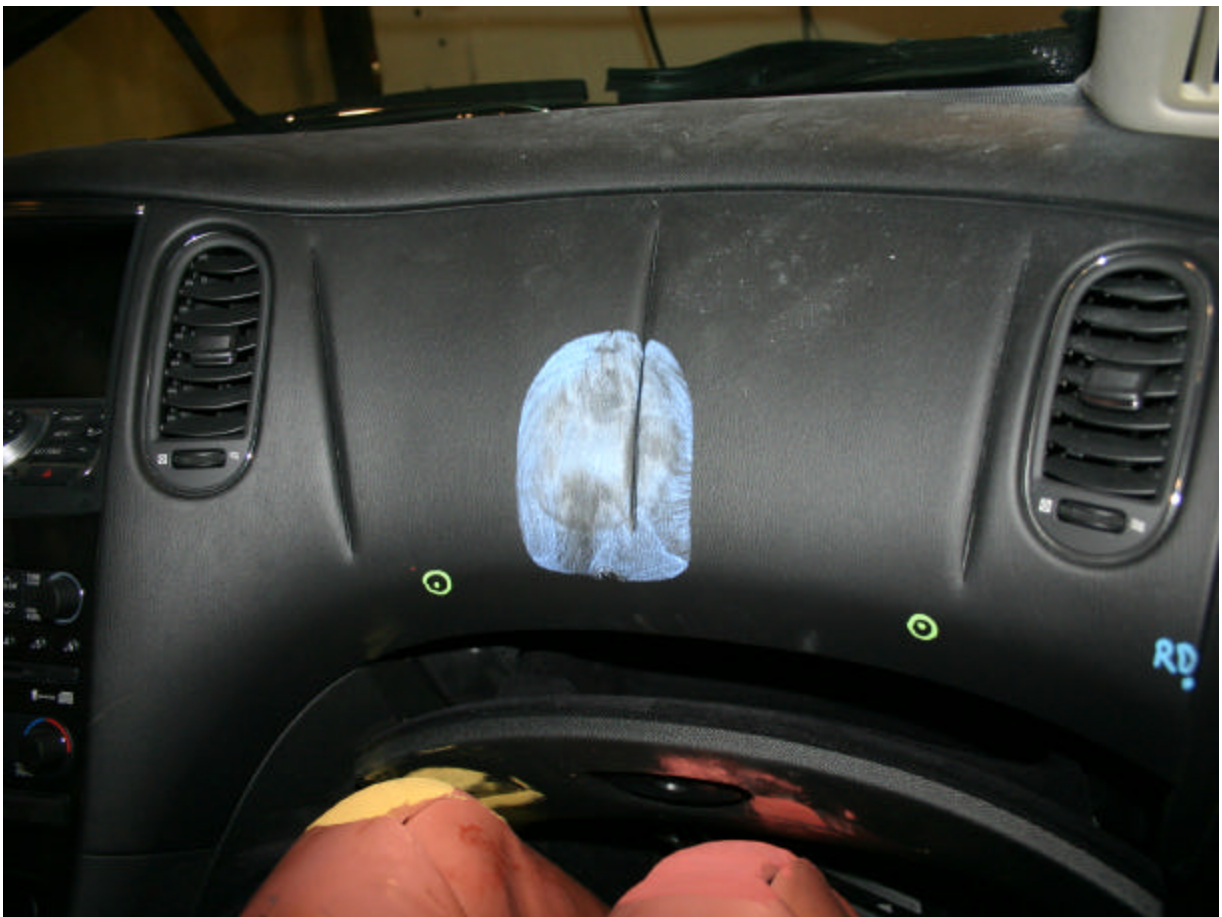
Post-Test Passenger Dummy Head Contact (Dash)
