REPORT NUMBER TR-P28001-16-NC

**NEW CAR ASSESMENT PROGRAM
FRONTAL BARRIER IMPACT TEST**

**TOYOTA MOTOR MANUFACTURING, INDIANA, INC.
2008 TOYOTA SEQUOIA SR5
5-DOOR MPV**

NHTSA NUMBER: M85115

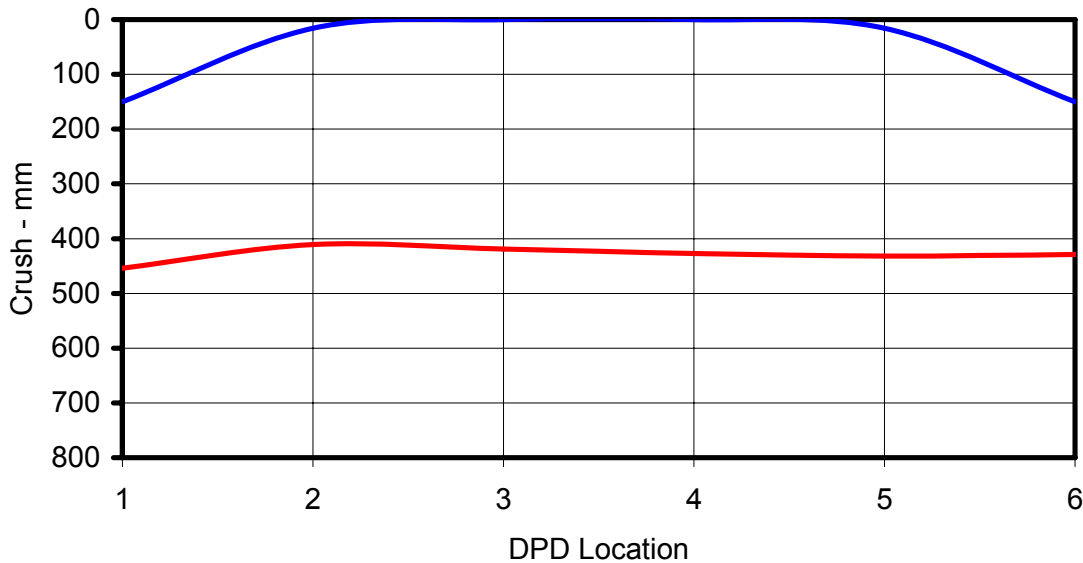
Collision Deformation Classification: 12FDEW6 Midpoint of Damage: Vehicle Centerline
 Damage Region Length: 1743 Impact Mode: Full frontal

No.	Measurement Description	Units	Pre-Test	Post-Test	Difference
C1	Crush zone 1 at left side of vehicle	mm	150	454	-304
C2	Crush zone 2 on left side of vehicle	mm	16	411	-395
C3	Crush zone 3 on left side of vehicle	mm	0	419	-419
C4	Crush zone 4 on right side of vehicle	mm	0	427	-427
C5	Crush zone 5 on right side of vehicle	mm	16	432	-416
C6	Crush zone 6 at right side of vehicle	mm	150	429	-279

The maximum static crush of the vehicle was 428 mm at the vehicle's centerline. Both the driver and passenger side doors remained closed and latched during the impact event, and were operable after the impact.

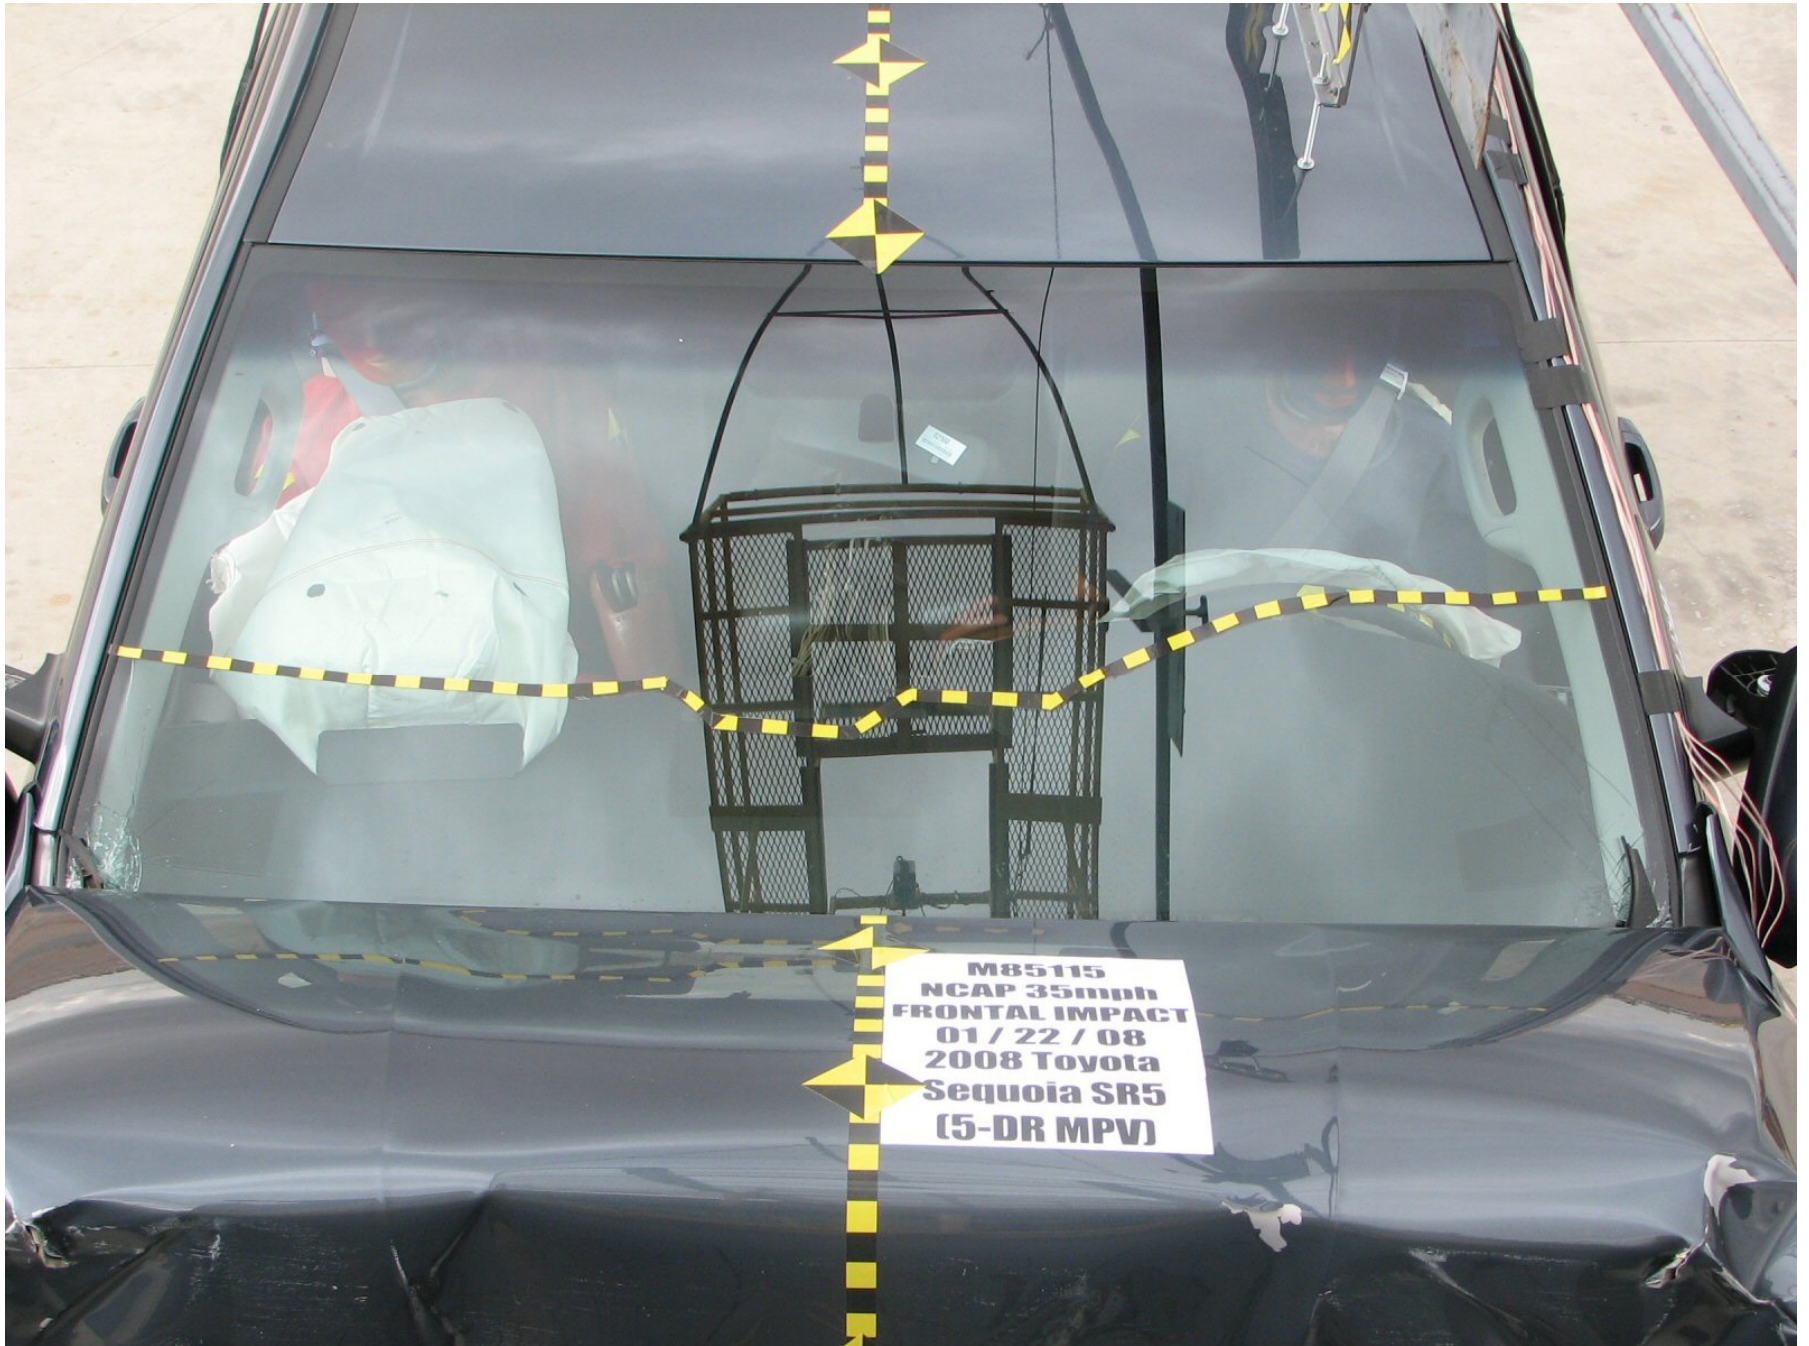
Figure A-19: Post-Test Windshield

There was 100% windshield retention and no intrusion into the protected zone of the windshield during impact. There was no Stoddard solvent leakage after the event, or during any phase of the static rollover.

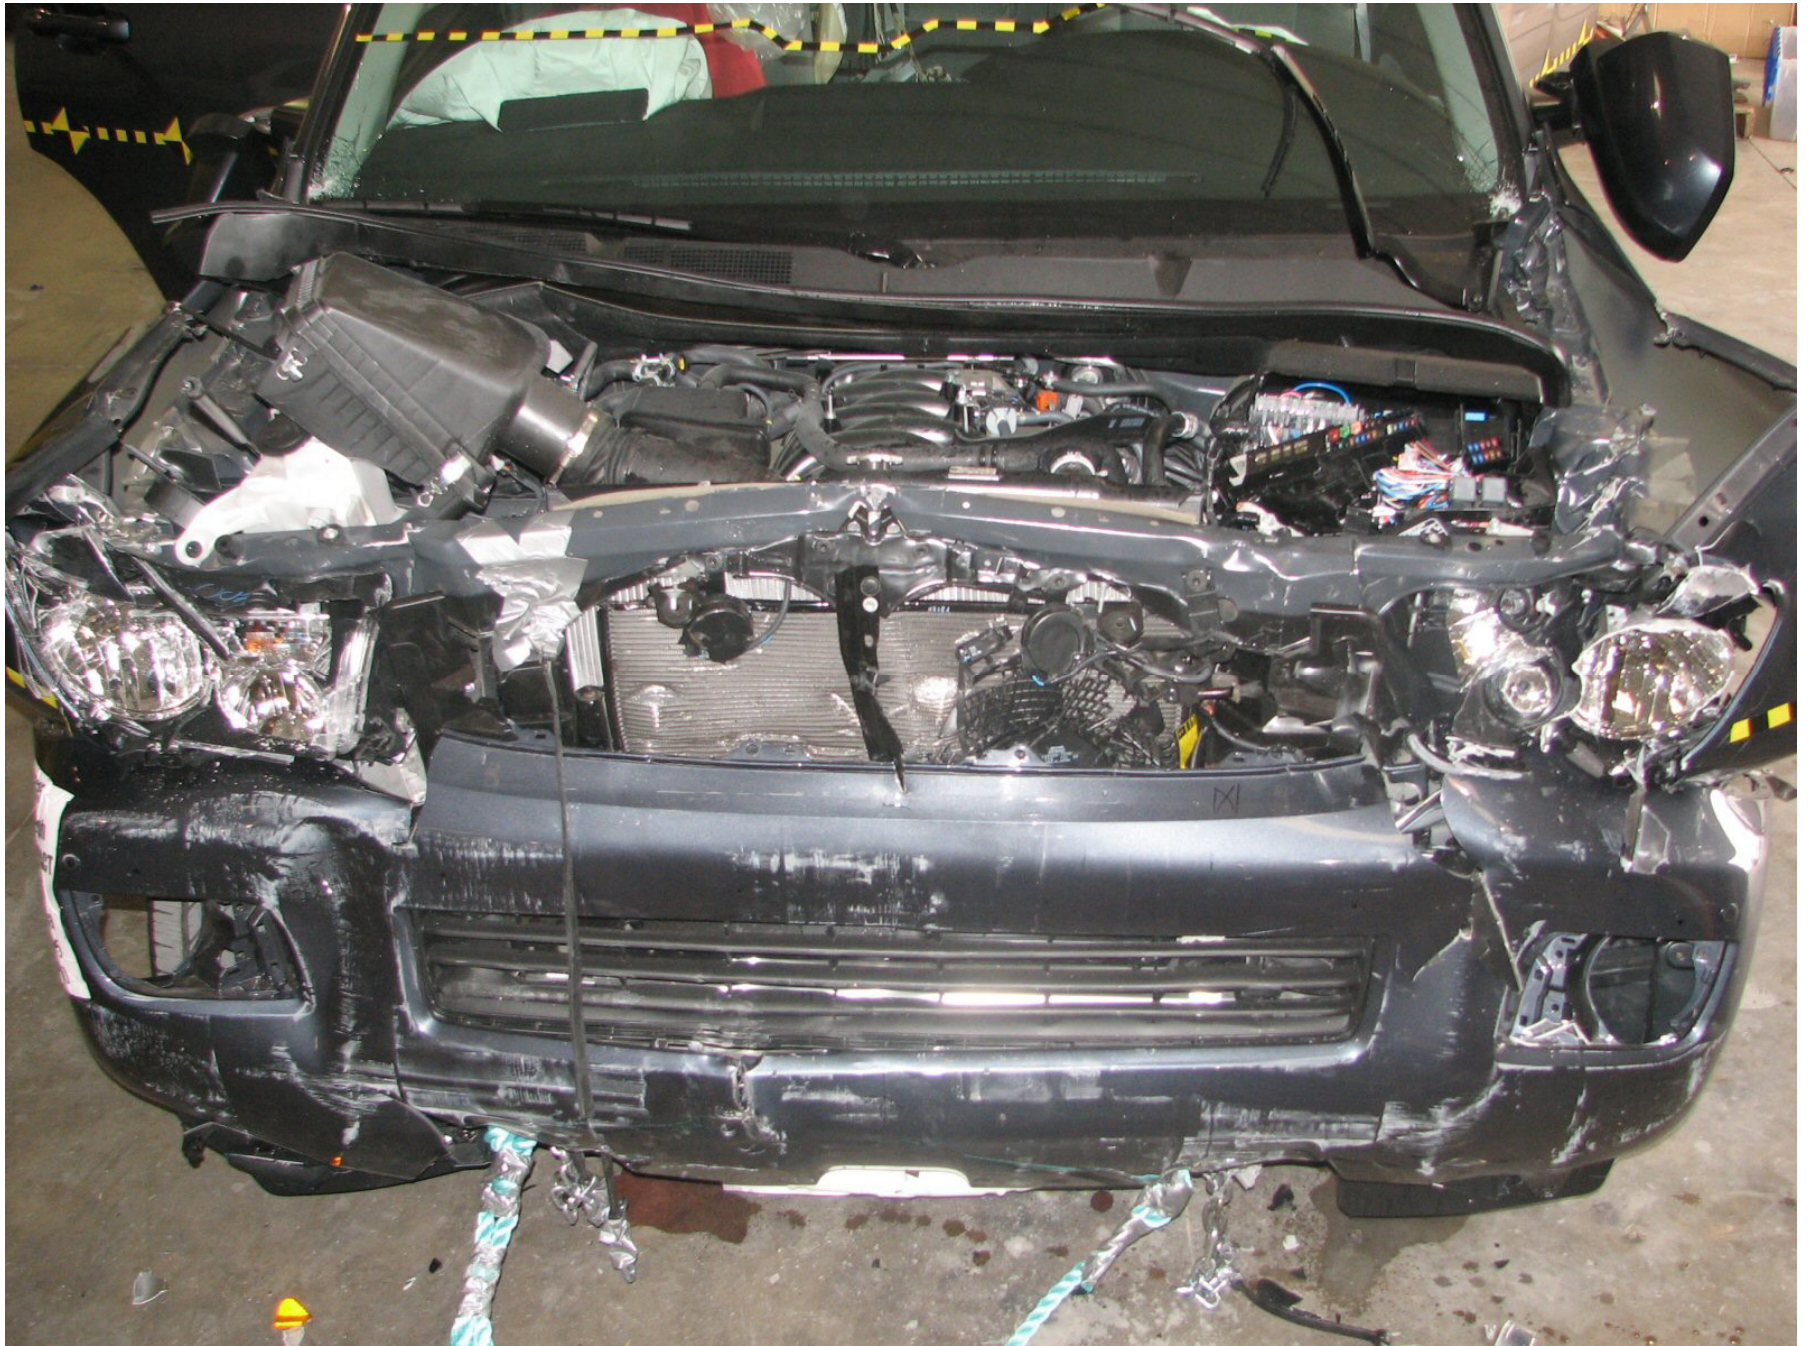
Figure A-21: Post-Test Engine Compartment (Vehicle Moved)

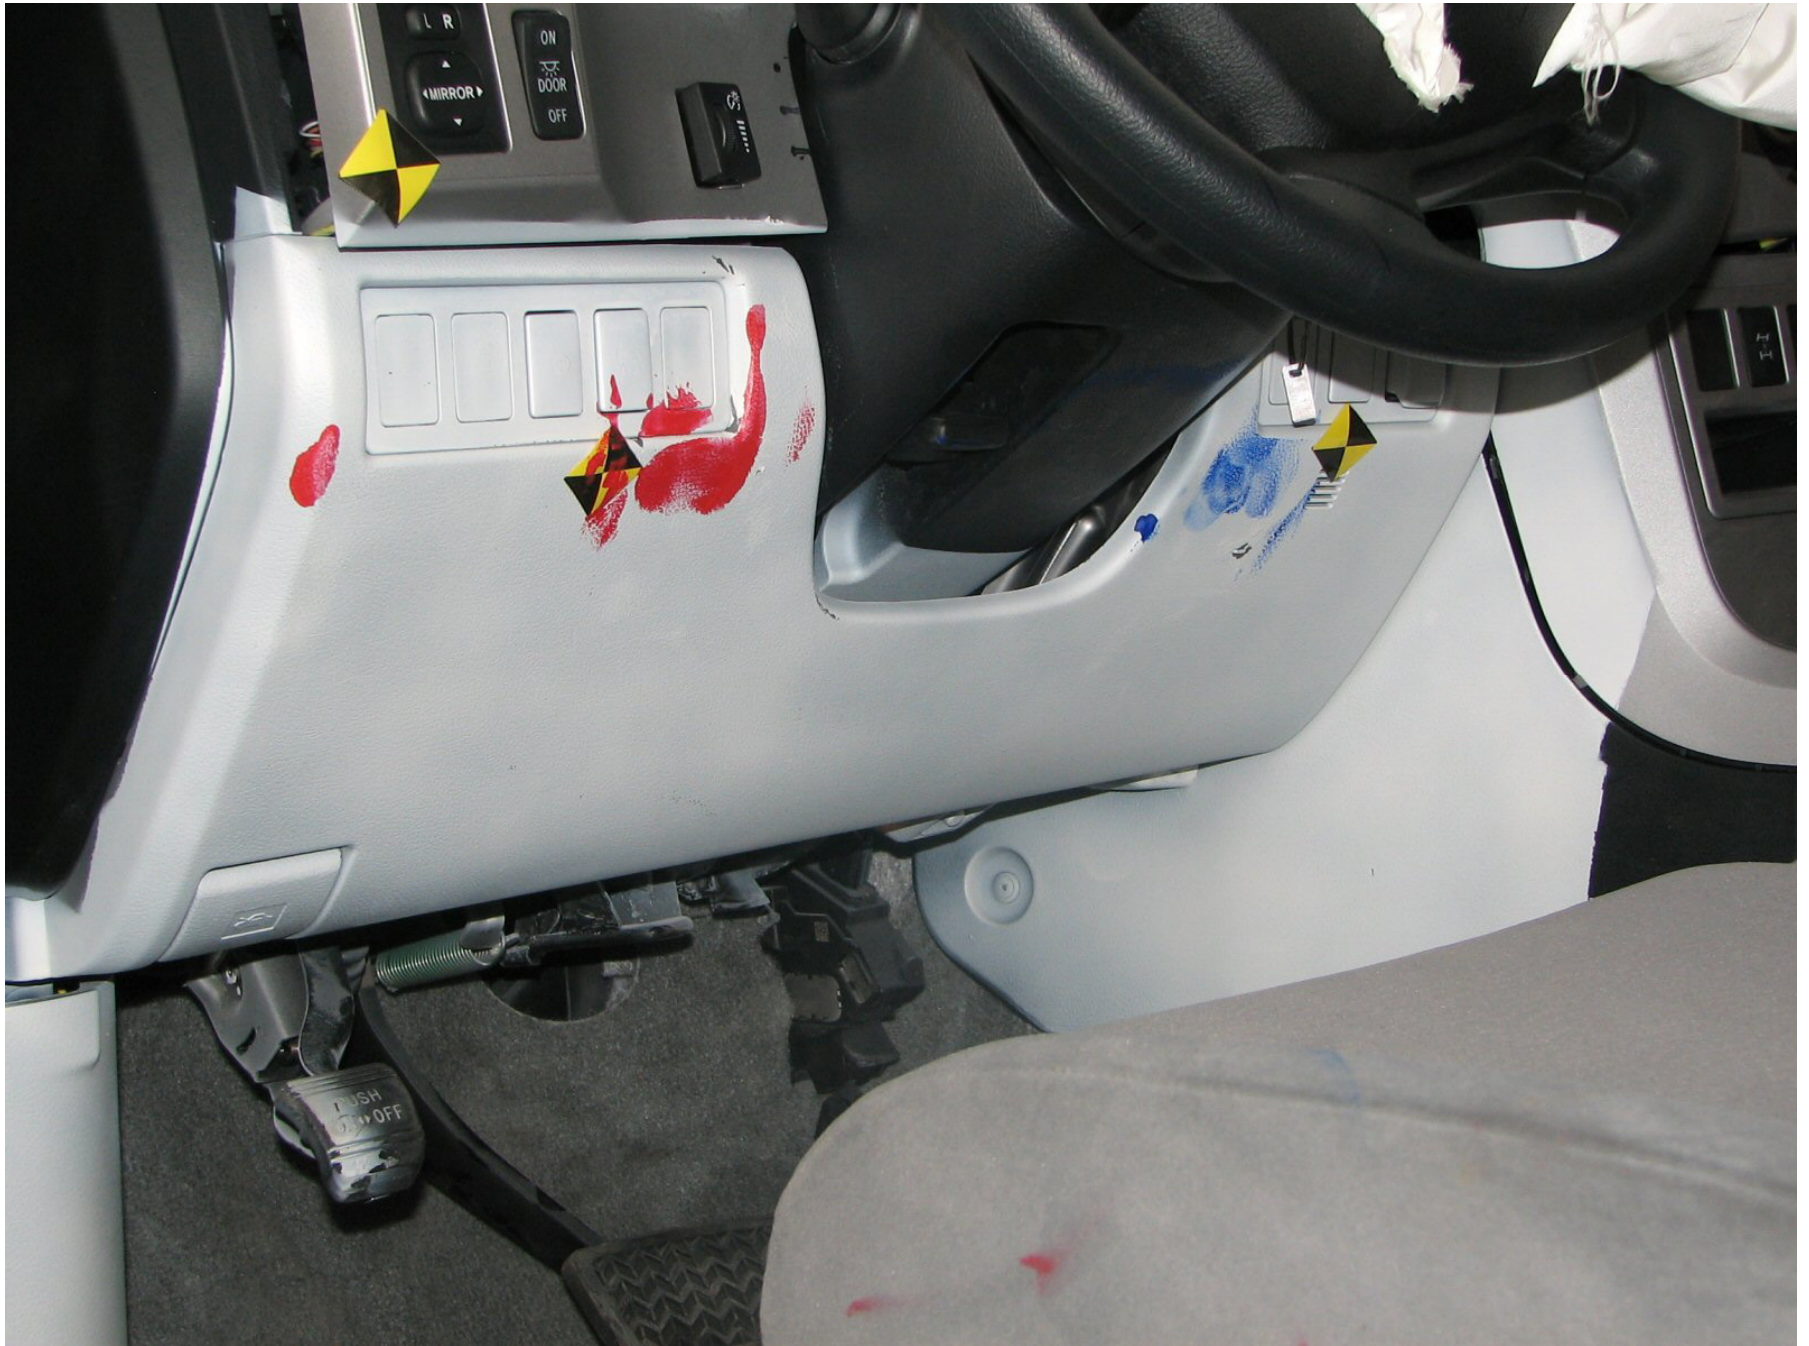
Figure A-39: Post-Test Driver Side Knee Bolster

The driver's visible contact points were as follows: The driver ATD's head, chest, and abdomen contacted the airbag. The head also contacted the headrest. Both knees contacted the bolster.

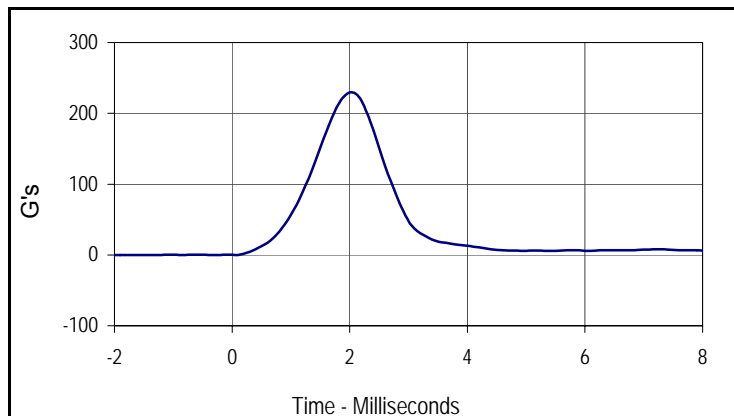
Tested Parameter	Units	Specification	Result	Pass/Fail
Laboratory Temperature	°C	18.9 to 25.6	21.1	Pass
Laboratory Relative Humidity	%	10 to 70	30	Pass
Peak Resultant Acceleration	G's	225.0 to 275.0	229.5	Pass
Peak Lateral Acceleration	G's	≤15.0	4.0	Pass
Is Acceleration Unimodal?	Yes/No	Yes	Yes	Pass
Overall Test Results			Pass

Curve Description			
Head Resultant			
CURNO	Type	SAE Class	Units
001	RES	1000	G's
Max	Time	Min	Time
229.5	2.0	0.0	-1.3

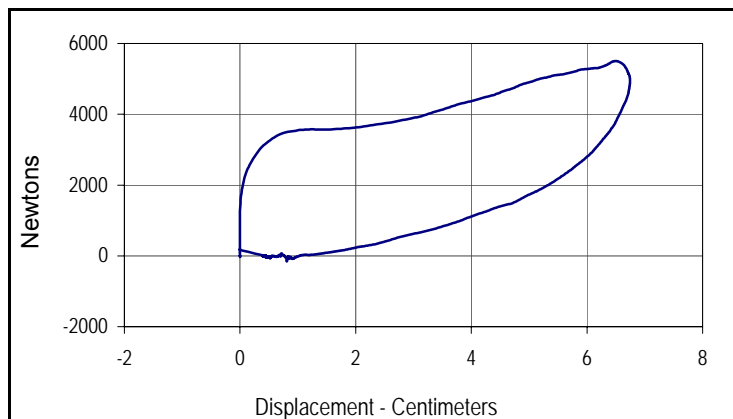
Tested Parameter	Units	Specification	Result	Pass/Fail
Laboratory Temperature	°C	20.6 to 22.2	21.1	Pass
Laboratory Relative Humidity	%	10 to 70	30	Pass
Probe Velocity	m/s	6.58 to 6.82	6.68	Pass
Peak Probe Force	Newtons	5159 to 5893	5503	Pass
Peak Sternum Deflection	CM	6.35 to 7.26	6.75	Pass
Internal Hysteresis	%	69 to 85	72.9	Pass
Overall Test Results				Pass

Curve Description			
Probe Force vs. Chest Deflection			
CURNO	Type	SAE Class	Hysteresis
001	FIL	180	72.9
Peak Probe Force		Peak Chest Deflection	
5503		6.75

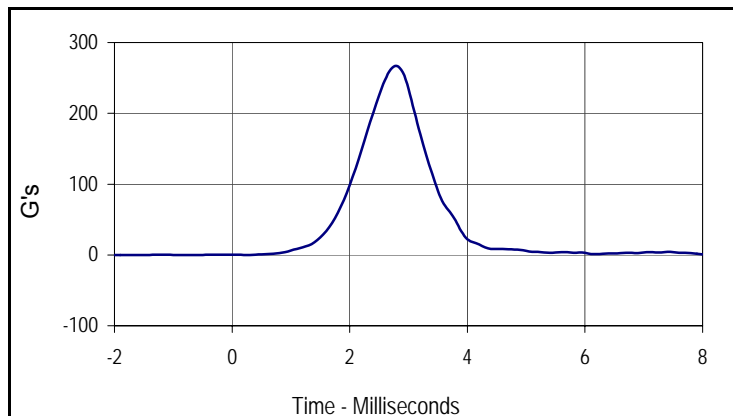
Tested Parameter	Units	Specification	Result	Pass/Fail
Laboratory Temperature	°C	18.9 to 25.6	21.1	Pass
Laboratory Relative Humidity	%	10 to 70	30	Pass
Peak Resultant Acceleration	G's	225.0 to 275.0	267.2	Pass
Peak Lateral Acceleration	G's	≤15.0	7.6	Pass
Is Acceleration Unimodal?	Yes/No	Yes	Yes	Pass
Overall Test Results			Pass

Curve Description			
Head Resultant			
CURNO	Type	SAE Class	Units
001	RES	1000	G's
Max	Time	Min	Time
267.2	2.8	0.0	-1.9

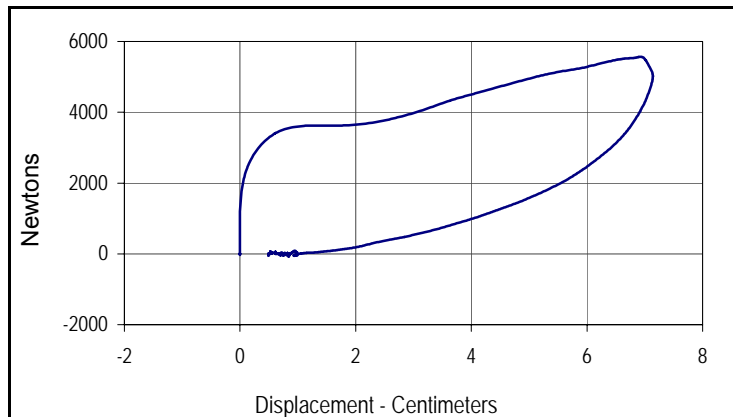
Tested Parameter	Units	Specification	Result	Pass/Fail
Laboratory Temperature	°C	20.6 to 22.2	21.1	Pass
Laboratory Relative Humidity	%	10 to 70	30	Pass
Probe Velocity	m/s	6.58 to 6.82	6.63	Pass
Peak Probe Force	Newtons	5159 to 5893	5565	Pass
Peak Sternum Deflection	CM	6.35 to 7.26	7.14	Pass
Internal Hysteresis	%	69 to 85	73.0	Pass
Overall Test Results				Pass

Curve Description			
Probe Force vs. Chest Deflection			
CURNO	Type	SAE Class	Hysteresis
001	FIL	180	73.0
Peak Probe Force		Peak Chest Deflection	
5565		7.14
