**REPORT NUMBER: T8001-MGA-2008-002**

**VEHICLE TO DEFORMABLE BARRIER CRASH TESTS  
IN SUPPORT OF NHTSA OFFSET FRONTAL PROGRAM**

**LEFT 40% OFFSET DEFORMABLE BARRIER IMPACT  
R94 BARRIER**

**2008 CHEVROLET AVEO LS 4-DOOR (R80173)**

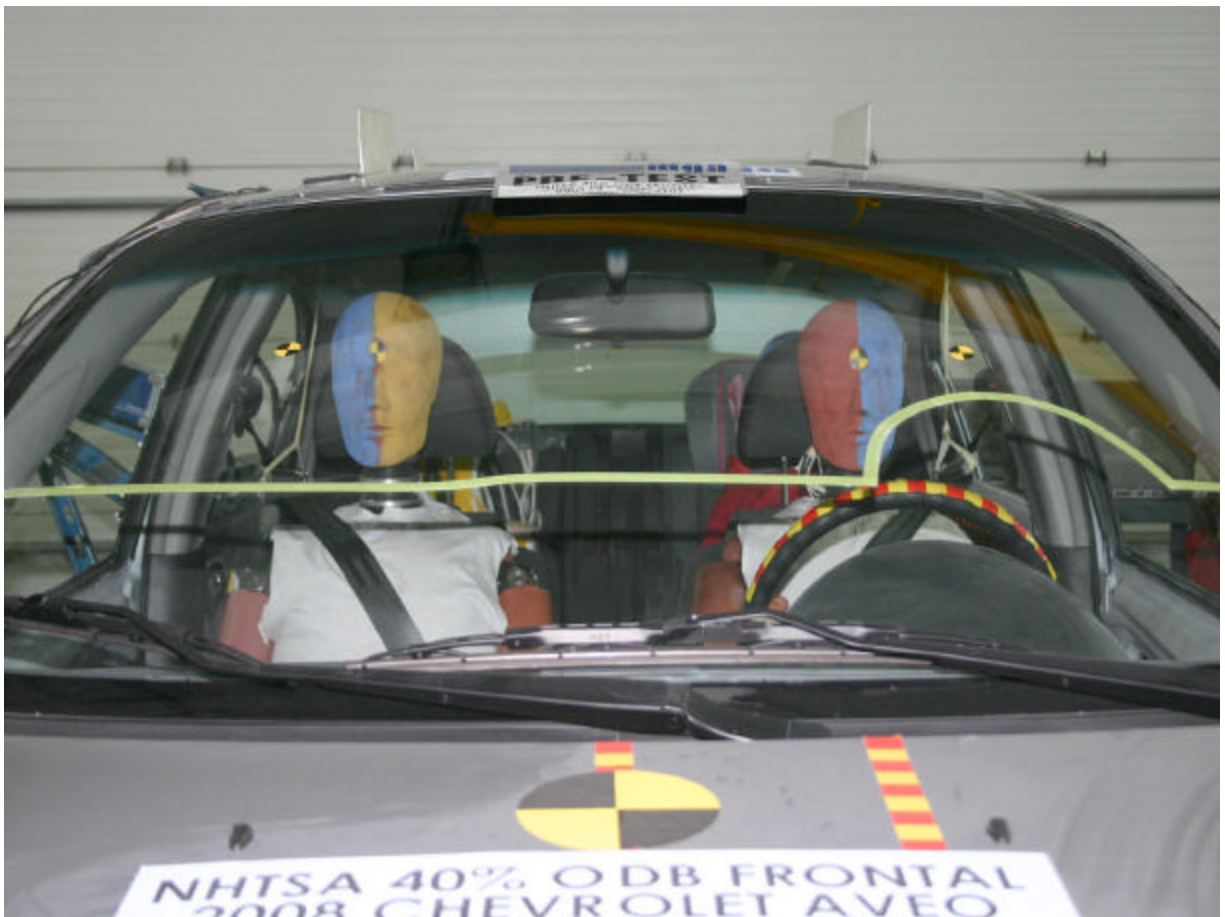
Pre-Test Windshield View

Post-Test Windshield View

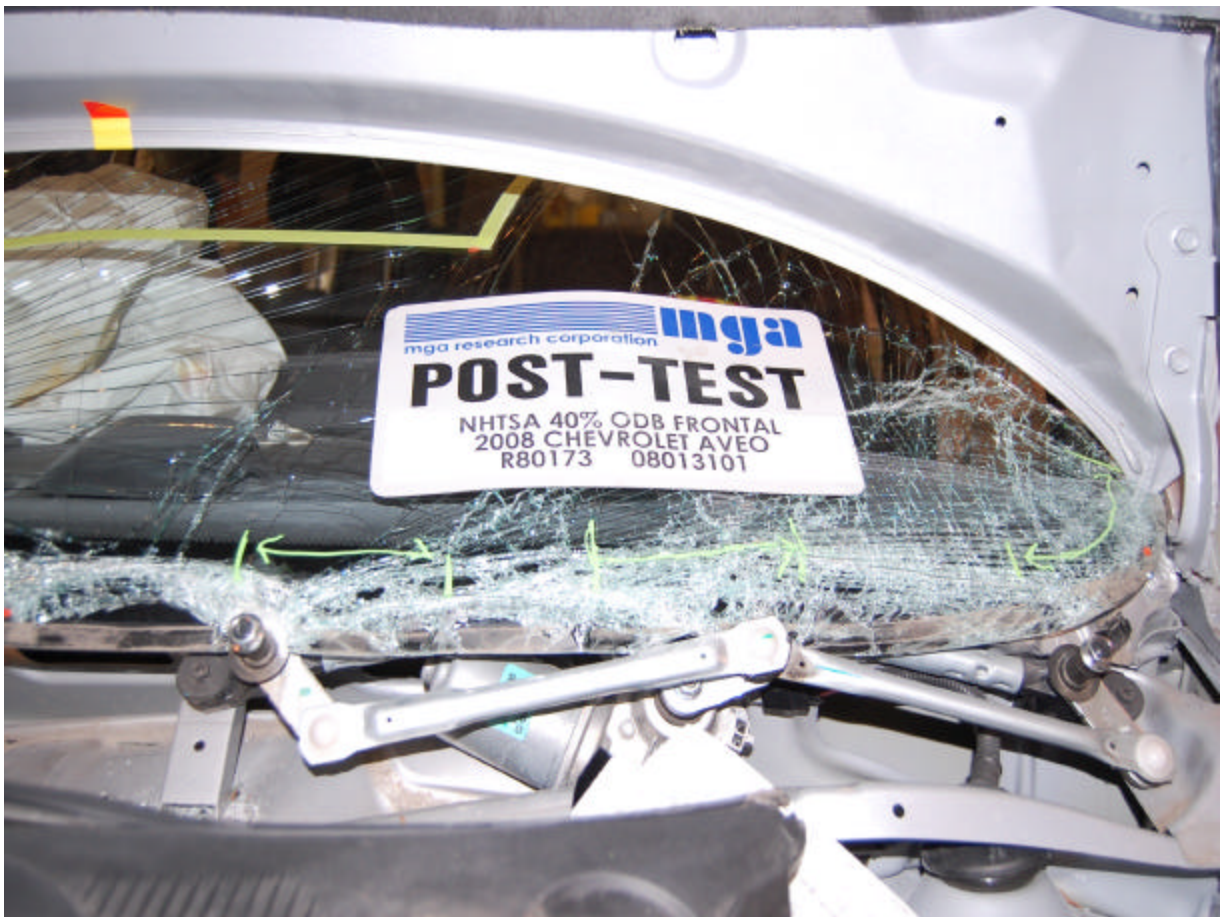
Post-Test Windshield Damage

| Description | Left Side | Right Side |
|---|---|---|
| Glazing Damage | The windshield cracked. | |

| | | <u>Page No.</u> |
|---|---|---|
| Photo No. 177. | Post-Test Windshield Damage | A-91 |
