**REPORT NUMBER TR-P28048-01-NC**

**NEW CAR ASSESMENT PROGRAM  
FRONTAL BARRIER IMPACT TEST**

**NISSAN MOTOR CO., LTD.  
2008 INFINITI EX35 AWD  
5-DOOR HATCHBACK**

**NHTSA NUMBER: N85202**

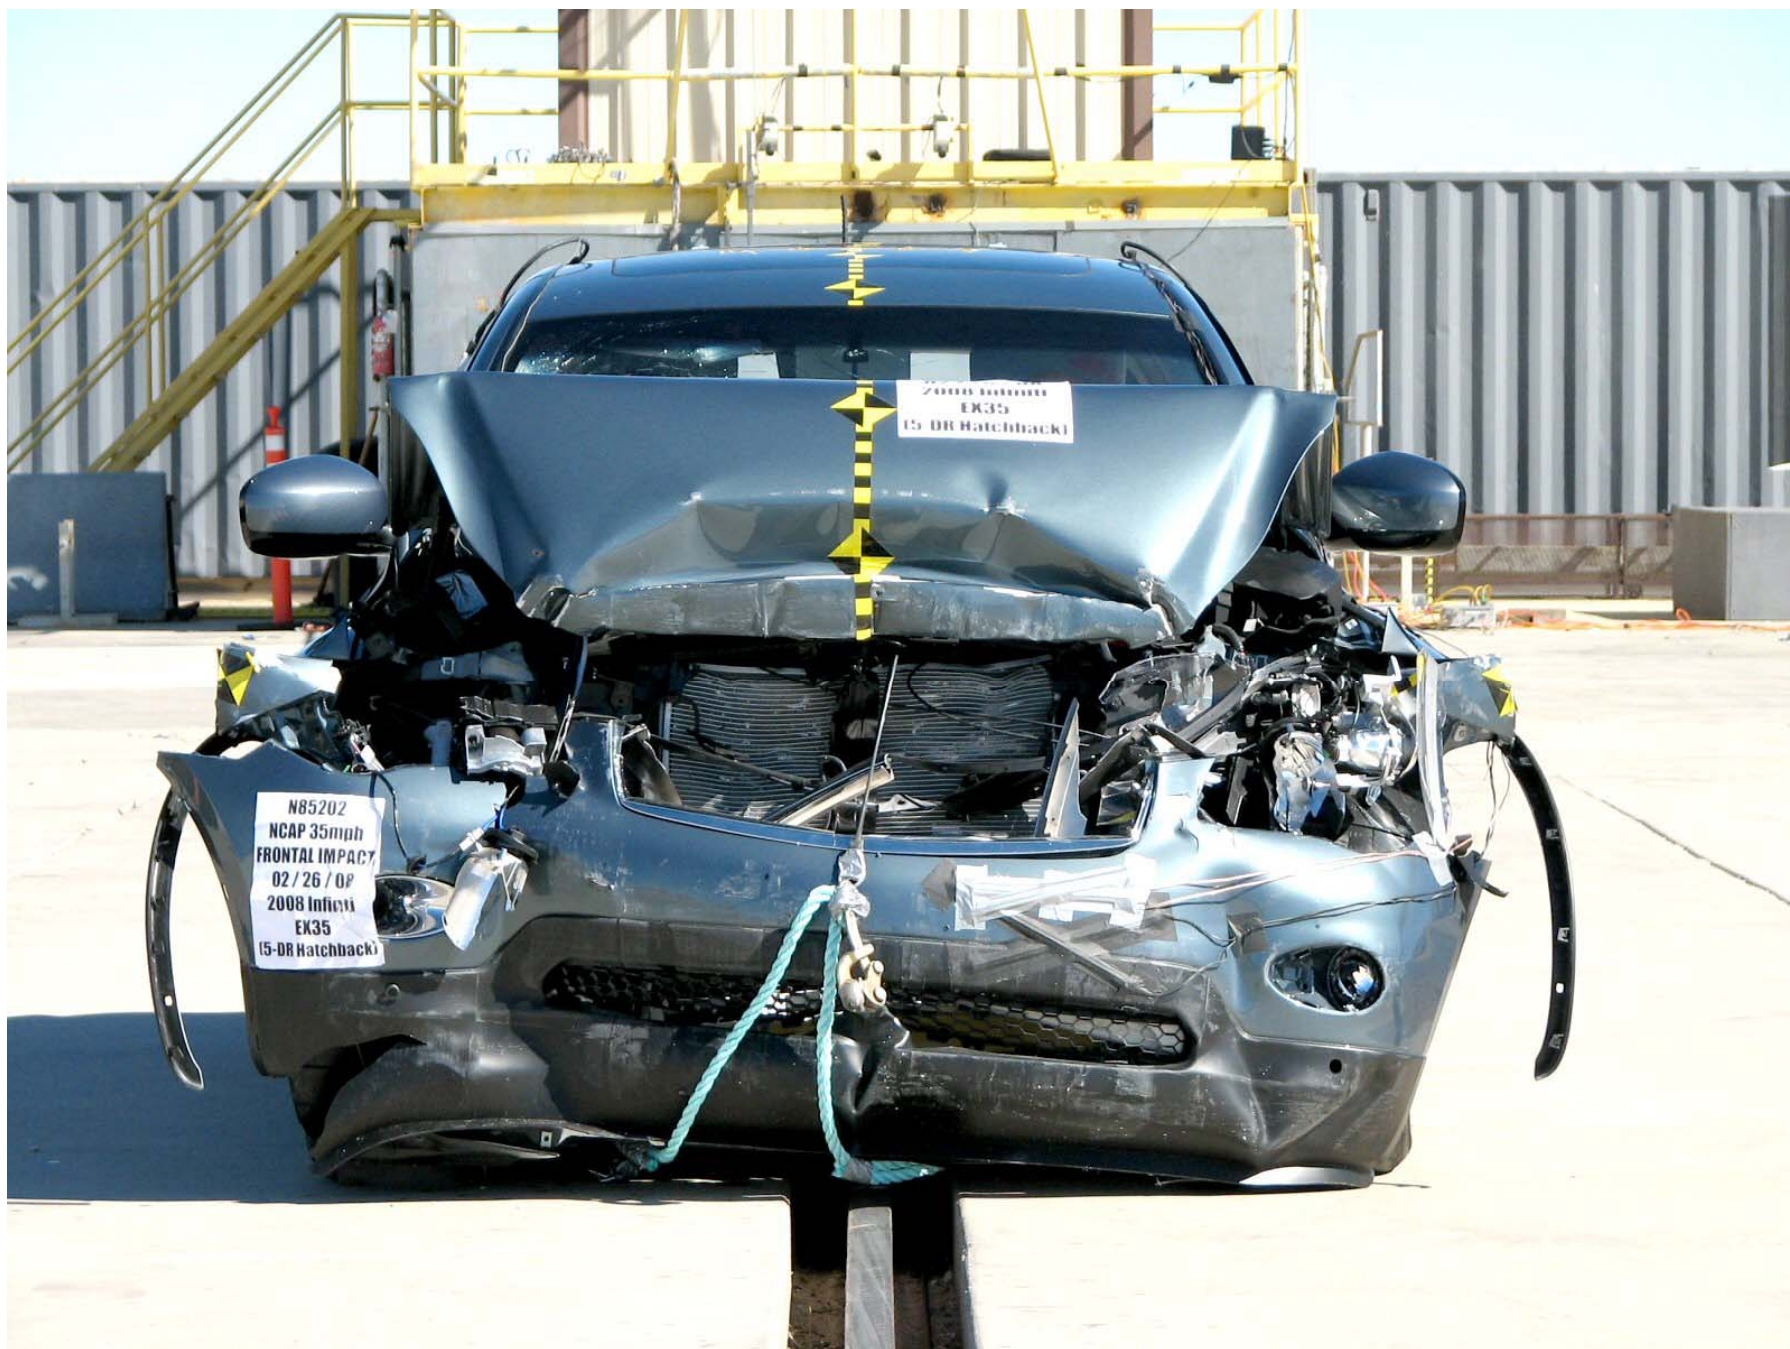
Figure A-7: Post-Test Front View (Vehicle Moved)

The maximum static crush of the vehicle was 495 mm at the vehicle's centerline. Both the driver and passenger side doors remained closed and latched during the impact event, and were operable after the impact.

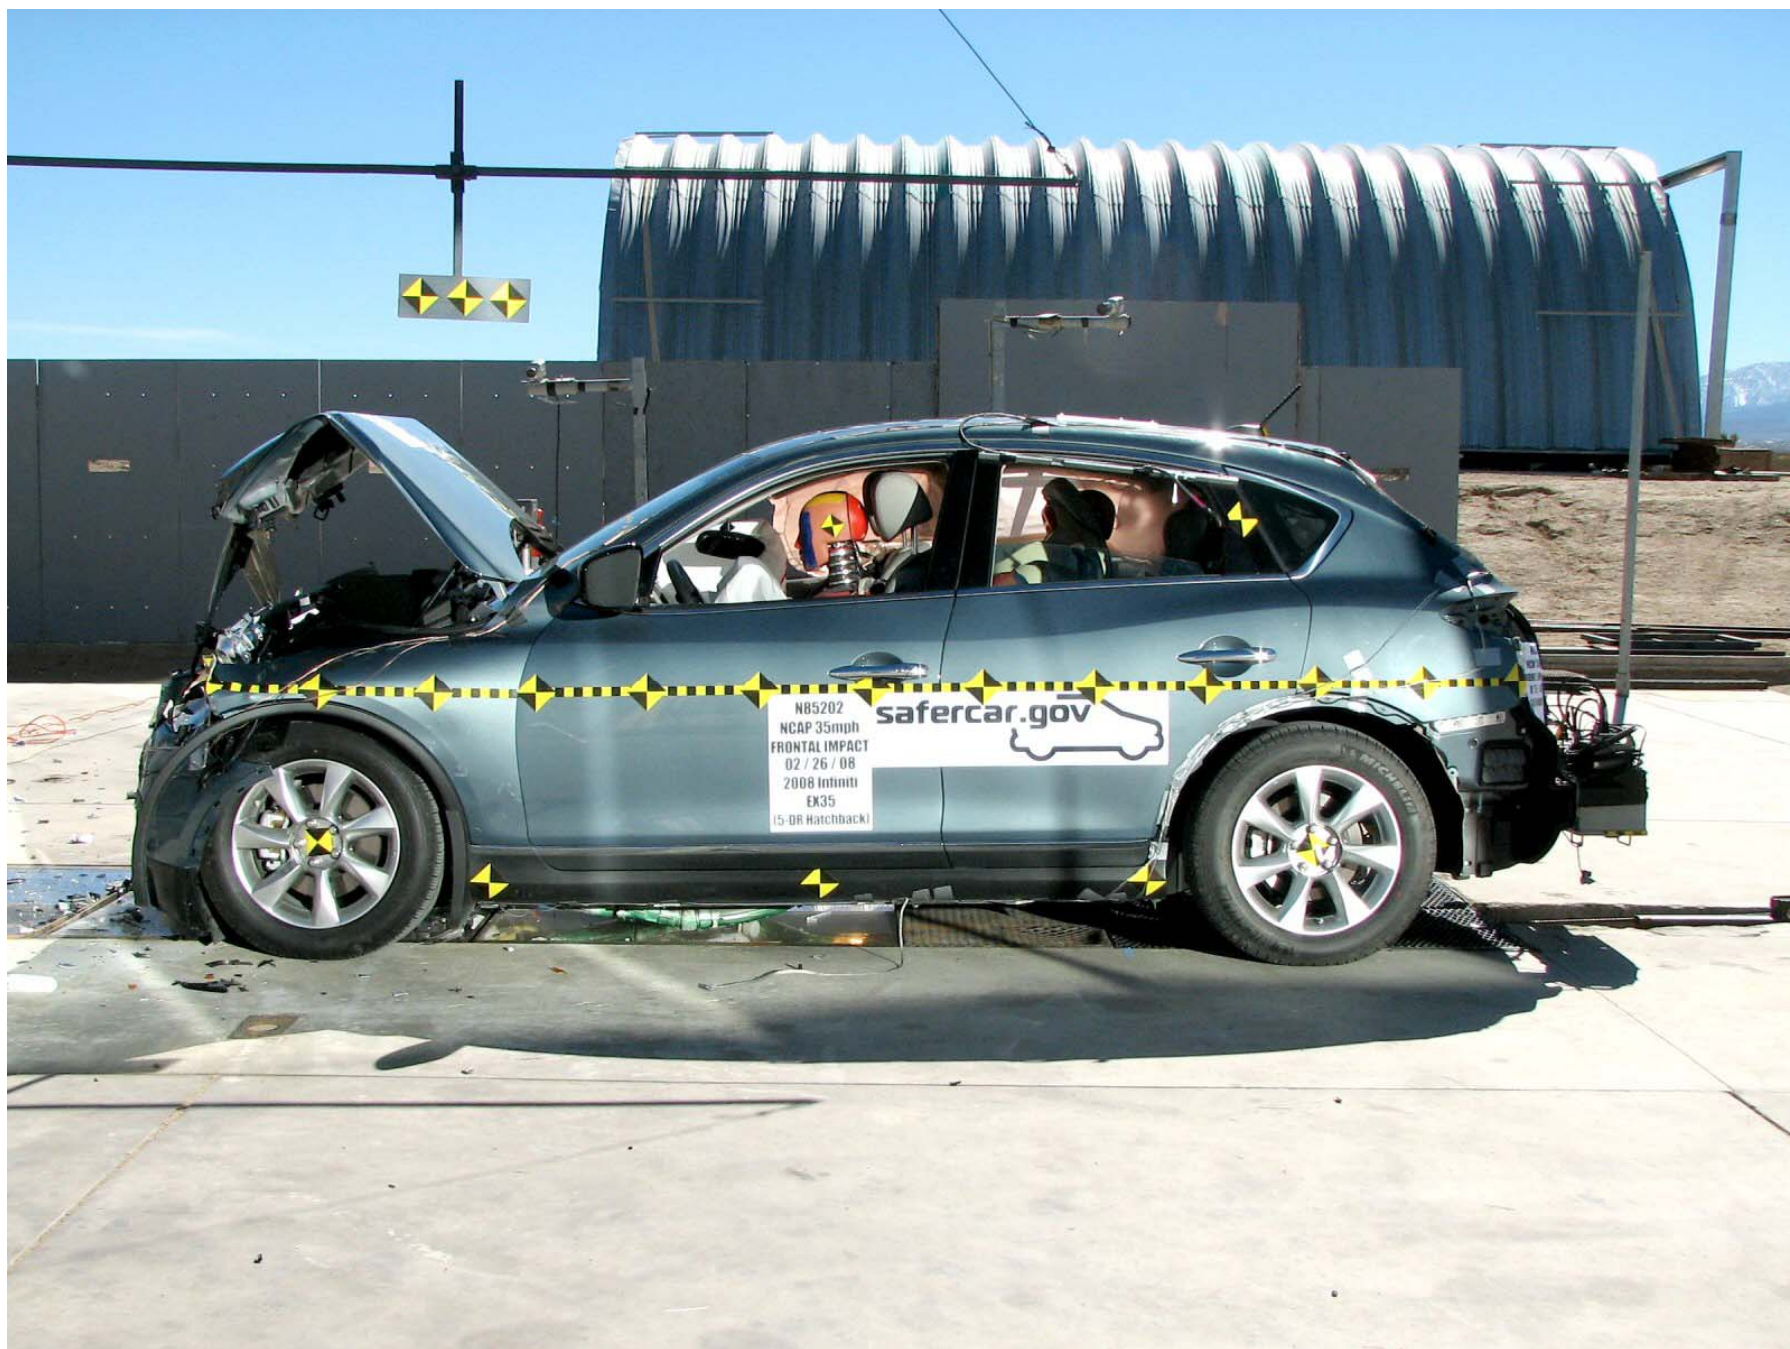
Figure A-9: Post-Test Left Side View

Collision Deformation Classification: 12FDEW6 Midpoint of Damage: Vehicle Centerline  
 Damage Region Length: 1390 Impact Mode: Full frontal

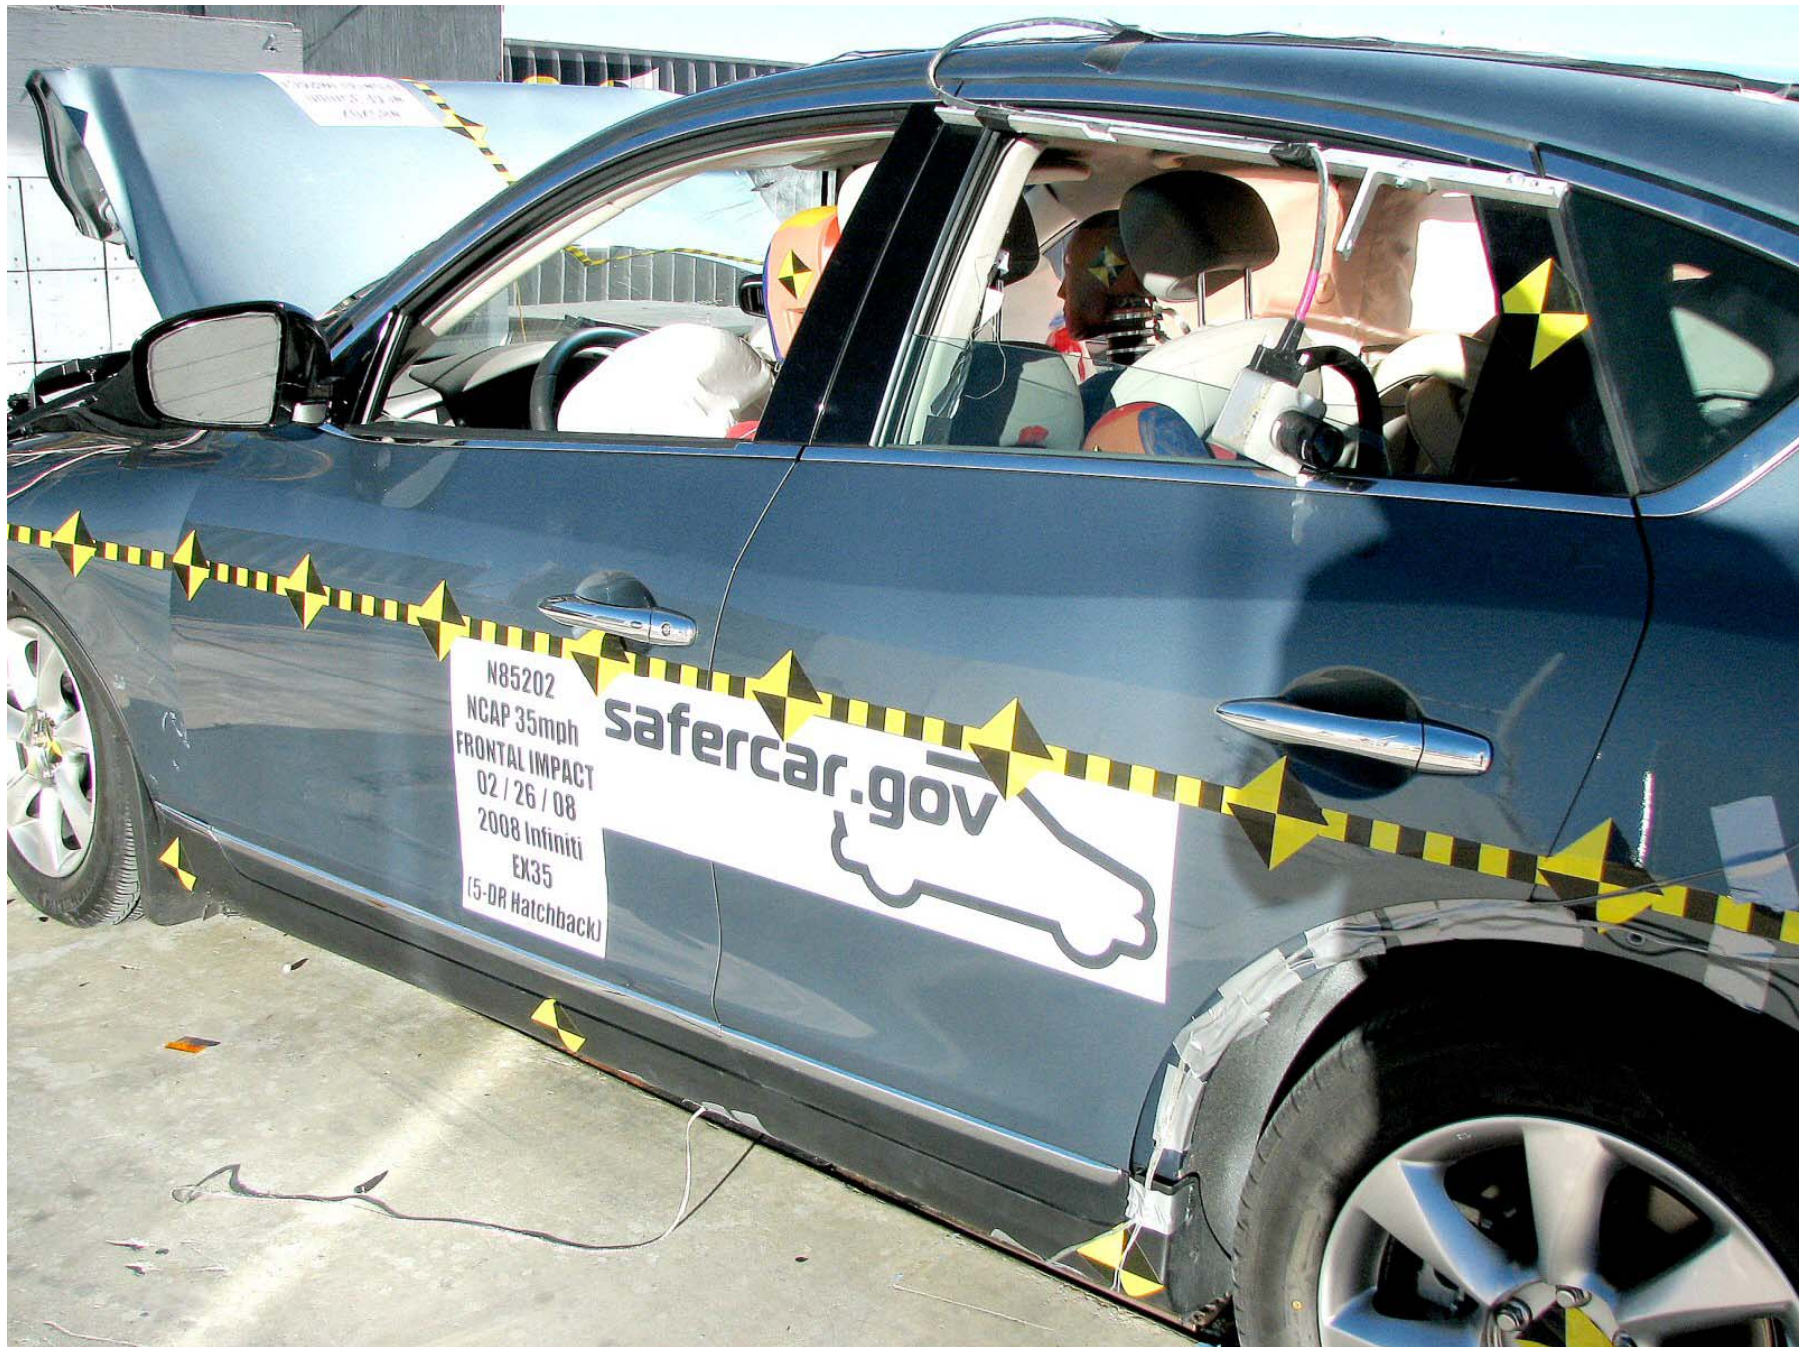
Figure A-16: Post-Test Left Side  $\frac{3}{4}$  View of Doors After Impact

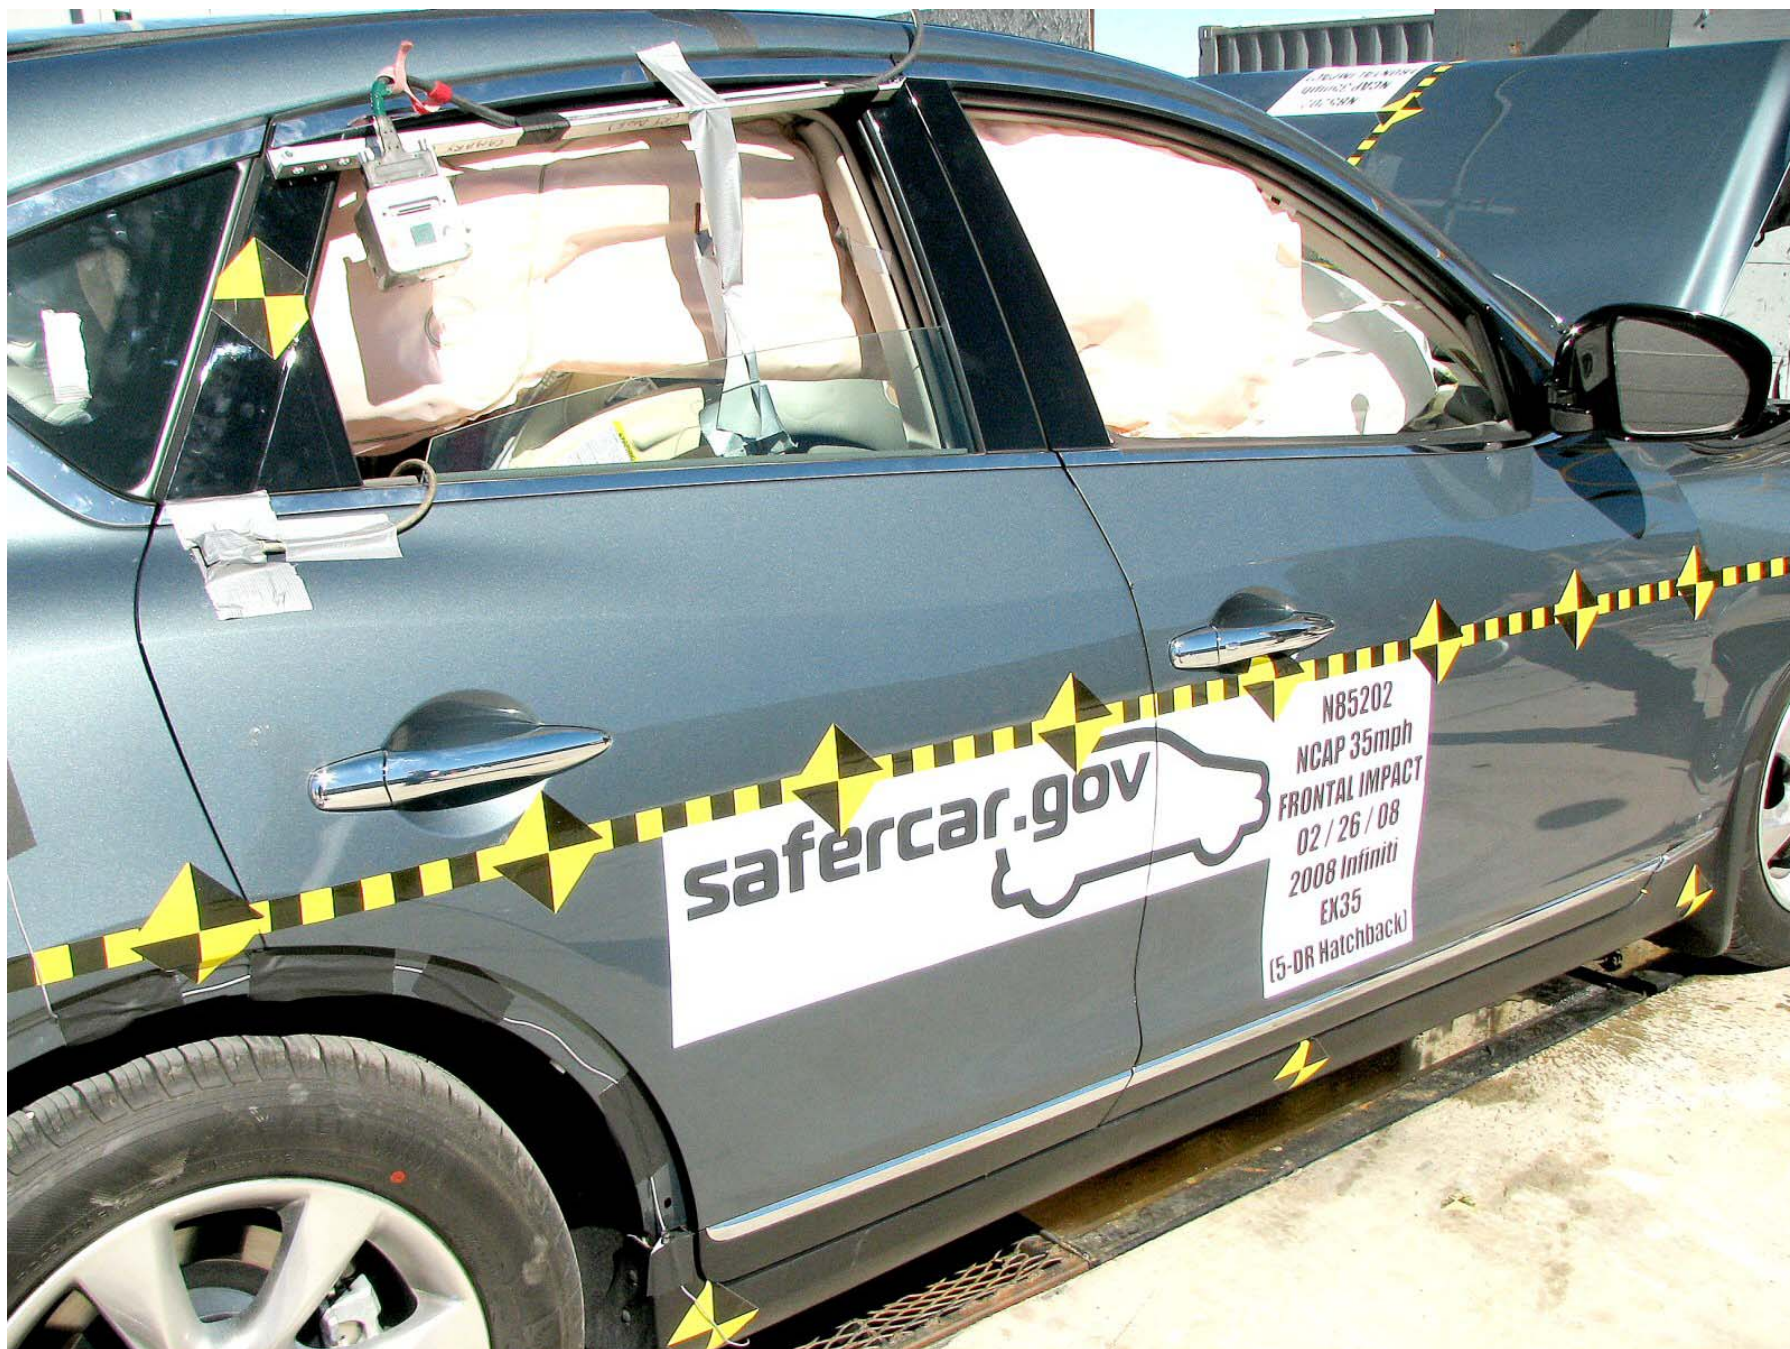
Figure A-17: Post-Test Right Side  $\frac{3}{4}$  View of Doors After Impact

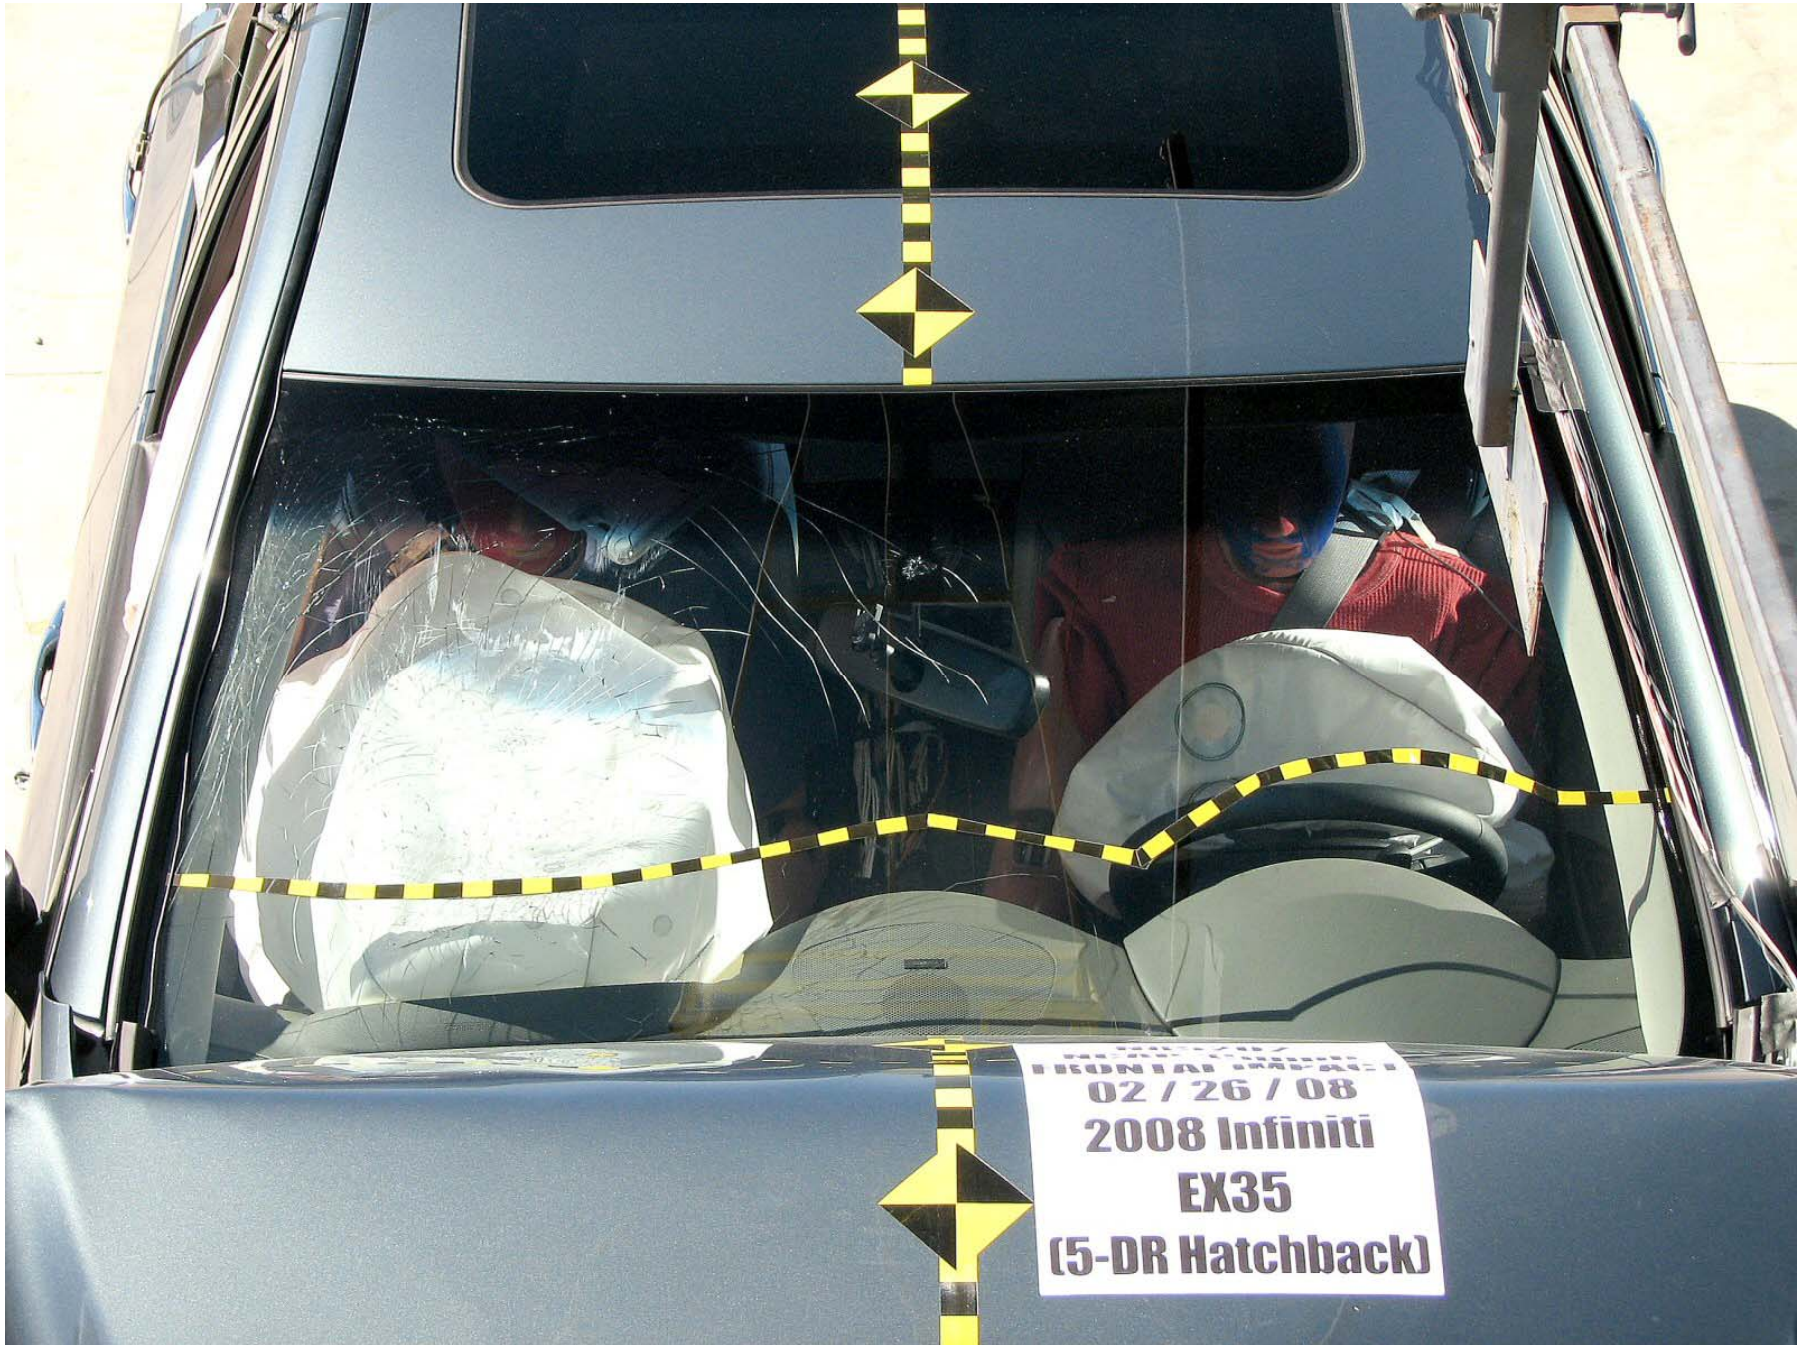
Figure A-19: Post-Test Windshield

There was 100% windshield retention and no intrusion into the protected zone of the windshield during impact. There was no Stoddard solvent leakage after the event, or during any phase of the static rollover.

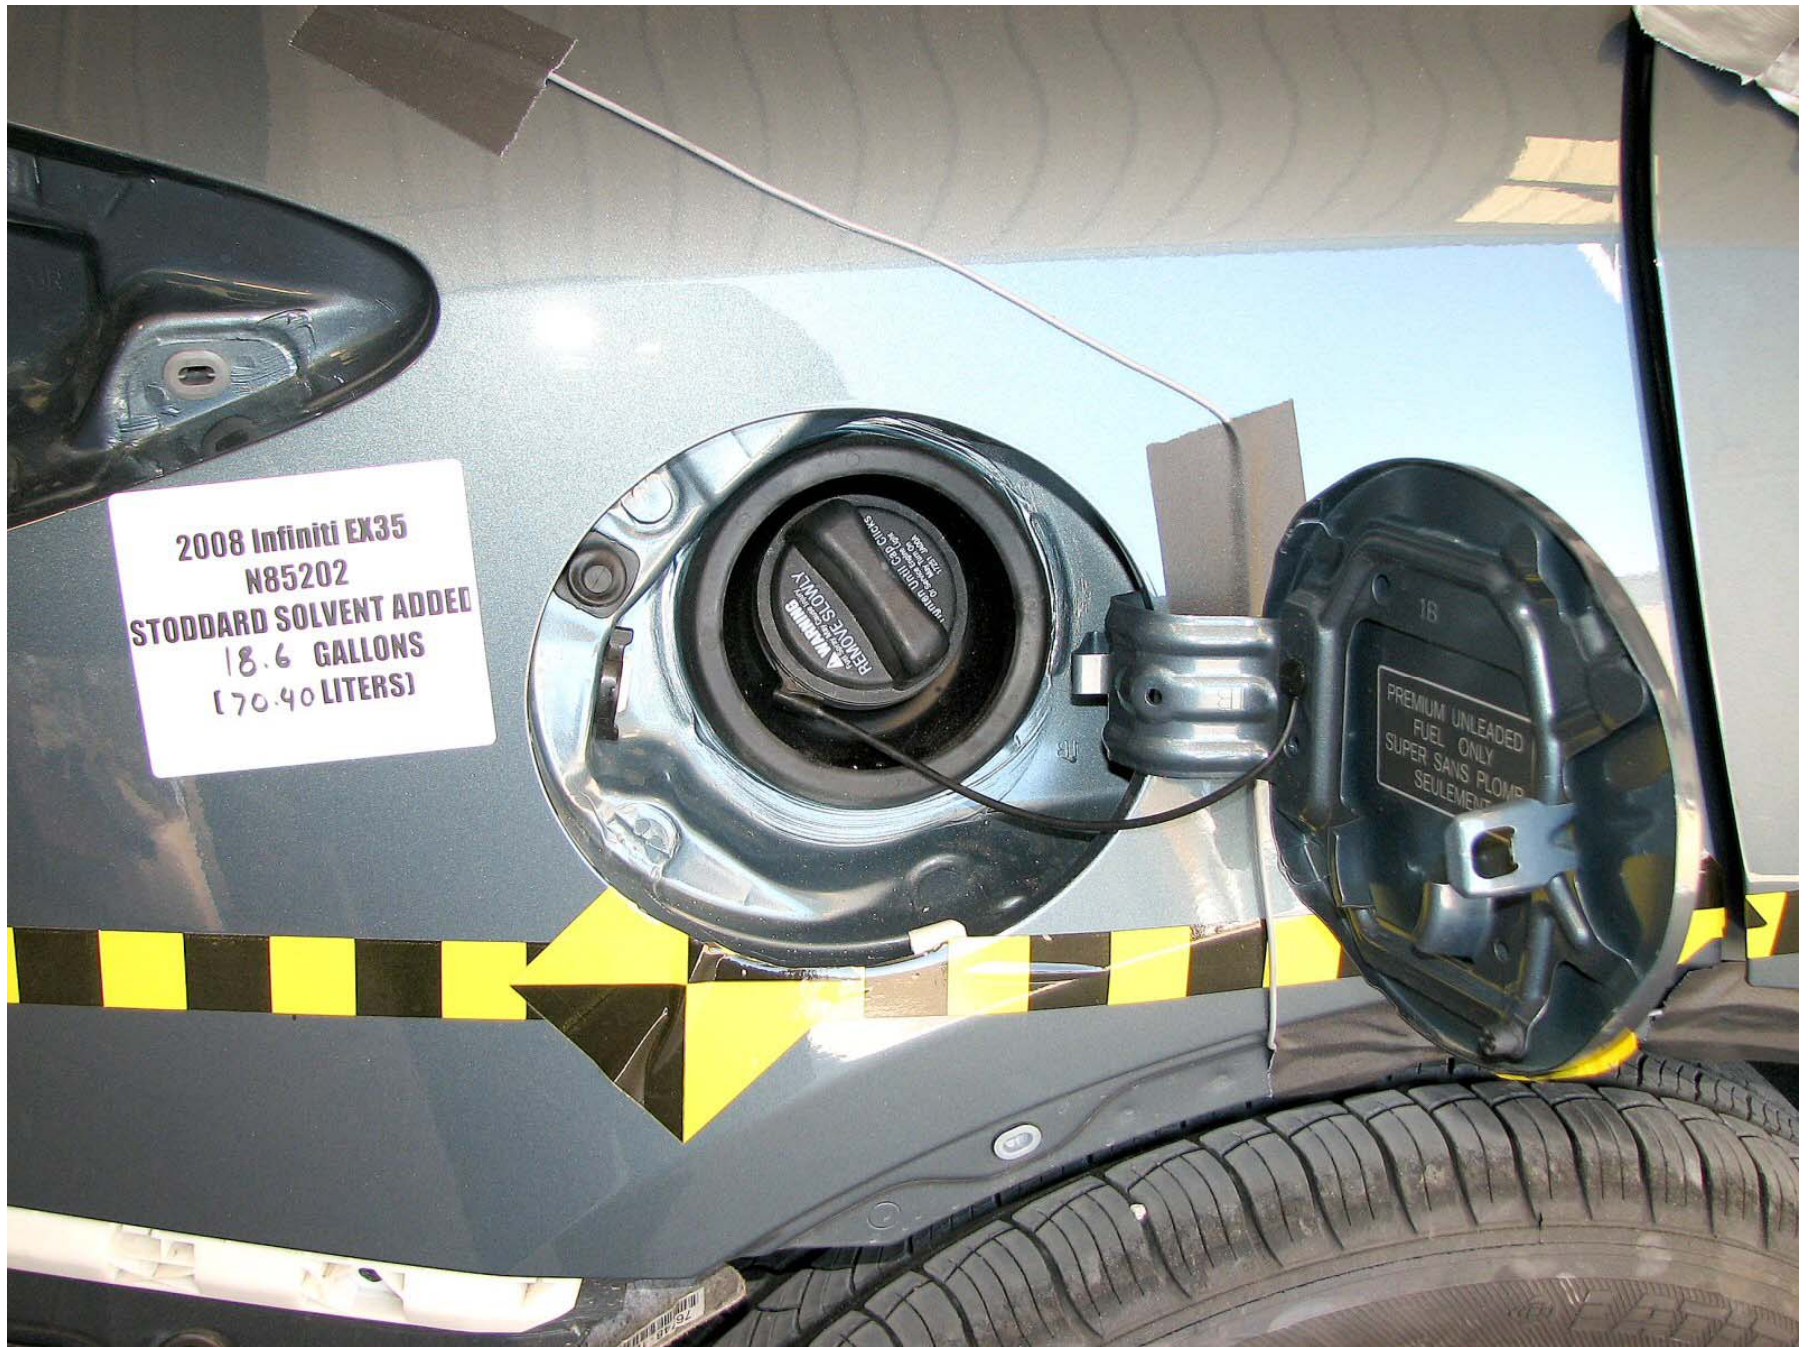
Figure A-23: Post-Test Fuel Cap

- A. From impact until vehicle motion ceases: 0  
(Maximum allowable = 1 ounce)
- B. For the 5 minute period after motion ceases: 0  
(Maximum allowable = 5 ounces)
- C. For the following 25 minutes: 0  
(Maximum allowable = 1 oz/minute)
- D. Spillage Details: No leakage occurred

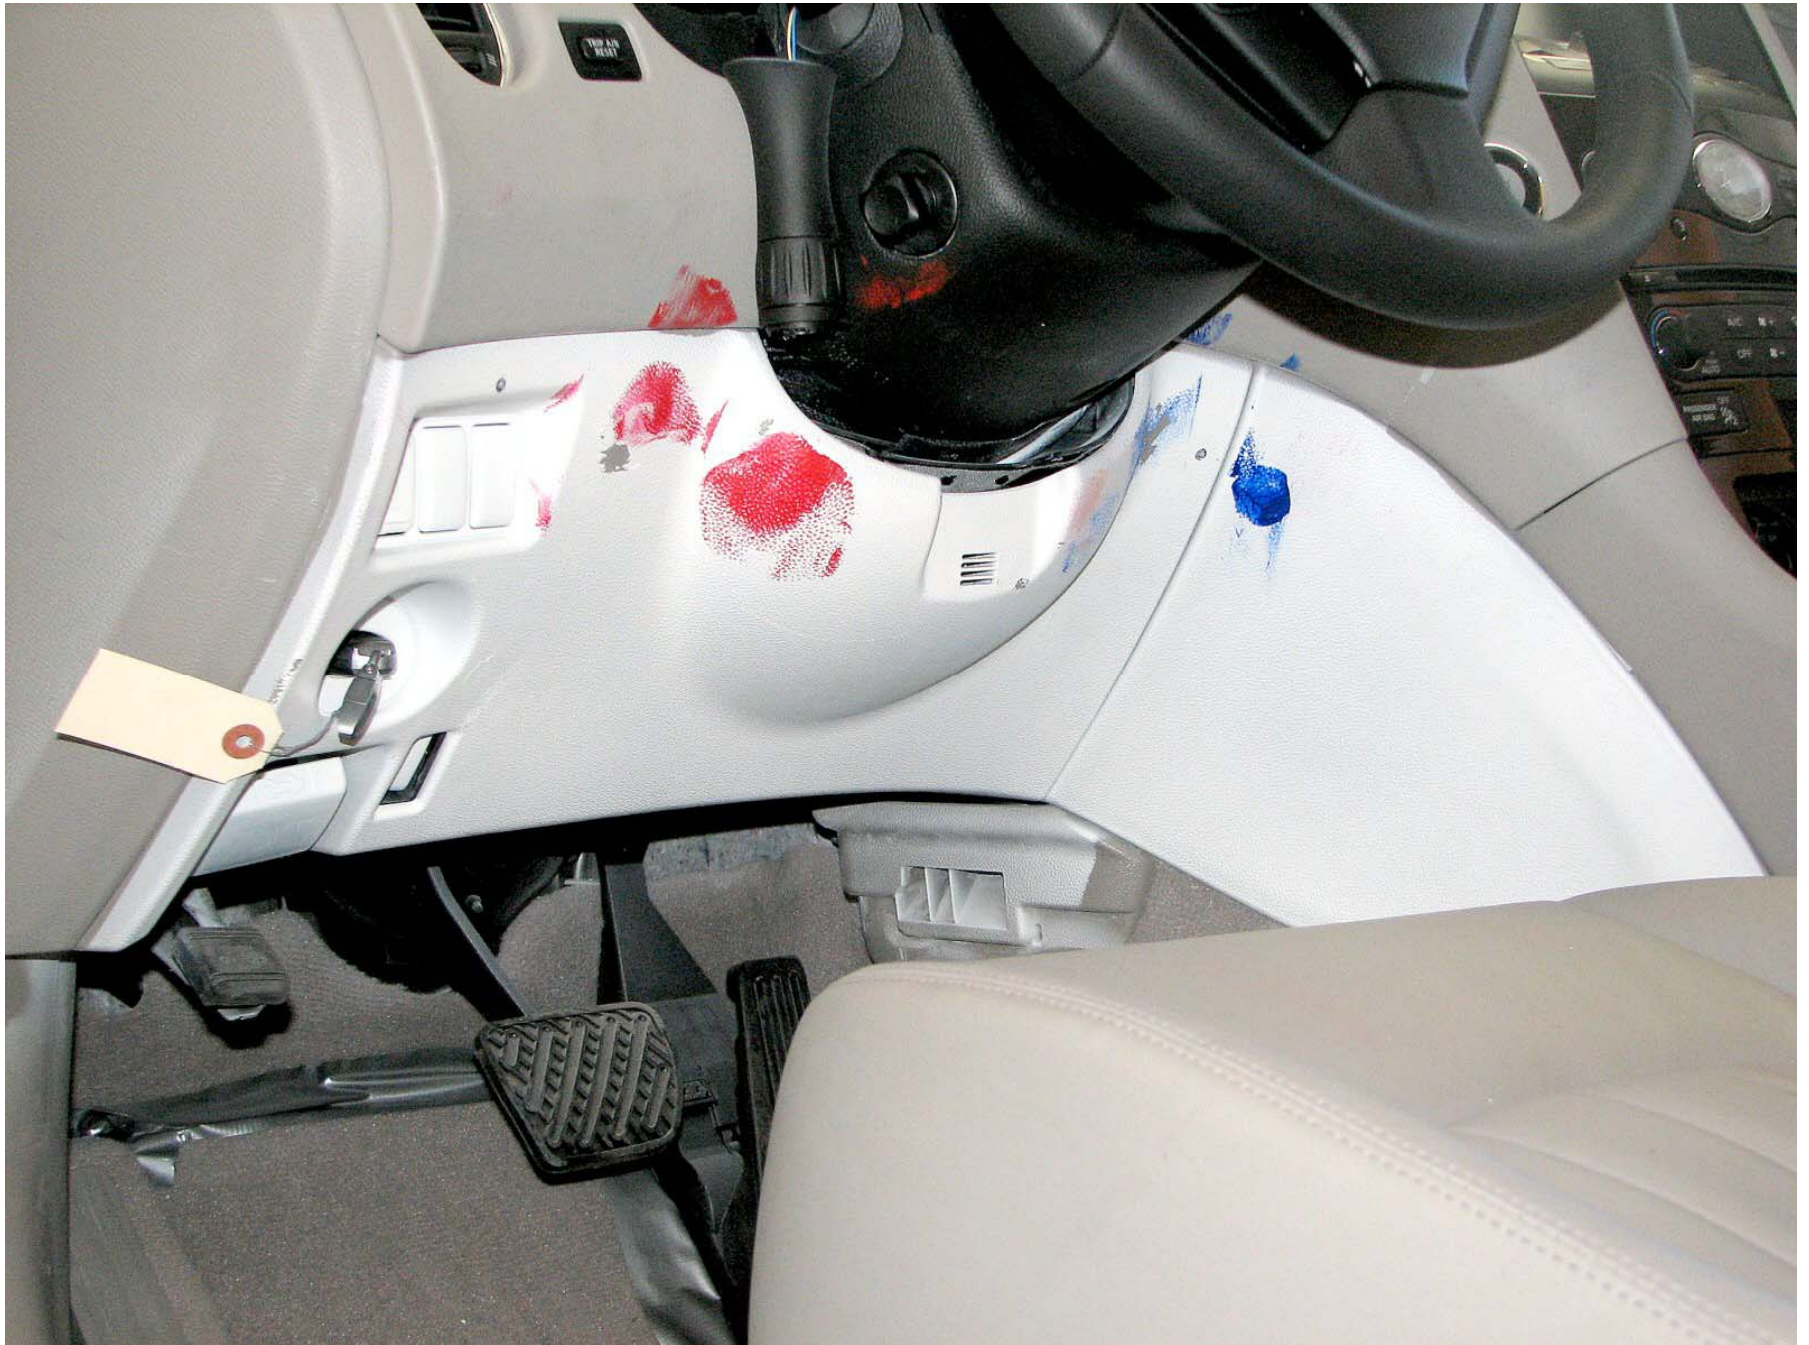
Figure A-39: Post-Test Driver Side Knee Bolster

The driver's visible contact points were as follows: The driver ATD's head and chest contacted the airbag. The head also contacted the headrest. Both knees contacted the bolster.

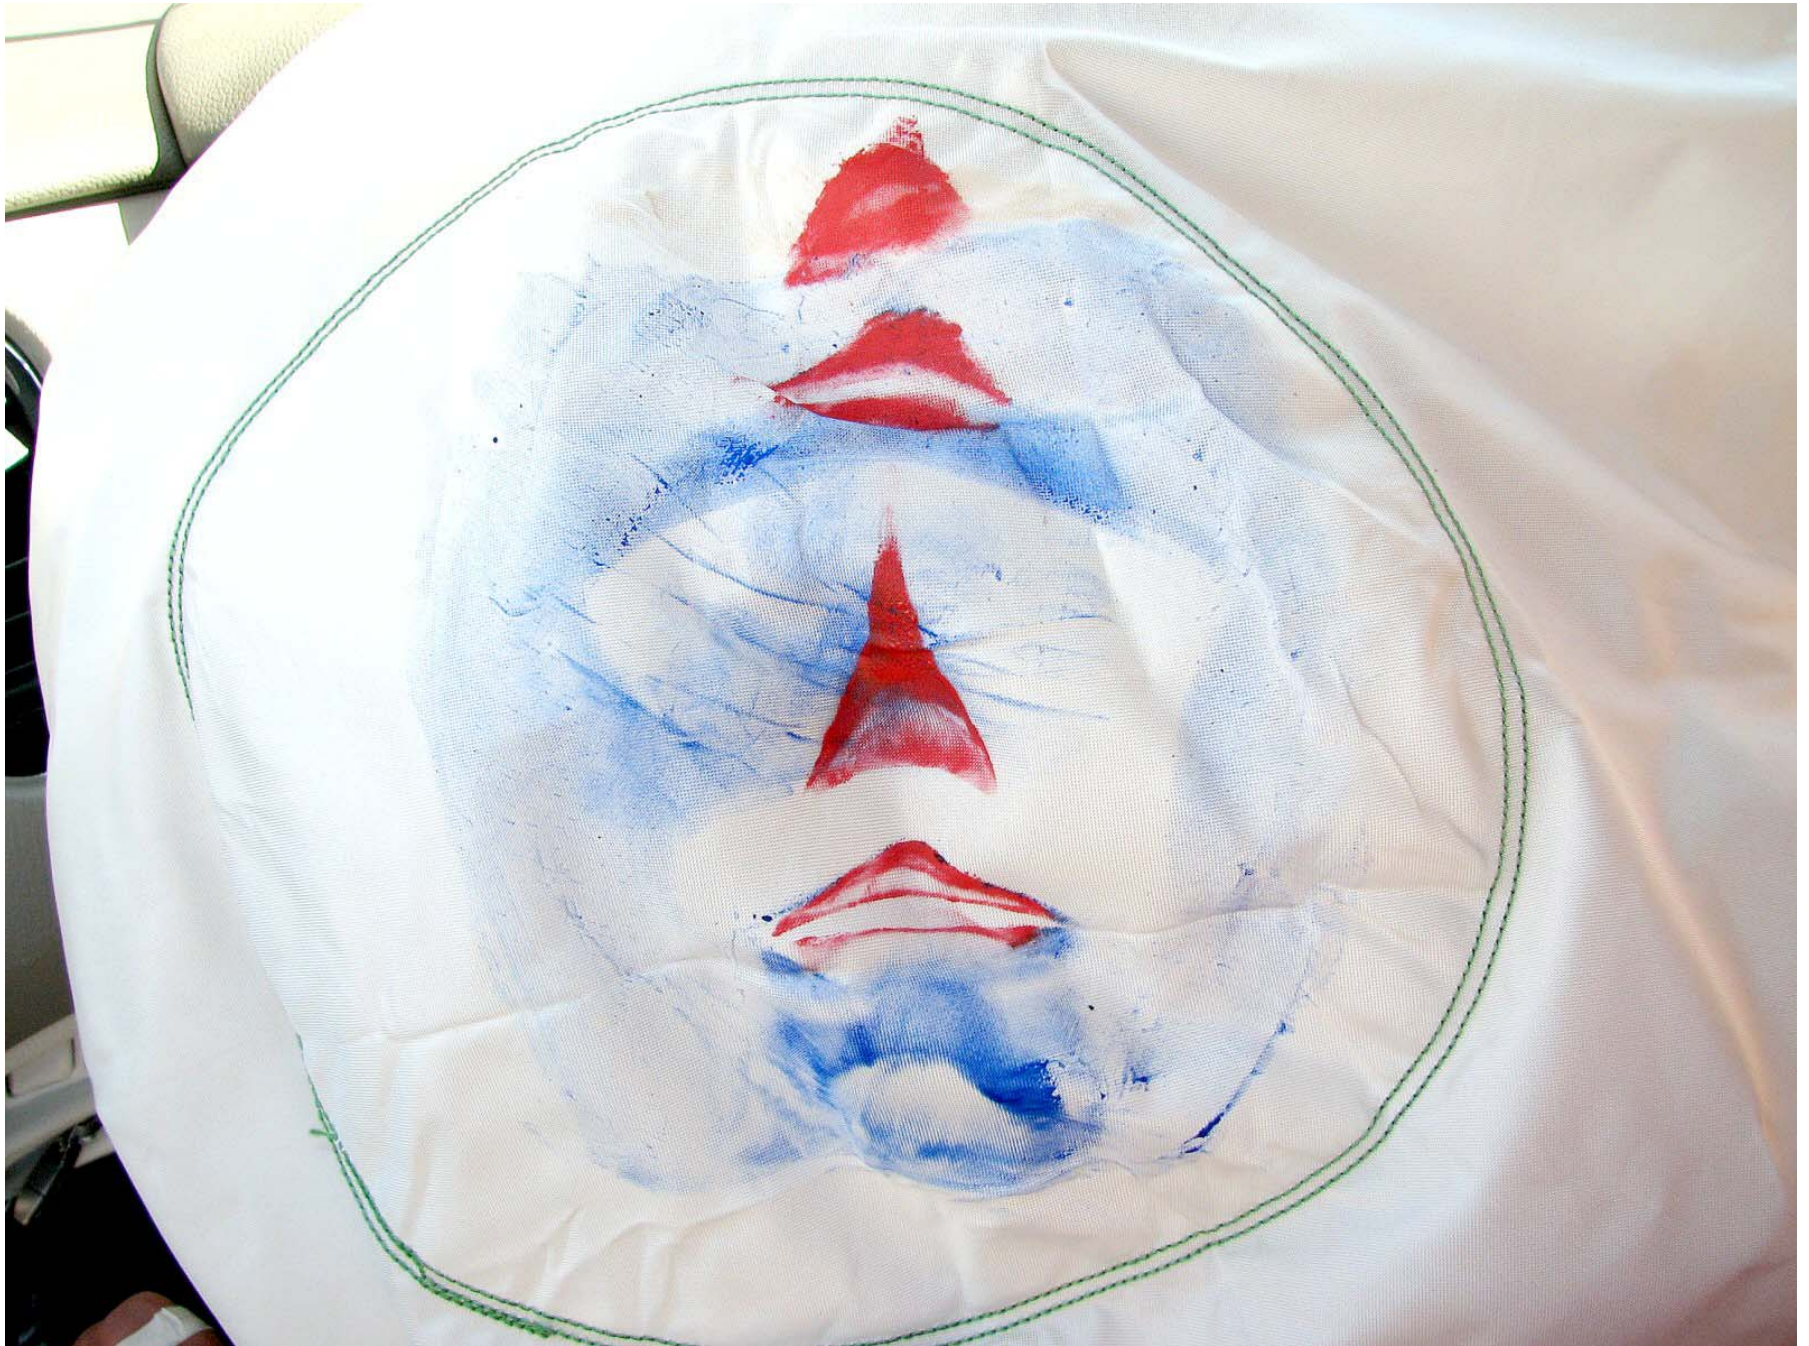
Figure A-43: Post-Test Driver Dummy Airbag Contact

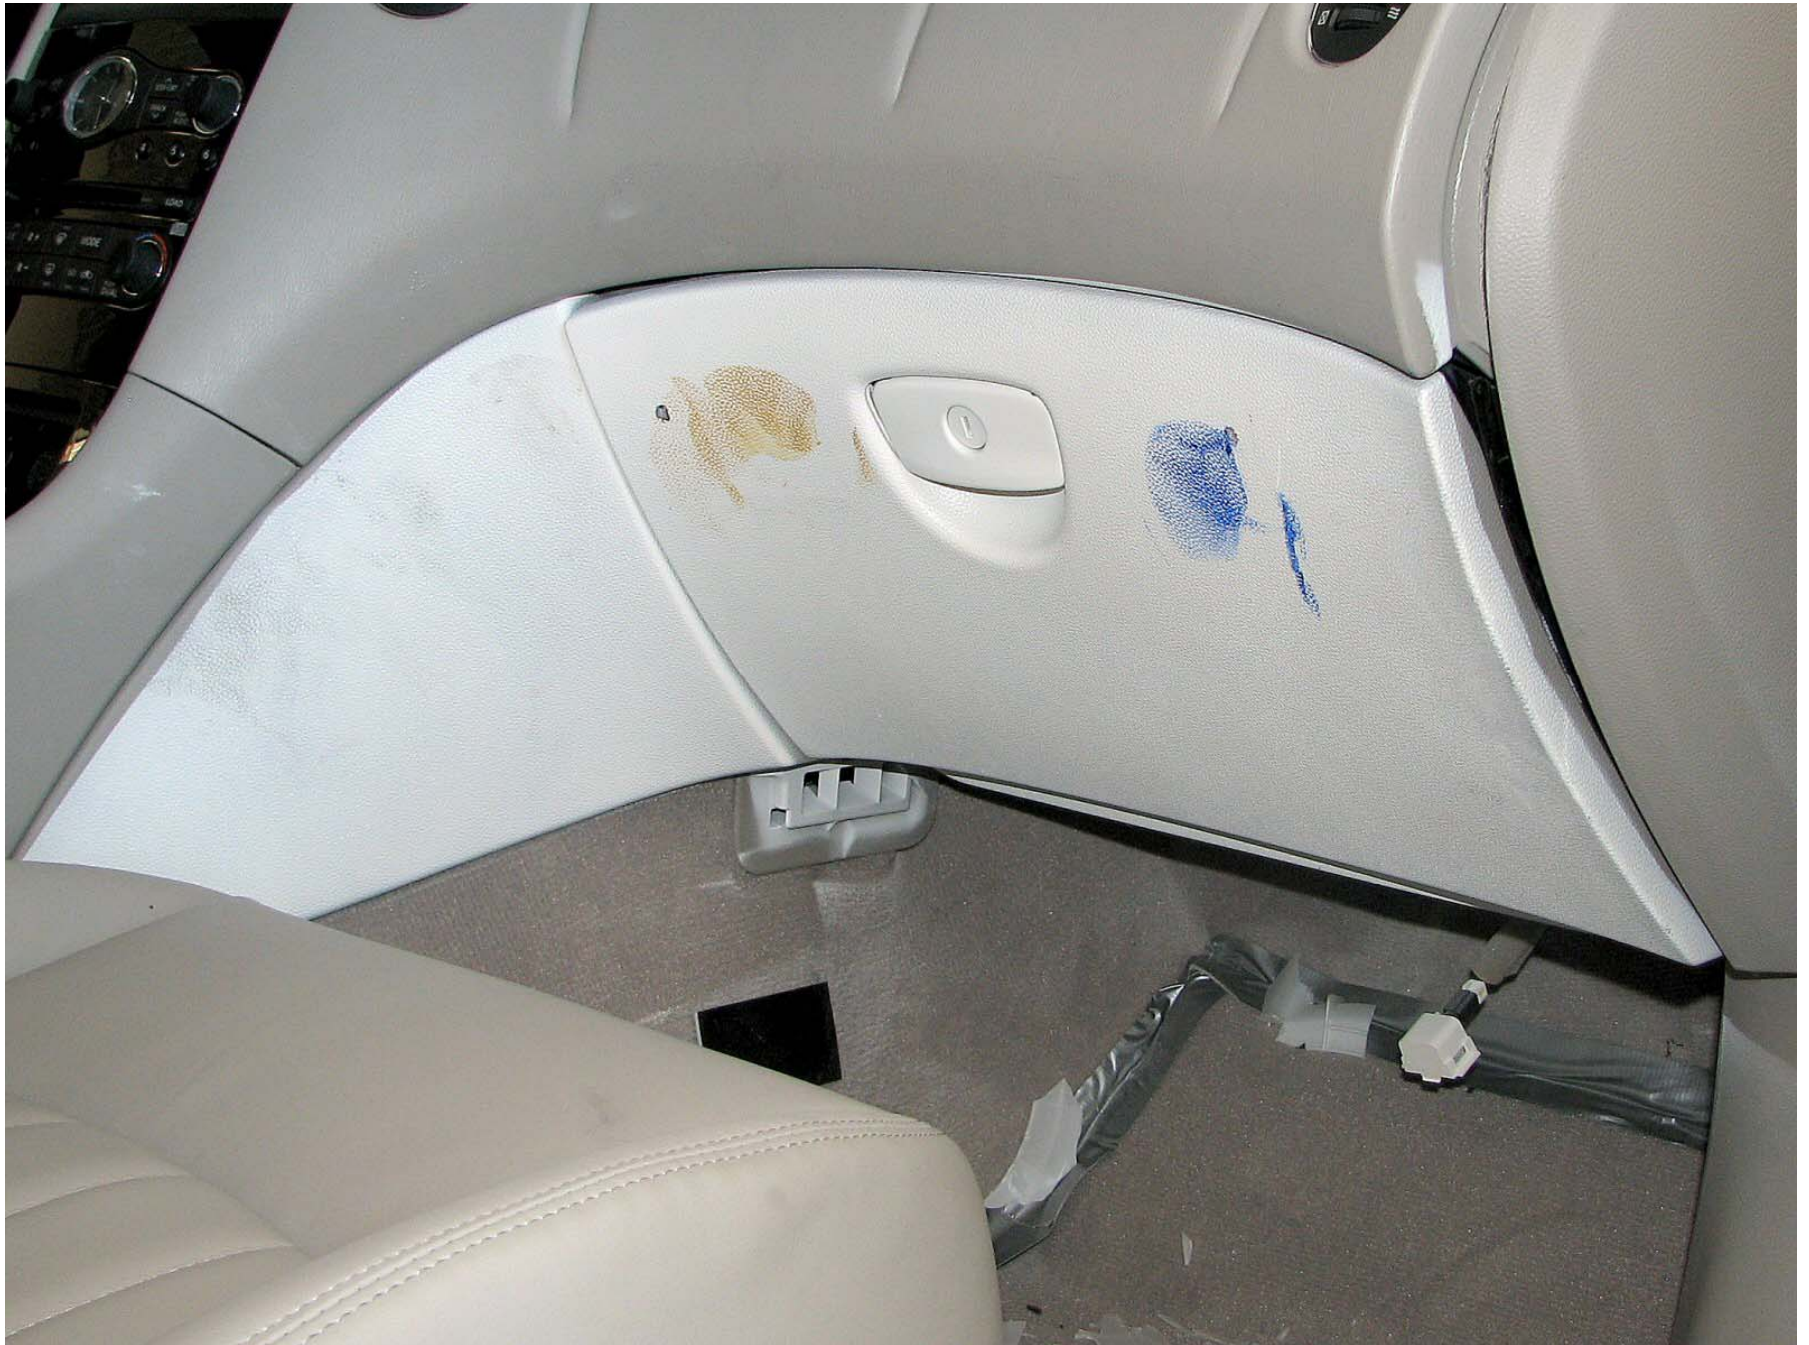
Figure A-53: Post-Test Passenger Side Glove Box

The passenger's visible contact points were as follows: The passenger ATD's head, chest, and abdomen contacted the airbag. The head also contacted the headrest. Both knees contacted the glovebox.
