**REPORT NUMBER TR-P28048-01-NC**

**NEW CAR ASSESMENT PROGRAM  
FRONTAL BARRIER IMPACT TEST**

**NISSAN MOTOR CO., LTD.  
2008 INFINITI EX35 AWD  
5-DOOR HATCHBACK**

**NHTSA NUMBER: N85202**

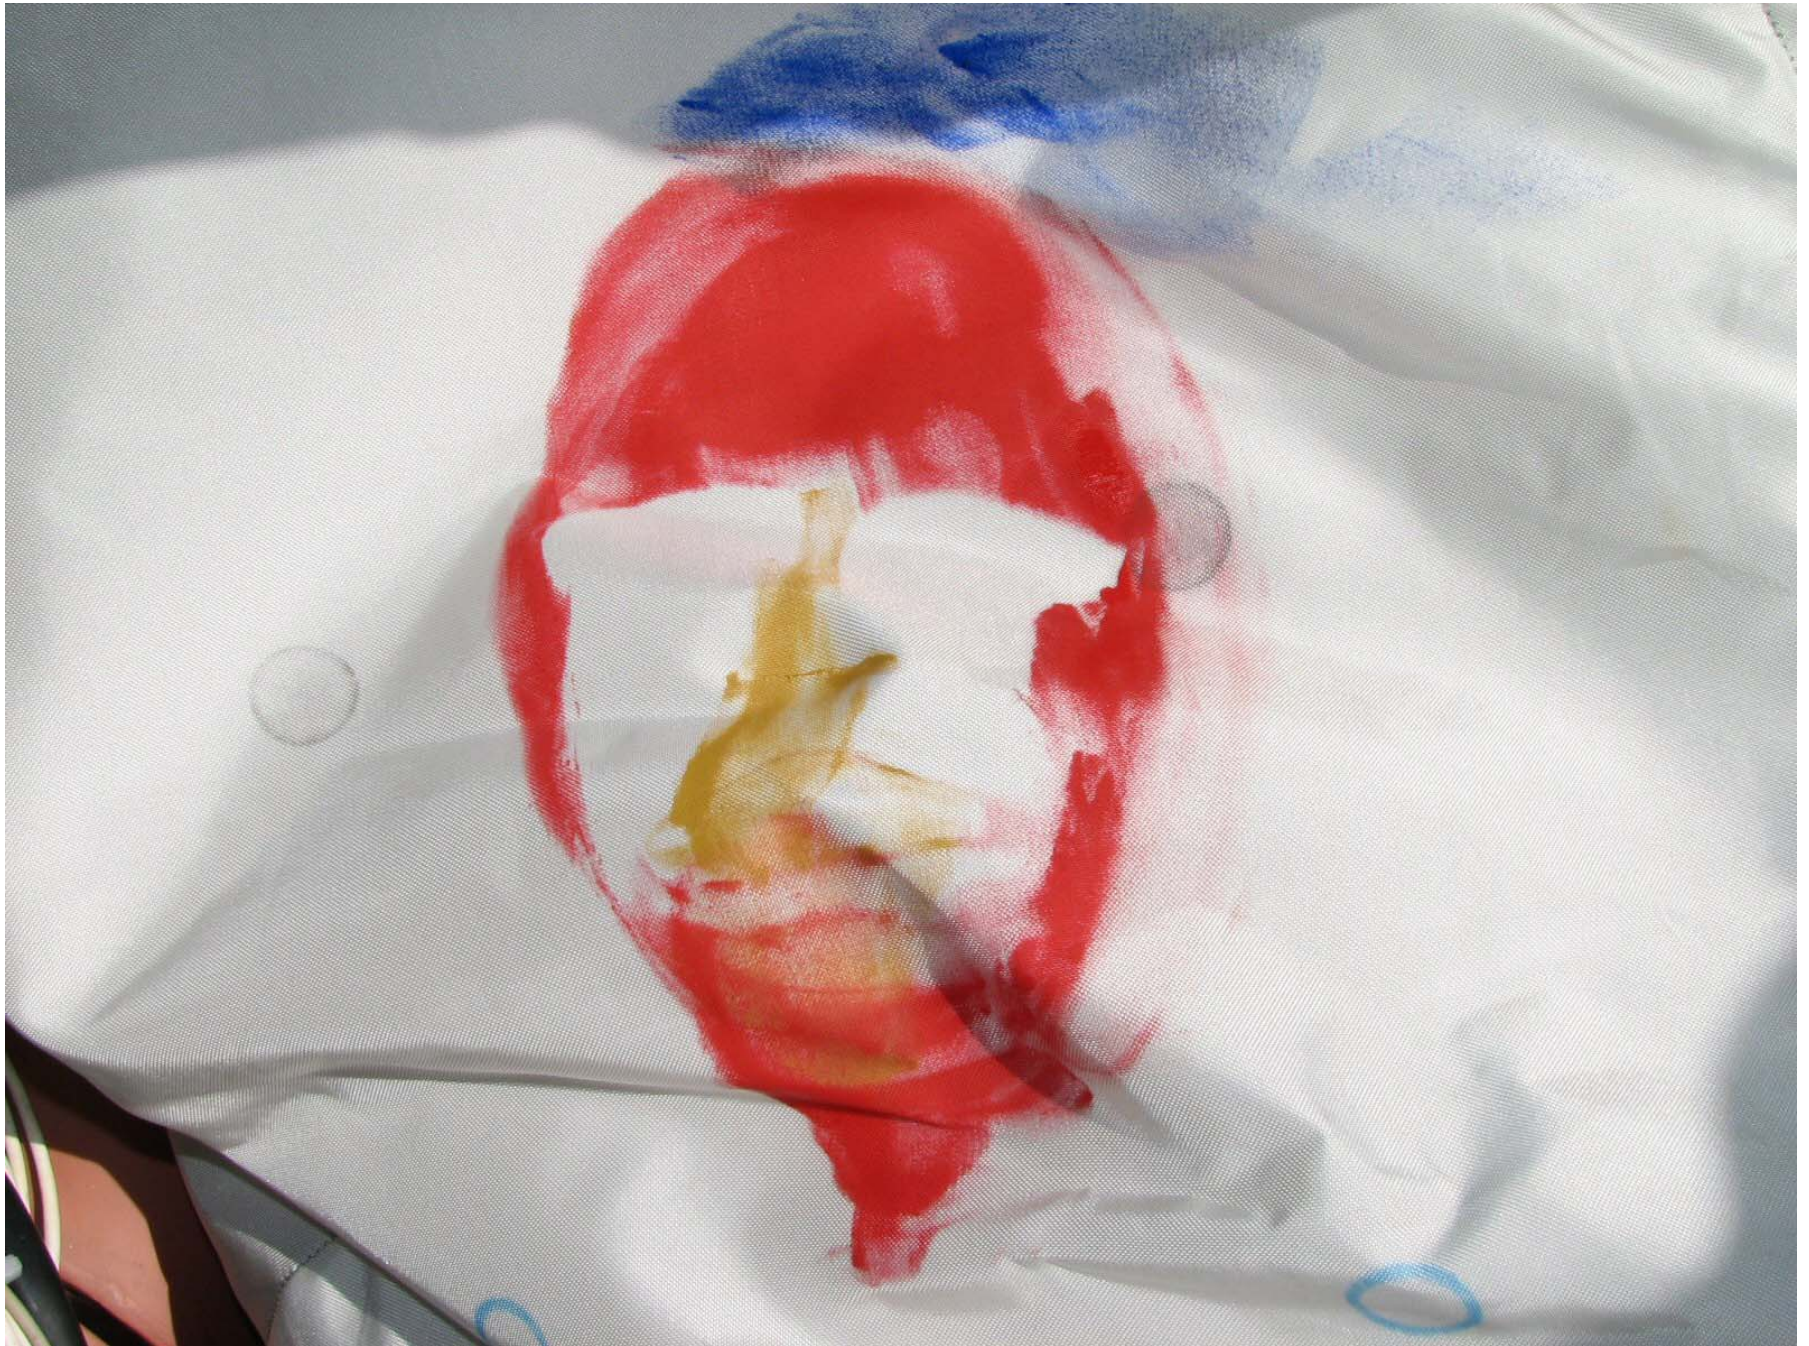
Figure A-57: Post-Test Passenger Dummy Airbag Contact

The passenger's visible contact points were as follows: The passenger ATD's head, chest, and abdomen contacted the airbag. The head also contacted the headrest. Both knees contacted the glovebox.

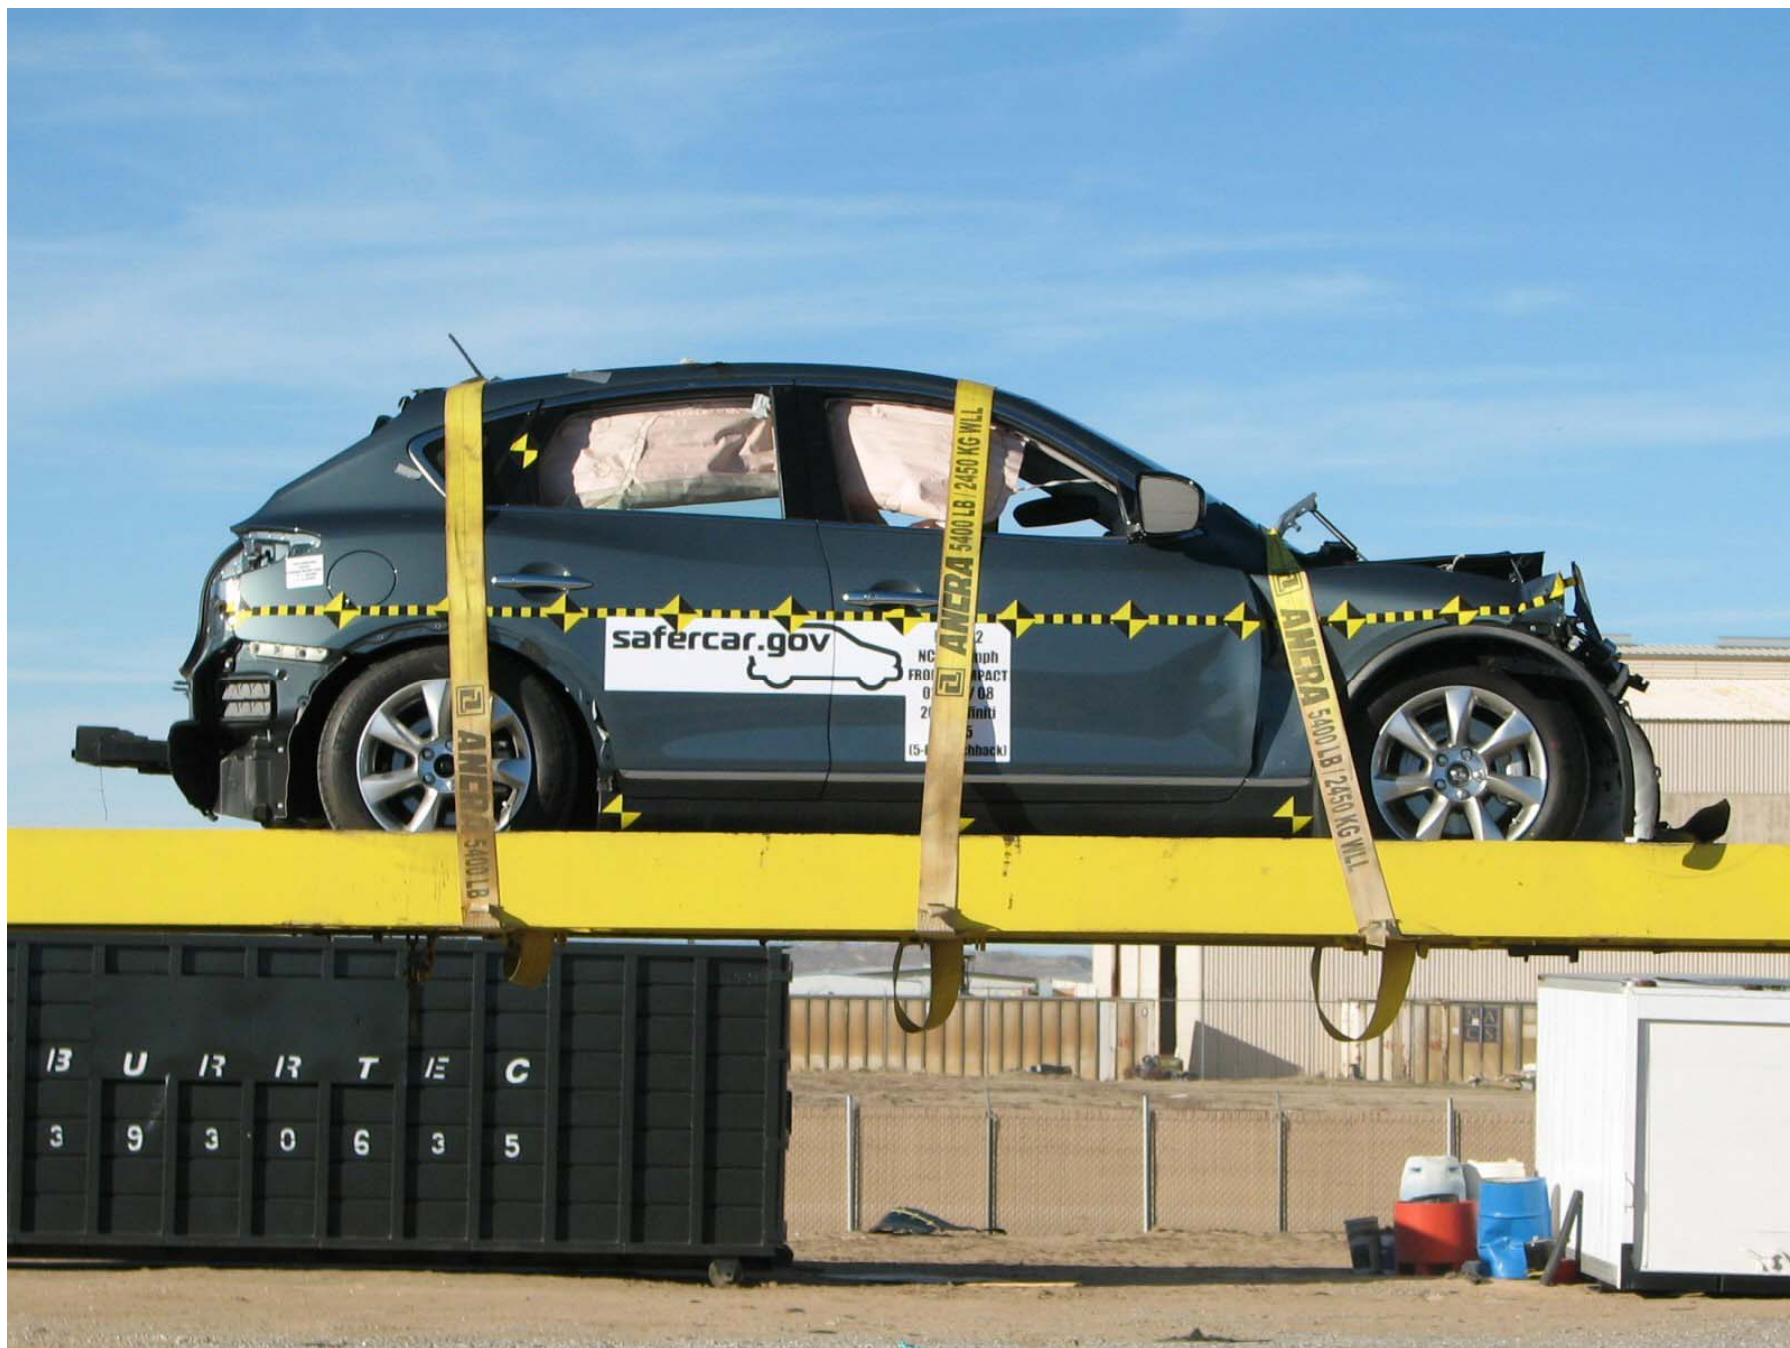
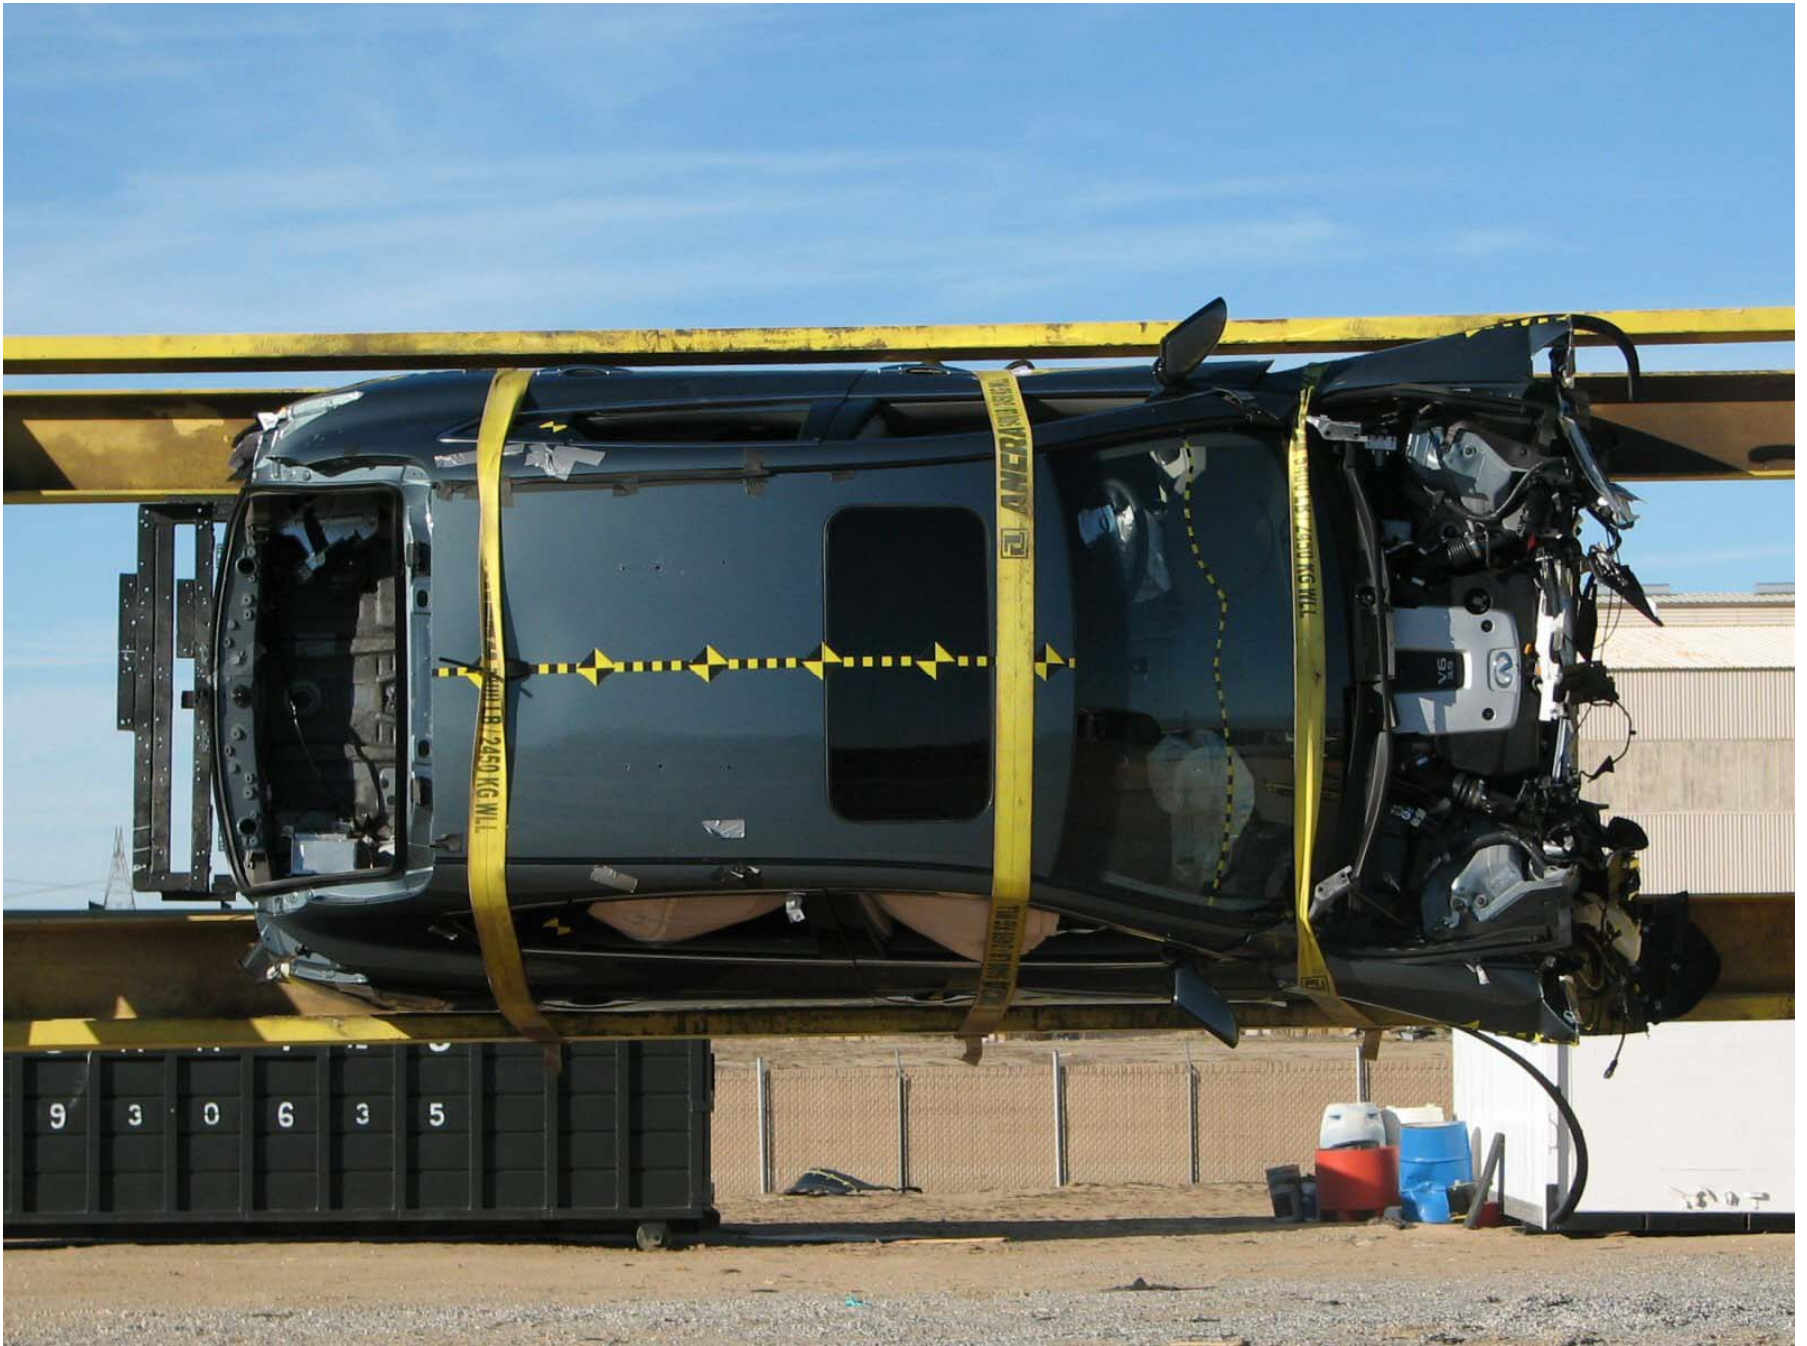
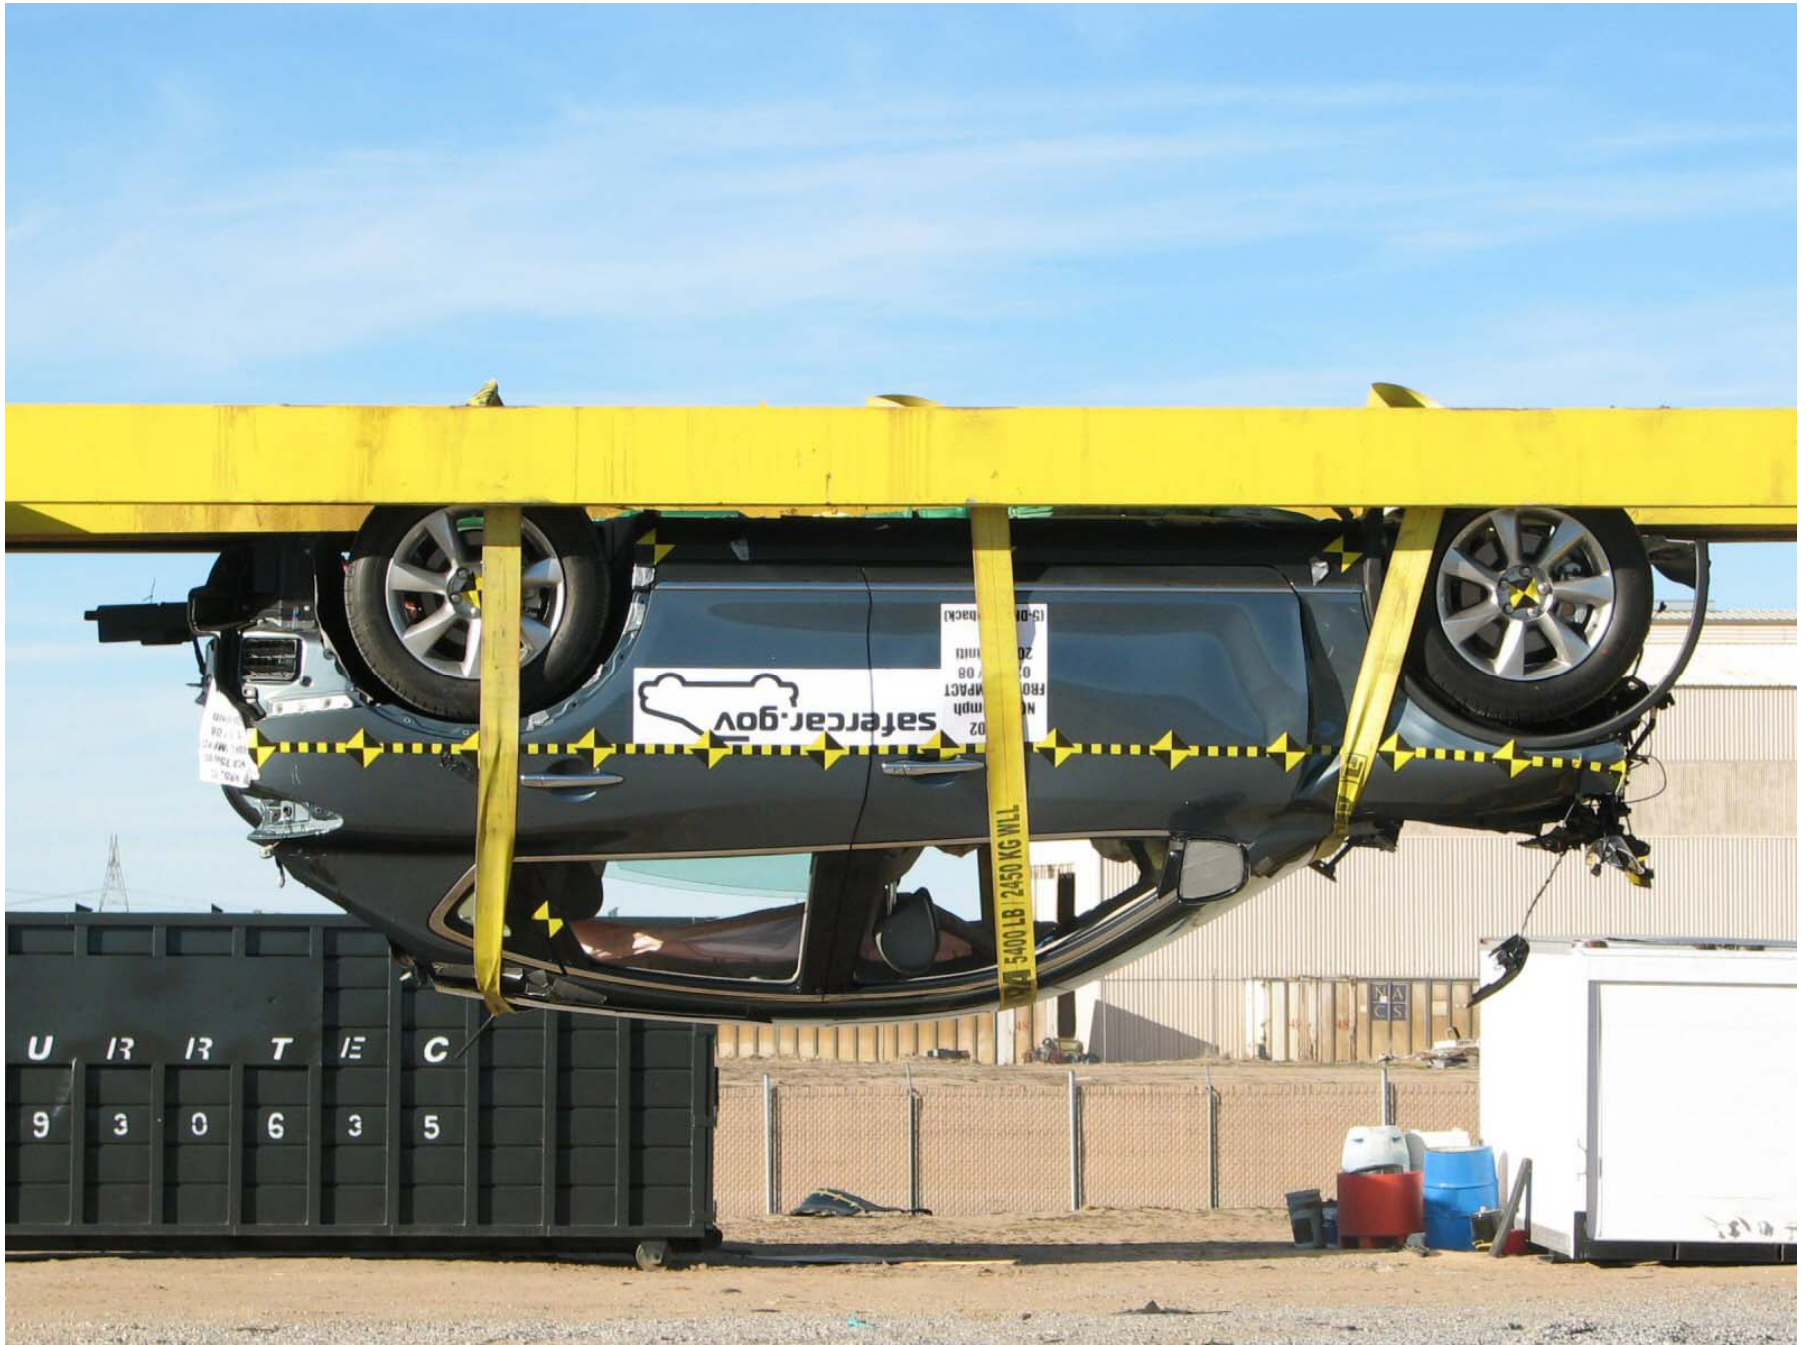
Figure A-58: Vehicle on Rollover Device (0°)

Figure A-59: Vehicle on Rollover Device (90°)

Figure A-60: Vehicle on Rollover Device (180°)

Figure A-61: Vehicle on Rollover Device (270°)

1. The specified fixture rollover rate for each 90° of rotation is 60 to 120 seconds.
2. The position hold time at each position is 300 seconds (minimum).
3. No solvent leakage occurred during rollover.

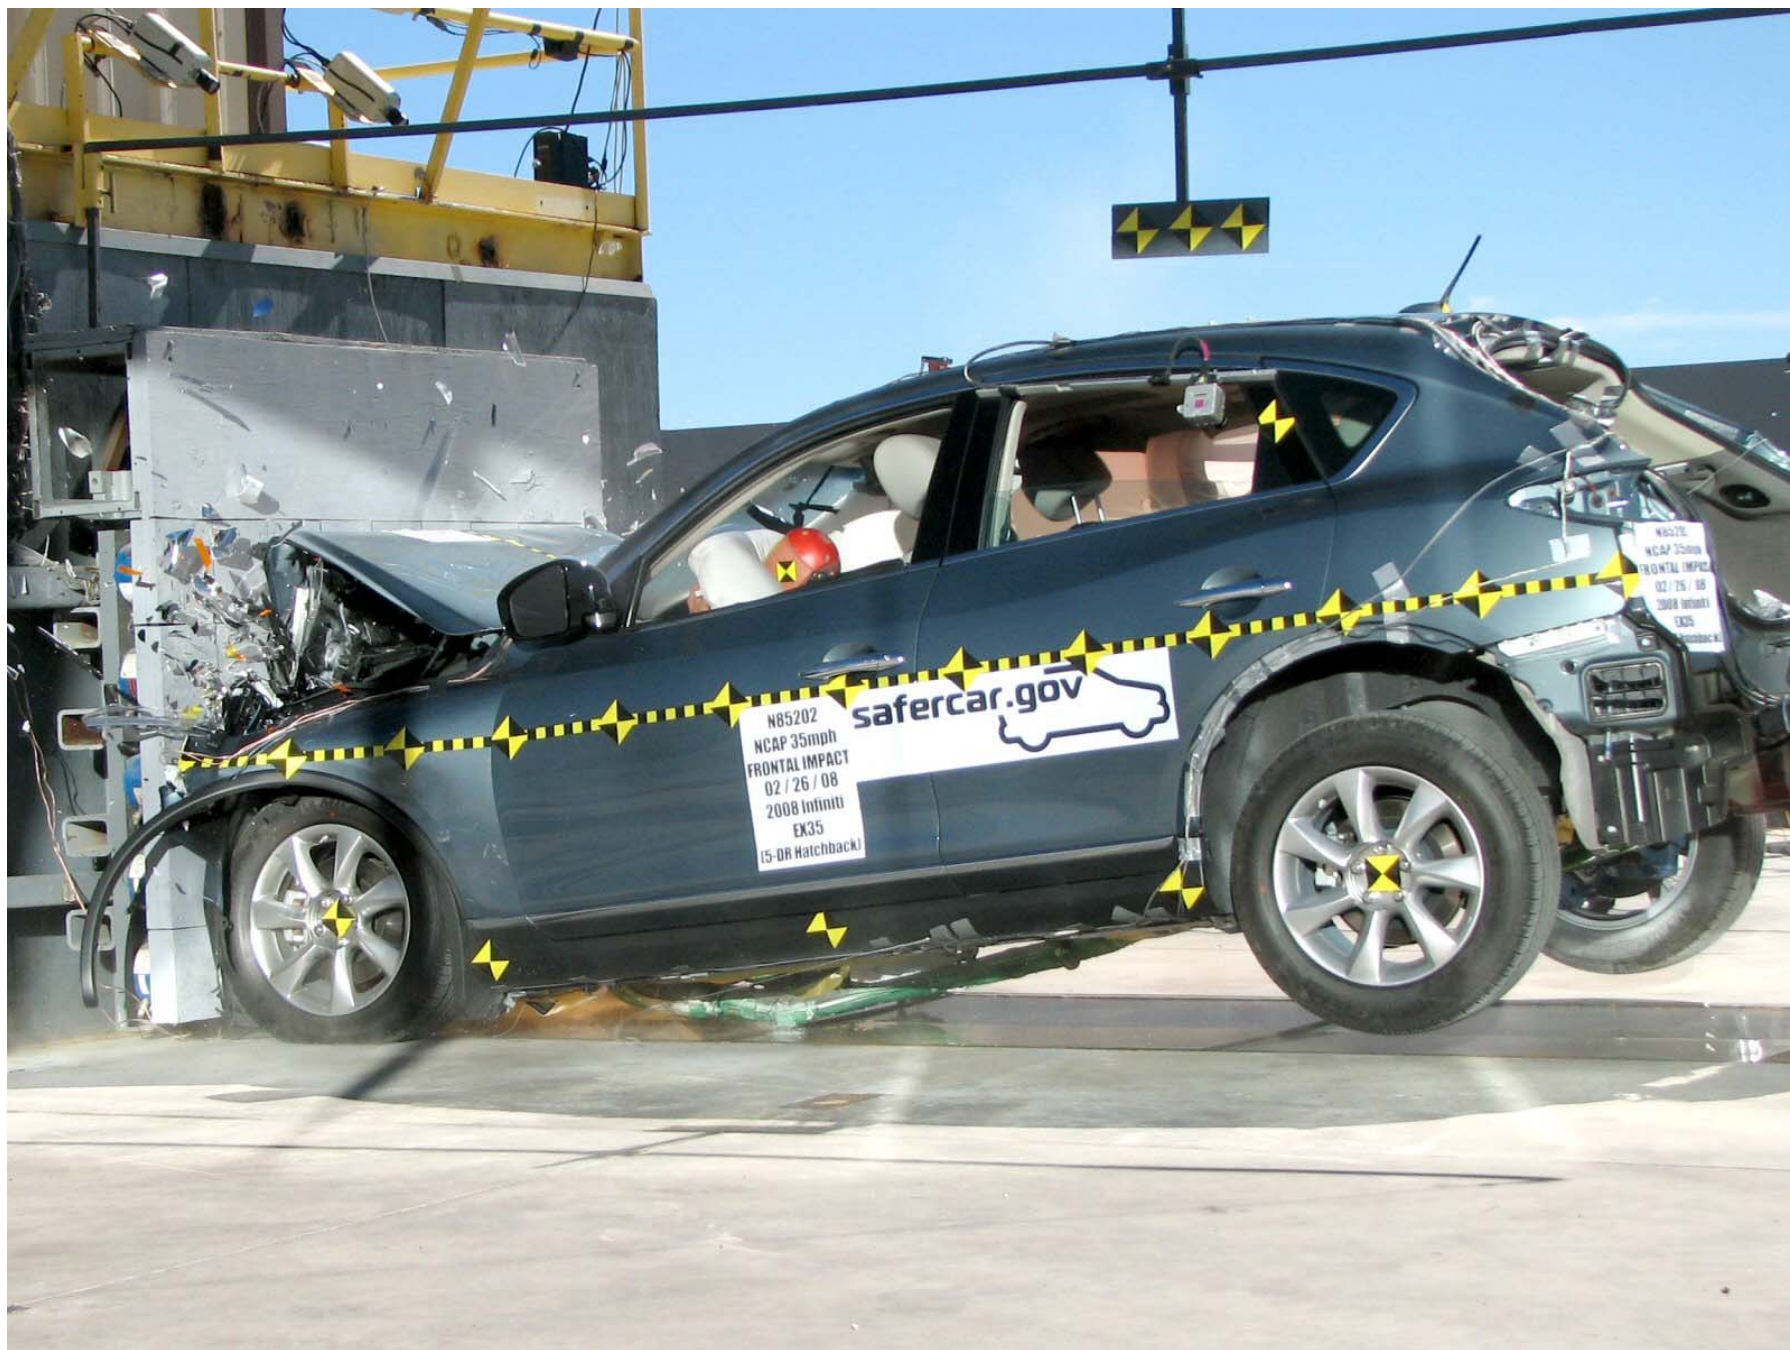
Figure A-62: Vehicle Impact

A load cell barrier consisting of 36 load cells was impacted by a 2008 Infiniti EX35 AWD 5-Door Hatchback at a velocity of 55.99 km/h. The test was performed at KARCO Engineering, LLC on February 26, 2008
