**NEW CAR ASSESSMENT PROGRAM  
SIDE IMPACT TEST**

**NISSAN MOTOR COMPANY, LTD.  
2009 NISSAN MURANO S 2WD  
NHTSA NUMBER: M95201**

**PREPARED BY:  
MGA RESEARCH CORPORATION  
5000 WARREN ROAD  
BURLINGTON, WI 53105**

**FINAL REPORT**

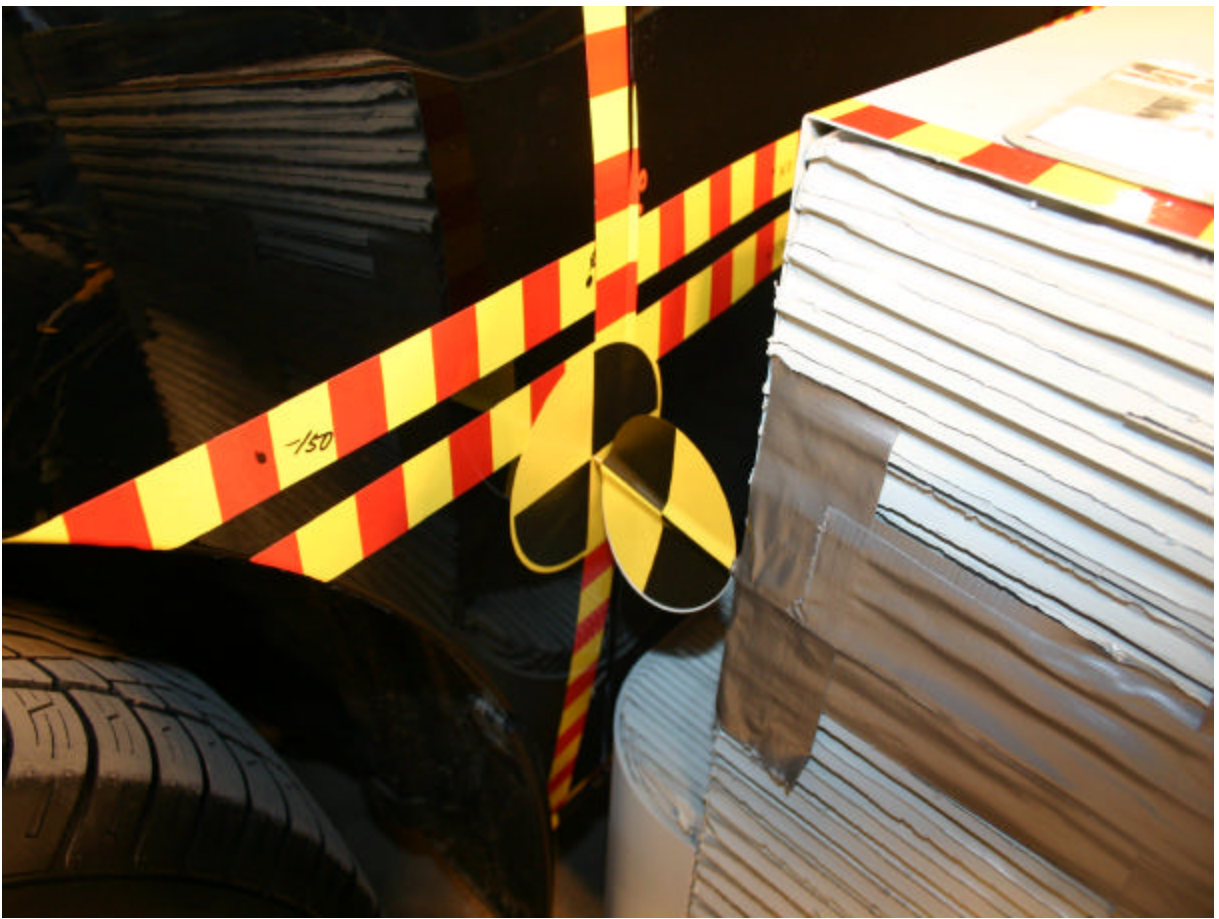
Pre-Test Left Impact Point

Post-Test Left Impact Point

The test vehicle sustained a maximum static crush of 295 mm at level 3, 1650 mm rearward of the vertical impact point. The driver and passenger SID/HIIs, Serial Nos. 271 and 904 respectively, were calibrated just prior to this test.

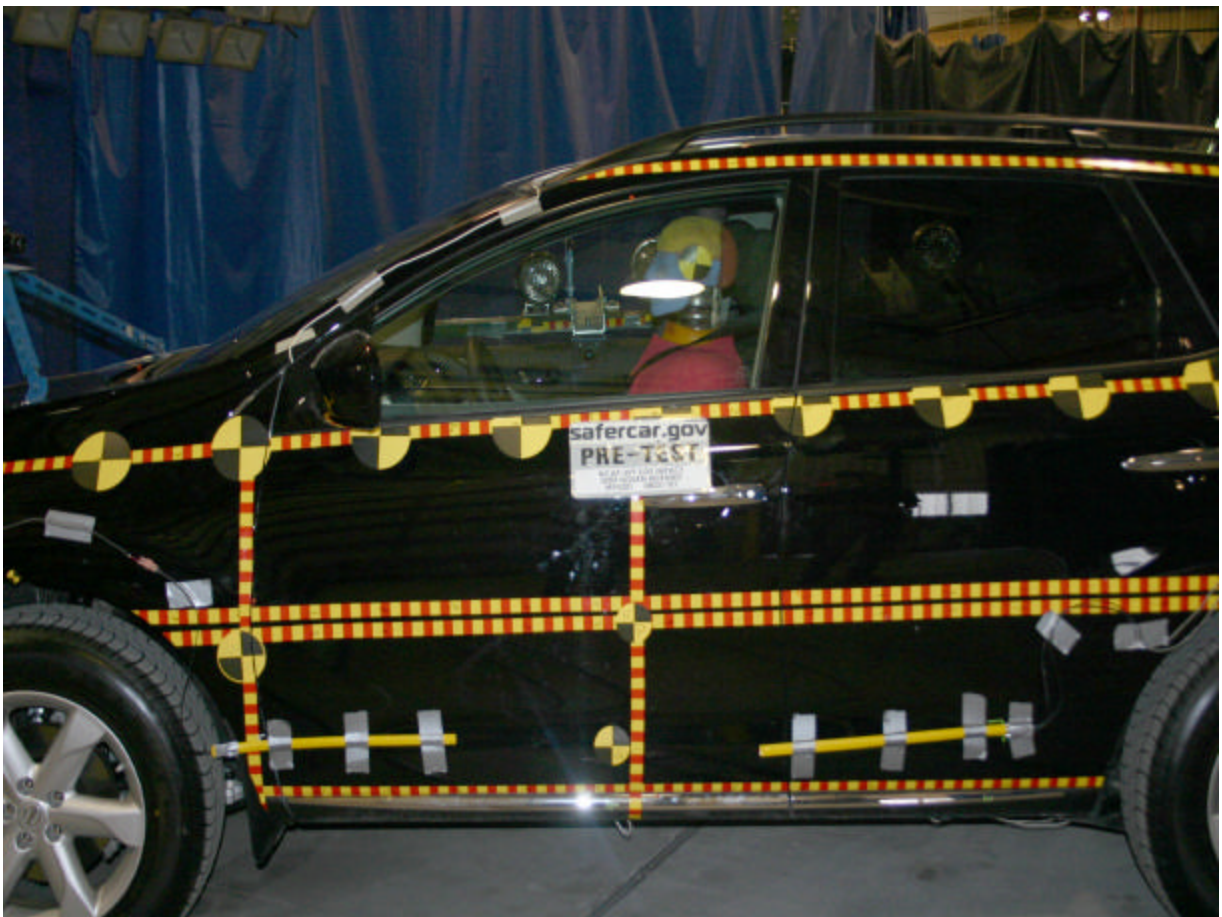
Pre-Test Left Side Impact Close-up

Post-Test Left Side Impact Close-up

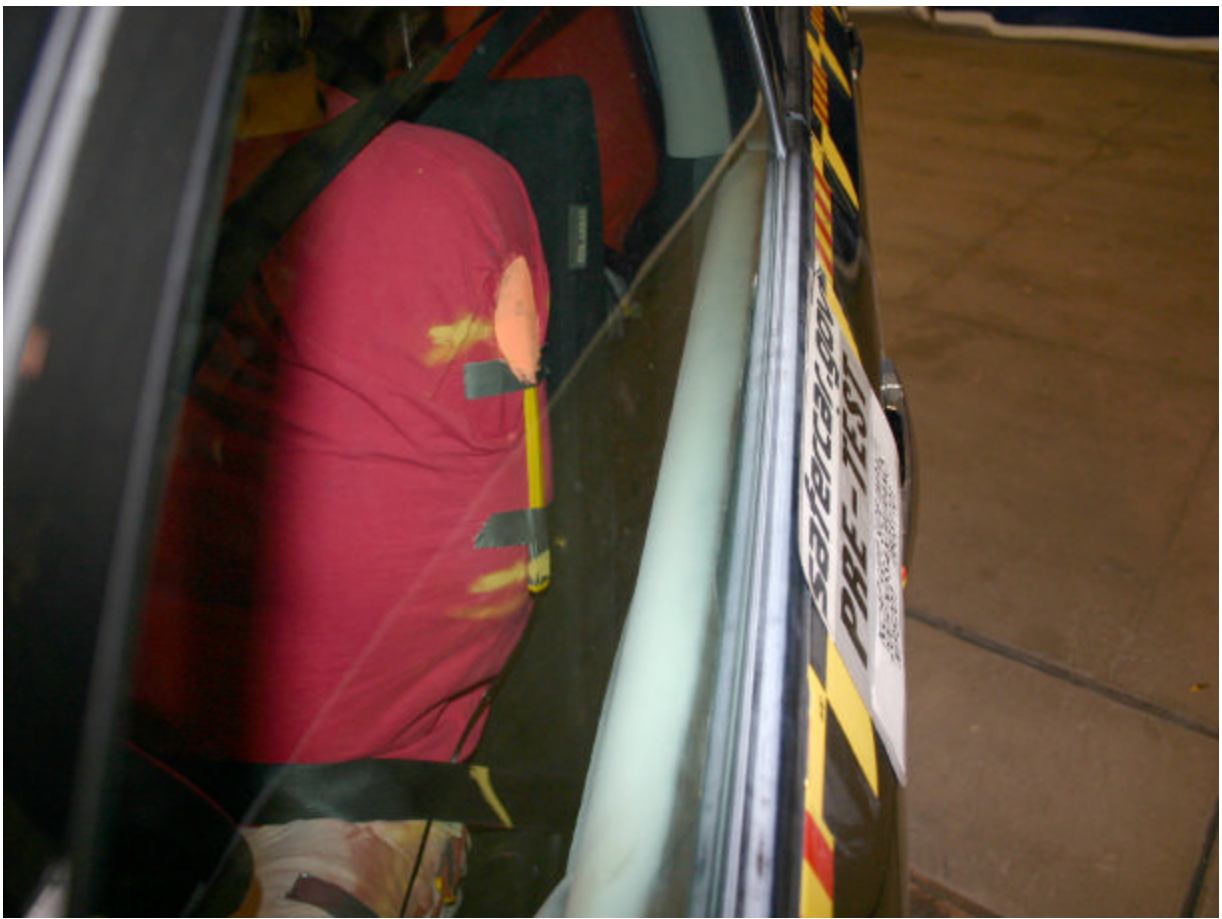
Pre-Test Driver Dummy Clearance From Door

Post-Test Driver Dummy Clearance From Door

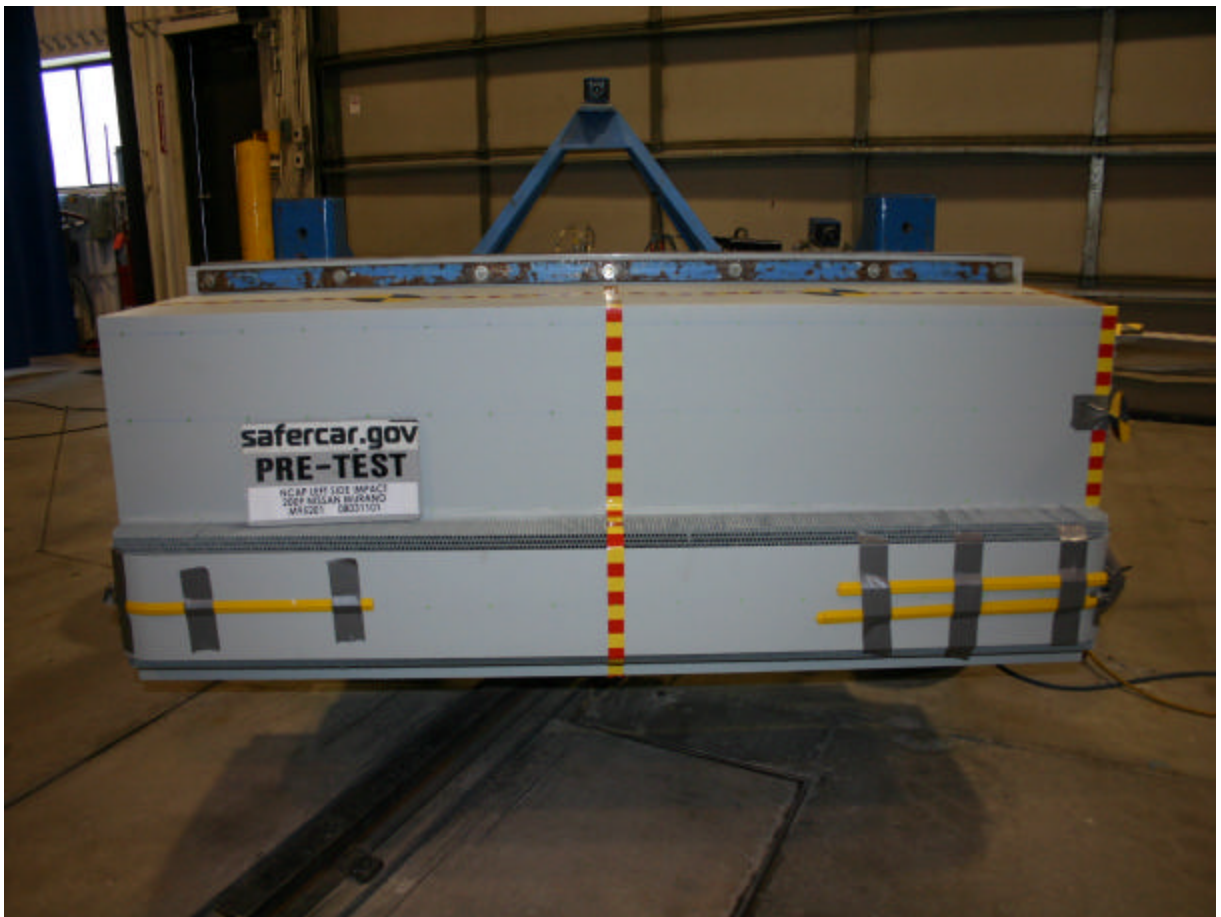
Pre-Test Front View of Deformable Barrier

Post-Test Front View of Deformable Barrier

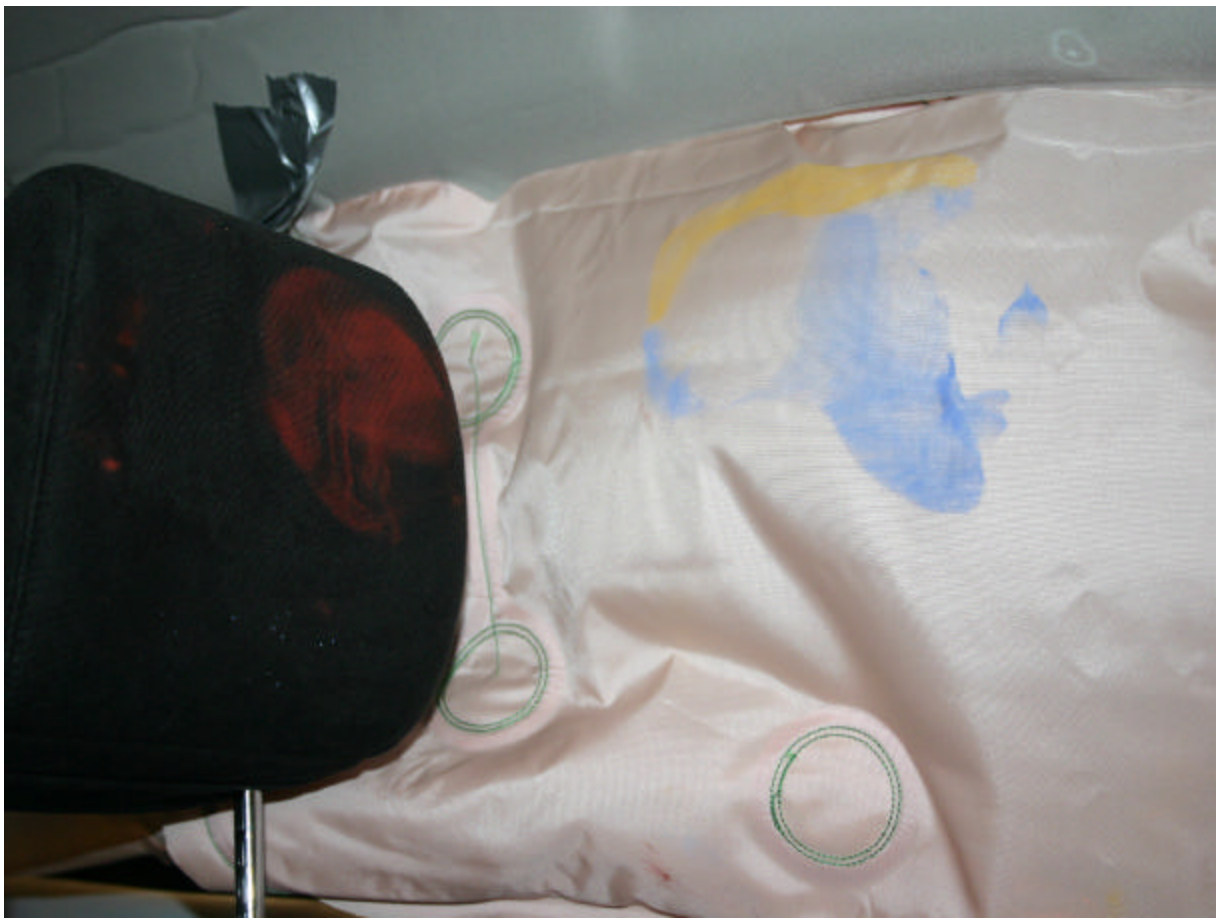
Post-Test Driver Dummy Head Contact

Post-Test Driver Dummy Mid Torso Contact

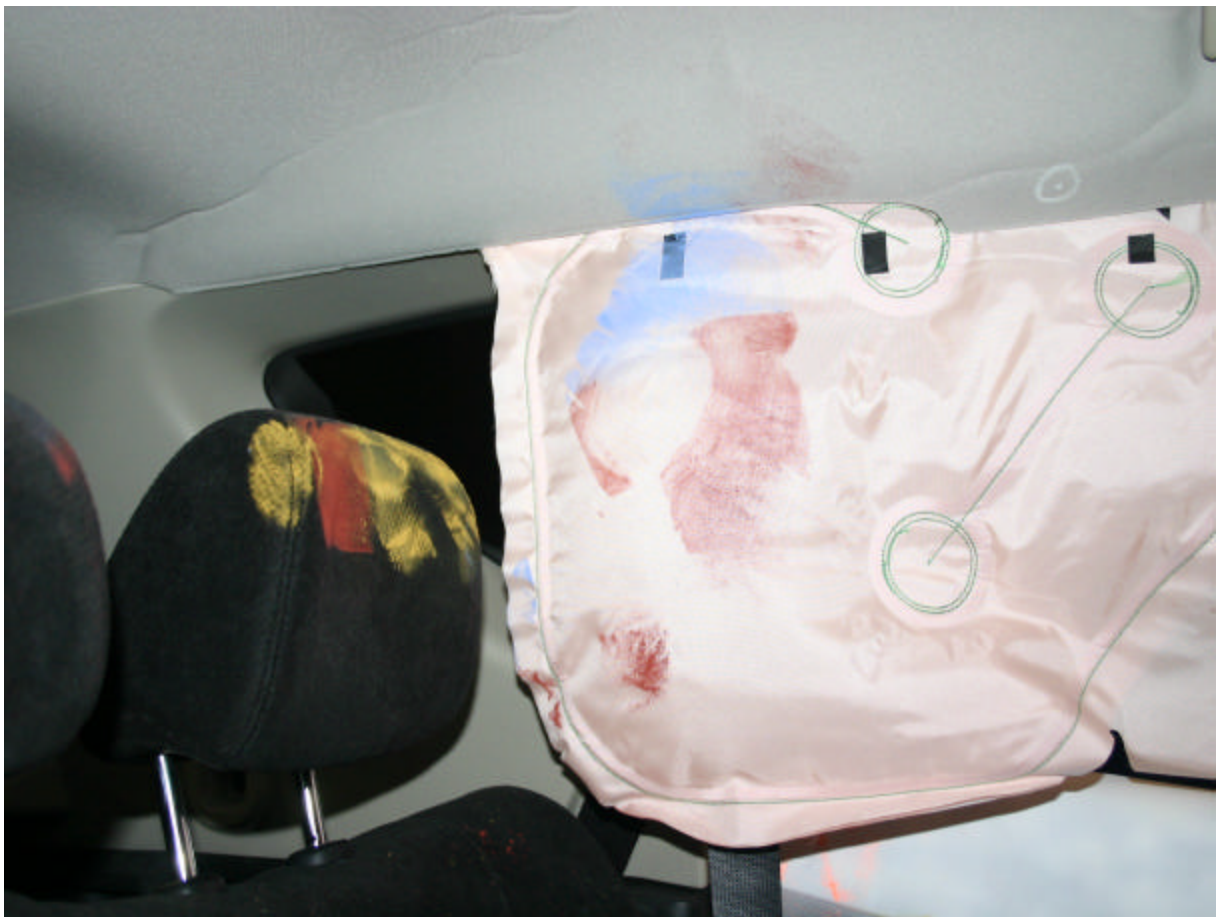
Post-Test Passenger Dummy Head Contact

Post-Test Passenger Dummy Mid Torso Contact
