REPORT NUMBER: T8001-MGA-2008-006

**VEHICLE TO DEFORMABLE BARRIER CRASH TESTS
IN SUPPORT OF NHTSA OFFSET FRONTAL PROGRAM**

**LEFT 40% OFFSET DEFORMABLE BARRIER IMPACT
R94 BARRIER**

2008 SATURN OUTLOOK FWD XE (R80176)

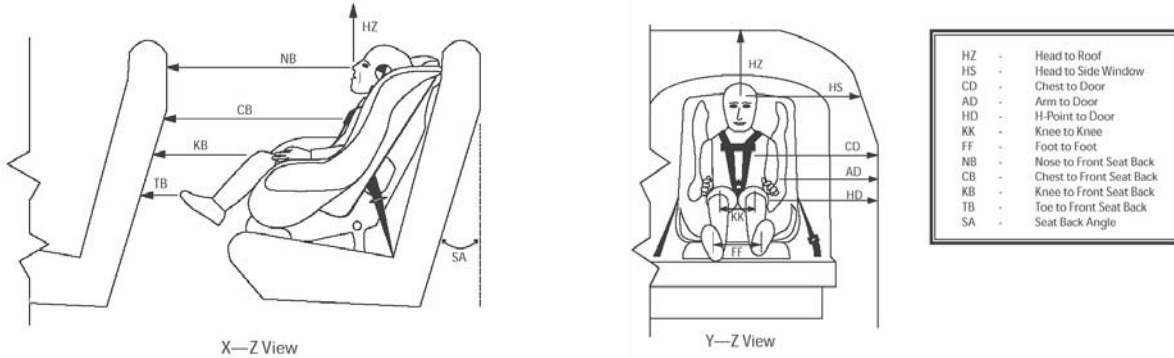
Dummy Measurements for CRS Passengers

Measurement	Pre-Test (mm)		Post-Test (mm)	
	P4 CRS		P4 CRS	
SA (deg)	15.9		15.2	
HS	357		556	
CD	368		429	
AD	224		218	
HD	275		270	
HZ	266		326	
NB	505		458	
CB	510		496	
KK	161		174	
FF	183		246	
KB - LEFT	238		267	
KB - RIGHT	228		293	
TB - LEFT	71		77	
TB - RIGHT	72		81	
Seat Top to Door	138		215	
Seat Bottom to Door	109		252

All dimensions in mm (unless noted)
 P4 – 2nd Row Left Rear Passenger (Forward Facing)

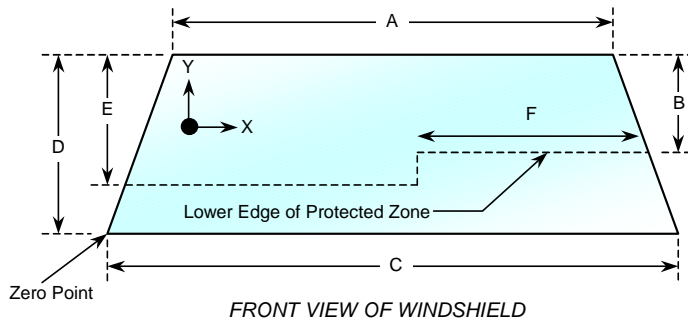
Item	Units	Value
A	mm	1320
B	mm	559
C	mm	1680
D	mm	850
E	mm	573
F	mm	486

AREA OF PROTECTED ZONE FAILURES - NONE

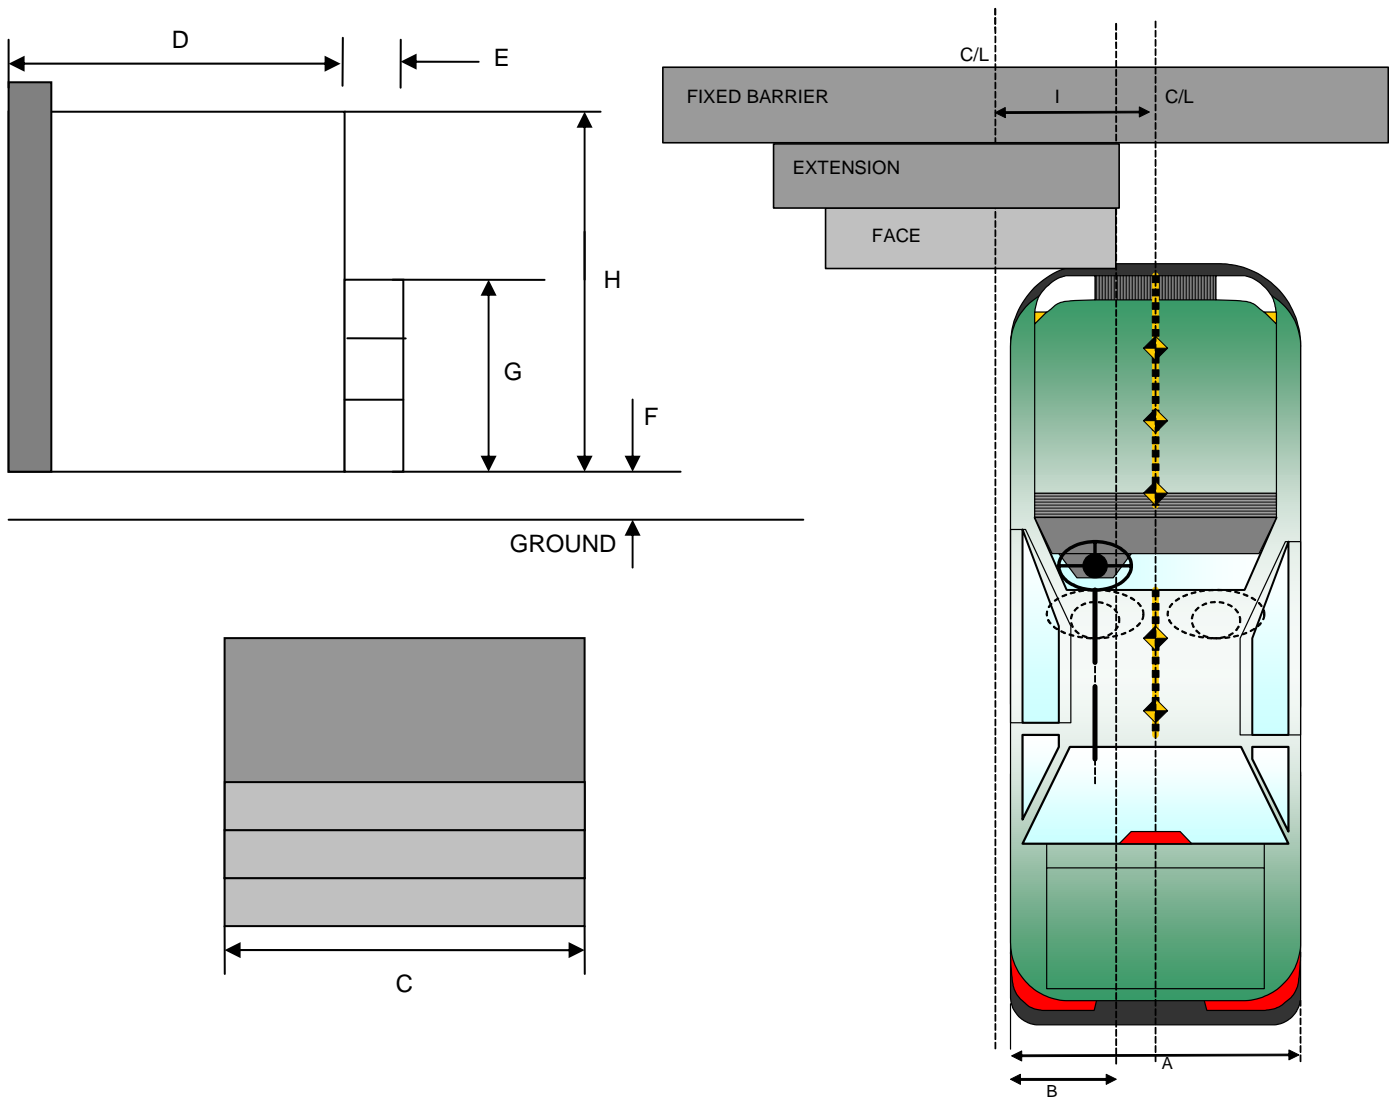
DATA SHEET 15
OFFSET BARRIER AND VEHICLE ORIENTATION

Location	Description	Measurement (mm)
A	Total Vehicle Width	2050
B	40% Overlap Distance	205
C	Deformable Face Width	1000
D	Single Stage Honeycomb Depth	450
E	Bumper Element Depth	90
F	Lower Edge Height From Ground	200
G	Bumper Element Height	330
H	Deformable Barrier Honeycomb Height	650
I	Offset Distance	705

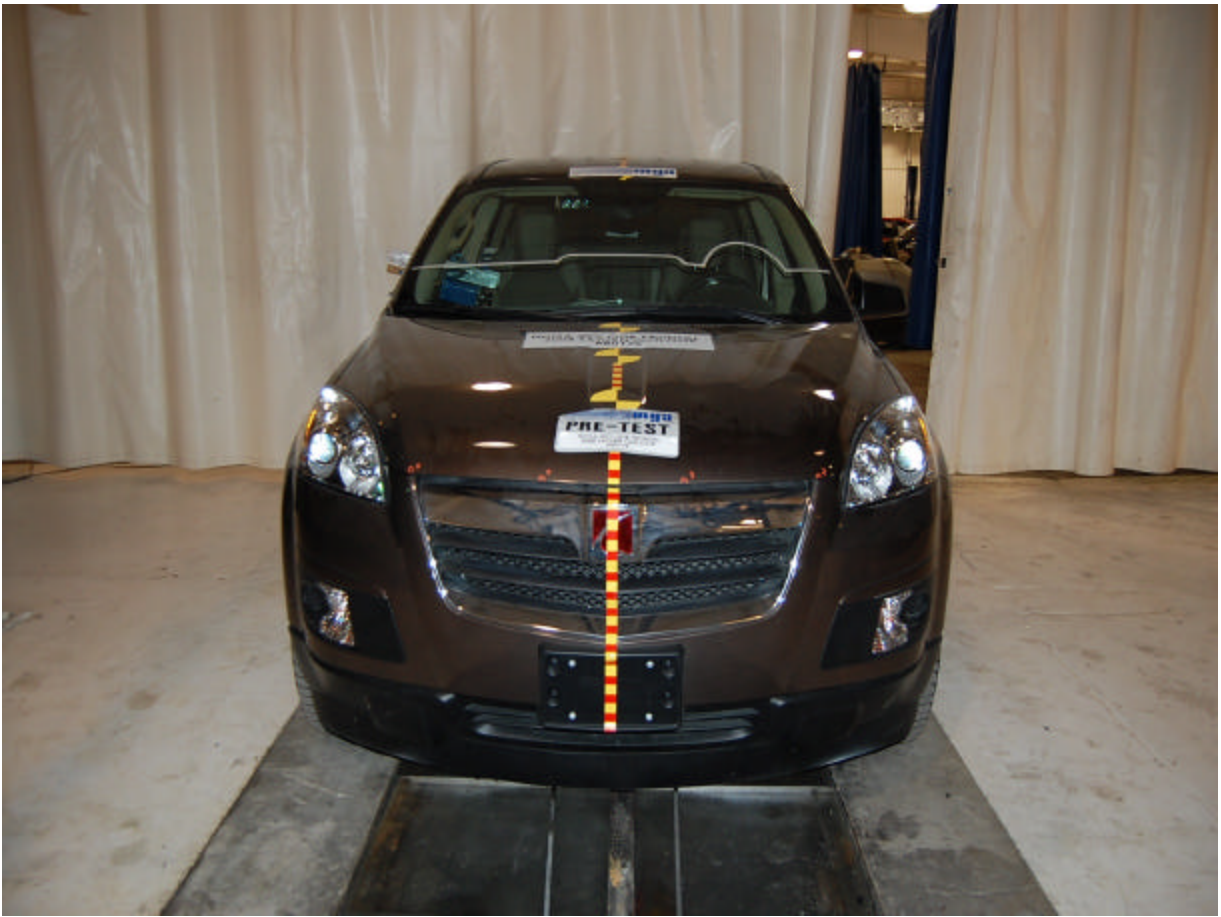
Pre-Test Front View

Post-Test Front View

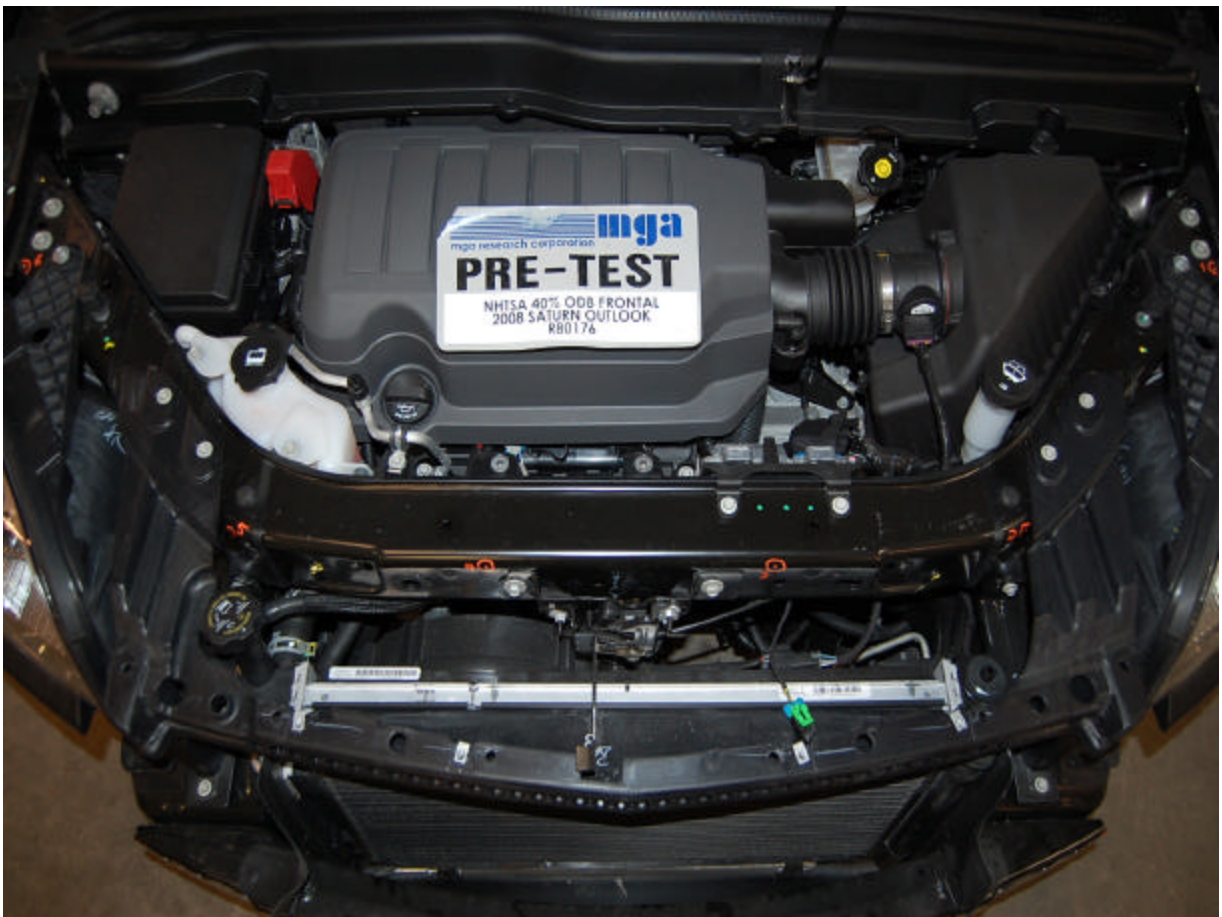
Pre-Test Engine Compartment View

Post-Test Engine Compartment View

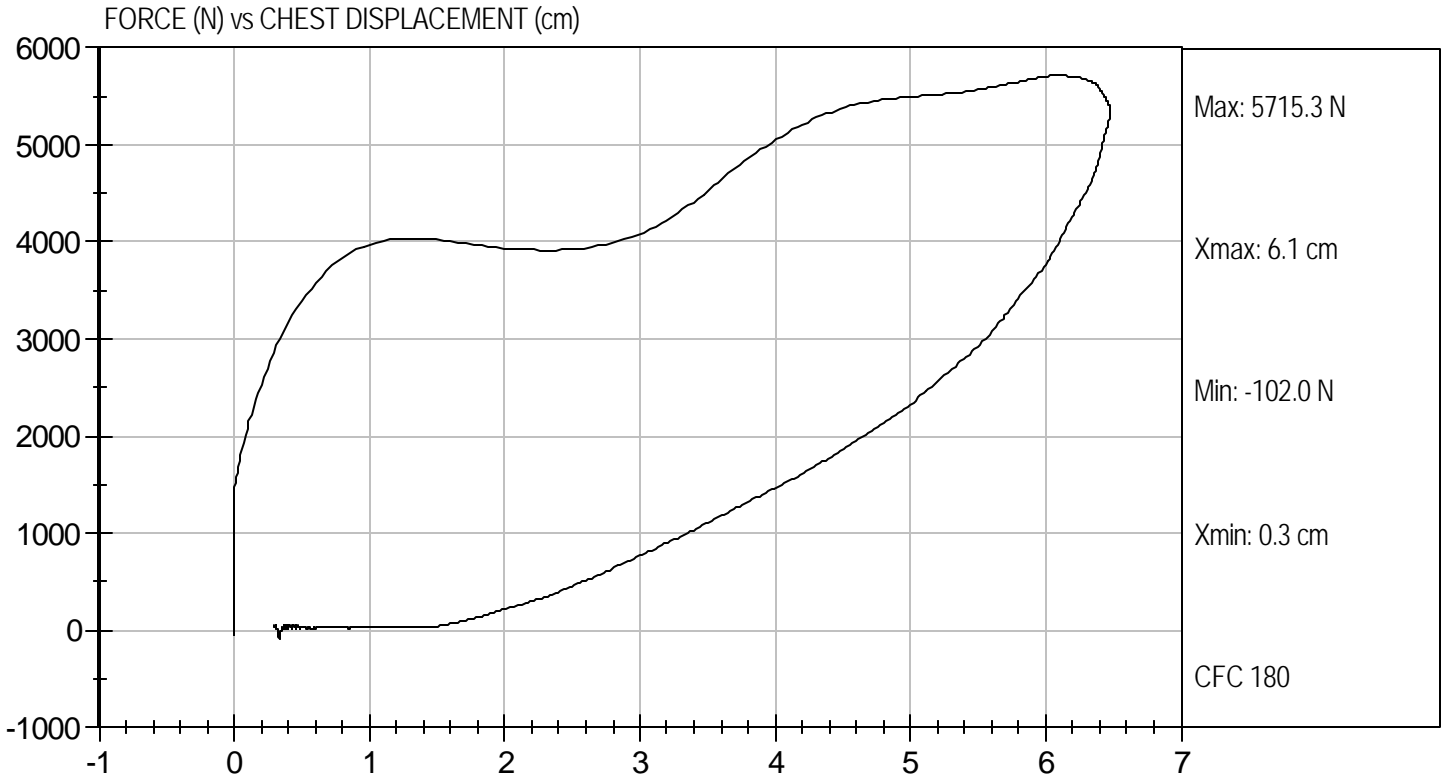
Test Desc: Thorax Impact
Component ID: D08484

Tested Parameter	Units	Specification	Result	Pass/Fail
Laboratory Temperature	deg C	20.6 to 22.2	20.7	Pass
Laboratory Relative Humidity	%	10 to 70	17	Pass
Probe Velocity	m/s	6.58 to 6.82	6.77	Pass
Peak Probe Force	N	5159 to 5893	5,715	Pass
Peak Sternum Displacement	cm	6.35 to 7.26	6.48	Pass
Internal Hysteresis	%	69 to 85	71	Pass
Overall Test Results				Pass

Test Date: 2/27/08
Velocity: 22.22 ft/s, 6.77 m/s

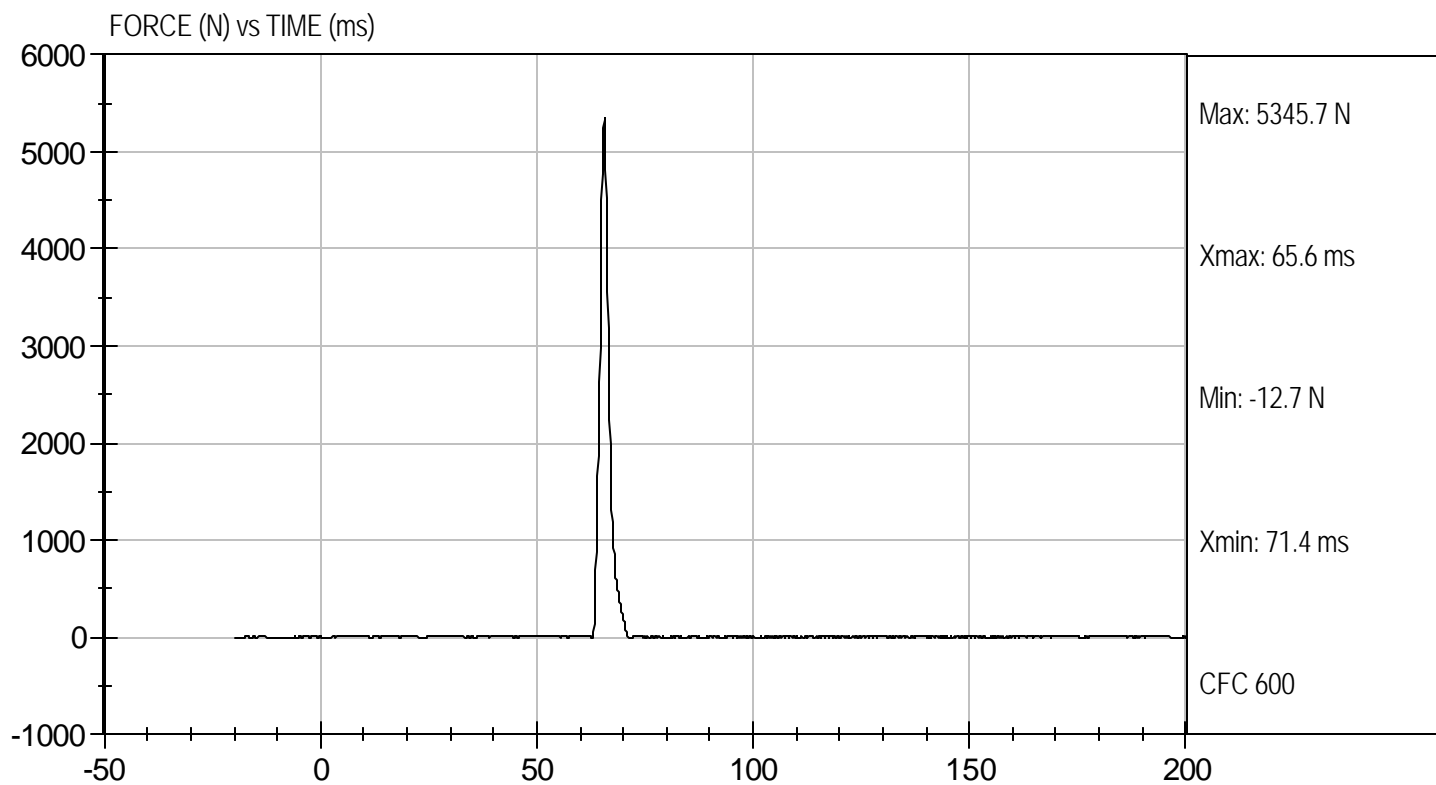
Test Desc: Right Knee
Component ID: D08485

Tested Parameter	Units	Specification	Result	Pass/Fail
Laboratory Temperature	deg C	18.9 to 25.5	20.1	Pass
Laboratory Relative Humidity	%	10 to 70	20	Pass
Probe Velocity	m/sec	2.07 to 2.13	2.10	Pass
Peak Probe Force	Newtons	4715 to 5782	5,346	Pass
Overall Test Results				Pass

Test Date: 3/4/08
Velocity: 6.89 ft/s, 2.10 m/s

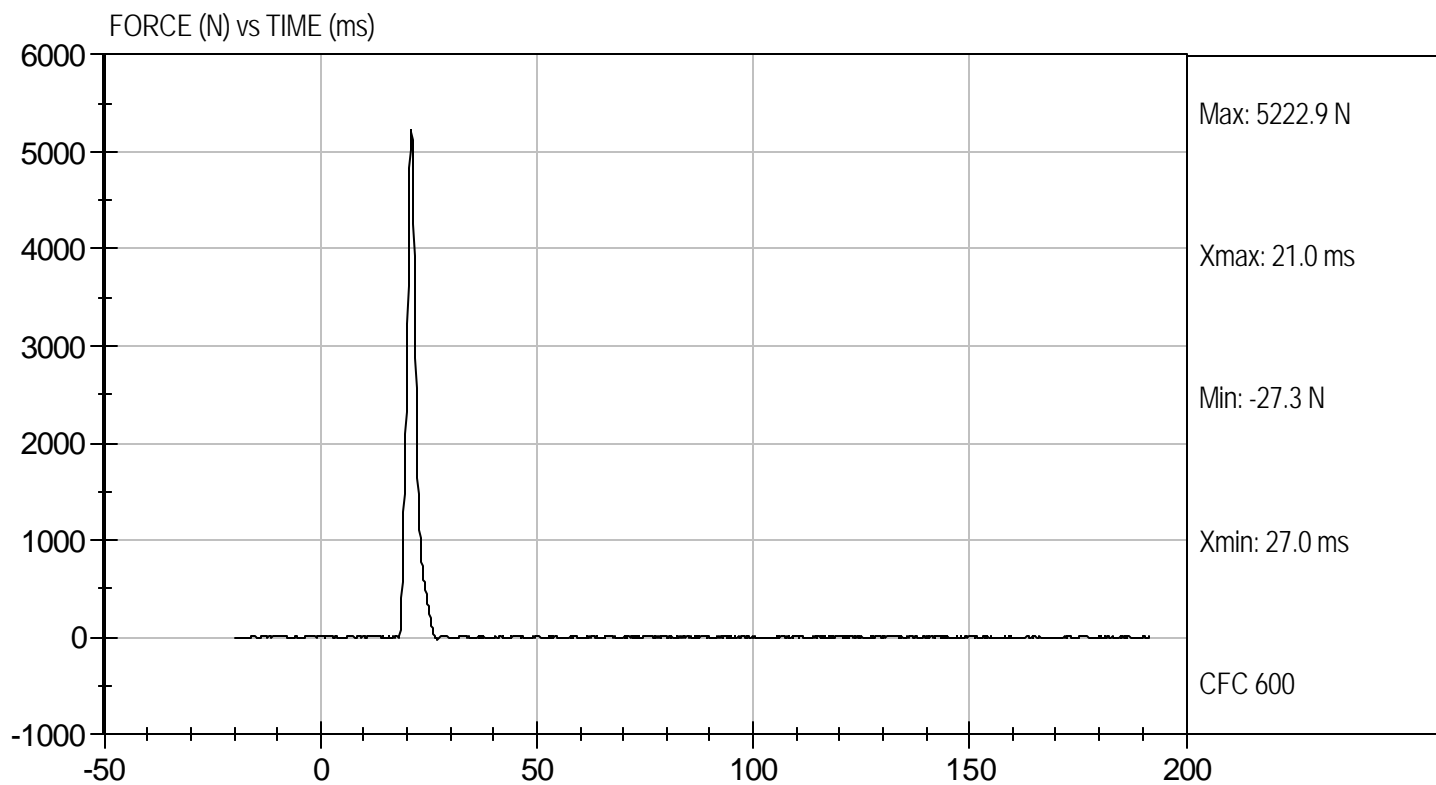
Test Desc: Left Knee
Component ID: D08486

Tested Parameter	Units	Specification	Result	Pass/Fail
Laboratory Temperature	deg C	18.9 to 25.5	20.1	Pass
Laboratory Relative Humidity	%	10 to 70	20	Pass
Probe Velocity	m/sec	2.07 to 2.13	2.10	Pass
Peak Probe Force	Newtons	4715 to 5782	5,223	Pass
Overall Test Results				Pass

Test Date: 3/4/08
Velocity: 6.89 ft/s, 2.10 m/s

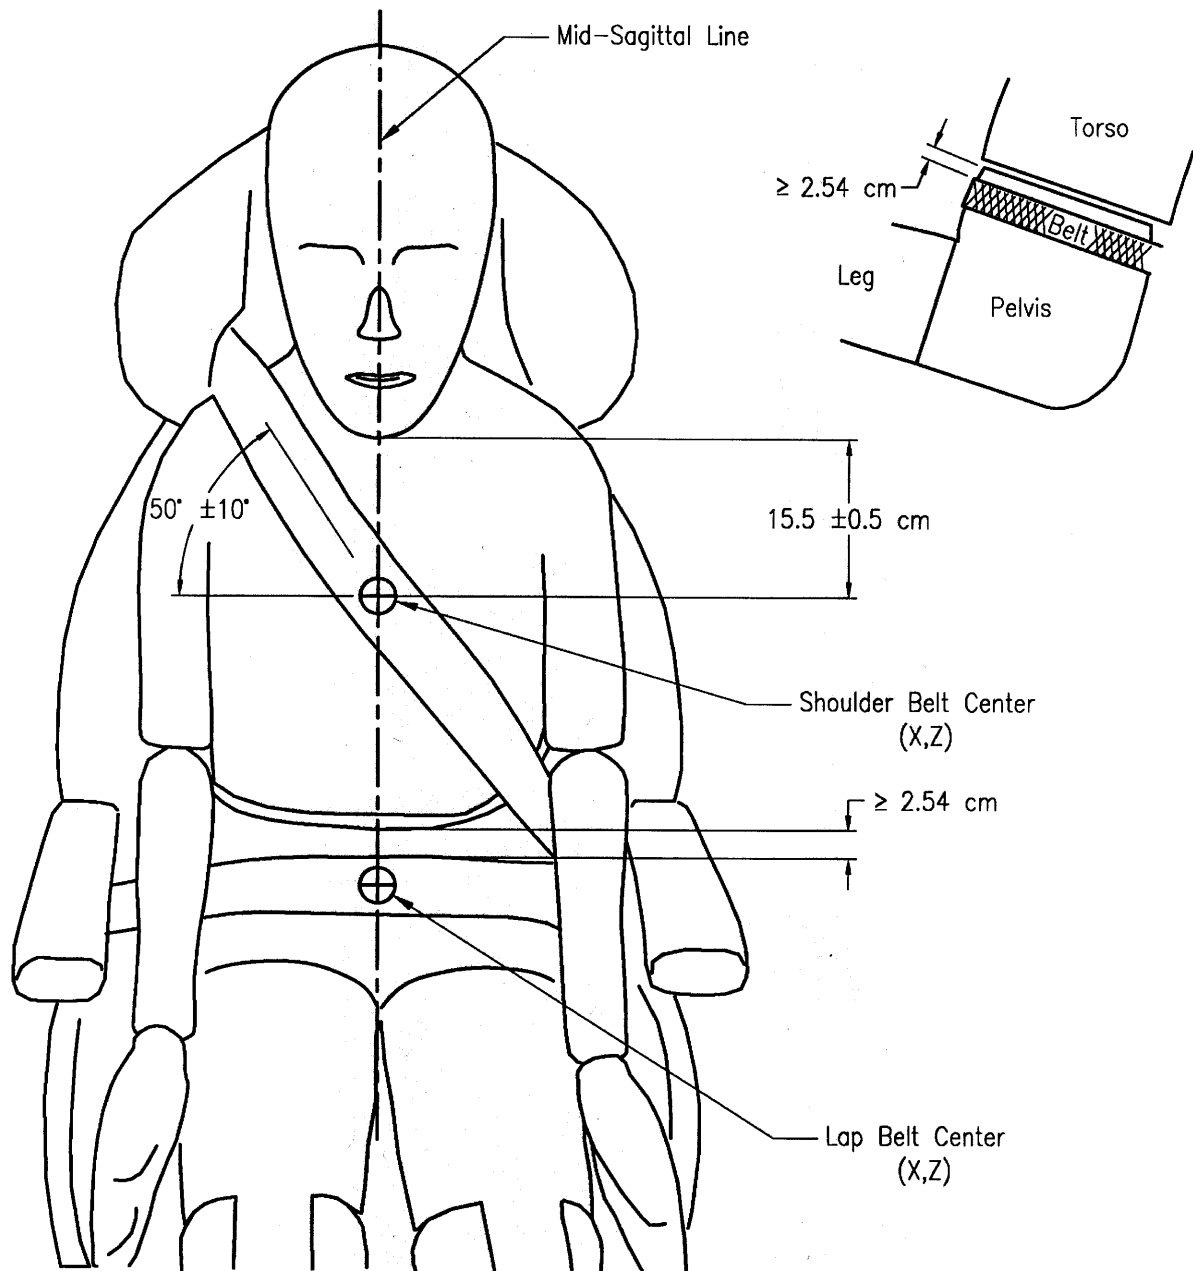
Figure 4. Overall Belt Placement for HIII-6C Dummy

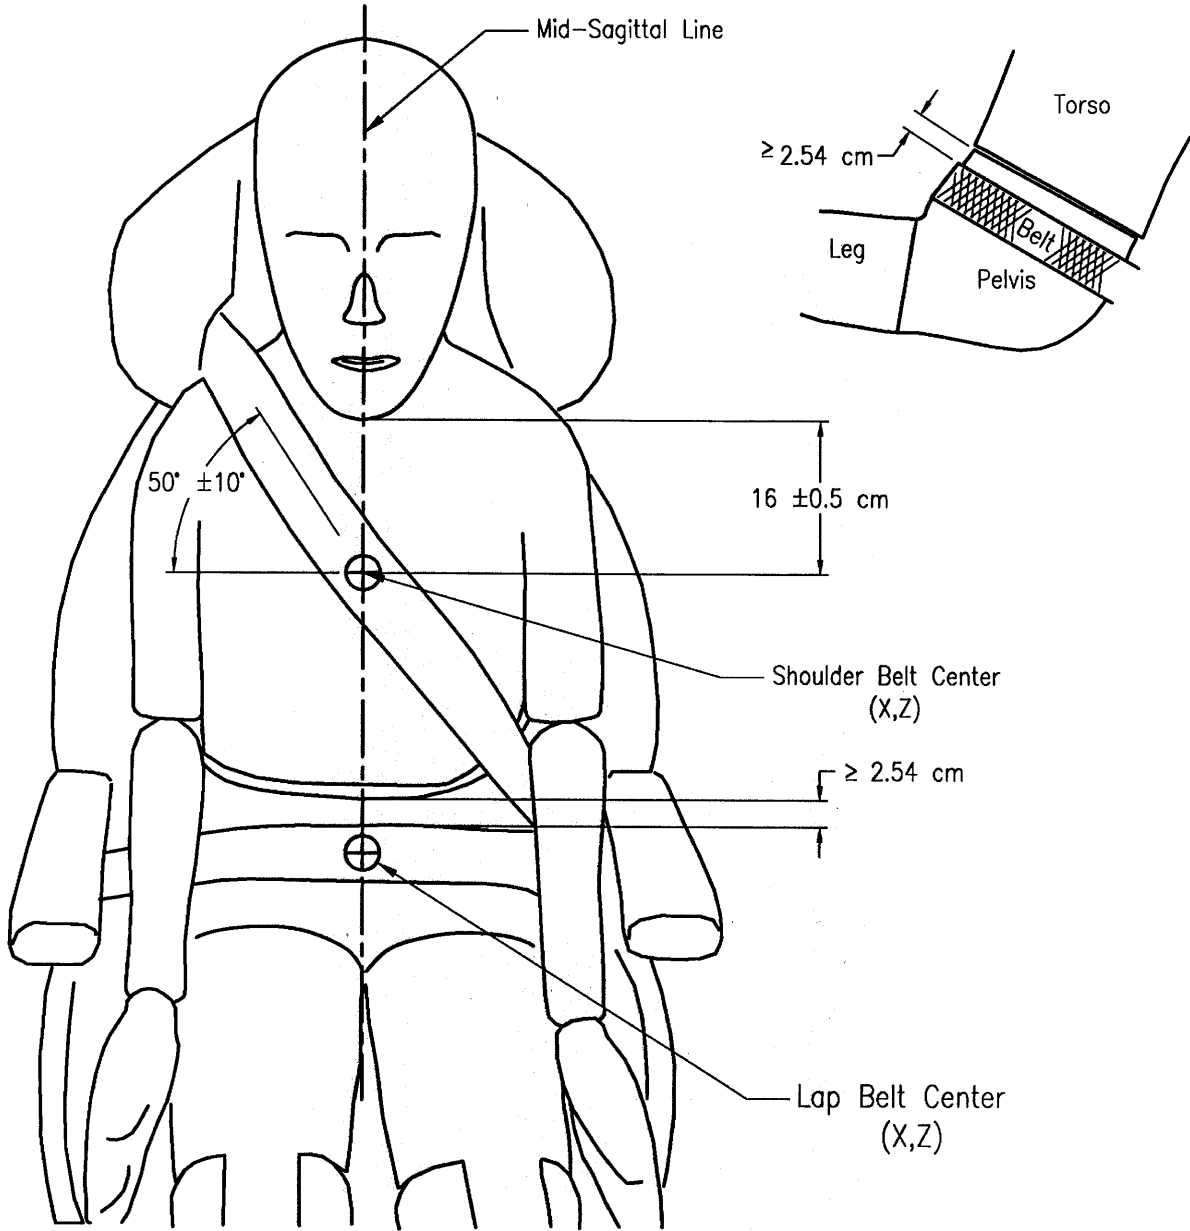
Figure 9. Overall Belt Placement for HIII-10C Dummy

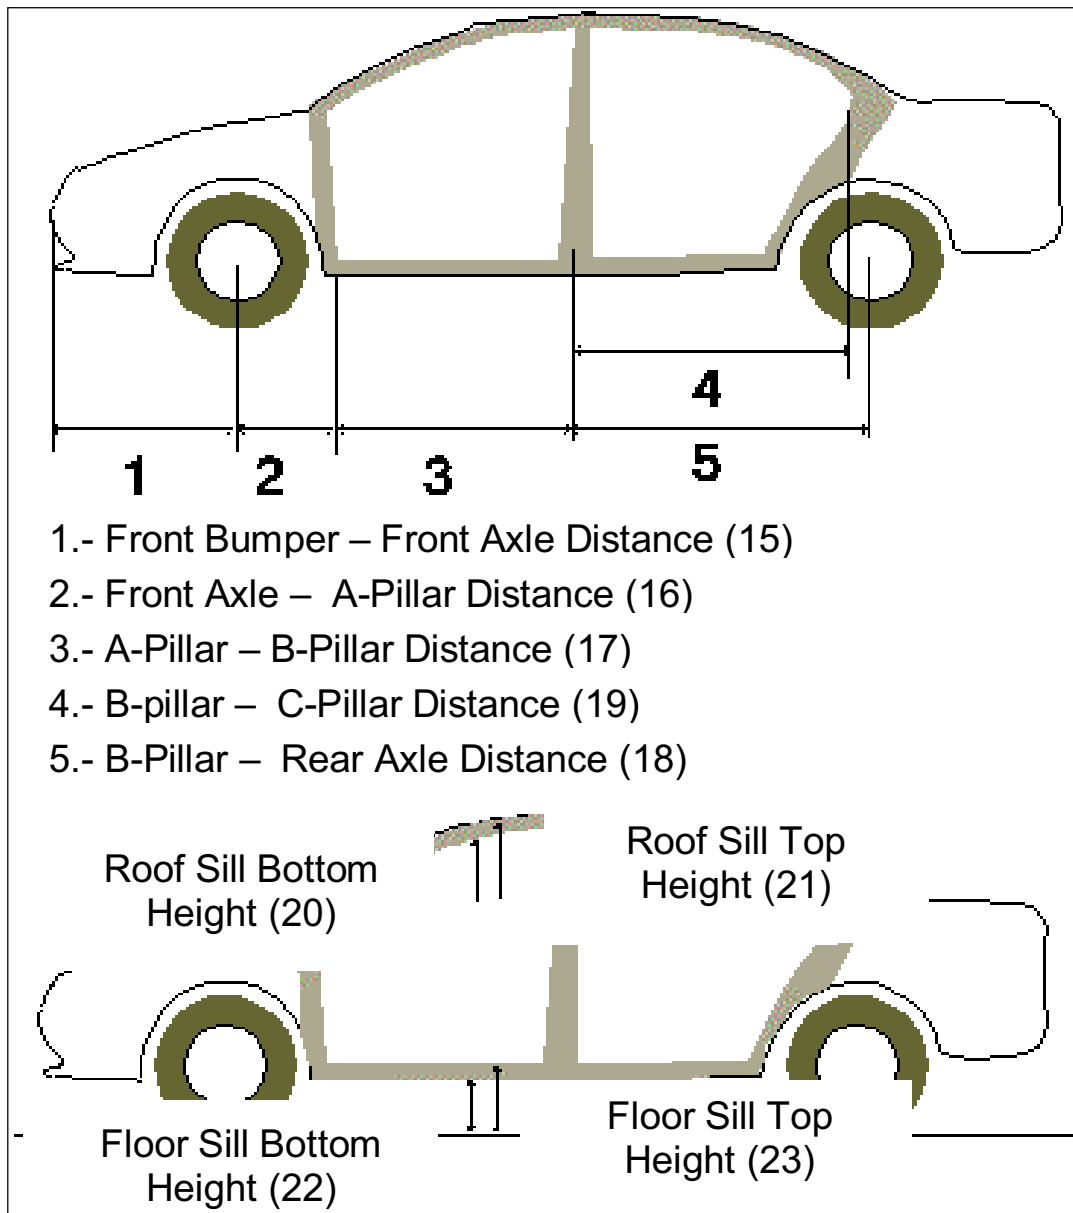
Figure 2.- Definition of the main resistant elements. Side elements.

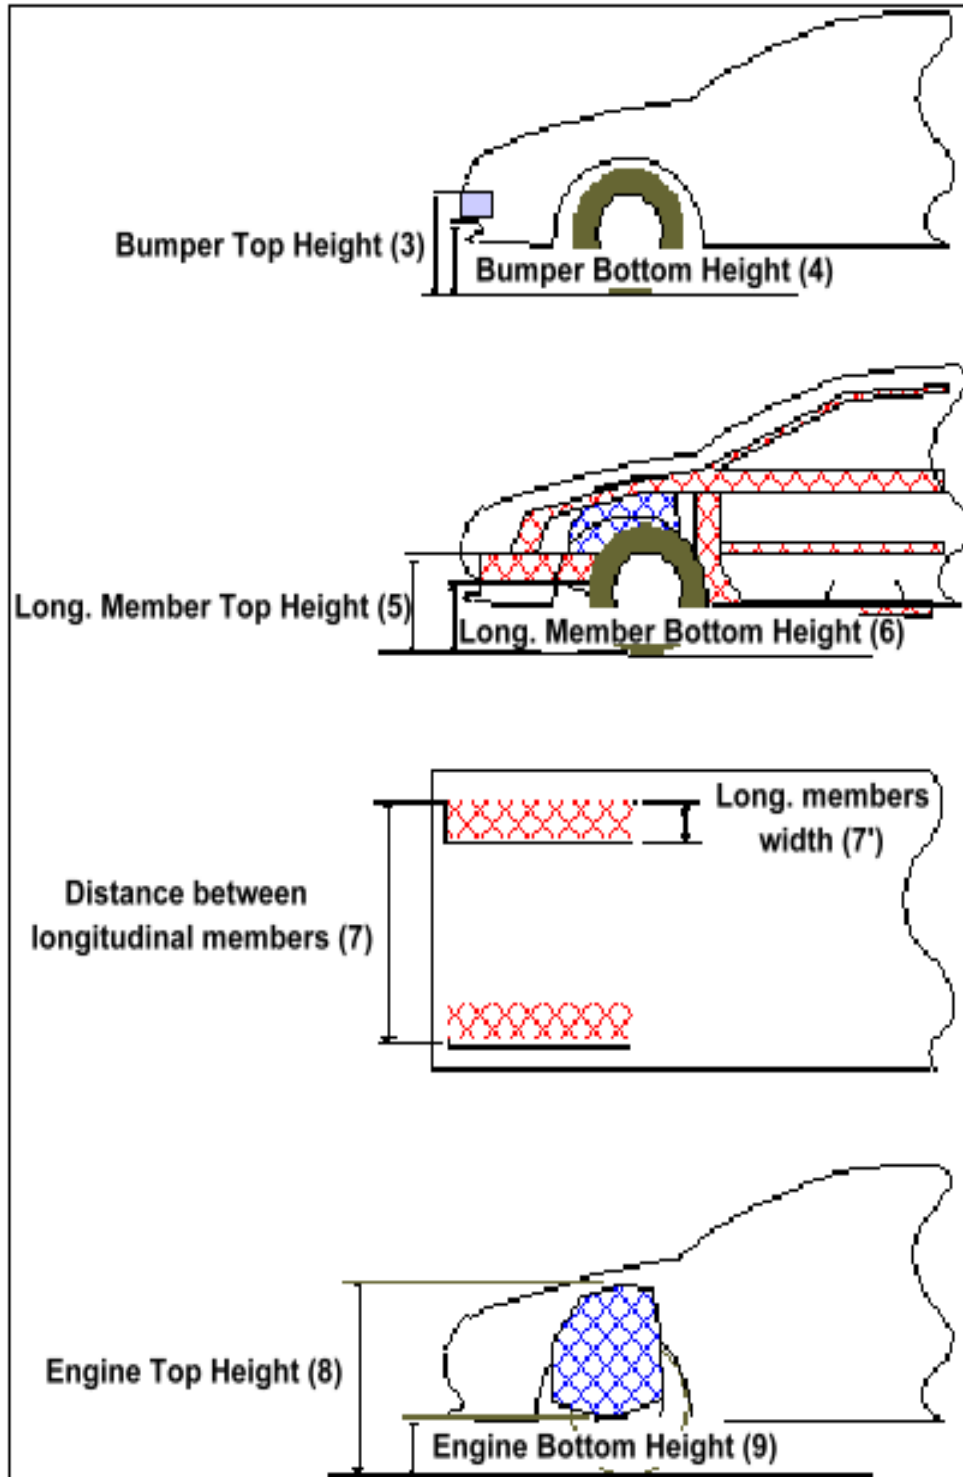
Figure 5.- Definition of the main resistant elements. Front elements.
