**REPORT NUMBER: NCAPSIDE-MGA-2008-015**

**NEW CAR ASSESSMENT PROGRAM  
SIDE IMPACT TEST**

**CHRYSLER LLC  
2009 DODGE JOURNEY SE  
NHTSA NUMBER: M90301**

**PREPARED BY:  
MGA RESEARCH CORPORATION  
5000 WARREN ROAD  
BURLINGTON, WI 53105**

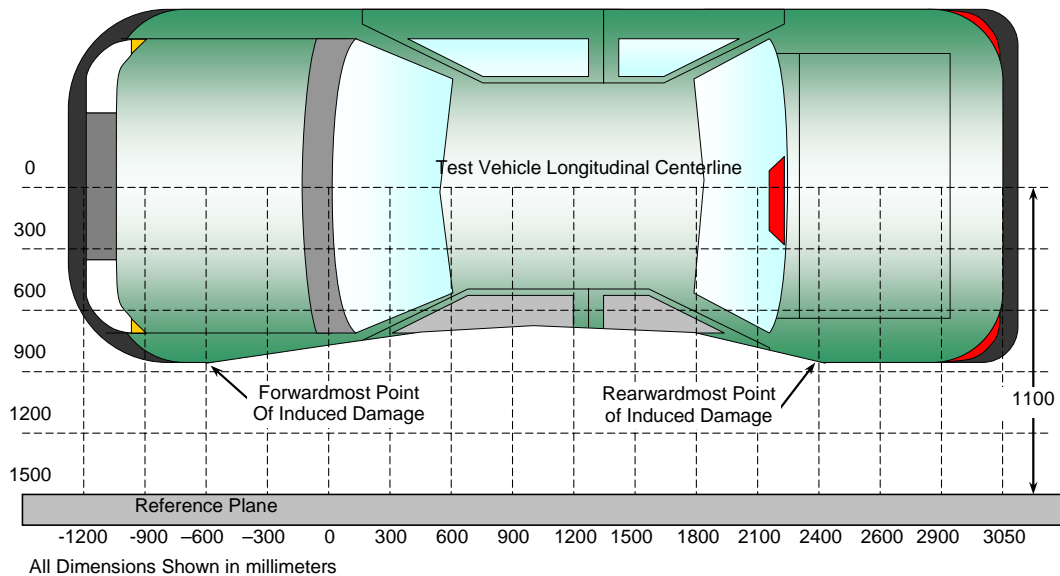
**DATA SHEET NO. 11**  
**VEHICLE DAMAGE PROFILE DISTANCES**

**TOP VIEW**

**DAMAGE PROFILE DISTANCES**

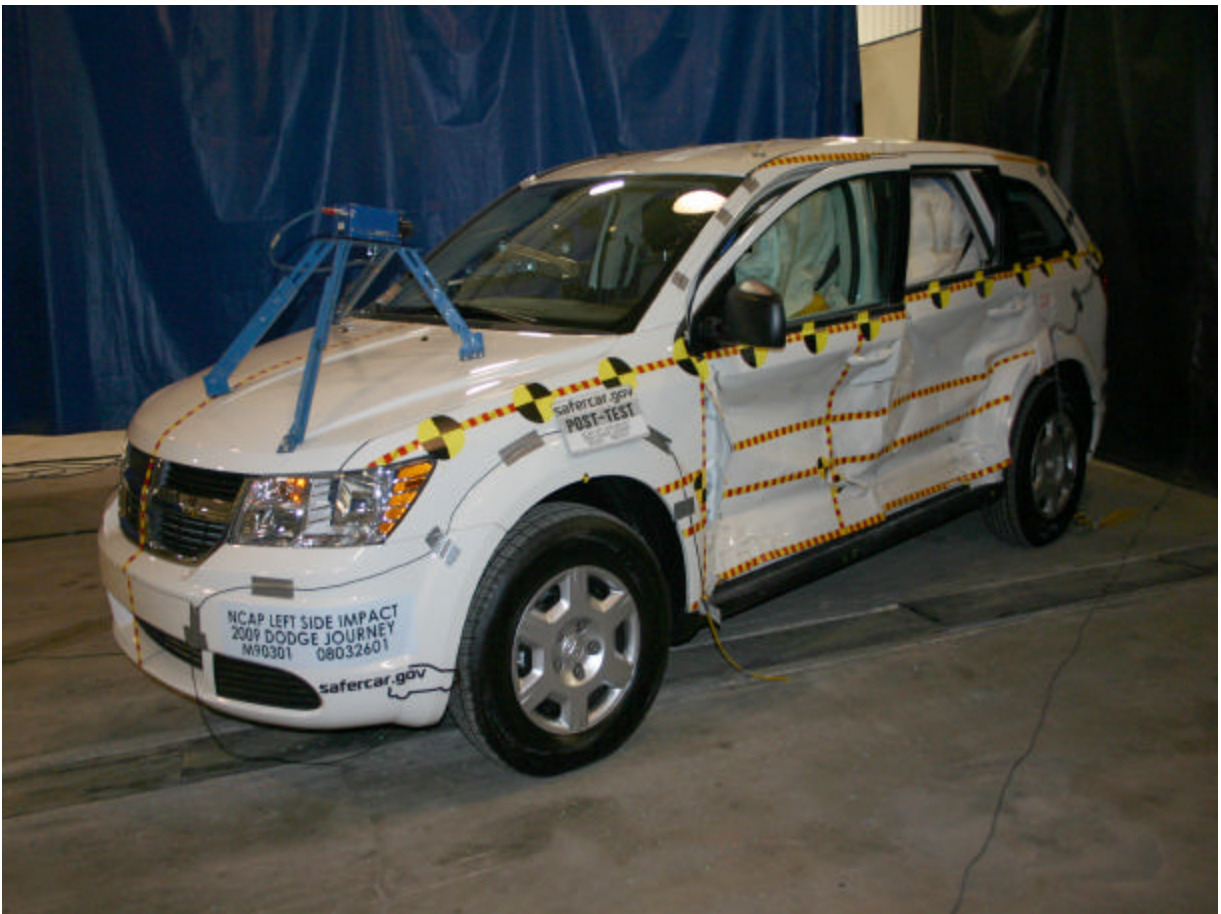
Post-Test Left Front  $\frac{3}{4}$  View

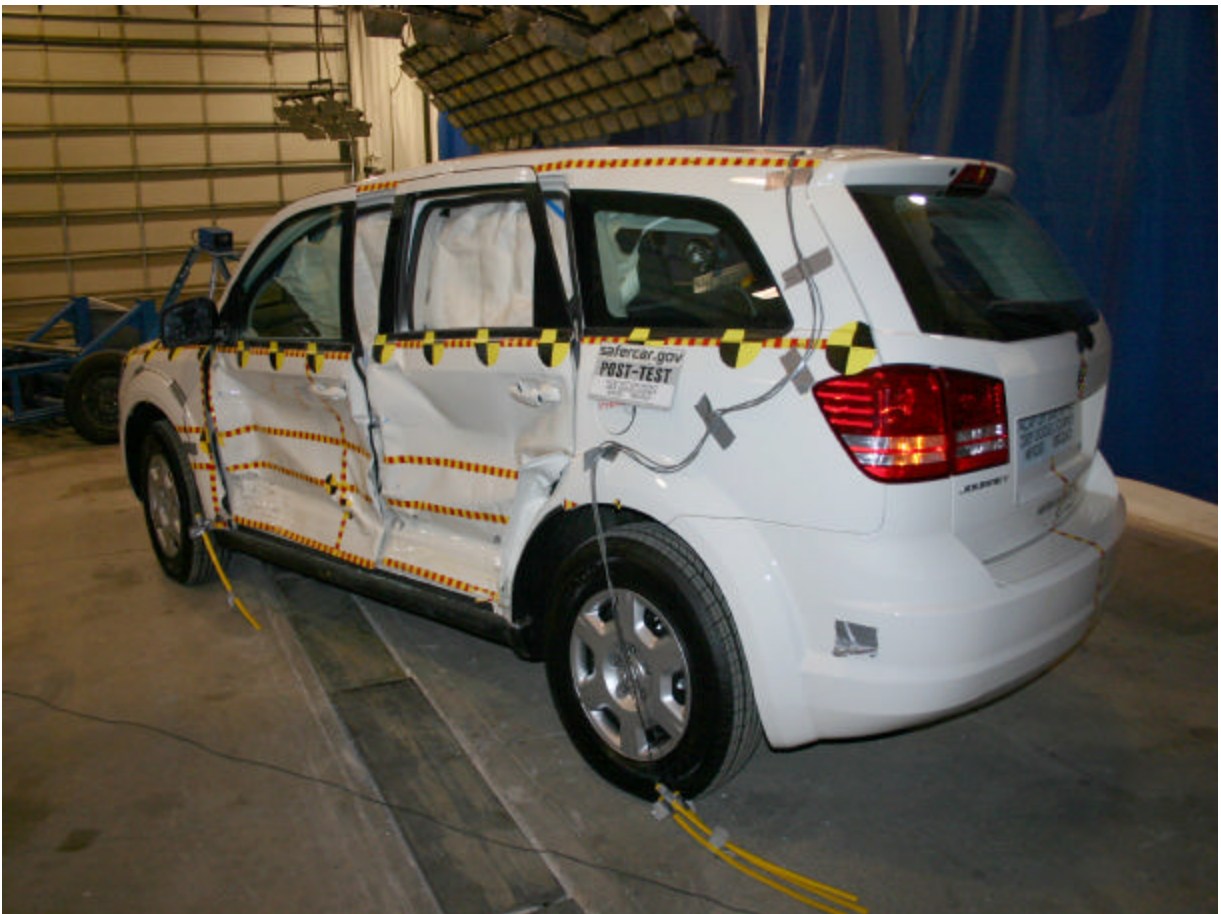
Post-Test Left Rear 3/4 View

Critical Areas of Performance	Observations and Conclusions
Pillar Performance	No Separation
Sill Separation	None
Windshield Damage	None
Window Damage	Left Rear Window Broke
Other Notable Effects	None

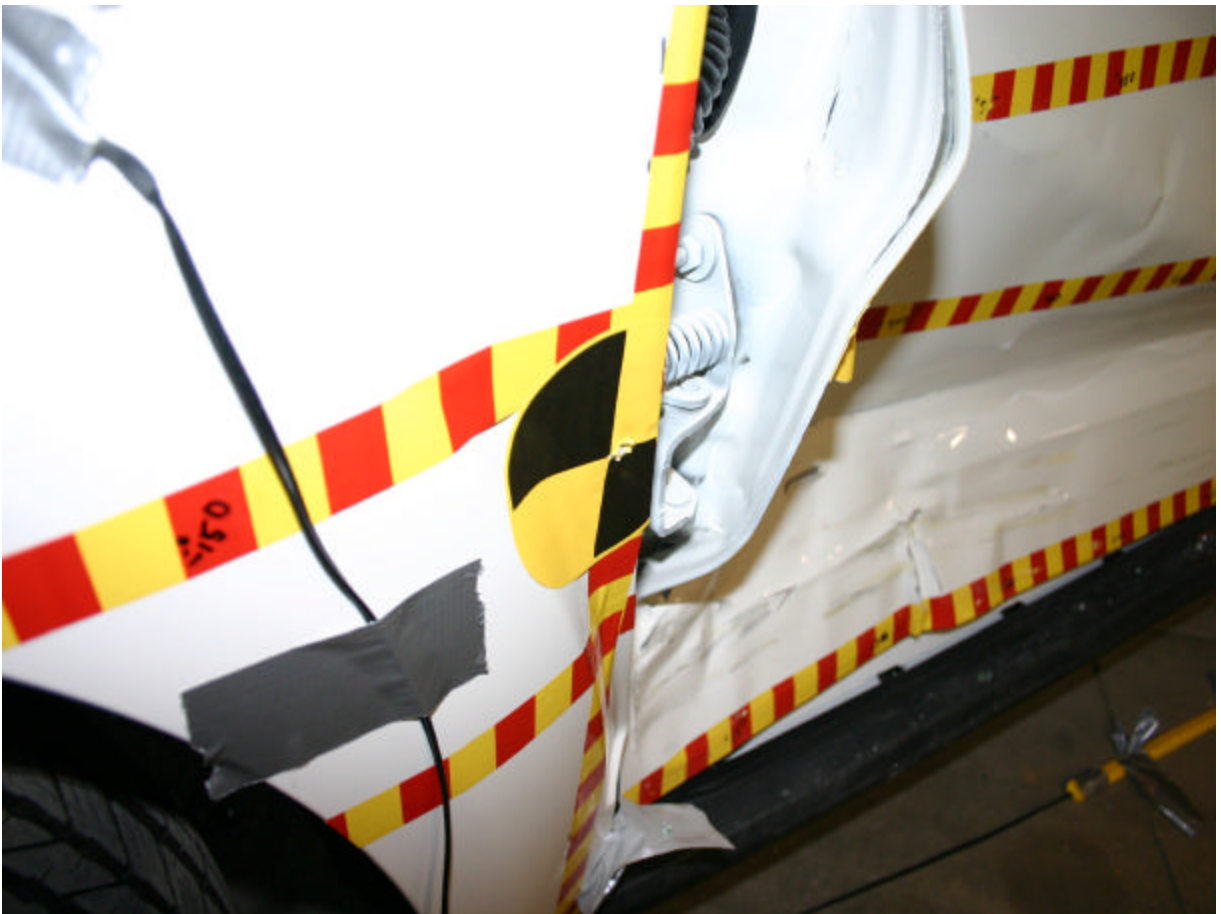
Post-Test Left Impact Point

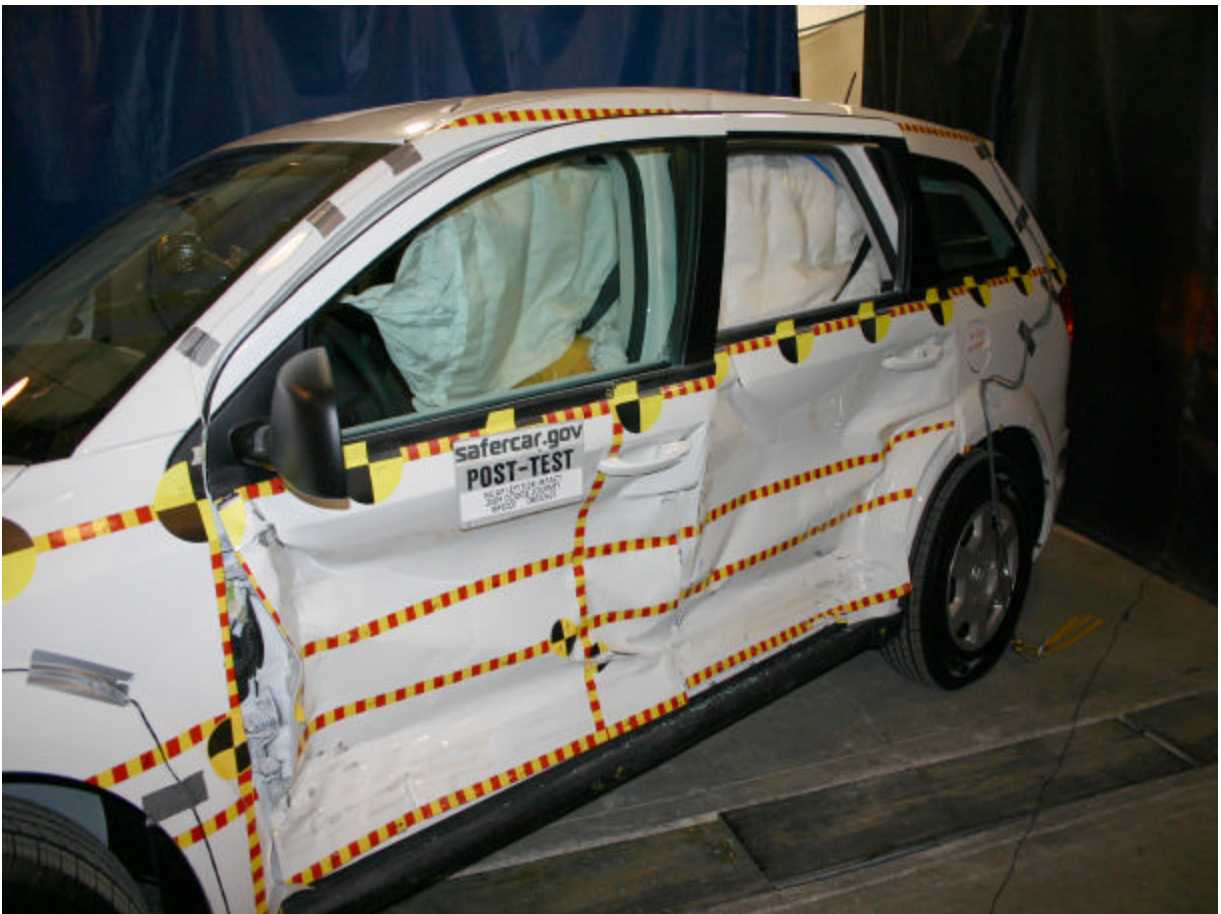
Post-Test Front 3/4 View of Left Side Doors

Description	Front	Rear
Locked/Unlocked Doors	Struck side doors were locked	Struck side doors were locked
Left Side Door Opening	Door became unlatched, but the opening was less than 6 inches.	Door remained closed and latched
Right Side Door Opening	Door remained closed and latched; Door opened without tools	Door remained closed and latched; Door opened without tools
Seat Movement	0	0
Seat Back Failure	None	None

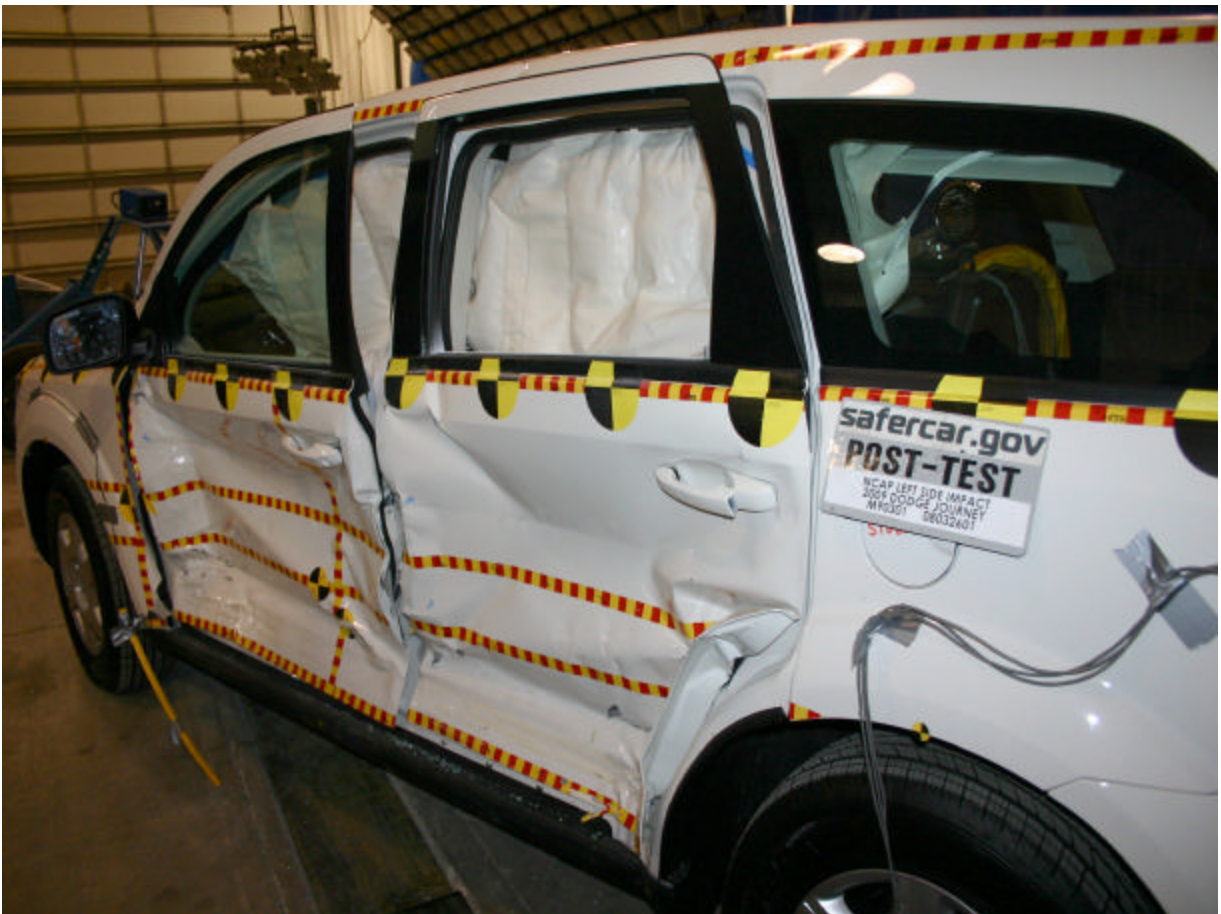
Post-Test Rear 3/4 View of Left Side Doors

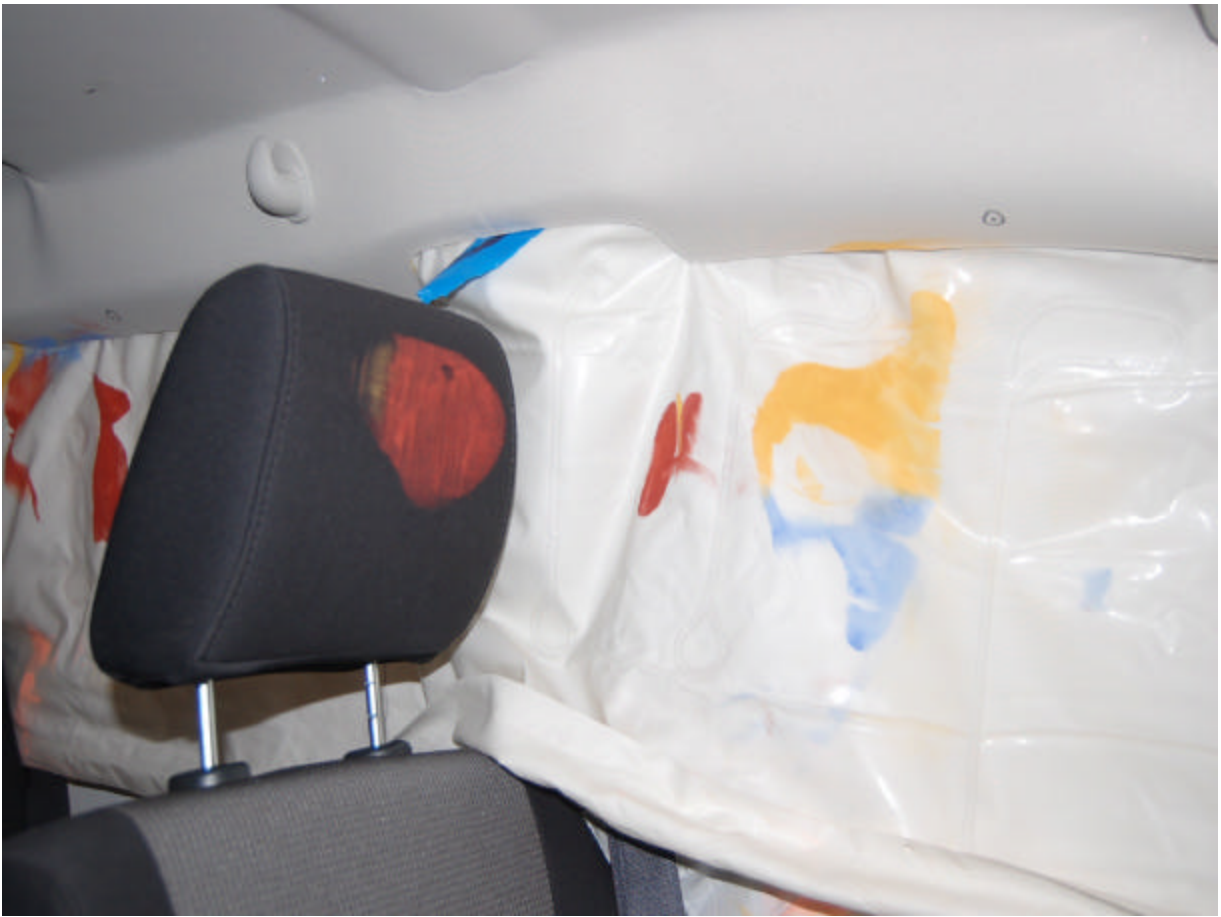
Post-Test Driver Dummy Head Contact

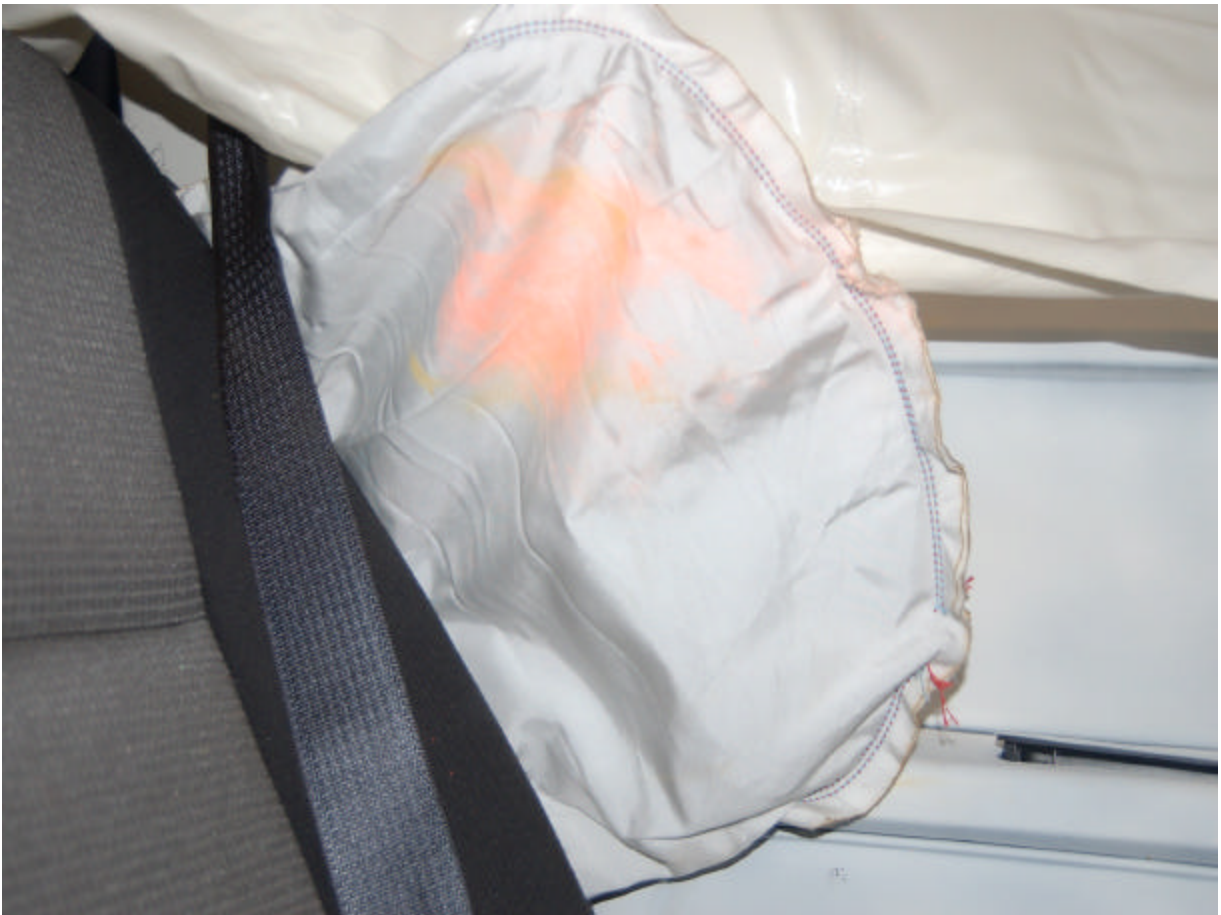
Post-Test Driver Dummy Torso Contact (SAB)

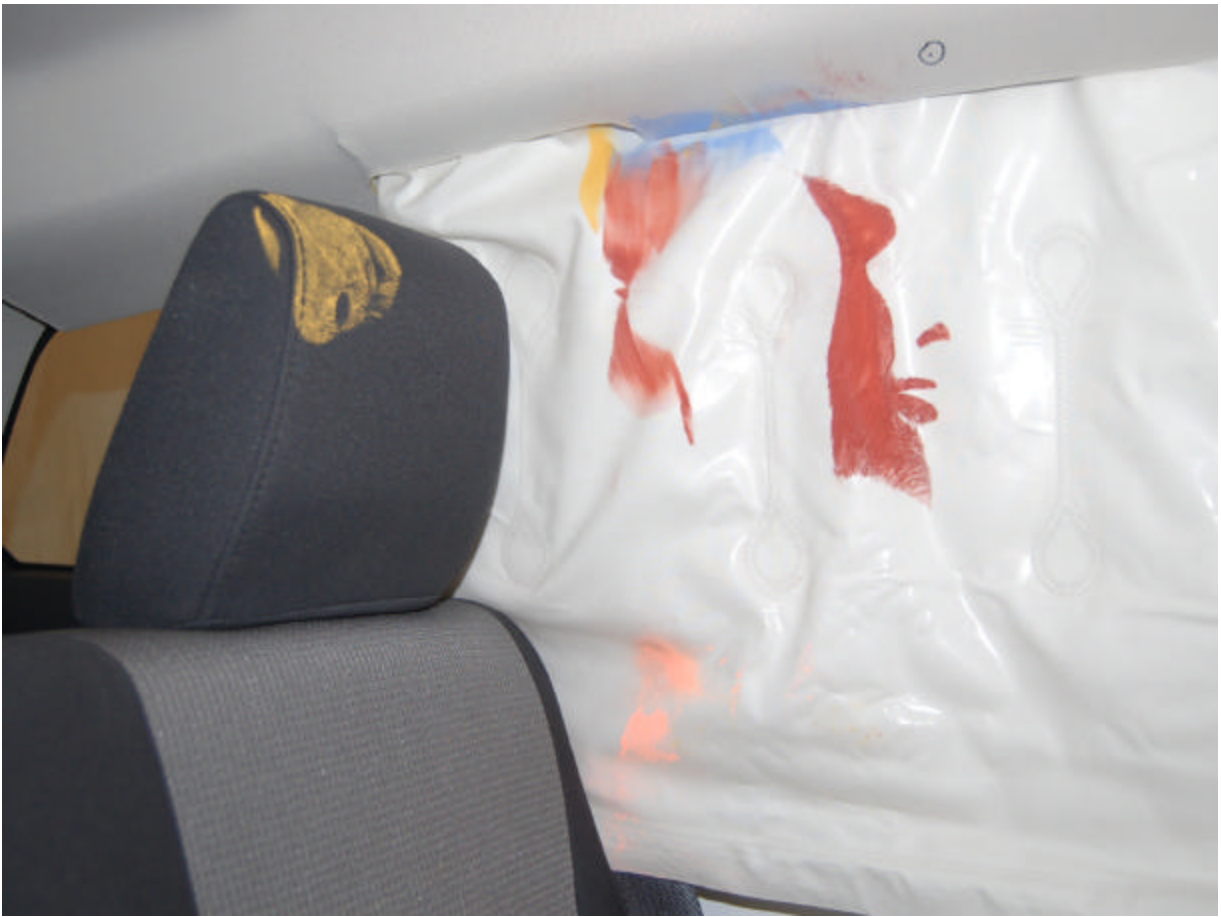
Post-Test Passenger Dummy Head Contact

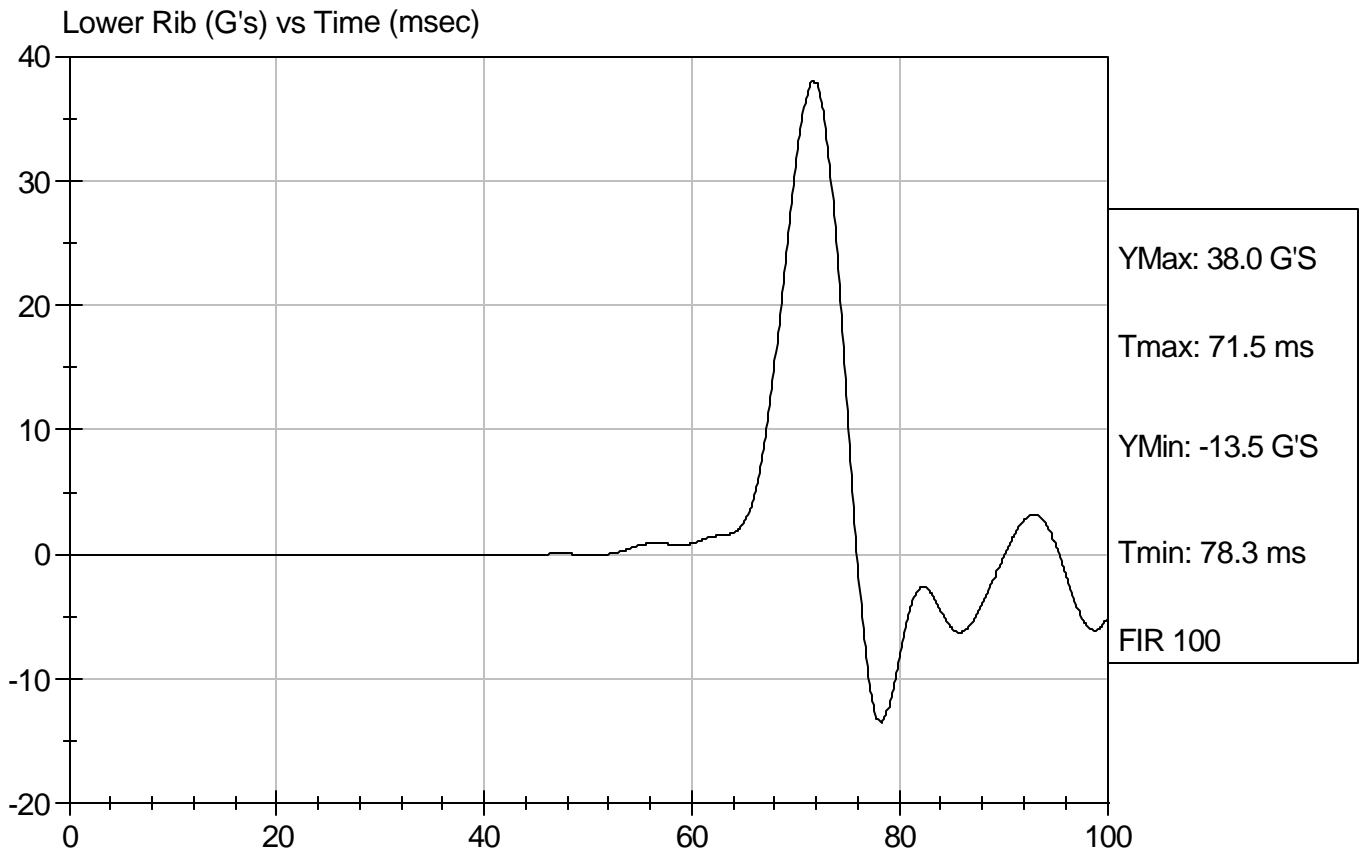
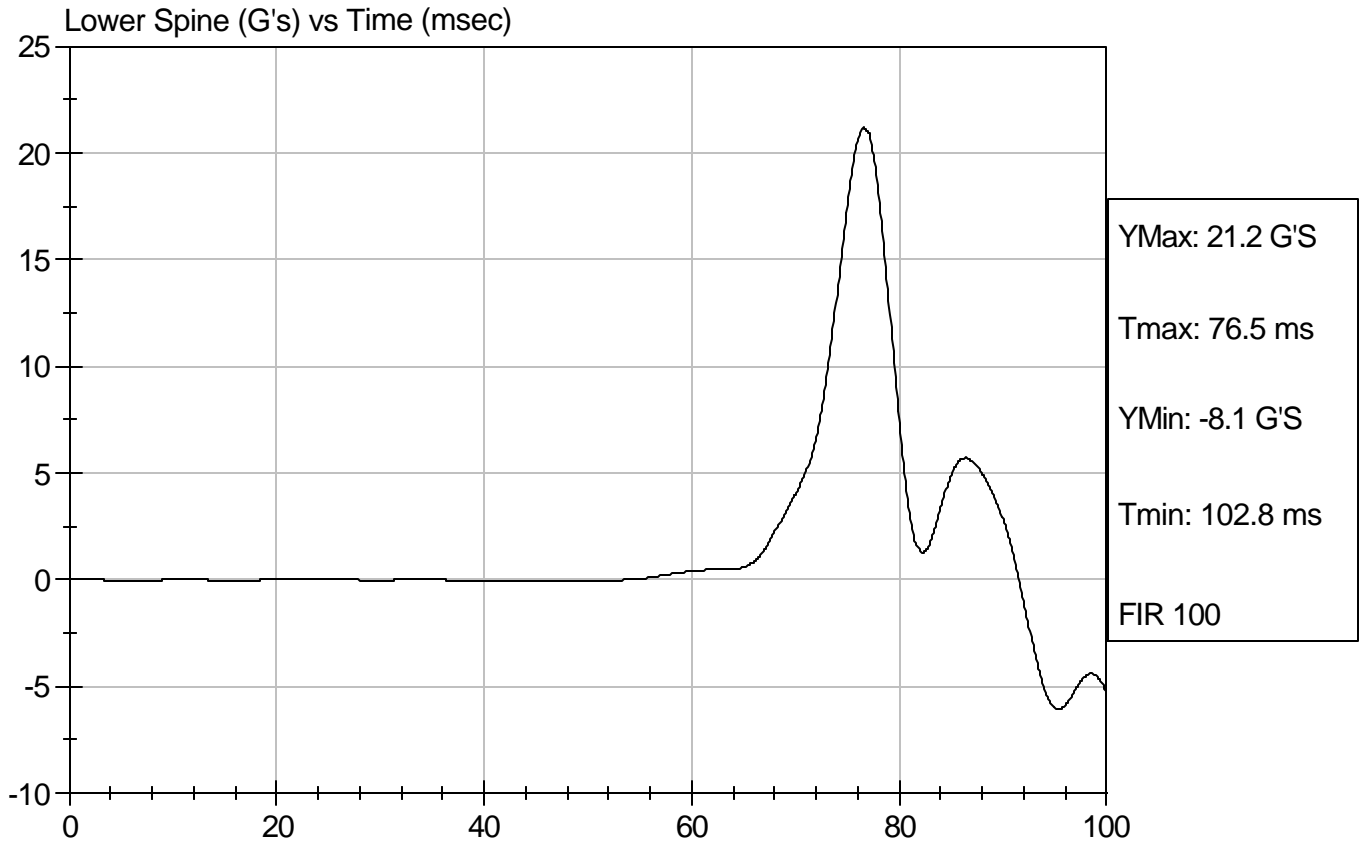
Test Desc: Thorax Impact  
Component ID: D08752

Tested Parameter	Units	Specification	Result	Pass/Fail
Laboratory Temperature	deg C	18.9 - 25.5	20.7	Pass
Laboratory Relative Humidity	%	10 to 70	22	Pass
Probe Velocity	m/s	4.22 - 4.31	4.23	Pass
Upper Rib	G's	37 - 46	41	Pass
Lower Rib	G's	37 - 46	38	Pass
Lower Spine	G's	15 - 22	21	Pass
Overall Test Results				Pass

Test Date: 3/12/08  
Speed: 13.89 ft/sec, 4.23 m/sec

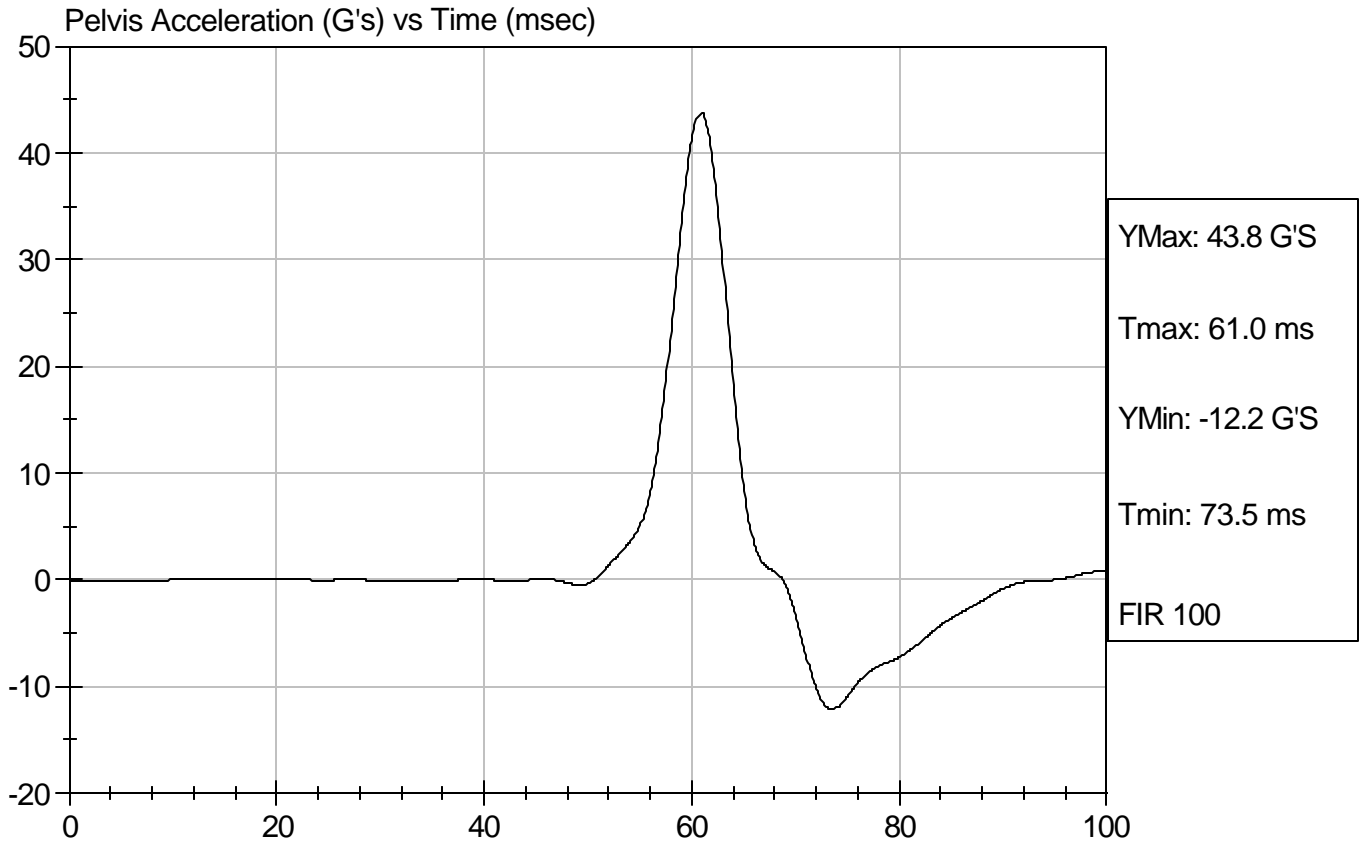
Test Desc: Pelvis Impact  
Component ID: D08753

Tested Parameter	Units	Specification	Result	Pass/Fail
Laboratory Temperature	deg C	18.9 to 25.5	20.7	Pass
Laboratory Relative Humidity	%	10 to 70	22	Pass
Probe Velocity	m/s	4.27 - 4.33	4.30	Pass
Pelvis Acceleration	G's	40 - 60	44	Pass
Overall Test Results				Pass

Test Date: 3/12/08  
Speed: 14.12 ft/sec, 4.30 m/sec

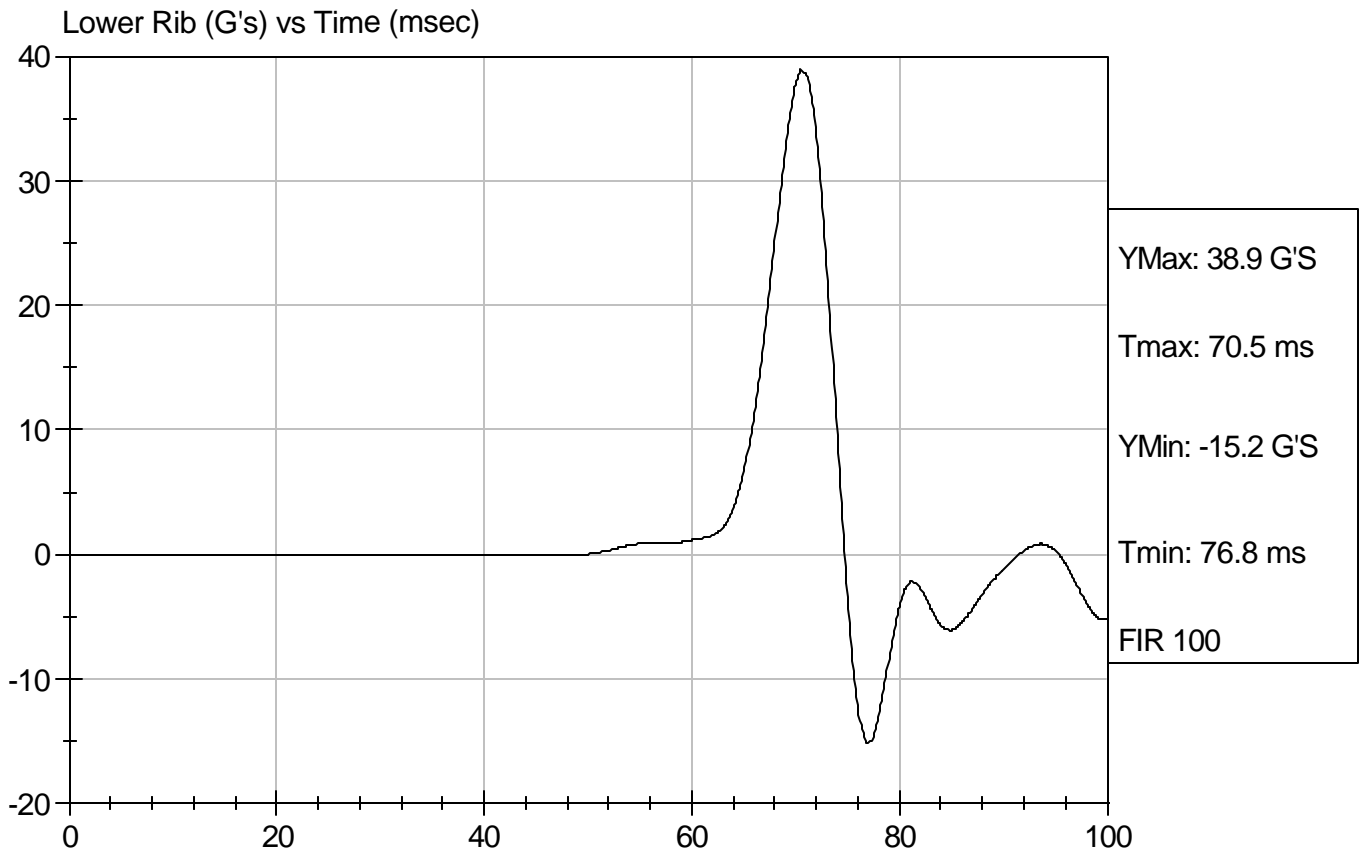
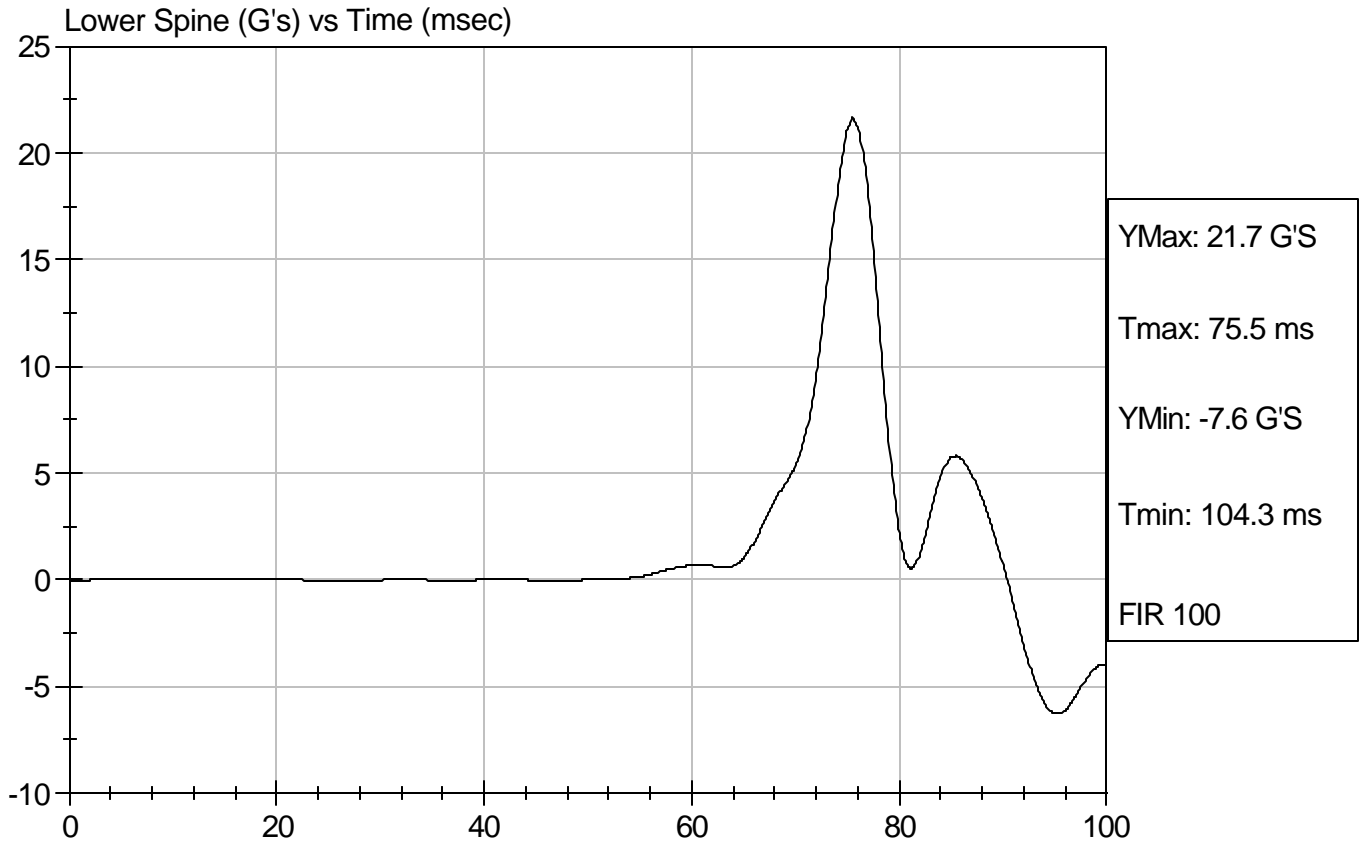
Test Desc: Thorax Impact  
Component ID: D08922

Tested Parameter	Units	Specification	Result	Pass/Fail
Laboratory Temperature	deg C	18.9 - 25.5	21.5	Pass
Laboratory Relative Humidity	%	10 to 70	21	Pass
Probe Velocity	m/s	4.22 - 4.31	4.23	Pass
Upper Rib	G's	37 - 46	41	Pass
Lower Rib	G's	37 - 46	39	Pass
Lower Spine	G's	15 - 22	22	Pass
Overall Test Results				Pass

Test Date: 3/26/08  
Speed: 13.88 ft/sec, 4.23 m/sec

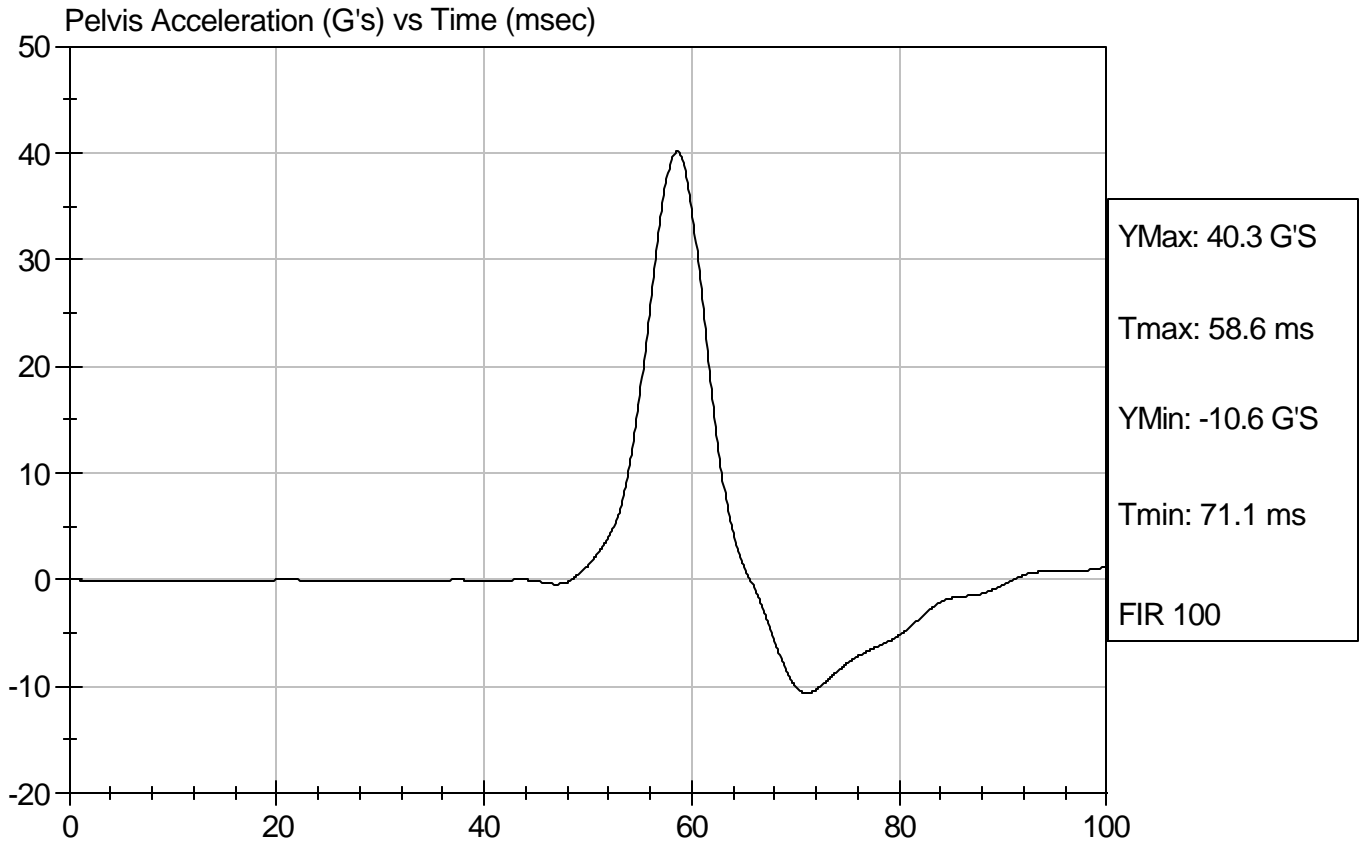
Test Desc: Pelvis Impact  
Component ID: D08923

Tested Parameter	Units	Specification	Result	Pass/Fail
Laboratory Temperature	deg C	18.9 to 25.5	21.5	Pass
Laboratory Relative Humidity	%	10 to 70	21	Pass
Probe Velocity	m/s	4.27 - 4.33	4.30	Pass
Pelvis Acceleration	G's	40 - 60	40	Pass
Overall Test Results				Pass

Test Date: 3/26/08  
Speed: 14.124 ft/sec, 4.30 m/sec

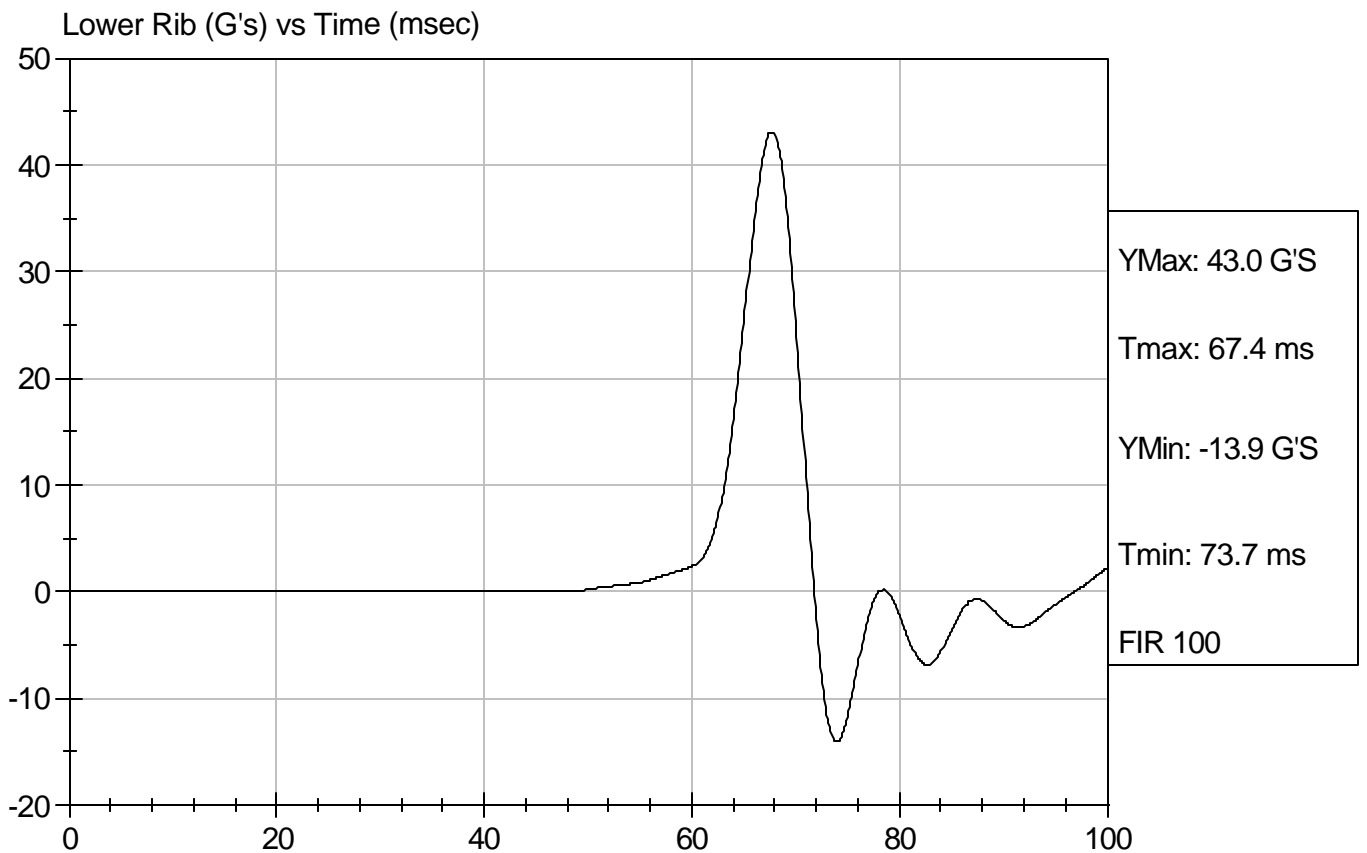
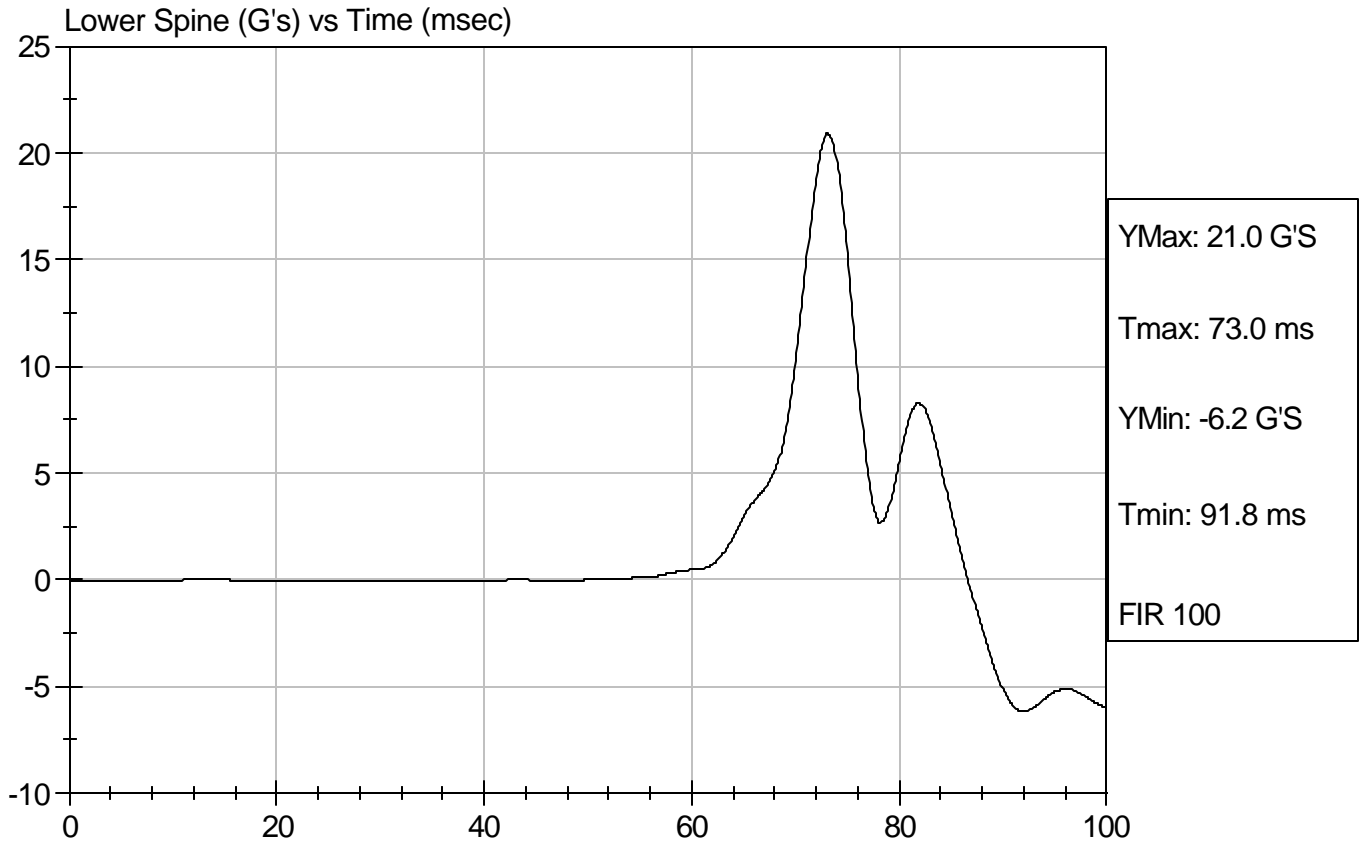
Test Desc: Thorax Impact  
Component ID: D08742

Tested Parameter	Units	Specification	Result	Pass/Fail
Laboratory Temperature	deg C	18.9 - 25.5	20.7	Pass
Laboratory Relative Humidity	%	10 to 70	22	Pass
Probe Velocity	m/s	4.22 - 4.31	4.23	Pass
Upper Rib	G's	37 - 46	44	Pass
Lower Rib	G's	37 - 46	43	Pass
Lower Spine	G's	15 - 22	21	Pass
Overall Test Results				Pass

Test Date: 3/12/08  
Speed: 13.89 ft/sec, 4.23 m/sec

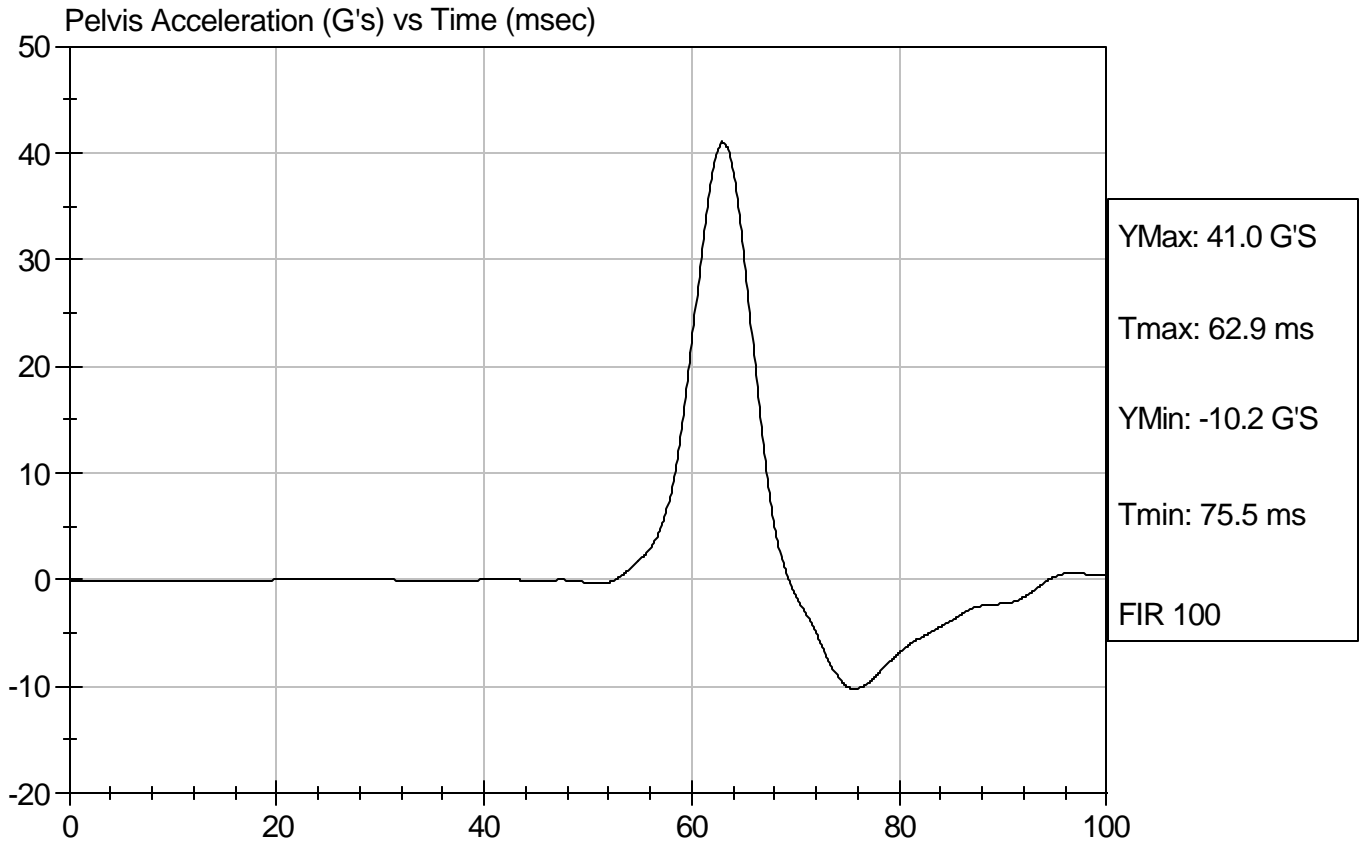
Test Desc: Pelvis Impact  
Component ID: D08743

Tested Parameter	Units	Specification	Result	Pass/Fail
Laboratory Temperature	deg C	18.9 to 25.5	20.7	Pass
Laboratory Relative Humidity	%	10 to 70	22	Pass
Probe Velocity	m/s	4.27 - 4.33	4.30	Pass
Pelvis Acceleration	G's	40 - 60	41	Pass
Overall Test Results				Pass

Test Date: 3/12/08  
Speed: 14.12 ft/sec, 4.30 m/sec
