REPORT NUMBER: NCAP-MGA-2008-015

**NEW CAR ASSESSMENT PROGRAM
FRONTAL BARRIER IMPACT TEST**

**CHRYSLER LLC
2009 DODGE JOURNEY SXT AWD
NHTSA NUMBER: M90300**

**PREPARED BY:
MGA RESEARCH CORPORATION
5000 WARREN ROAD
BURLINGTON, WI 53105**

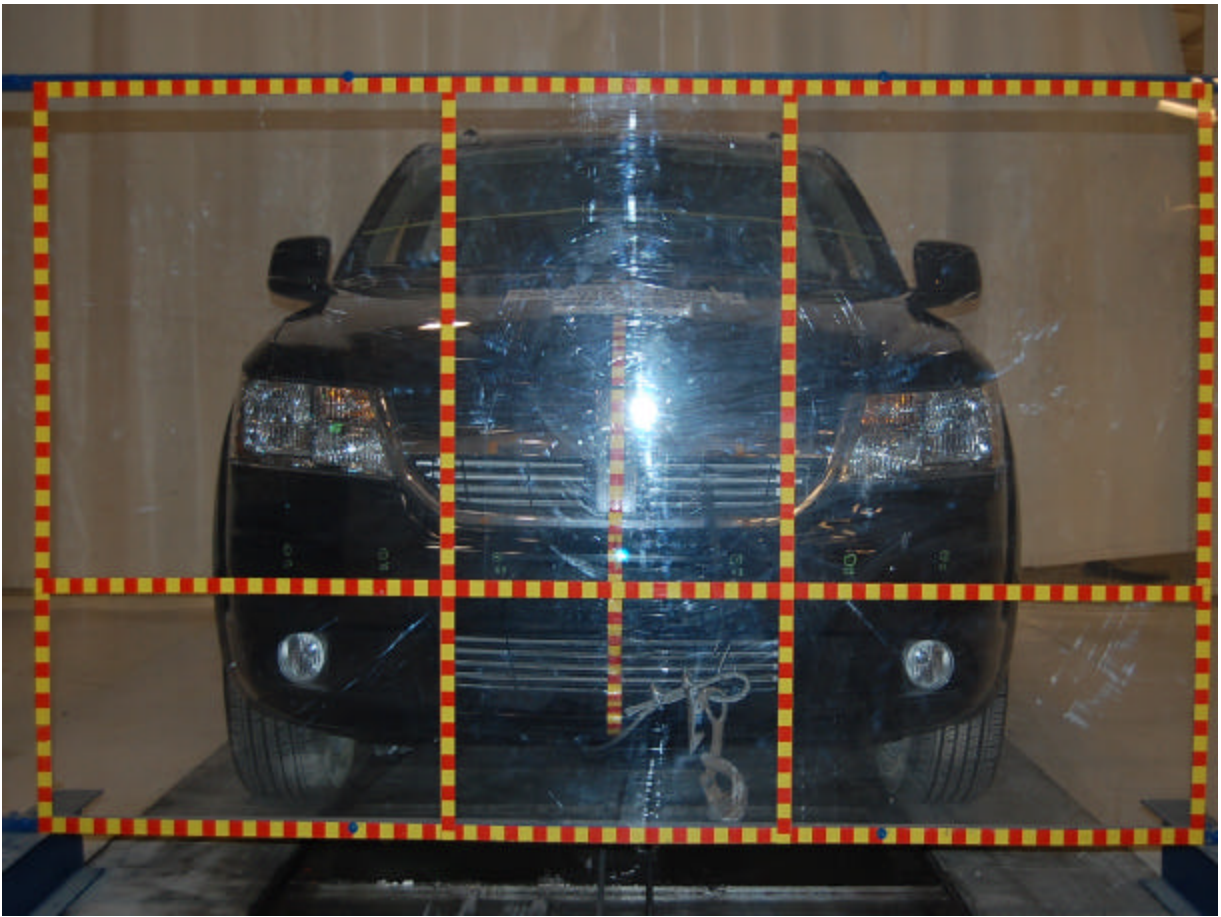
Load Cell Location

A load cell barrier was impacted by a 2009 Dodge Journey SXT AWD at a velocity of 56.6 kph. The test was performed at MGA Research Corporation on March 27, 2008. Pre-and post-test photographs of the vehicle and dummies can be found in Appendix A.

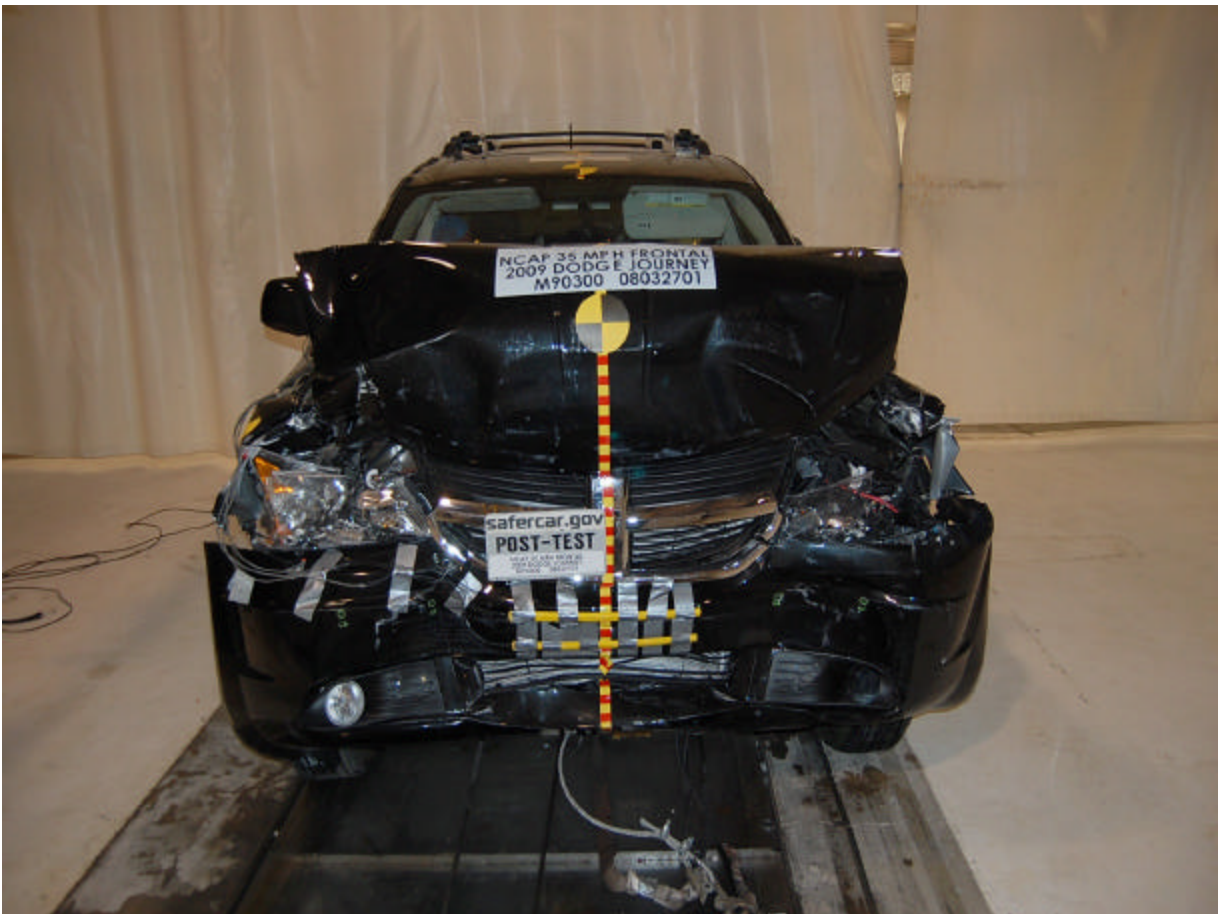
Post-Test Front View

The maximum static crush of the vehicle was 628 mm and both the driver and passenger side doors remained closed and latched during the impact event and were operable after the impact.

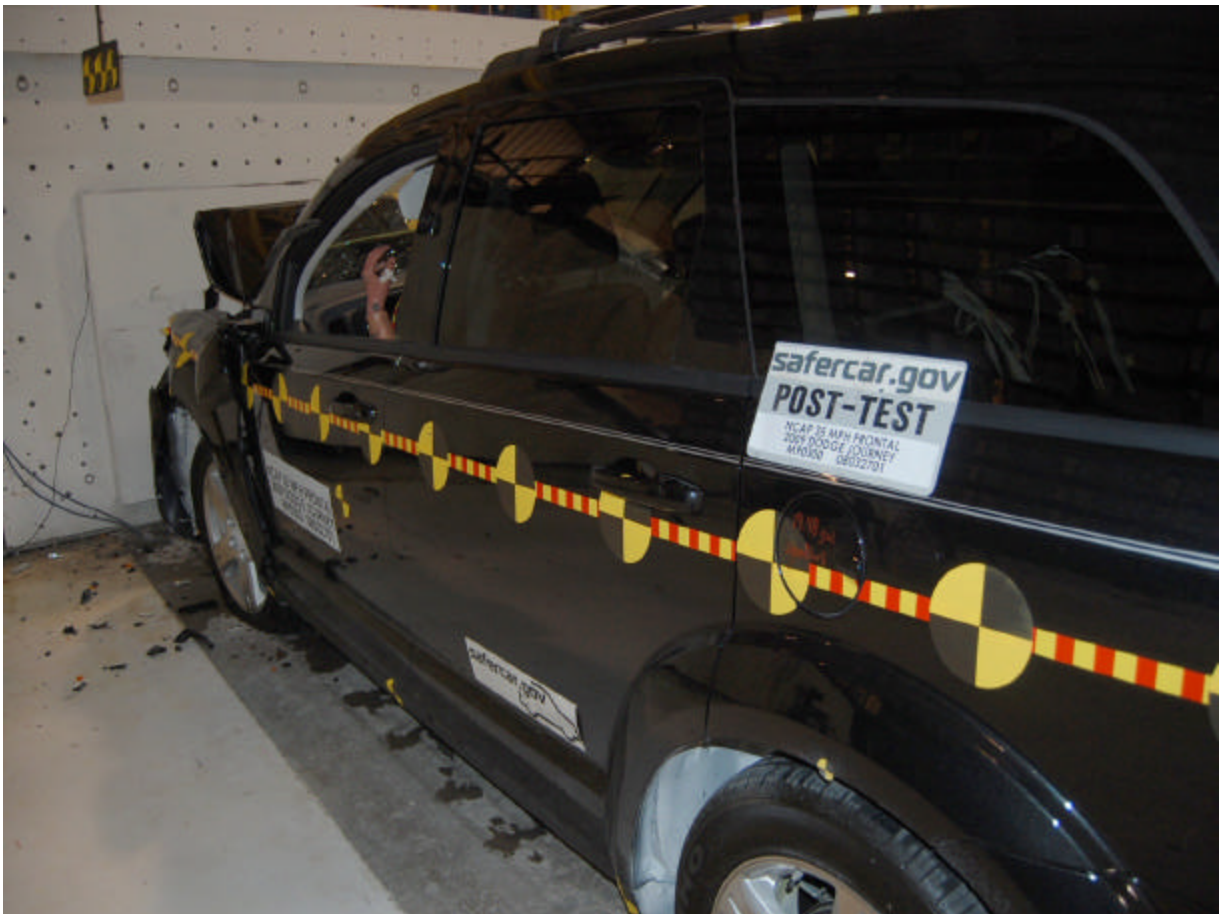
Post-Test Left Side 3/4 View of Doors After Impact

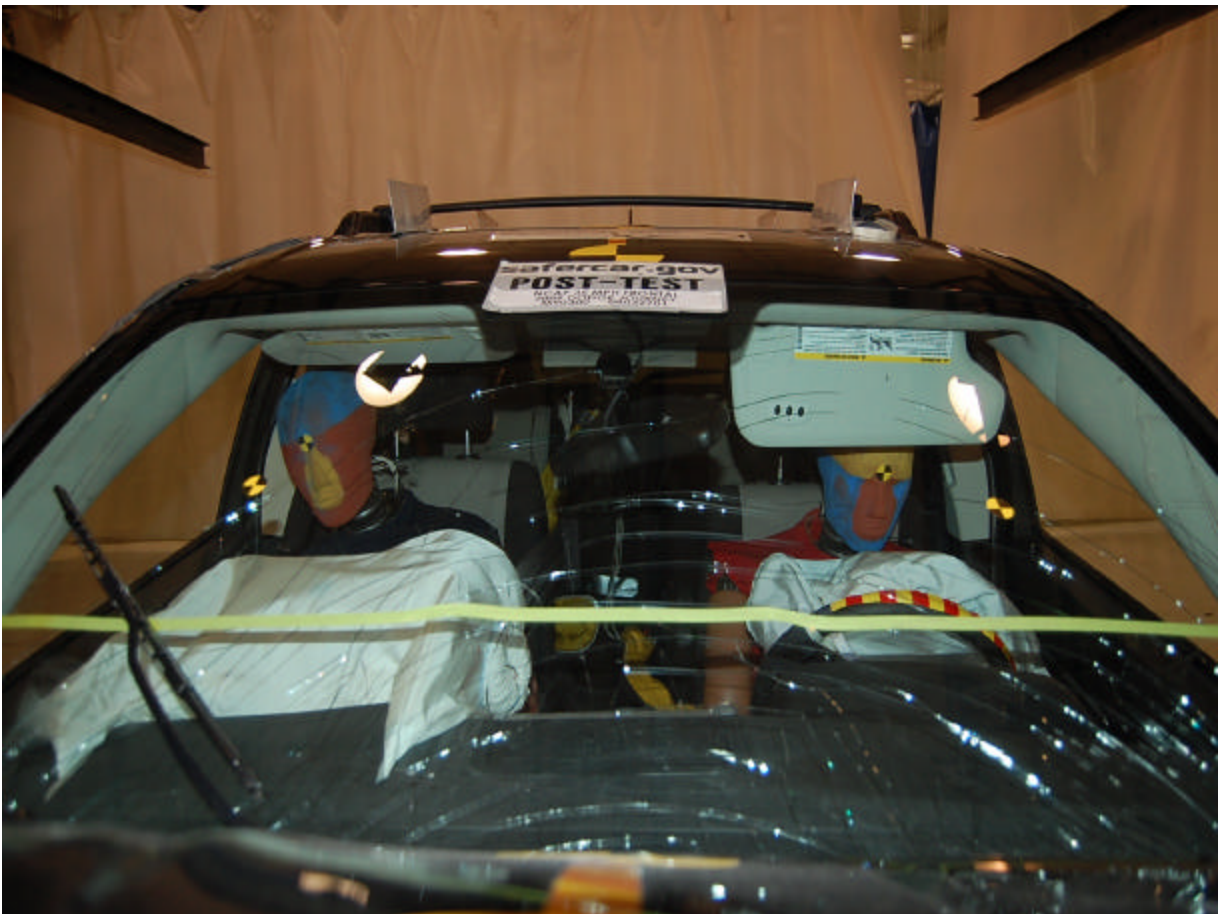
Post-Test Windshield View

There was 100 percent windshield retention and no intrusion into the protected zone of the windshield during the event. There was no Stoddard Solvent leakage after the event or during any phase of the static rollover.

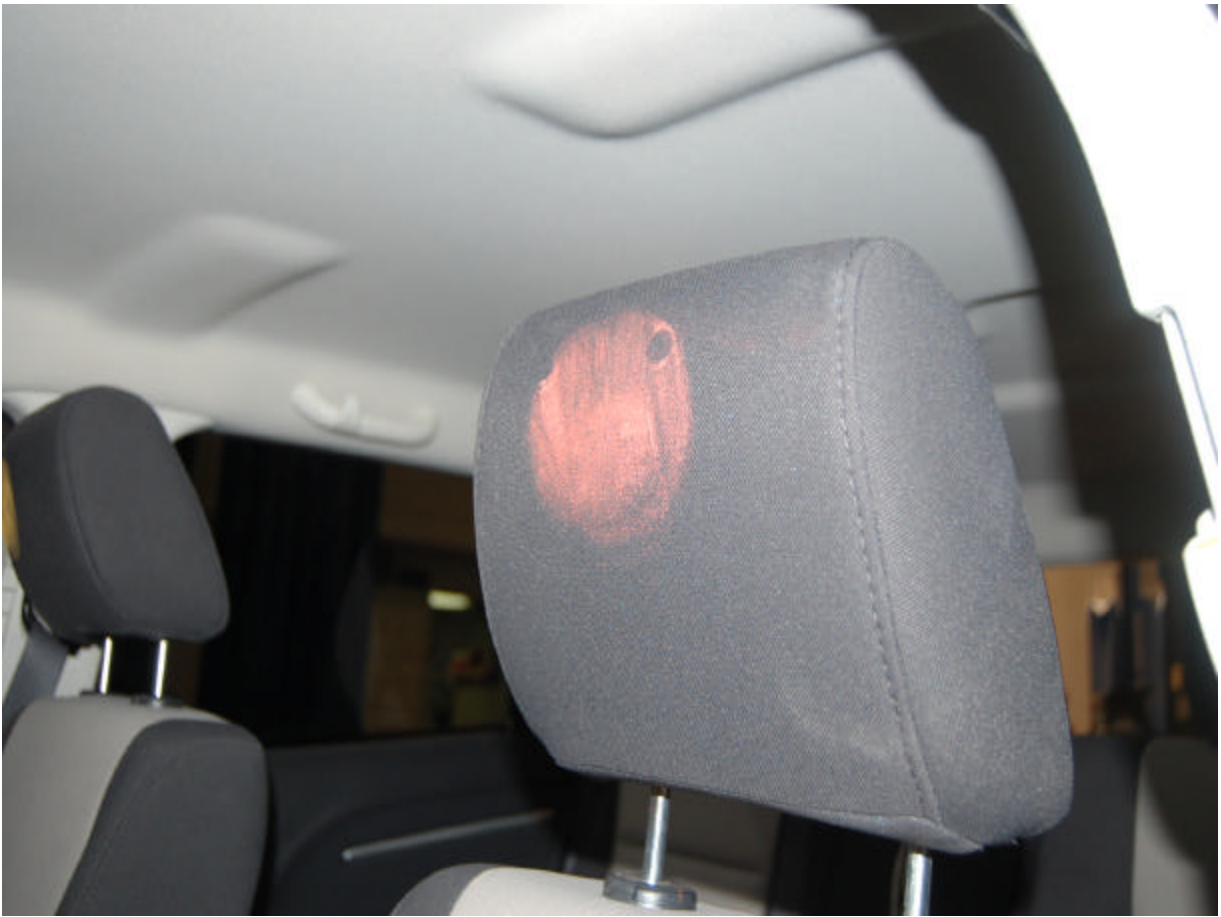
Post-Test Driver Dummy Head Contact (Headrest)

The driver's head and chest contacted the airbag. The driver's head also contacted the headrest. The driver's knees contacted the knee bolster. The passenger's head and chest contacted the airbag. The passenger's head also contacted the headrest. The passenger's knees contacted the glove box.

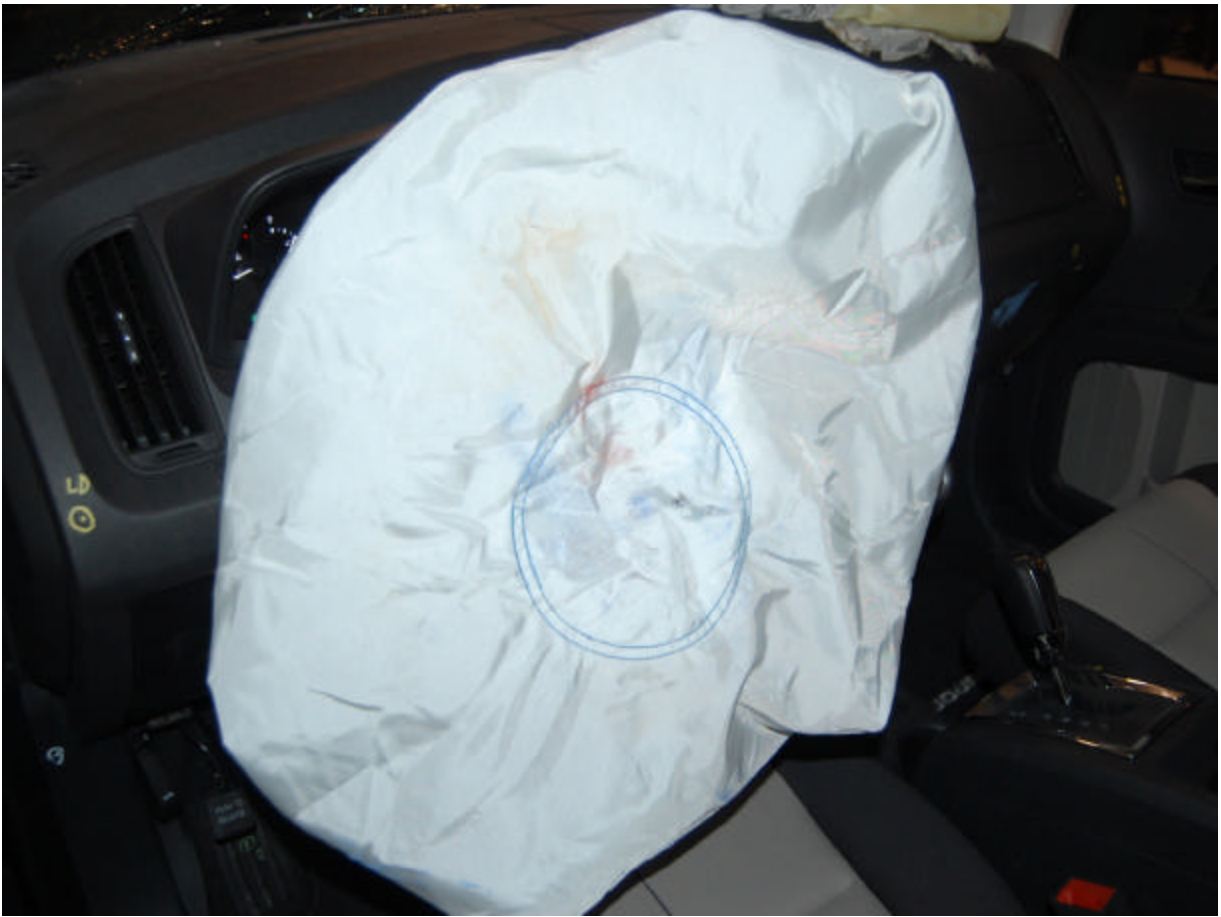
Post-Test Driver Dummy Airbag Contact

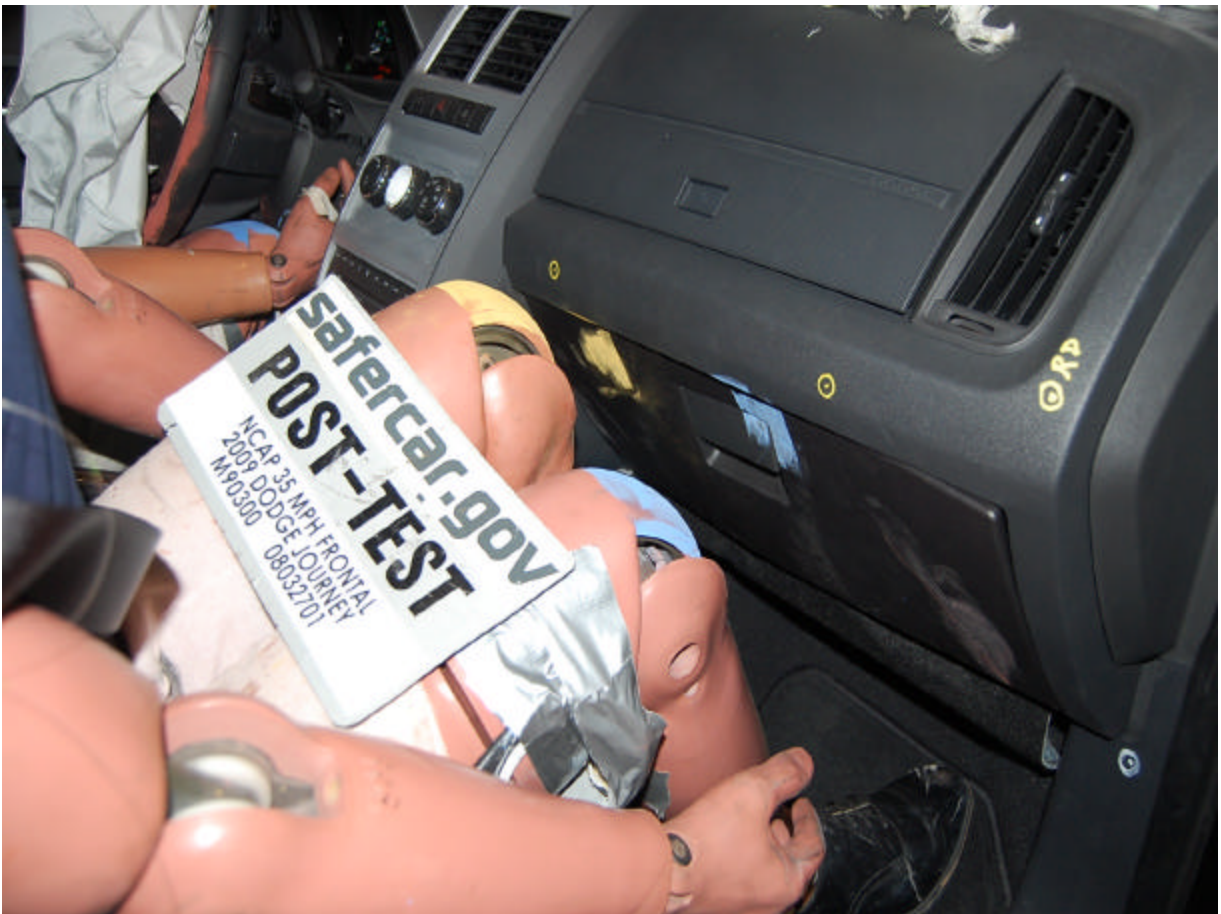
Post-Test Passenger Side Glove Box

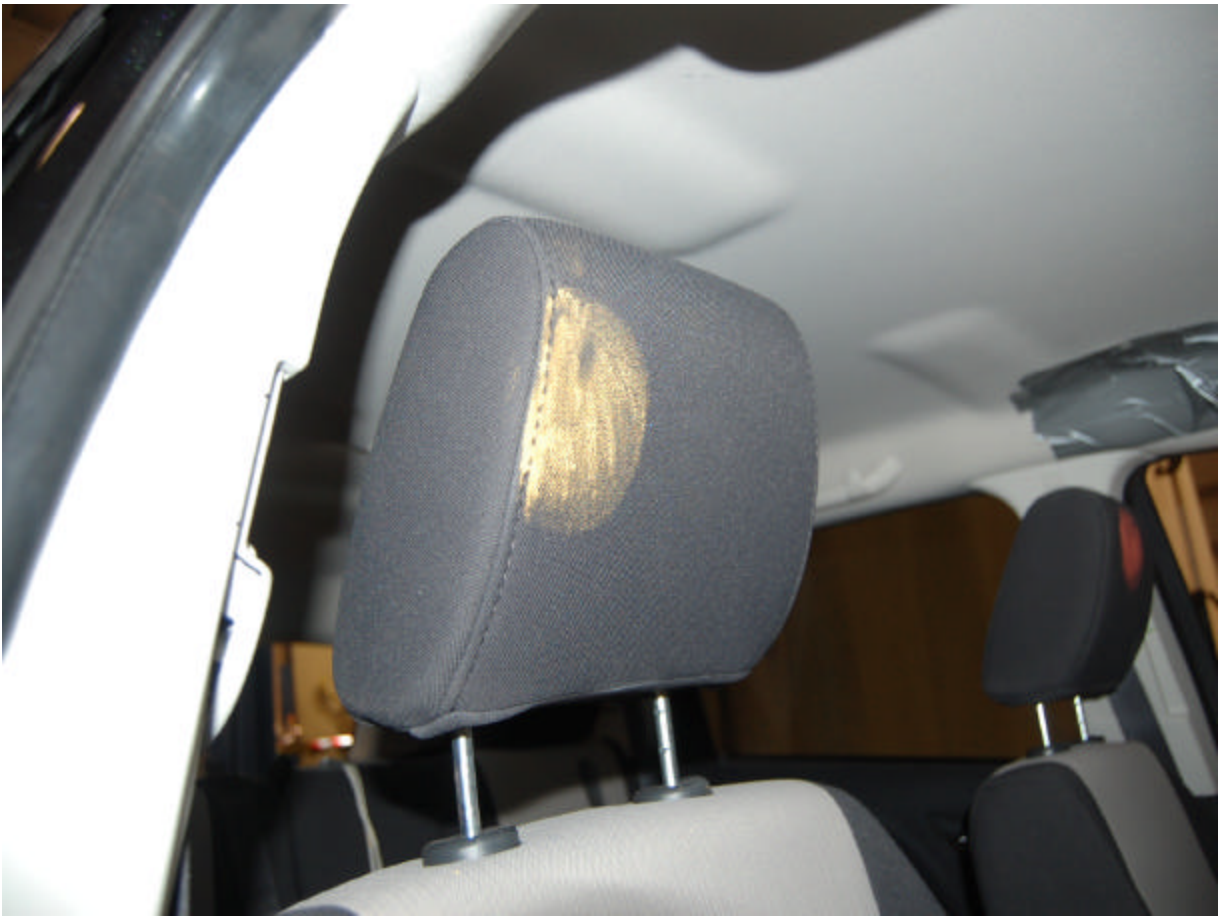
Post-Test Passenger Dummy Head Contact (Headrest)

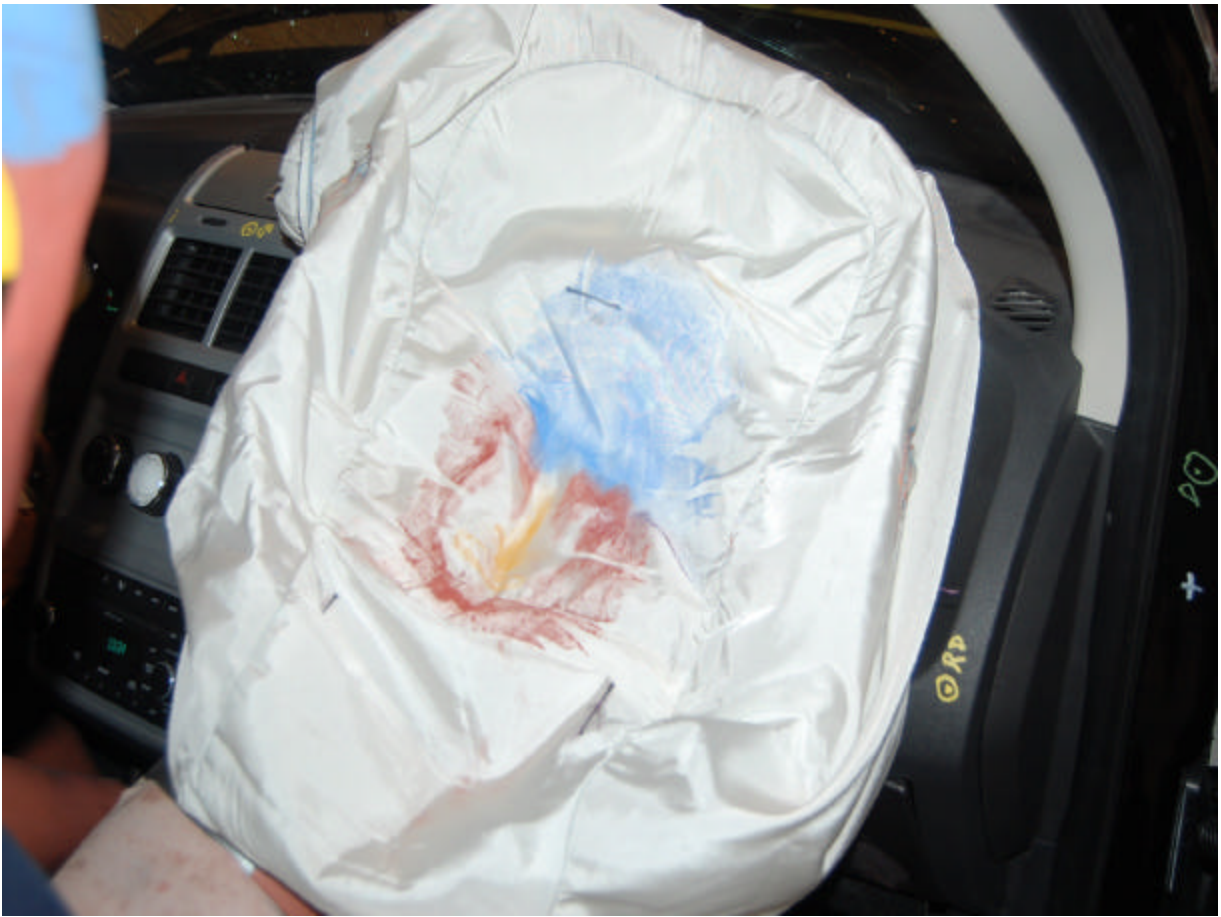
Post-Test Passenger Dummy Airbag Contact
