**REPORT NUMBER TR-P28001-18-NC**

**NEW CAR ASSESMENT PROGRAM  
FRONTAL BARRIER IMPACT TEST**

**HYUNDAI MOTOR MANUFACTURING  
2009 HYUNDAI SONATA  
4-DOOR SEDAN**

**NHTSA NUMBER: M90500**

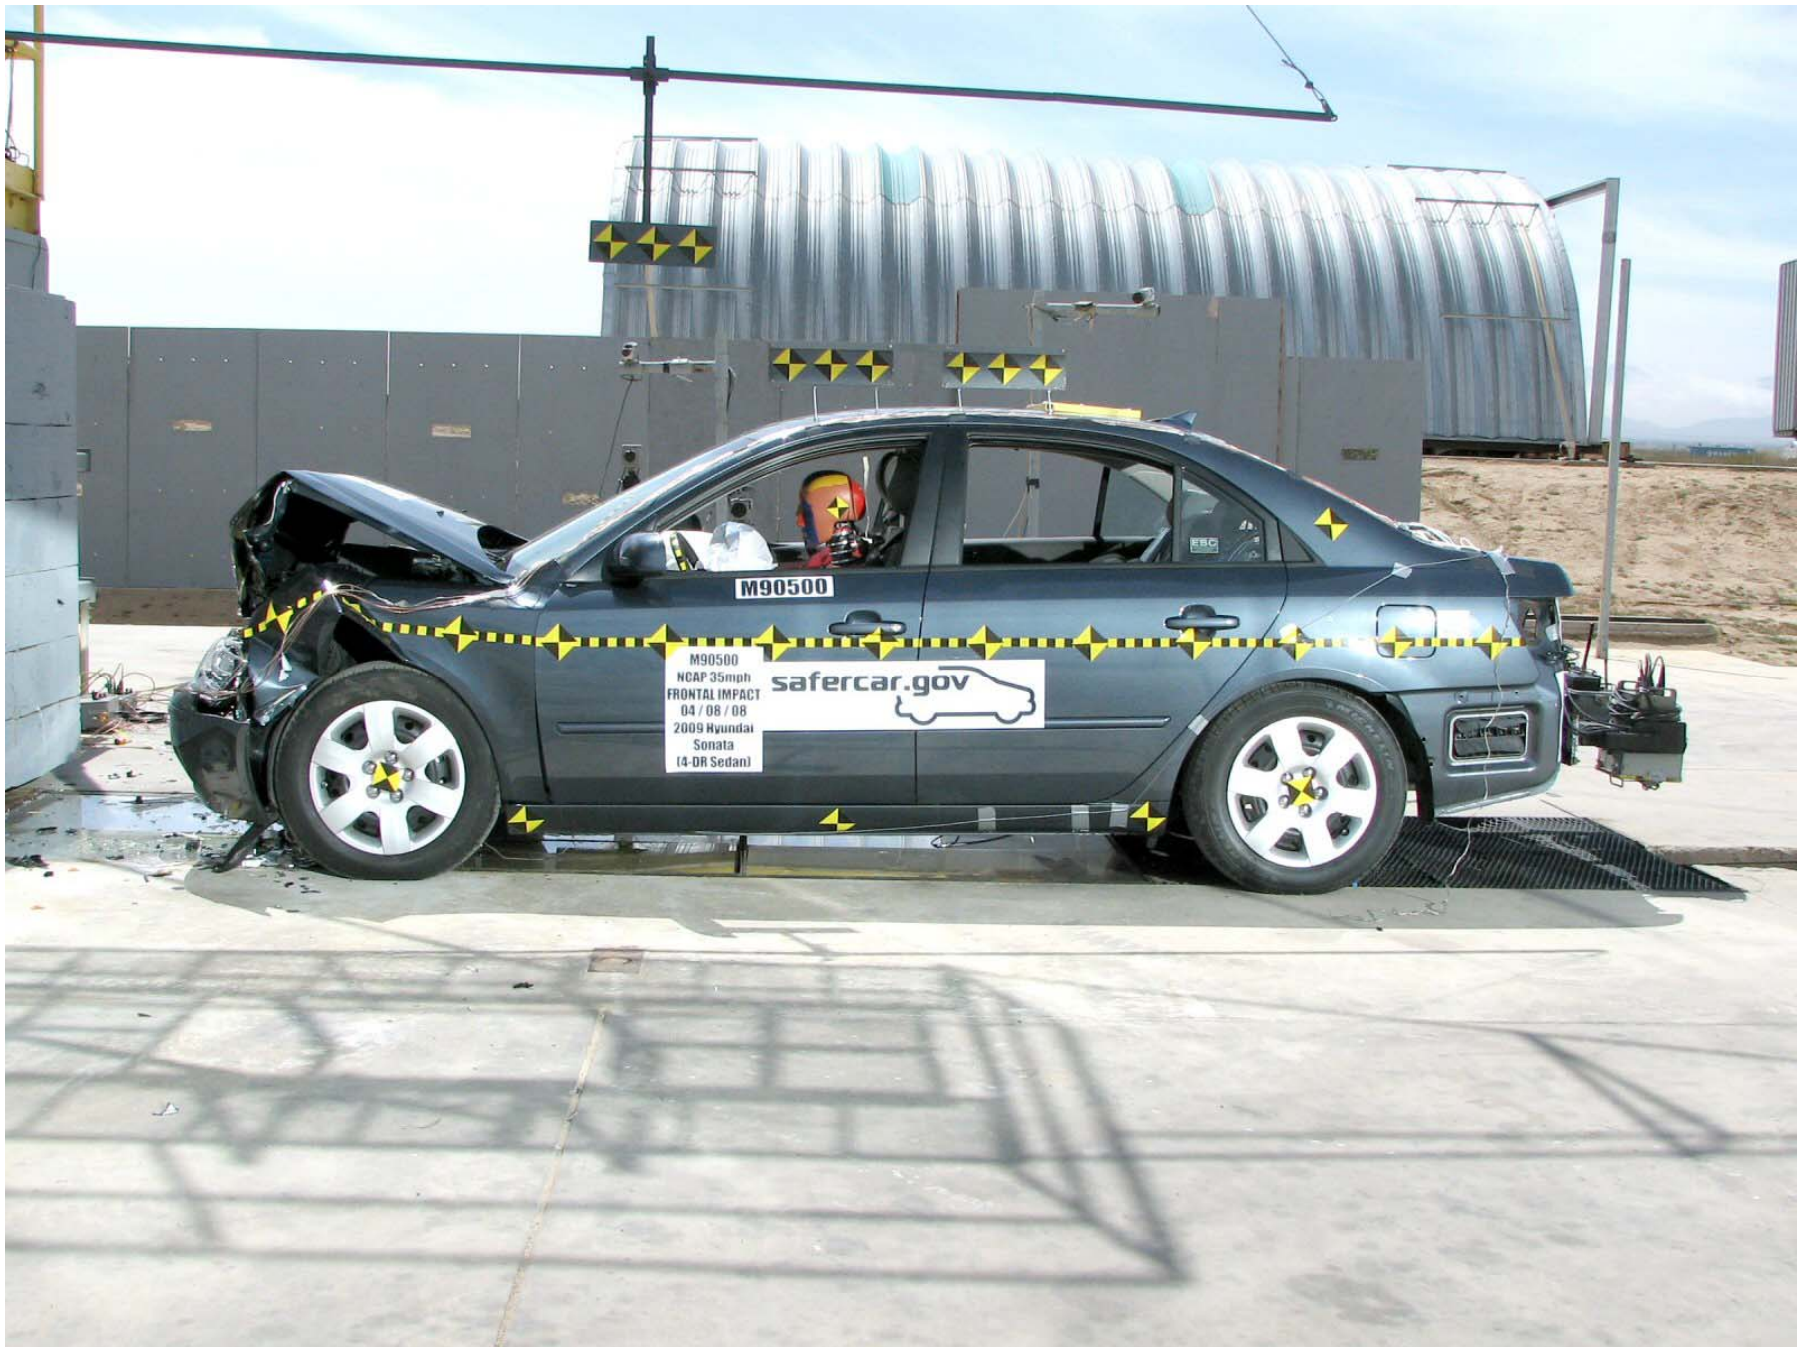
Figure A-9: Post-Test Left Side View

The maximum static crush of the vehicle was 375 mm at the vehicle's centerline. Both the driver and passenger side doors remained closed and latched during the impact event, and were operable after the impact.

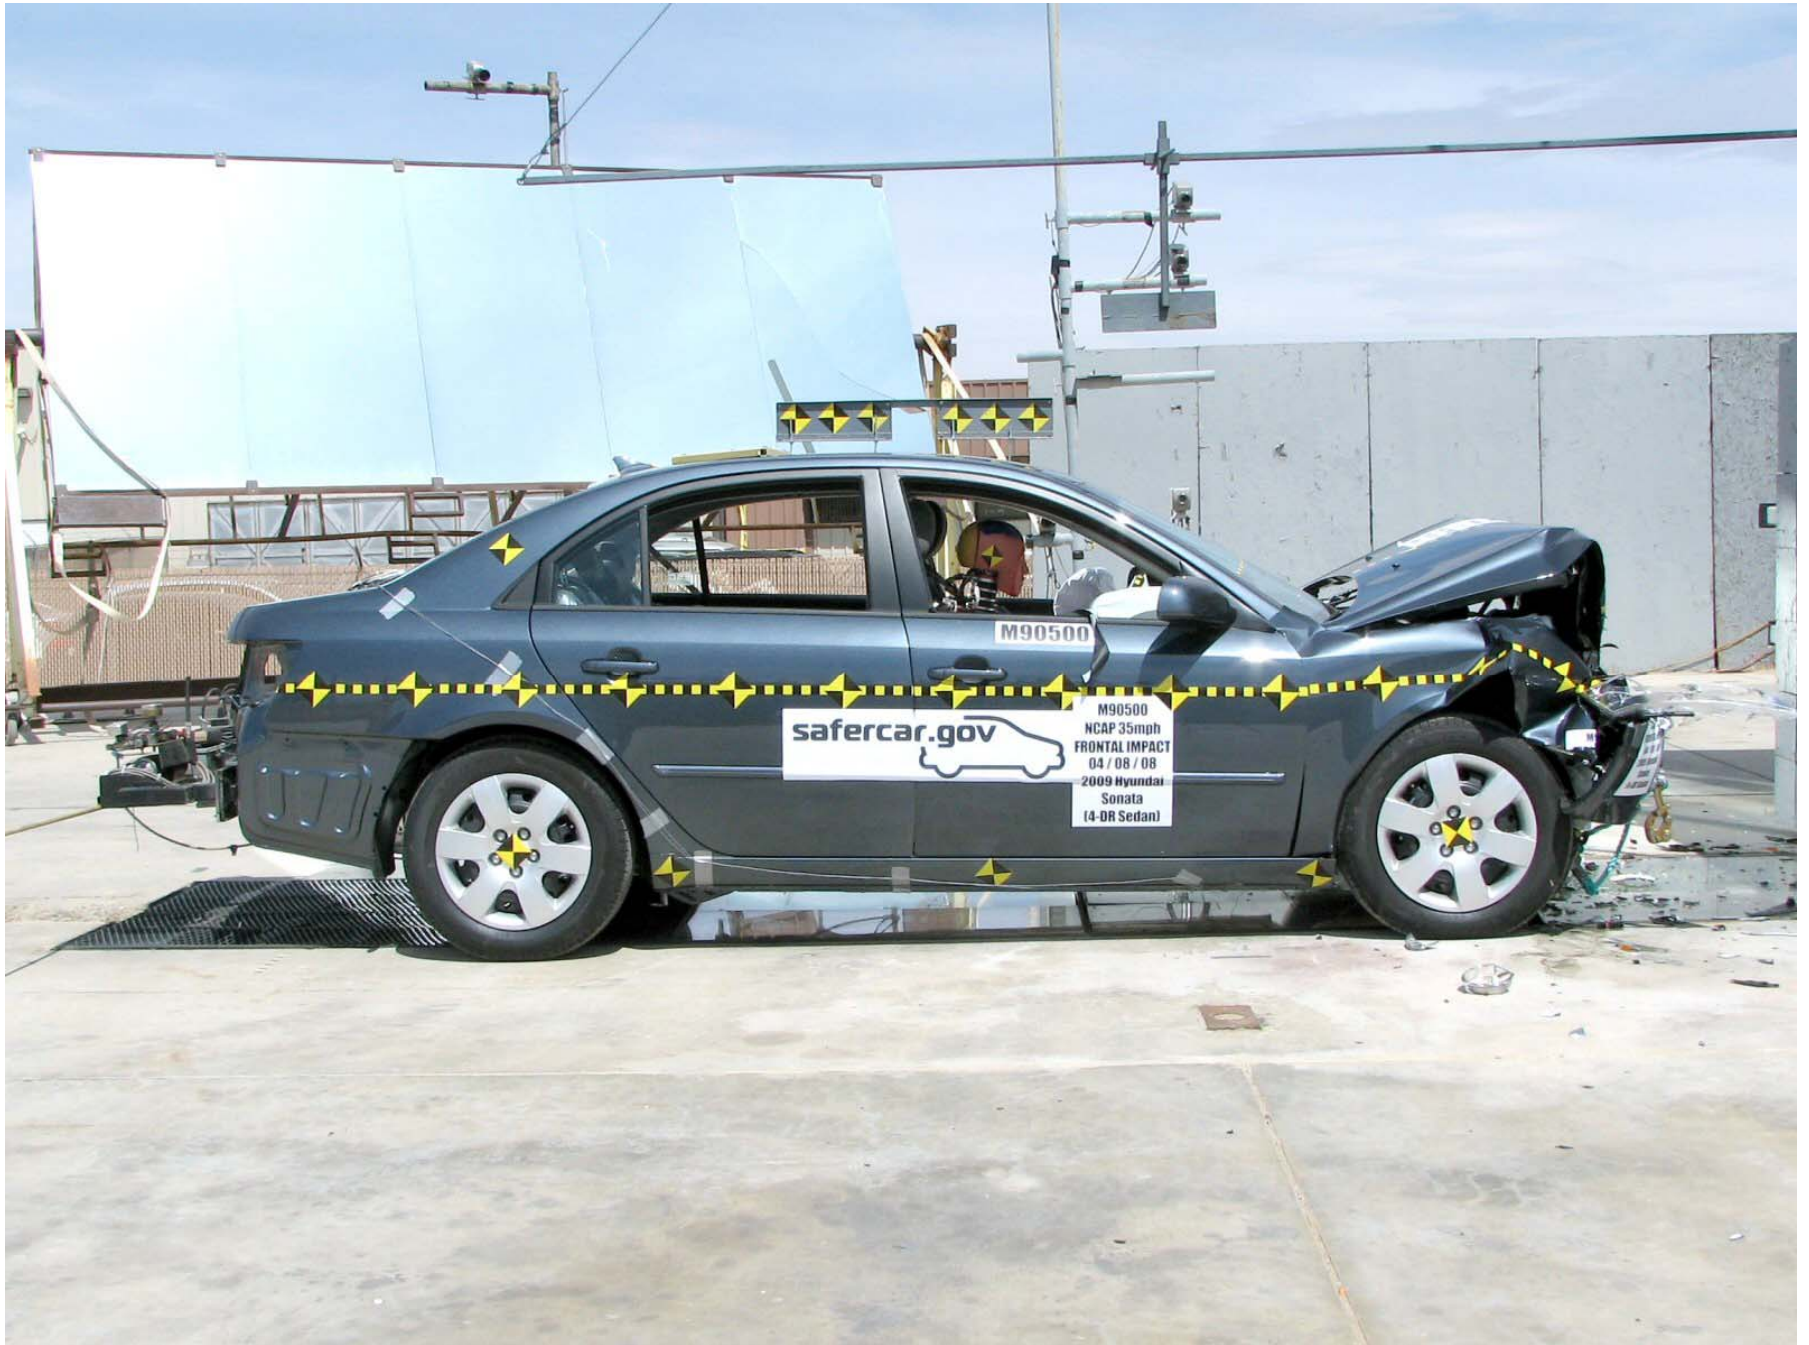
Figure A-11: Post-Test Right Side View

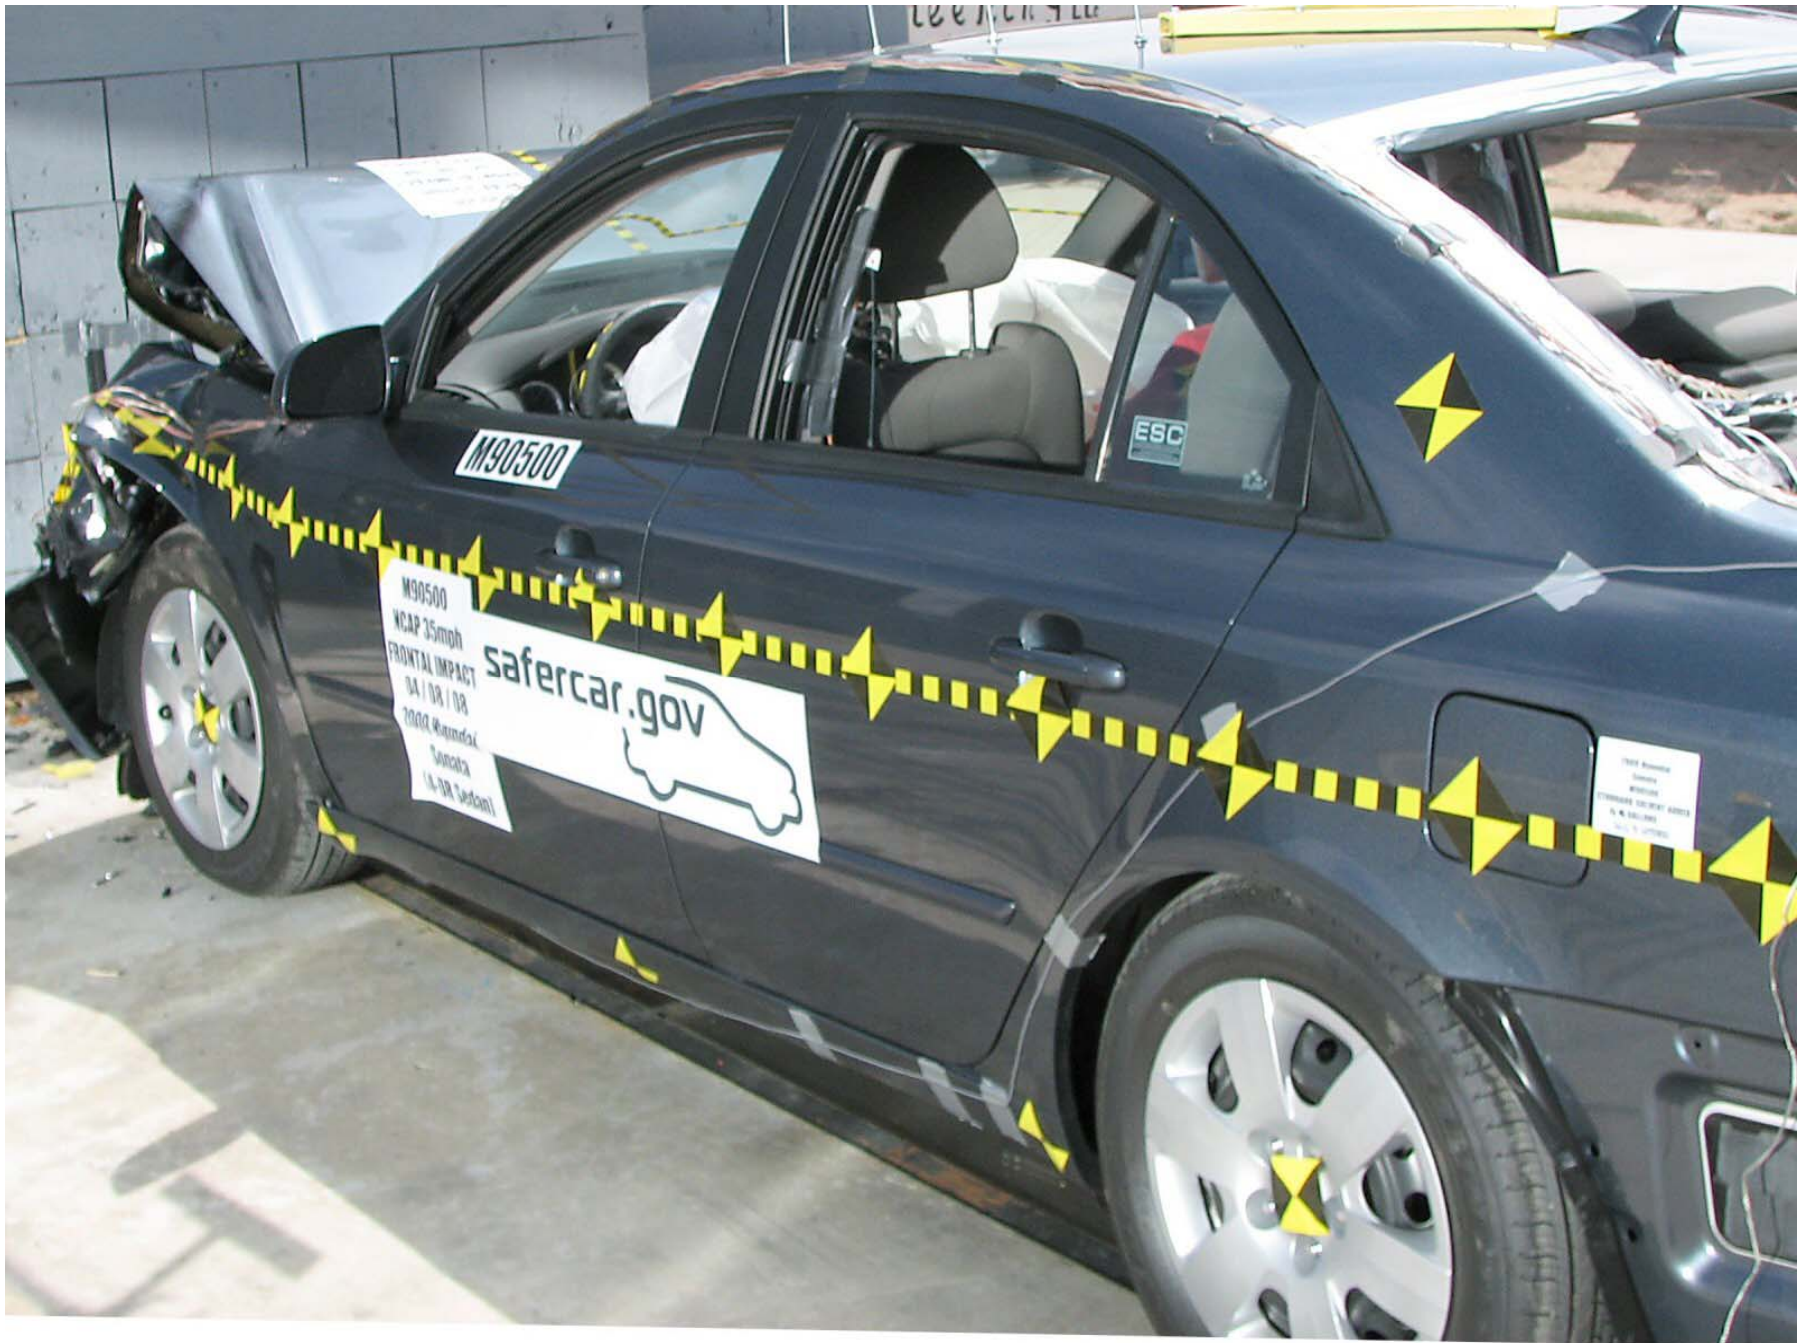
Figure A-16: Post-Test Left Side  $\frac{3}{4}$  View of Doors After Impact

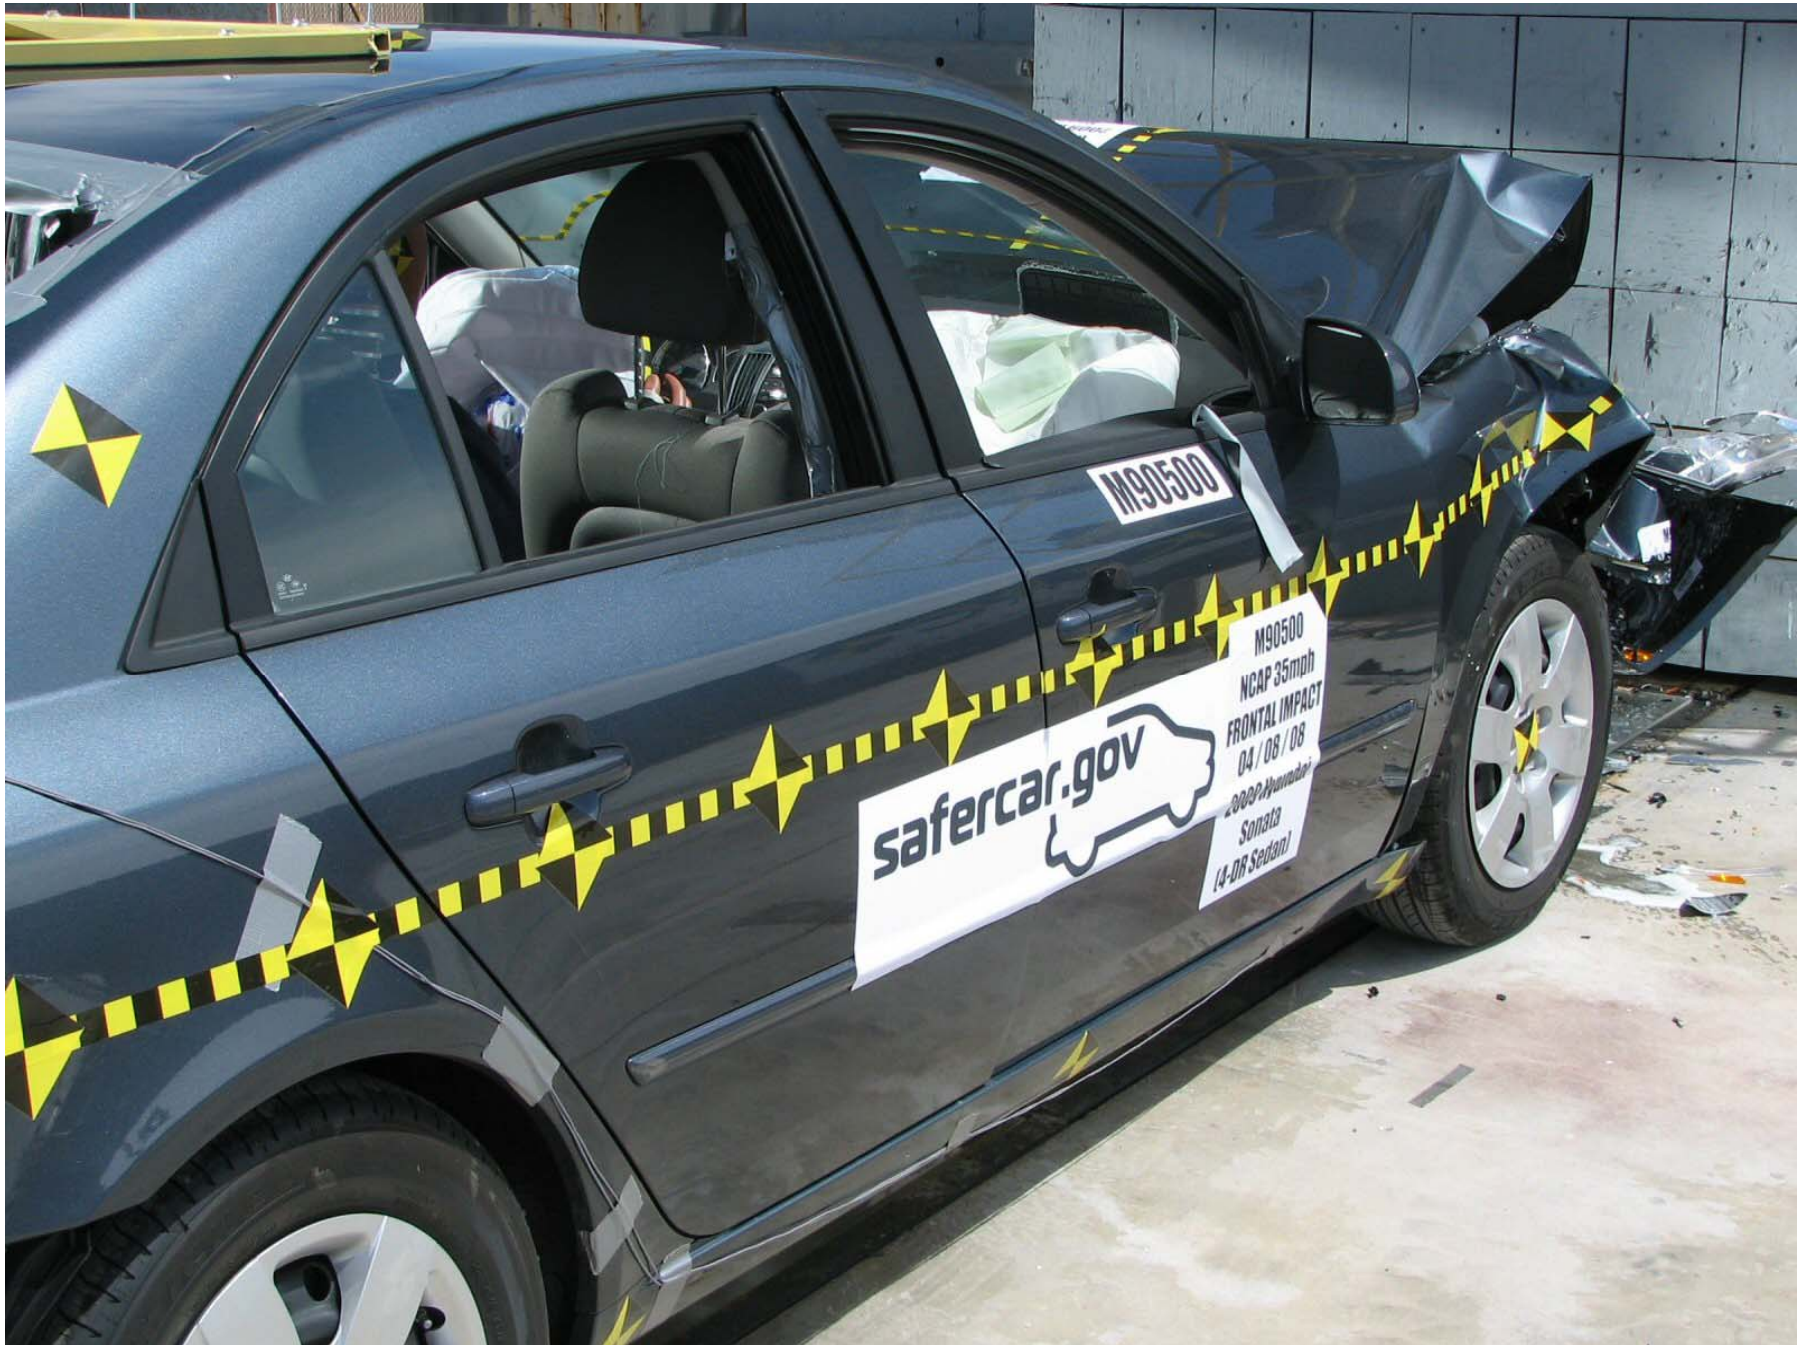
Figure A-17: Post-Test Right Side  $\frac{3}{4}$  View of Doors After Impact

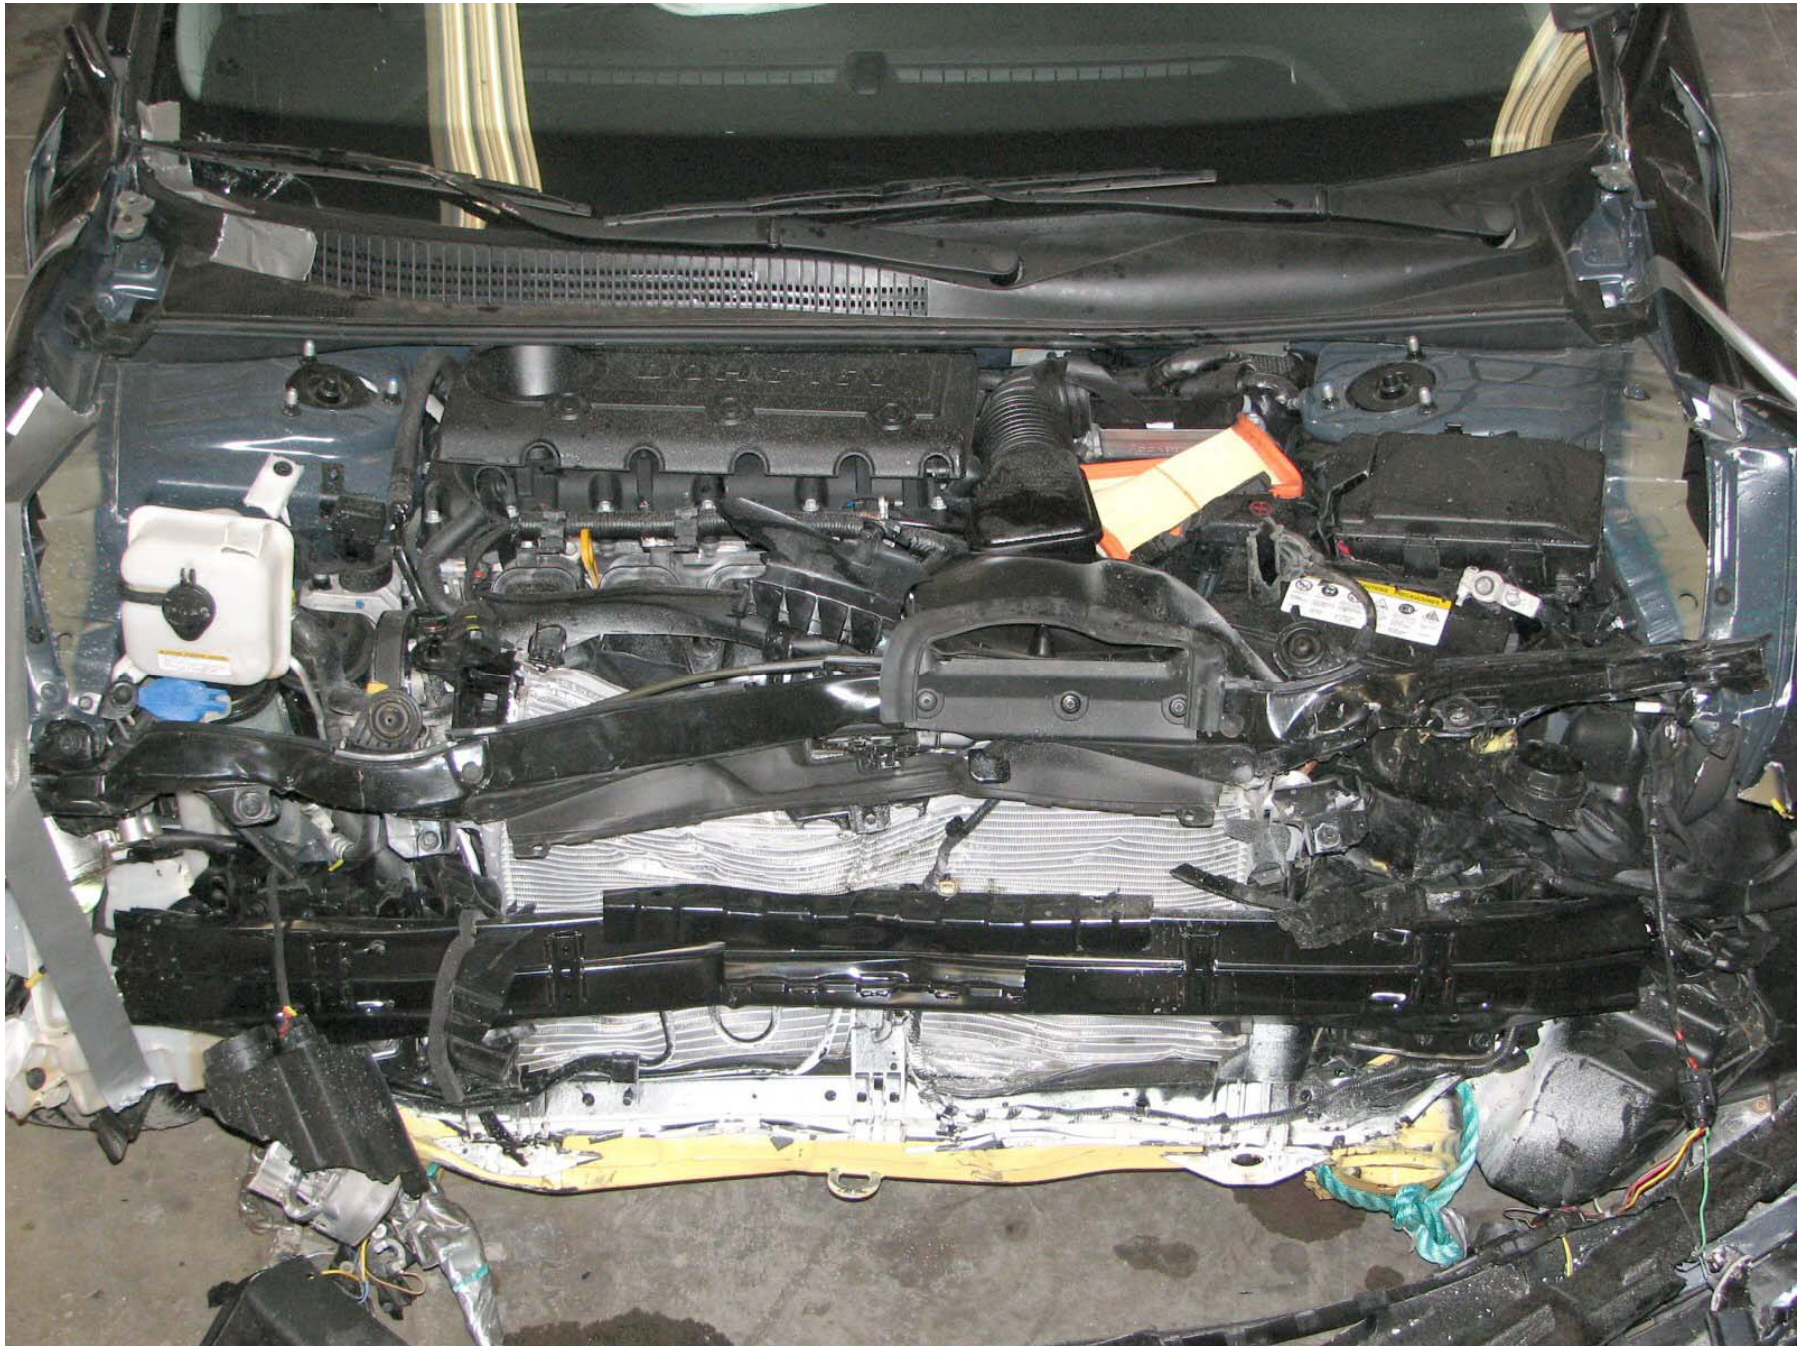
Figure A-21: Post-Test Engine Compartment (Vehicle Moved)

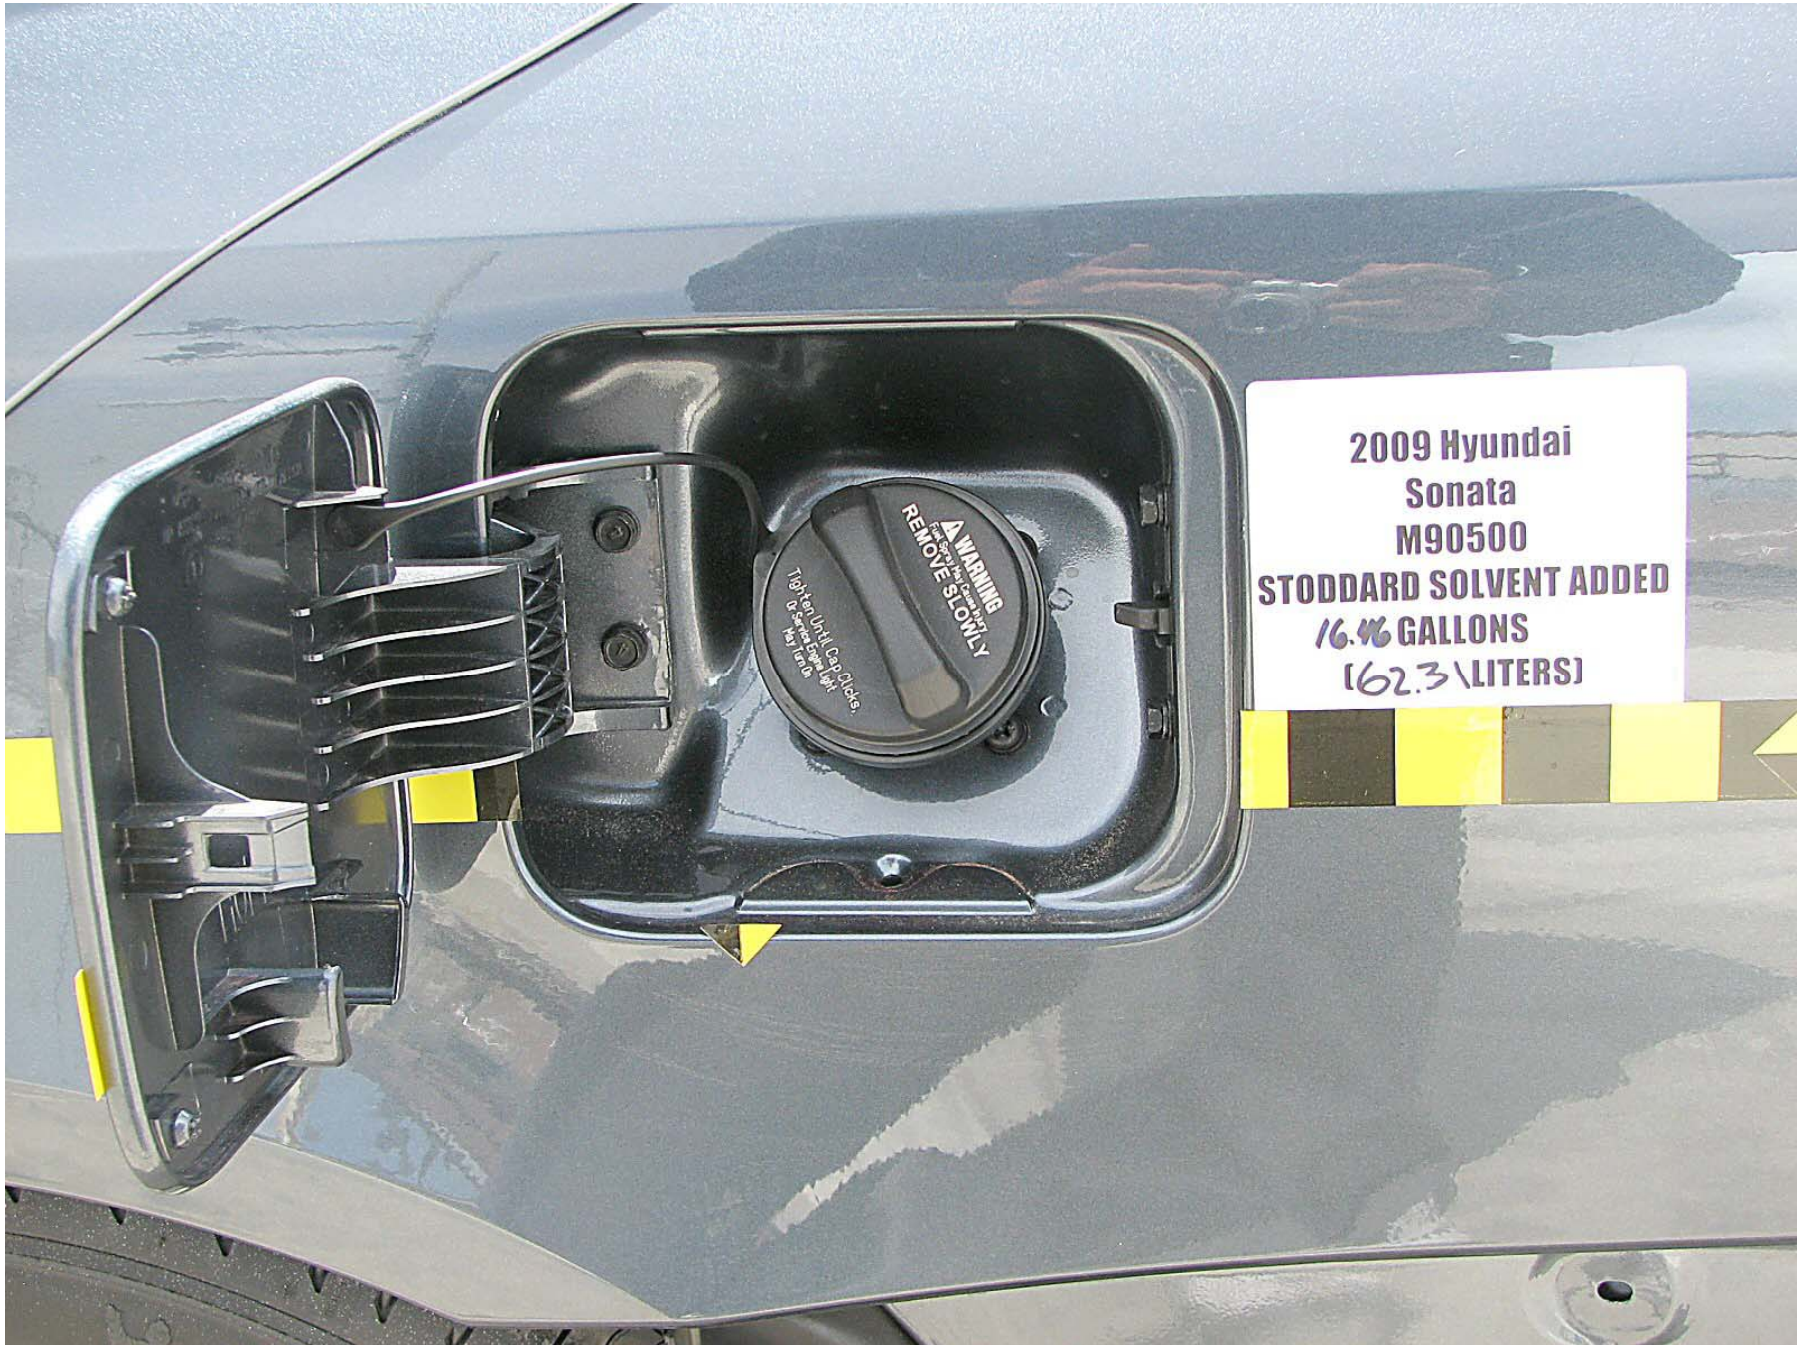
2009 Hyundai  
Sonata  
M90500  
STODDARD SOLVENT ADDED  
16.46 GALLONS  
(62.3 LITERS)

Figure A-23: Post-Test Fuel Cap

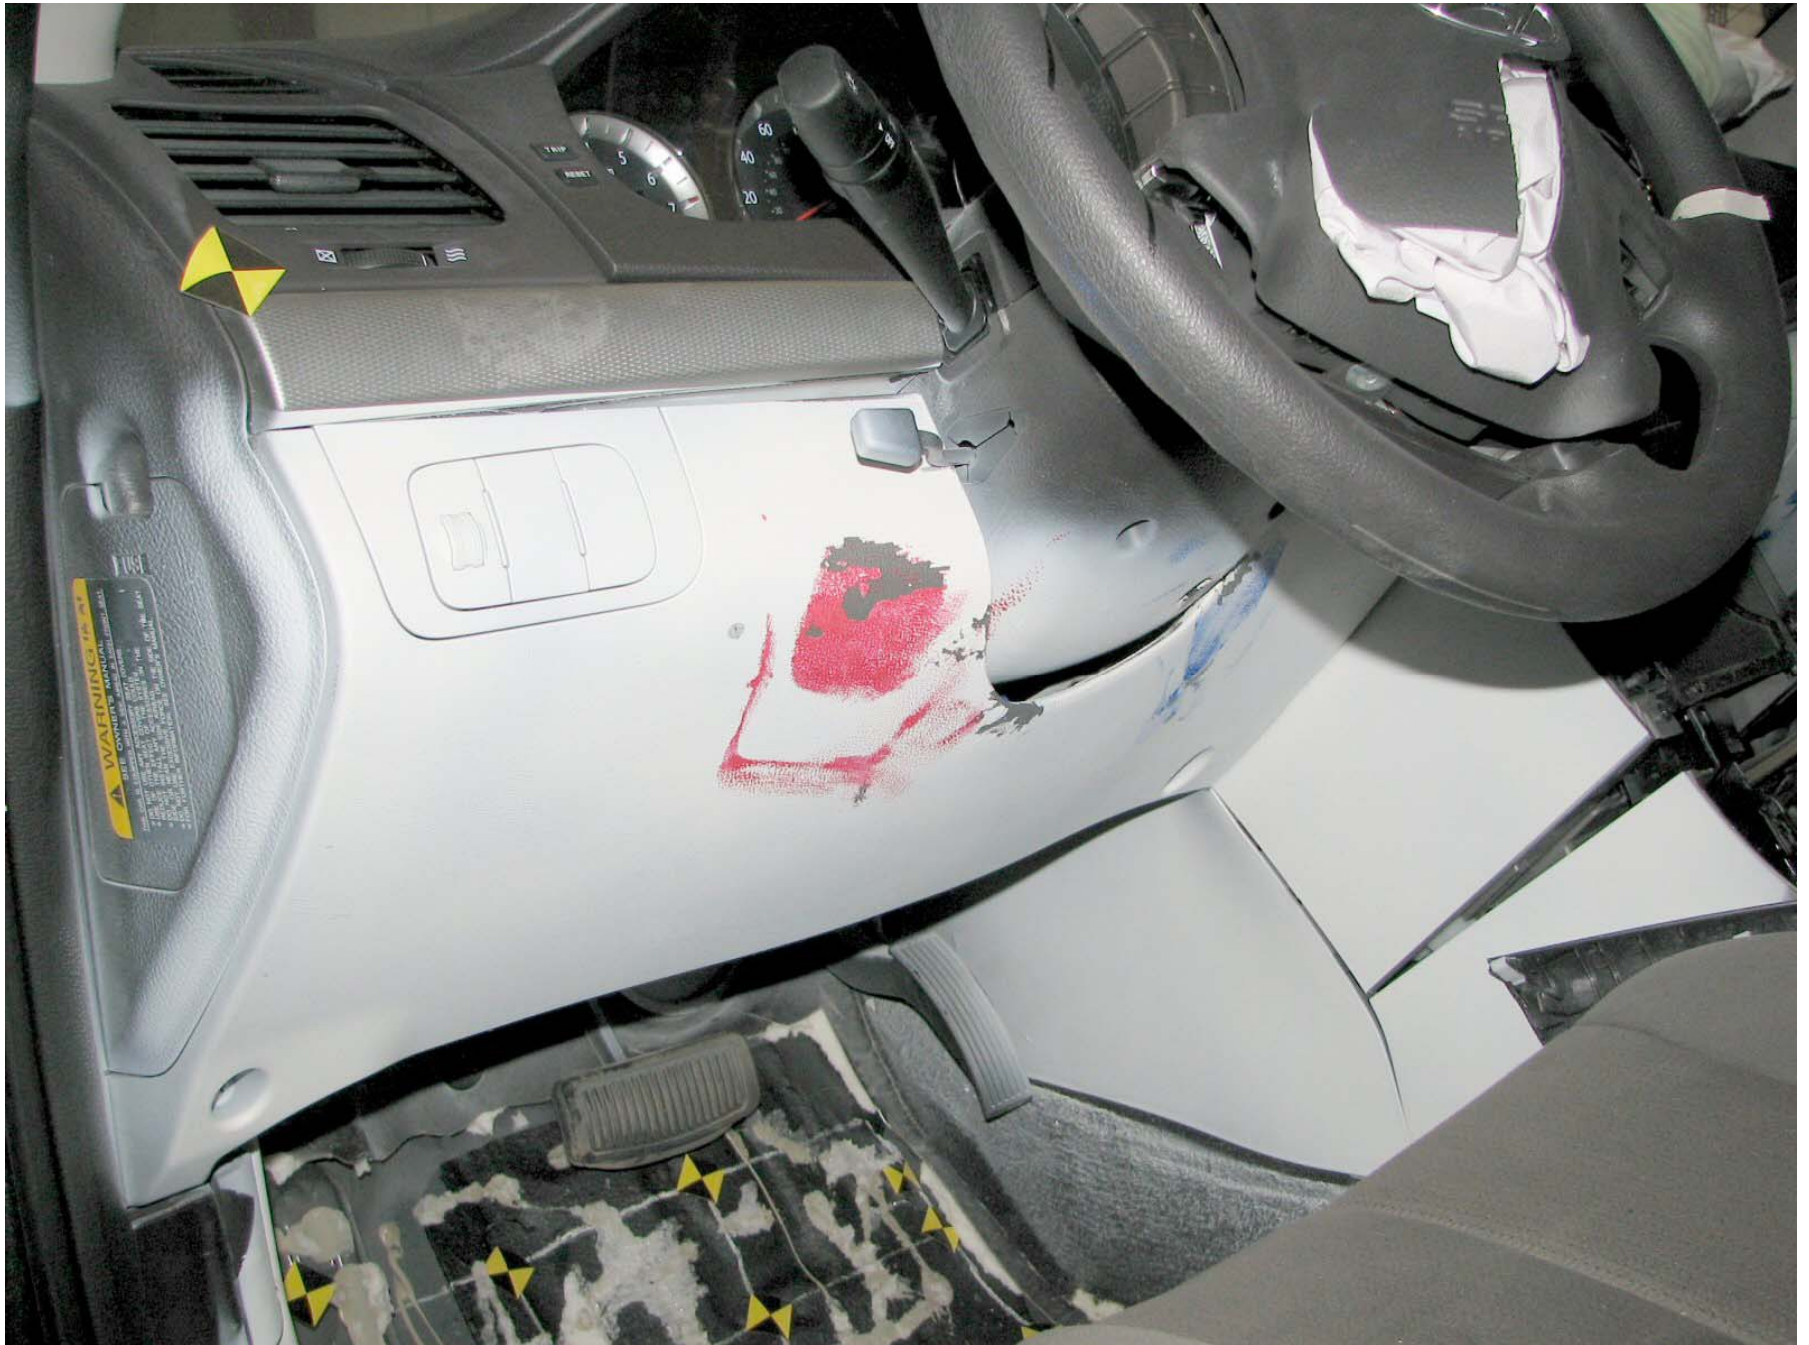
Figure A-39: Post-Test Driver Side Knee Bolster

The driver's visible contact points were as follows: The driver ATD's head, chest, and abdomen contacted the airbag. The head also contacted the headrest. Both knees contacted the bolster.

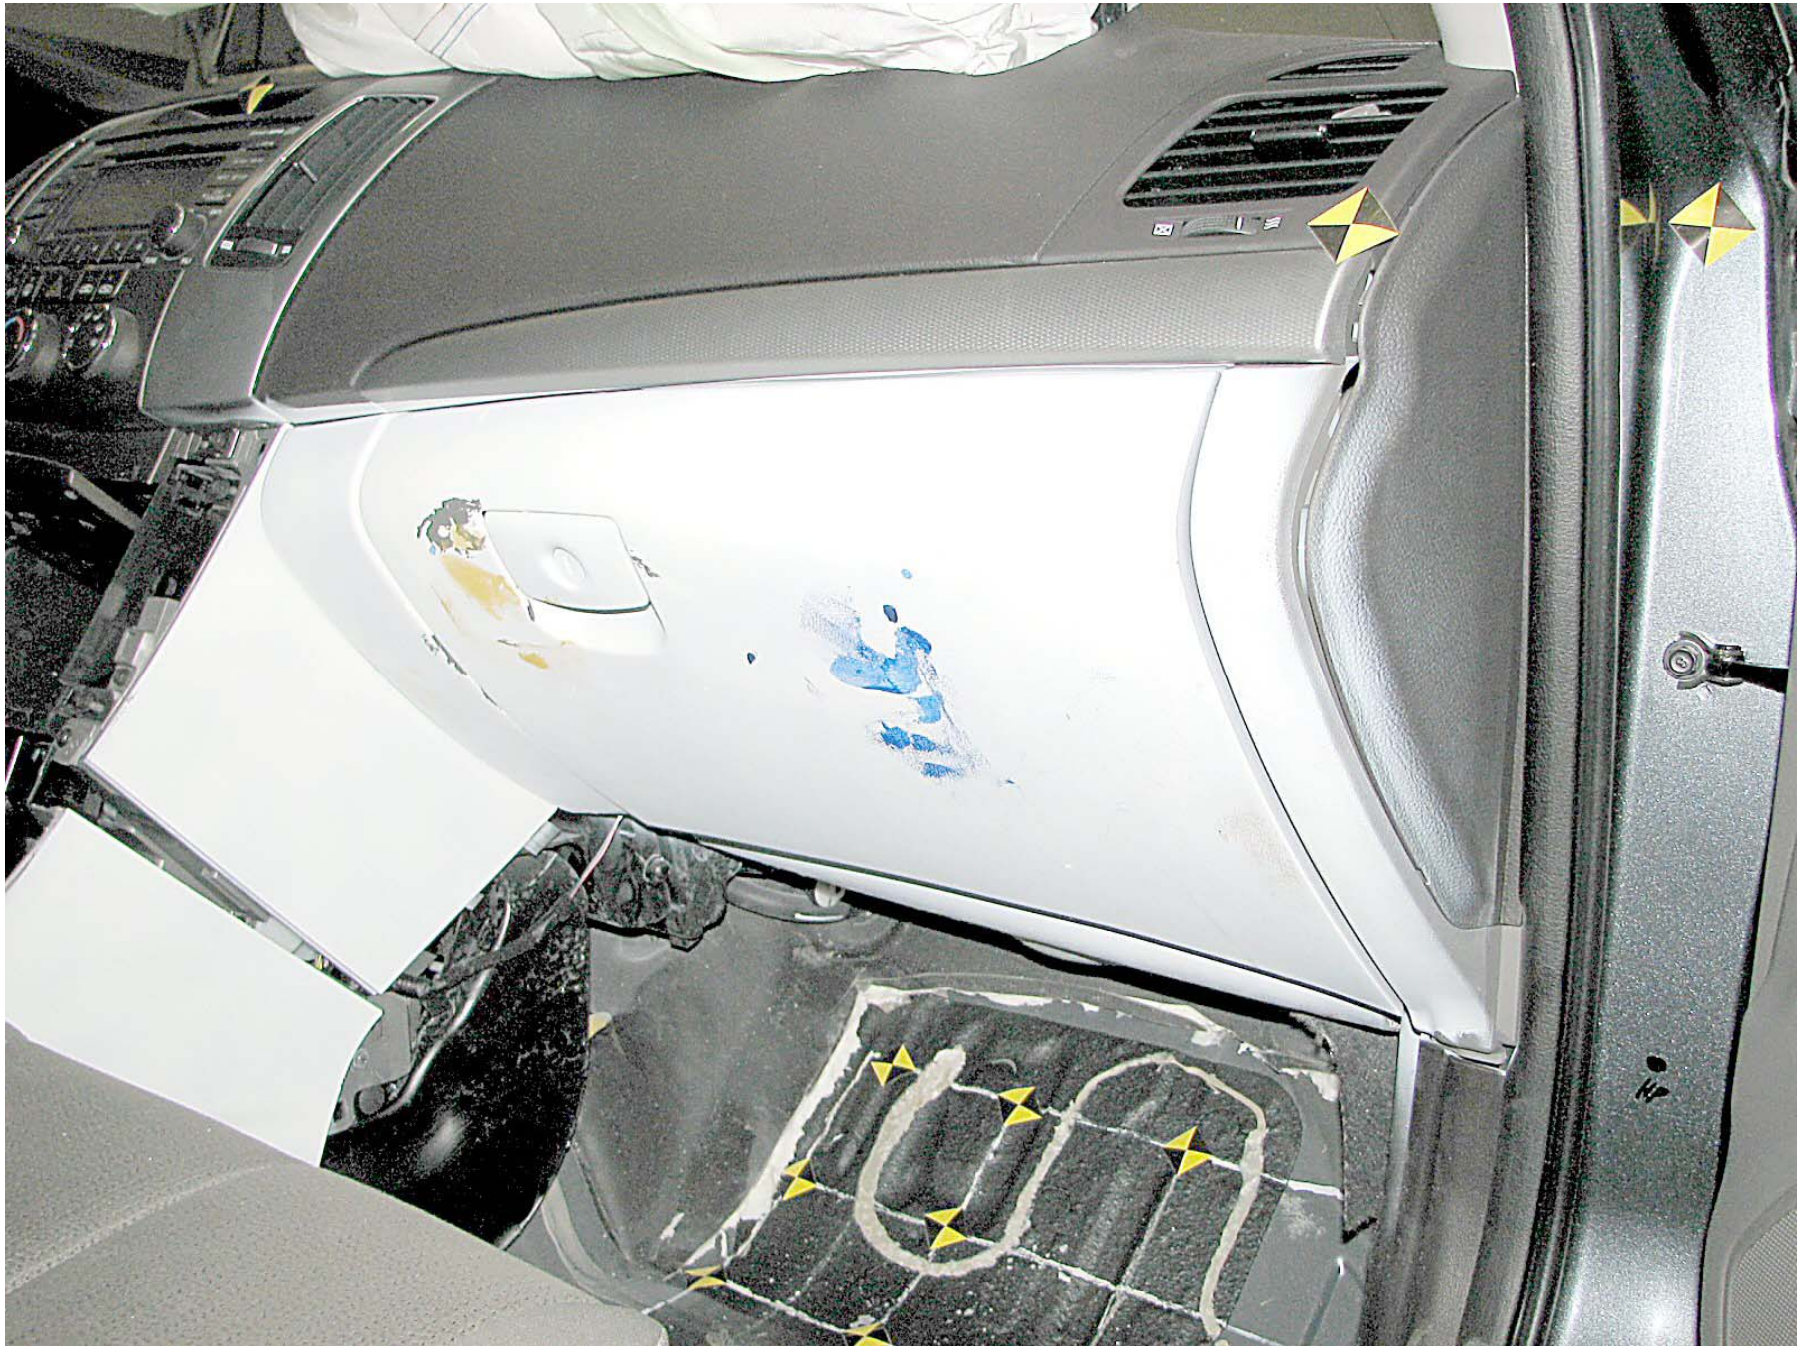
Figure A-53: Post-Test Passenger Side Glove Box

The passenger's visible contact points were as follows: The passenger ATD's head, chest, and abdomen contacted the airbag. The head also contacted the headrest. Both knees contacted the glovebox.

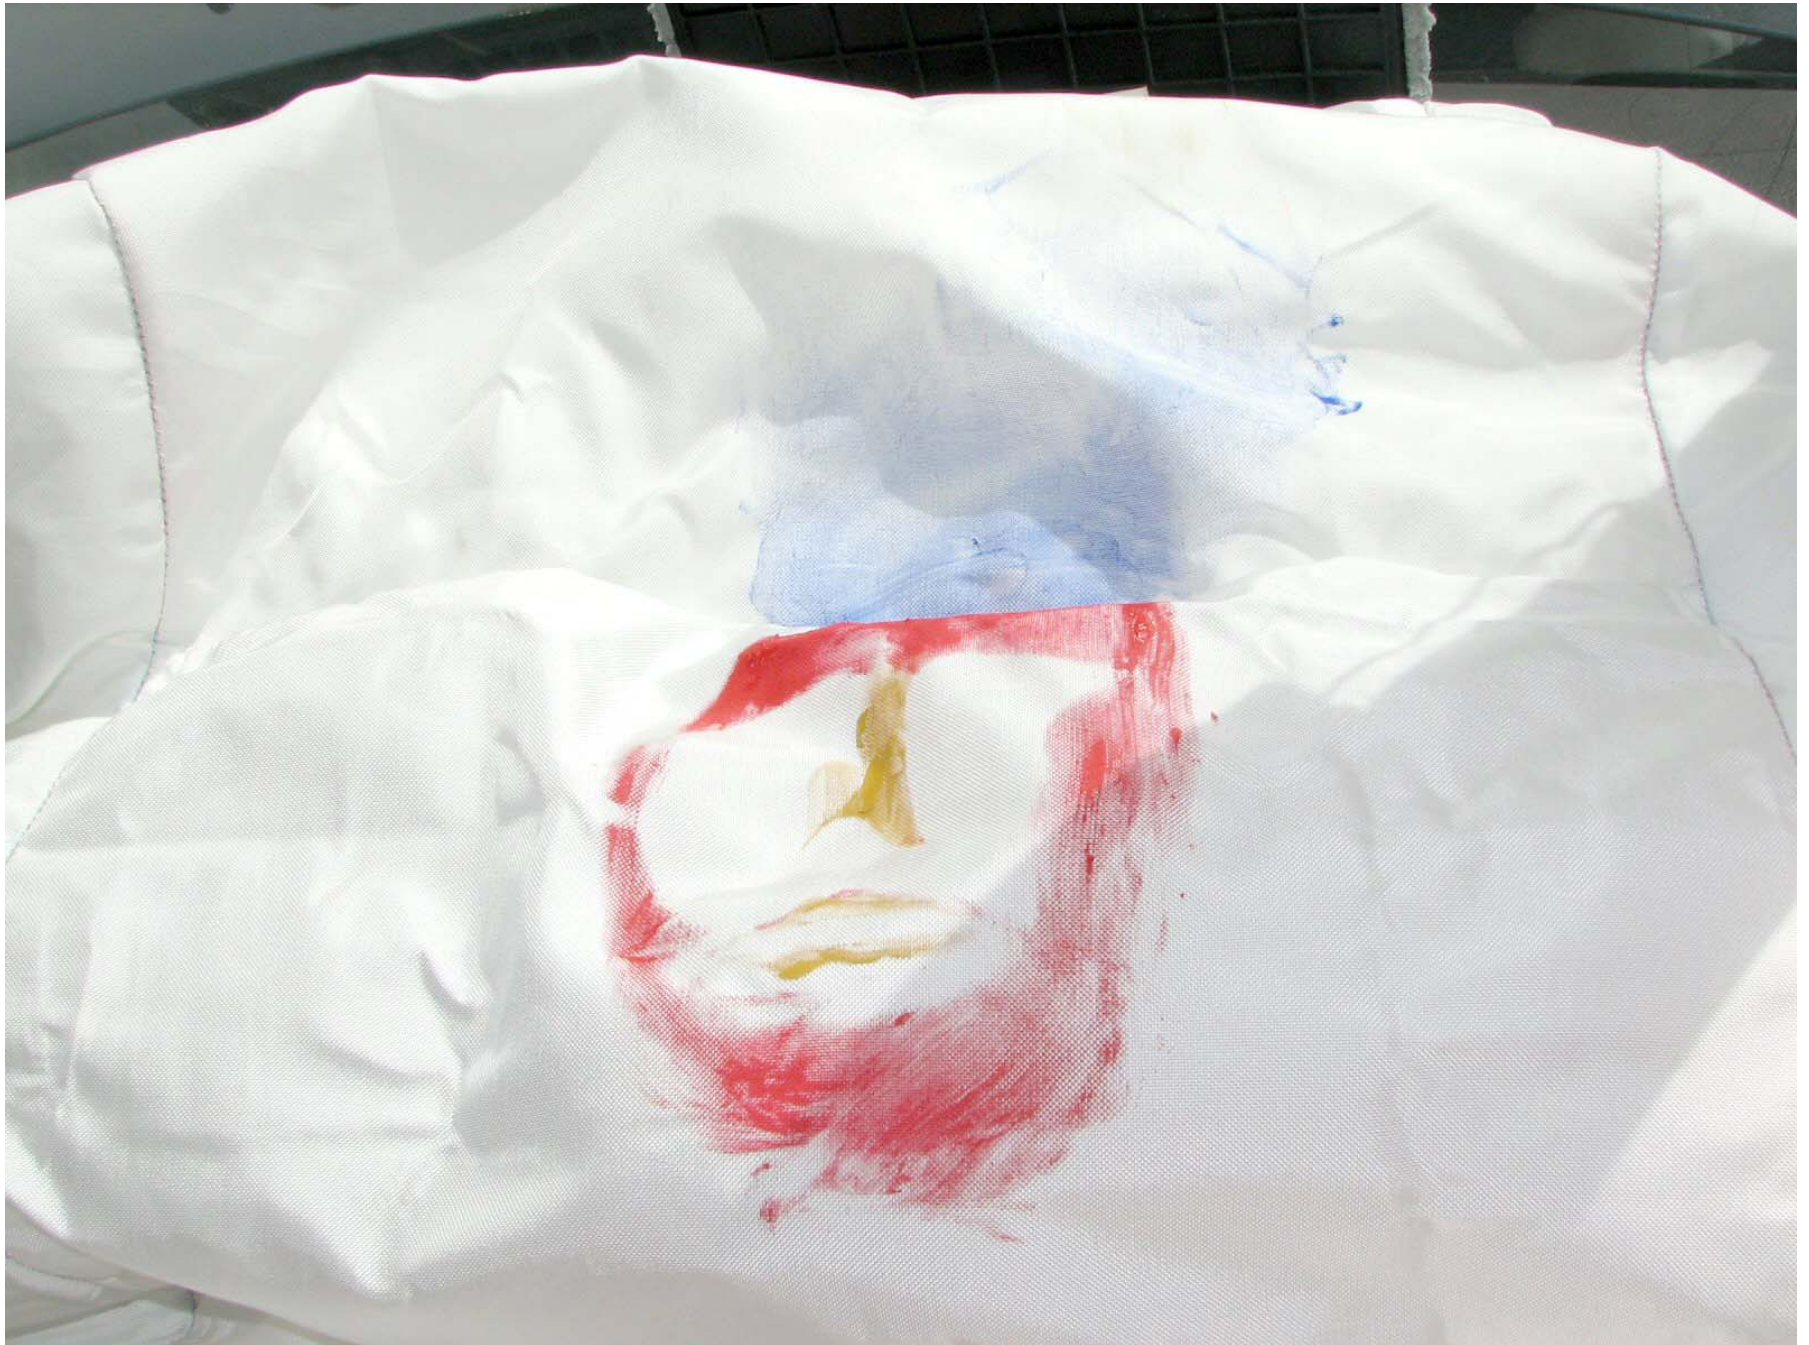
Figure A-57: Post-Test Passenger Dummy Airbag Contact
