**REPORT NUMBER TR-P28001-18-NC**

**NEW CAR ASSESMENT PROGRAM  
FRONTAL BARRIER IMPACT TEST**

**HYUNDAI MOTOR MANUFACTURING  
2009 HYUNDAI SONATA  
4-DOOR SEDAN**

**NHTSA NUMBER: M90500**

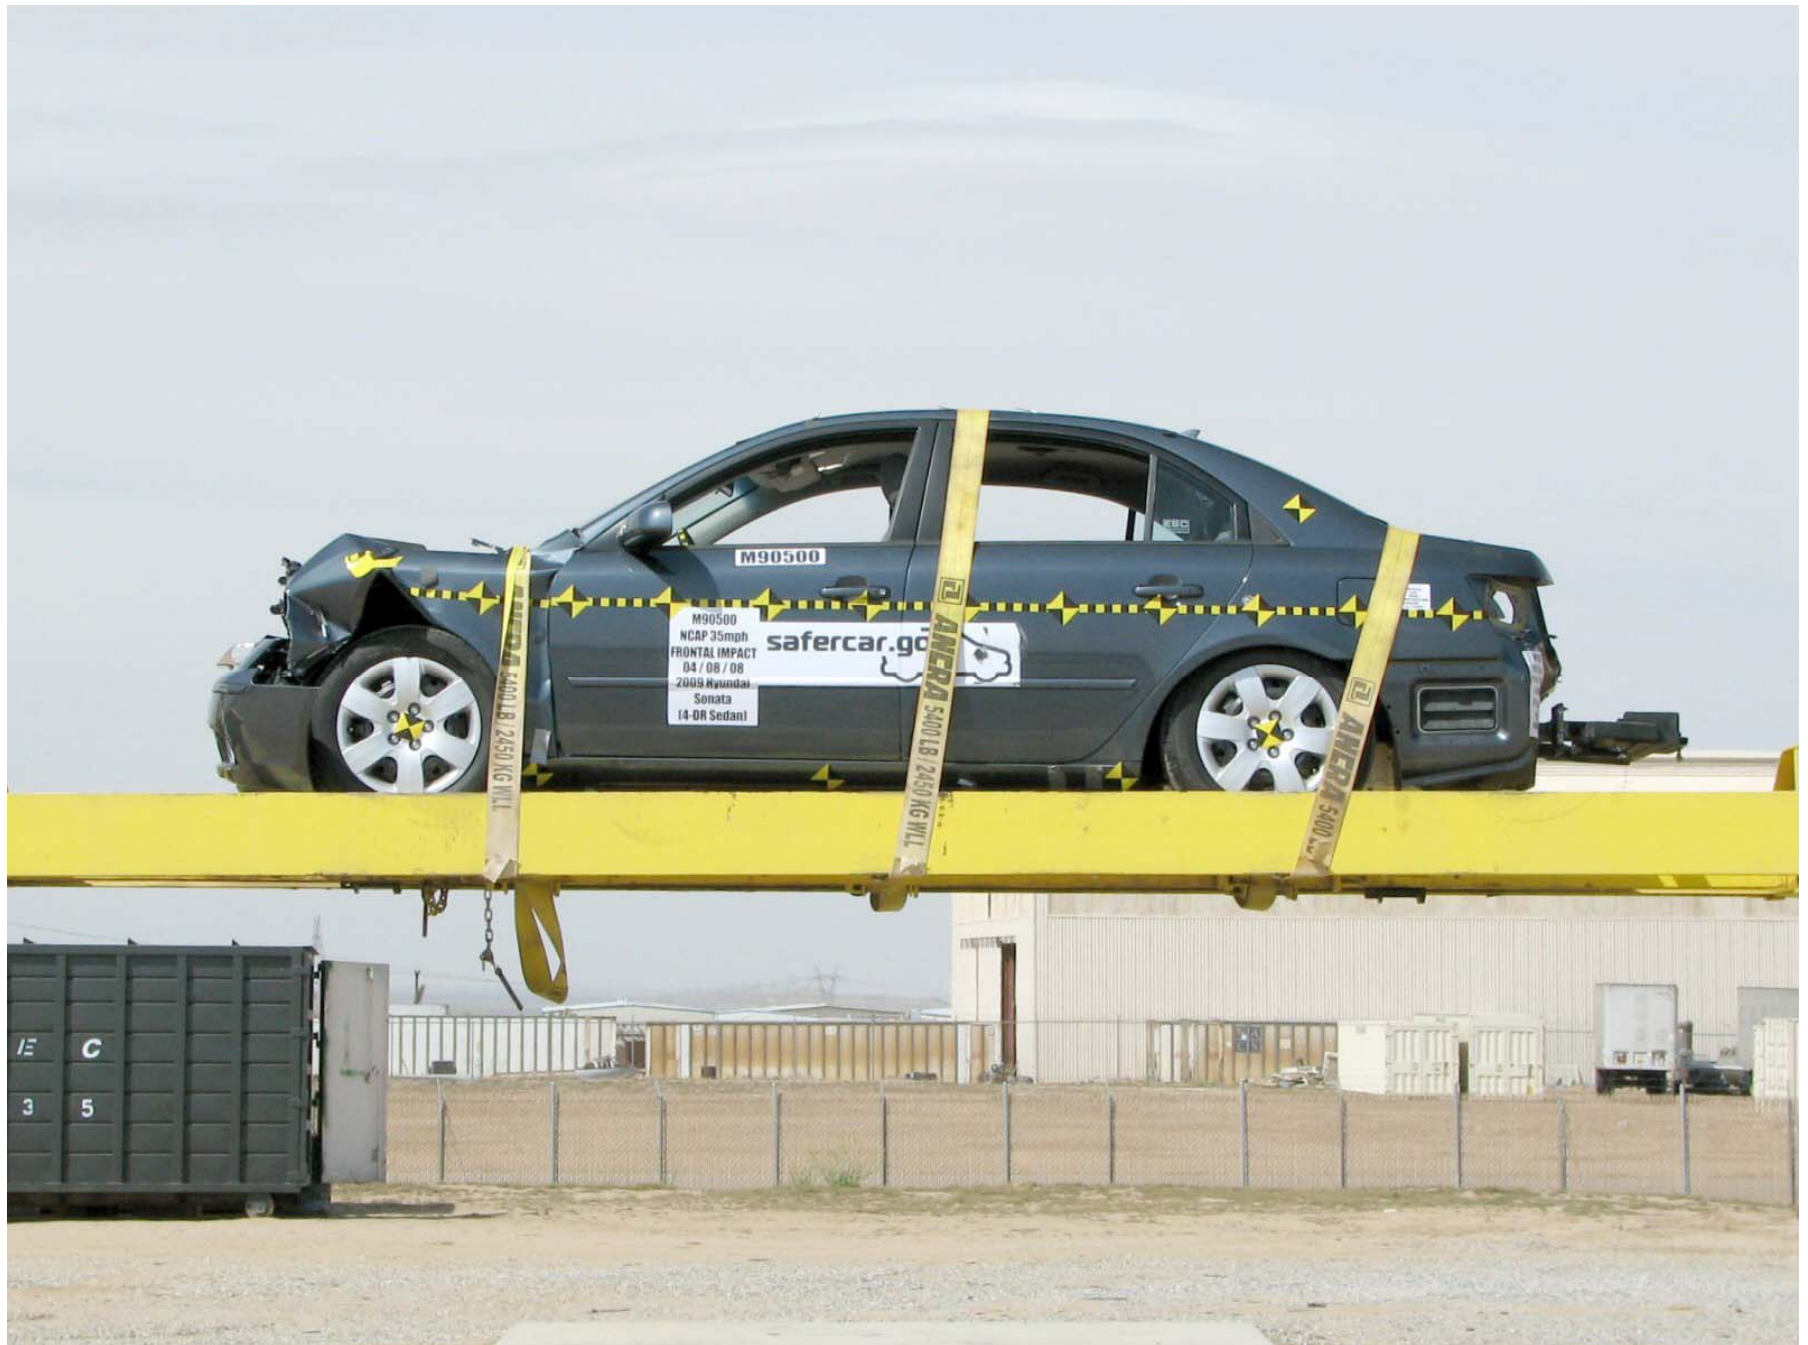
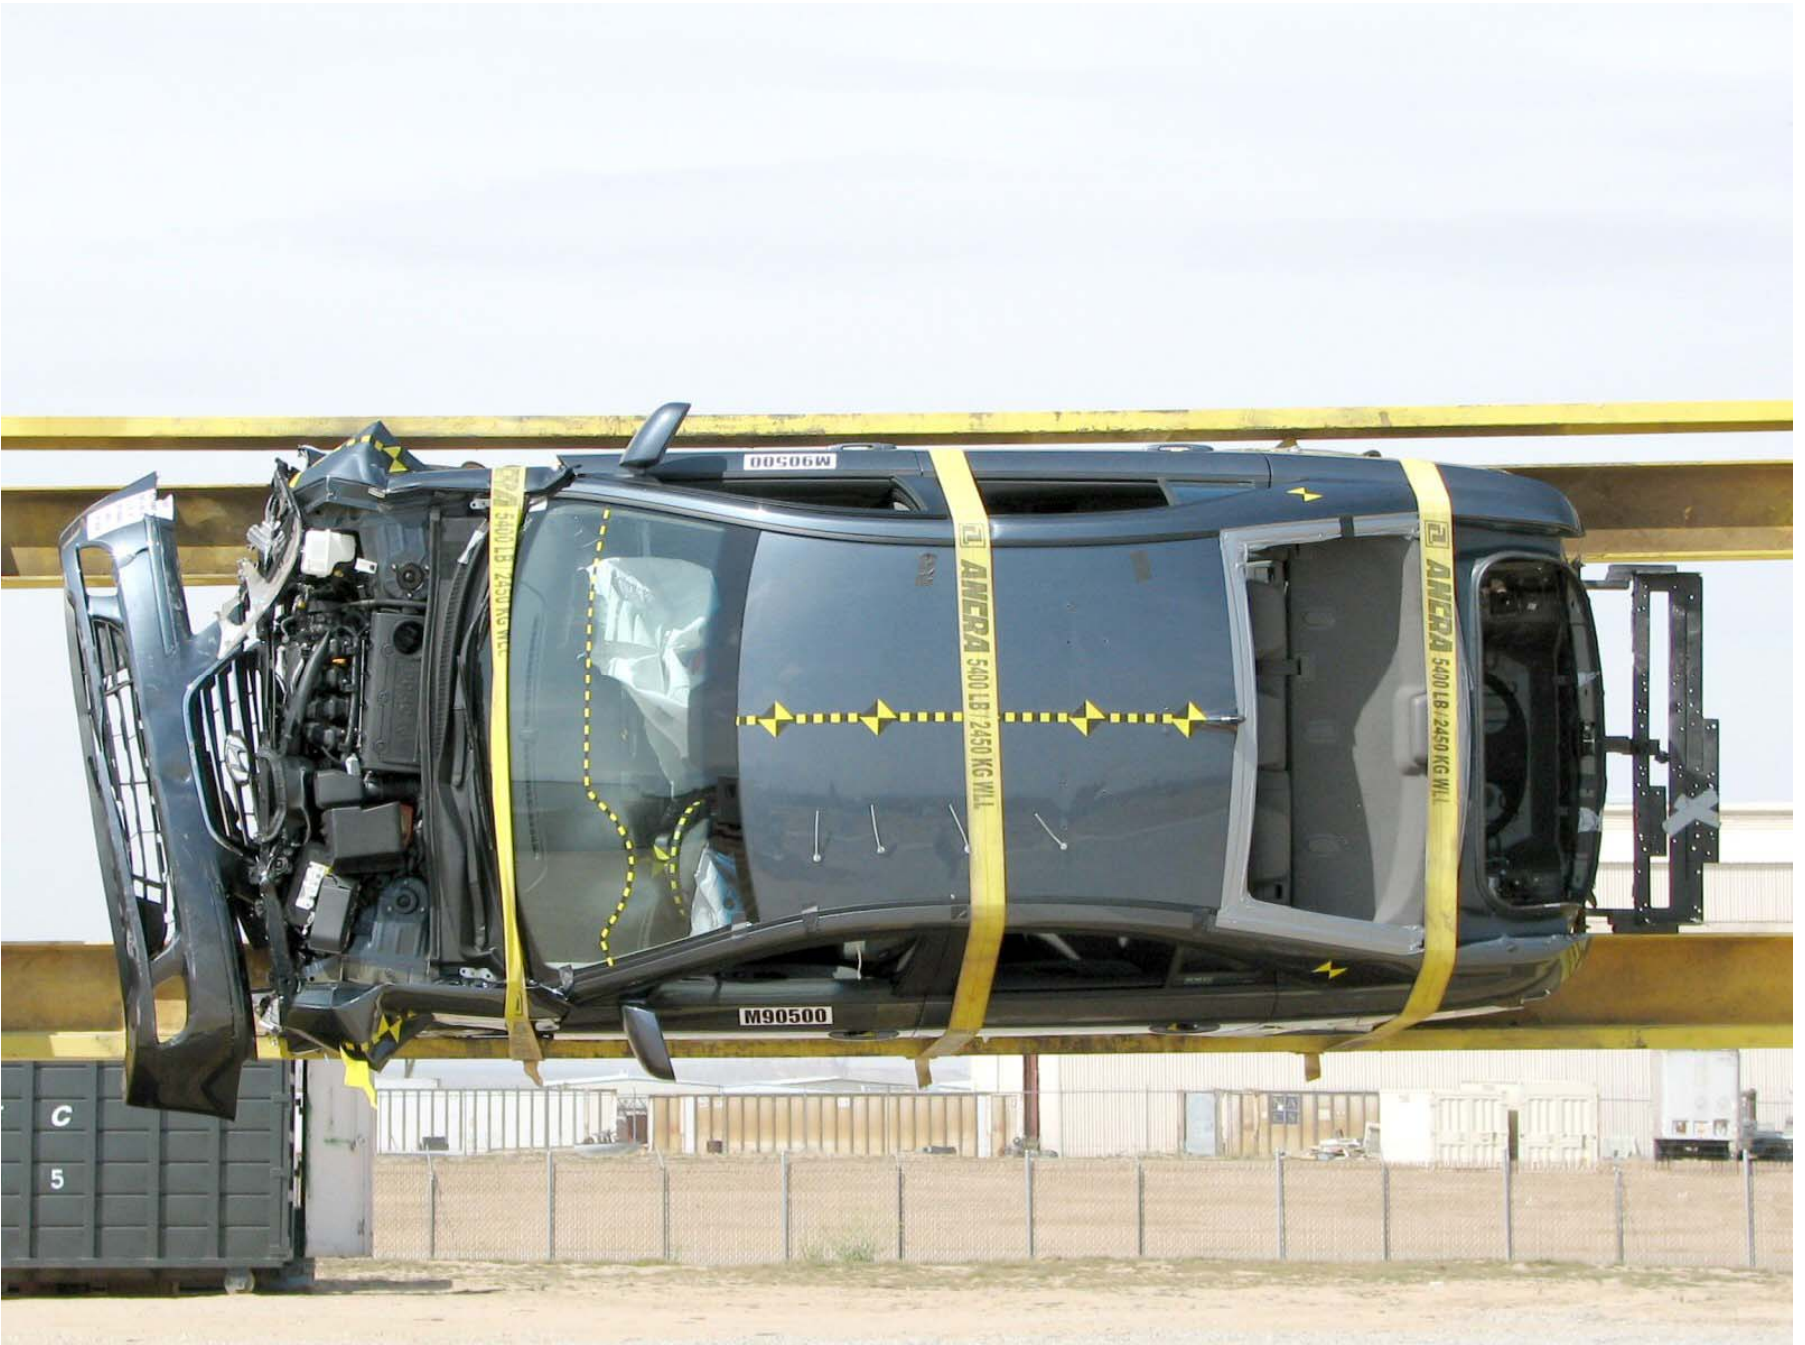
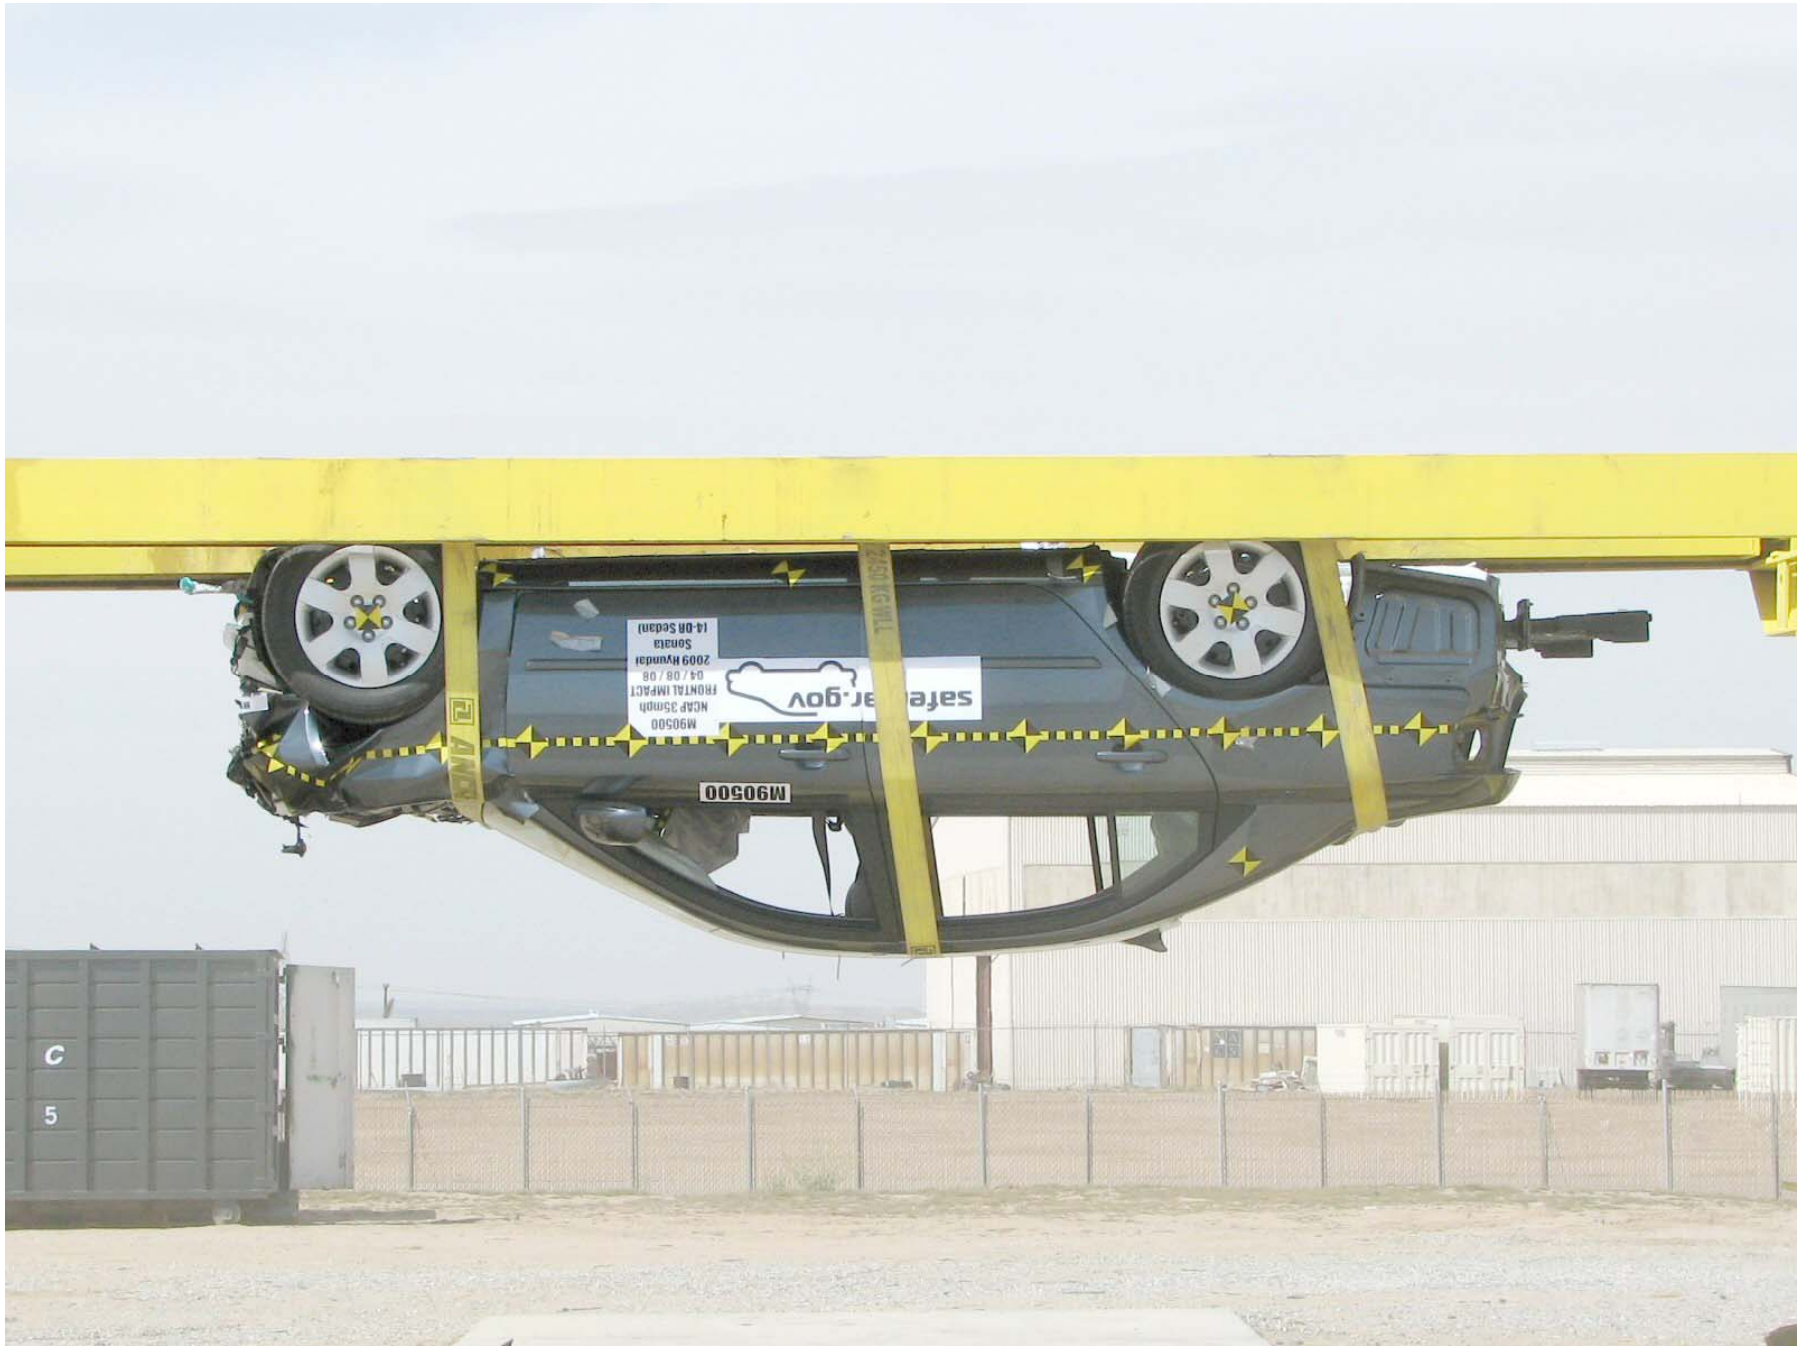
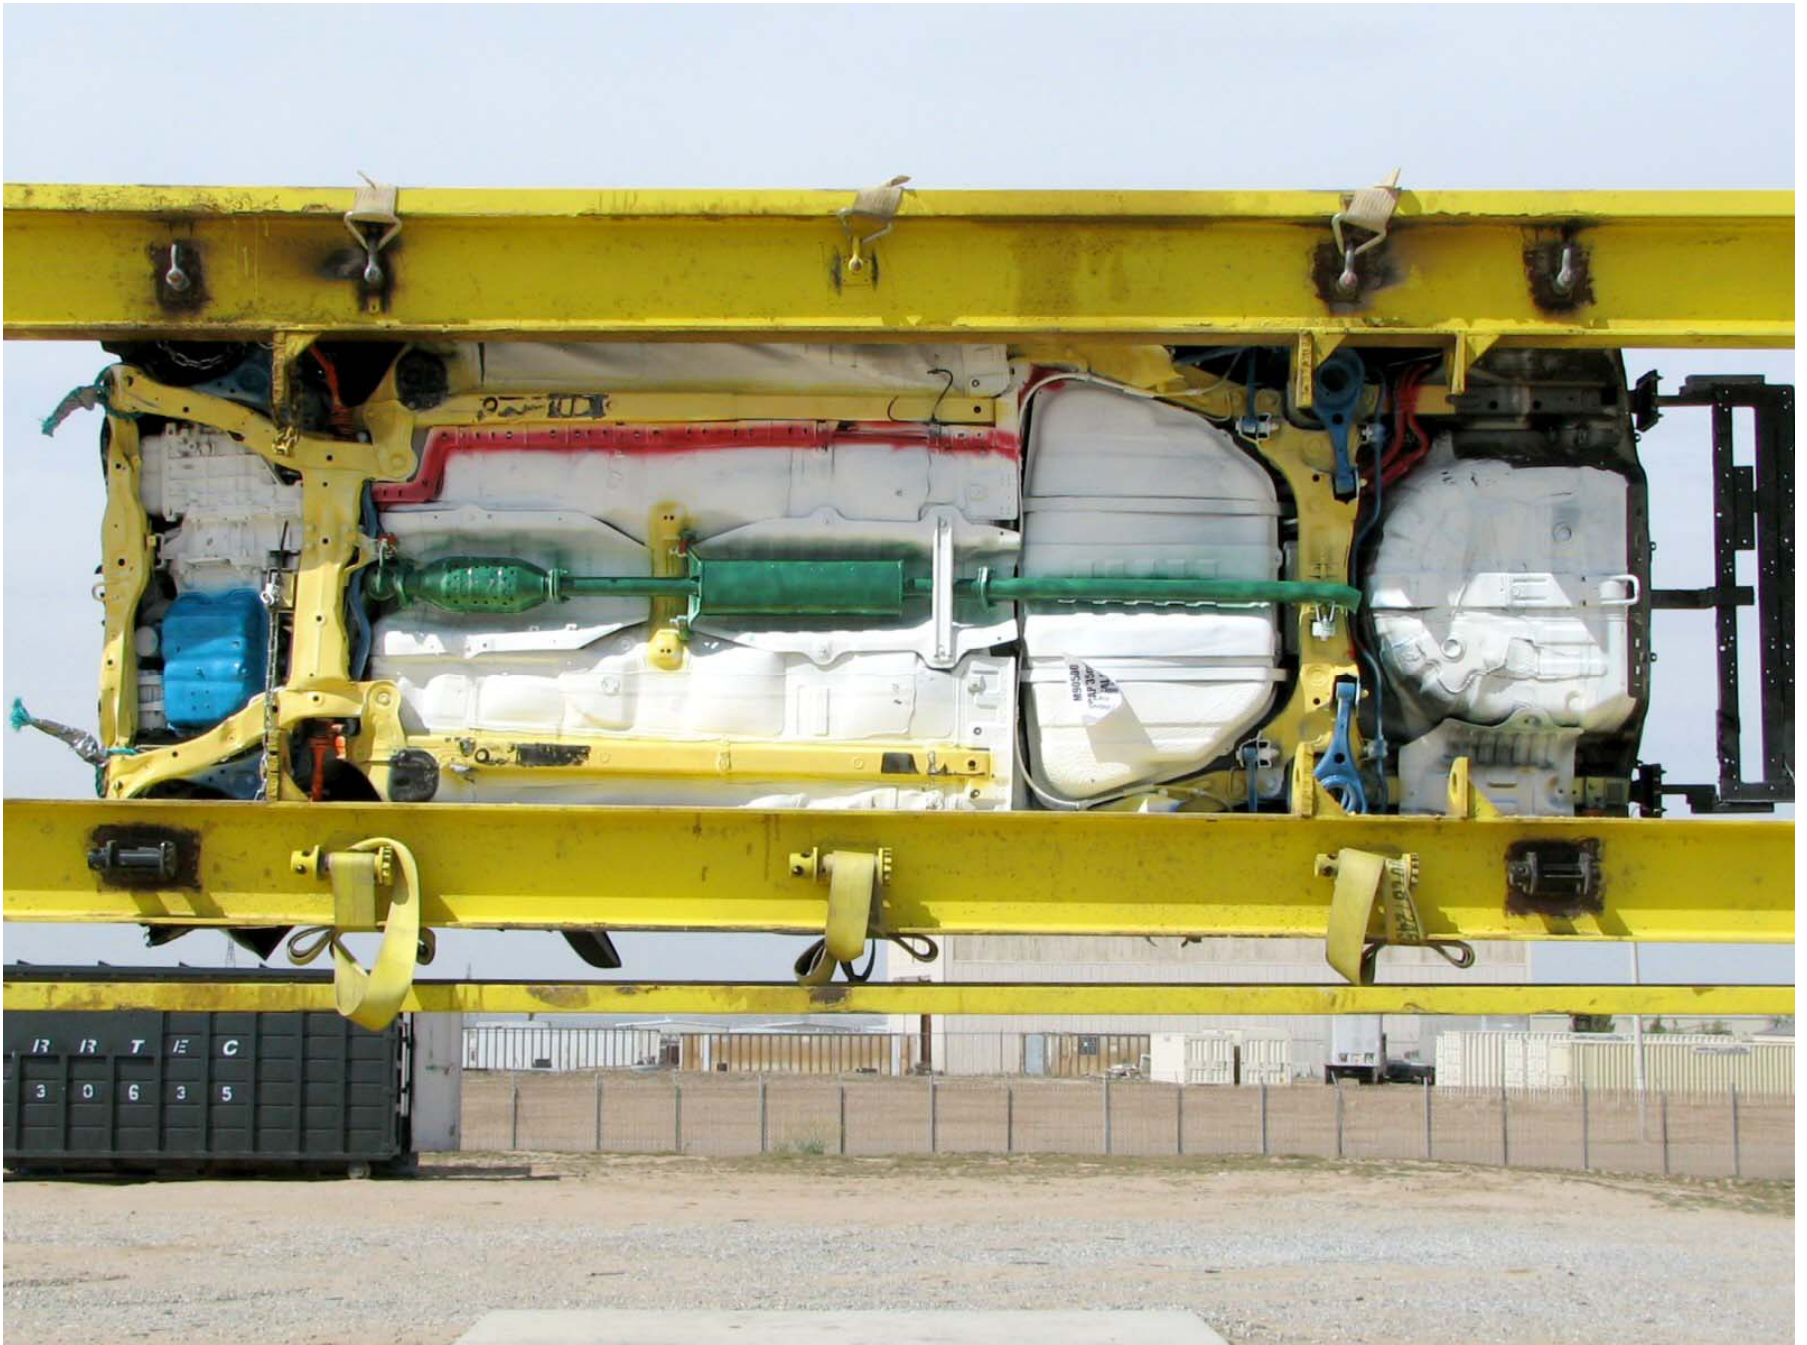
Figure A-58: Vehicle on Rollover Device (0°)

Figure A-59: Vehicle on Rollover Device (90°)

Figure A-60: Vehicle on Rollover Device (180°)

Figure A-61: Vehicle on Rollover Device (270°)

1. The specified fixture rollover rate for each 90° of rotation is 60 to 120 seconds.
2. The position hold time at each position is 300 seconds (minimum).
3. No solvent leakage occurred during rollover.

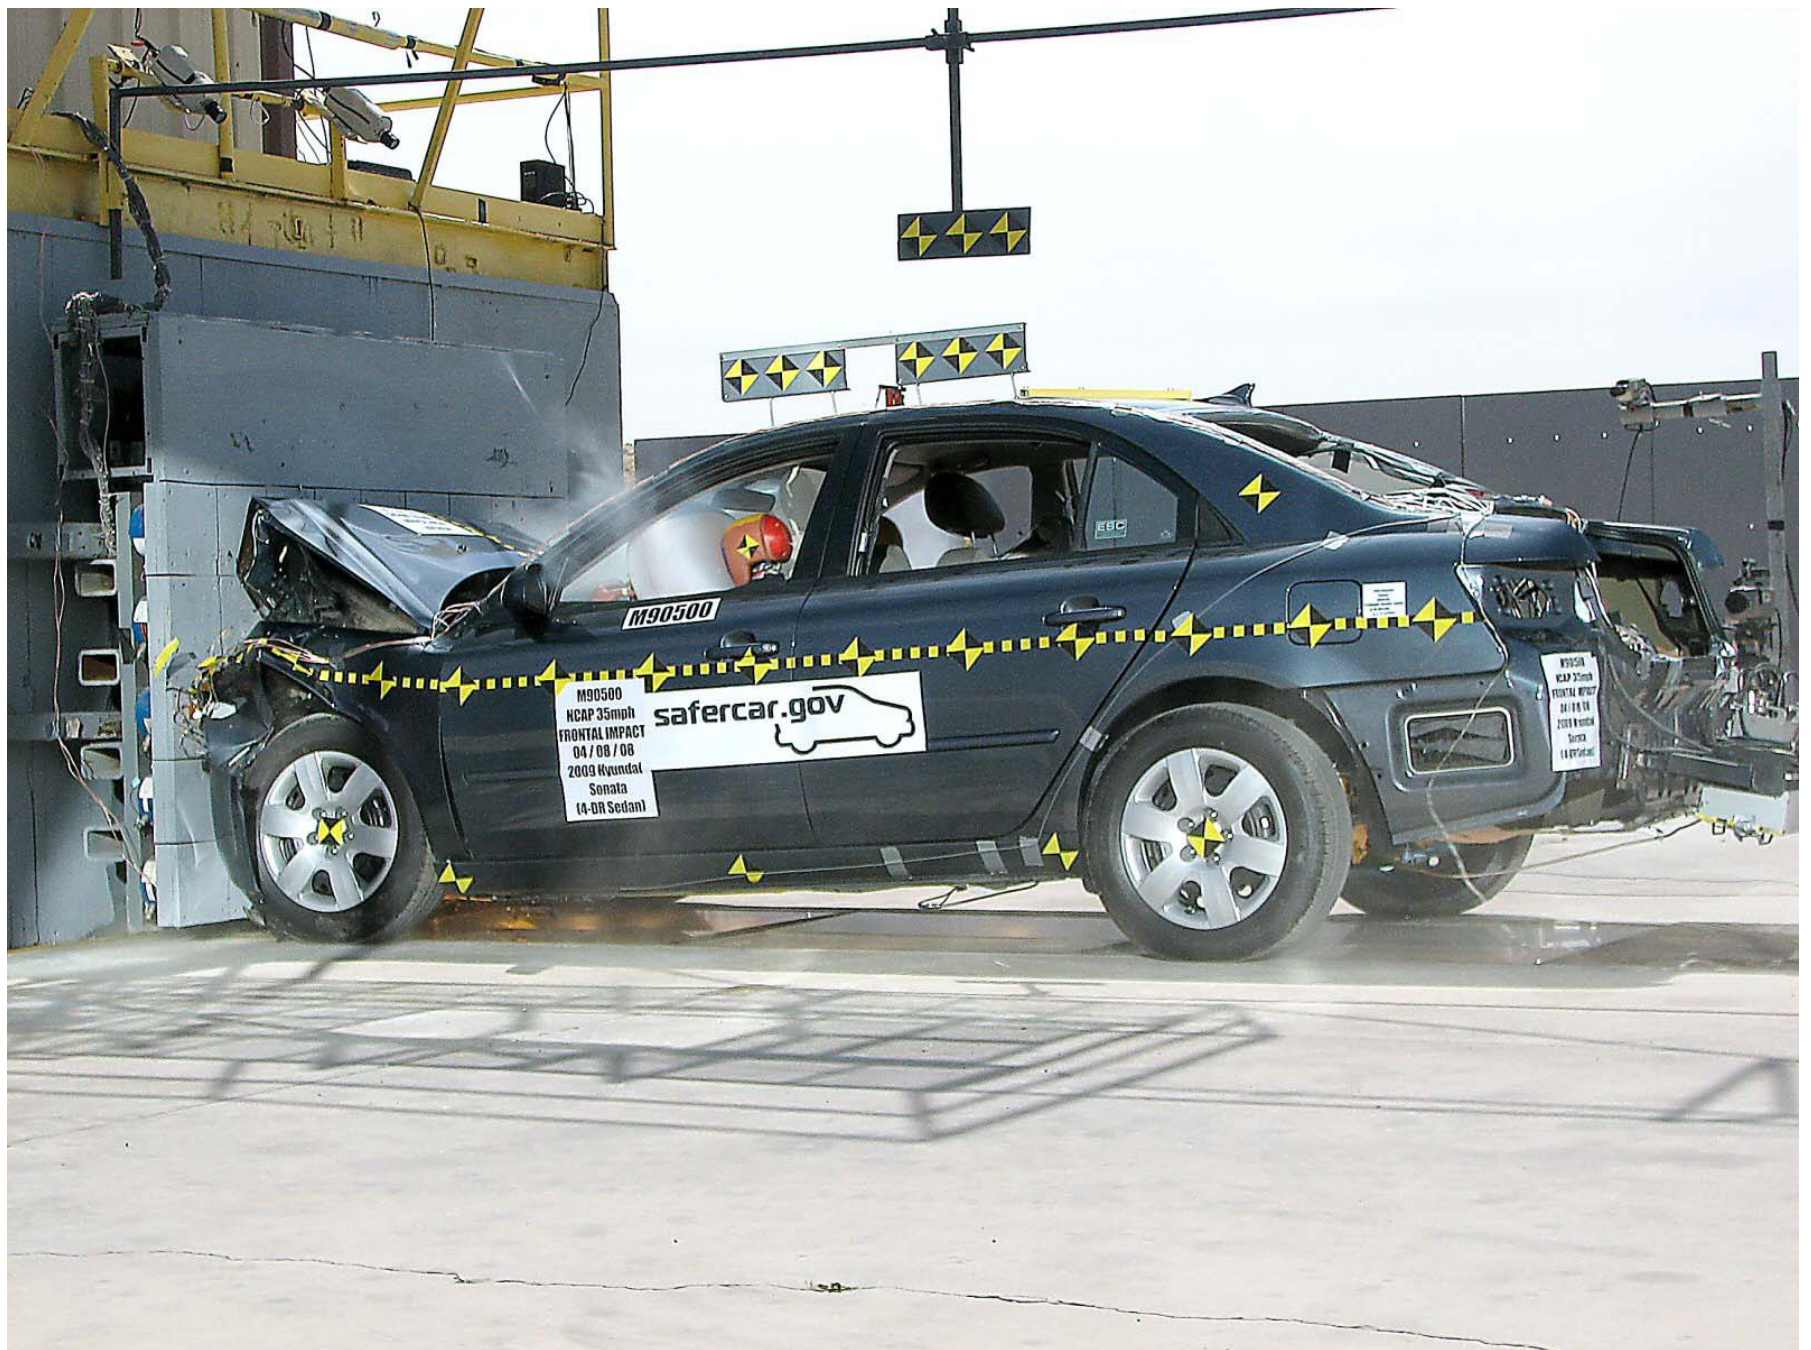
Figure A-62: Vehicle Impact

A load cell barrier consisting of 36 load cells was impacted by a 2009 Hyundai Sonata 4-Door Sedan at a velocity of 56.08 km/h. The test was performed at KARCO Engineering, LLC on April 8, 2008
