**REPORT NUMBER: NCAP-MGA-2008-017**

**NEW CAR ASSESSMENT PROGRAM  
FRONTAL BARRIER IMPACT TEST**

**TOYOTA MOTOR MANUFACTURING, CANADA, INC.  
2009 TOYOTA COROLLA MATRIX 5-DOOR S AWD  
NHTSA NUMBER: M95103**

**PREPARED BY:  
MGA RESEARCH CORPORATION  
5000 WARREN ROAD  
BURLINGTON, WI 53105**

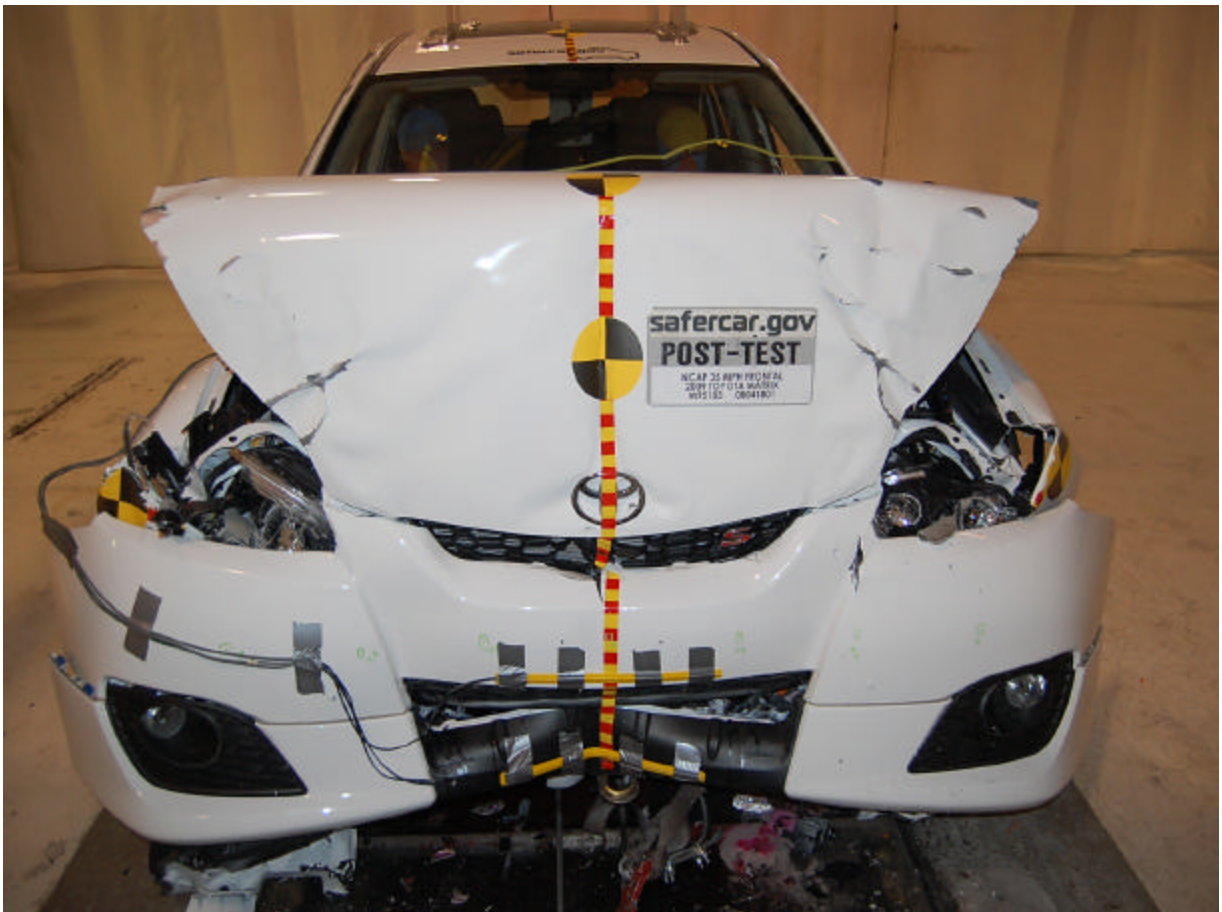
Post-Test Front View

The maximum static crush of the vehicle was 566 mm and both the driver and passenger side doors remained closed and latched during the impact event and were operable after the impact.

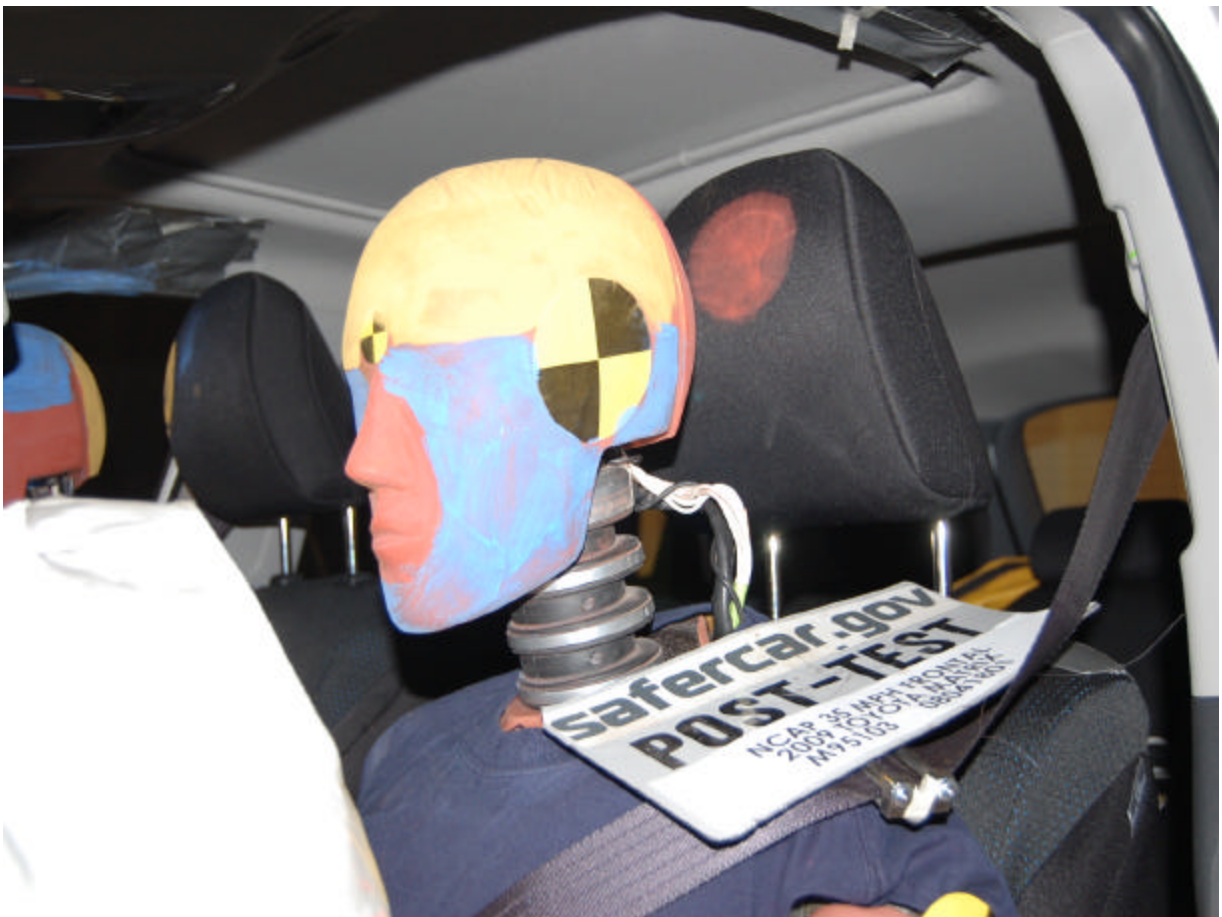
Post-Test Driver Dummy Head Contact (Headrest)

The driver's head and chest contacted the airbag. The driver's head also contacted the headrest. The driver's knees contacted the knee bolster. The passenger's head and chest contacted the airbag. The passenger's head also contacted the headrest and side header. The passenger's knees contacted the glove box.

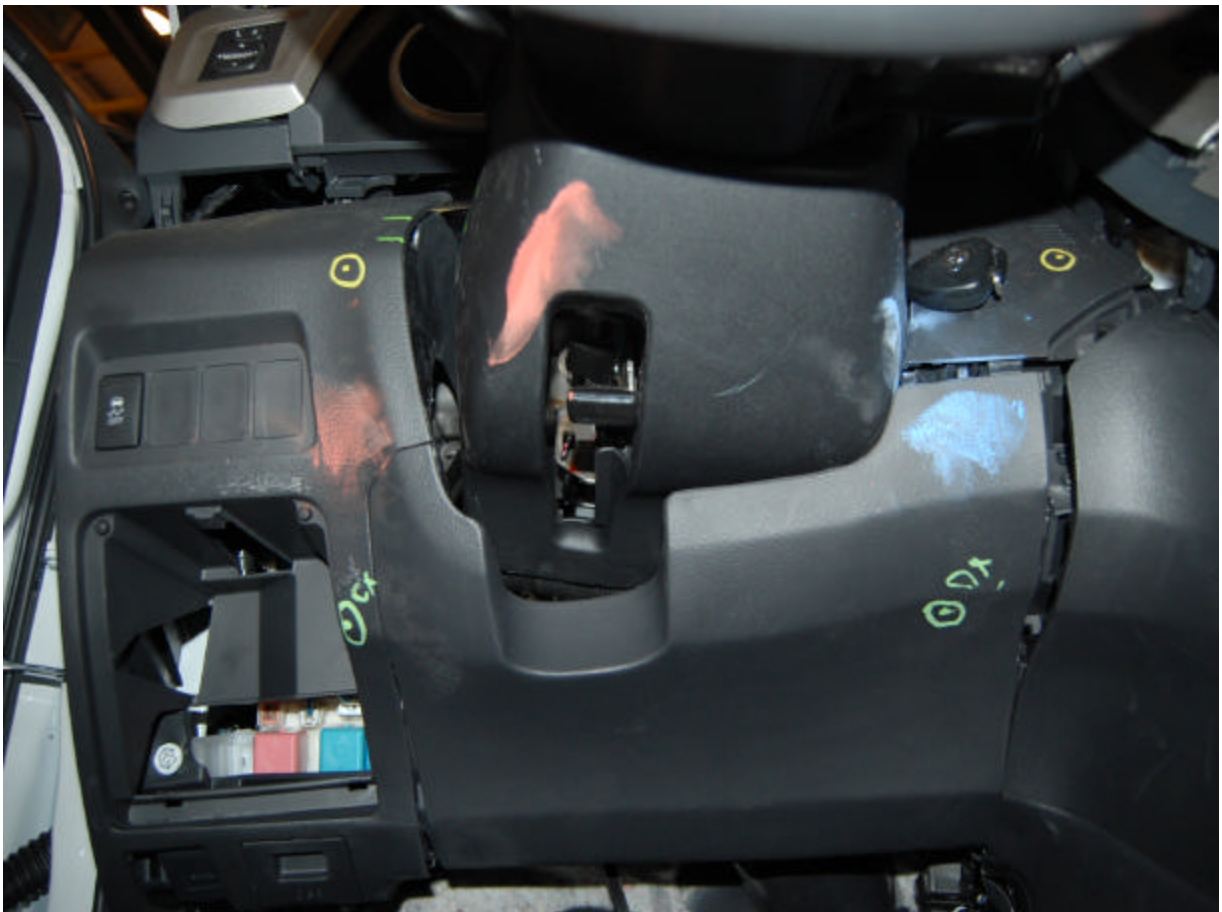
Post-Test Driver Dummy Knee Contact

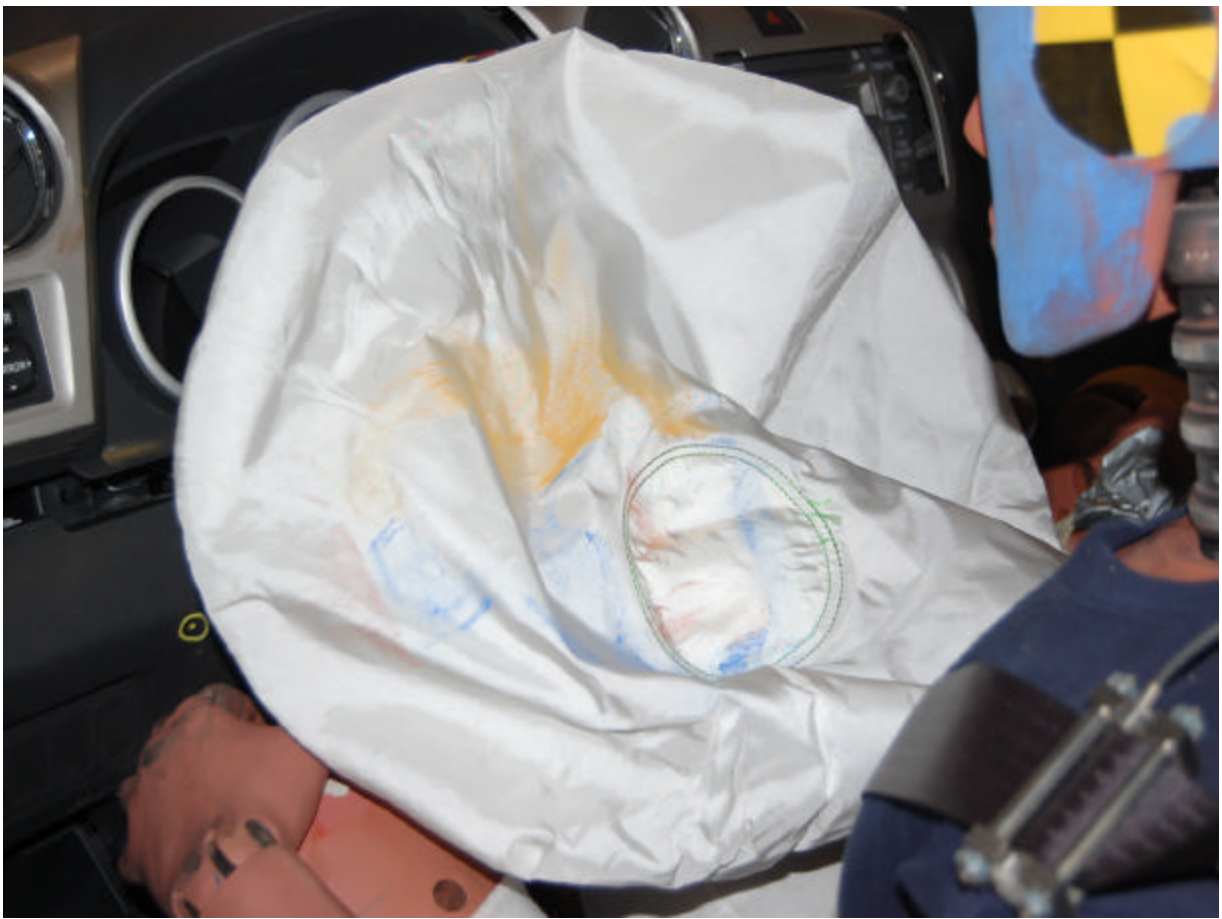
Post-Test Driver Dummy Airbag Contact

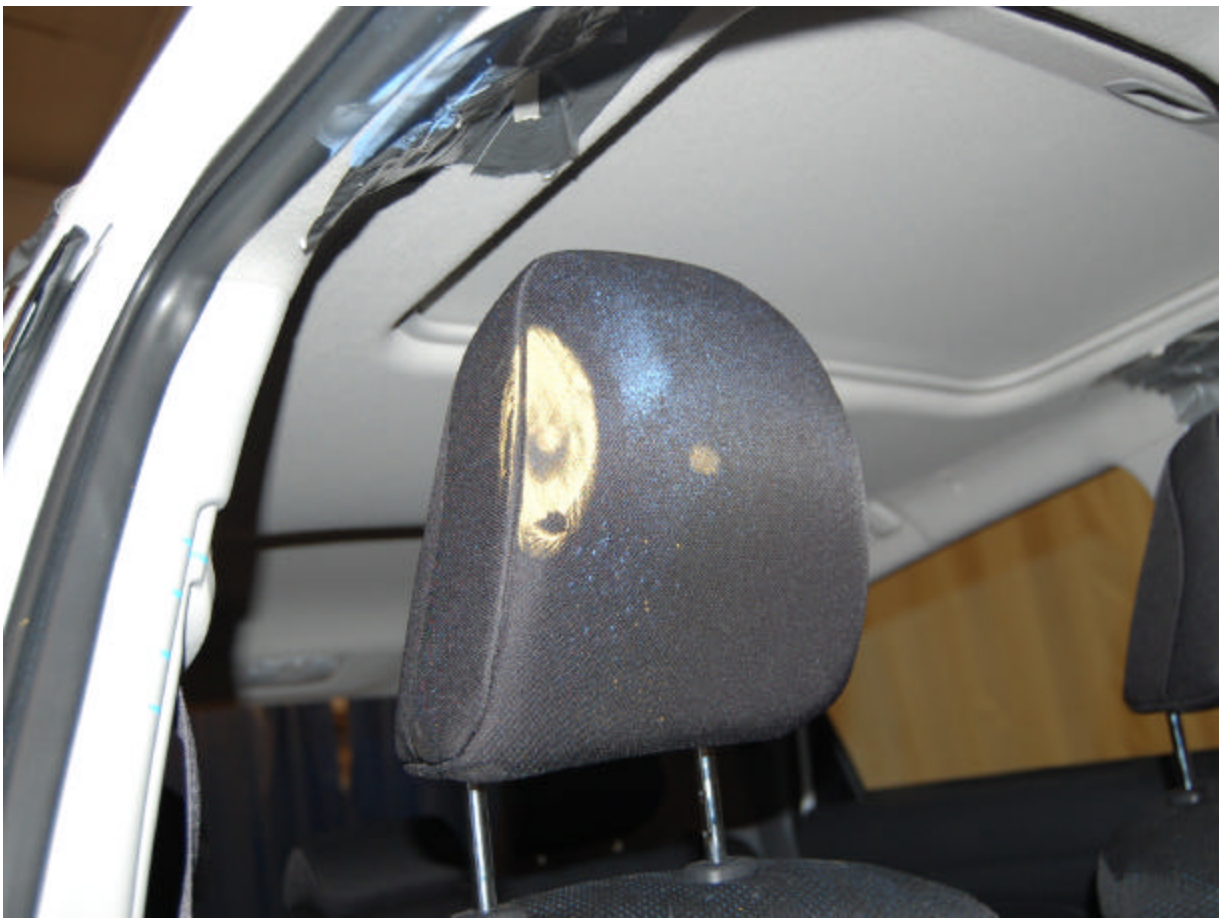
Post-Test Passenger Dummy Head Contact (Headrest)

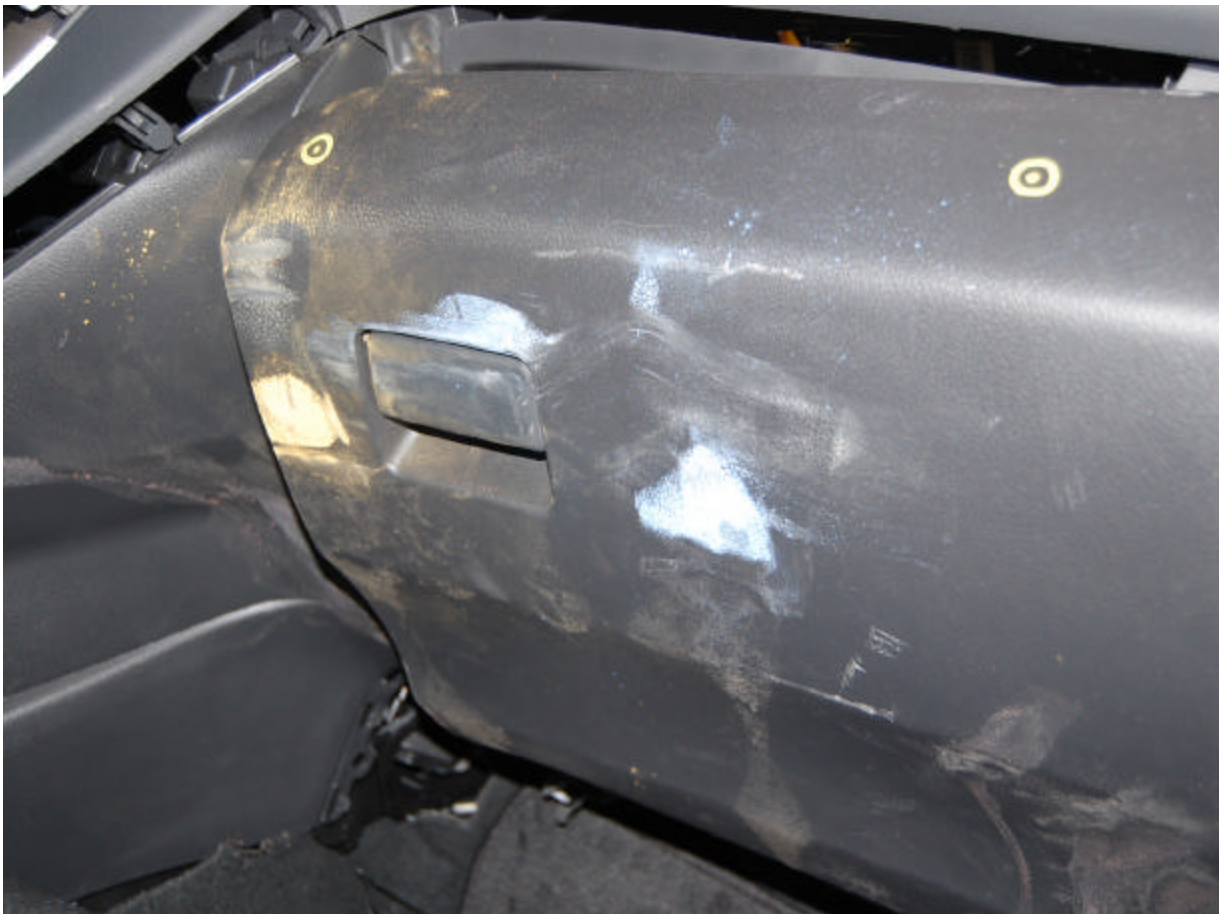
Post-Test Passenger Dummy Knee Contact

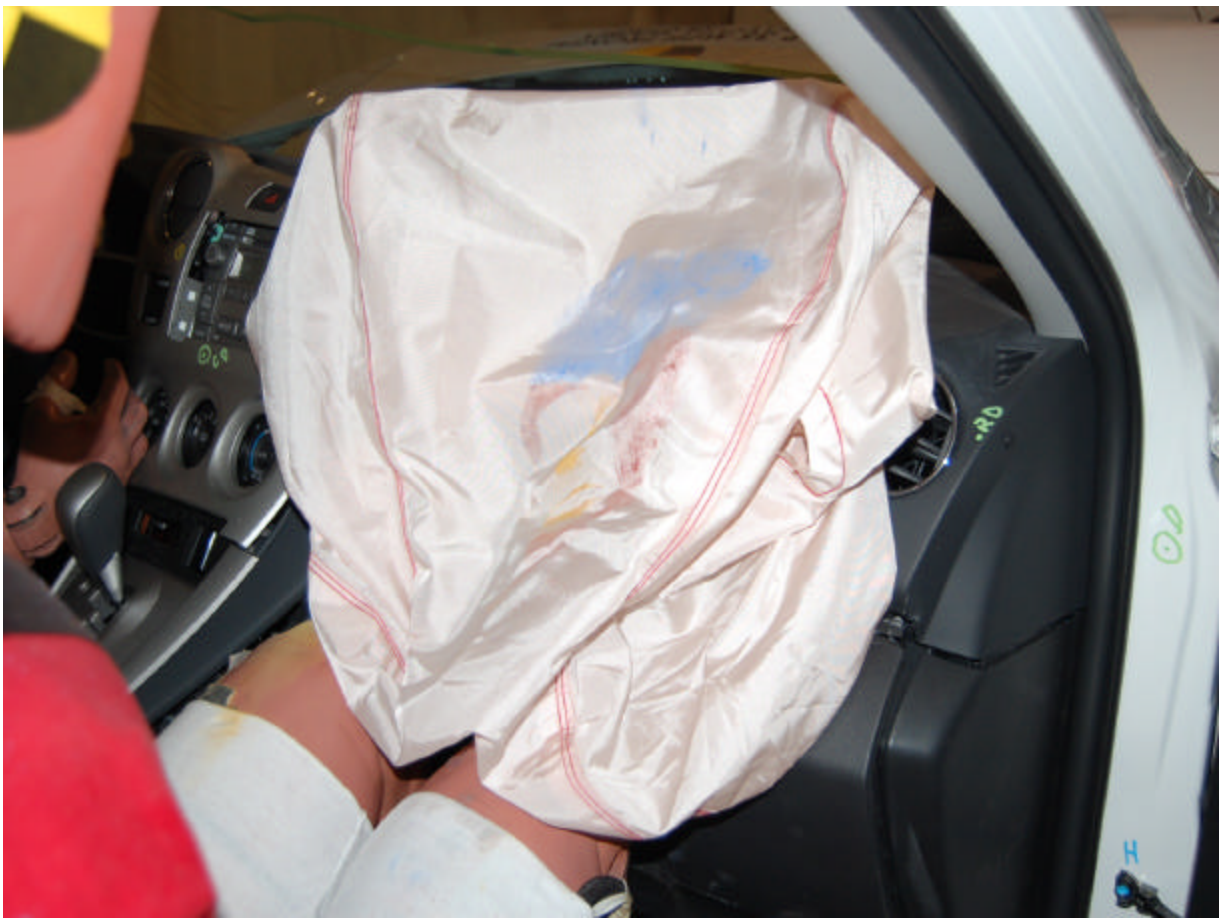
Post-Test Passenger Dummy Airbag Contact

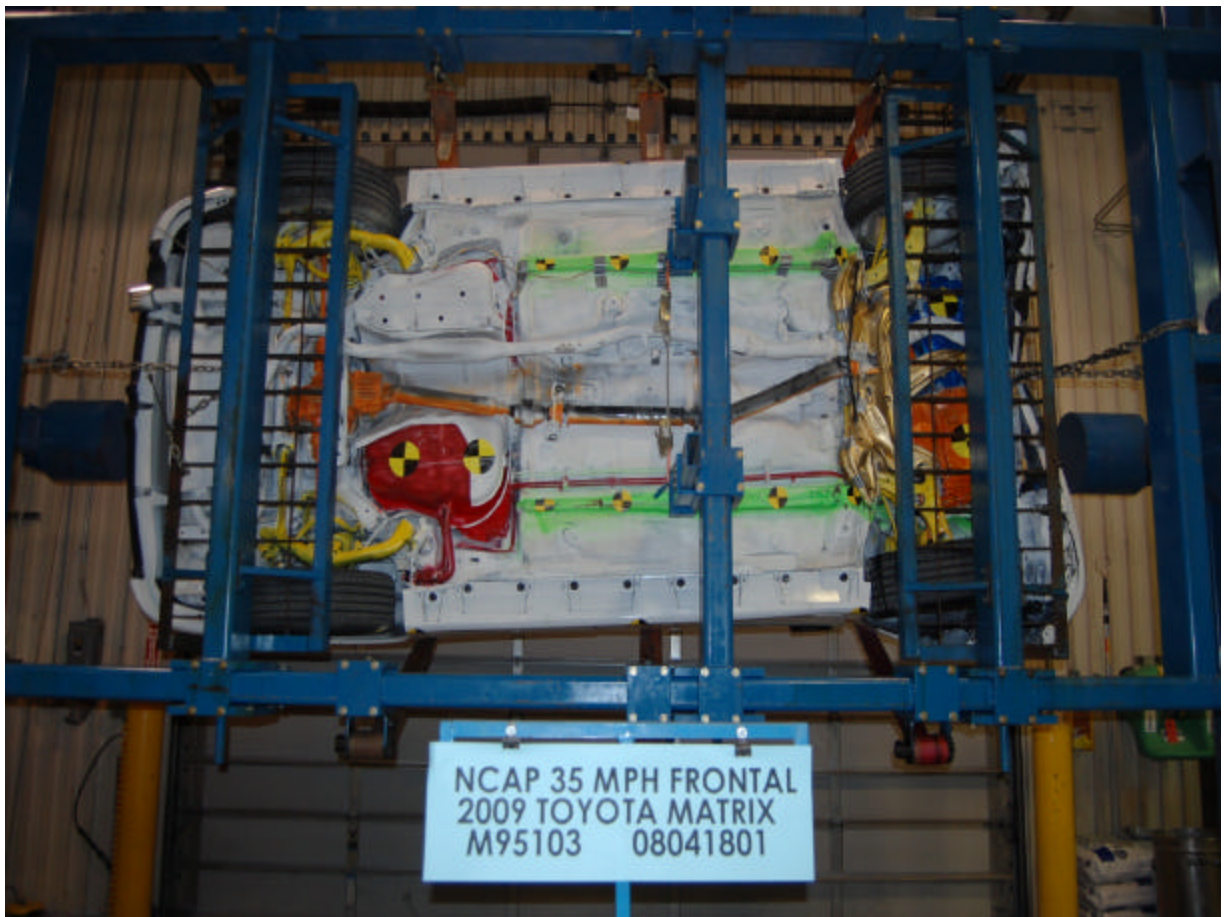
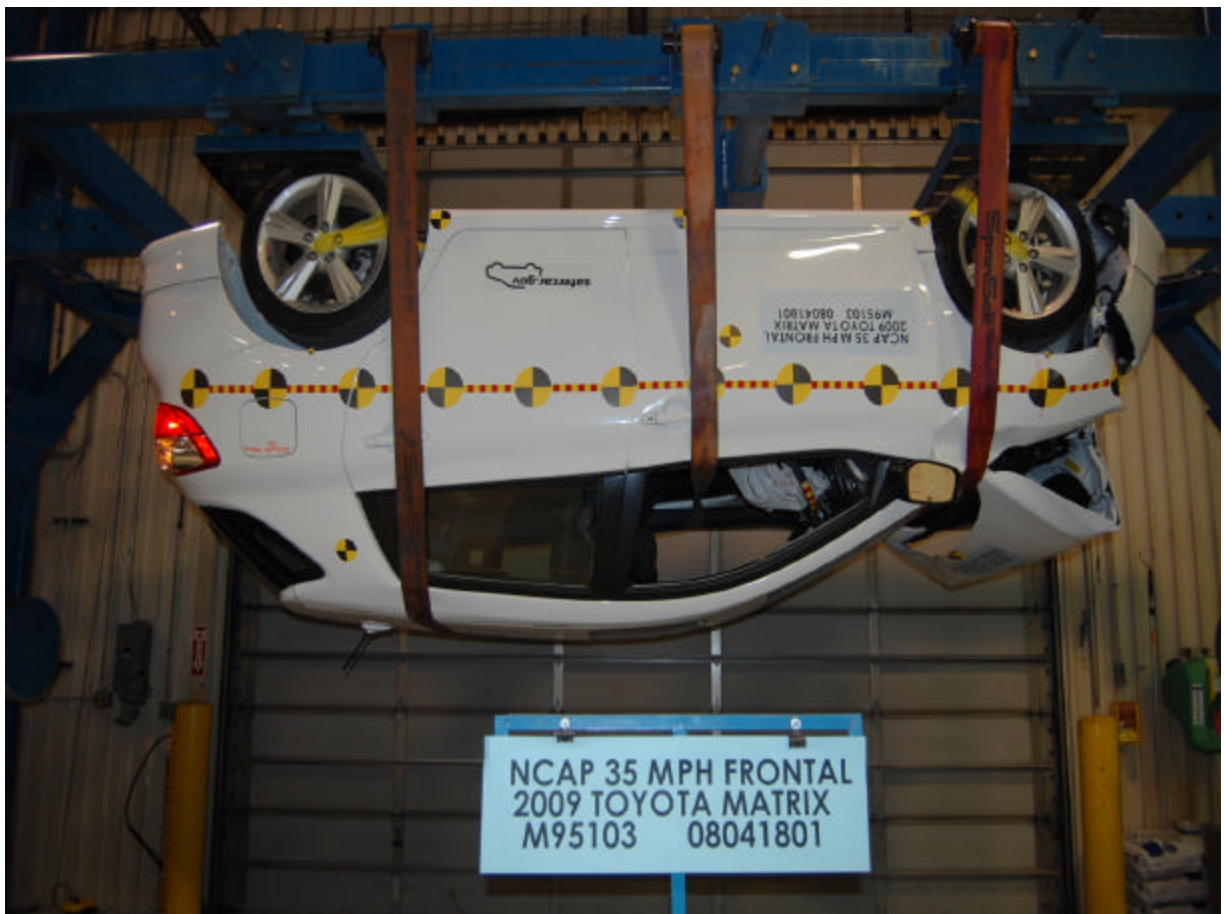
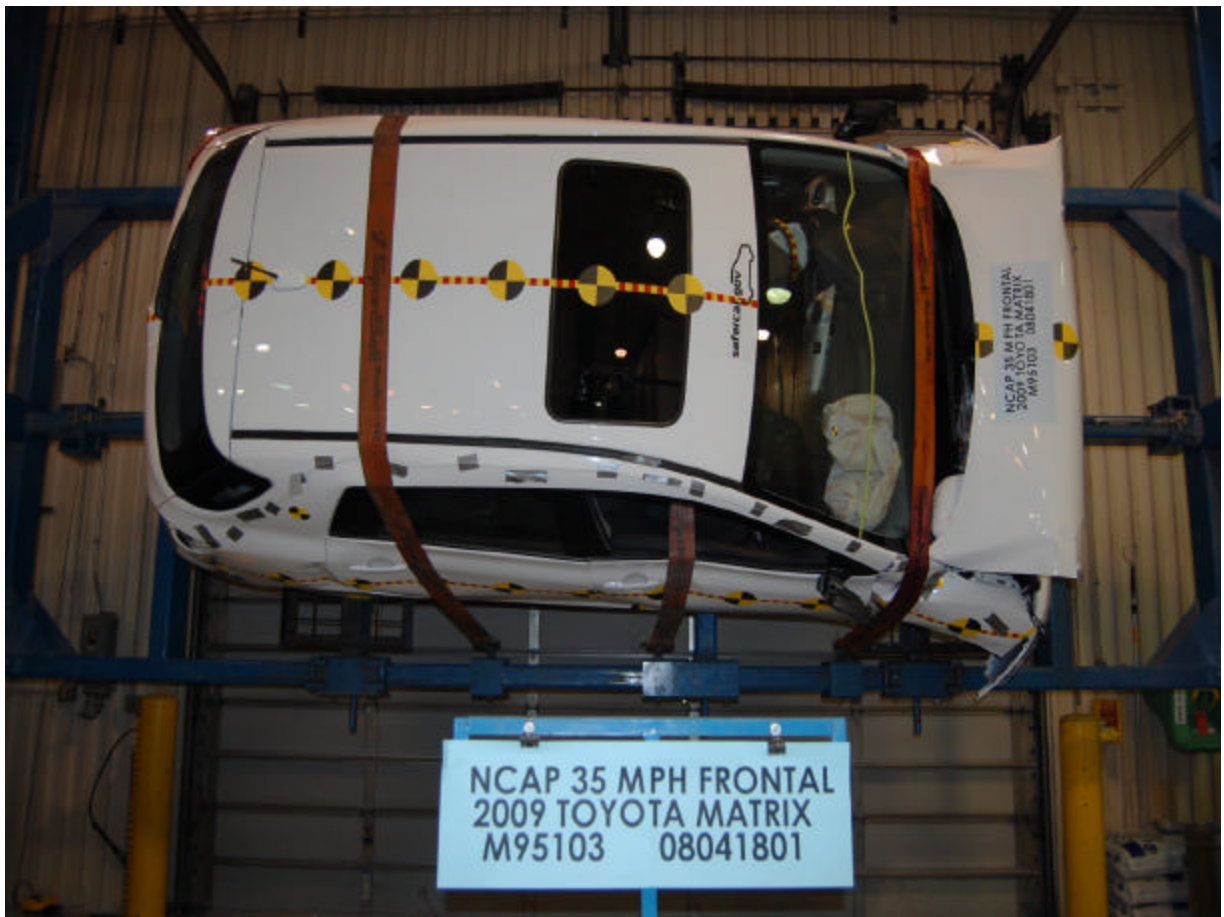
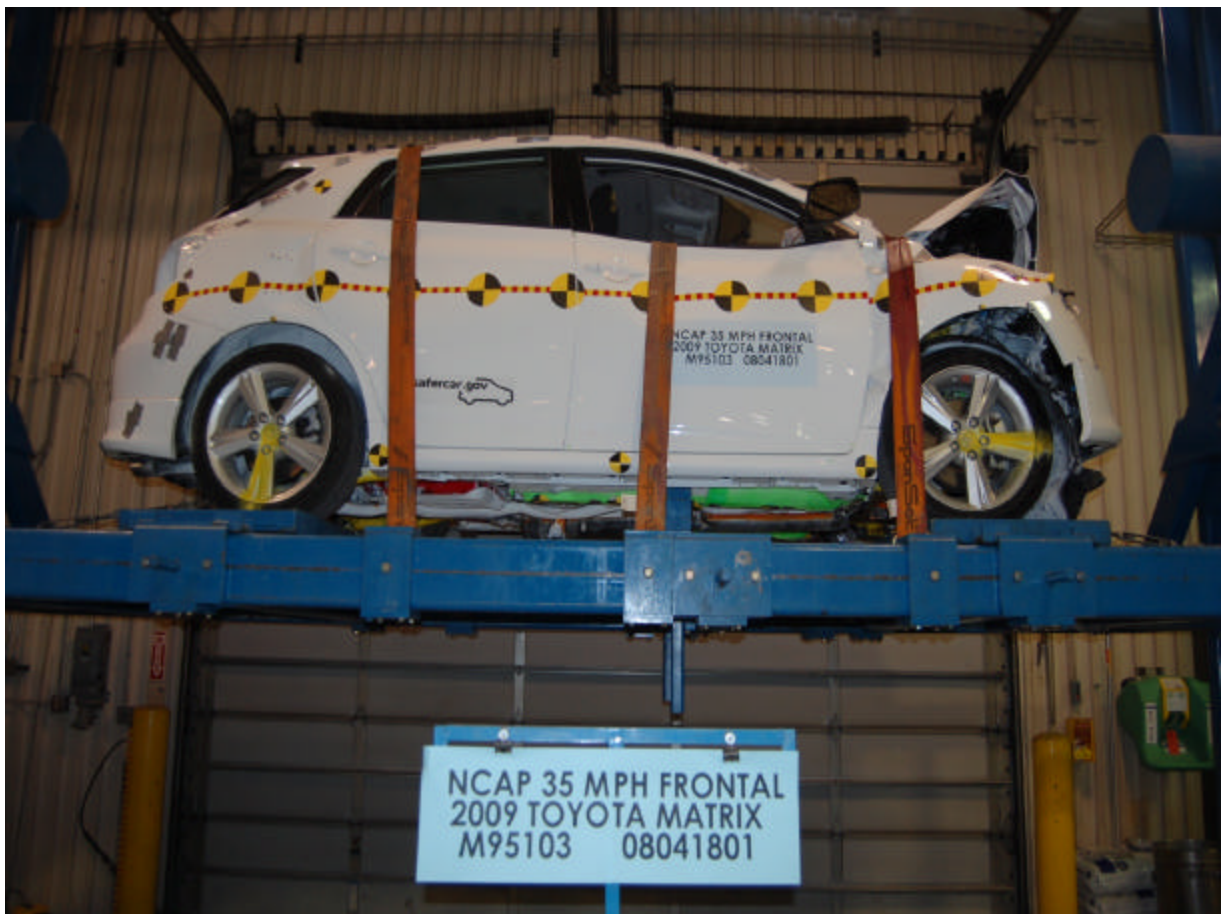
Rollover 90 Degrees

Rollover 180 Degrees

Rollover 270 Degrees

Rollover 360 Degrees

There was 100 percent windshield retention and no intrusion into the protected zone of the windshield during the event. There was no Stoddard Solvent leakage after the event or during any phase of the static rollover.
