REPORT NUMBER: ECE 66-MGA-2007-002

**ECE REGULATION 66 BASED RESEARCH
TEST OF MOTOR COACH ROOF STRENGTH**

**1991 PREVOST LEMIRAGE MOTOR COACH
NHTSA NO.: CM0801**

**PREPARED BY:
MGA RESEARCH CORPORATION
5000 WARREN ROAD
BURLINGTON, WI 53105**

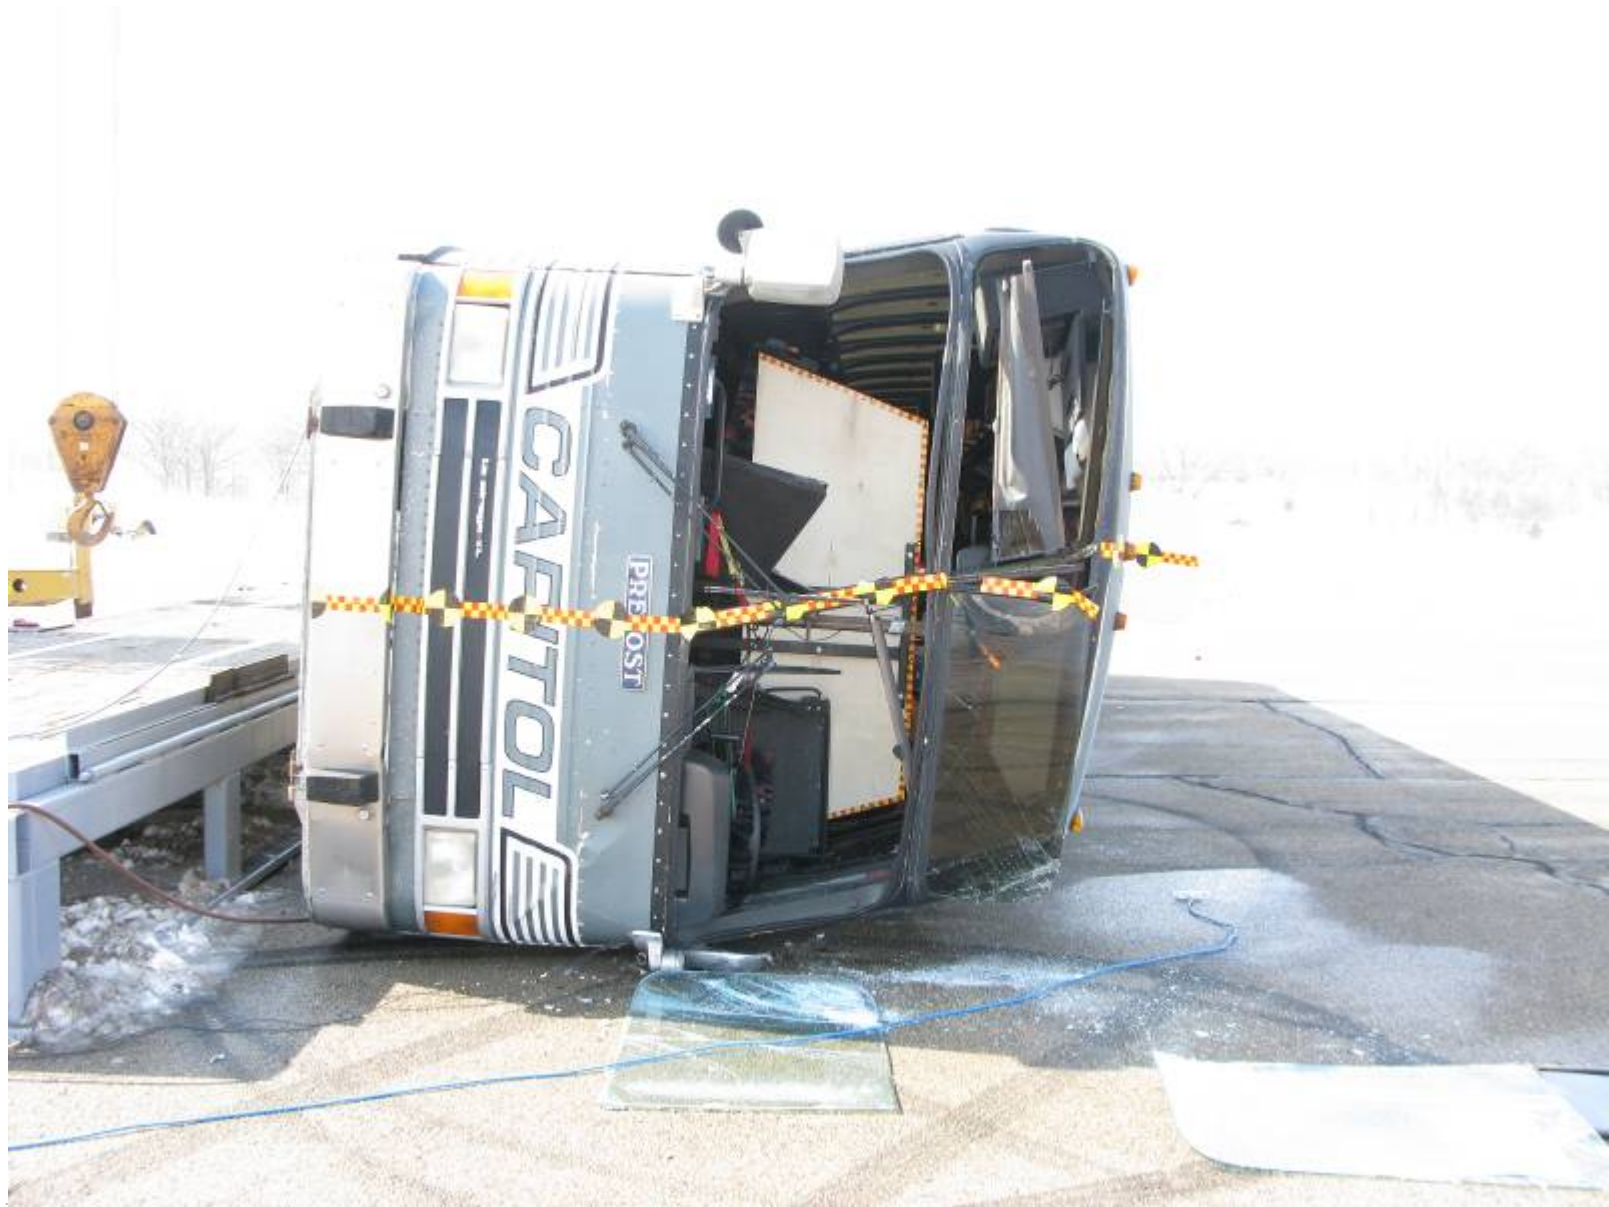
A-54.

Post-Test Front View of Bus after Roll

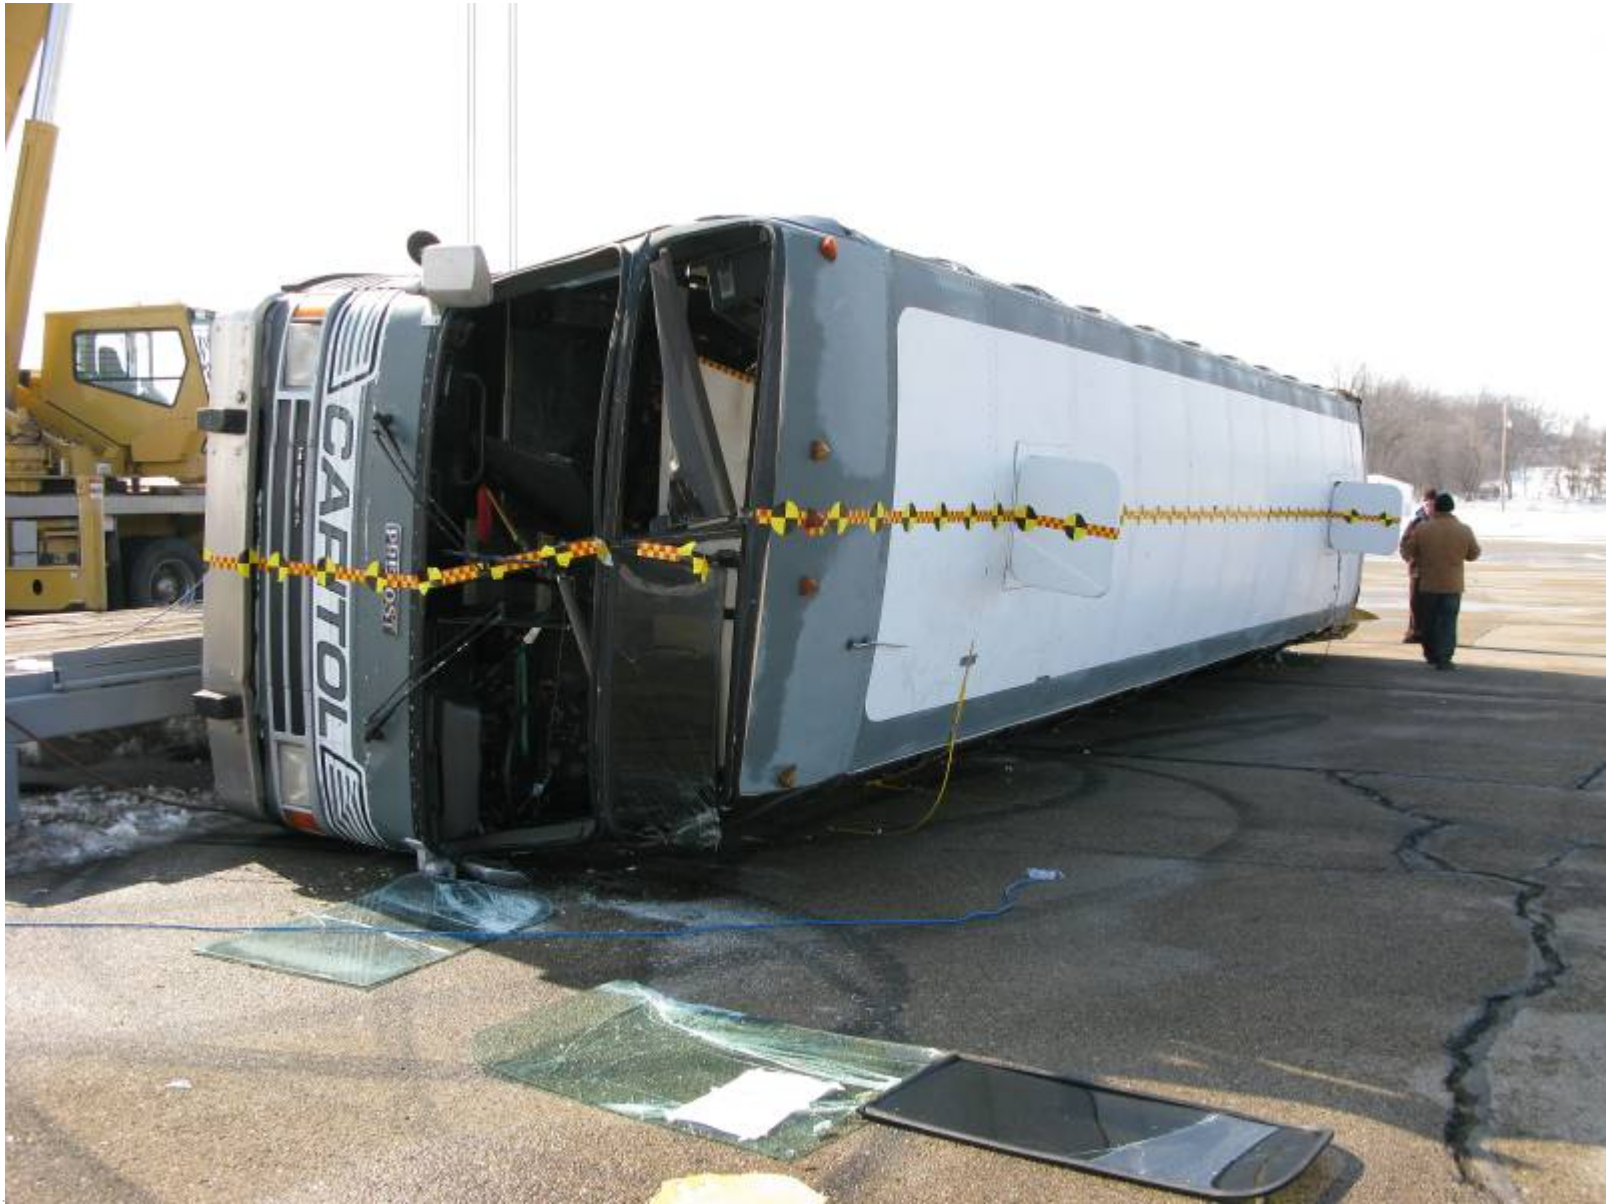
A-55.

Post-Test ¾ View of Bus Roof after Roll

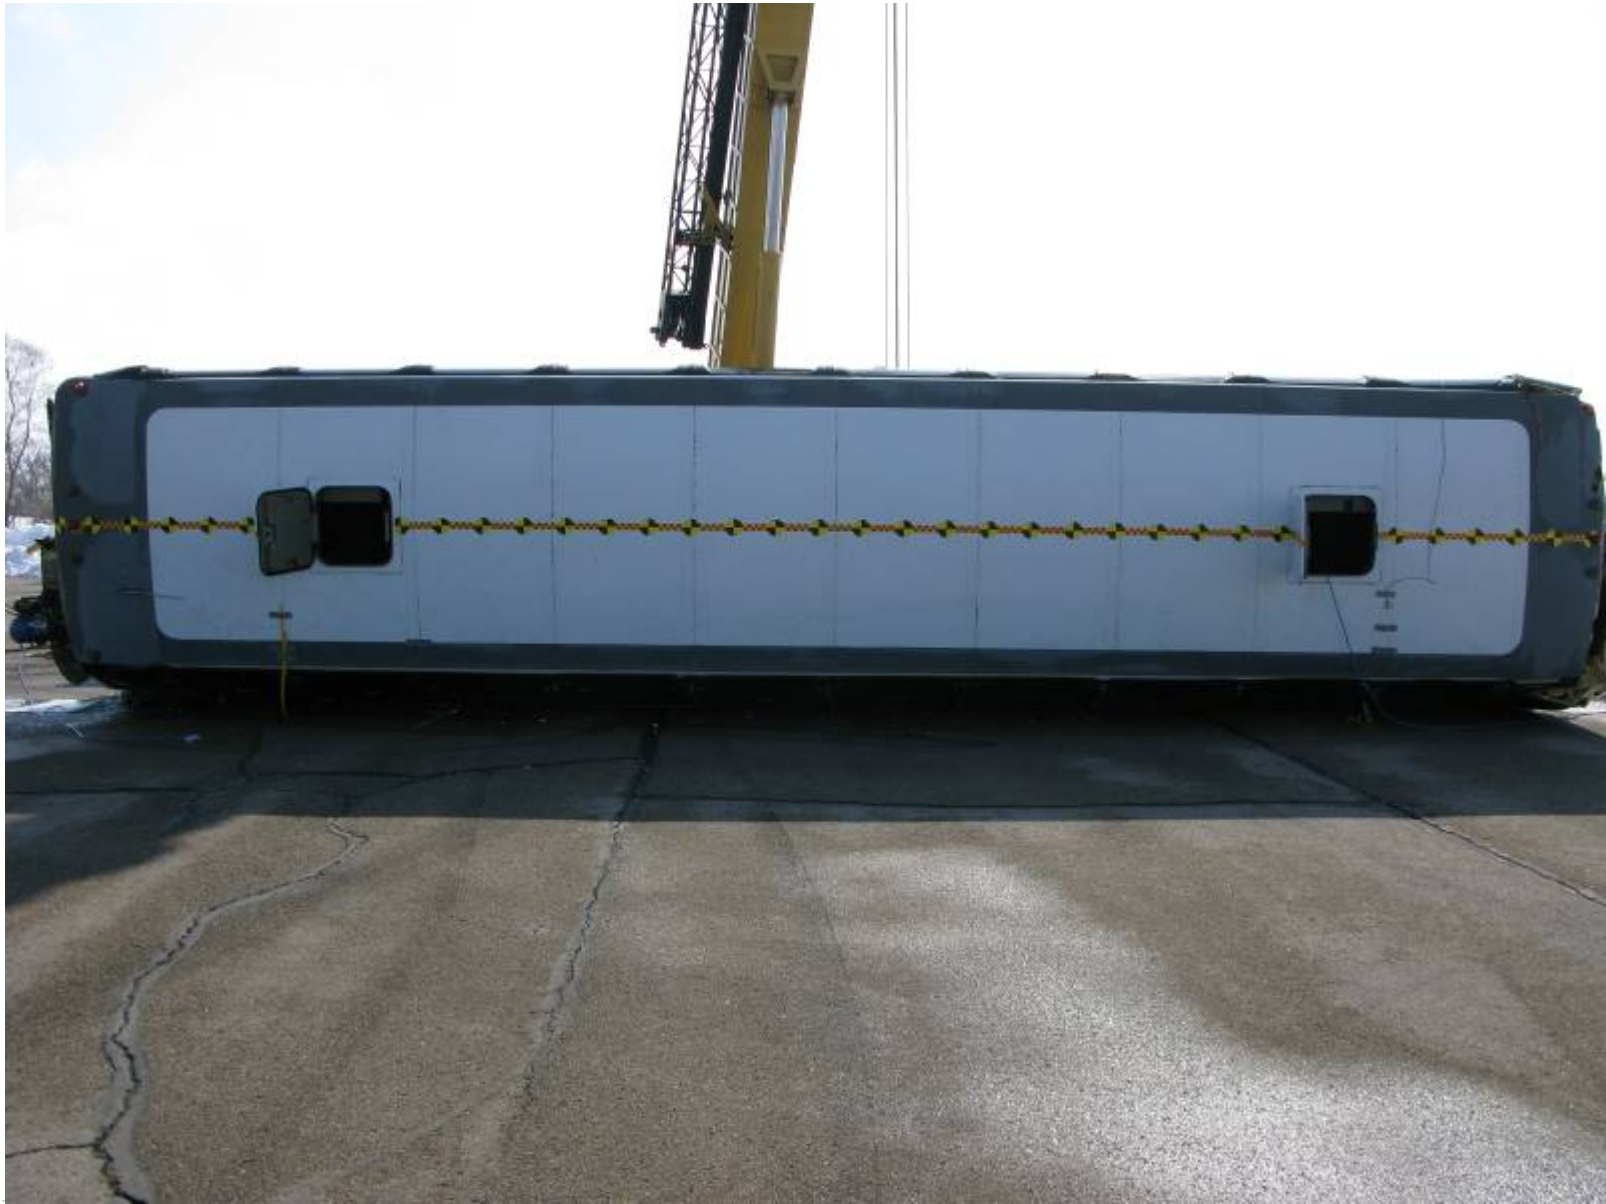
A-56.

Post-Test View of Bus Roof after Roll

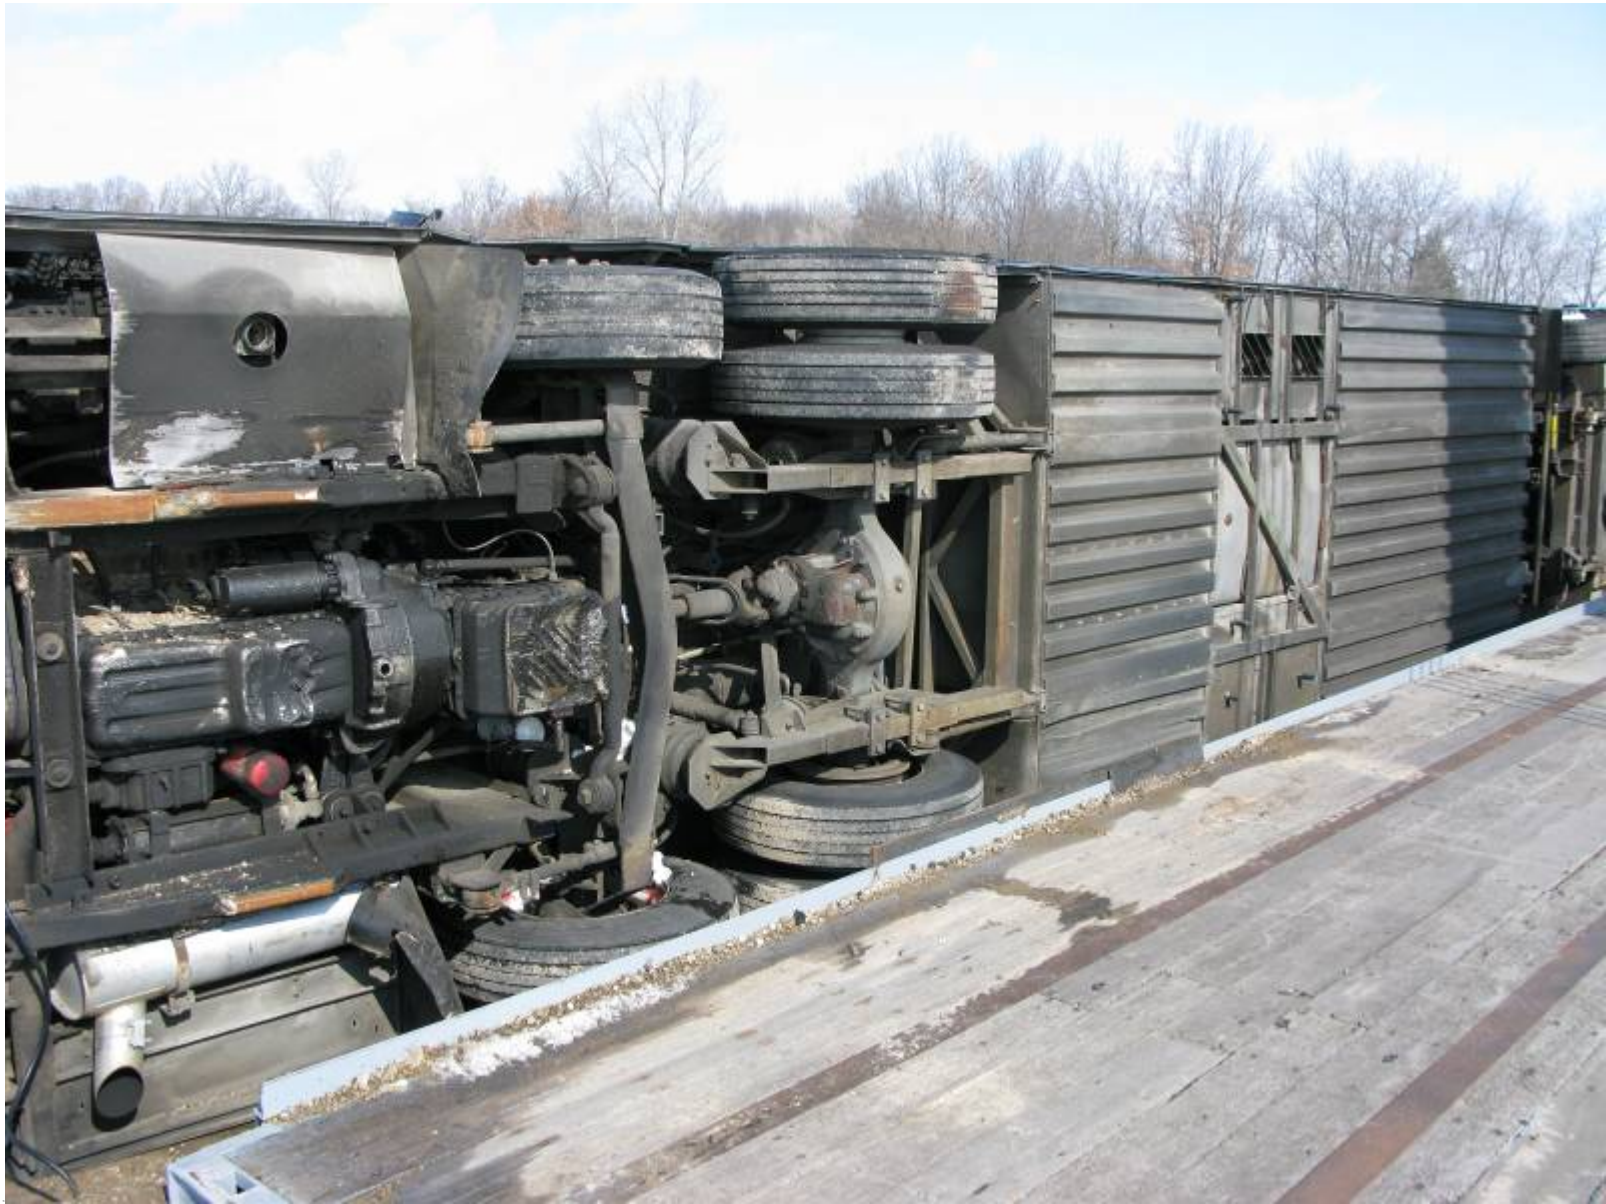
A-57.

Post-Test Rear Underbody of Bus after Roll

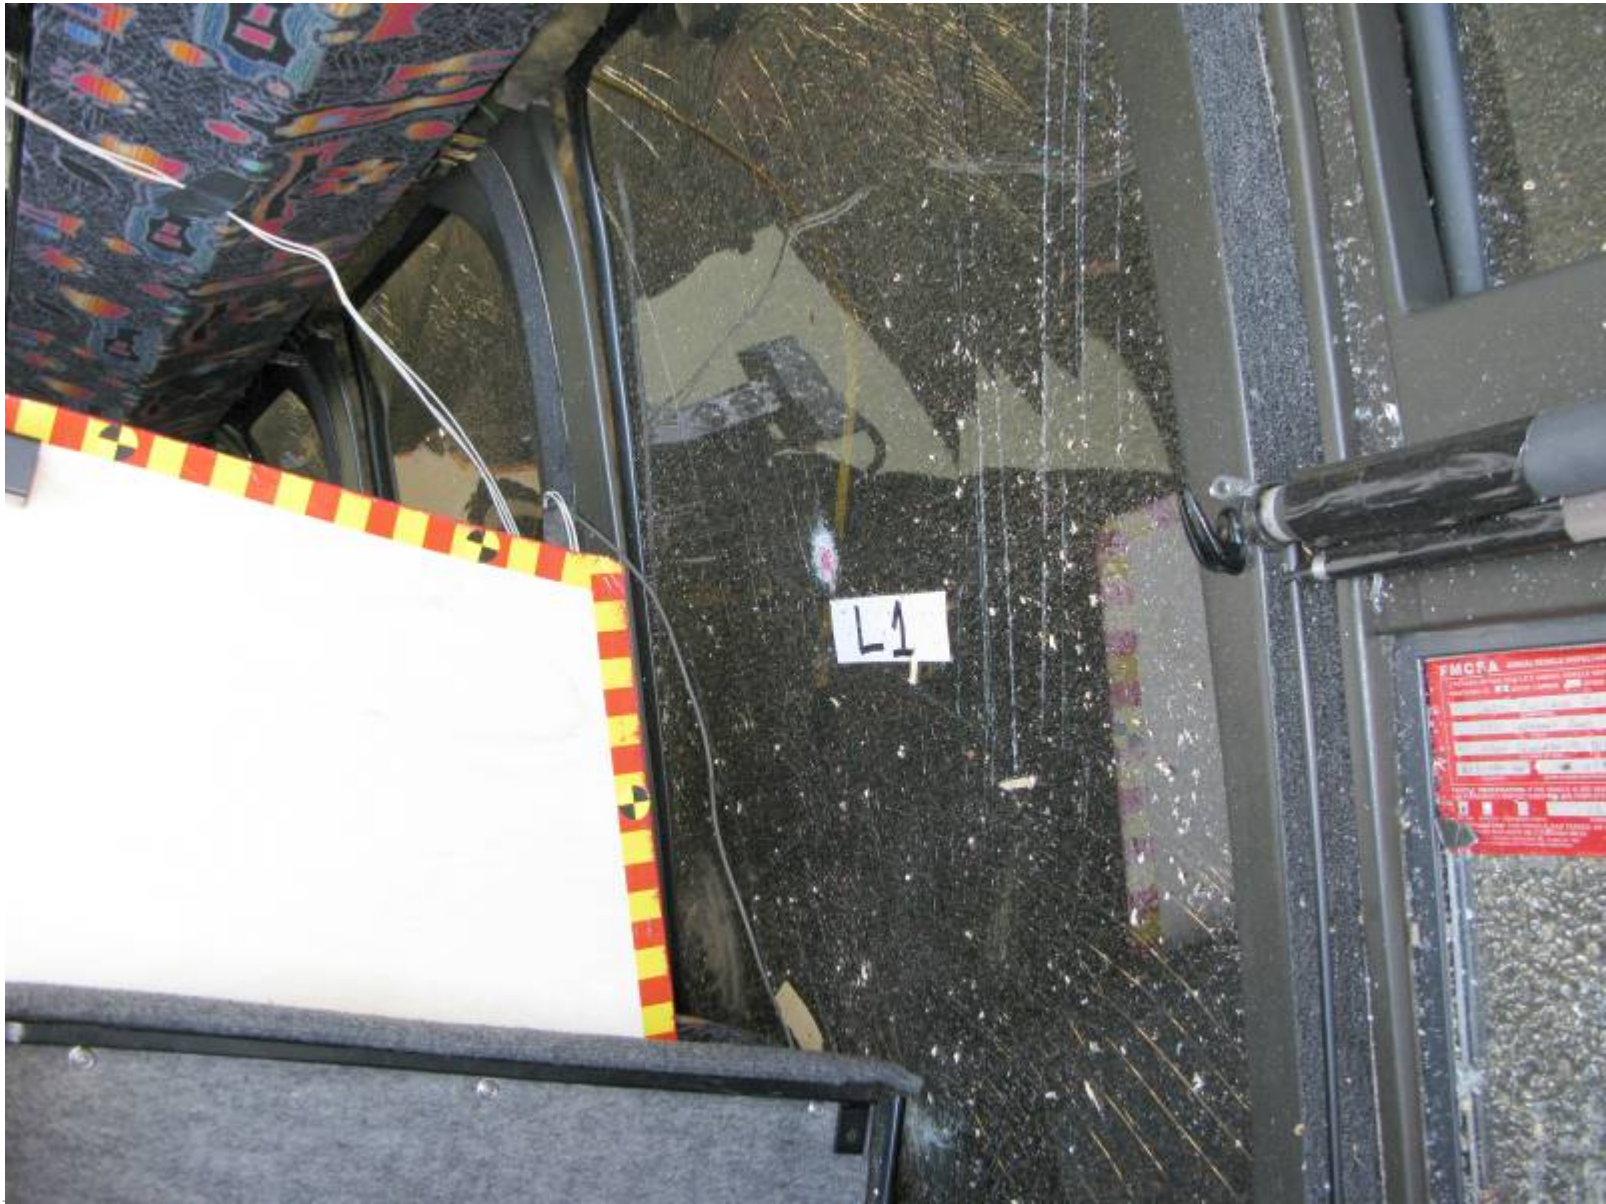
A-72.

Post-Test Window Damage (Left Window 1)

Impact Surface:	Asphalt
Impact Location:	Left side of bus.
Residual Space Template Contact:	<p>The left interior sidewall made contact with the front residual space template (T₁) leaving a transfer mark and cracks on window L1 and a transfer mark on the sidewall beneath window L1.</p> <p>There was no evidence of the interior contacting either the middle (T₂) or rear (T₃) residual space templates.</p>
Unrestrained ATD Contact: (in order of occurrence)	<p style="text-align: center;">Left side of the pelvis to the inboard arm rest.</p> <p style="text-align: center;">Top of the head to the left window.</p> <p style="text-align: center;">Back to the bottom of the left luggage rack.</p>
Restrained ATD Contact: (in order of occurrence)	<p style="text-align: center;">Knees to the left passenger seat.</p> <p style="text-align: center;">Top of head to the left sidewall.</p>
Additional Post-Test Observations:	<p>The arm rest at the unrestrained ATD location rotated up into to its stowed position. (The armrest was not designed to lock in position.)</p> <p>The restrained ATD's seat detached from its mounts and rolled into the left side of the bus. The seat to wall mounts detached first, followed by the floor mounts.</p> <p>The front windshields (left and right) lost retention during the impact.</p> <p style="text-align: center;">The roof emergency exits opened during the impact.</p> <p style="text-align: center;">Several emergency exits windows unlatched during the impact.</p> <p>Most of the seats on the right side of the bus detached from their wall mounts.</p>

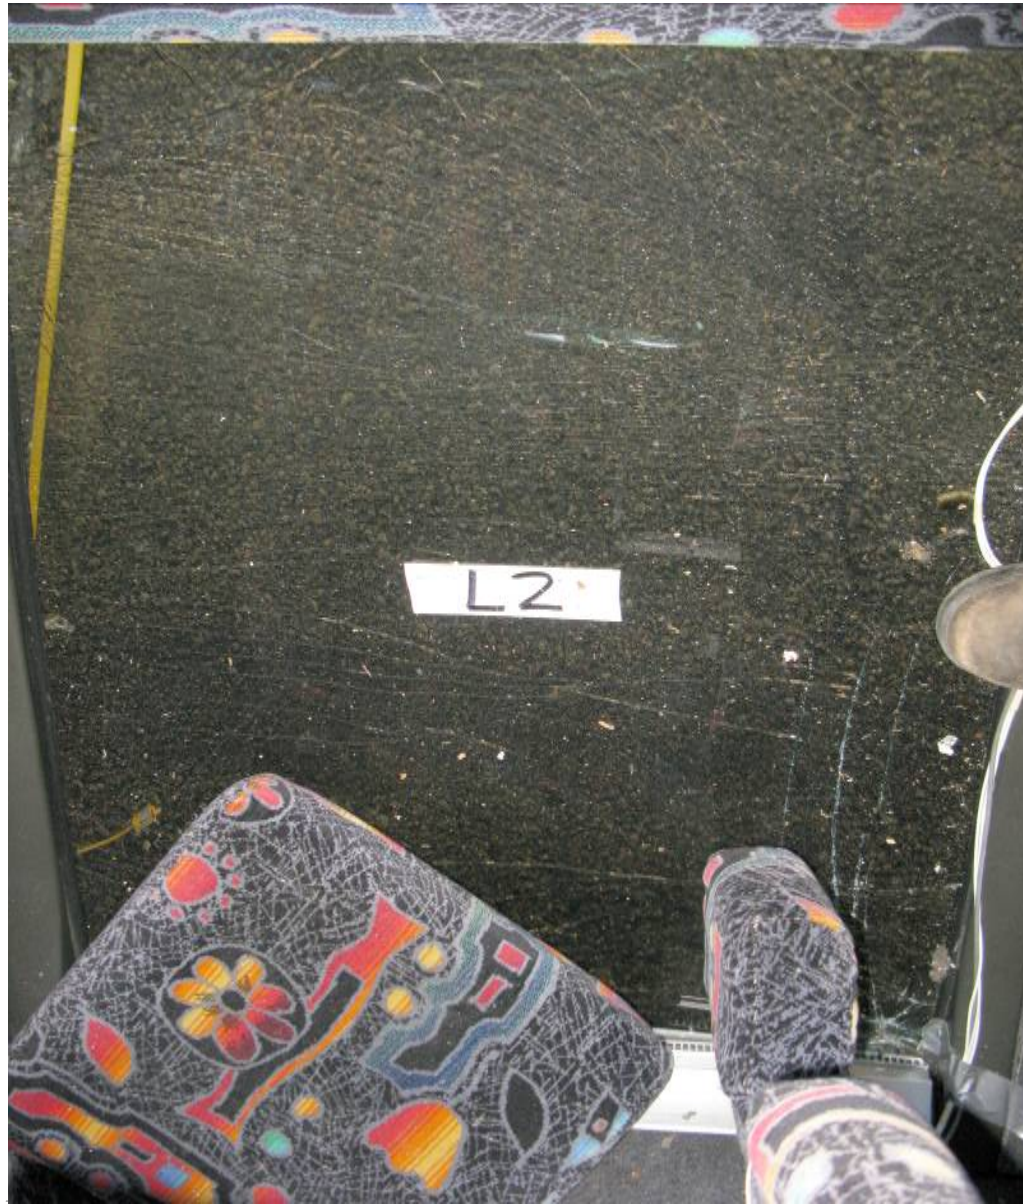
A-73.

Post-Test Window Damage (Left Window 2)

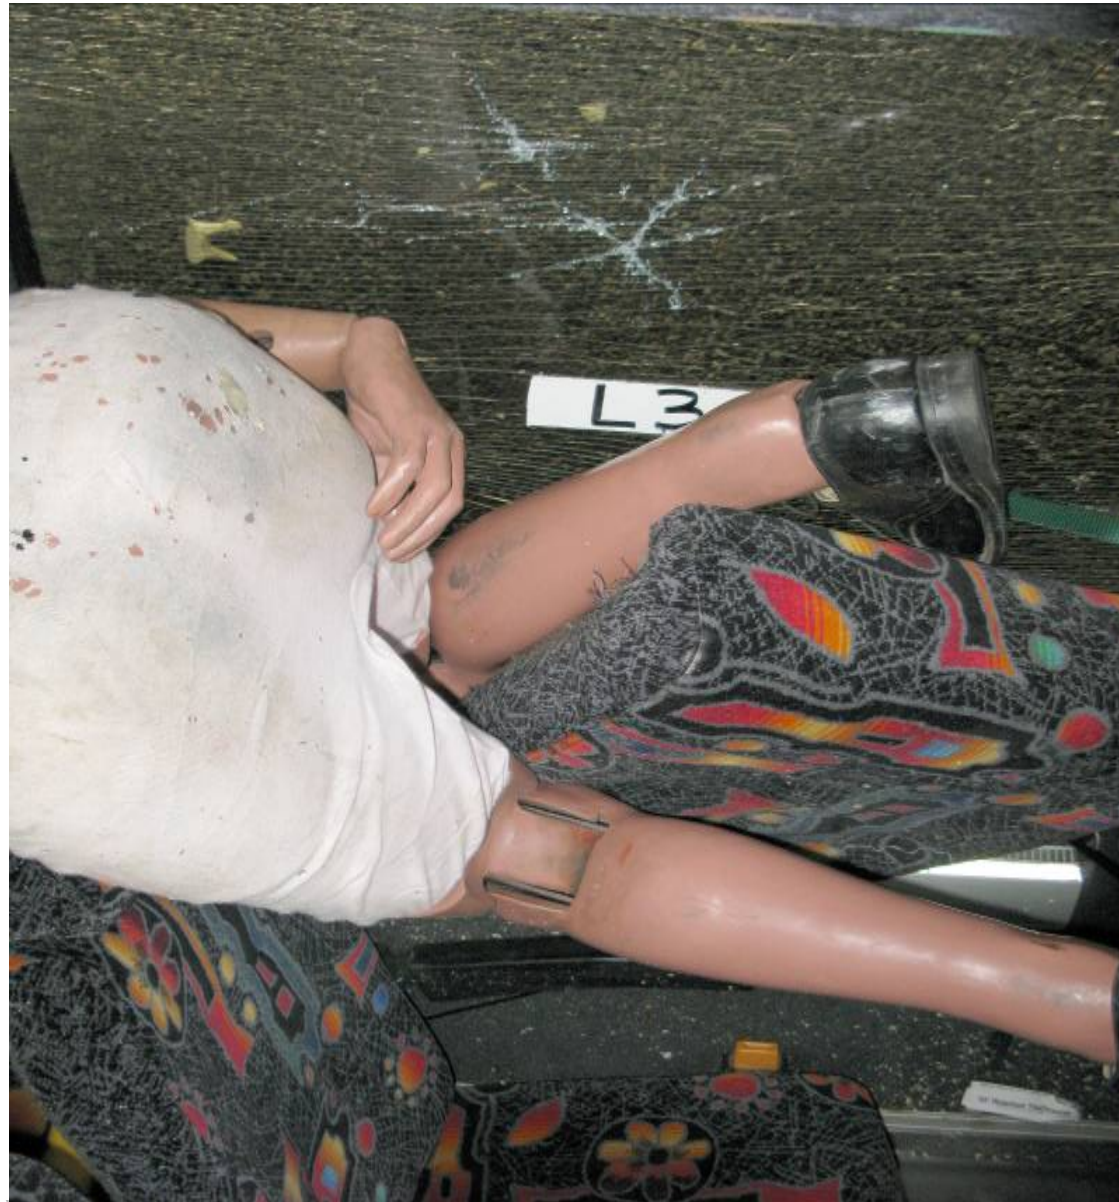
A-74.

Post-Test Window Damage (Left Window 3)

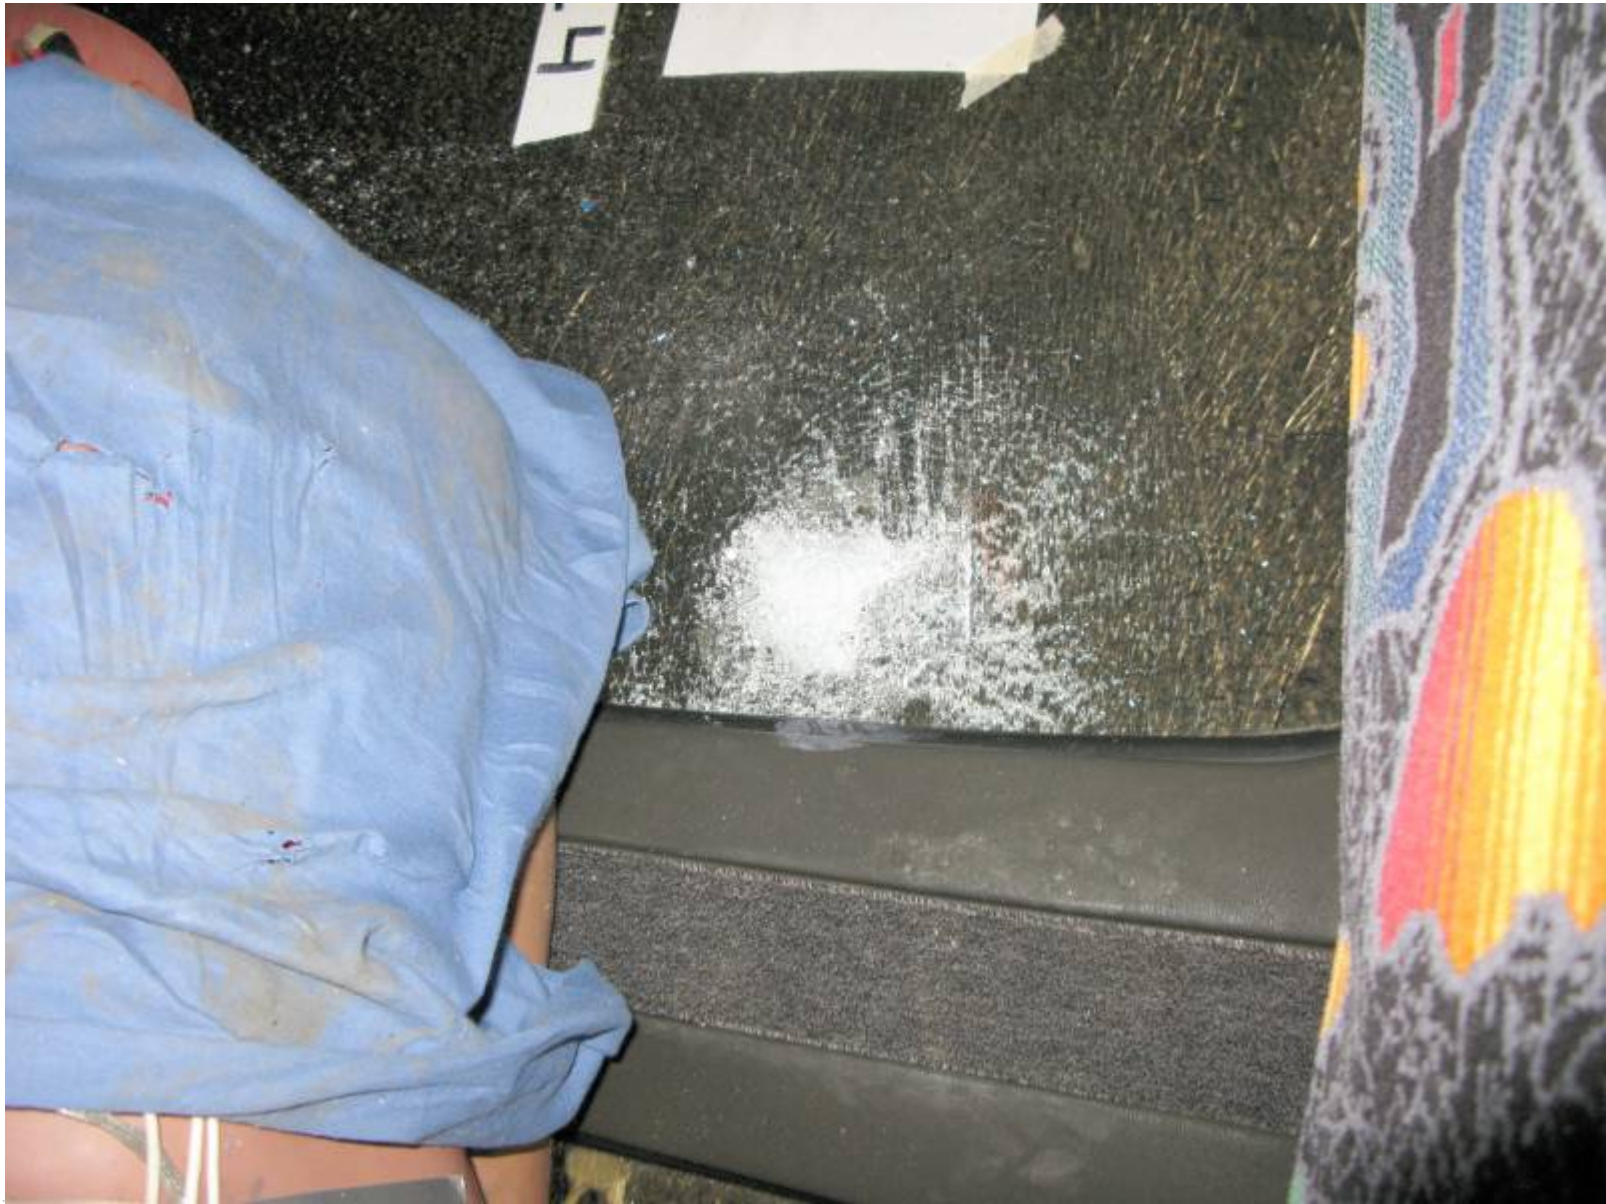
A-75.

Post-Test Window Damage (Left Window 4)

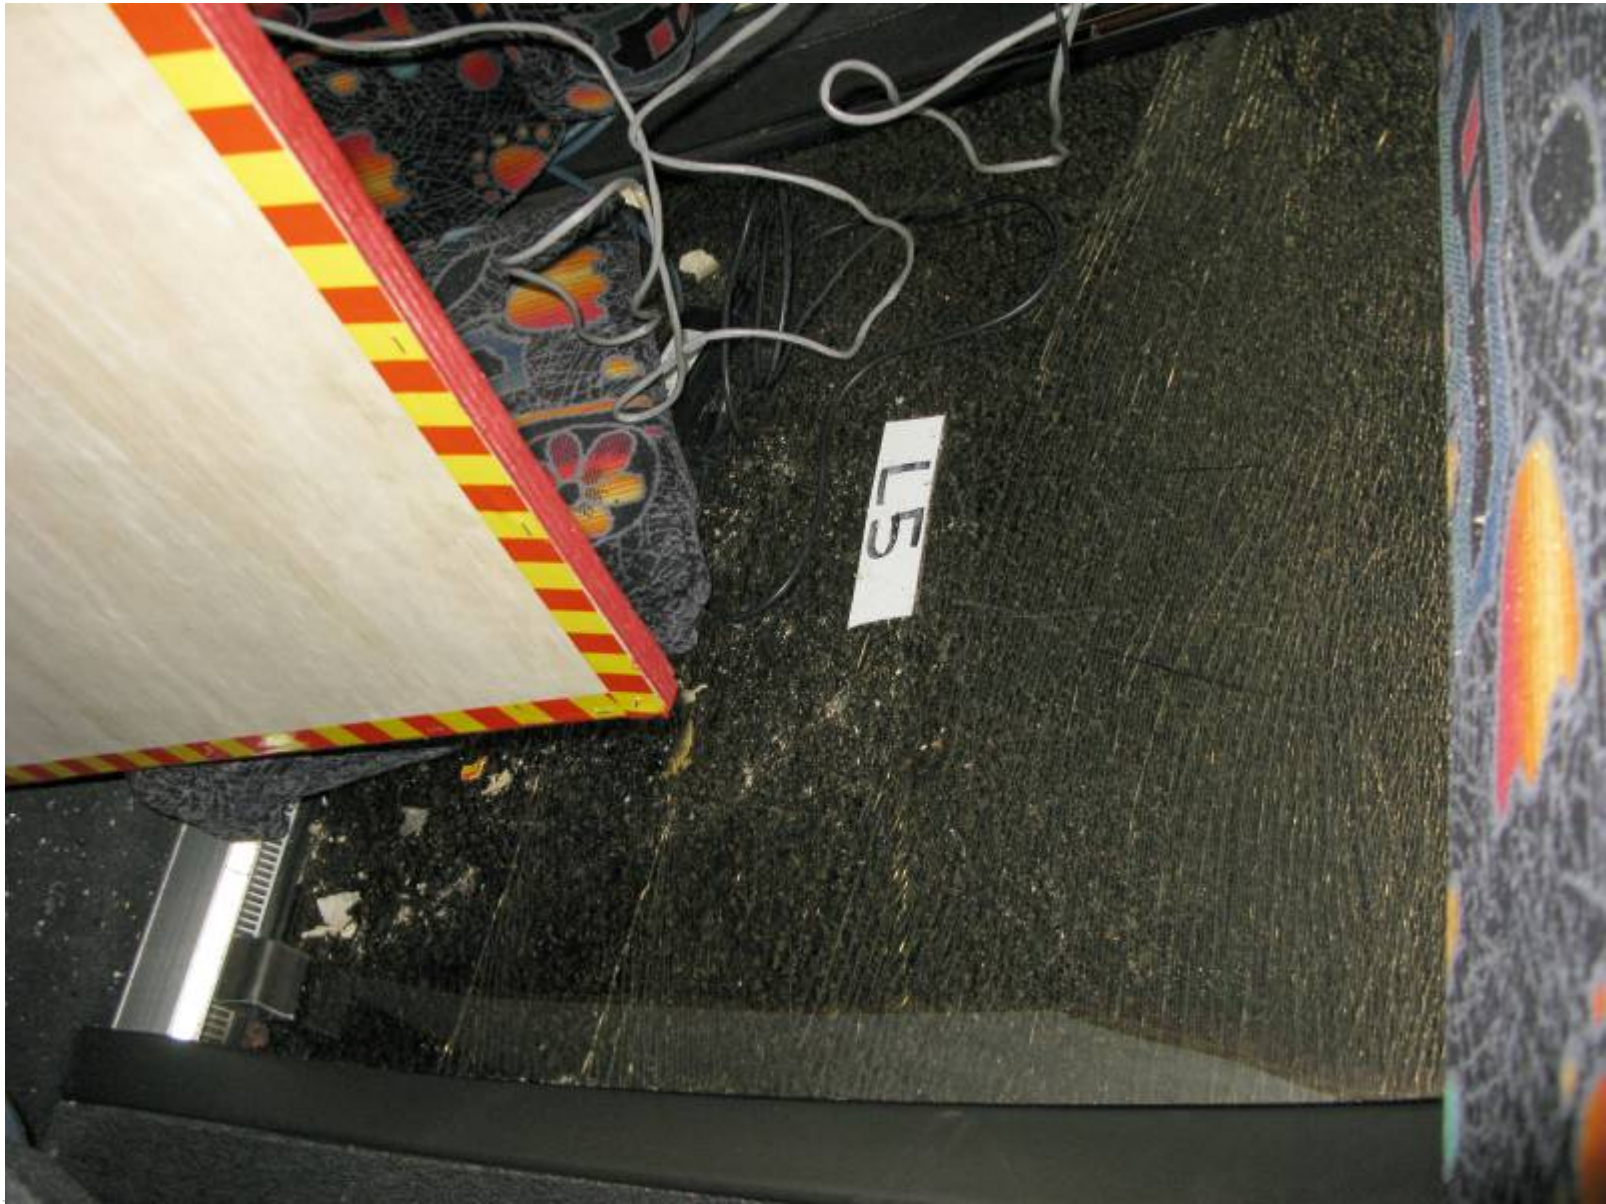
A-76.

Post-Test Window Damage (Left Window 5)

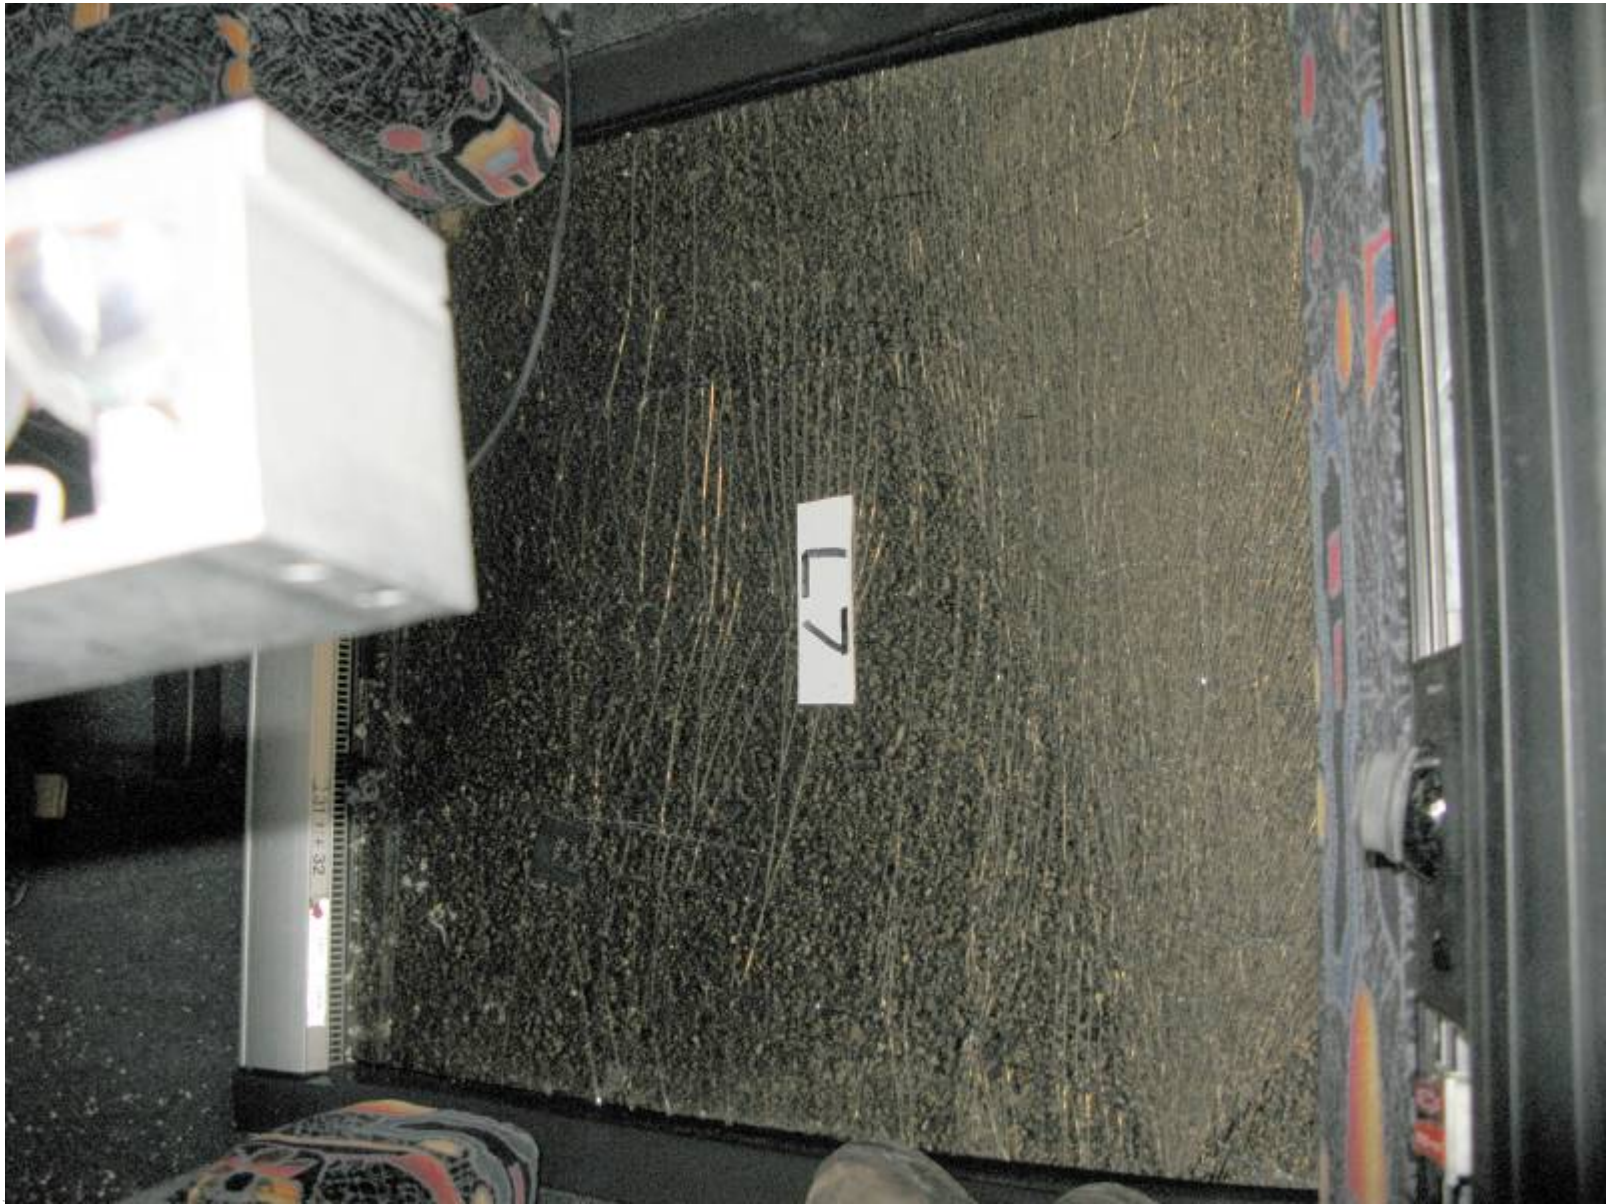
A-77.

Post-Test Window Damage (Left Window 7)

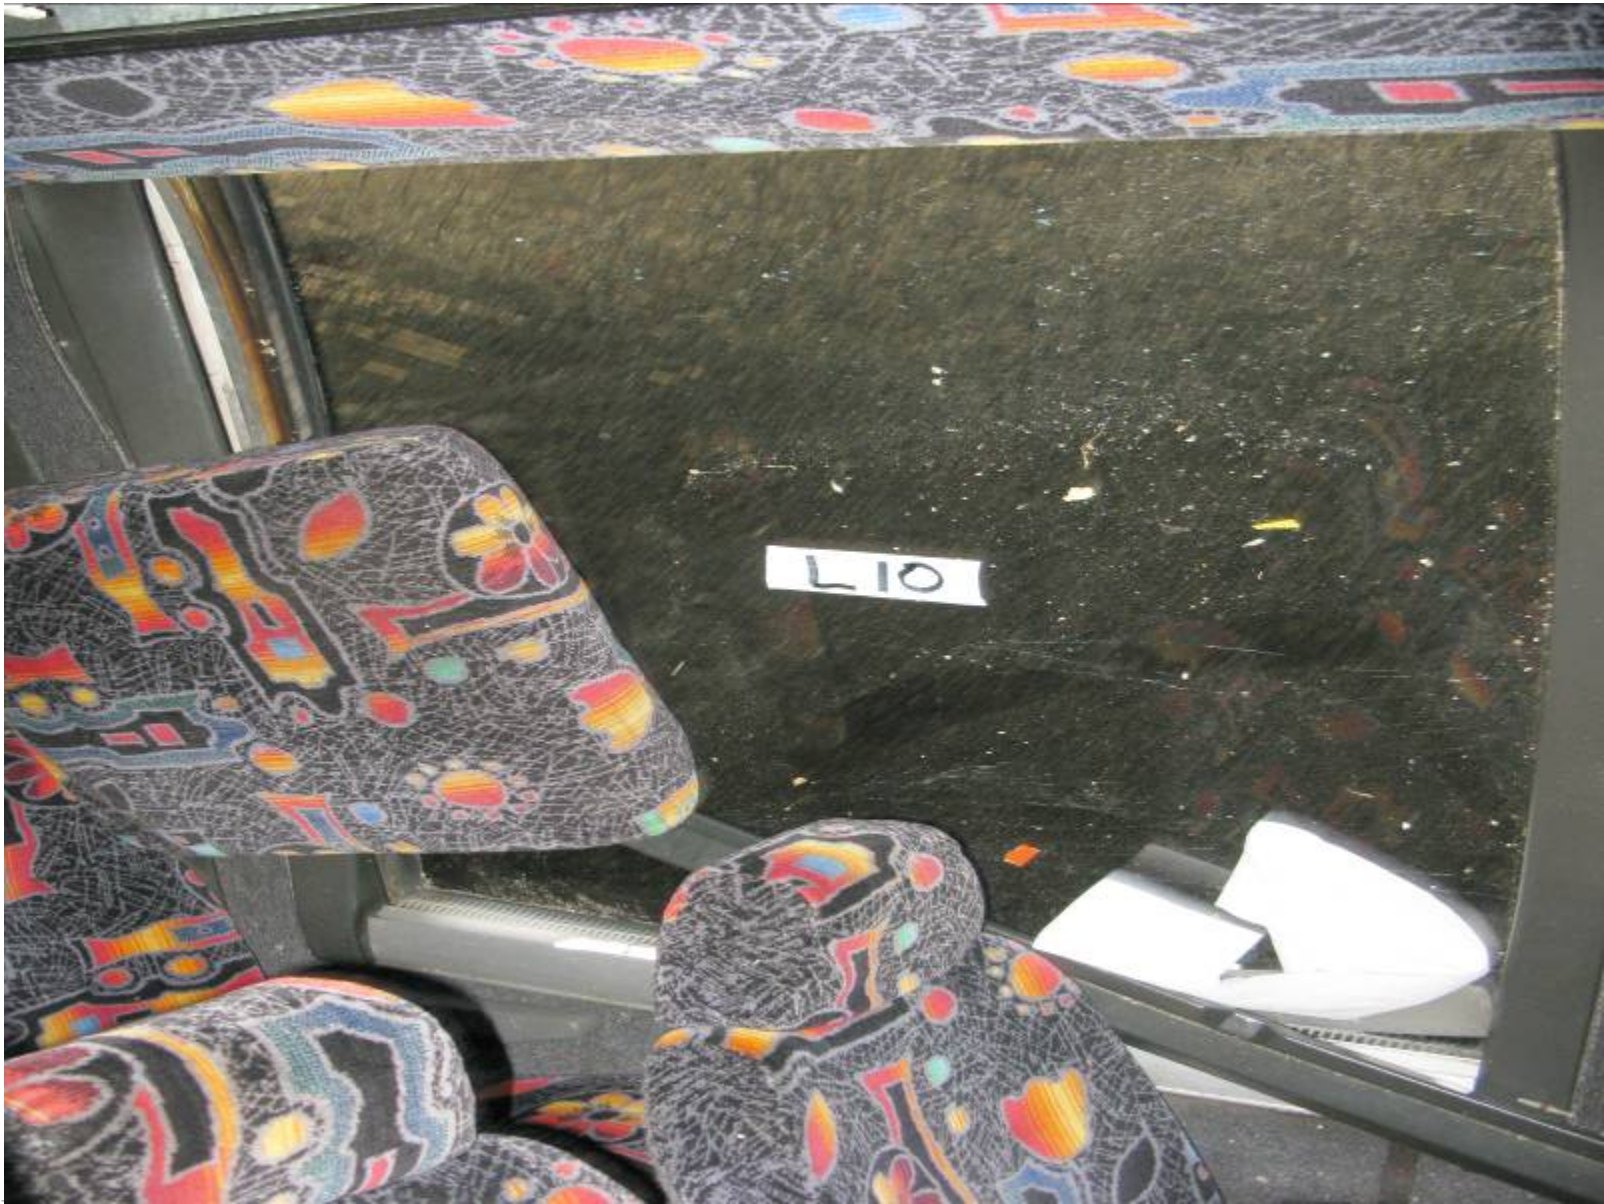
A-79.

Post-Test Window Damage (Left Window 10)

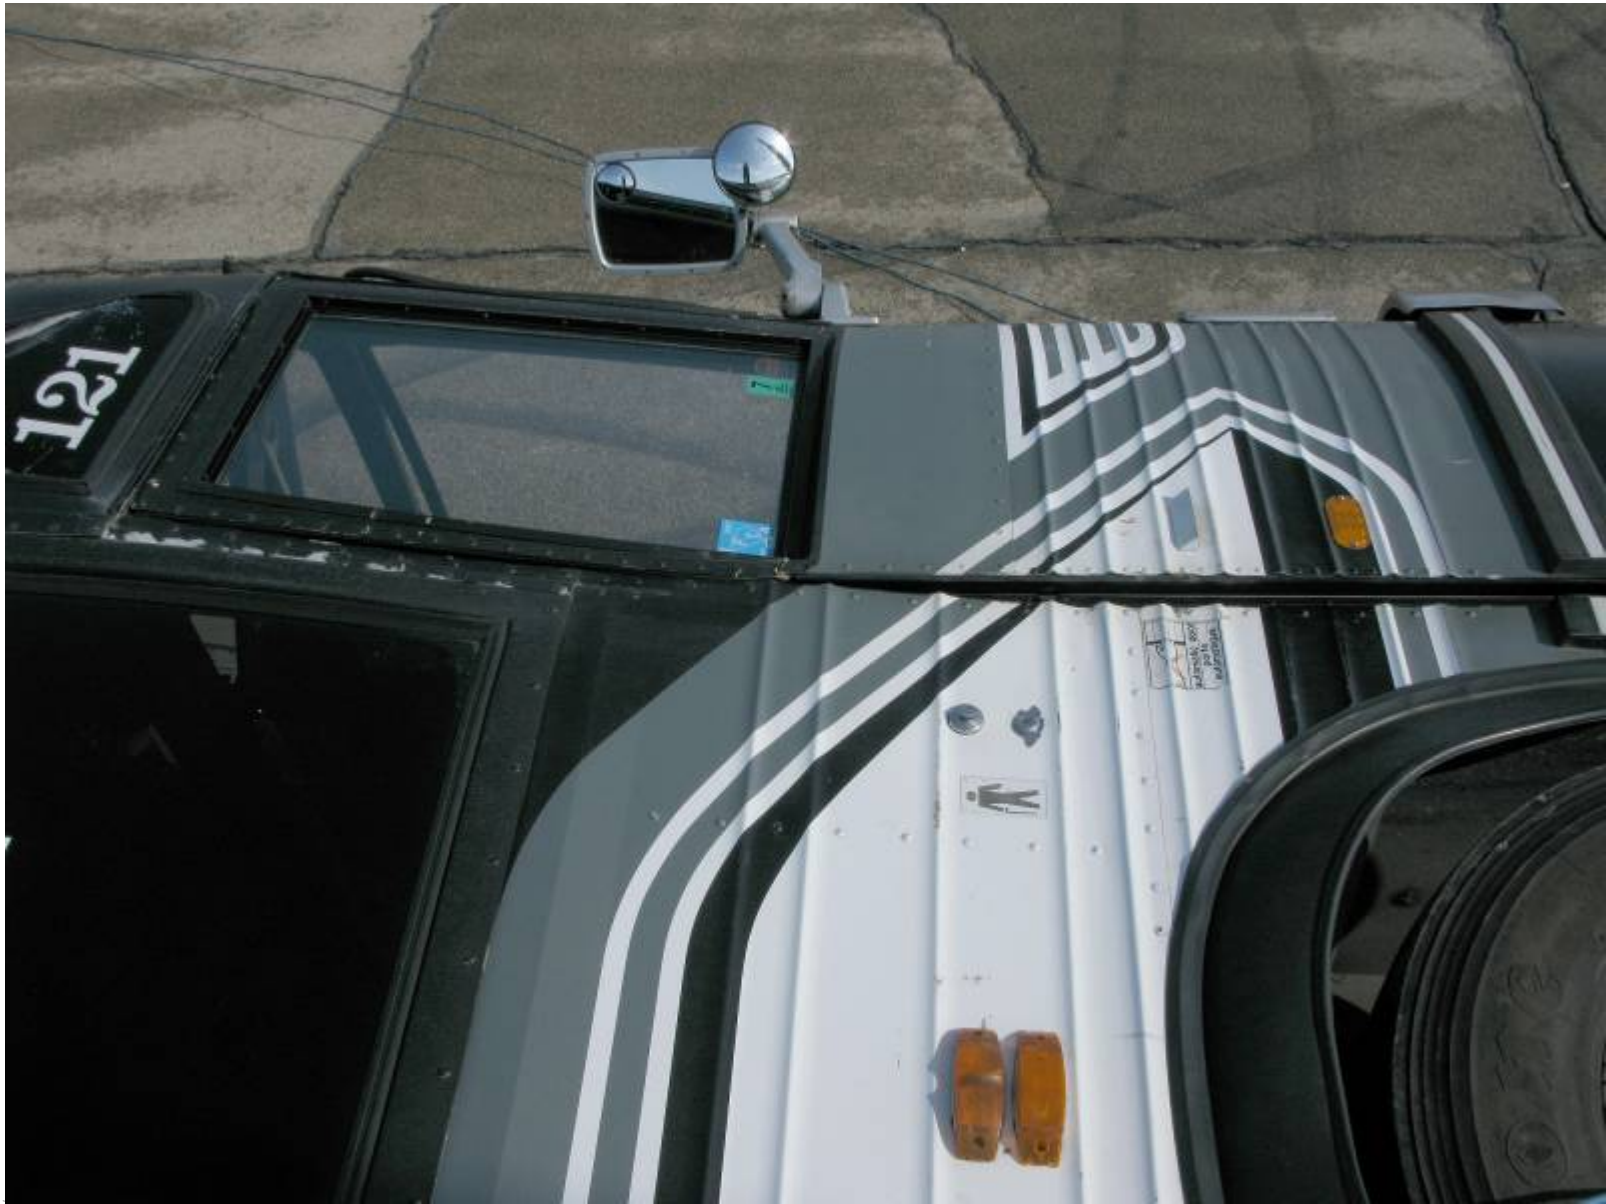
A-80.

Post-Test Exterior Damage Right Front Side of Bus View 1
