REPORT NUMBER: ECE 66-MGA-2007-002

**ECE REGULATION 66 BASED RESEARCH
TEST OF MOTOR COACH ROOF STRENGTH**

**1991 PREVOST LEMIRAGE MOTOR COACH
NHTSA NO.: CM0801**

**PREPARED BY:
MGA RESEARCH CORPORATION
5000 WARREN ROAD
BURLINGTON, WI 53105**

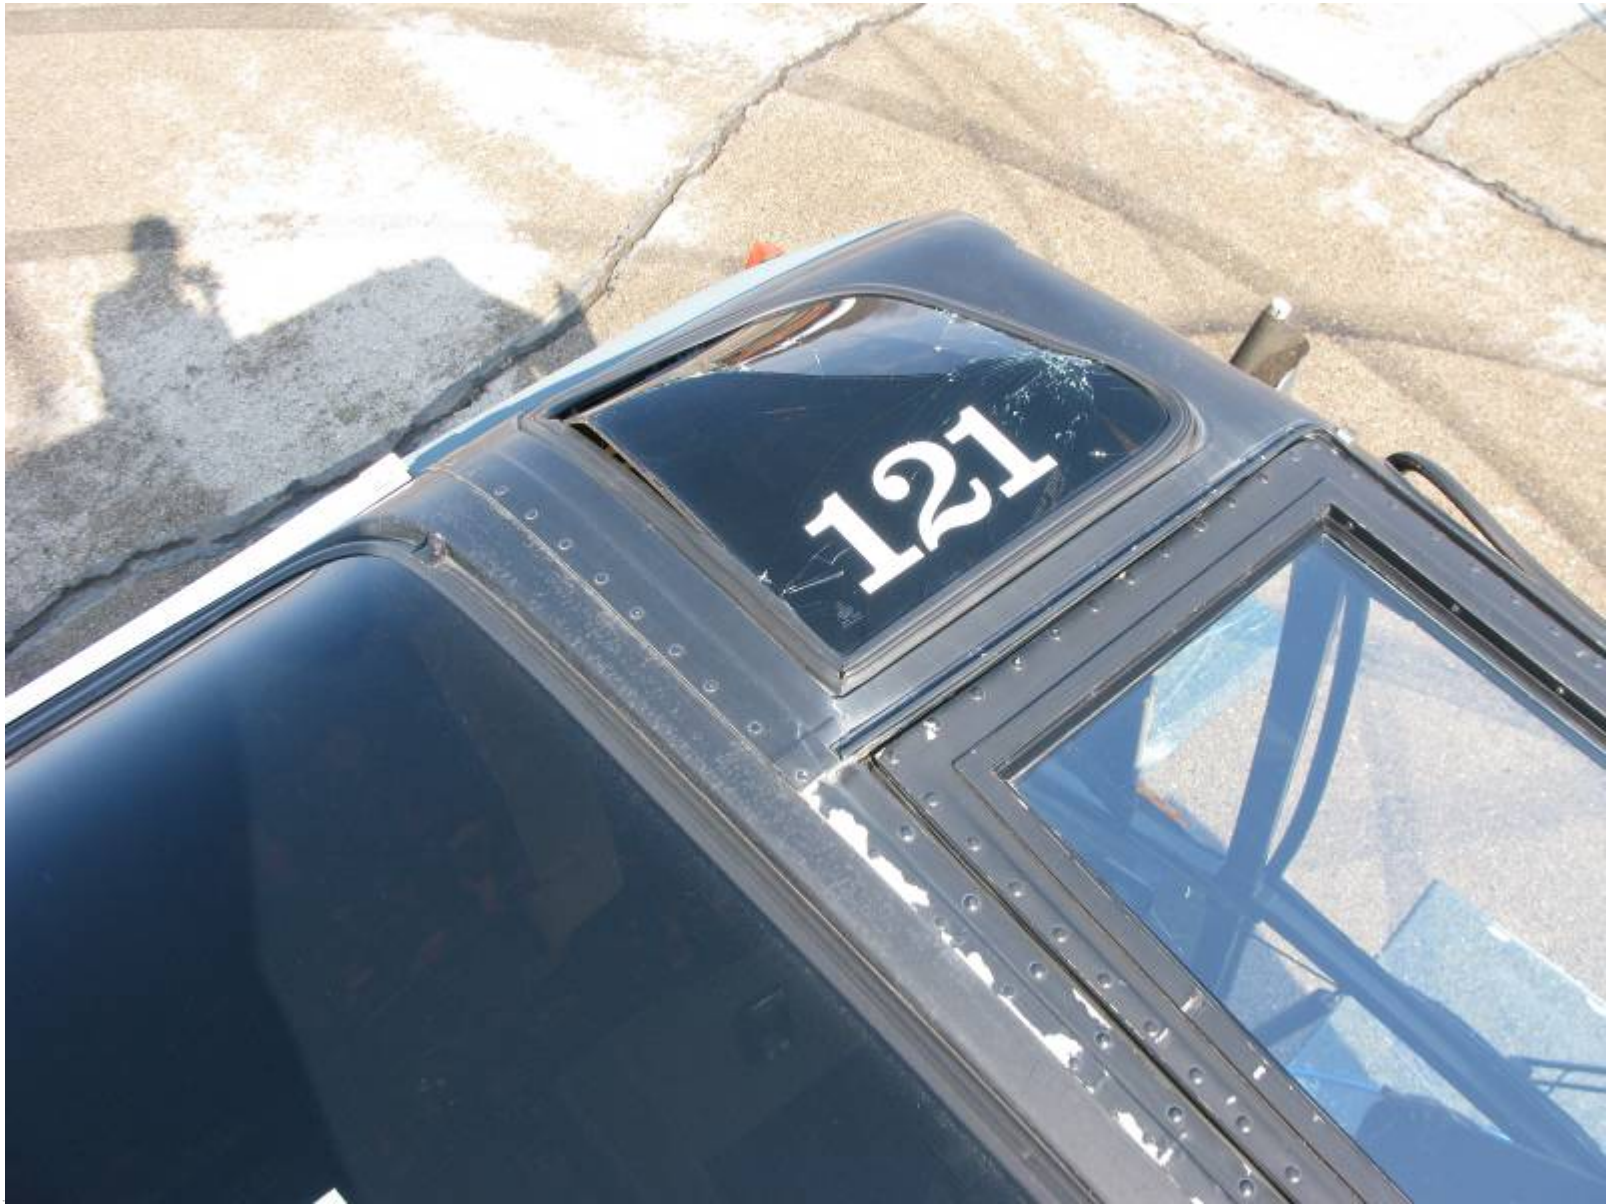
A-81.

Post-Test Exterior Damage Right Front Side of Bus View 2

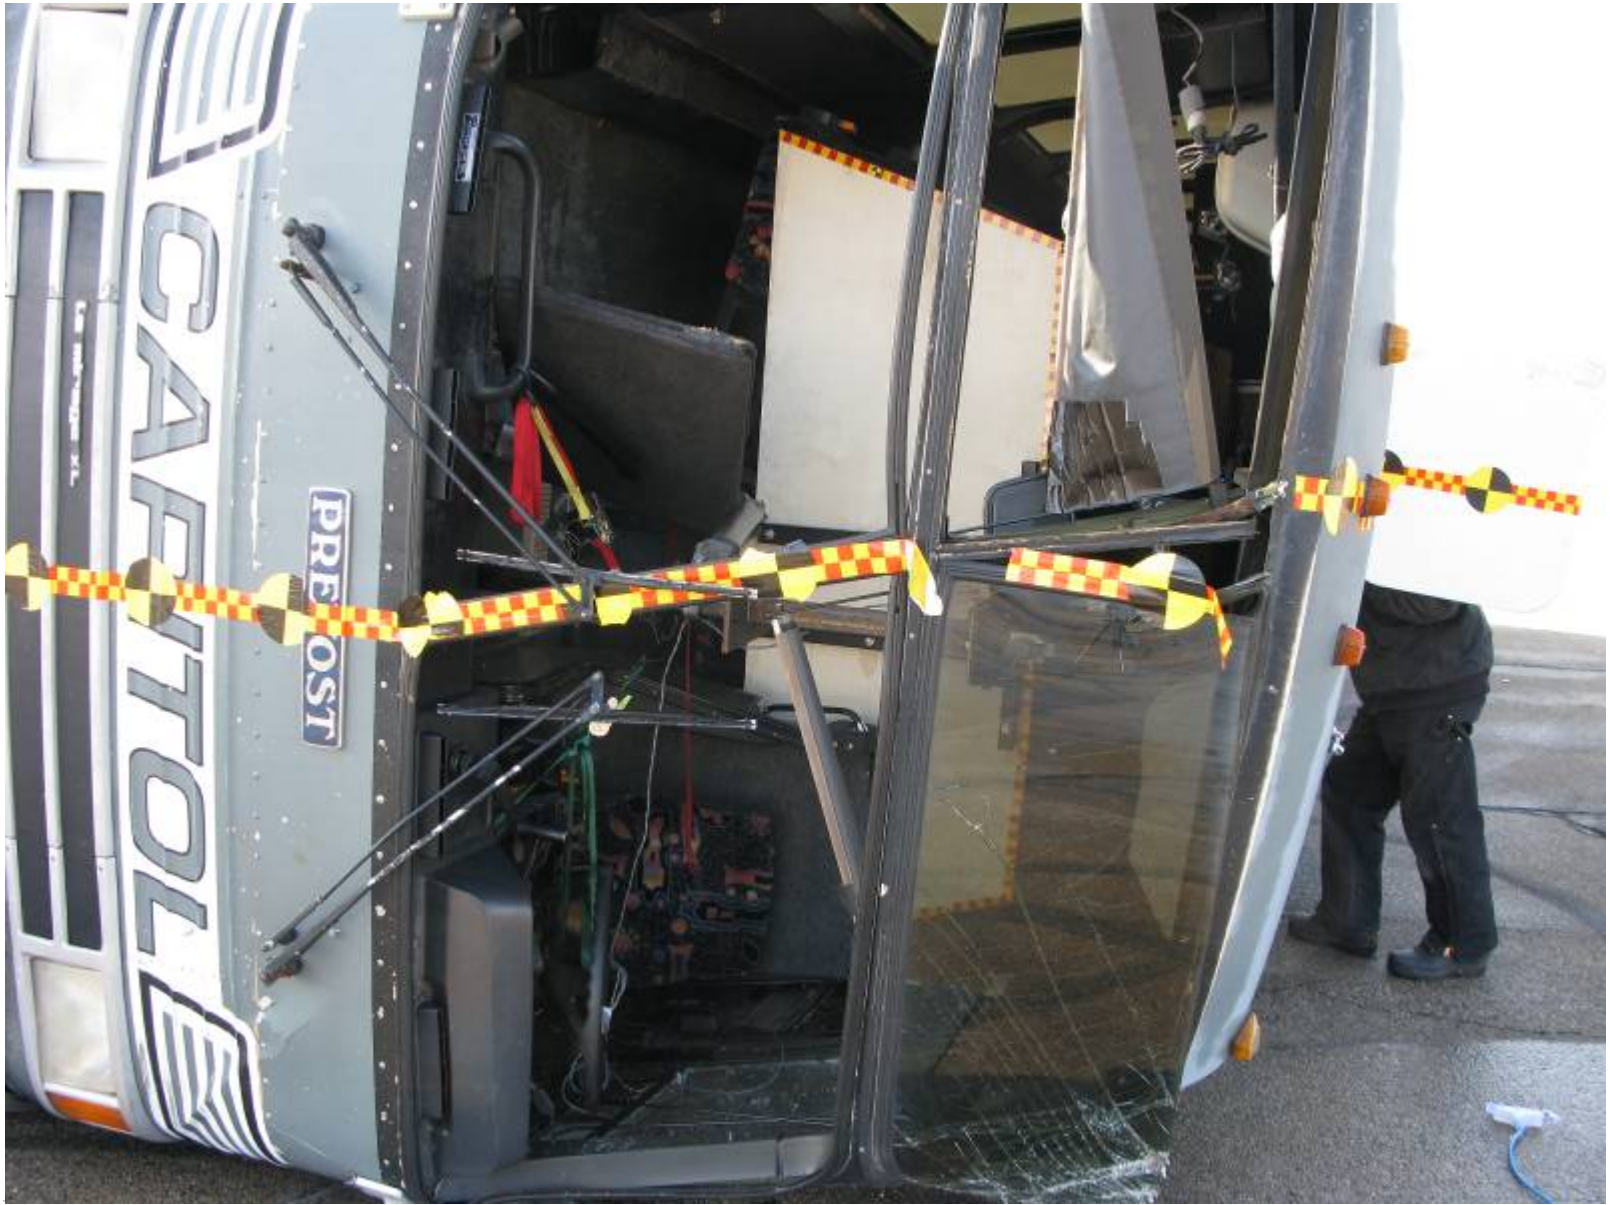
A-82.

Post-Test Exterior Damage Windshield

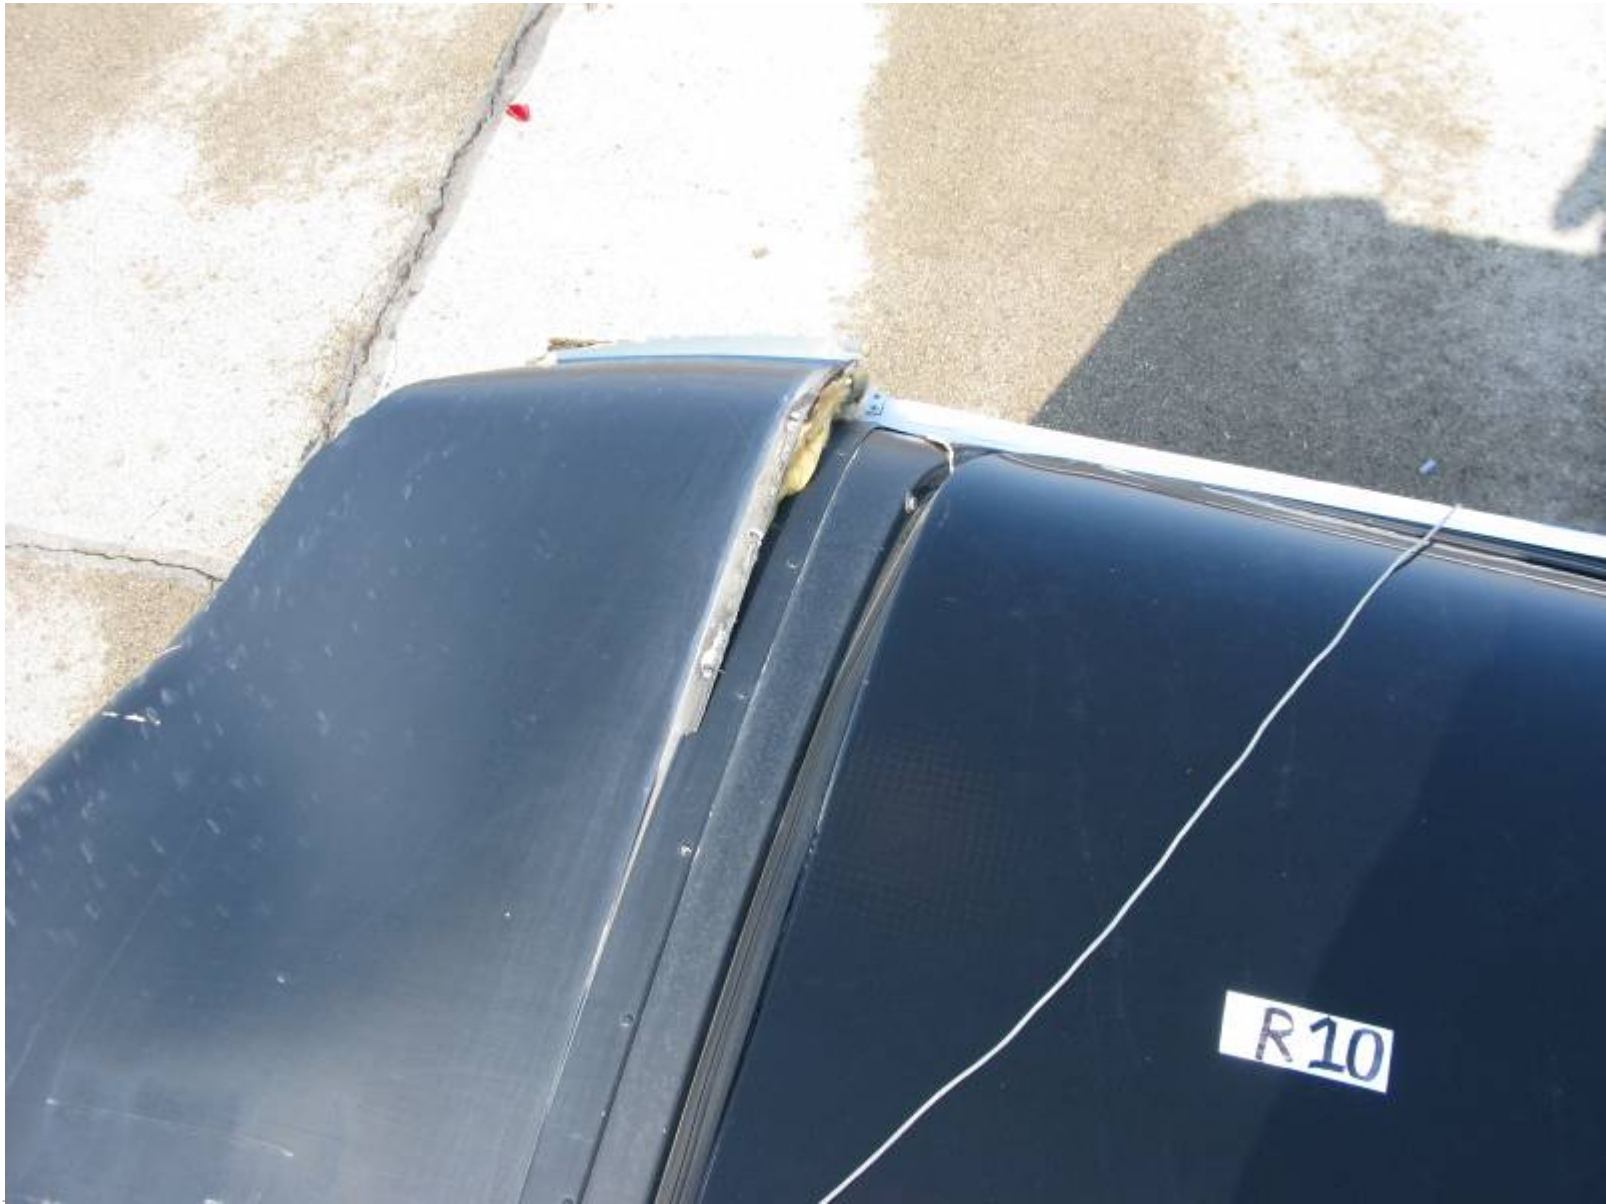
A-84.

Post-Test Exterior Right Rear Side of Bus Damage
