REPORT NUMBER: T8001-MGA-2008-008

**VEHICLE TO DEFORMABLE BARRIER CRASH TESTS
IN SUPPORT OF NHTSA OFFSET FRONTAL PROGRAM**

**LEFT 50% OFFSET DEFORMABLE BARRIER IMPACT
PDB BARRIER**

2007 FORD FIVE HUNDRED SEL 4-DOOR (R70205)

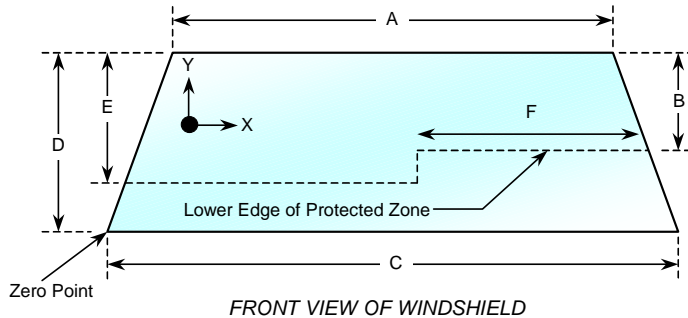
Item	Units	Value
A	mm	1330
B	mm	490
C	mm	1658
D	mm	835
E	mm	550
F	mm	552

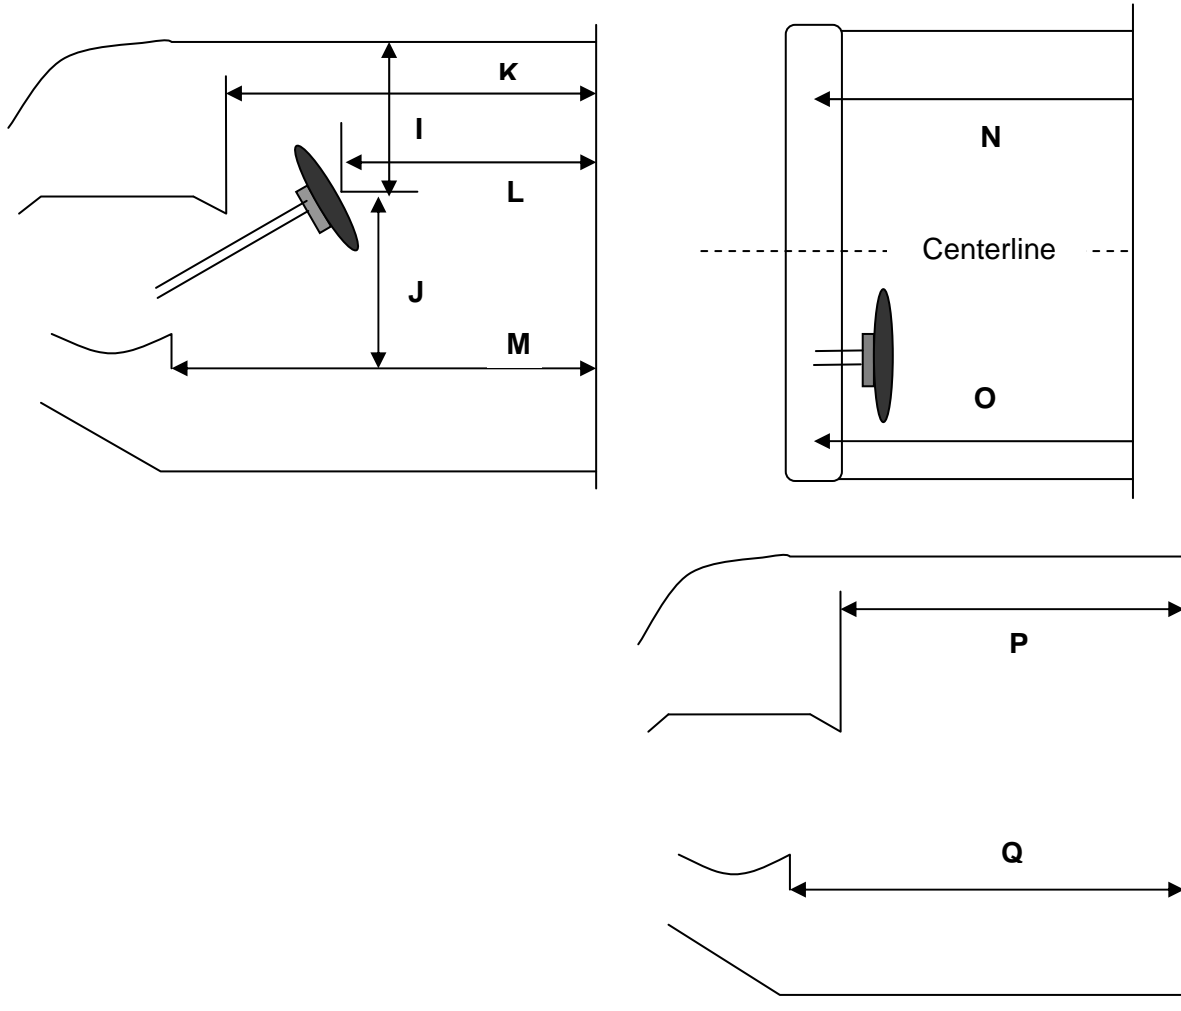
Measurements	Pre-Test (mm)	Post-Test (mm)	Difference (mm)
I	455	460	-5
J	633	625	8
K	2060	2045	15
L	1862	1885	-23
M	2226	2194	32
N	2070	2065	5
O	2094	2078	16
P= K (PASS)	2060	2054	6
Q= M (PASS)	2236	2230	6
