**REPORT NUMBER: NCAP-MGA-2008-018**

**NEW CAR ASSESSMENT PROGRAM  
FRONTAL BARRIER IMPACT TEST**

**GENERAL MOTORS DE MEXICO, S. DE R.L. DE C.V.  
2008 SATURN VUE XR  
NHTSA NUMBER: G80102**

**PREPARED BY:  
MGA RESEARCH CORPORATION  
5000 WARREN ROAD  
BURLINGTON, WI 53105**

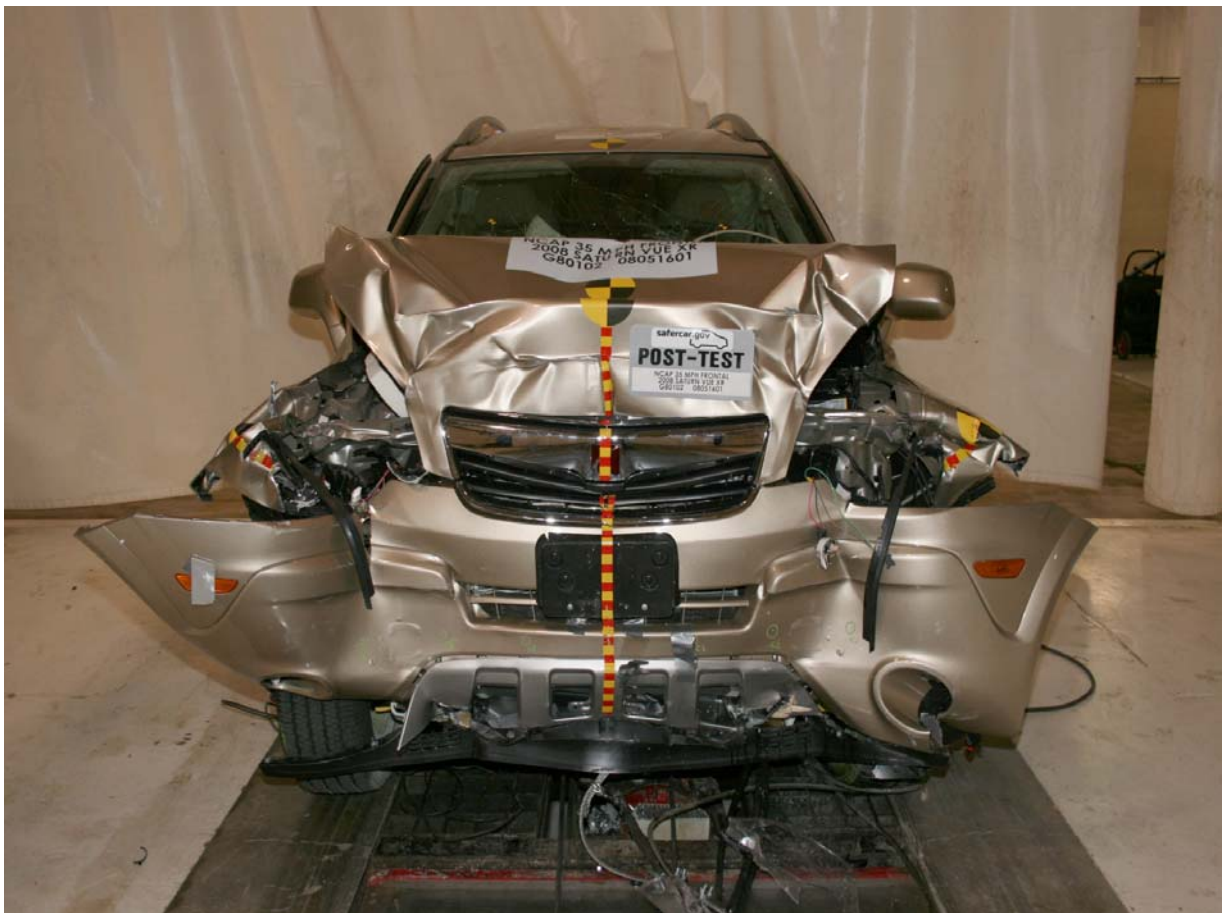
Post-Test Front View

The maximum static crush of the vehicle was 545 mm and both the driver and passenger side doors remained closed and latched during the impact event and were operable after the impact.

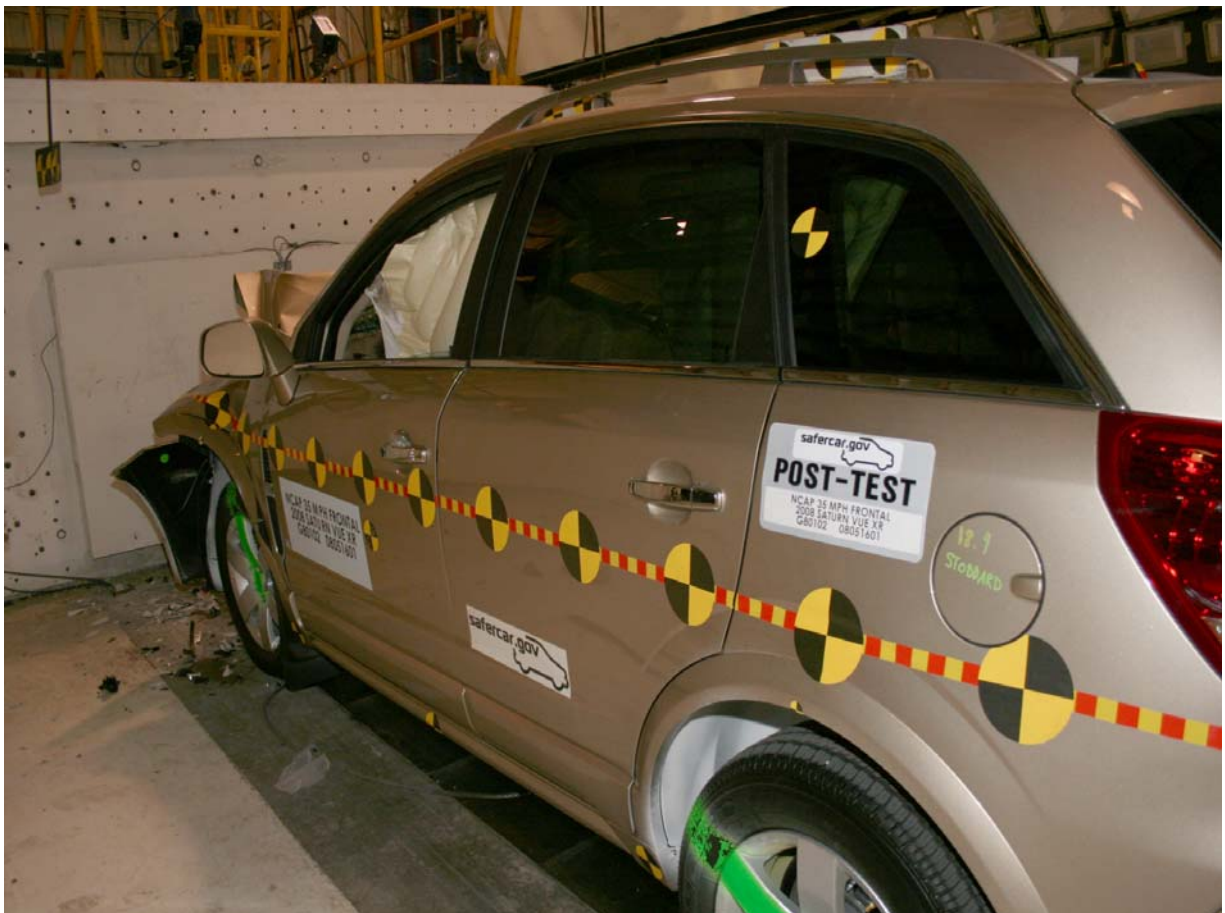
Post-Test Left Side 3/4 View of Doors After Impact

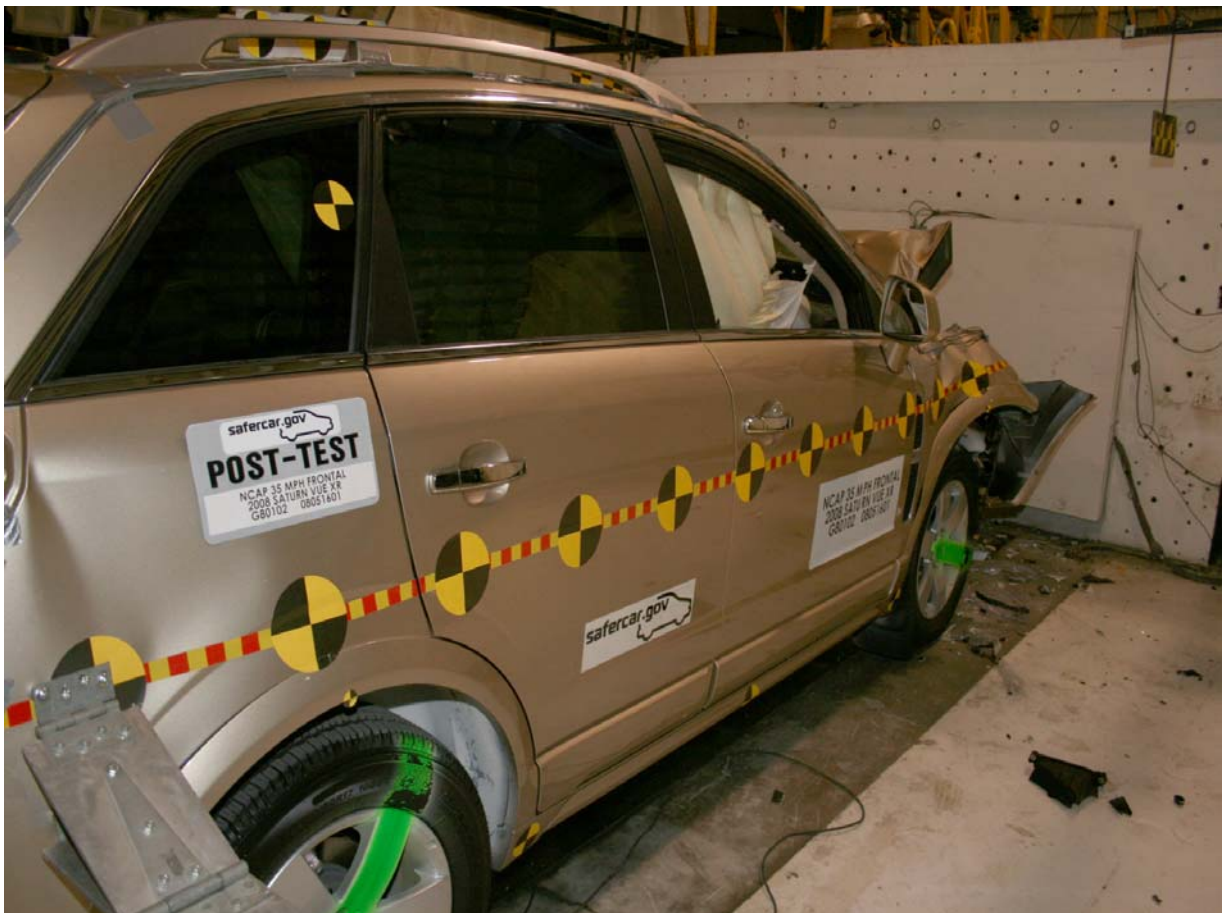
Post-Test Right Side  $\frac{3}{4}$  View of Doors After Impact

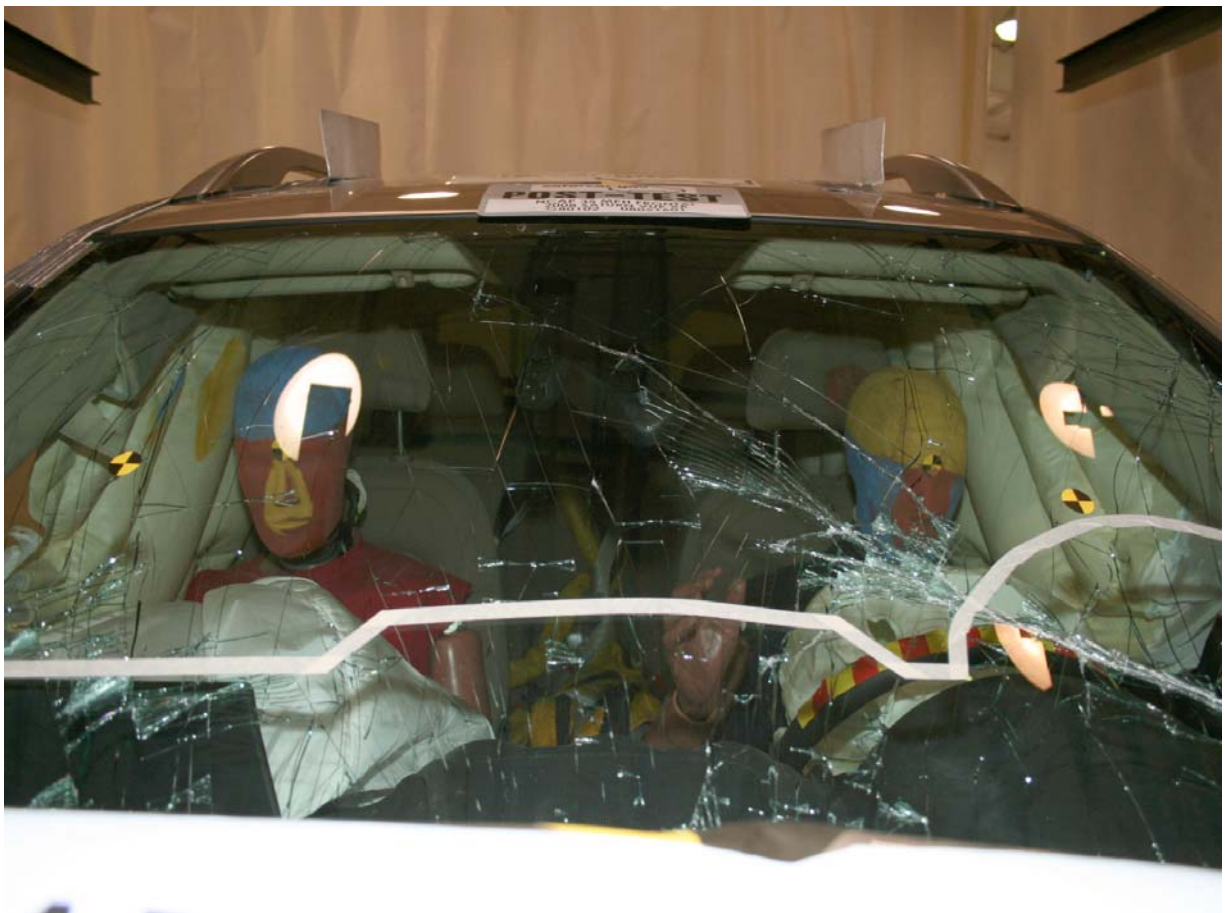
Post-Test Windshield View

There was 100 percent windshield retention and no intrusion into the protected zone of the windshield during the event. There was no Stoddard Solvent leakage after the event or during any phase of the static rollover.

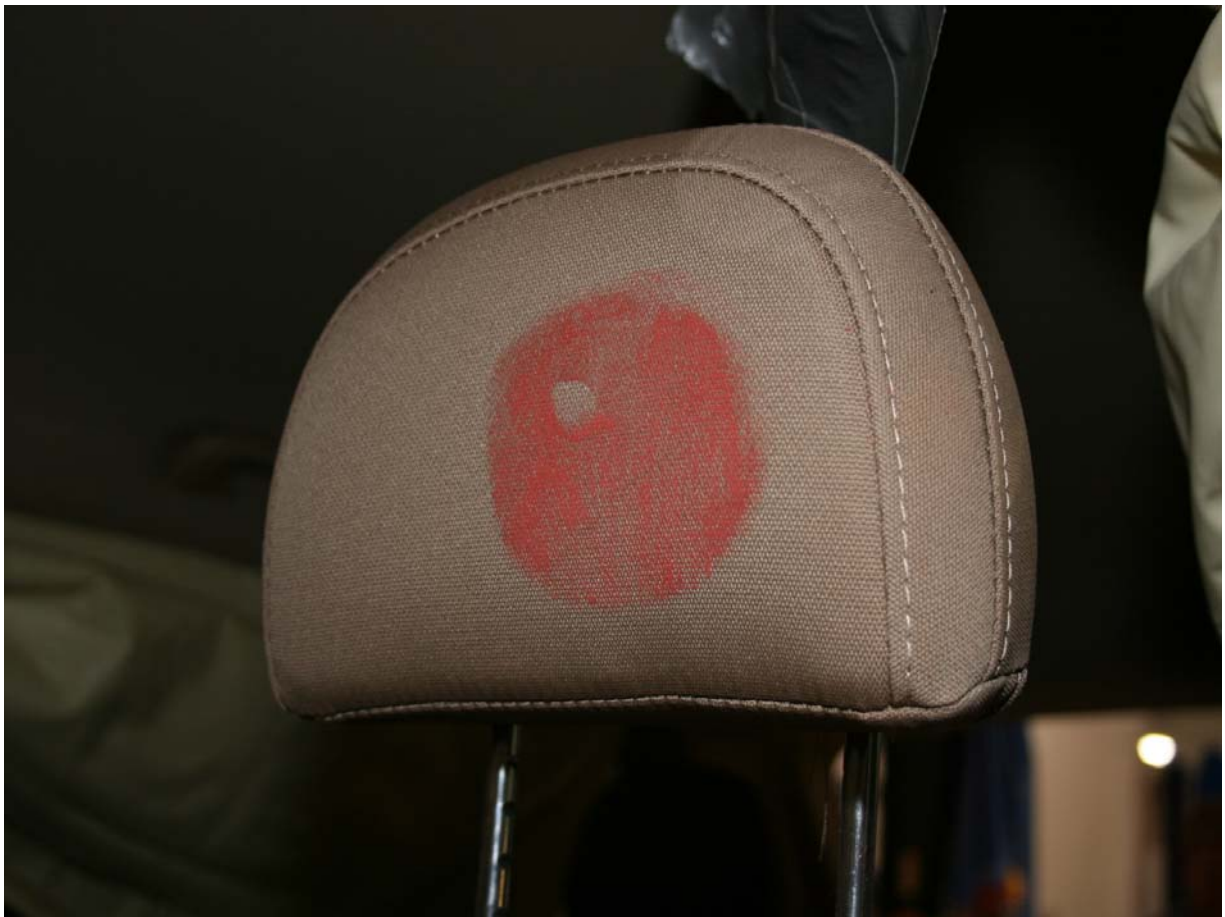
Post-Test Driver Dummy Head Contact (Headrest)

The driver's head and chest contacted the airbag. The driver's head also contacted the headrest. The driver's knees contacted the knee bolster. The passenger's head and chest contacted the airbag. The passenger's head also contacted the headrest. The passenger's knees contacted the glove box.

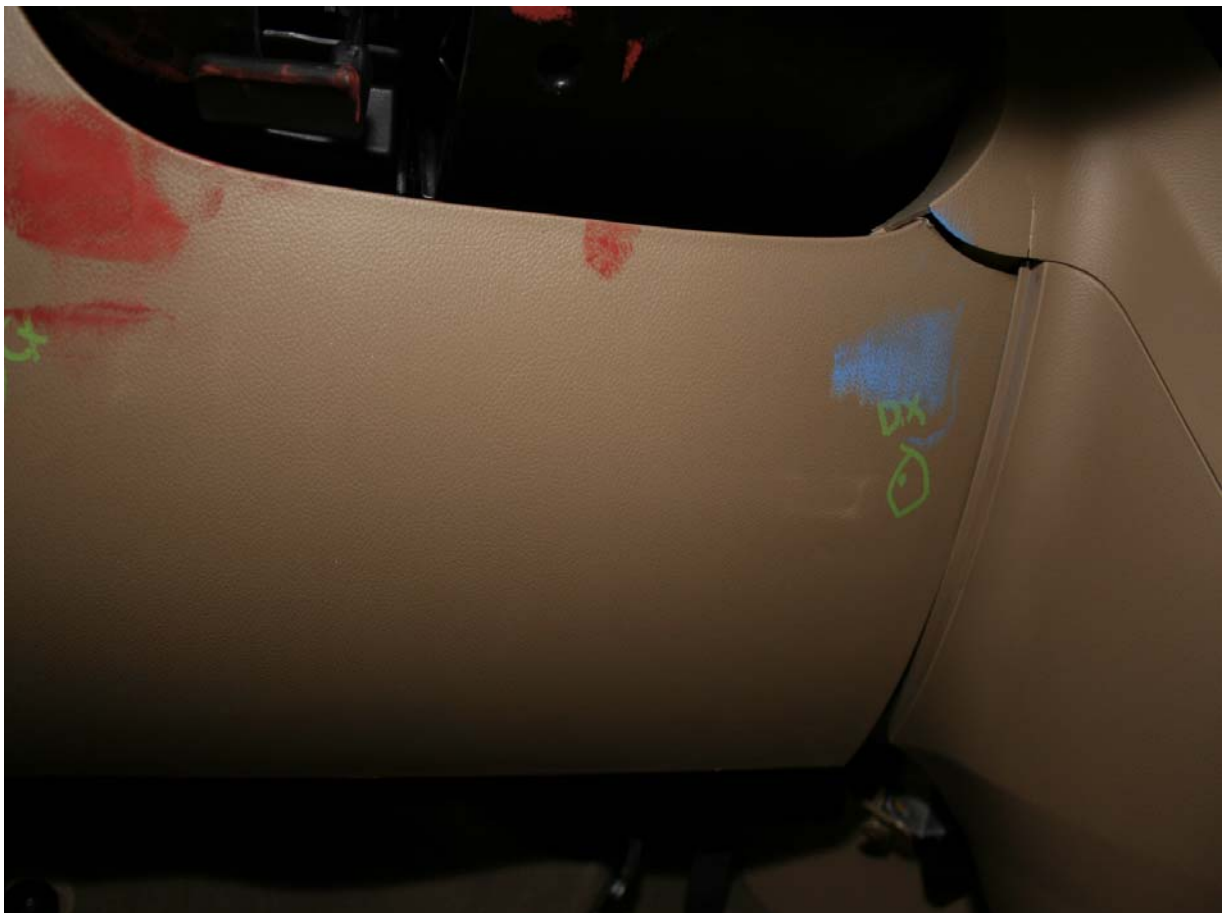
Post-Test Driver Dummy Knee Contact

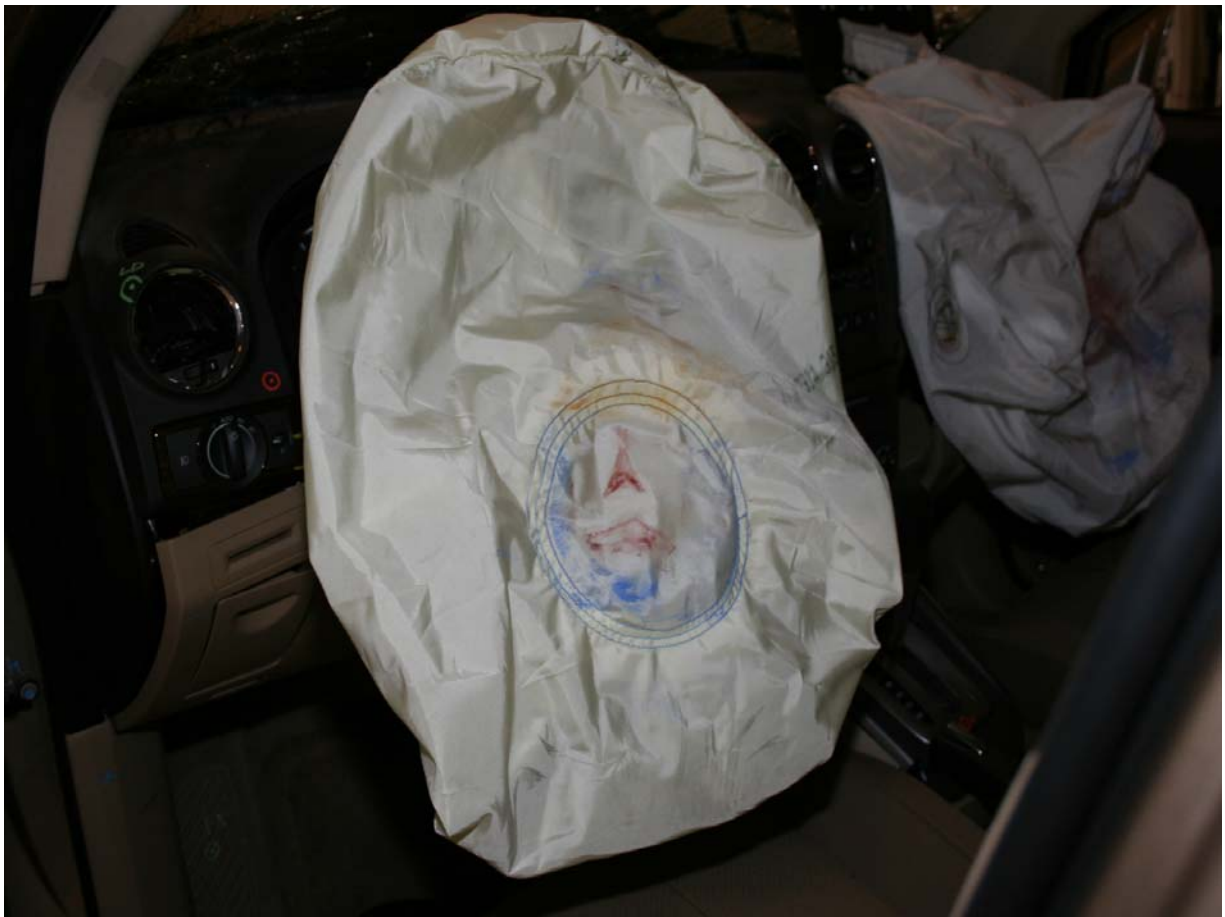
Post-Test Driver Dummy Airbag Contact

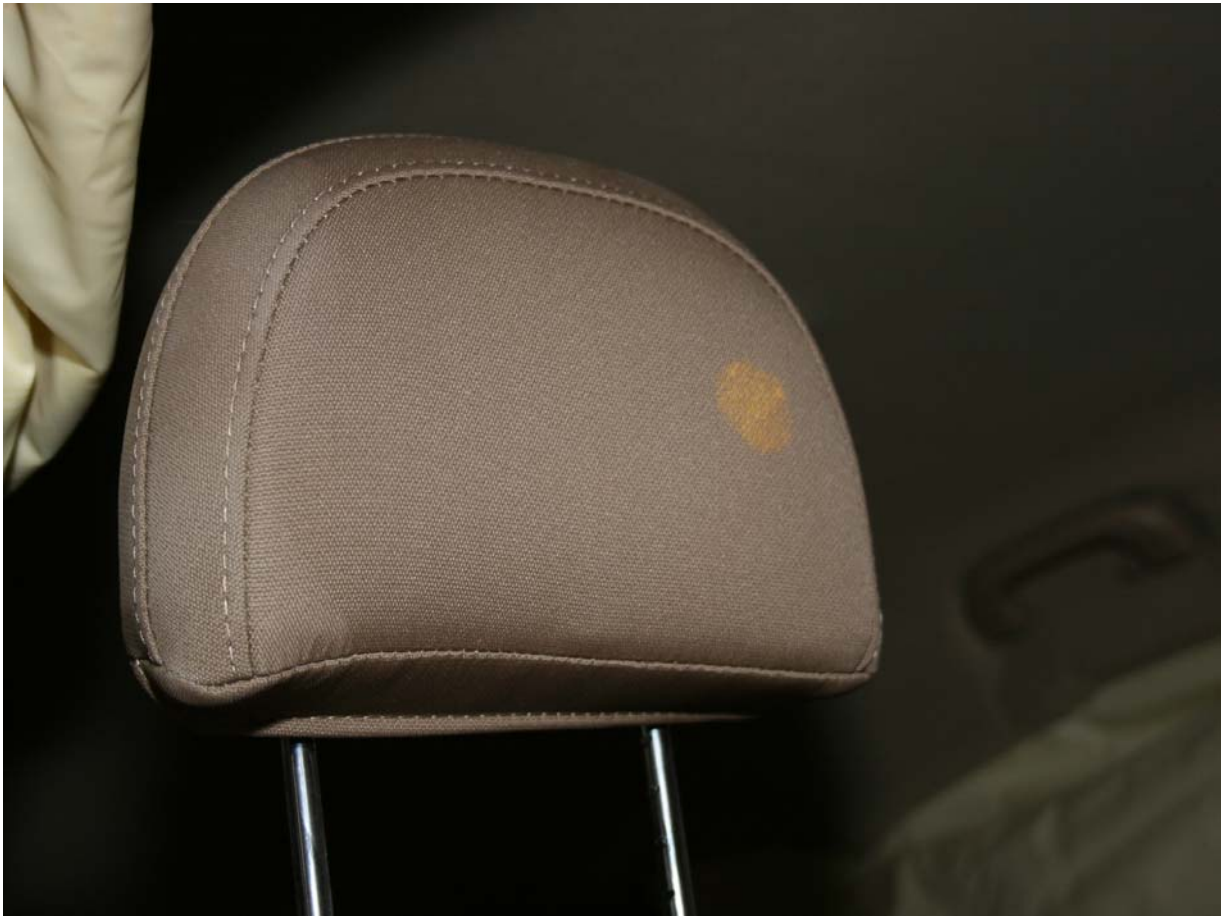
Post-Test Passenger Dummy Head Contact (Headrest)

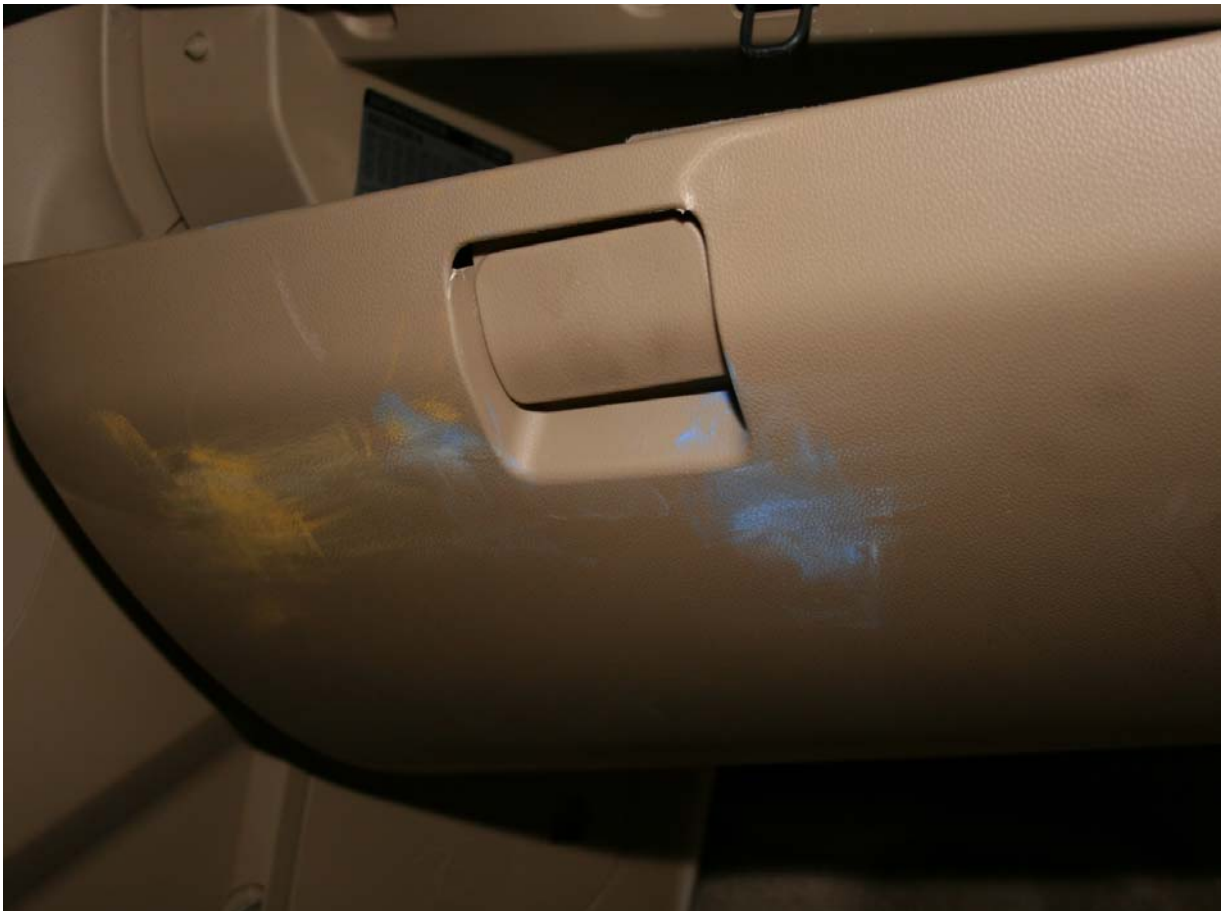
Post-Test Passenger Dummy Knee Contact

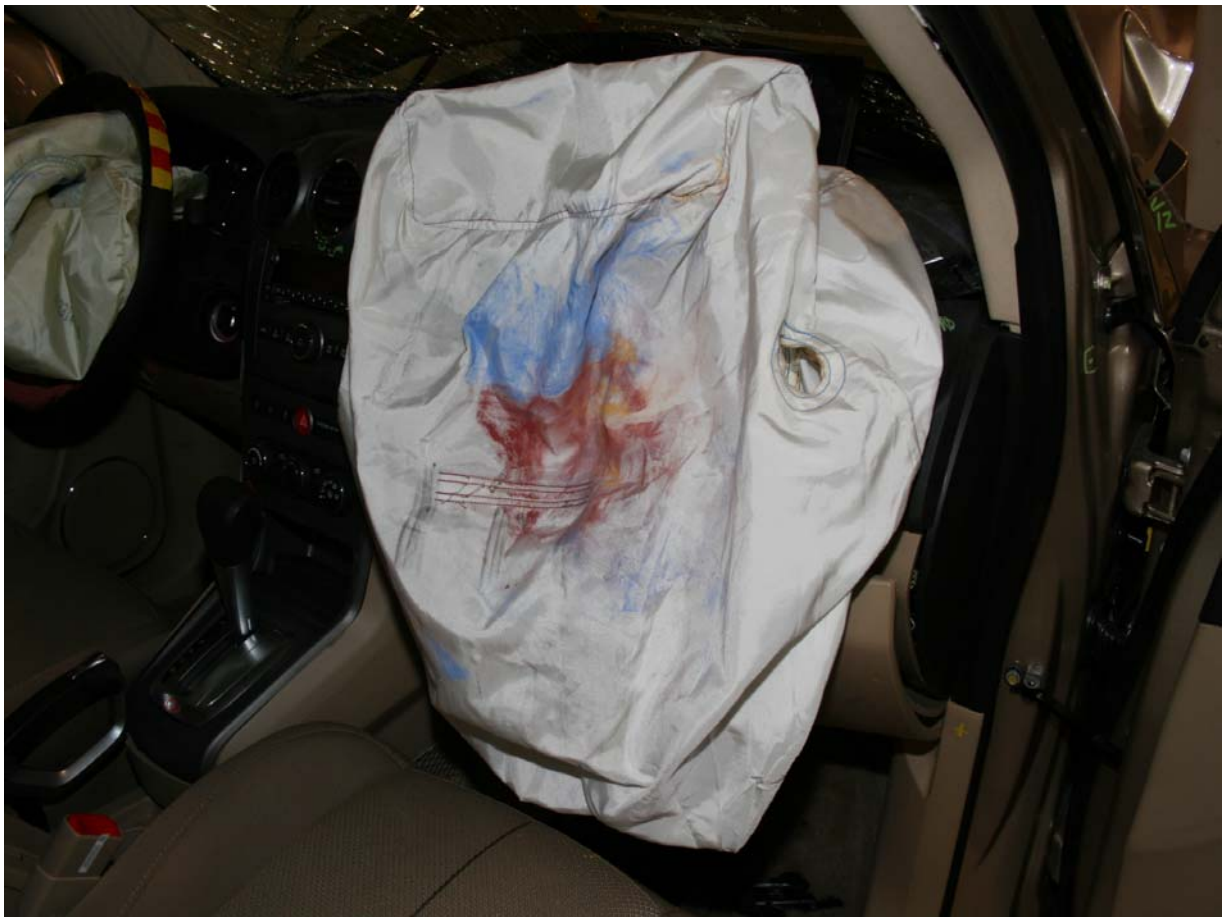
Post-Test Passenger Dummy Airbag Contact

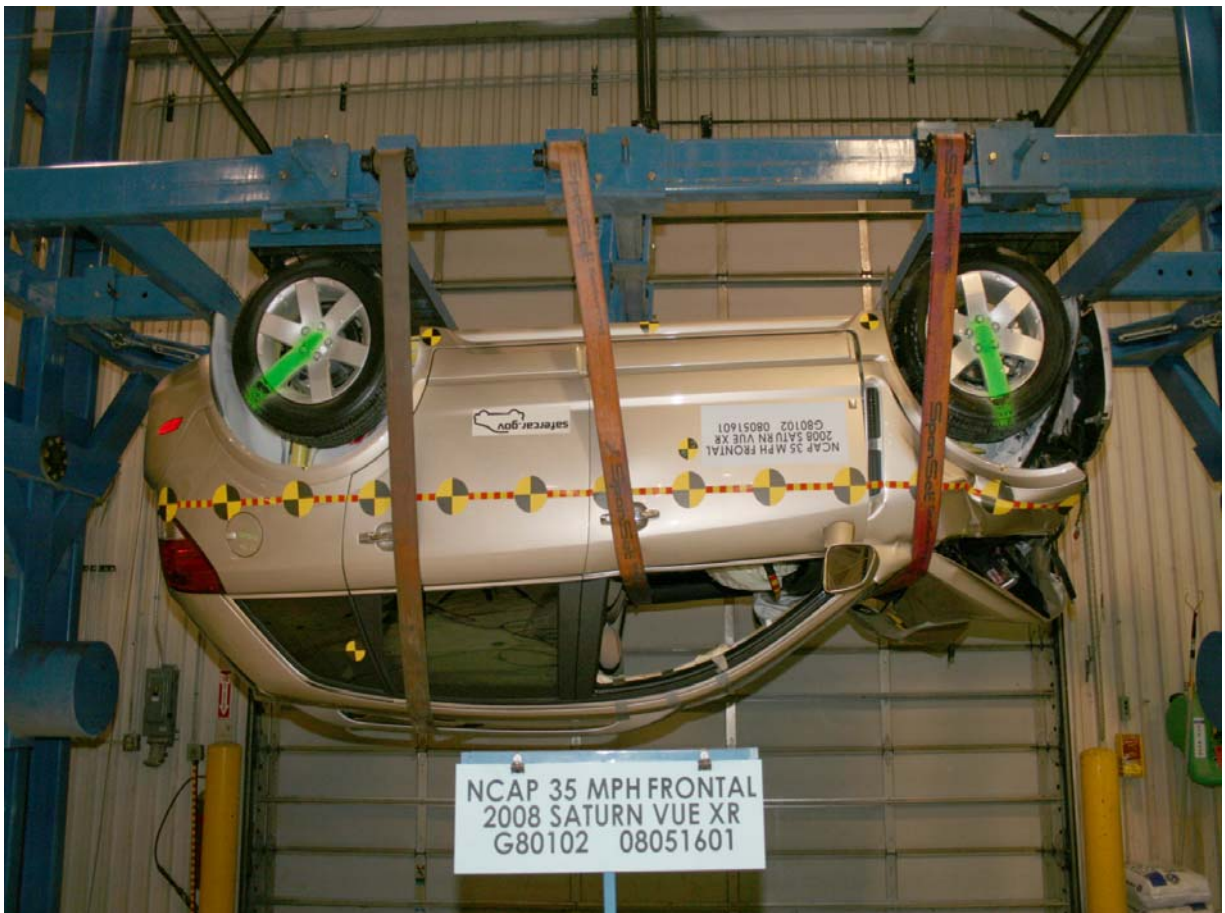
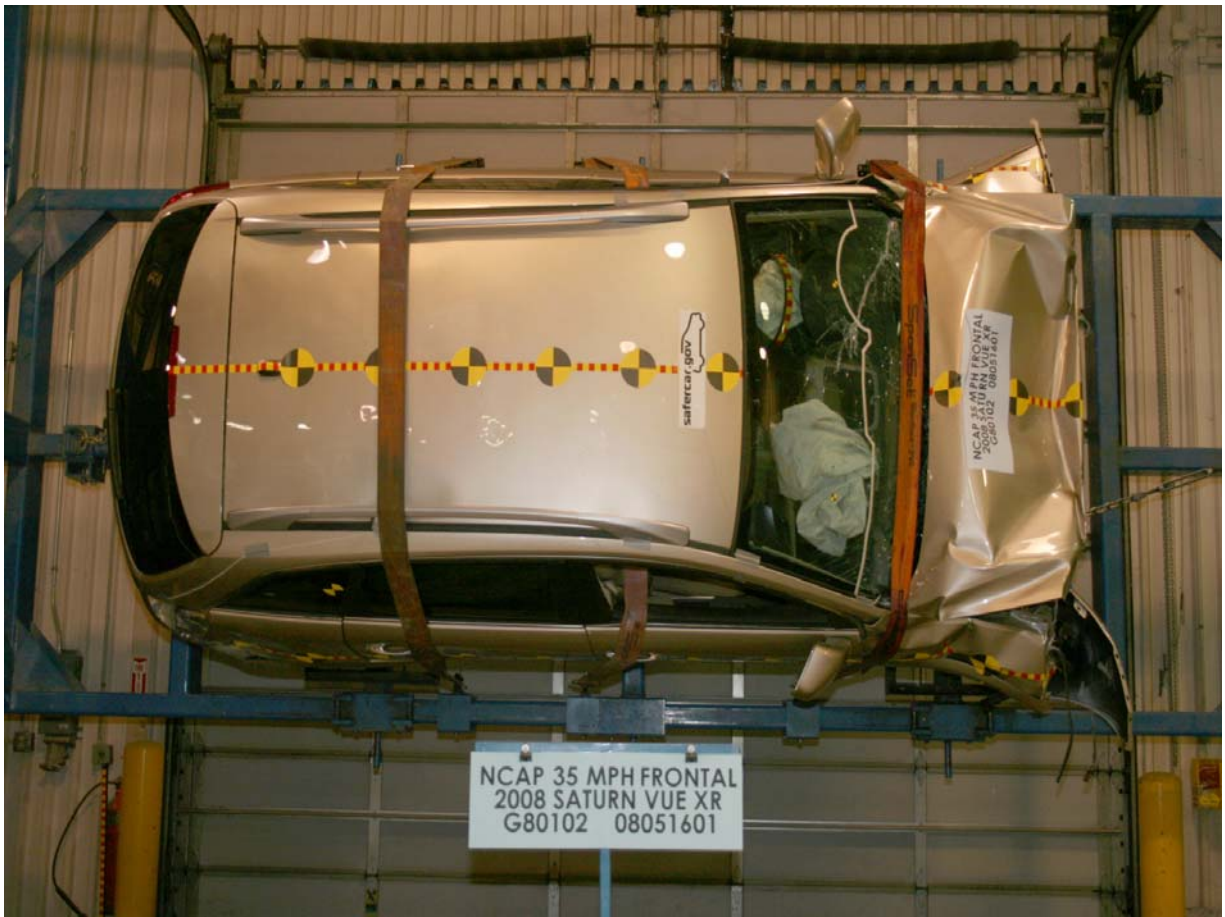
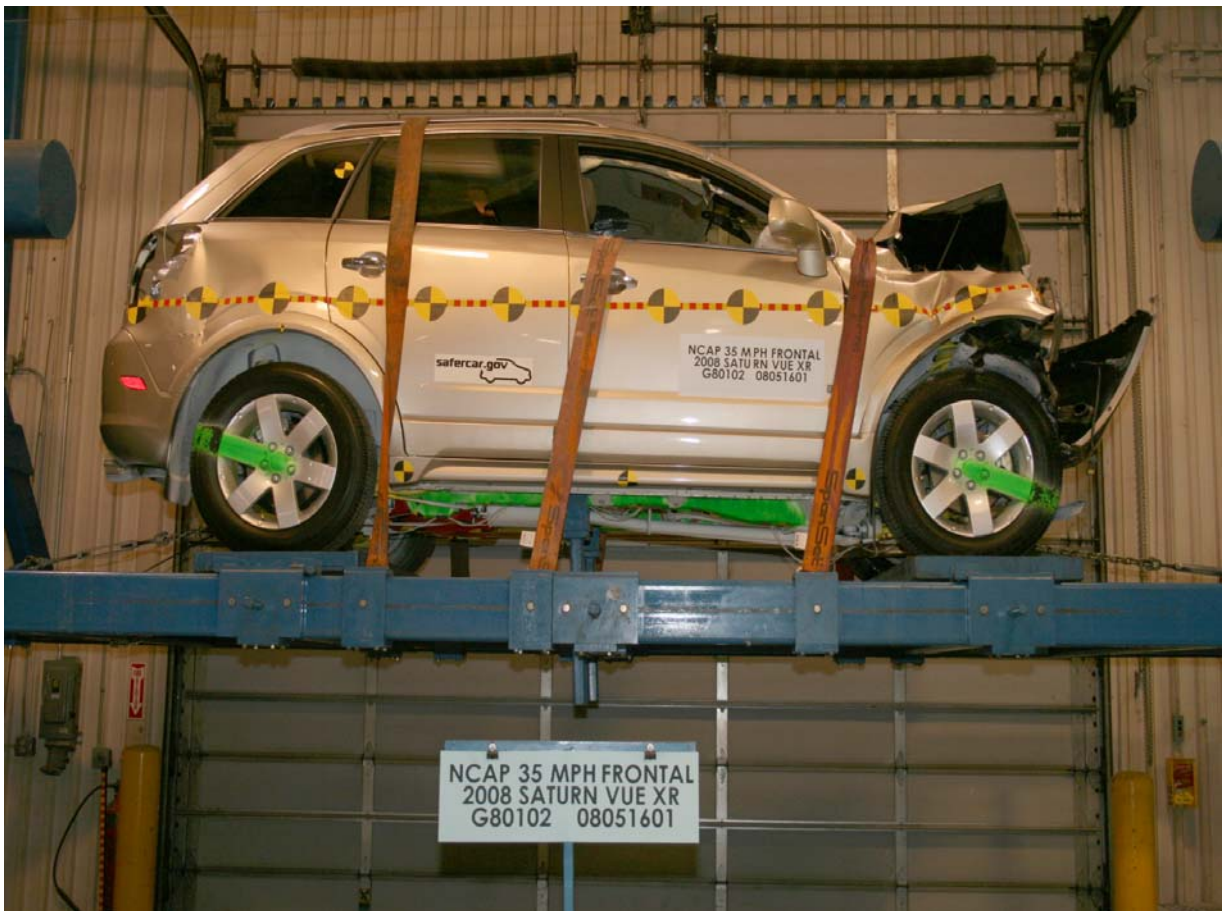
Rollover 90 Degrees

Rollover 180 Degrees

Rollover 270 Degrees

Rollover 360 Degrees
