**NEW CAR ASSESSMENT PROGRAM  
SIDE IMPACT TEST**

**HONDA MOTOR CO., LTD  
2009 ACURA TSX  
4-DOOR SEDAN**

**NHTSA NUMBER: H95301**

**FINAL REPORT**

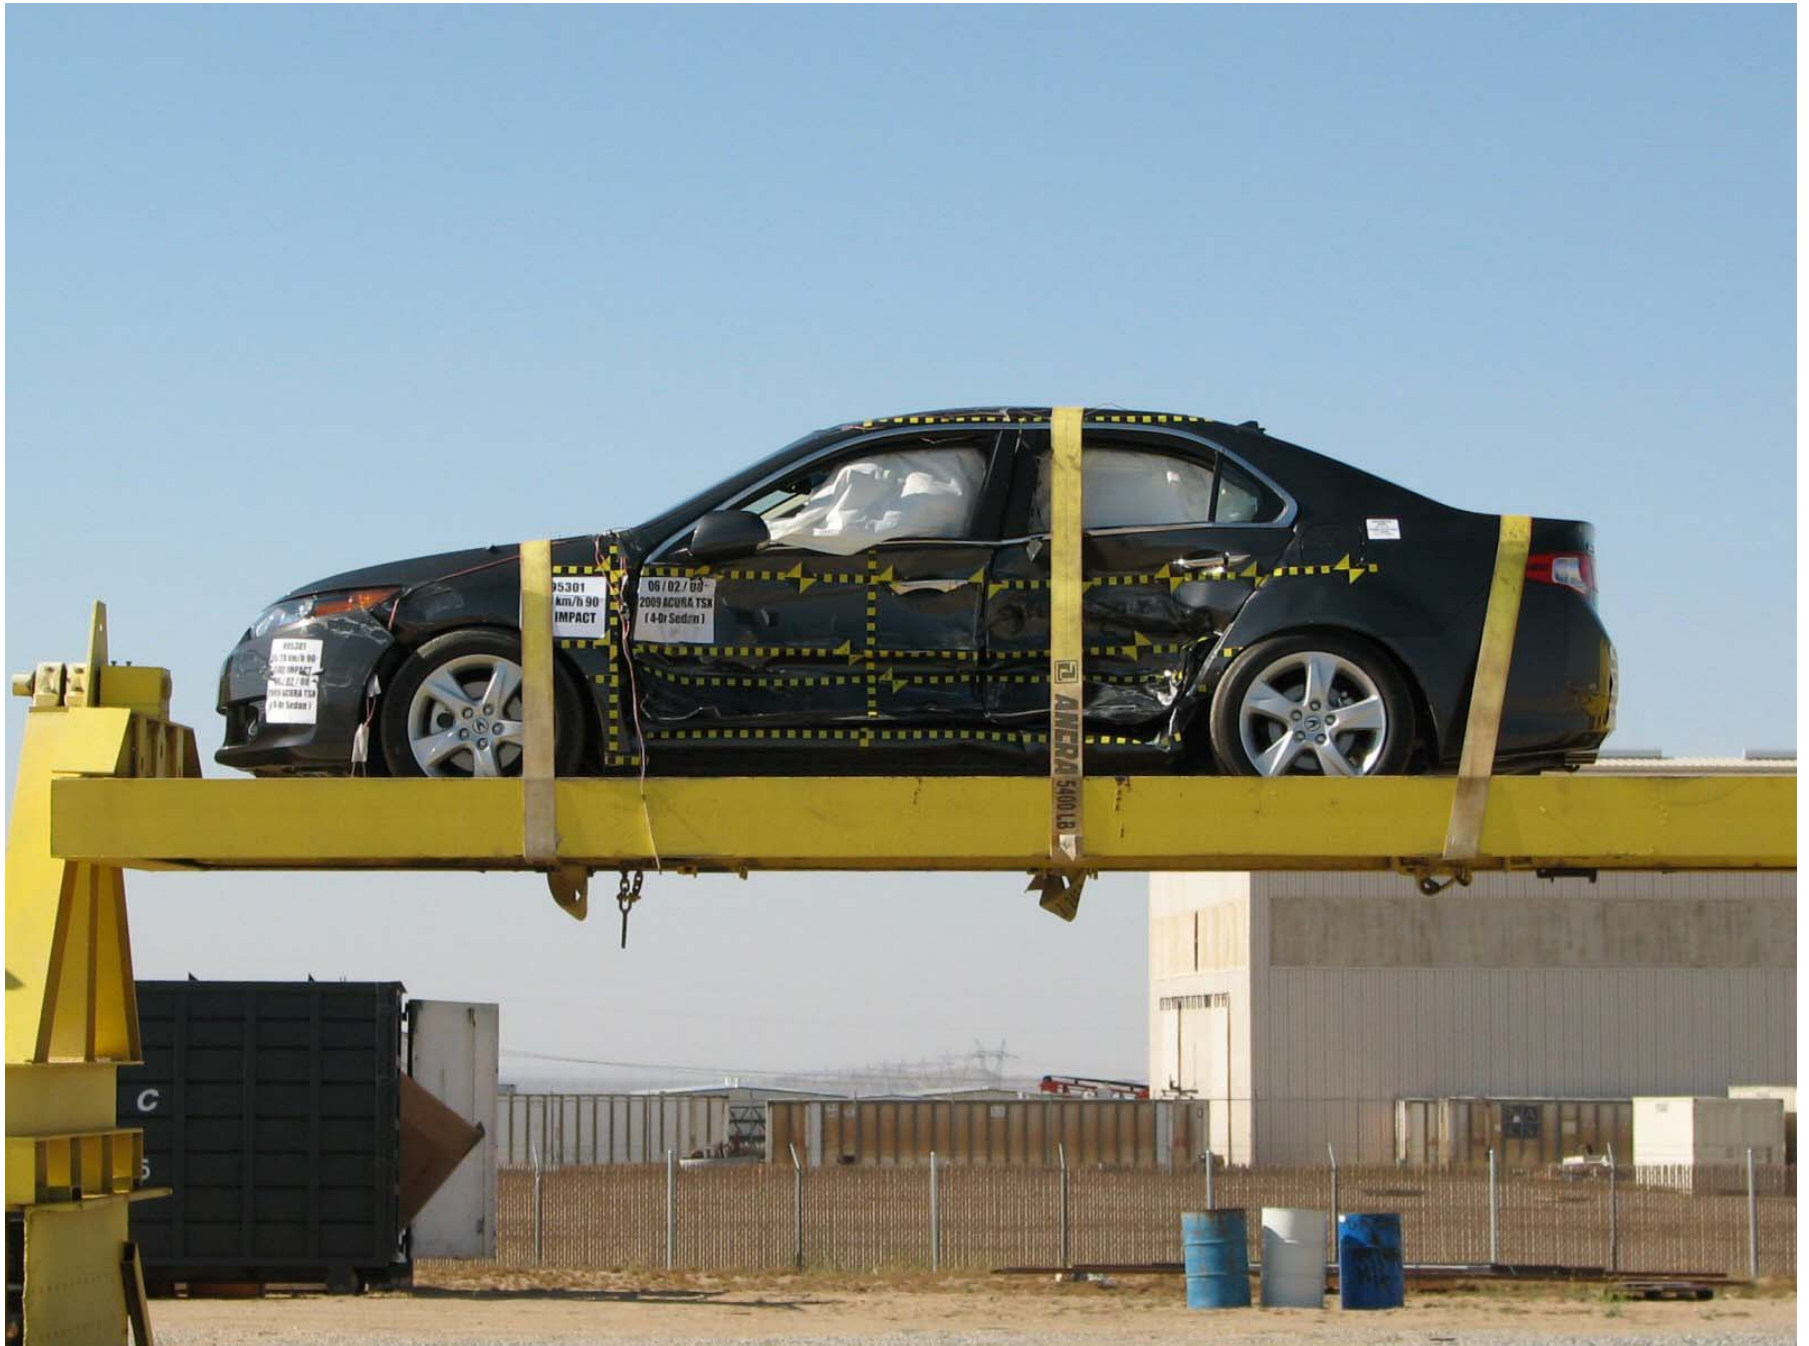
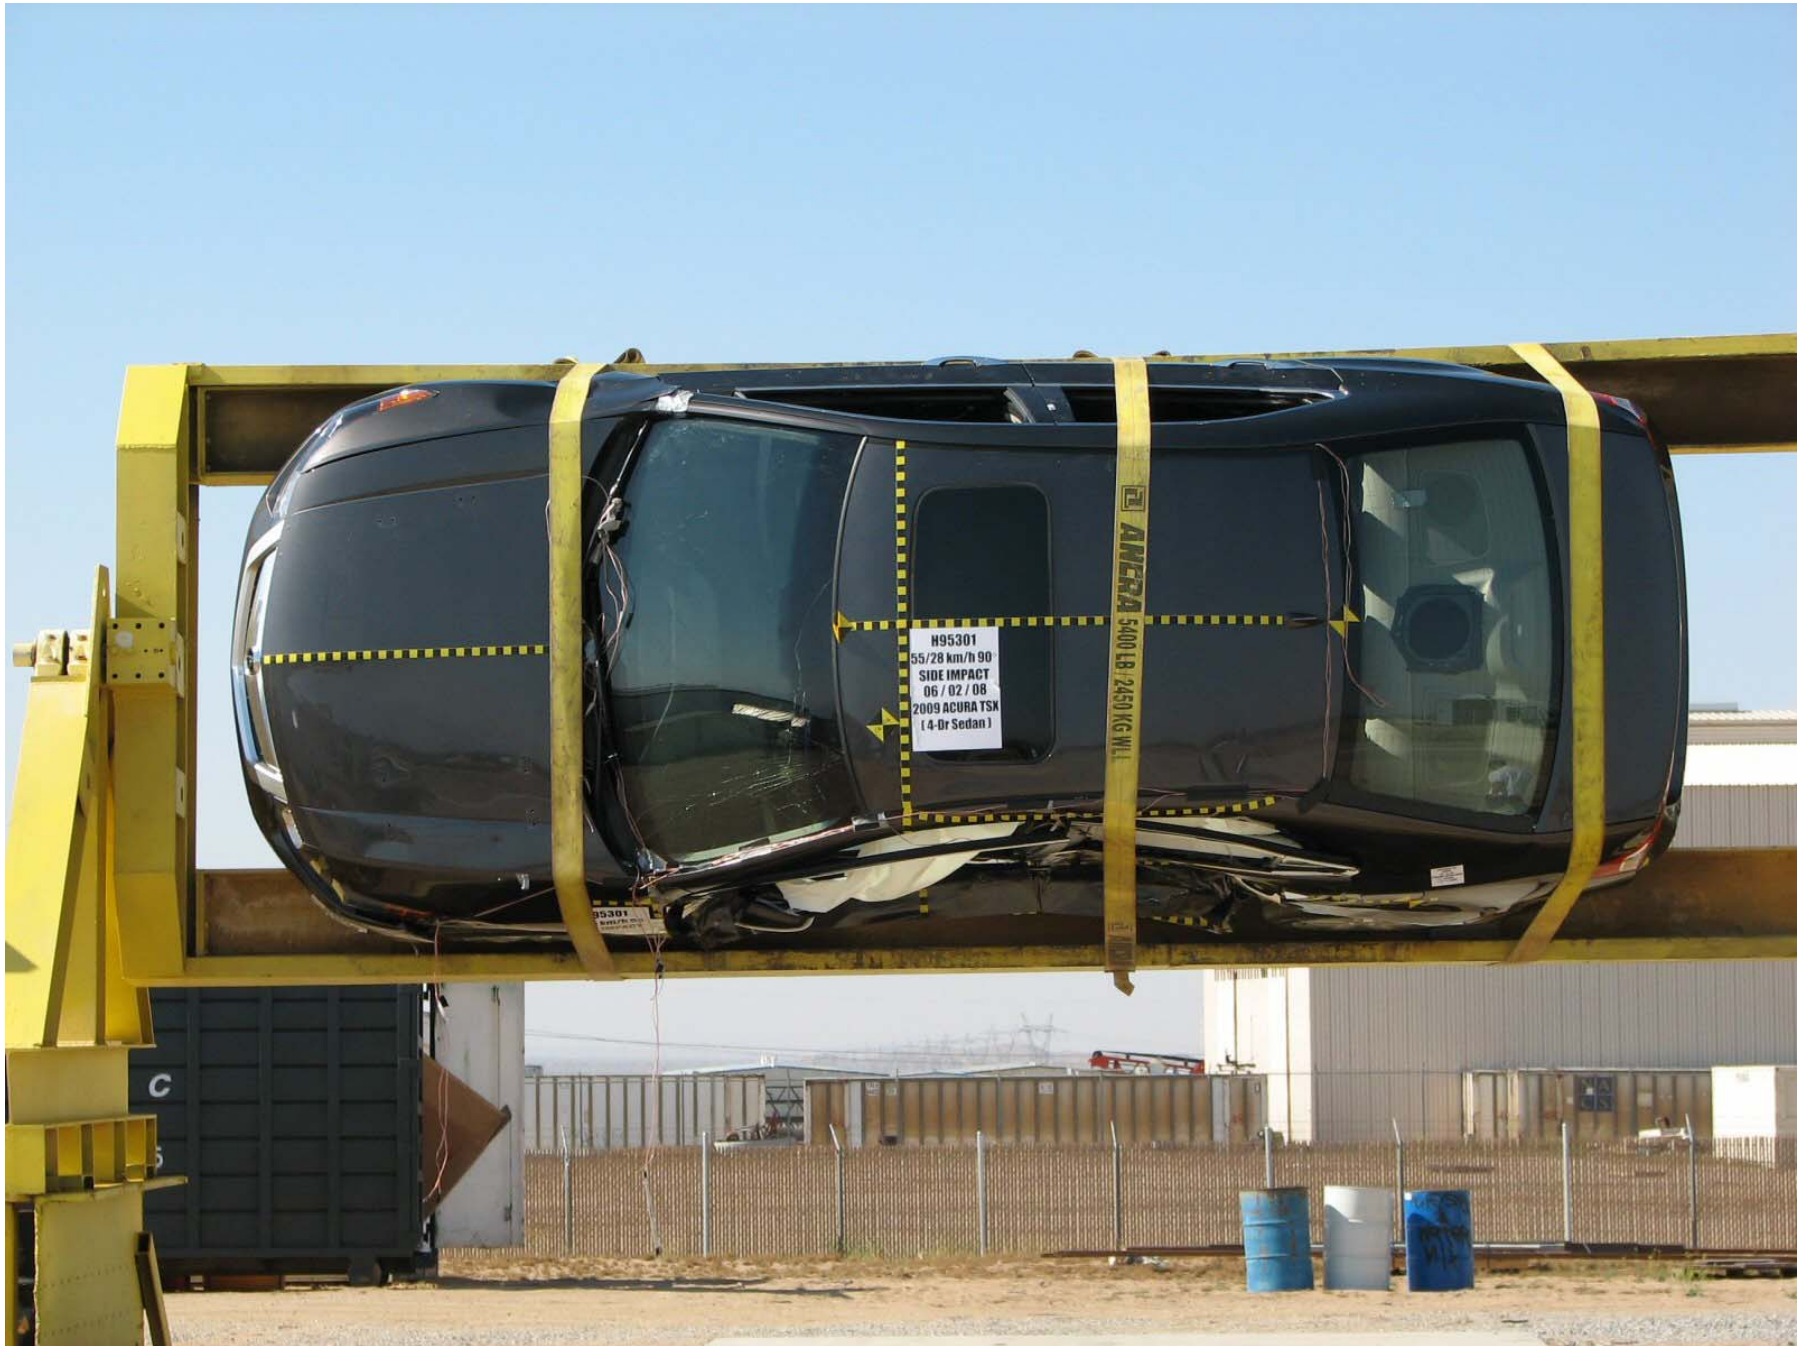
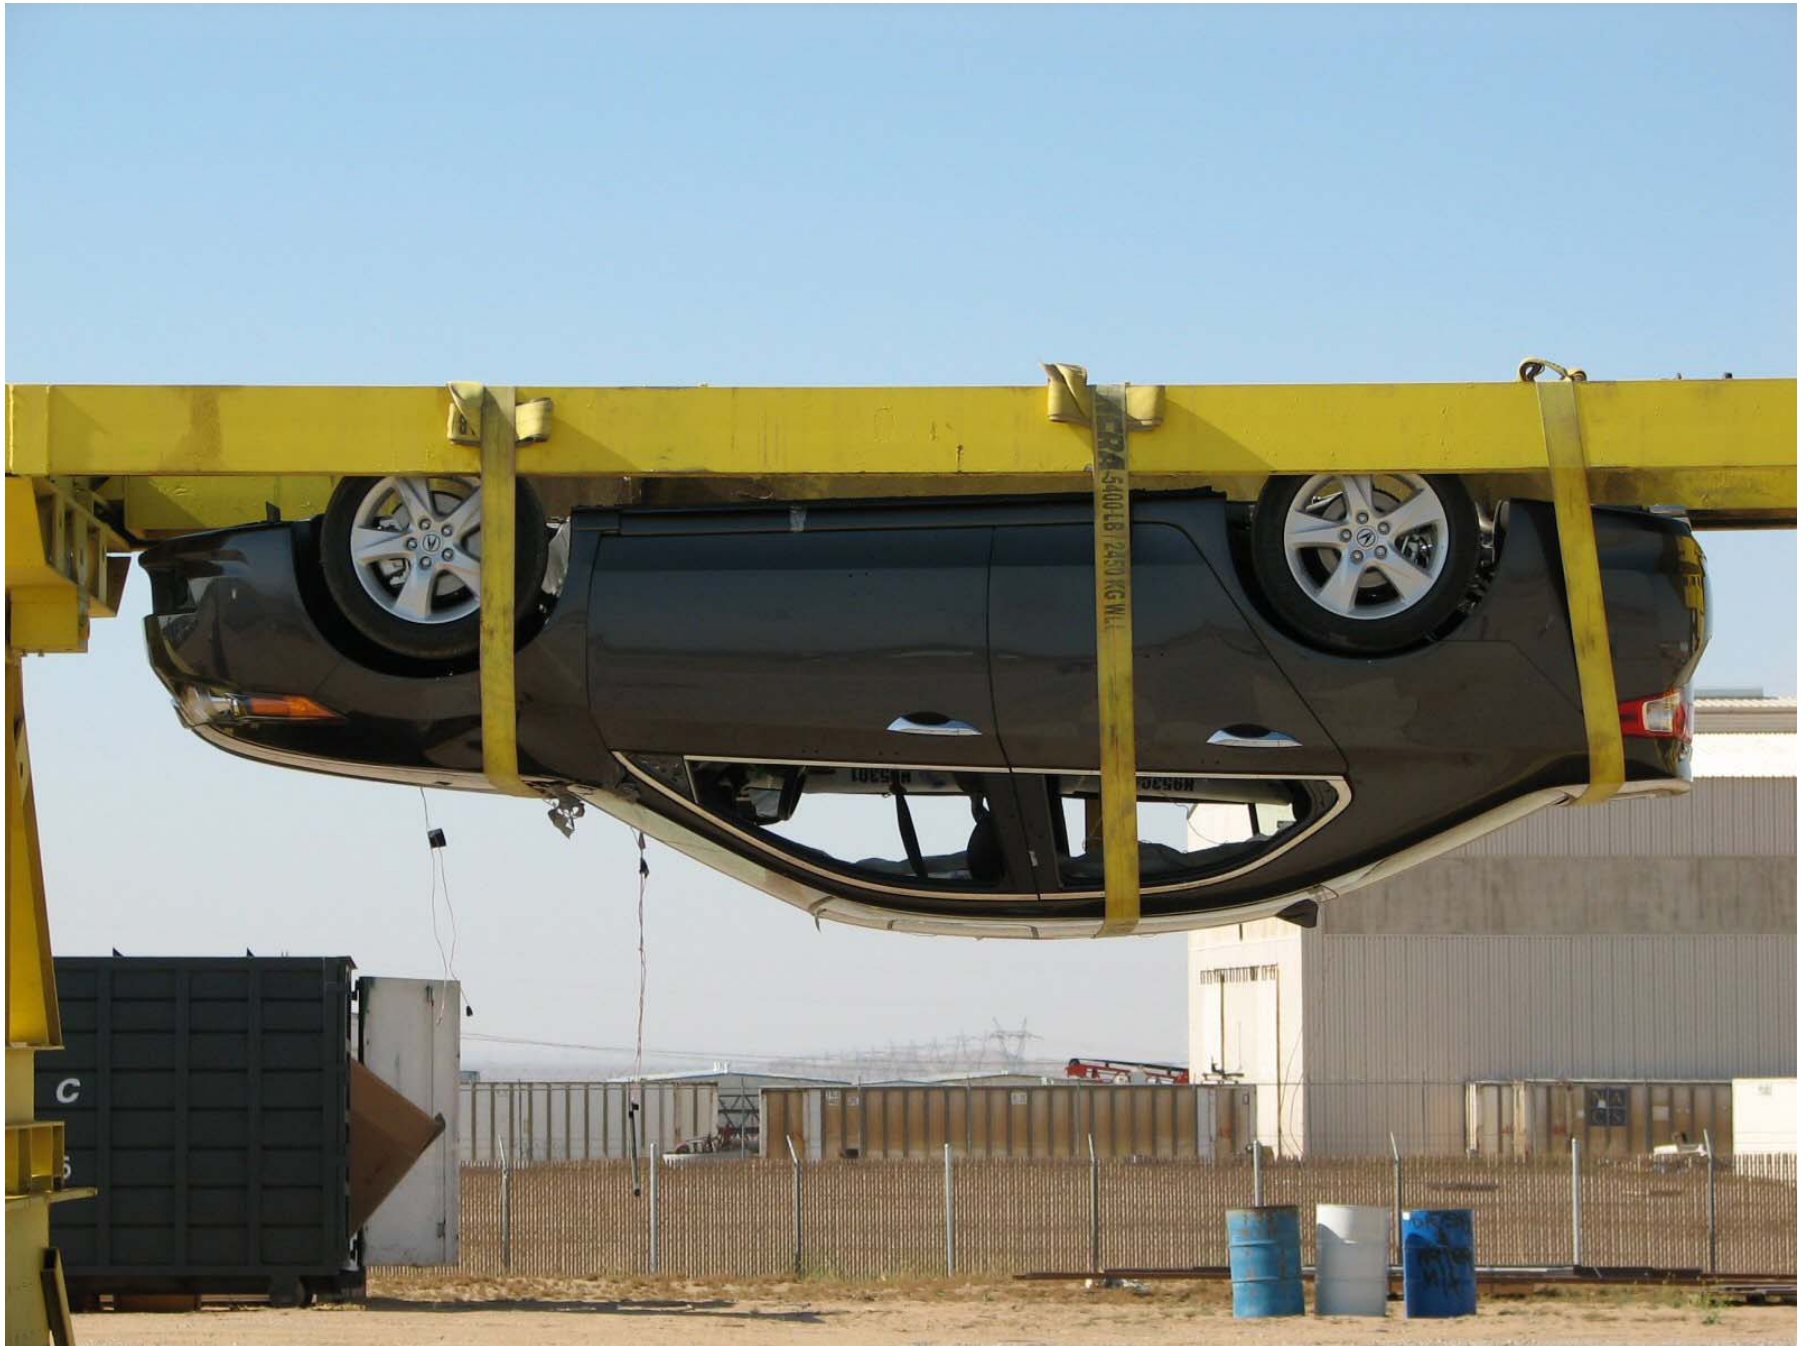
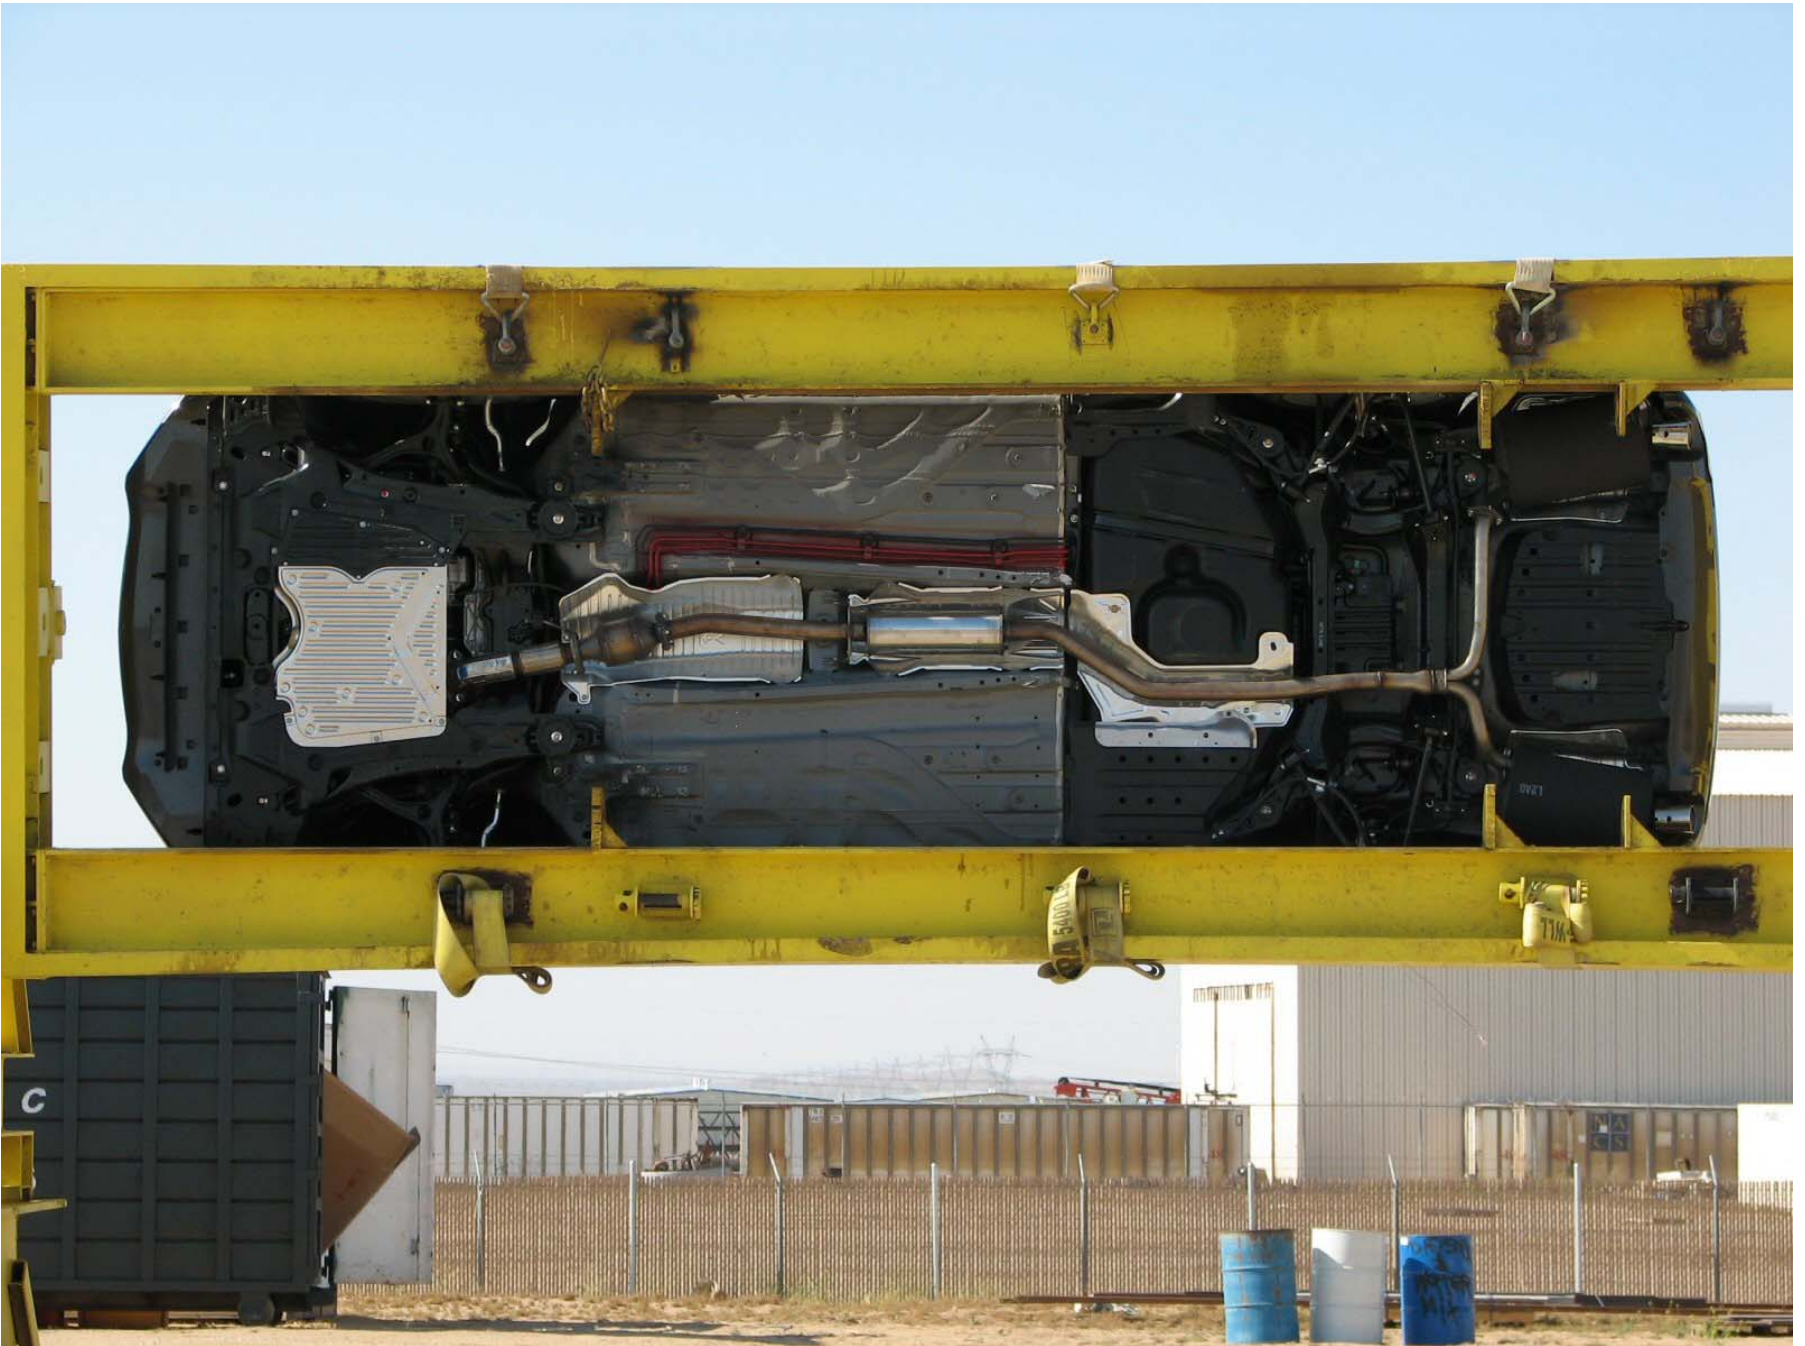
Figure A-61: Vehicle on Rollover Device (0°)

Figure A-62: Vehicle on Rollover Device (90°)

Figure A-63: Vehicle on Rollover Device (180°)

Figure A-64: Vehicle on Rollover Device (270°)

1. The specified fixture rollover rate for each 90° of rotation is 60 to 120 seconds.
2. The position hold time at each position is 300 seconds (minimum).
3. Details of Stoddard Solvent spillage locations.  
No solvent leakage occurred during static rollover testing.
