**NEW CAR ASSESSMENT PROGRAM  
SIDE IMPACT TEST**

**HONDA MFG. OF ALABAMA, LLC  
2009 HONDA PILOT EX  
5-DOOR MPV**

**NHTSA NUMBER: M95301**

**FINAL REPORT**

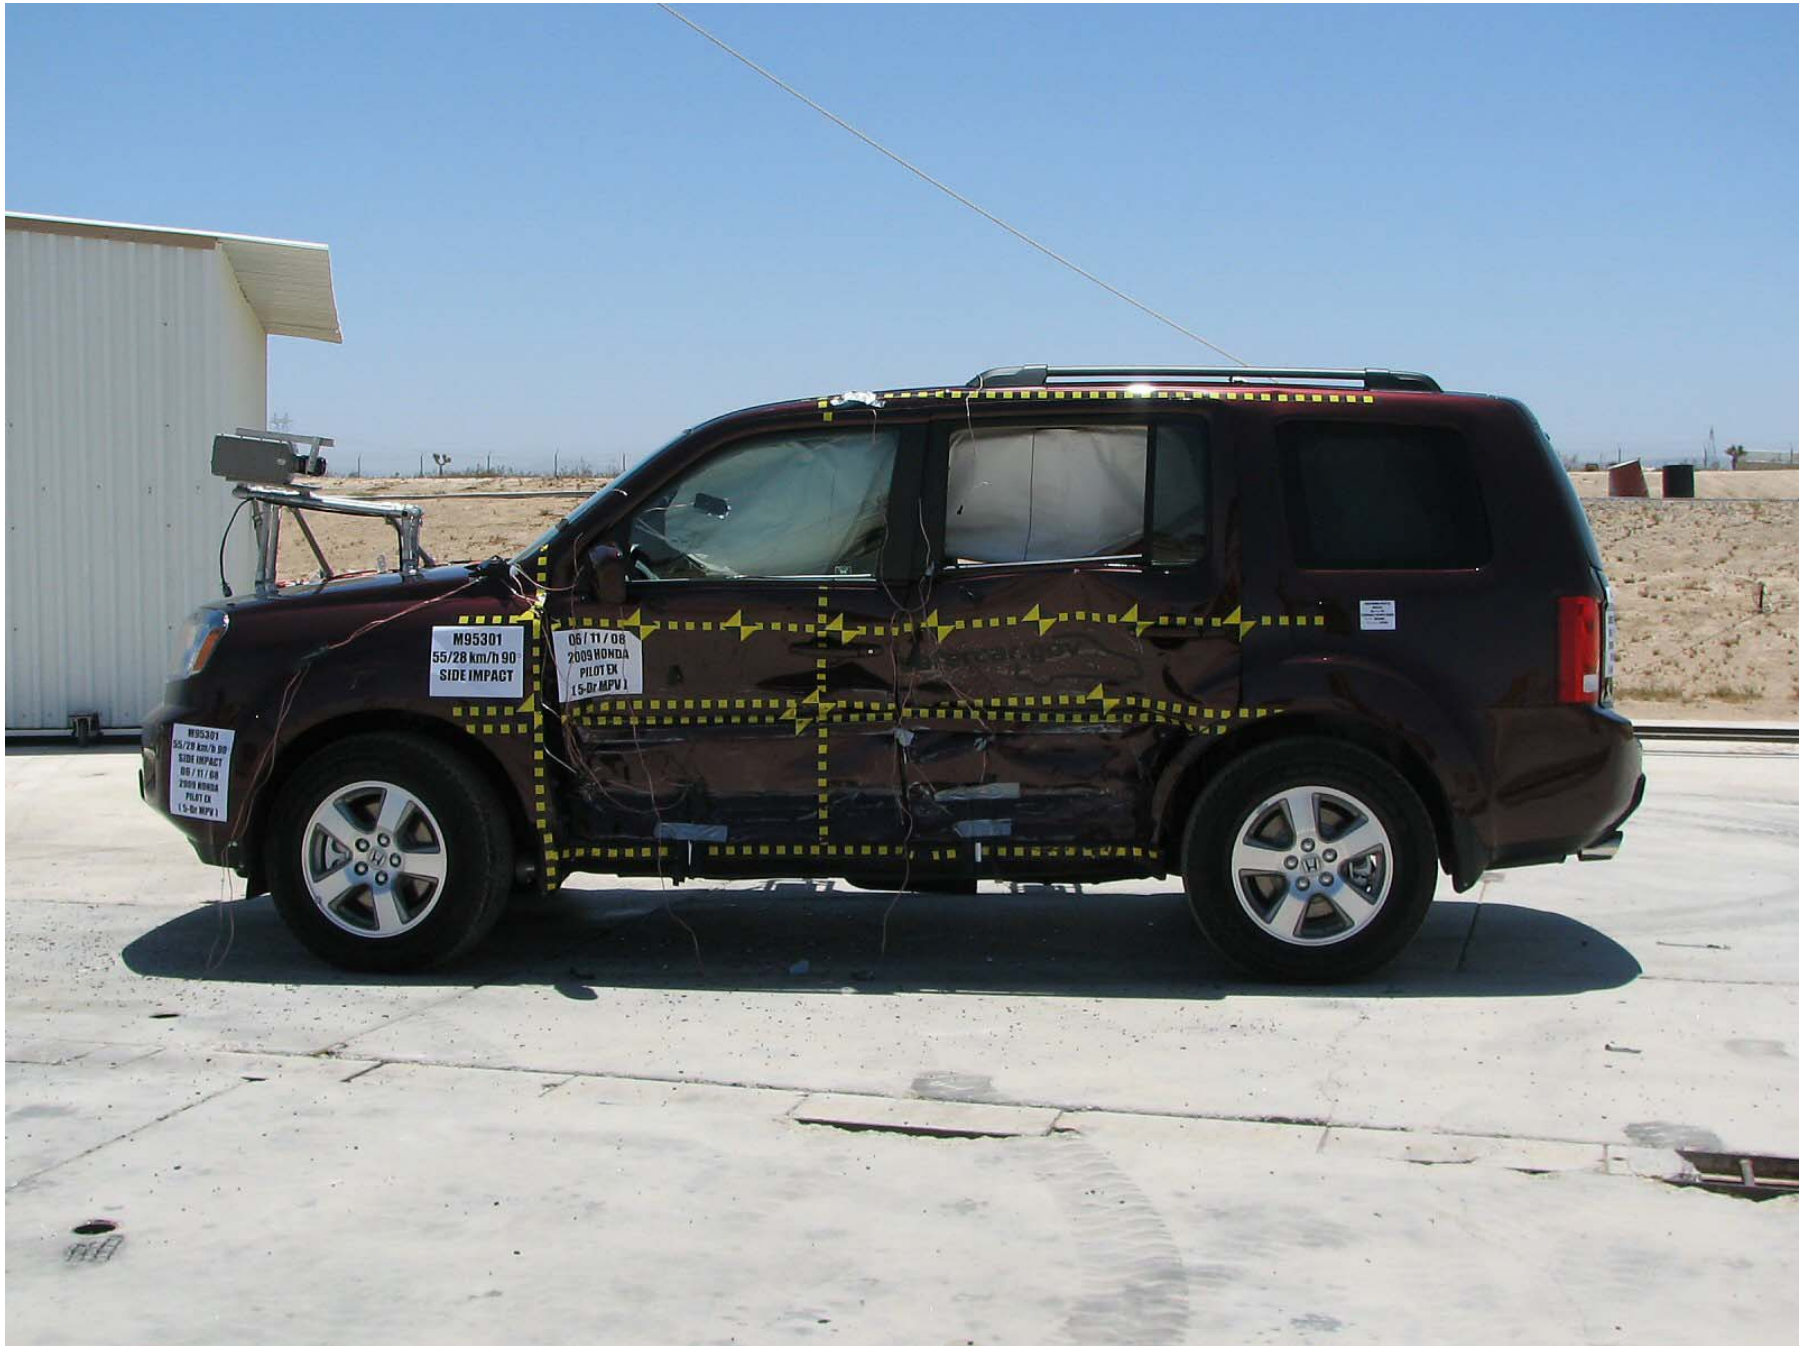
Figure A-10: Post-Test Left Side View

Both the driver and passenger doors remained closed during the impact. The test vehicle sustained a maximum static crush of 248 mm at level 3, 1050 mm rearward of the left vertical impact point. The driver SID/Hybrid III, Serial No. 275 and the passenger SID/Hybrid III, Serial No. 274 were calibrated prior to this test. The SID/Hybrid III injury criteria are summarized as follows:

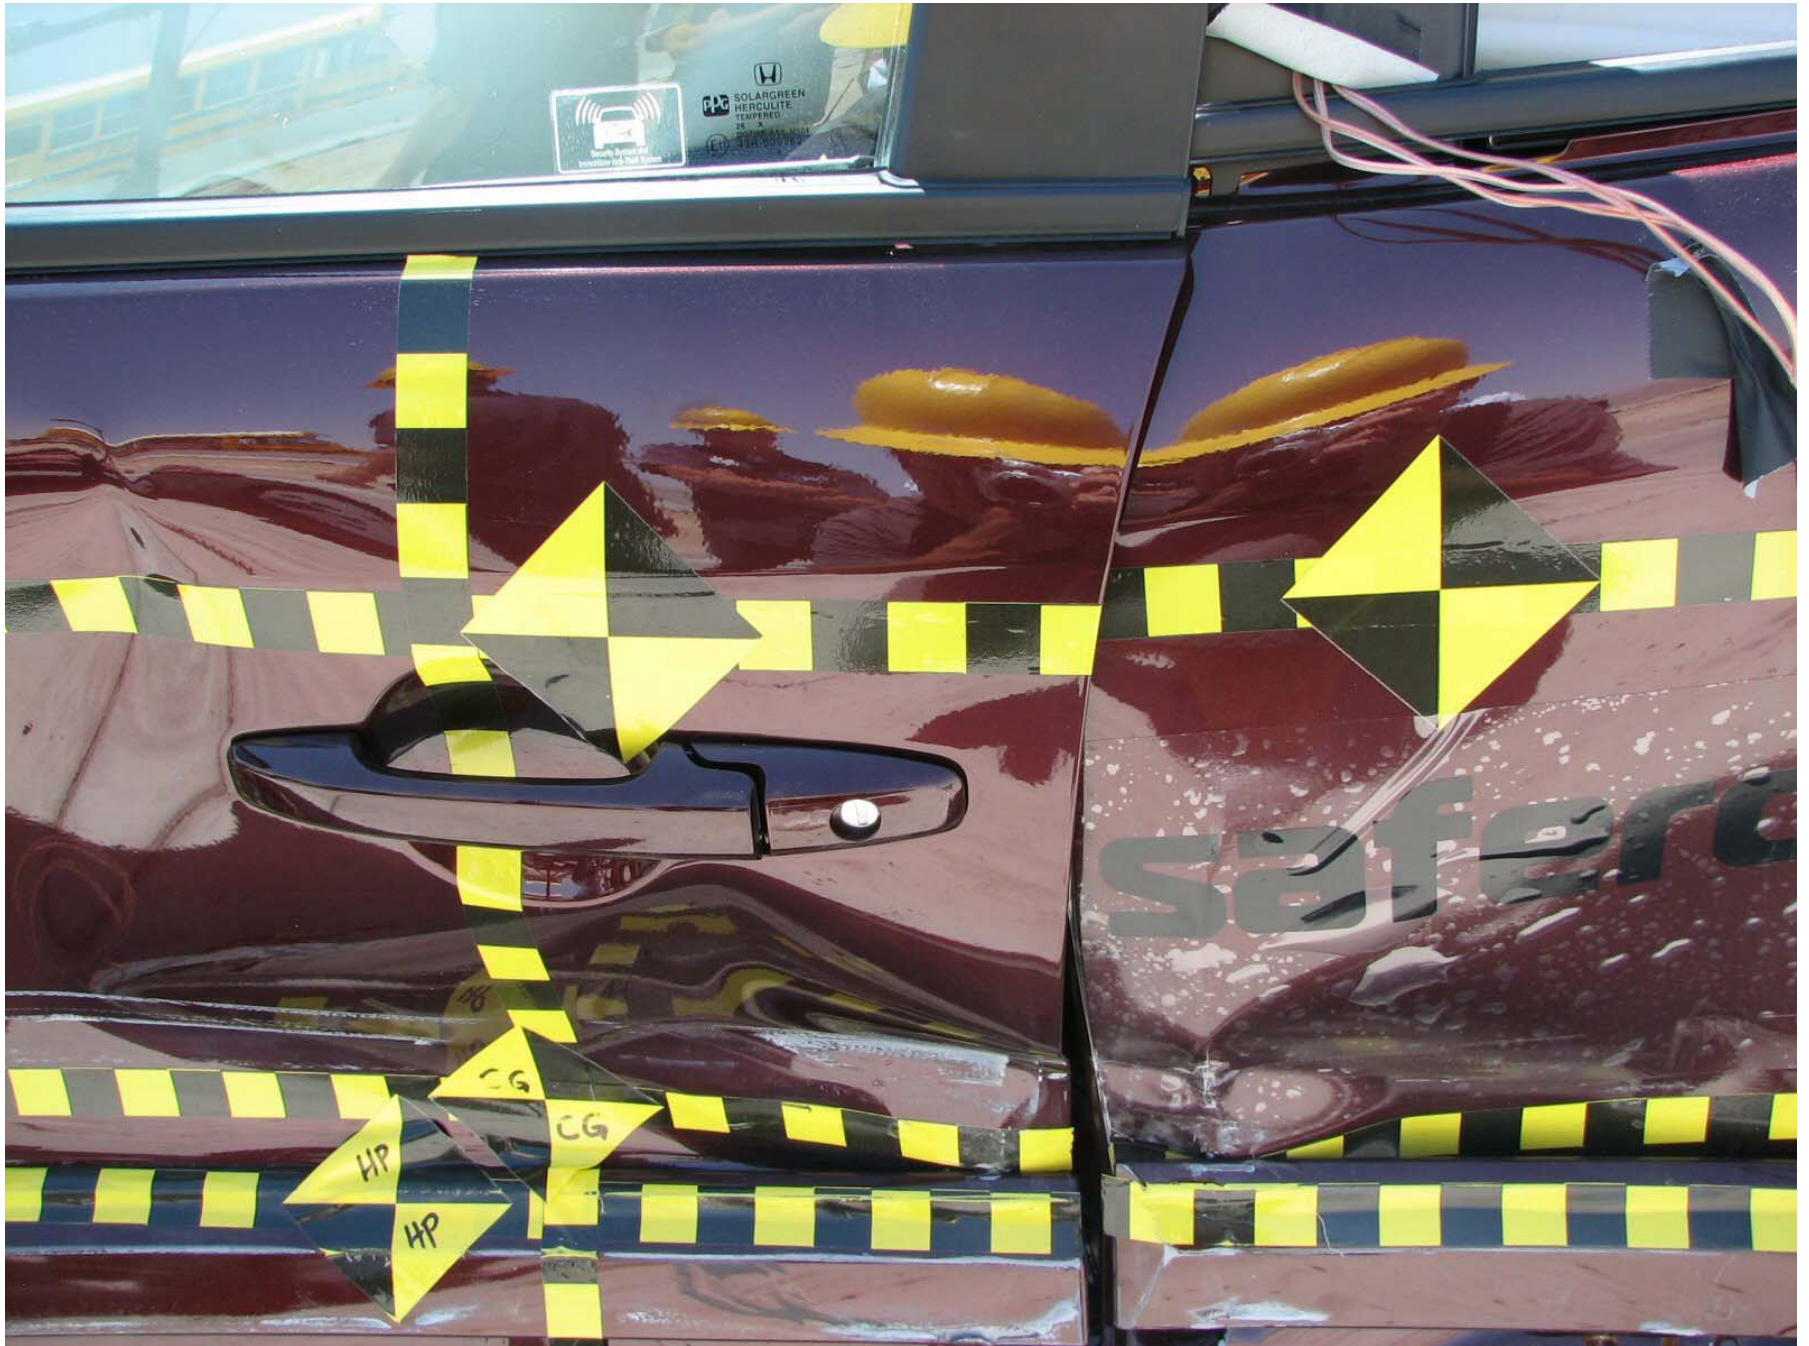
Figure A-32: Post-Test Left Front Door

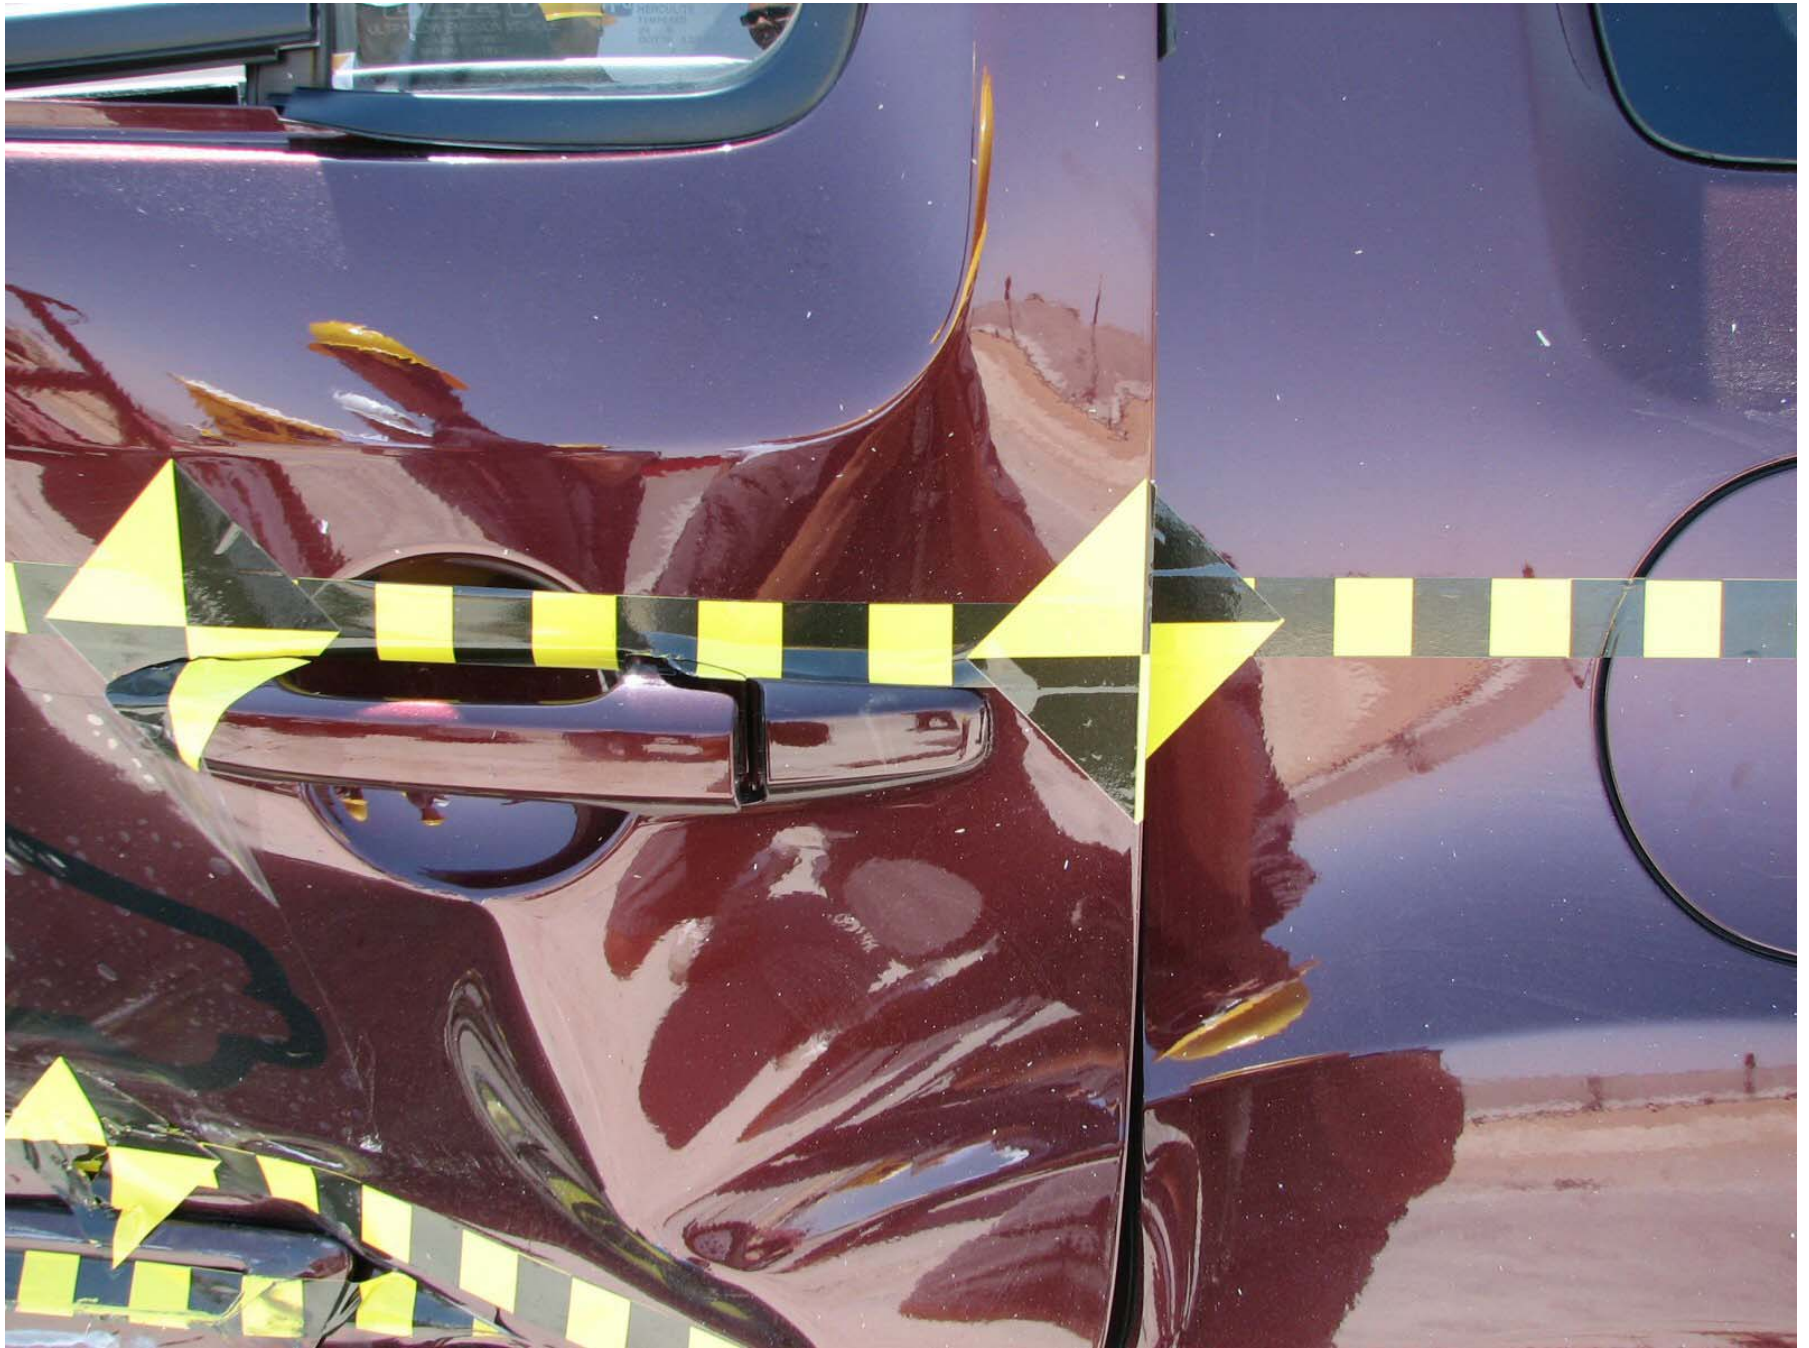
Figure A-34: Post-Test Left Rear Door

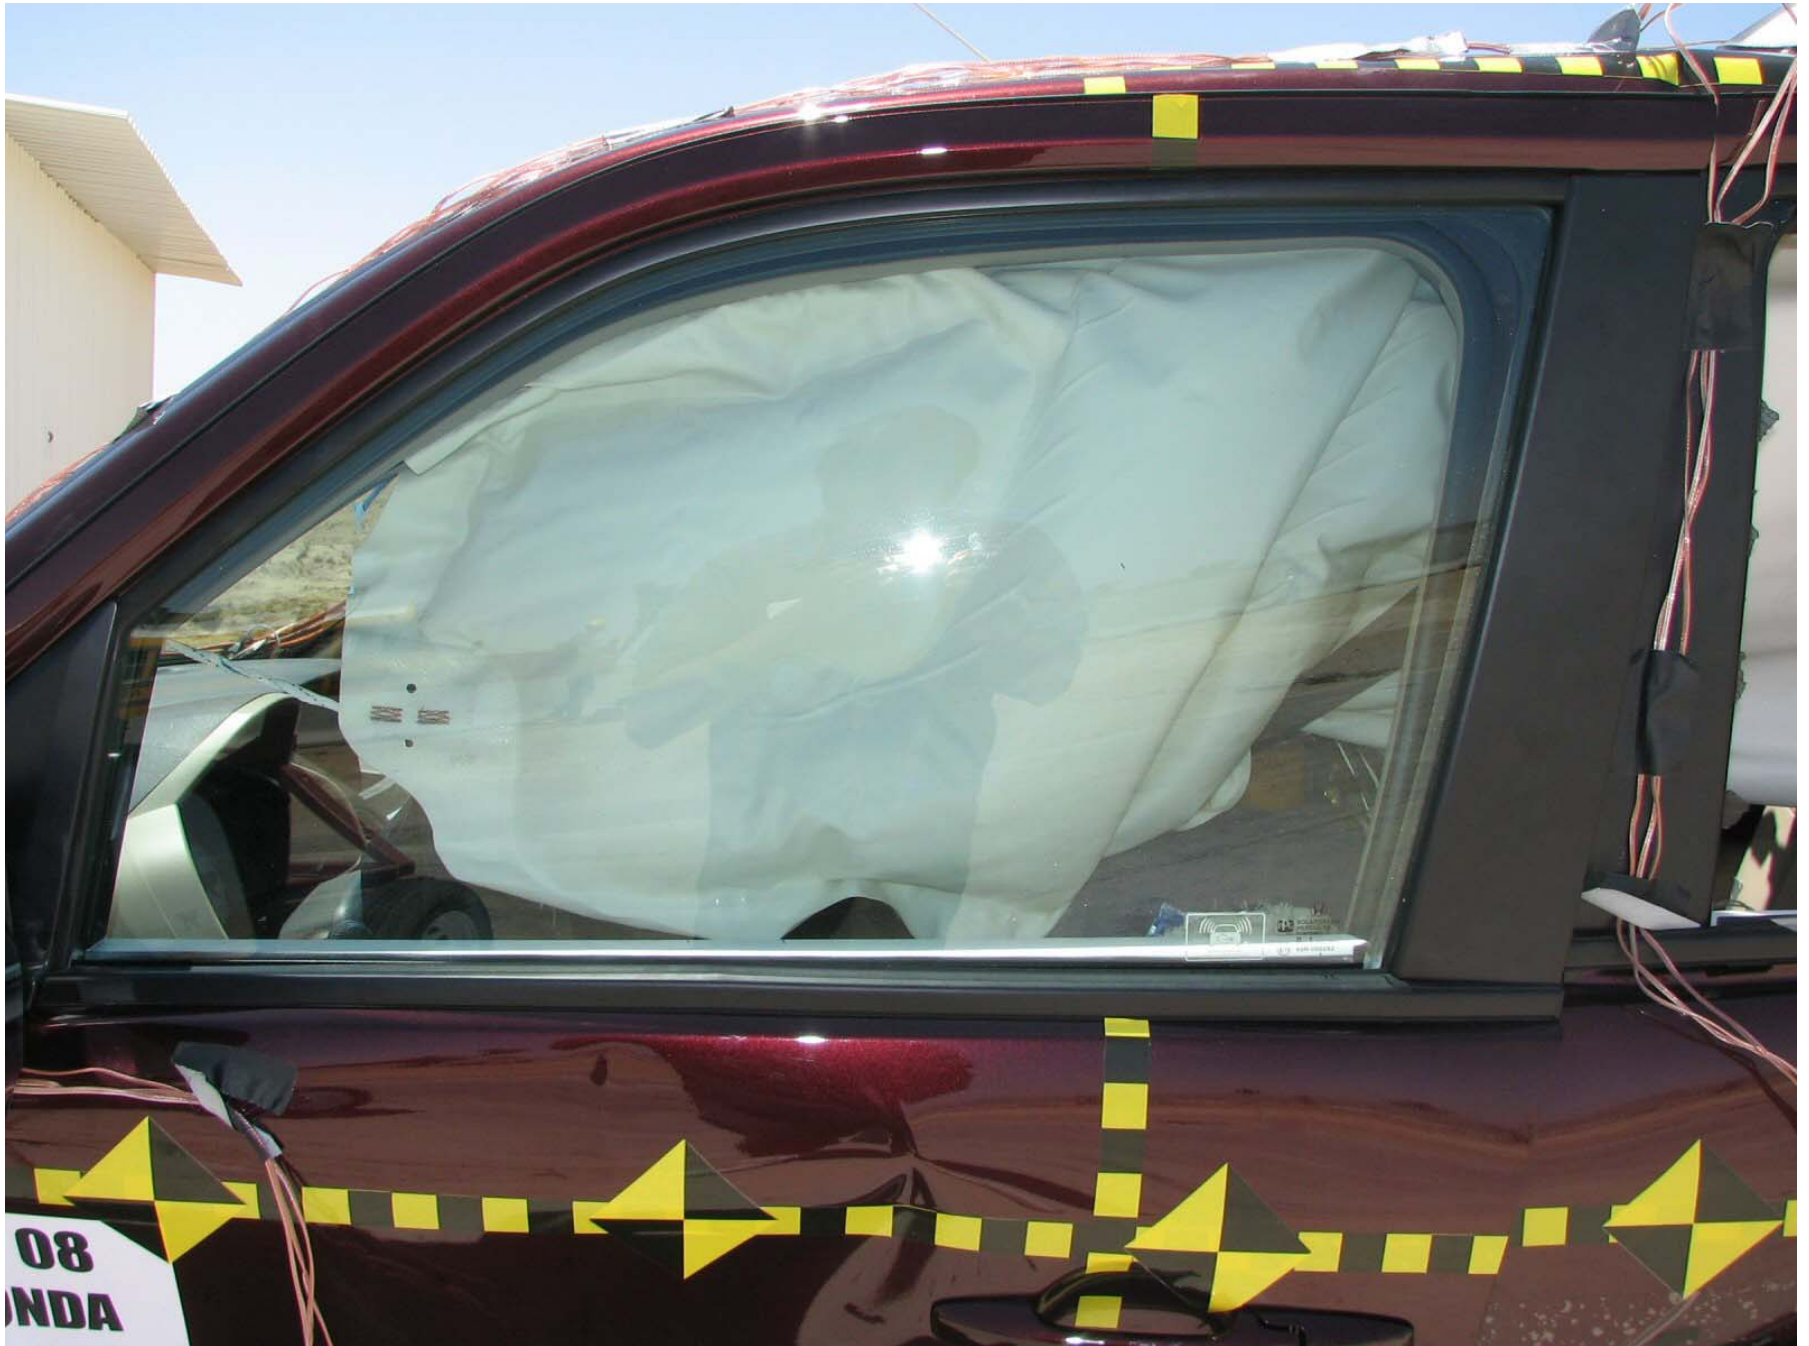
Figure A-37: Post-Test Driver Dummy (Through Window)

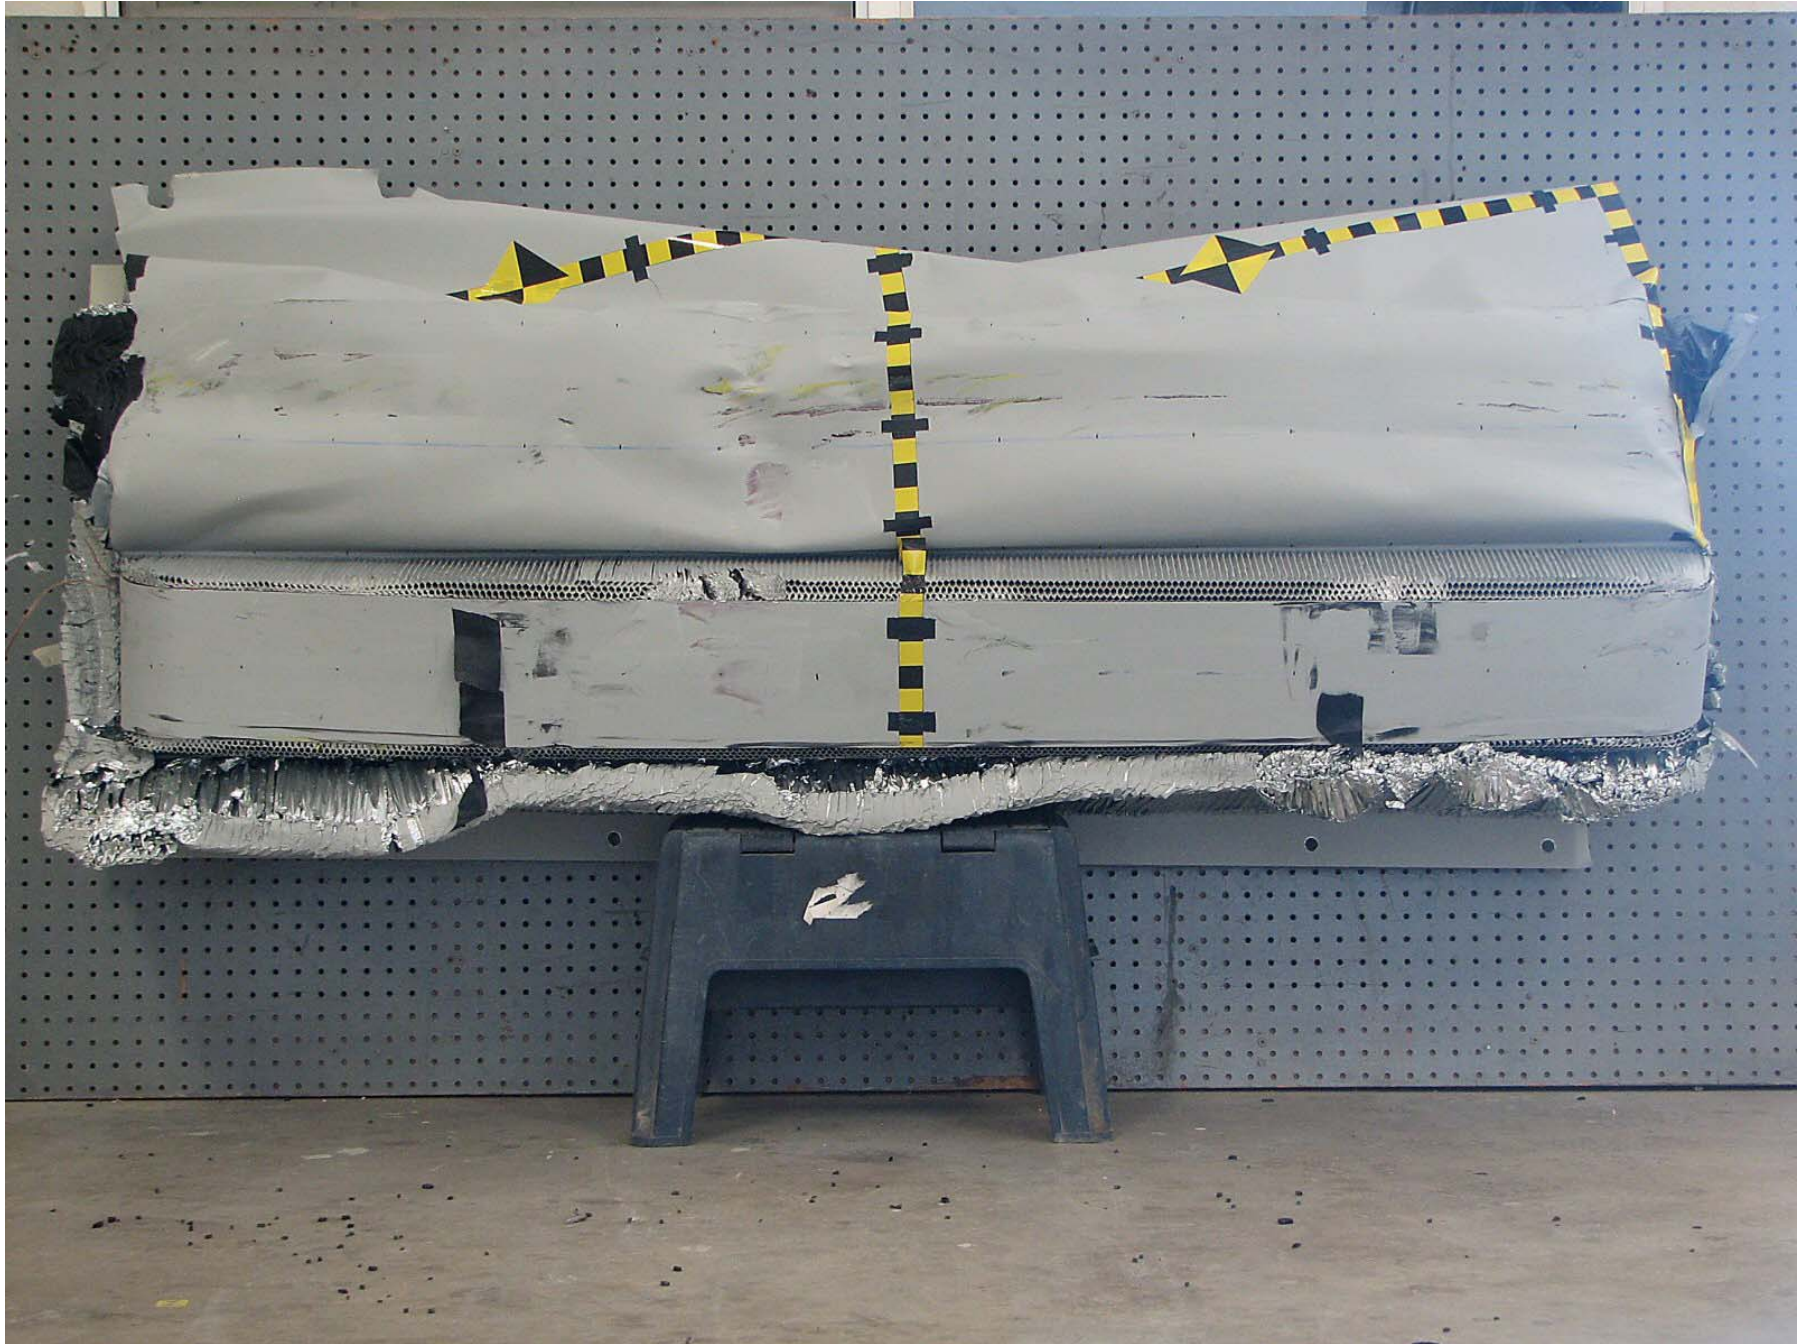
Figure A-54: Post-Test Front View of Deformable Barrier

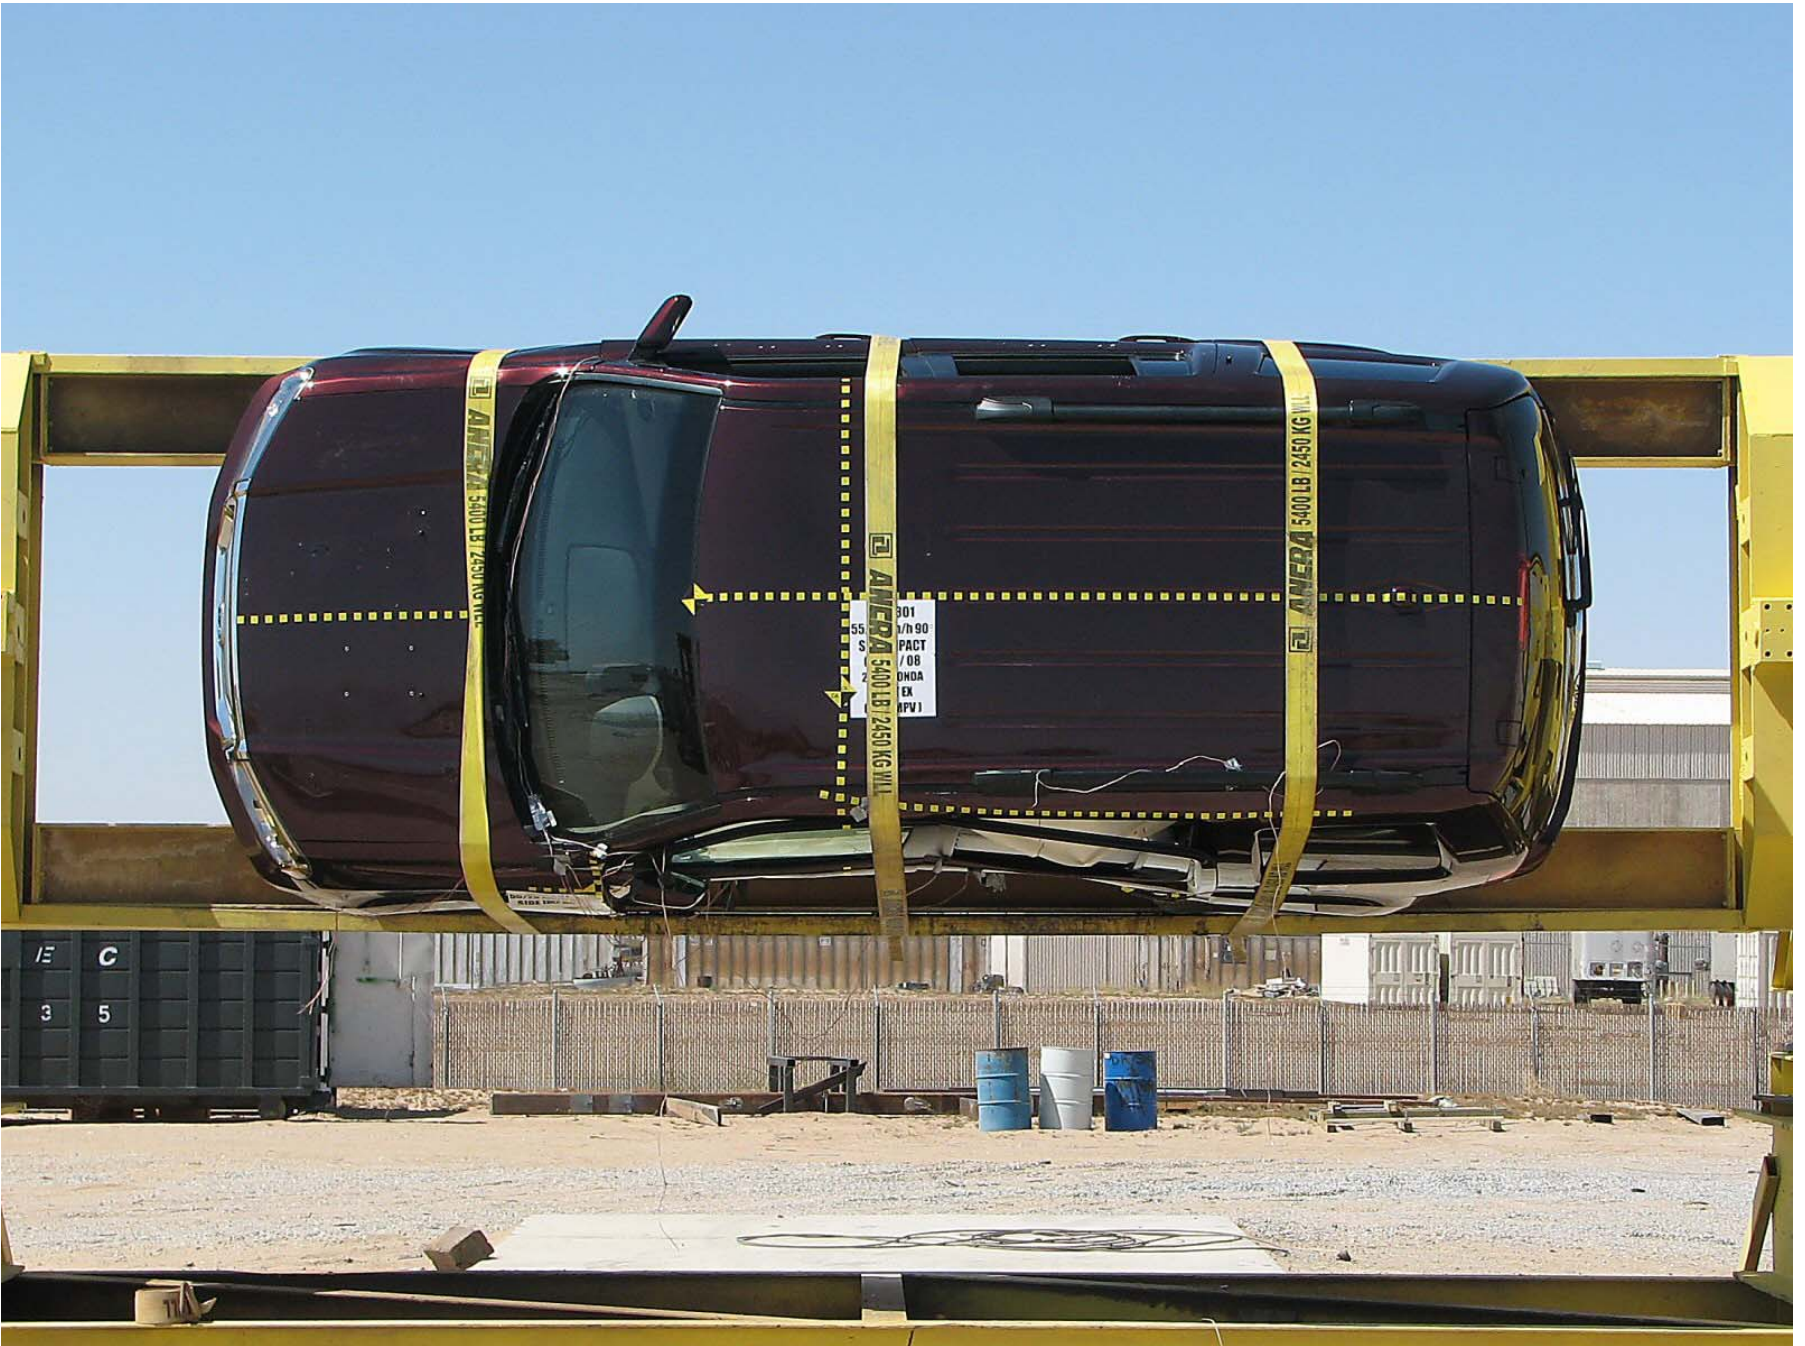
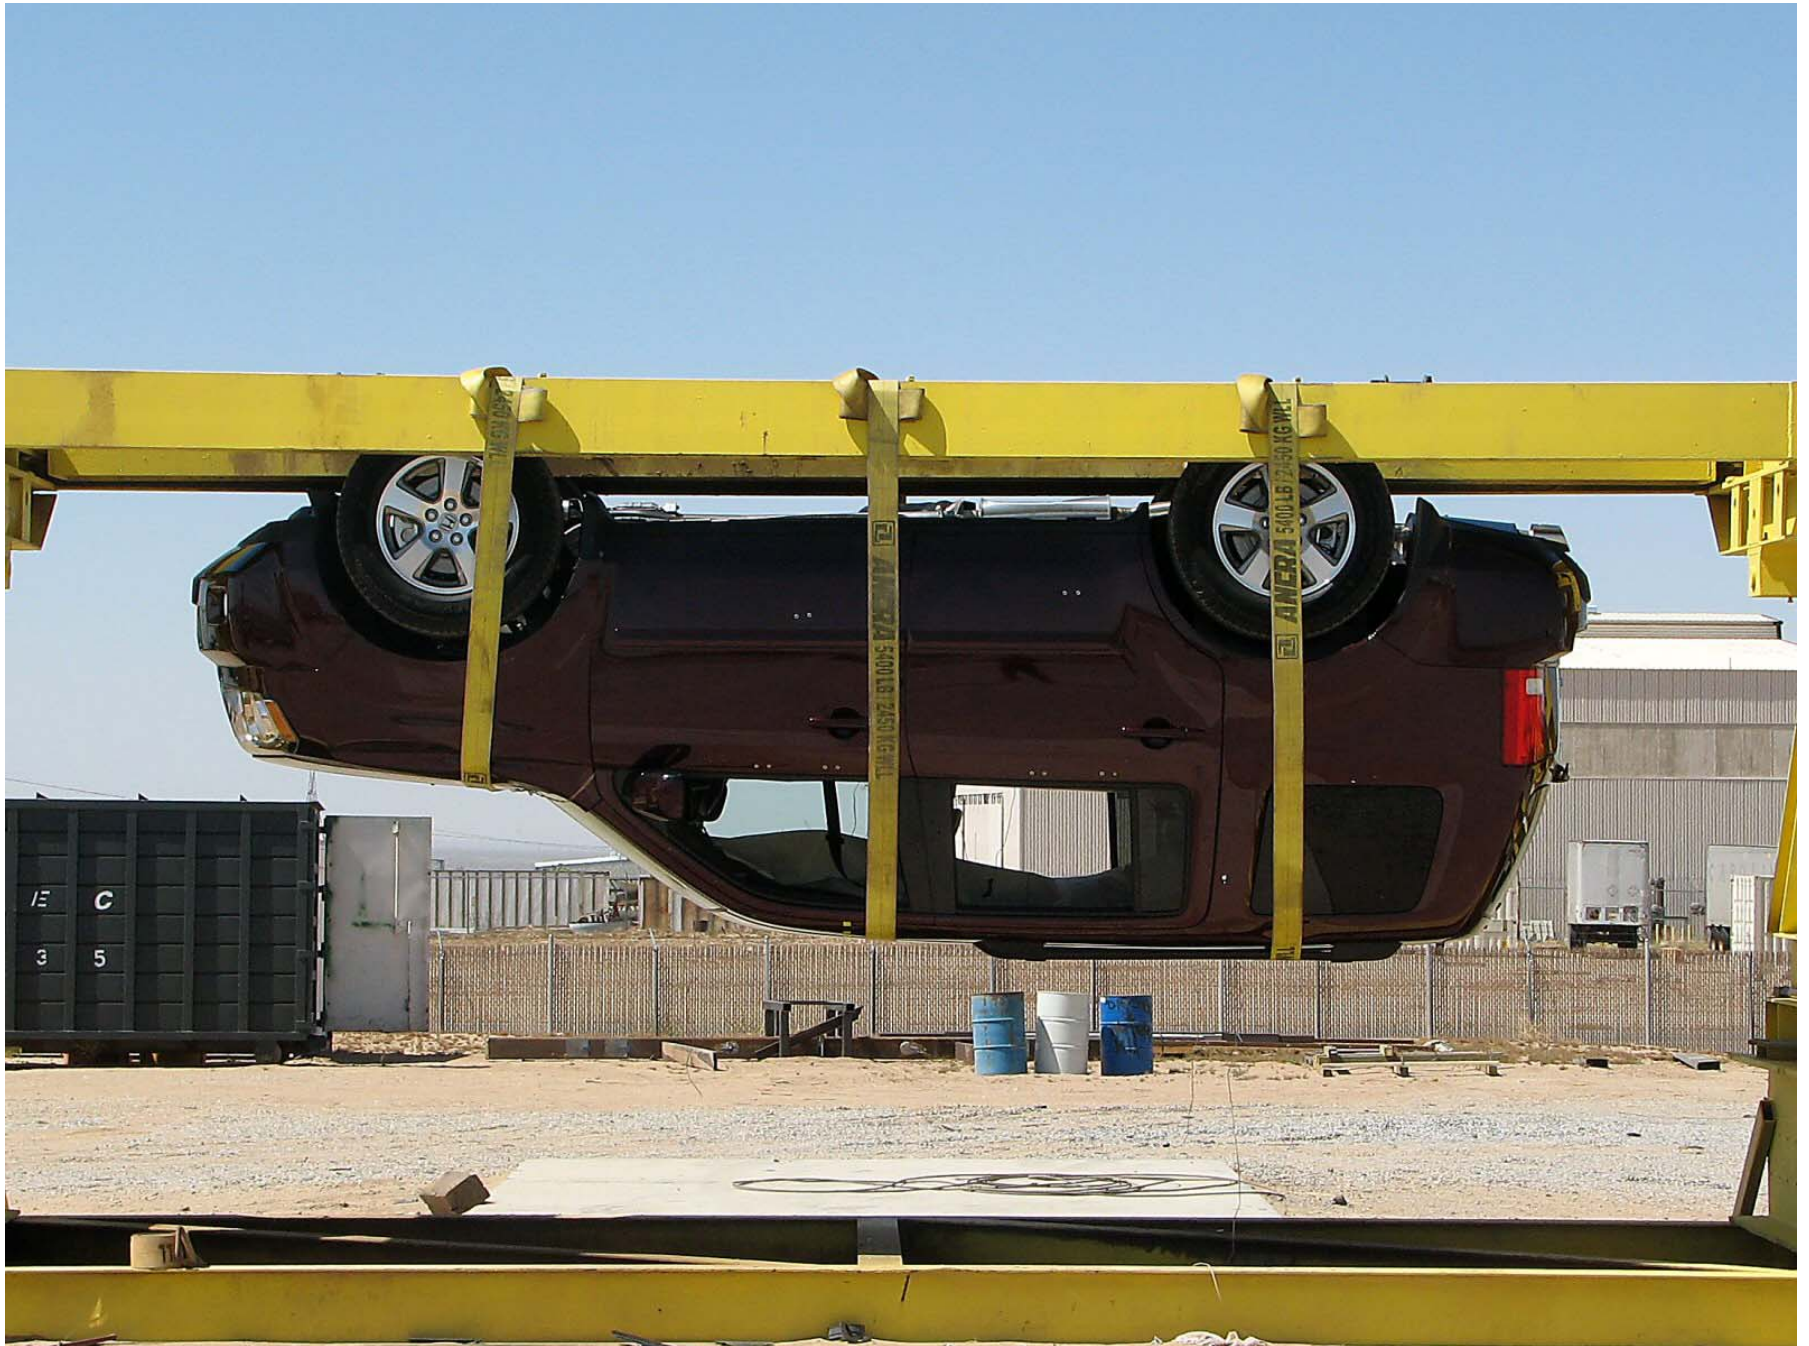
Figure A-61: Vehicle on Rollover Device (0°)

Figure A-62: Vehicle on Rollover Device (90°)

Figure A-63: Vehicle on Rollover Device (180°)

Figure A-64: Vehicle on Rollover Device (270°)

1. The specified fixture rollover rate for each 90° of rotation is 60 to 120 seconds.
2. The position hold time at each position is 300 seconds (minimum).
3. Details of Stoddard Solvent spillage locations.  
No solvent leakage occurred during static rollover testing.

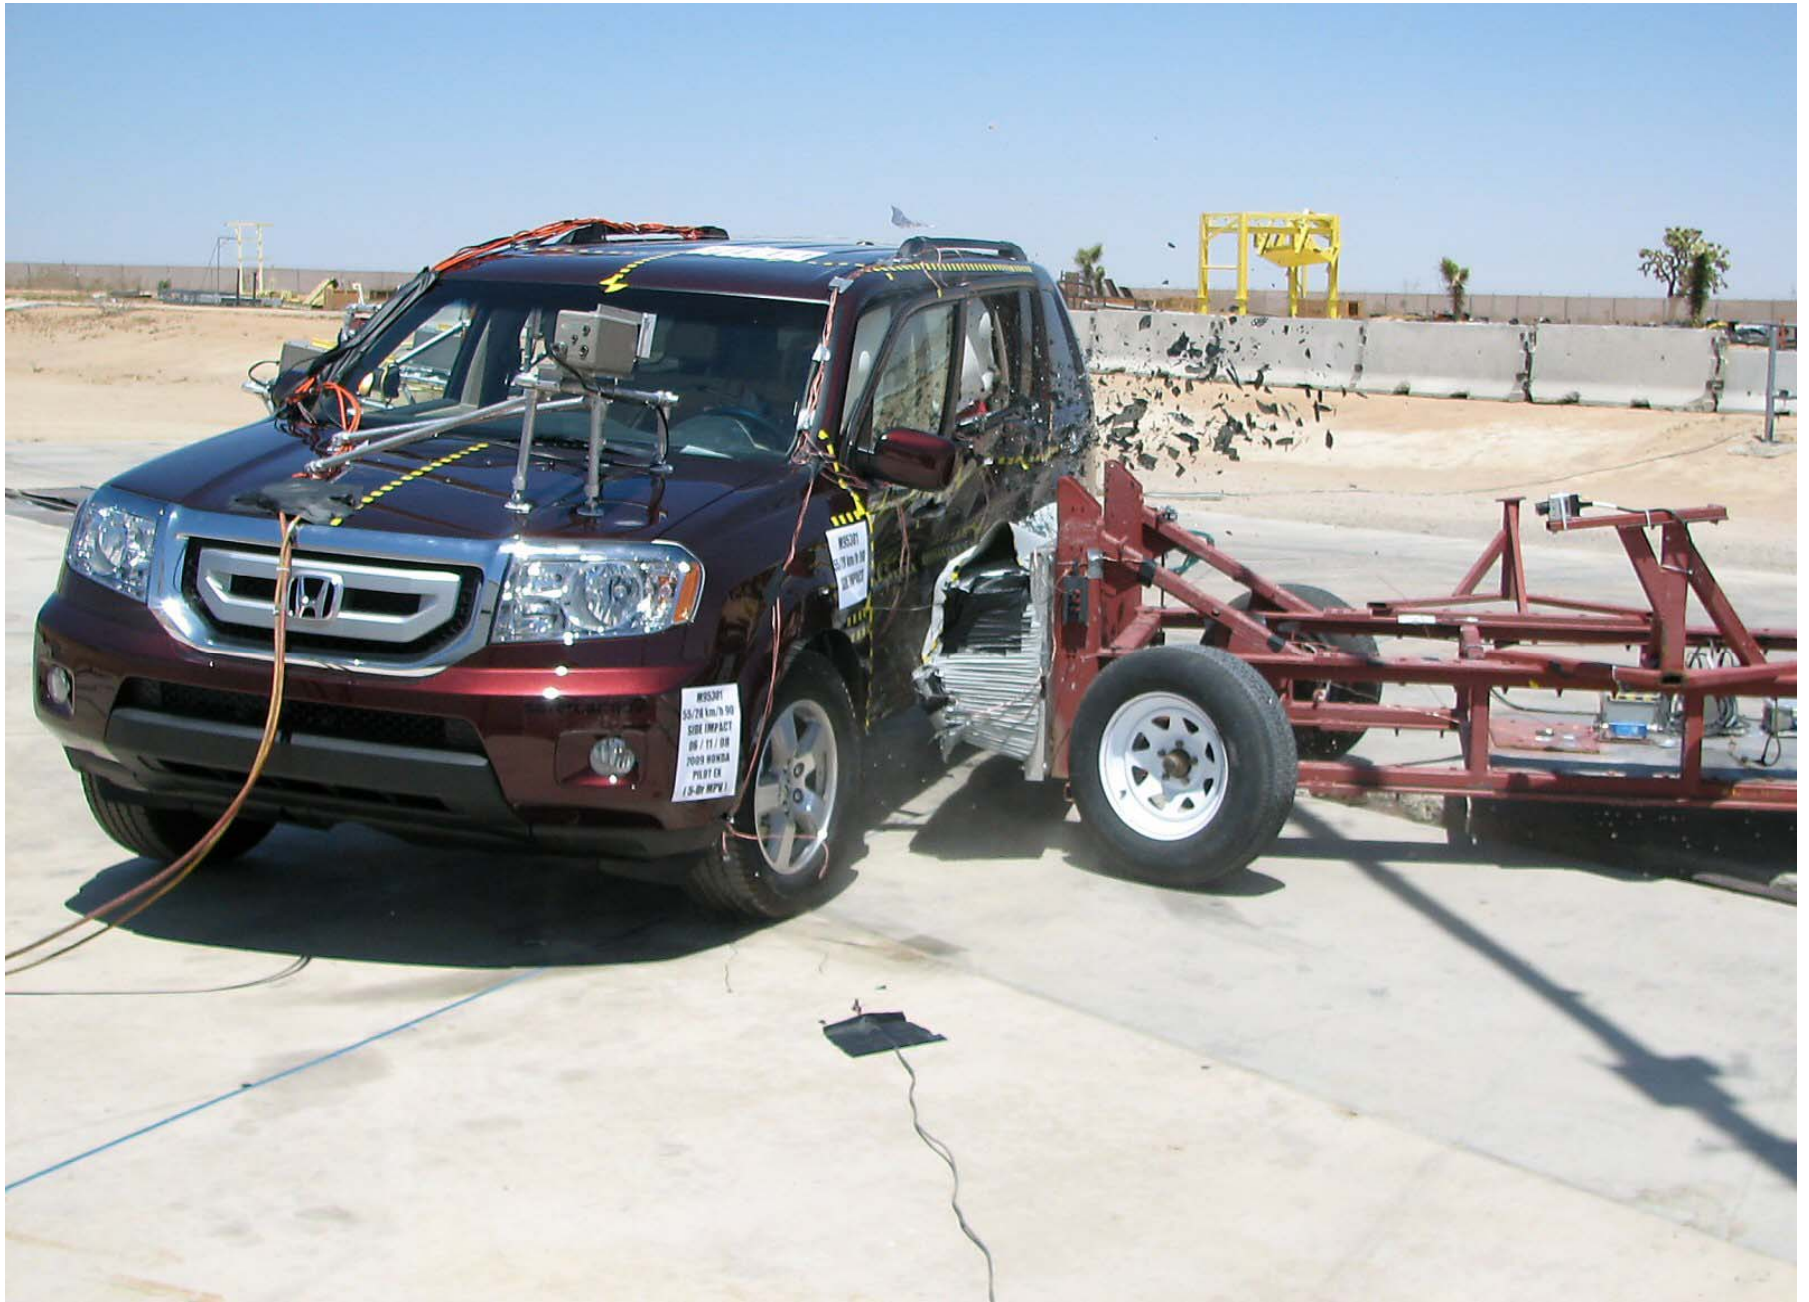
Figure A-65: Vehicle Impact

A model year 2009 Honda Pilot EX 5-Dr MPV was impacted on the left (driver's) side by a Moving Deformable Barrier (MDB) which was moving forward in a 27° crabbed position to the tow road guidance system at a velocity of 62.18 km/h. The specified impact velocity range is from 61.14 to 62.75 km/h. The test (target) vehicle was stationary and positioned 63° to the line of forward motion. The weight of the vehicle as tested was 2155 kg and the test weight of the MDB was 1361 kg. The test was conducted at KARCO Engineering, LLC in Adelanto, California, on June 11, 2008.
