**REPORT NUMBER TR-P28001-20-NC**

**NEW CAR ASSESMENT PROGRAM  
FRONTAL BARRIER IMPACT TEST**

**HONDA MFG. OF ALABAMA, LLC  
2009 HONDA PILOT EX 4WD  
5-DOOR MPV**

**NHTSA NUMBER: M95300**

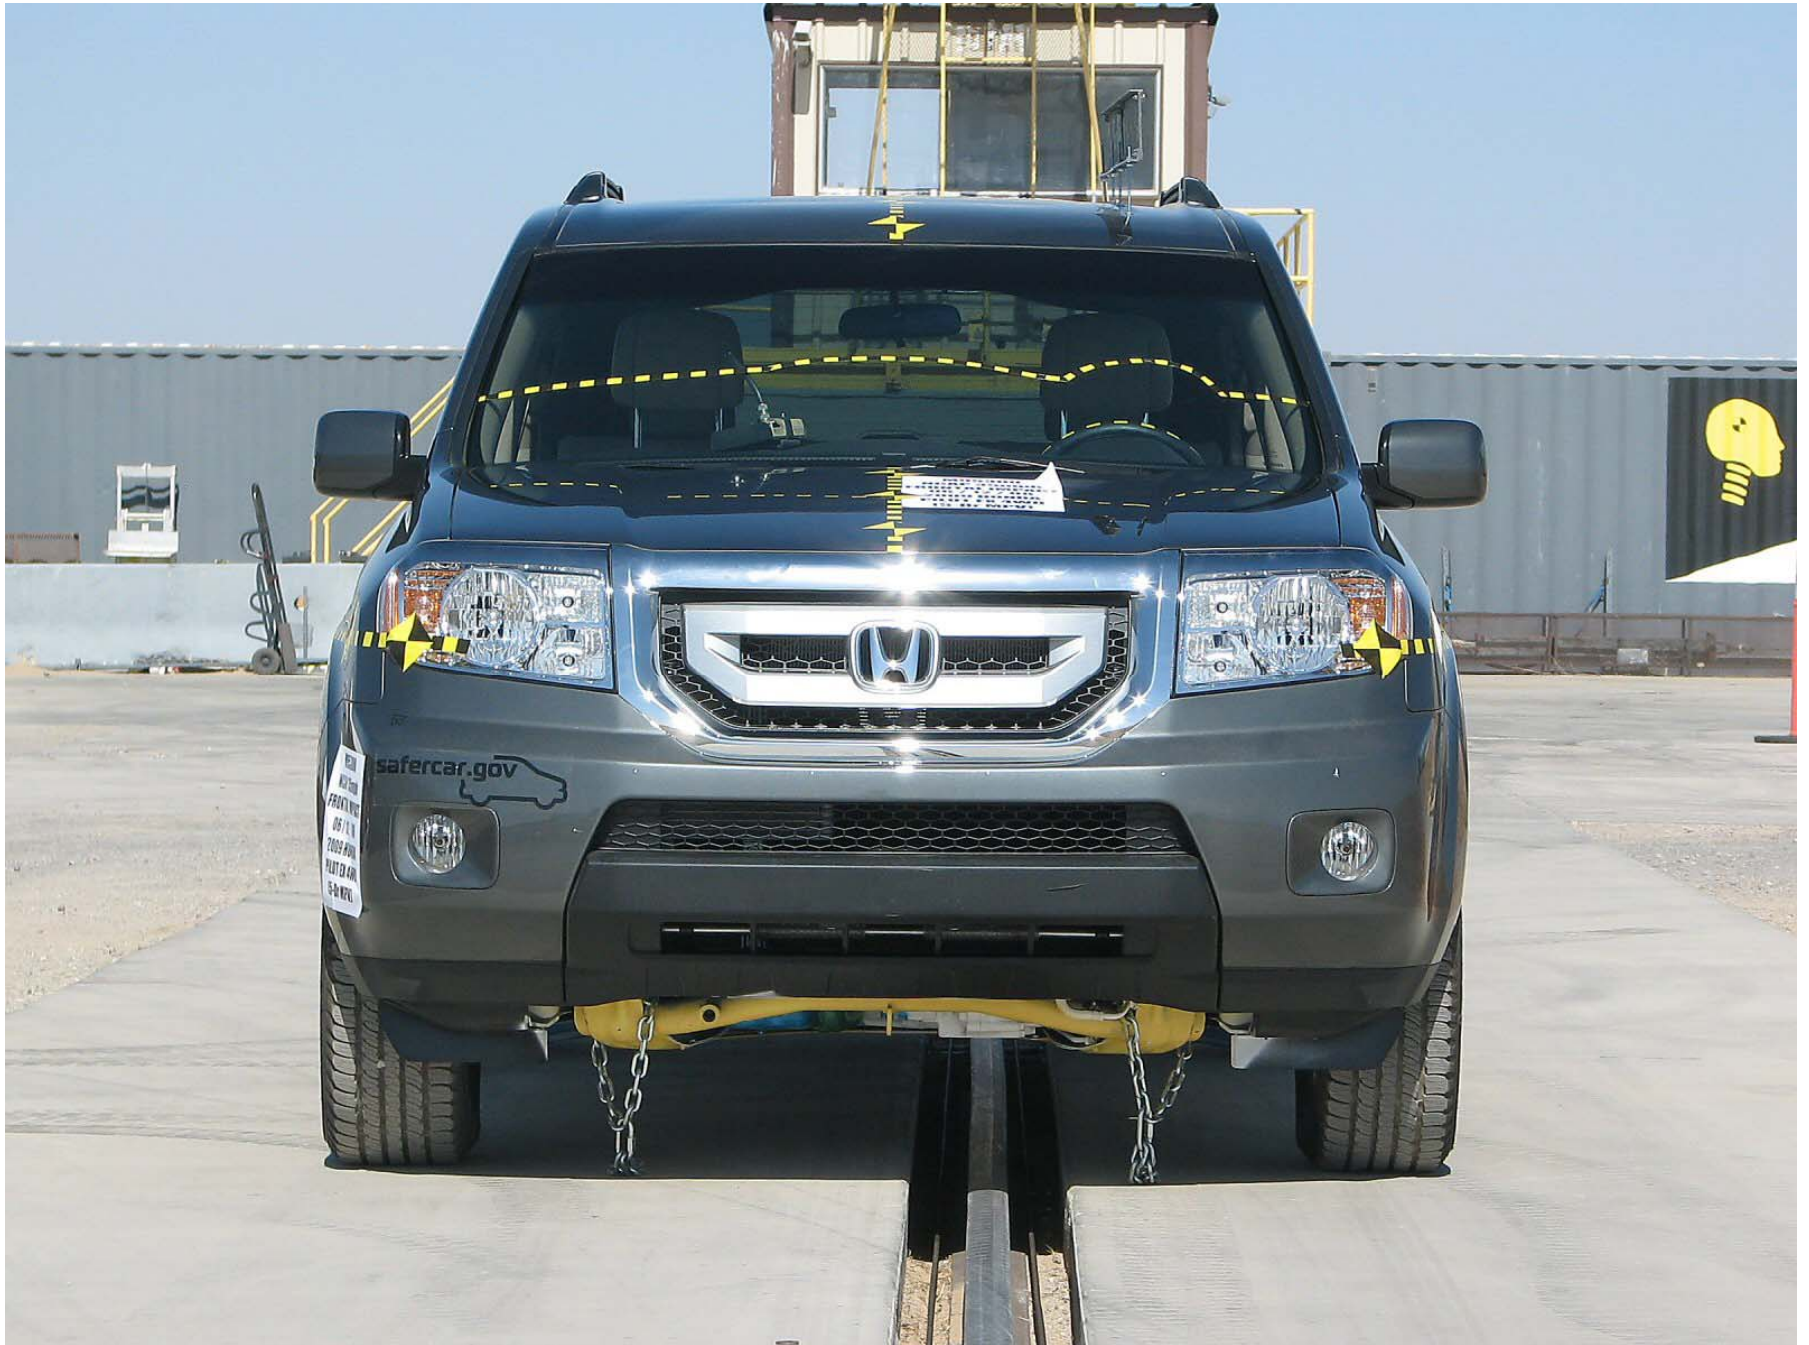
Figure A-6: Pre-Test Front View

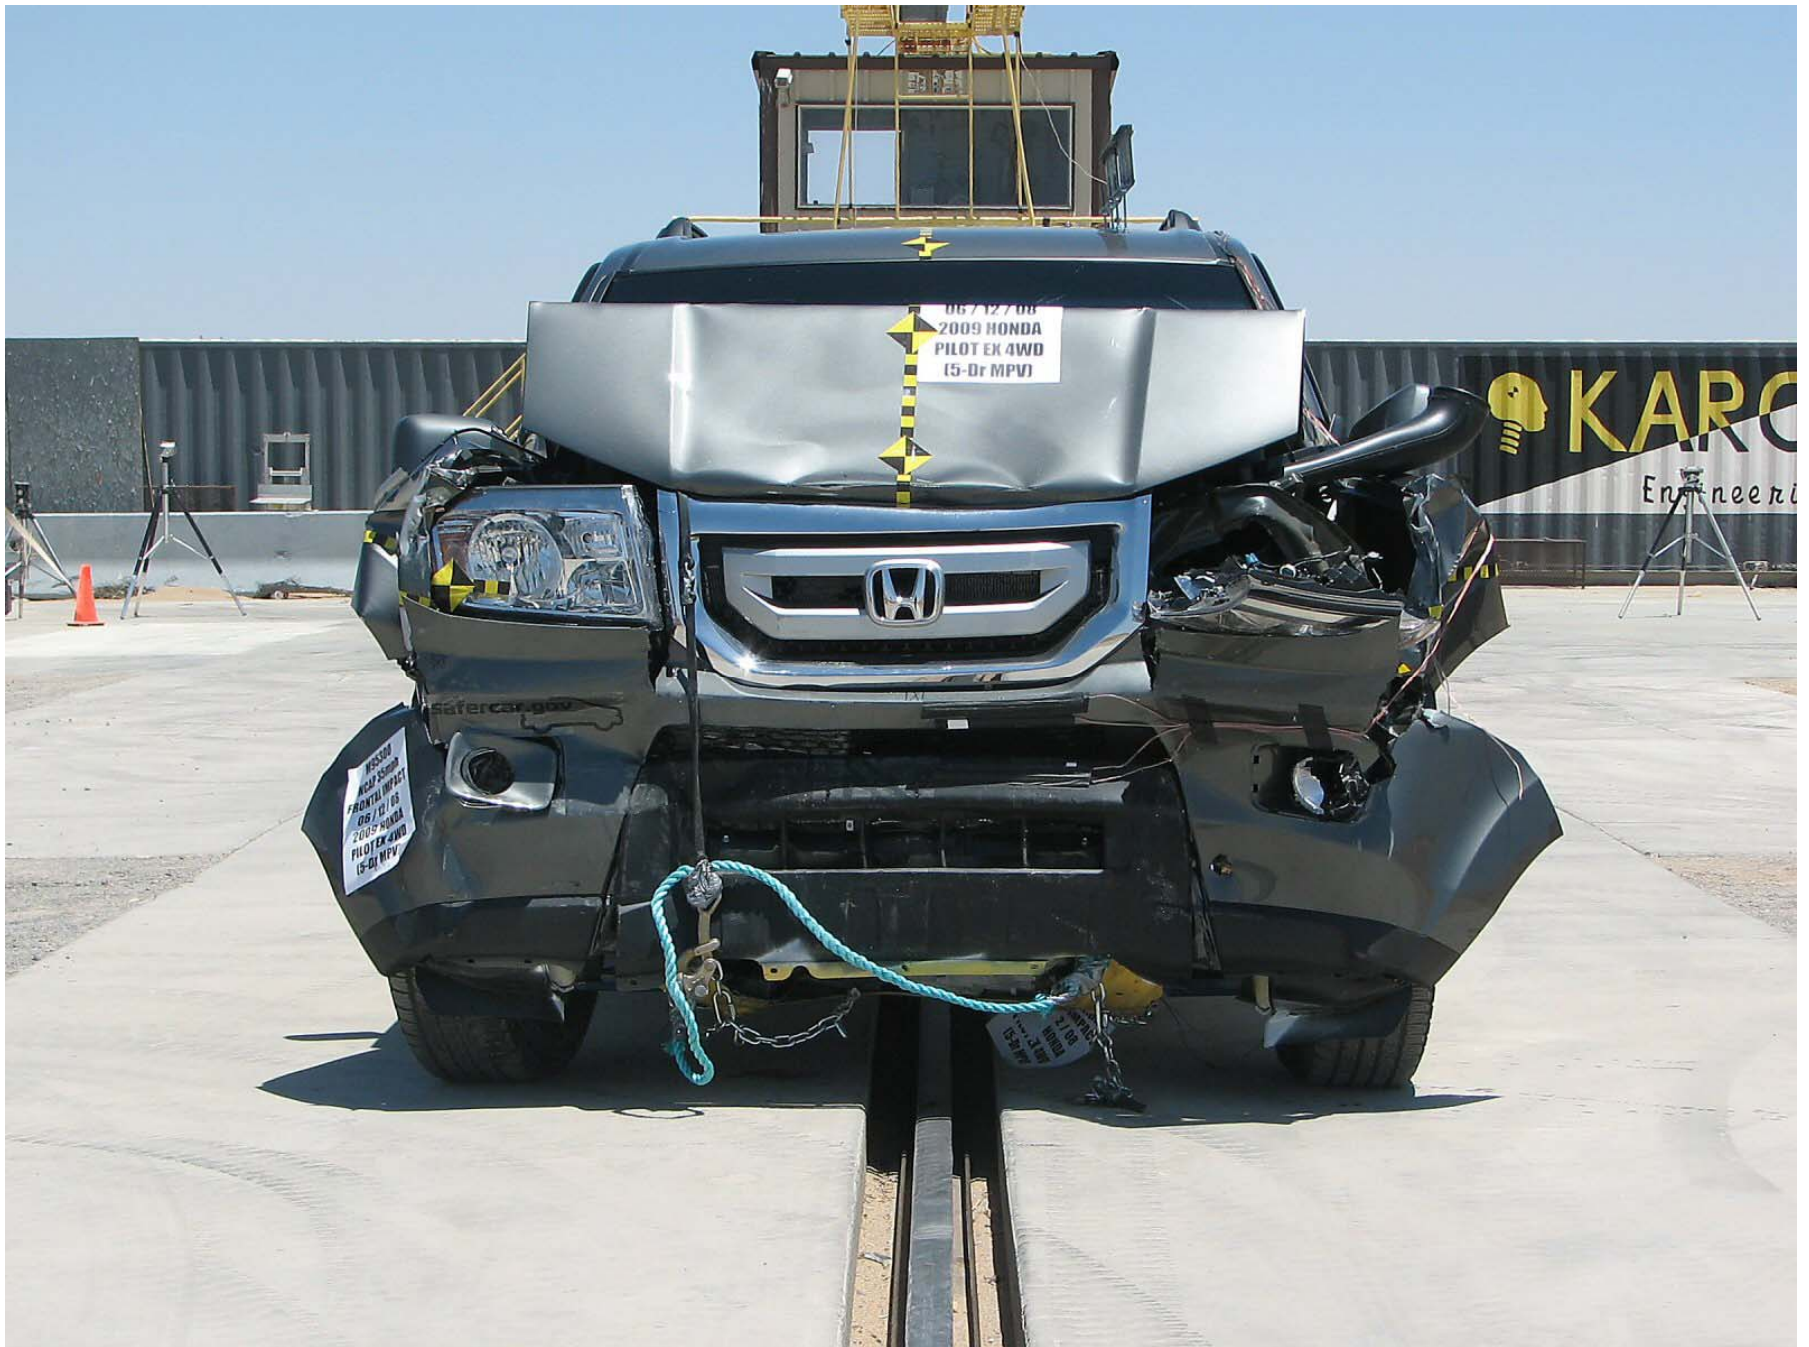
Figure A-7: Post-Test Front View (Vehicle Moved)

The maximum static crush of the vehicle was 440 mm at the vehicle's centerline. Both the driver and passenger side doors remained closed and latched during the impact event, and were operable after the impact.

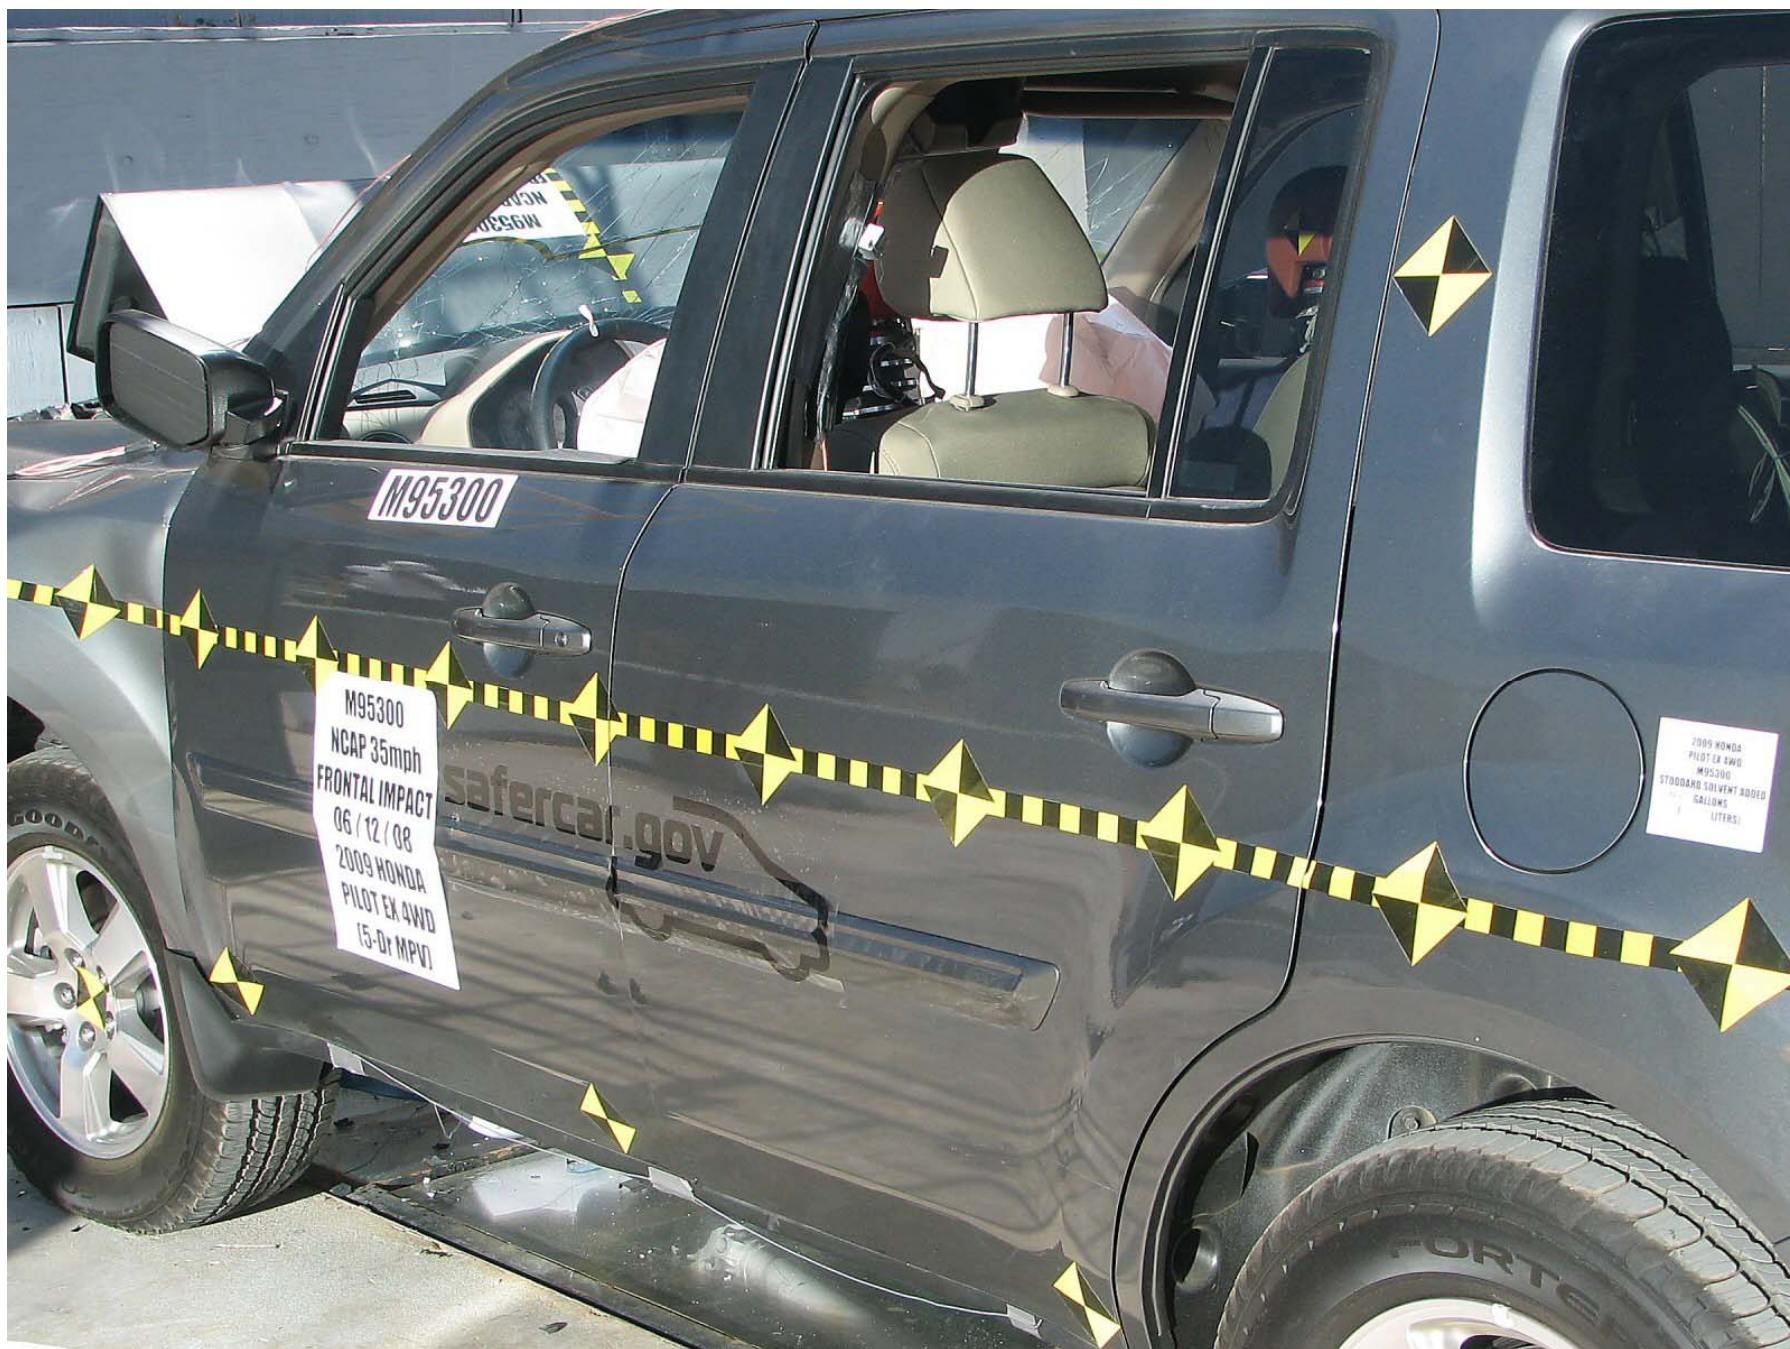
Figure A-16: Post-Test Left Side ¾ View of Doors After Impact

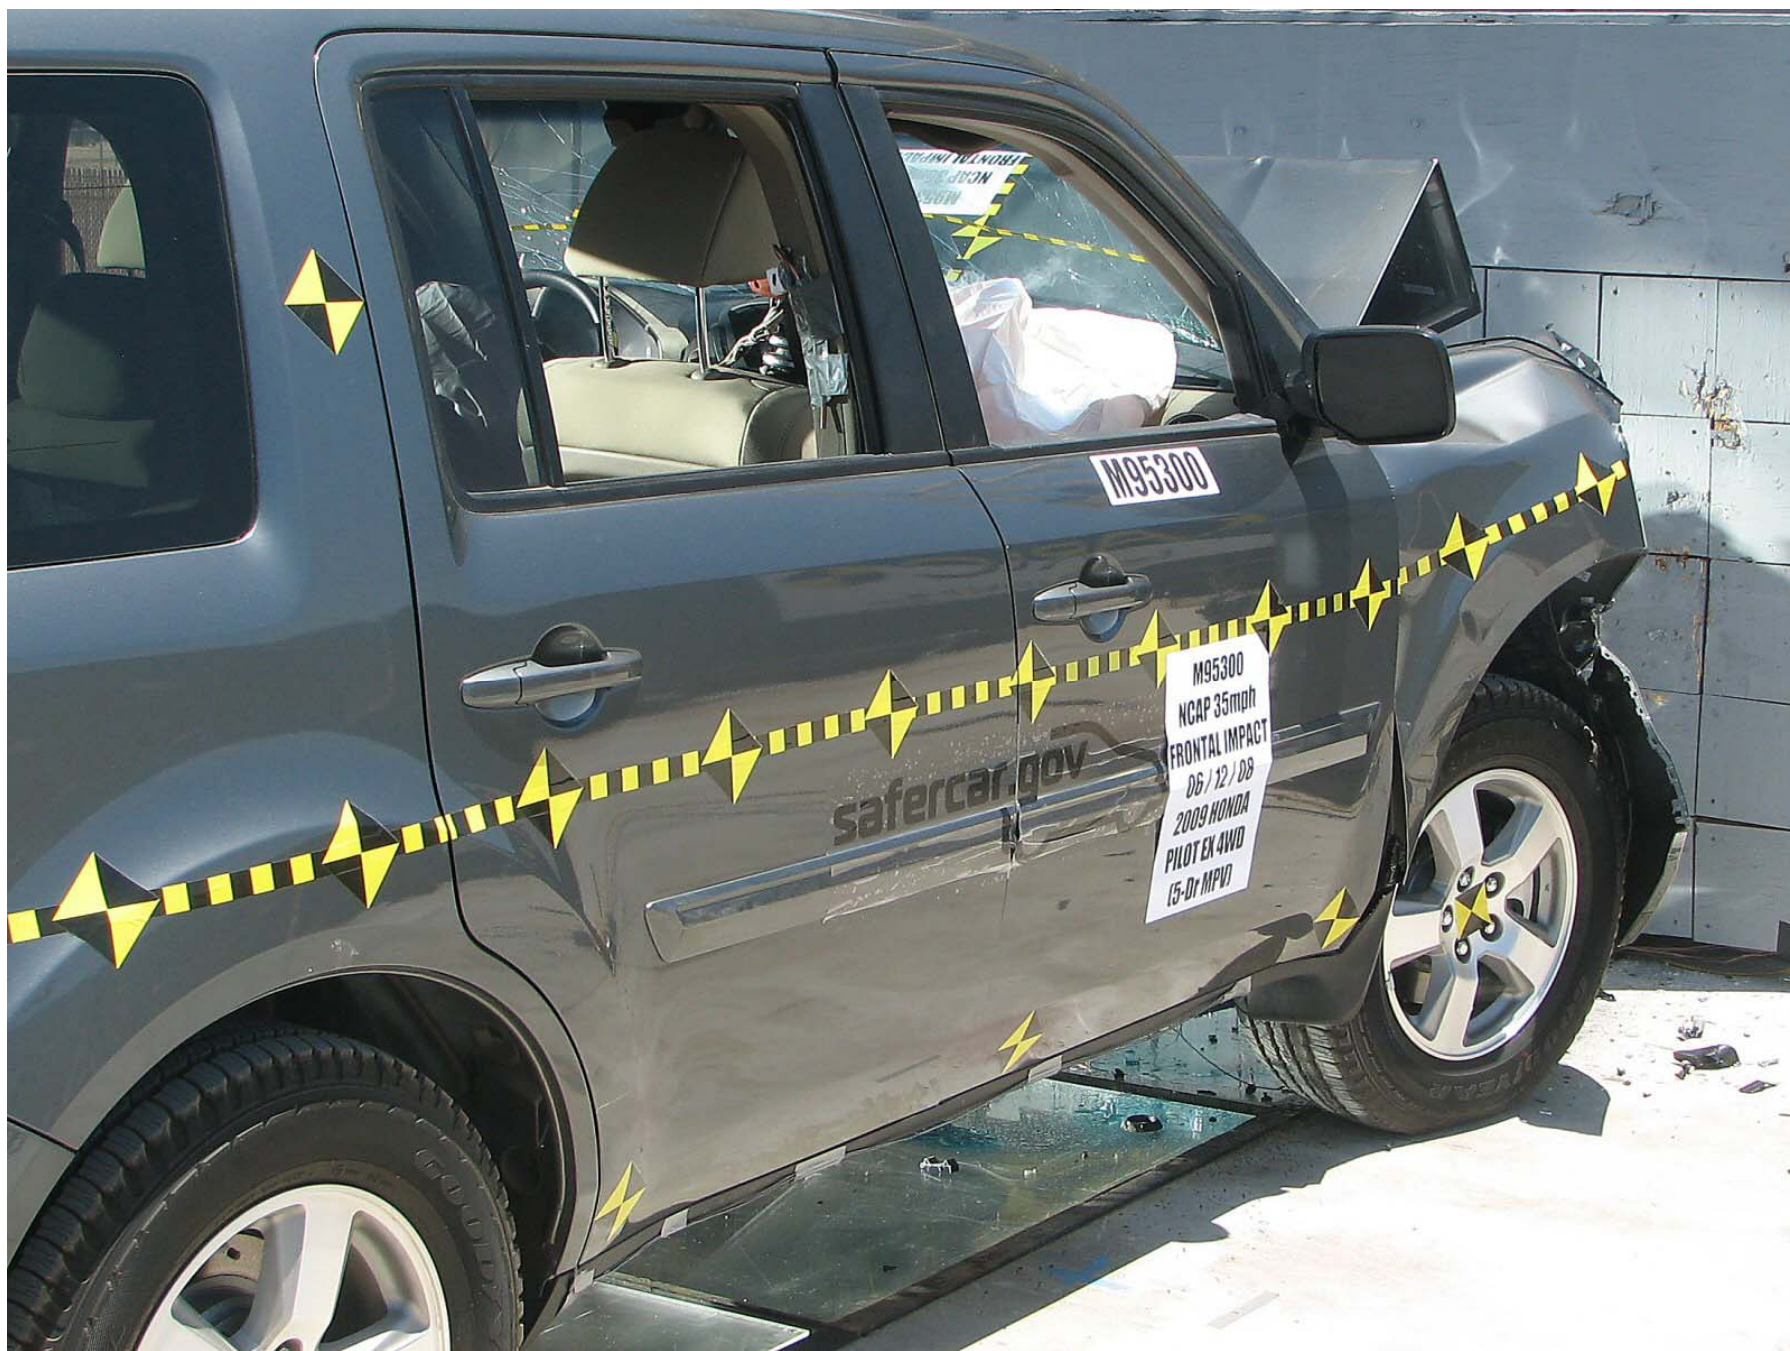
Figure A-17: Post-Test Right Side  $\frac{3}{4}$  View of Doors After Impact

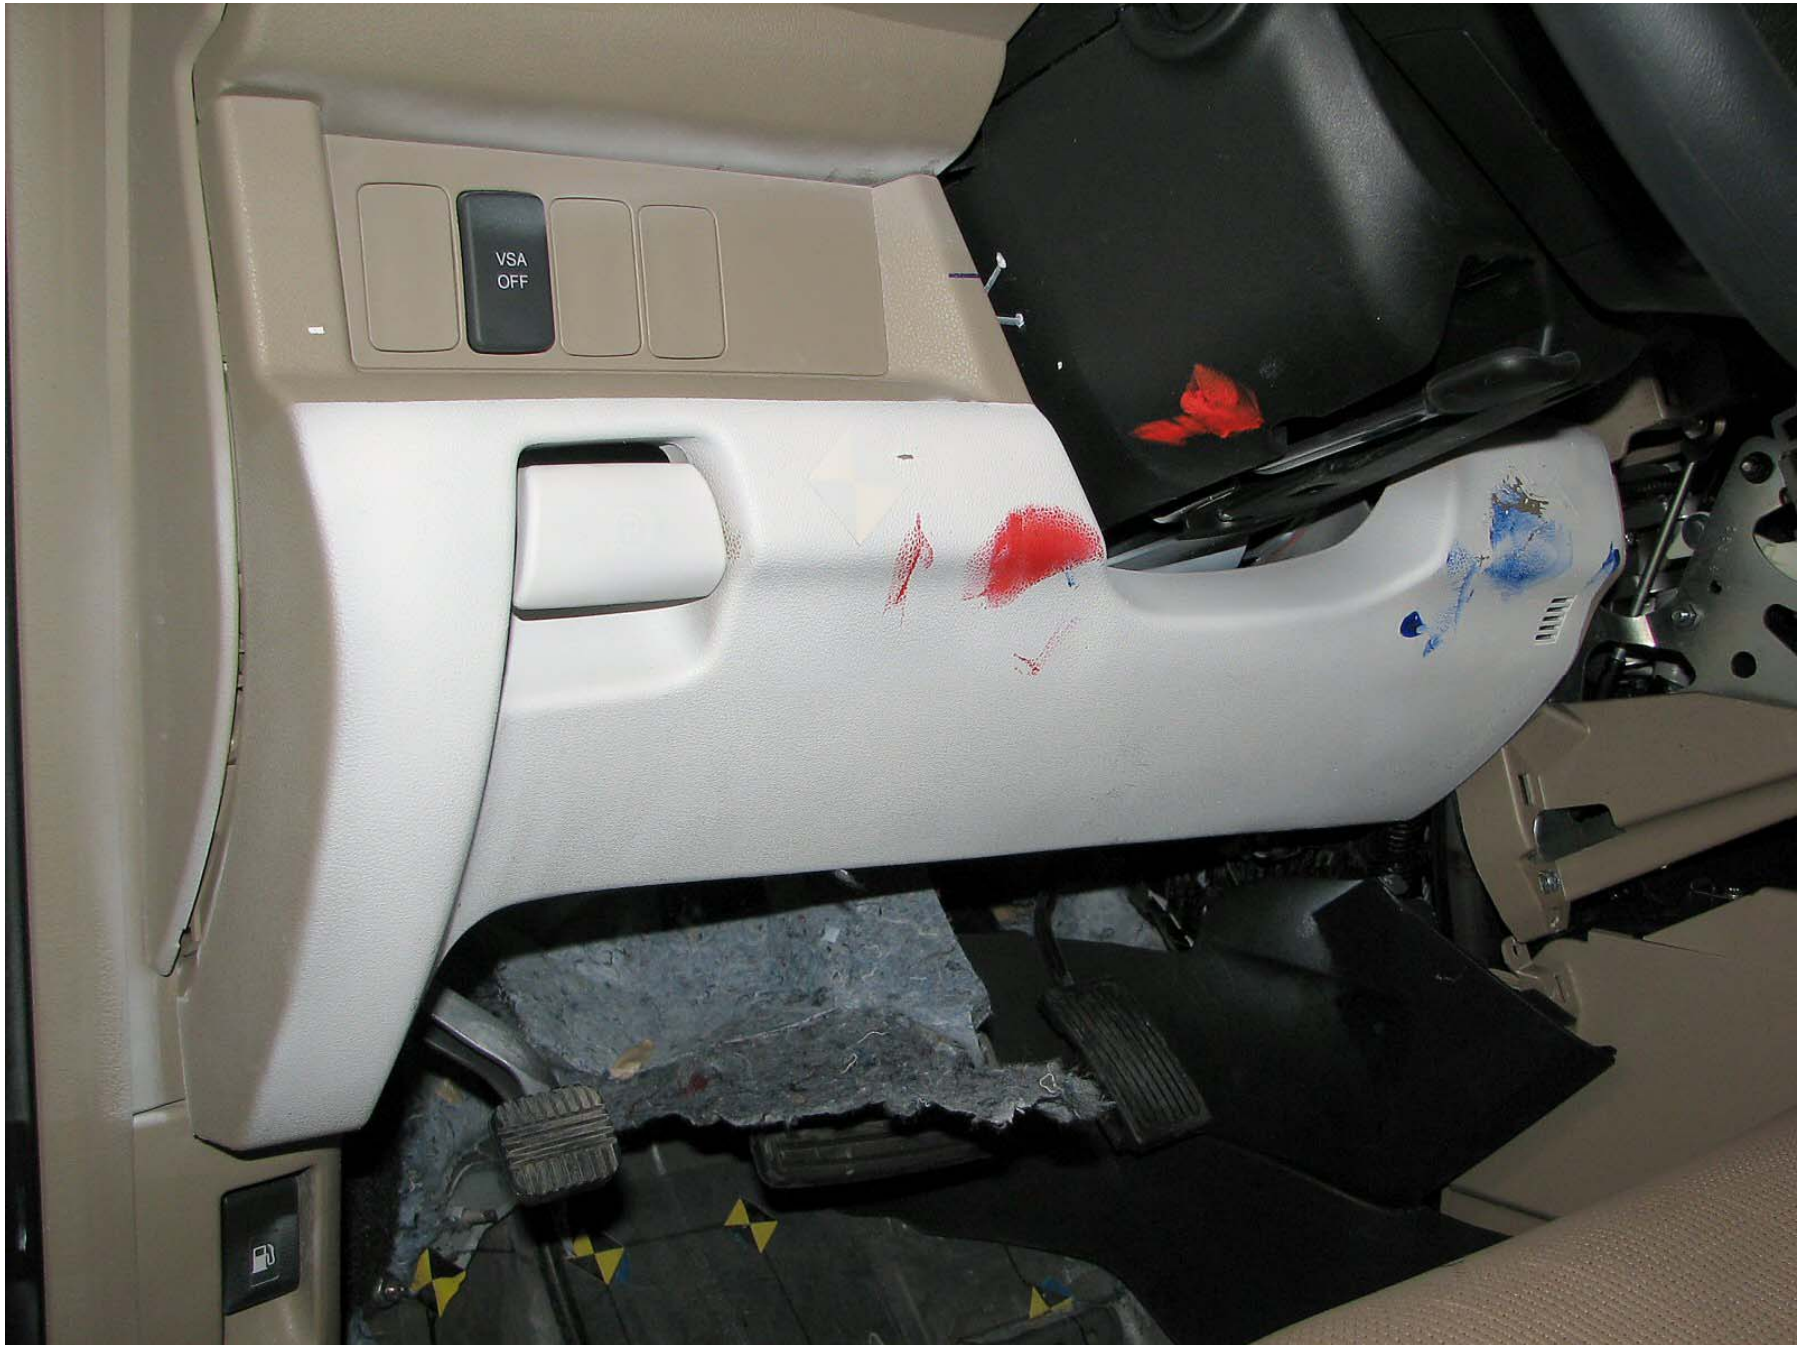
Figure A-39: Post-Test Driver Side Knee Bolster

The driver's visible contact points were as follows: The driver ATD's head, chest, and abdomen contacted the airbag. The head also contacted the headrest. Both knees contacted the bolster.

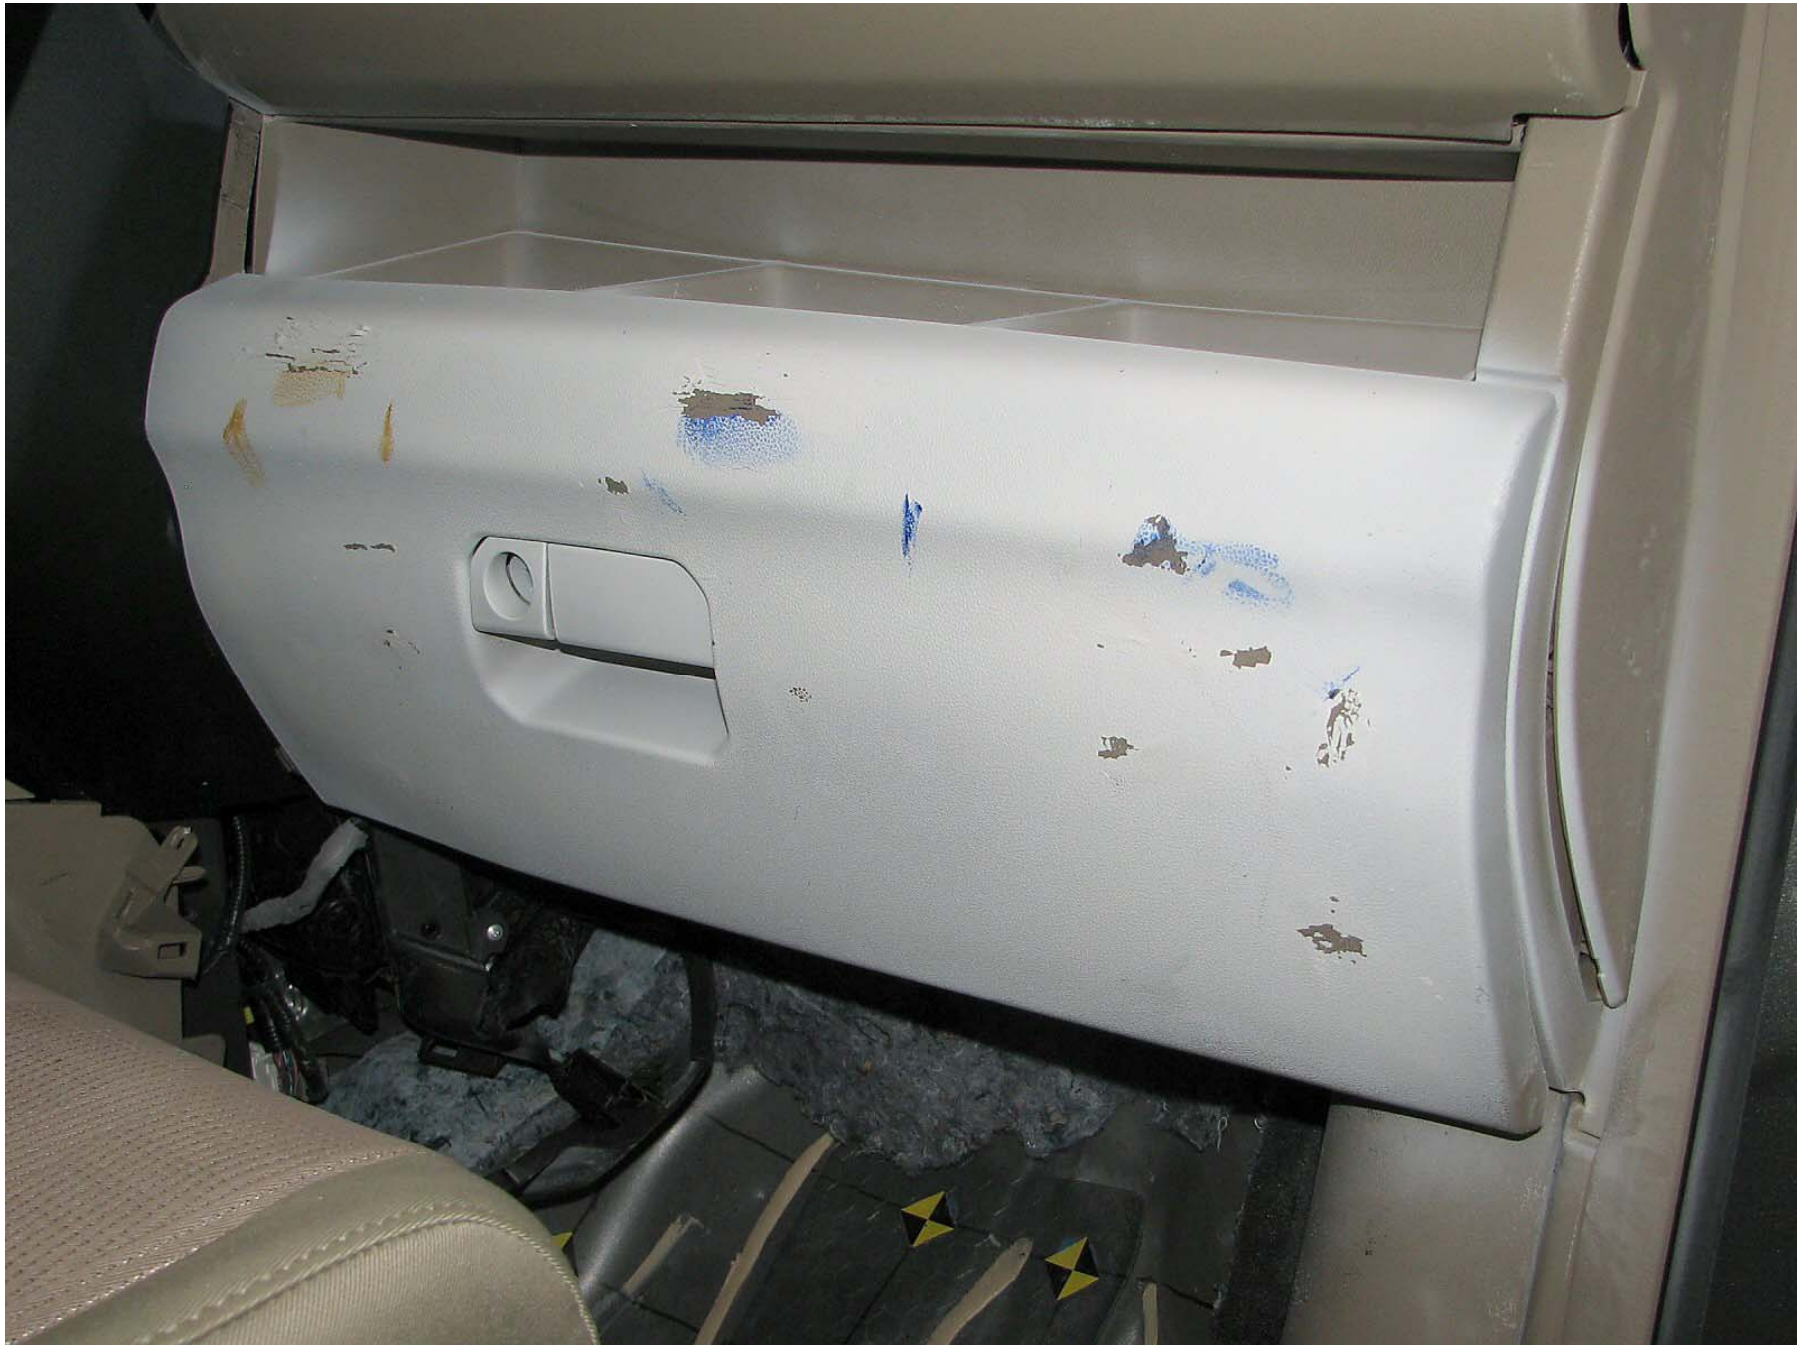
Figure A-53: Post-Test Passenger Side Glove Box

The passenger's visible contact points were as follows: The passenger ATD's head, chest, and abdomen contacted the airbag. The head also contacted the headrest. Both knees contacted the glovebox.

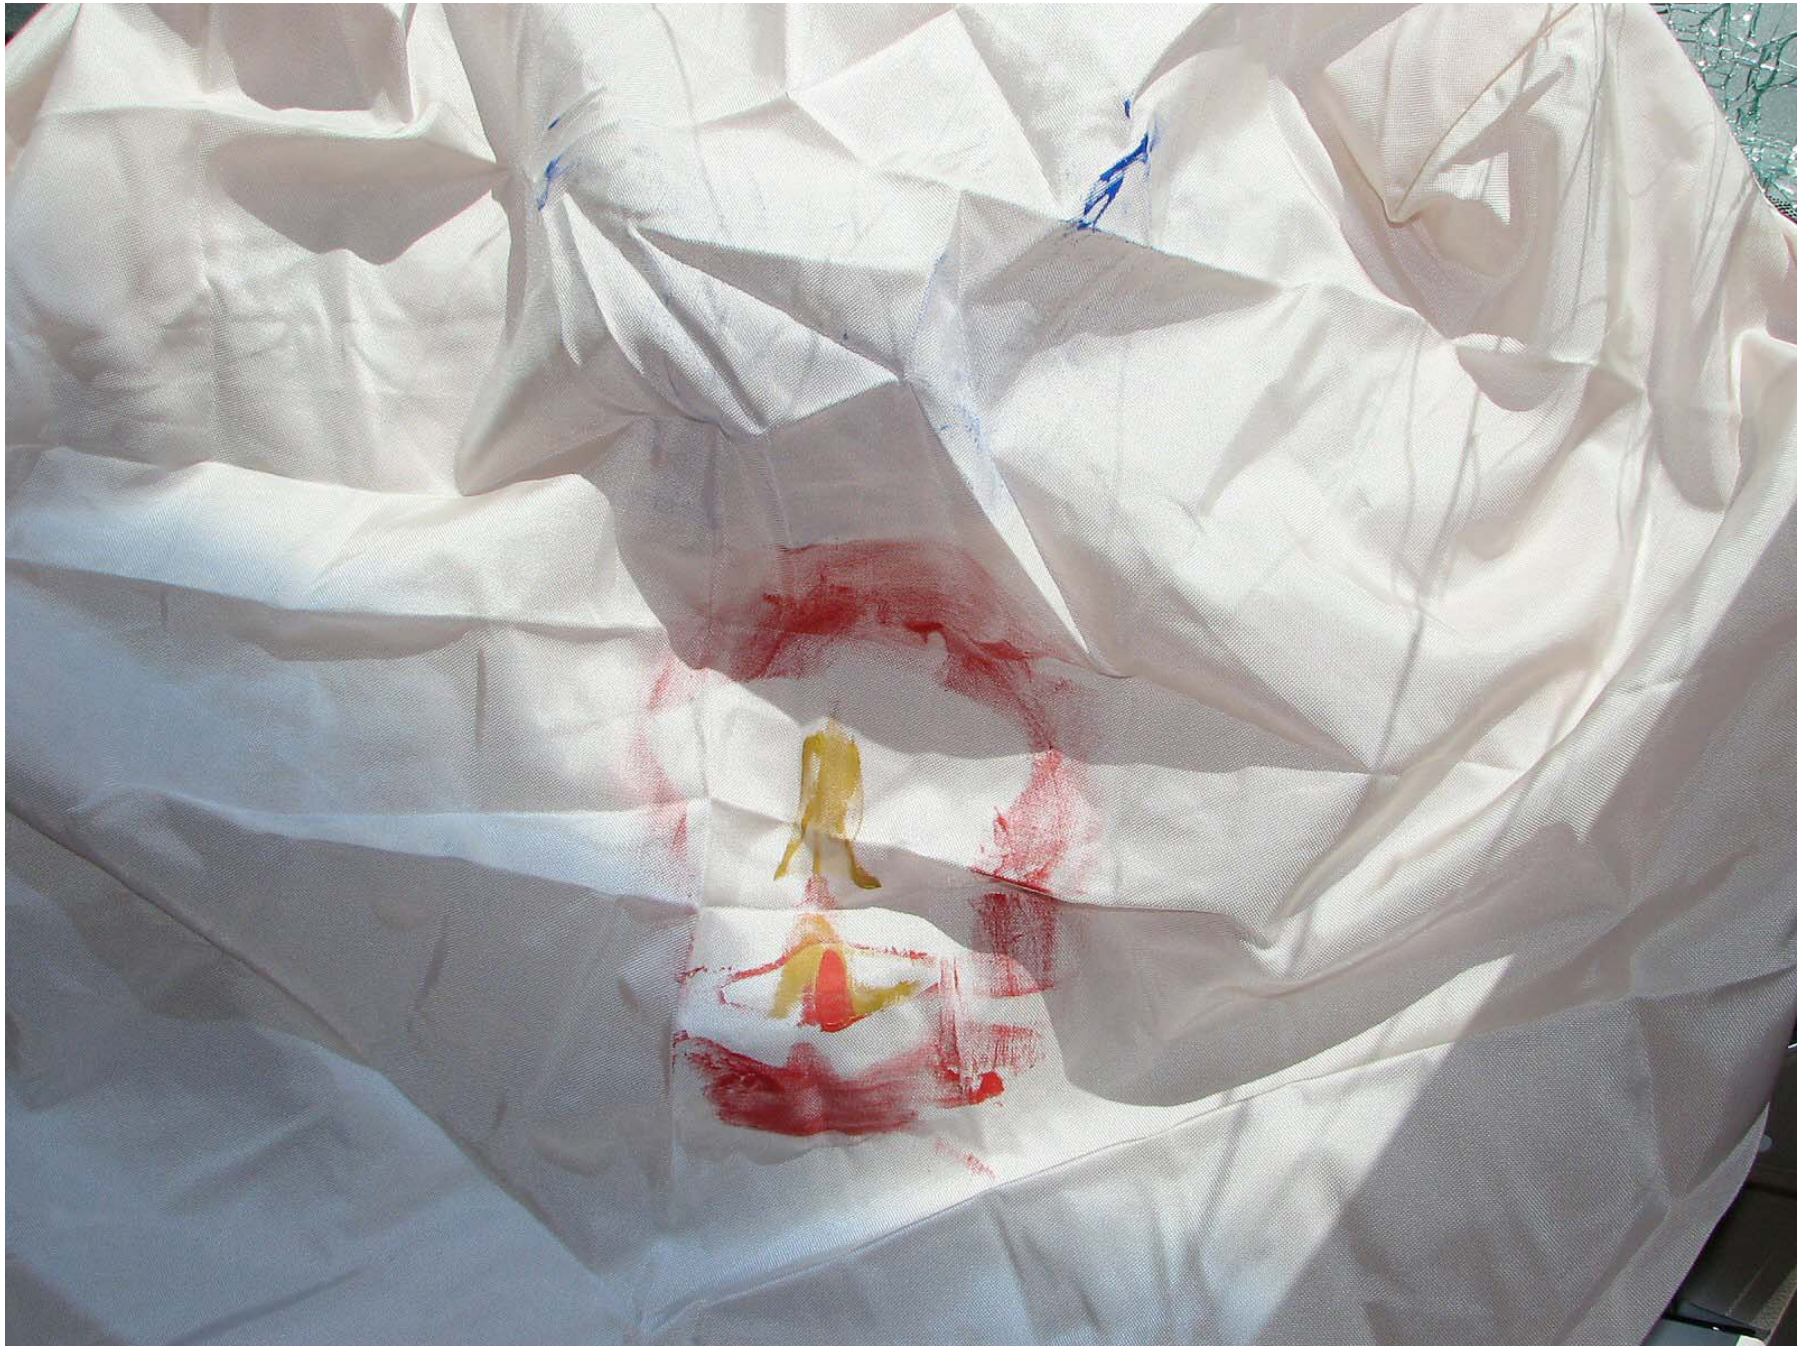
Figure A-57: Post-Test Passenger Dummy Airbag Contact
