**REPORT NUMBER TR-P28001-20-NC**

**NEW CAR ASSESMENT PROGRAM  
FRONTAL BARRIER IMPACT TEST**

**HONDA MFG. OF ALABAMA, LLC  
2009 HONDA PILOT EX 4WD  
5-DOOR MPV**

**NHTSA NUMBER: M95300**

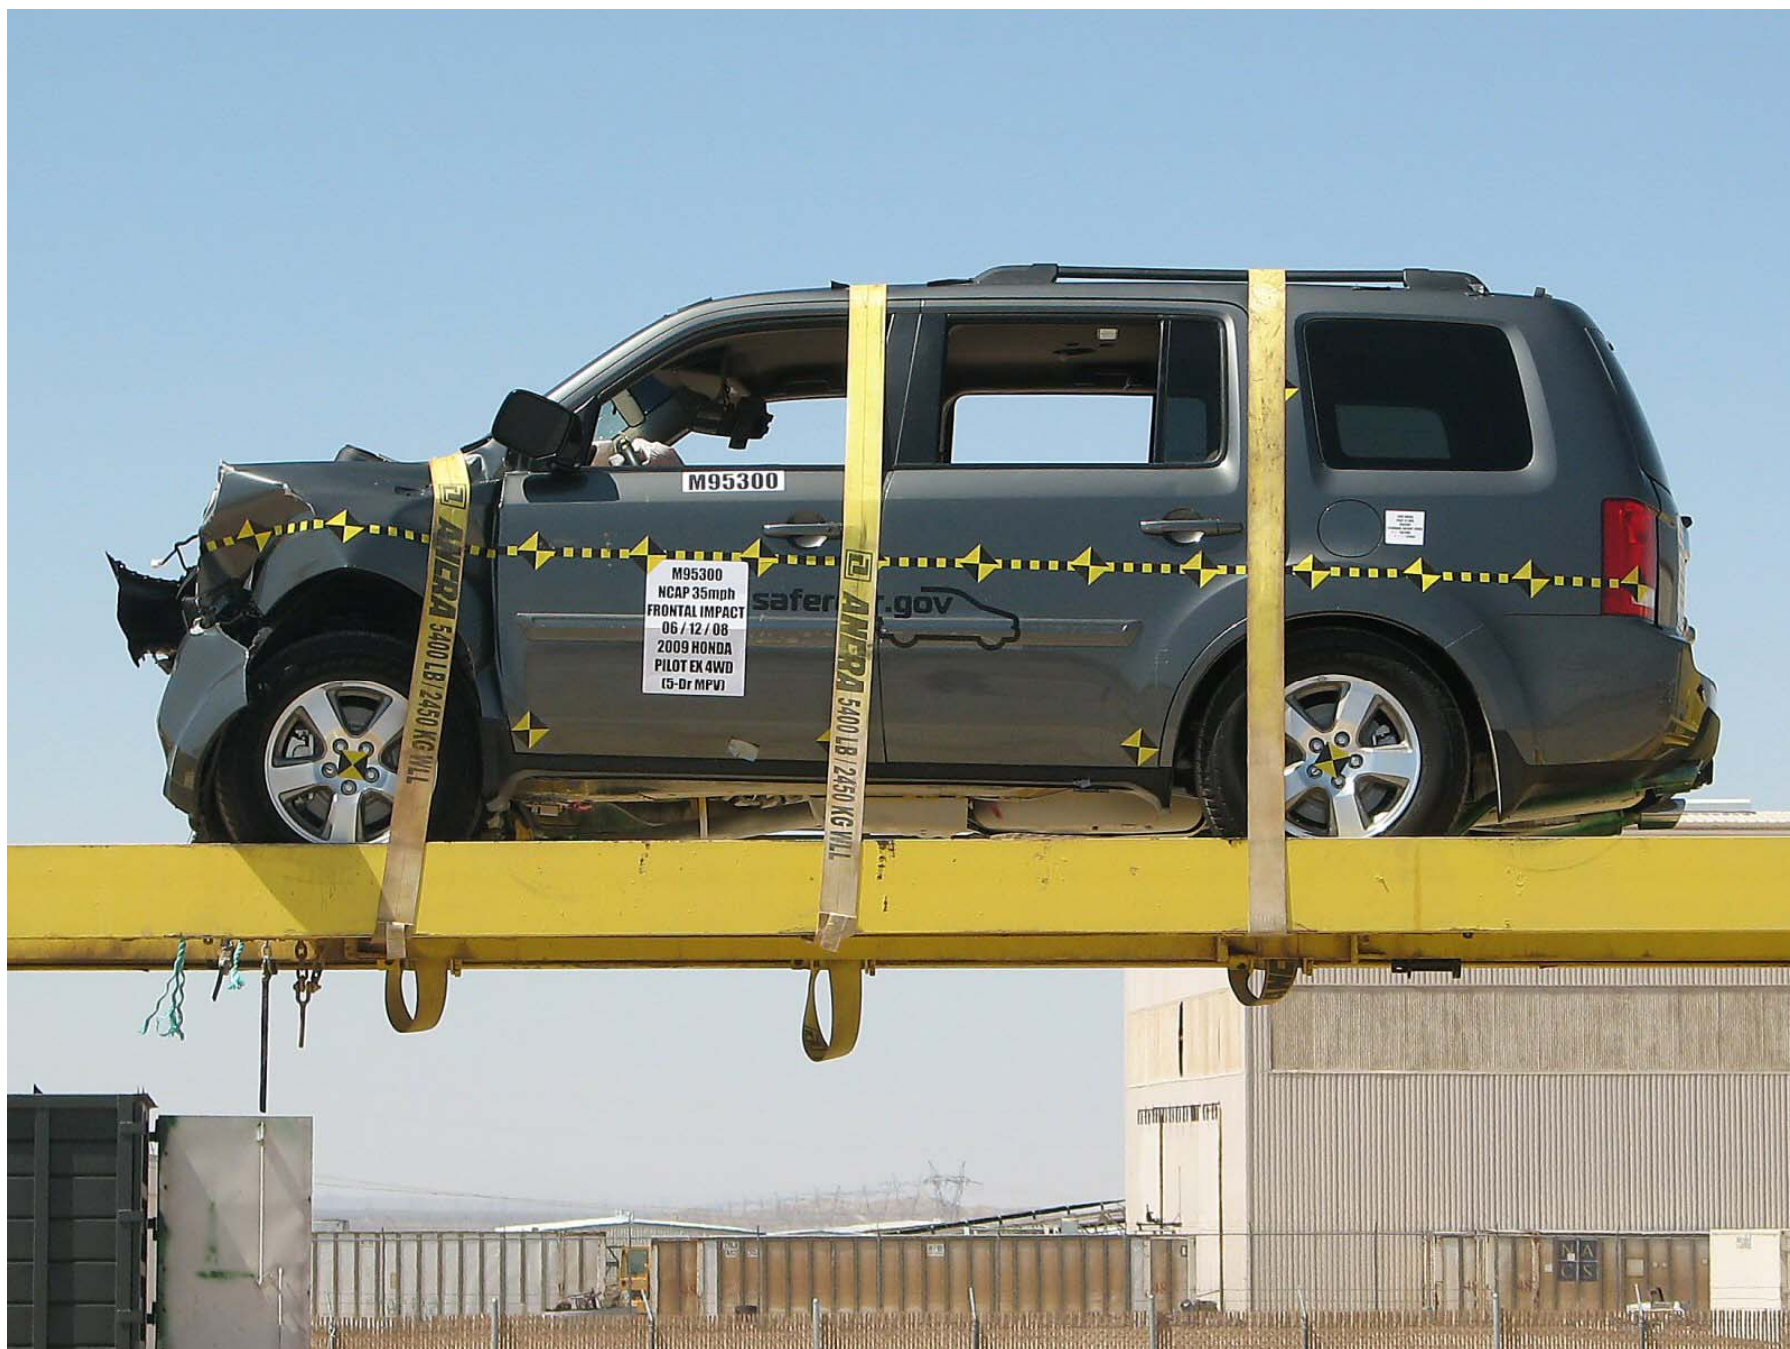
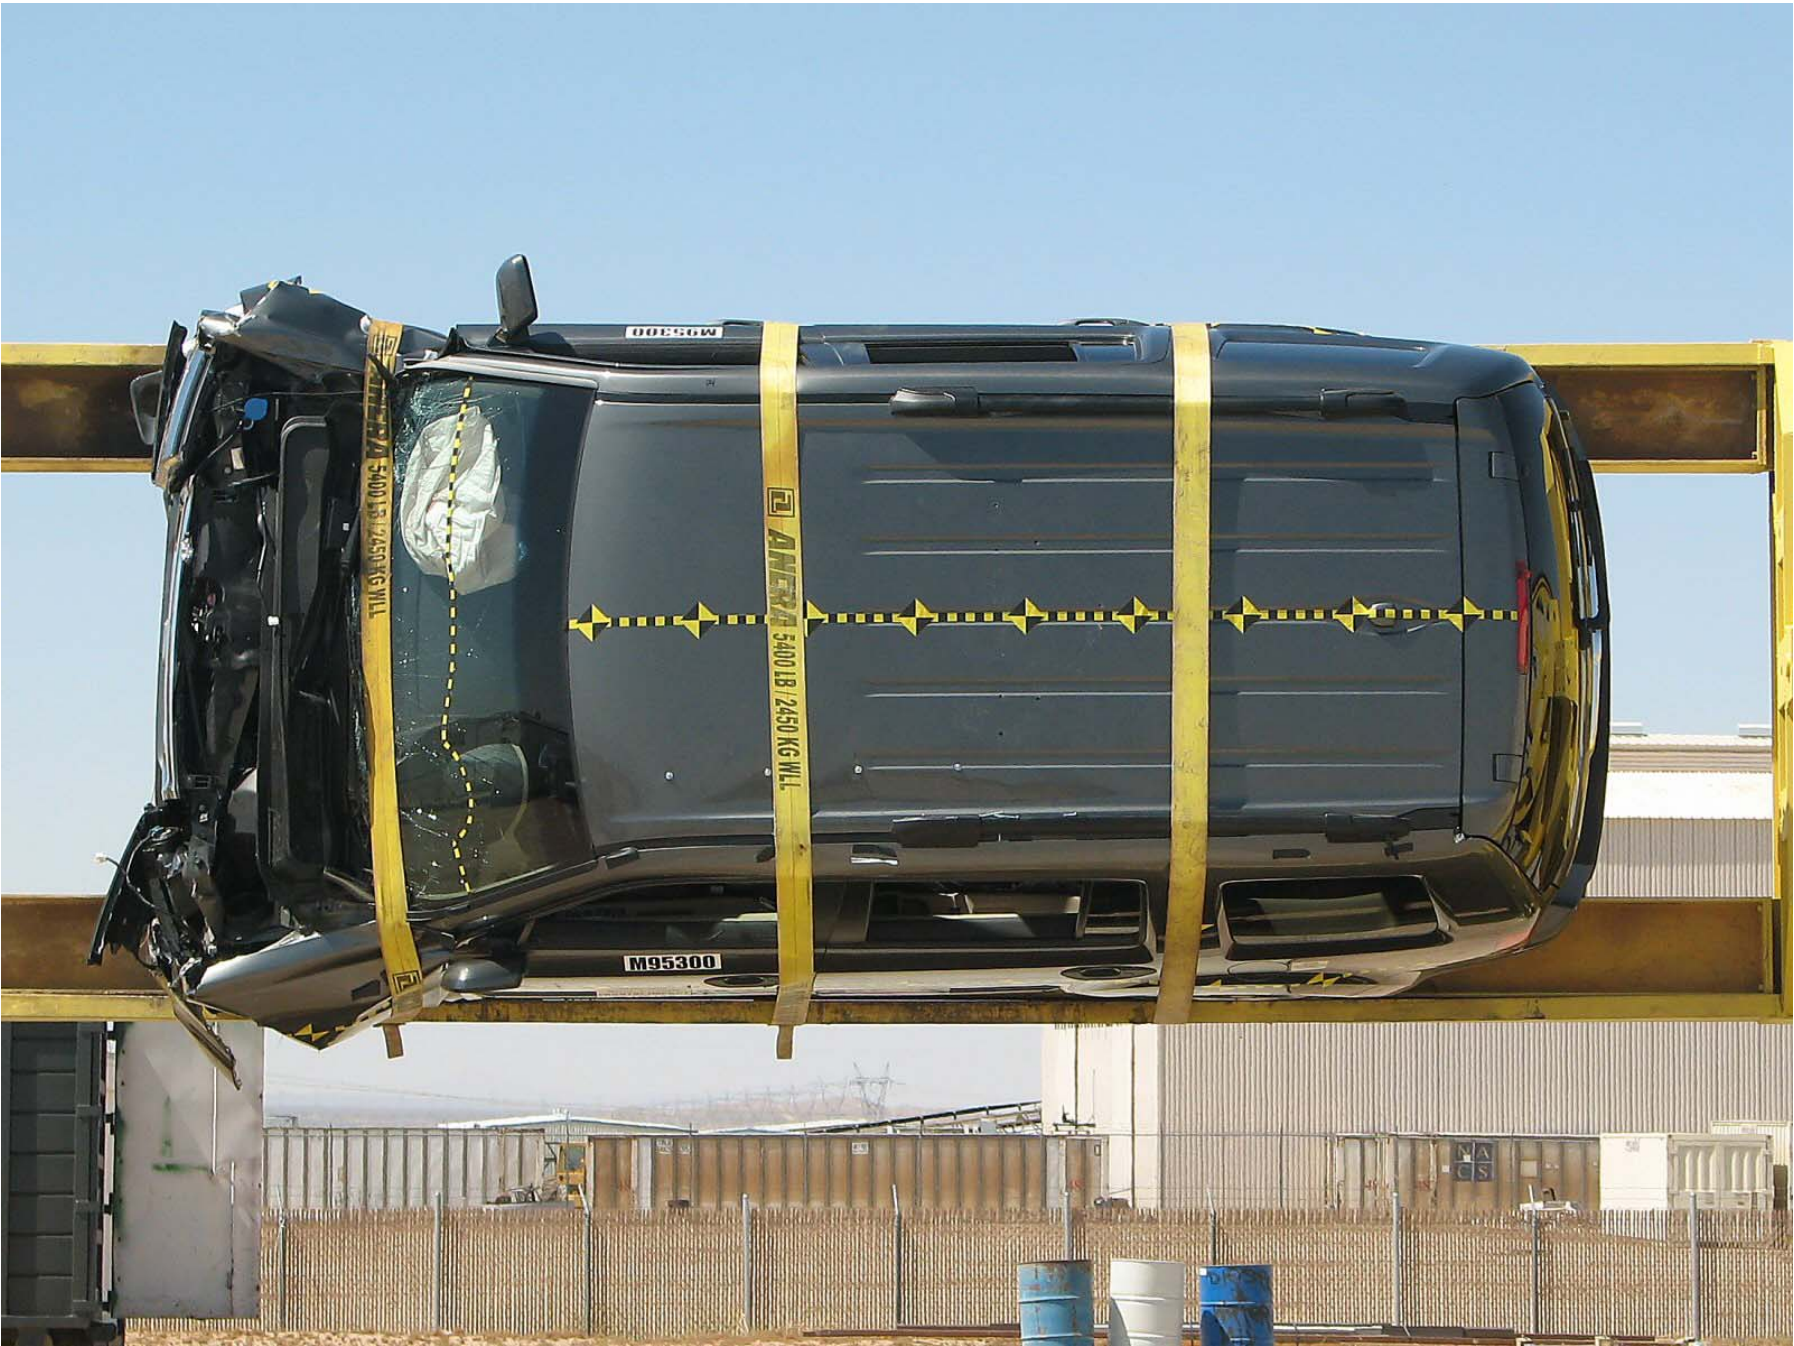
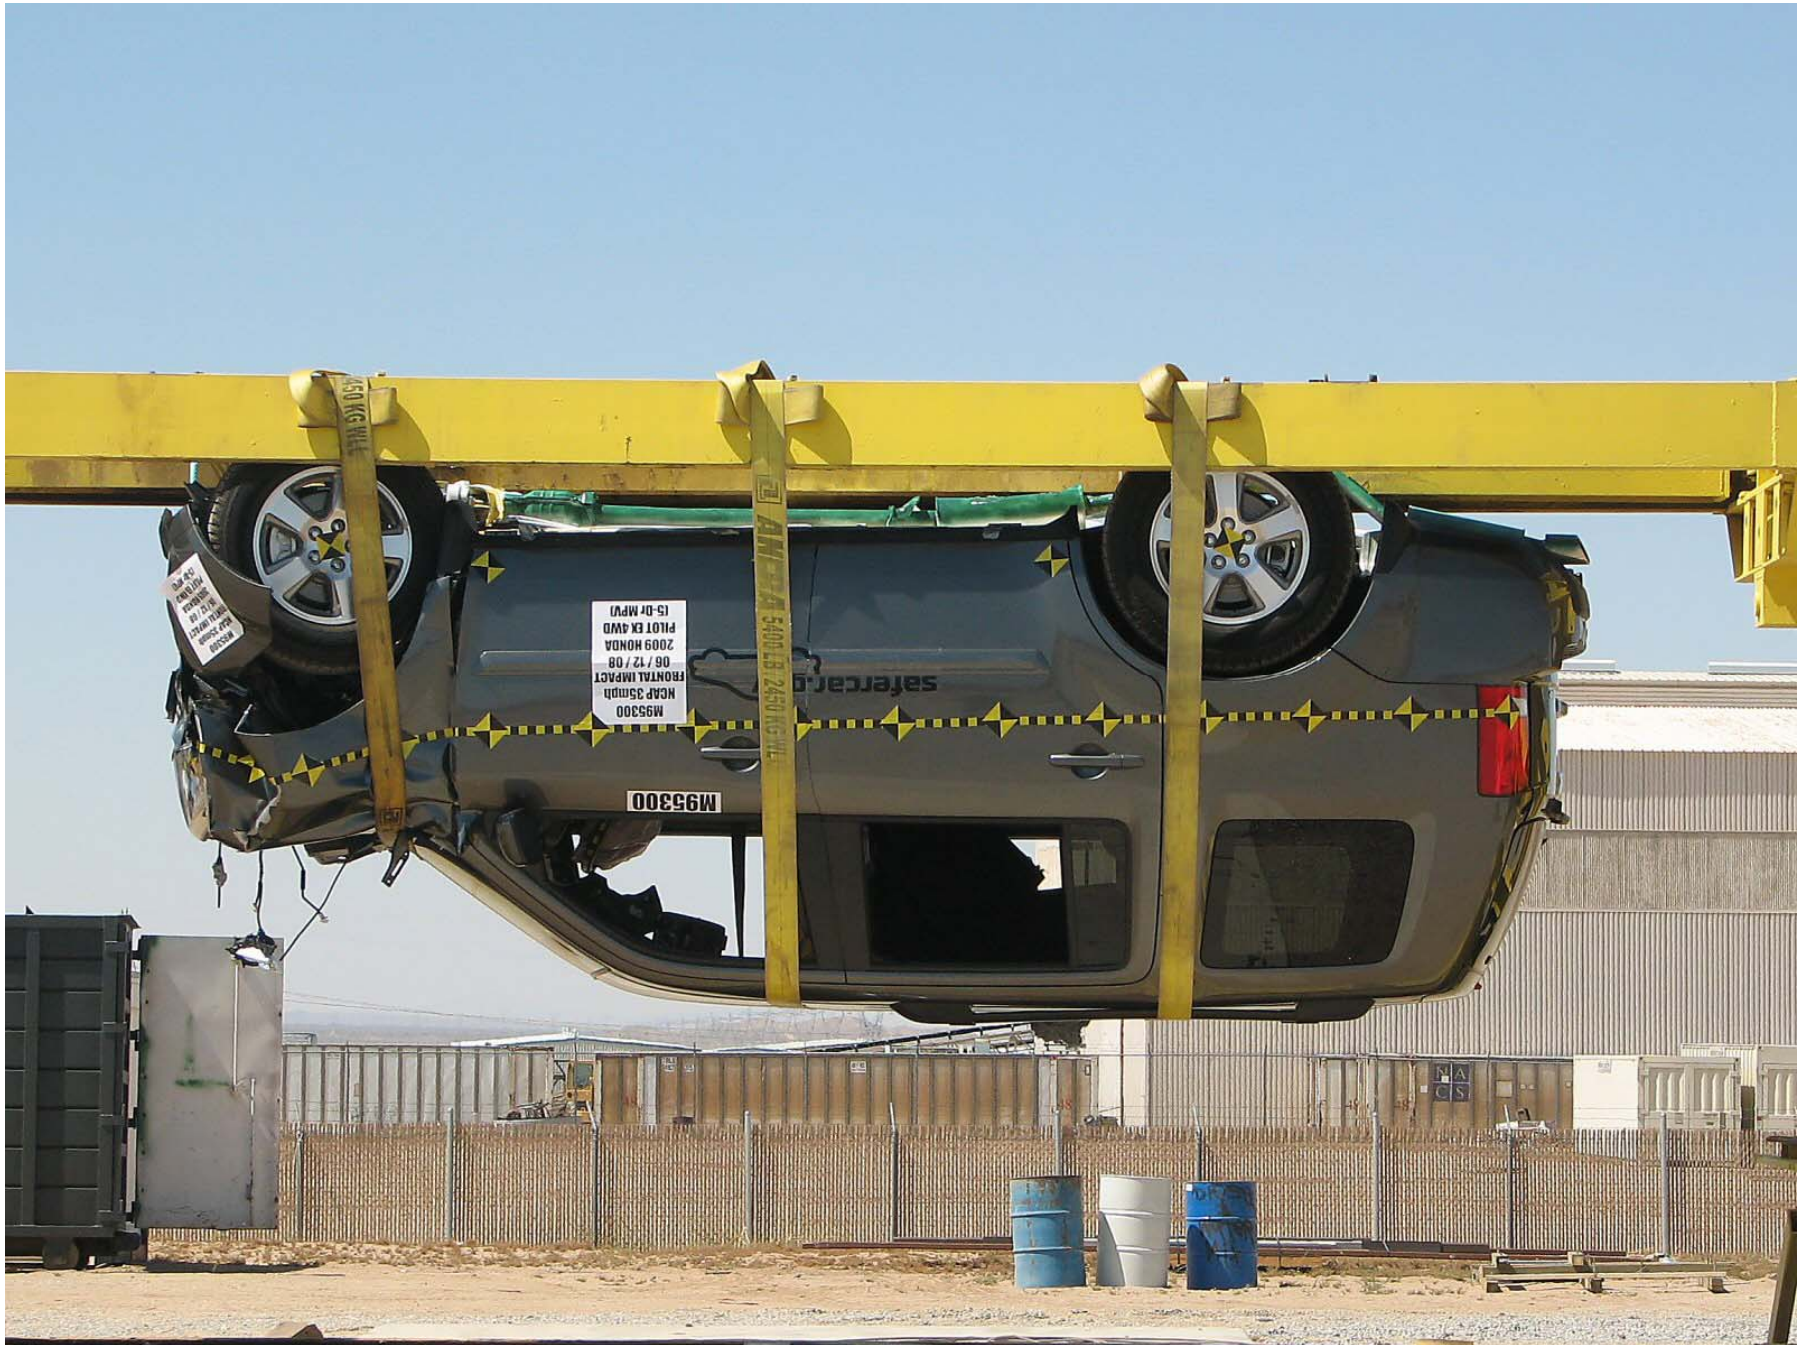
Figure A-58: Vehicle on Rollover Device (0°)

Figure A-59: Vehicle on Rollover Device (90°)

Figure A-60: Vehicle on Rollover Device (180°)

Figure A-61: Vehicle on Rollover Device (270°)

There was 100% windshield retention and no intrusion into the protected zone of the windshield during impact. There was no Stoddard solvent leakage after the event, or during any phase of the static rollover.

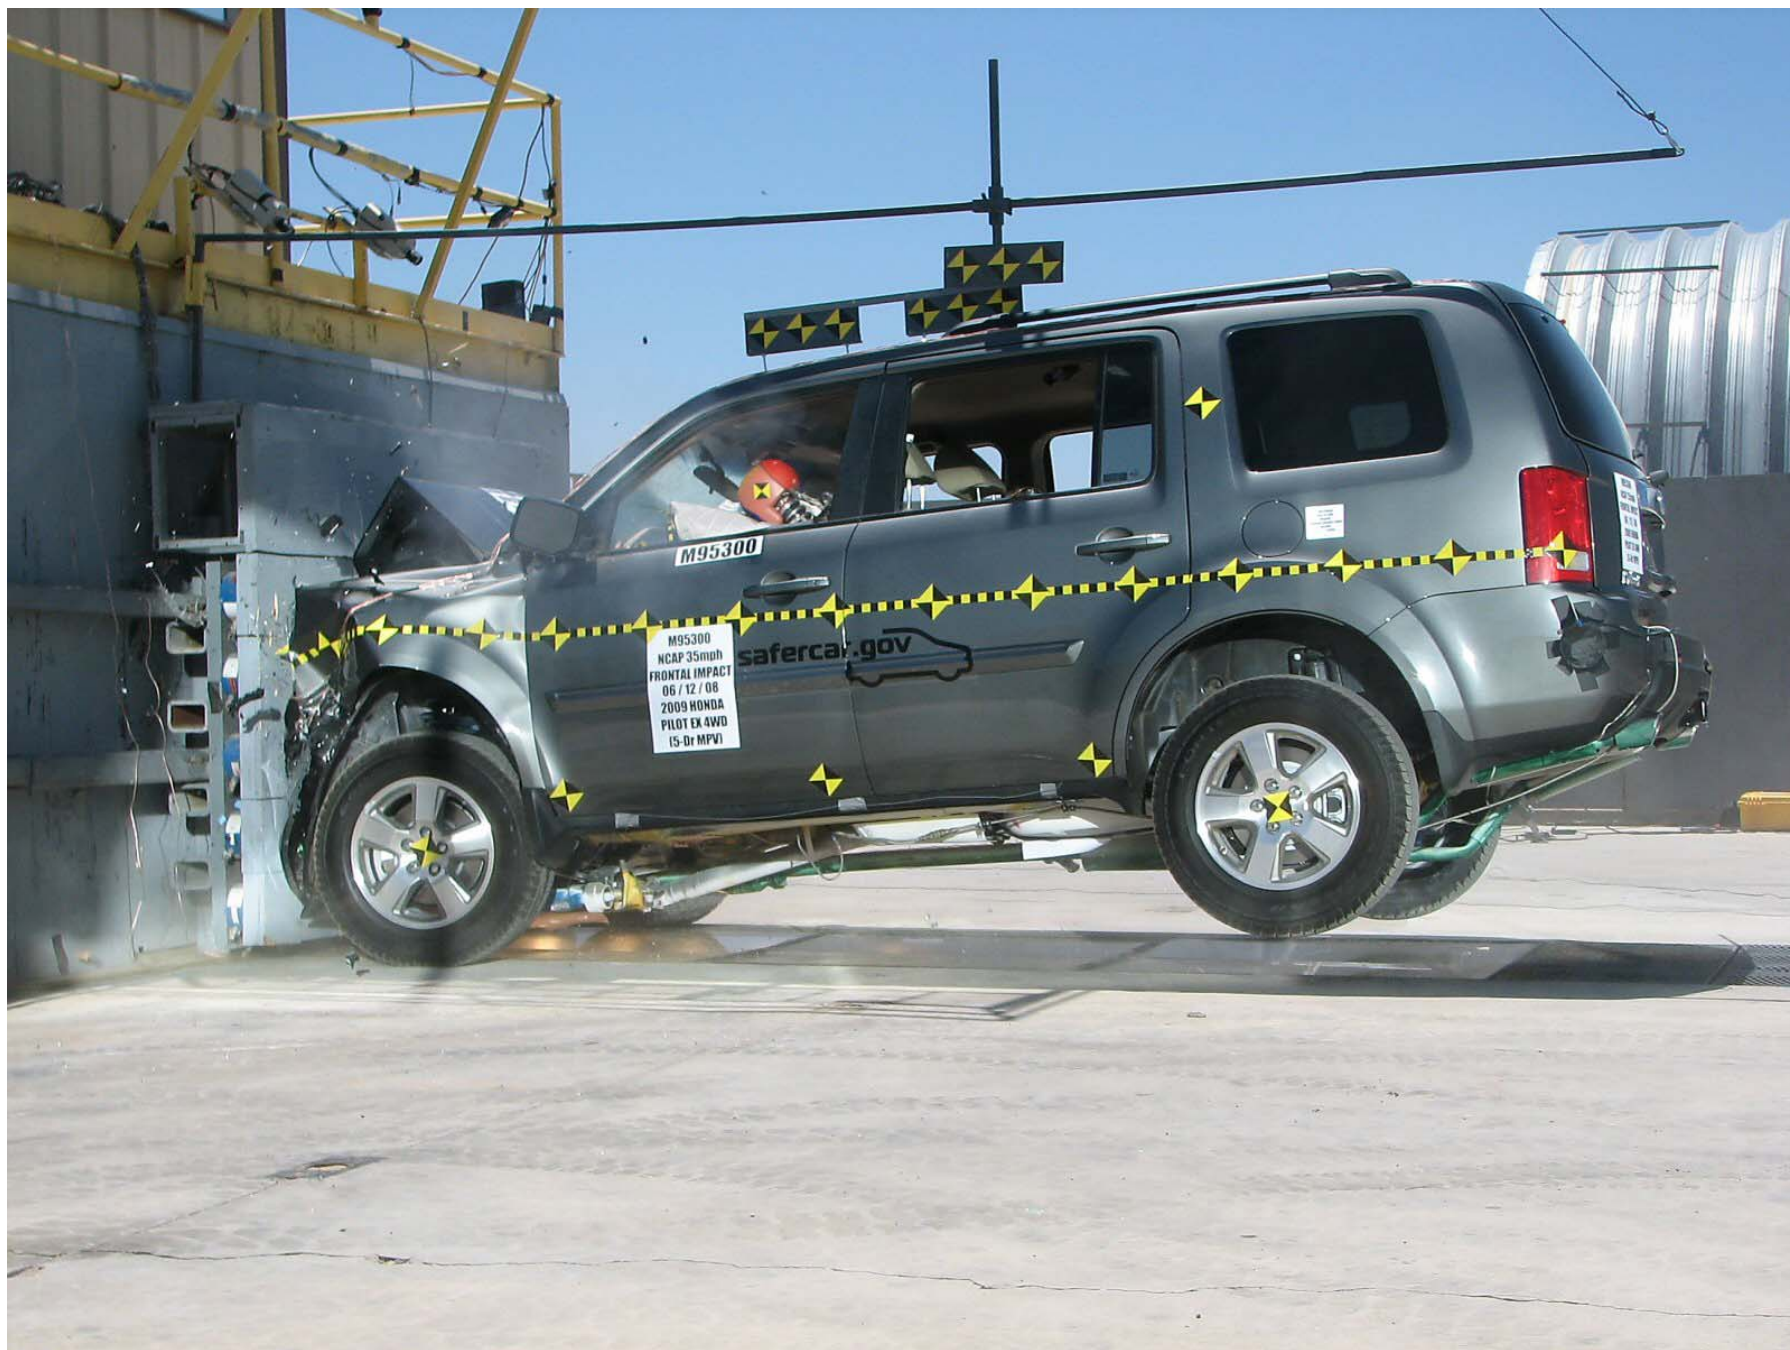
Figure A-62: Vehicle Impact

A load cell barrier consisting of 36 load cells was impacted by a 2009 Honda Pilot EX 4WD 5-Door MPV at a velocity of 56.24 km/h. The test was performed at KARCO Engineering, LLC on June 12, 2008
