REPORT NUMBER TR-P28001-21-NC

**NEW CAR ASSESMENT PROGRAM
FRONTAL BARRIER IMPACT TEST**

**FORD MOTOR CO.
2009 FORD FLEX SEL AWD
5-DOOR MPV**

NHTSA NUMBER: M90200

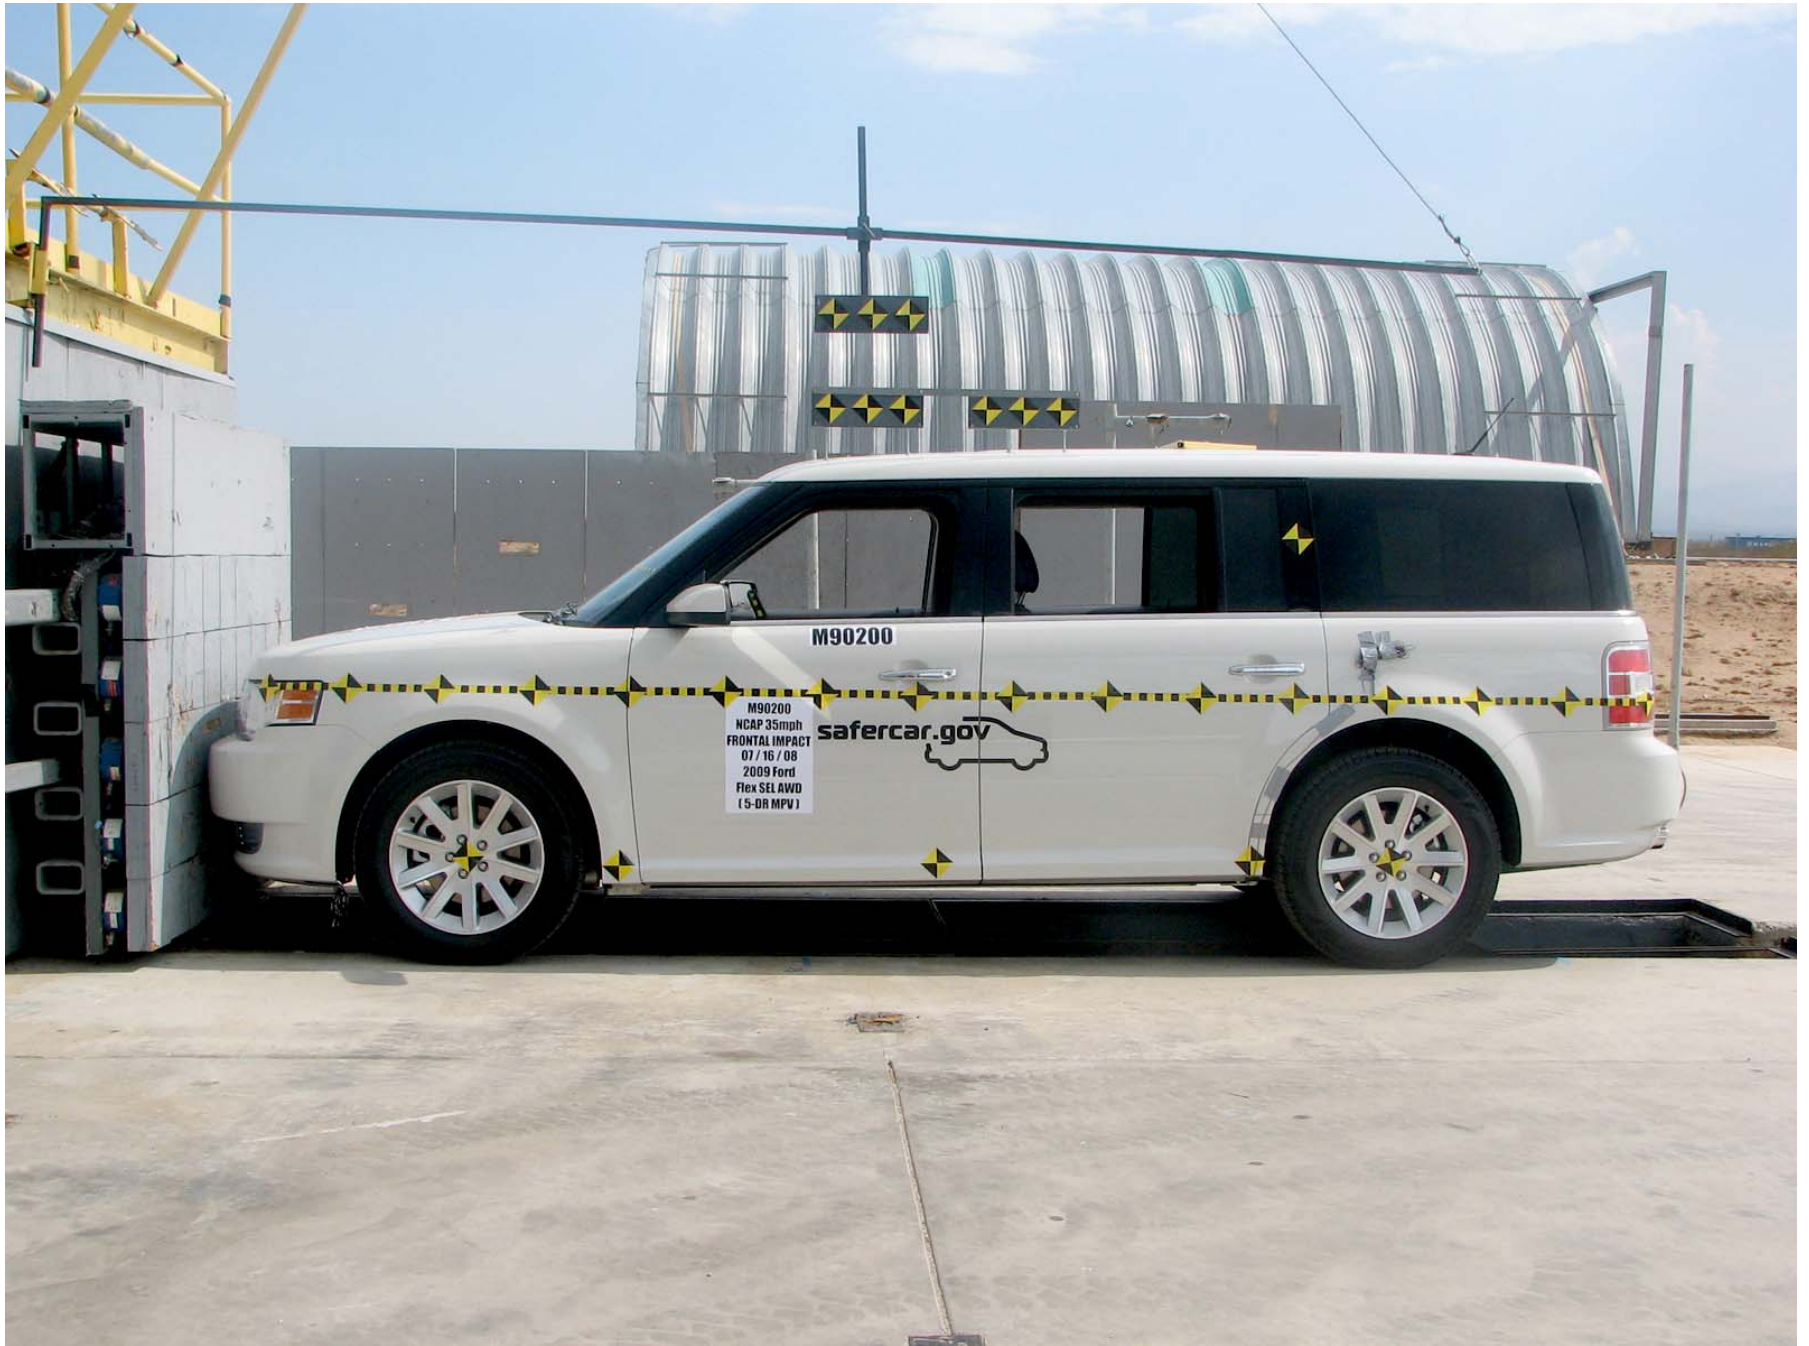
Figure A-8: Pre-Test Left Side View

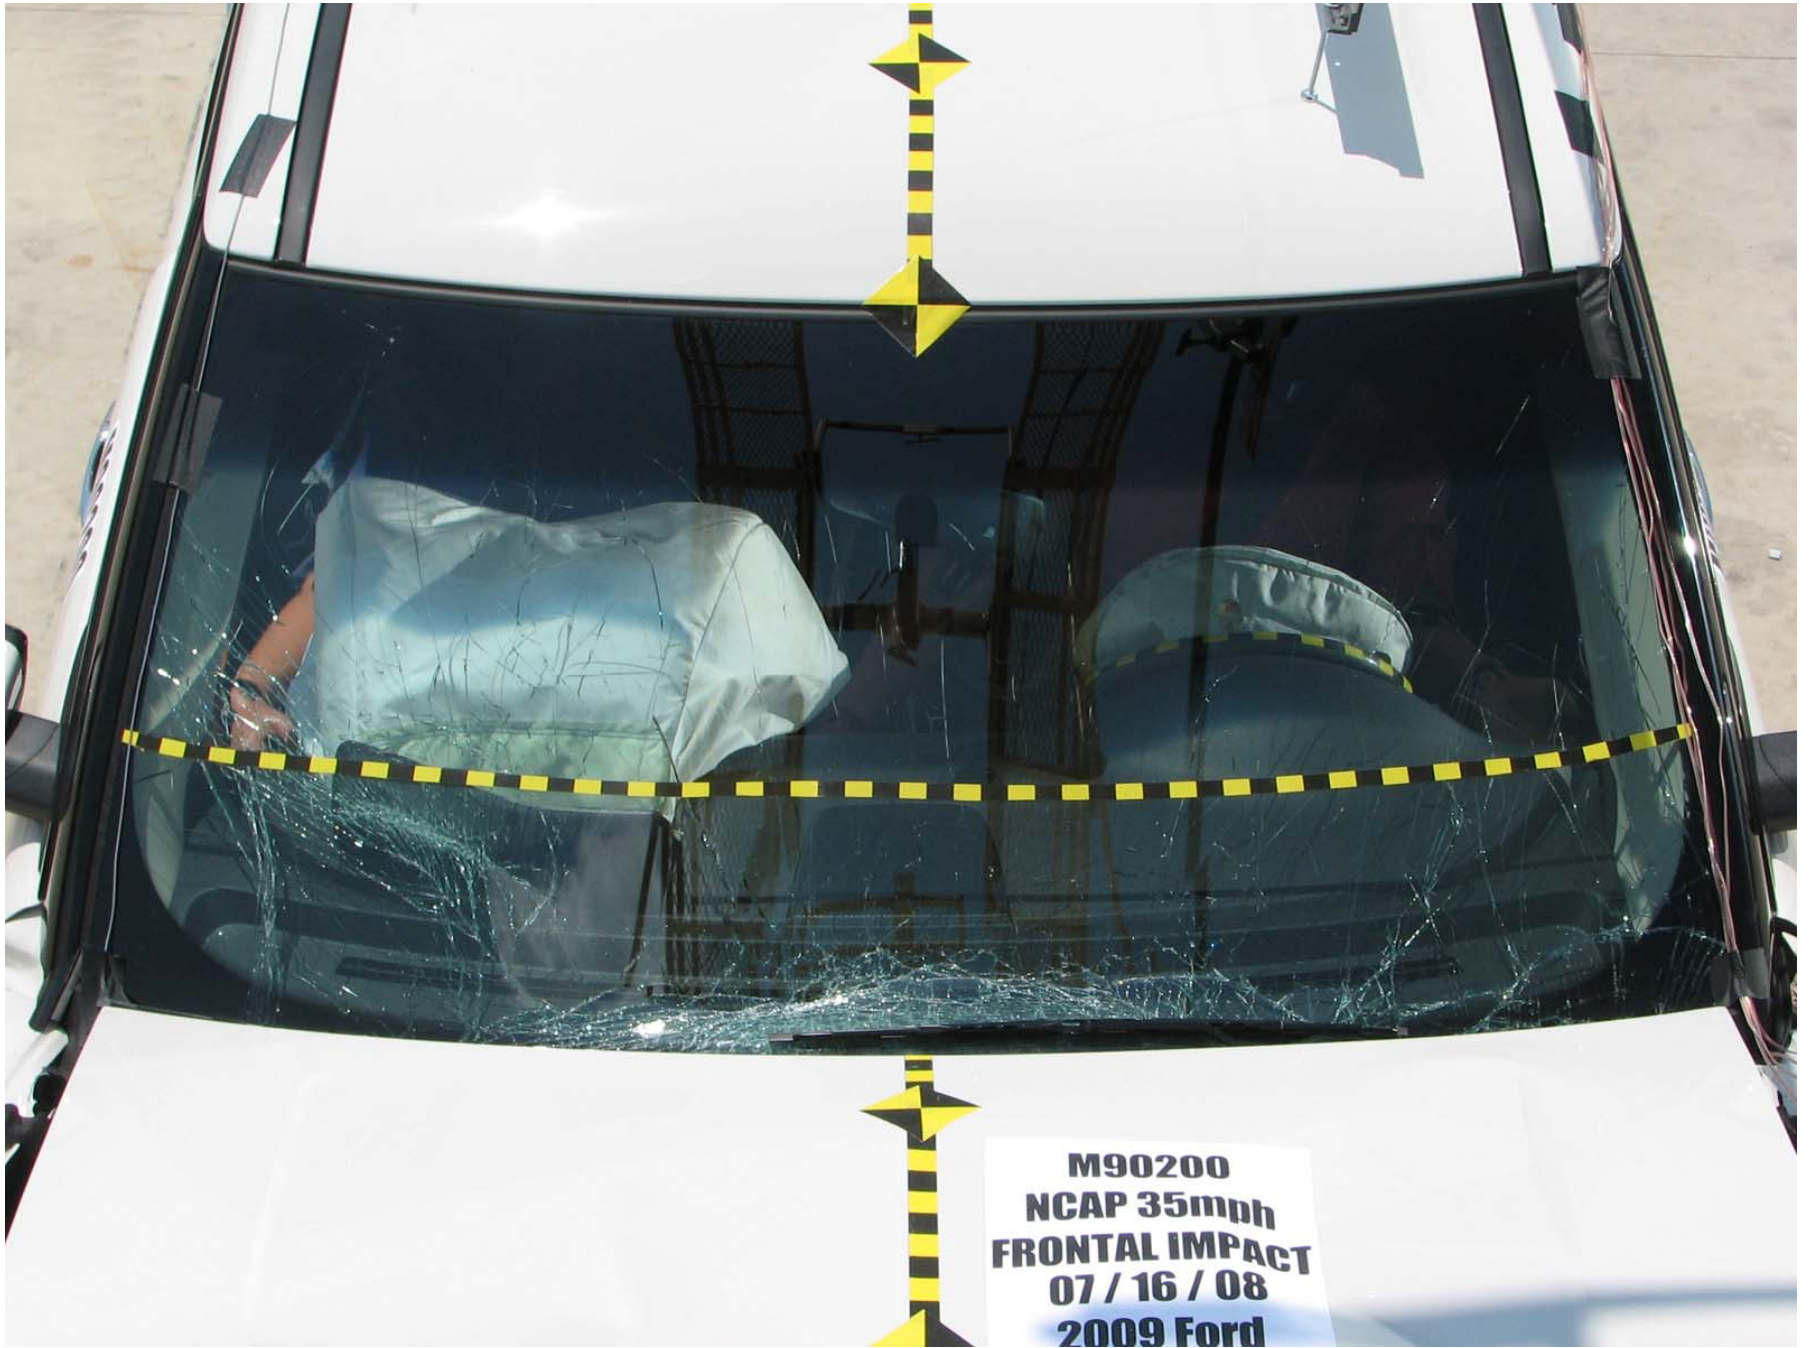
Figure A-19: Post-Test Windshield

There was 100% windshield retention and no intrusion into the protected zone of the windshield during impact. There was no Stoddard solvent leakage after the event, or during any phase of the static rollover.

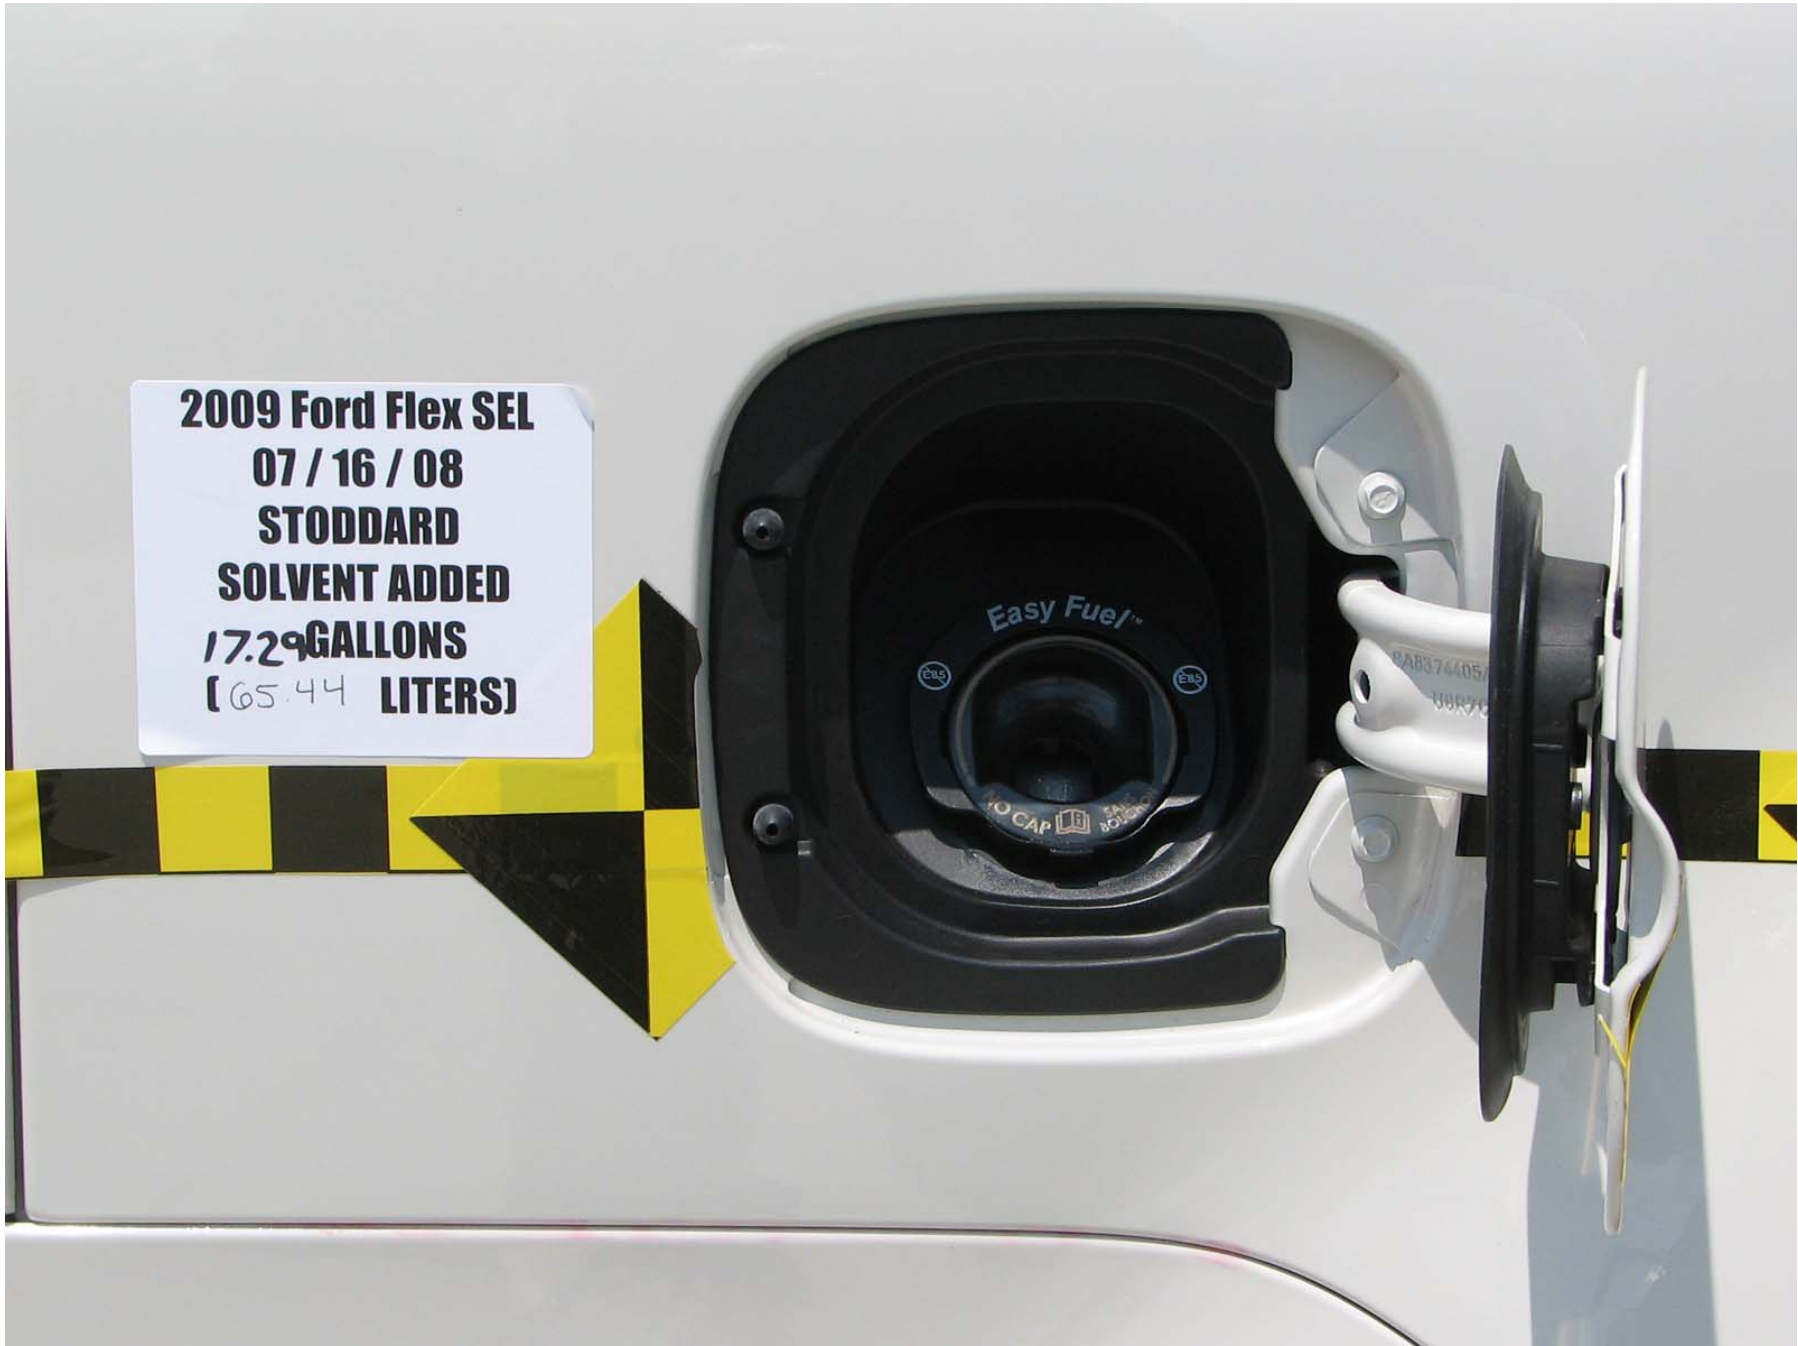
2009 Ford Flex SEL
07 / 16 / 08
STODDARD
SOLVENT ADDED
17.29 GALLONS
(65.44 LITERS)

Figure A-23: Post-Test Fuel Cap

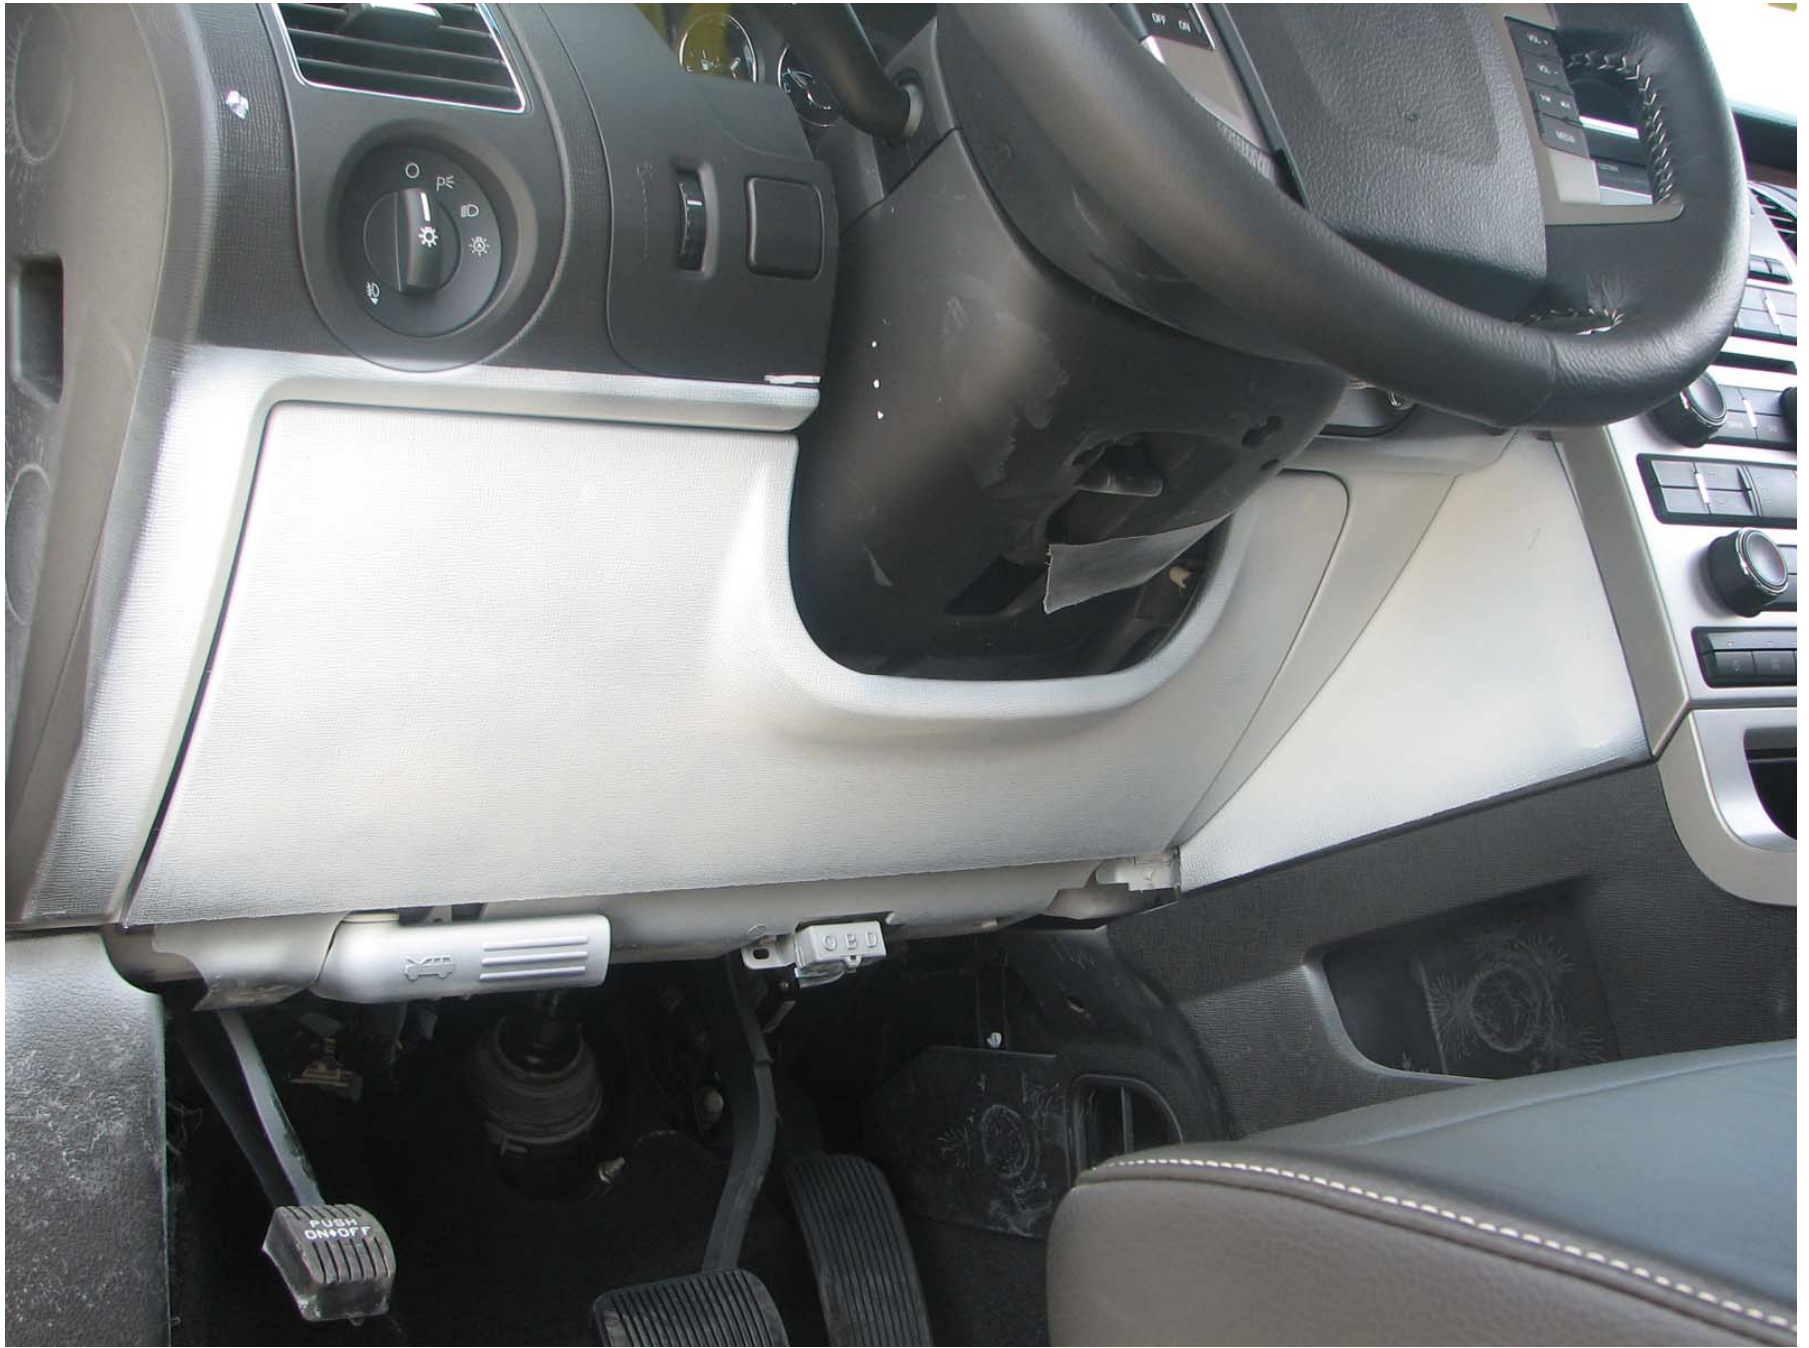
Figure A-38: Pre-Test Driver Side Knee Bolster

The driver's visible contact points were as follows: The driver ATD's head, chest, and abdomen contacted the airbag. Both knees contacted the bolster.

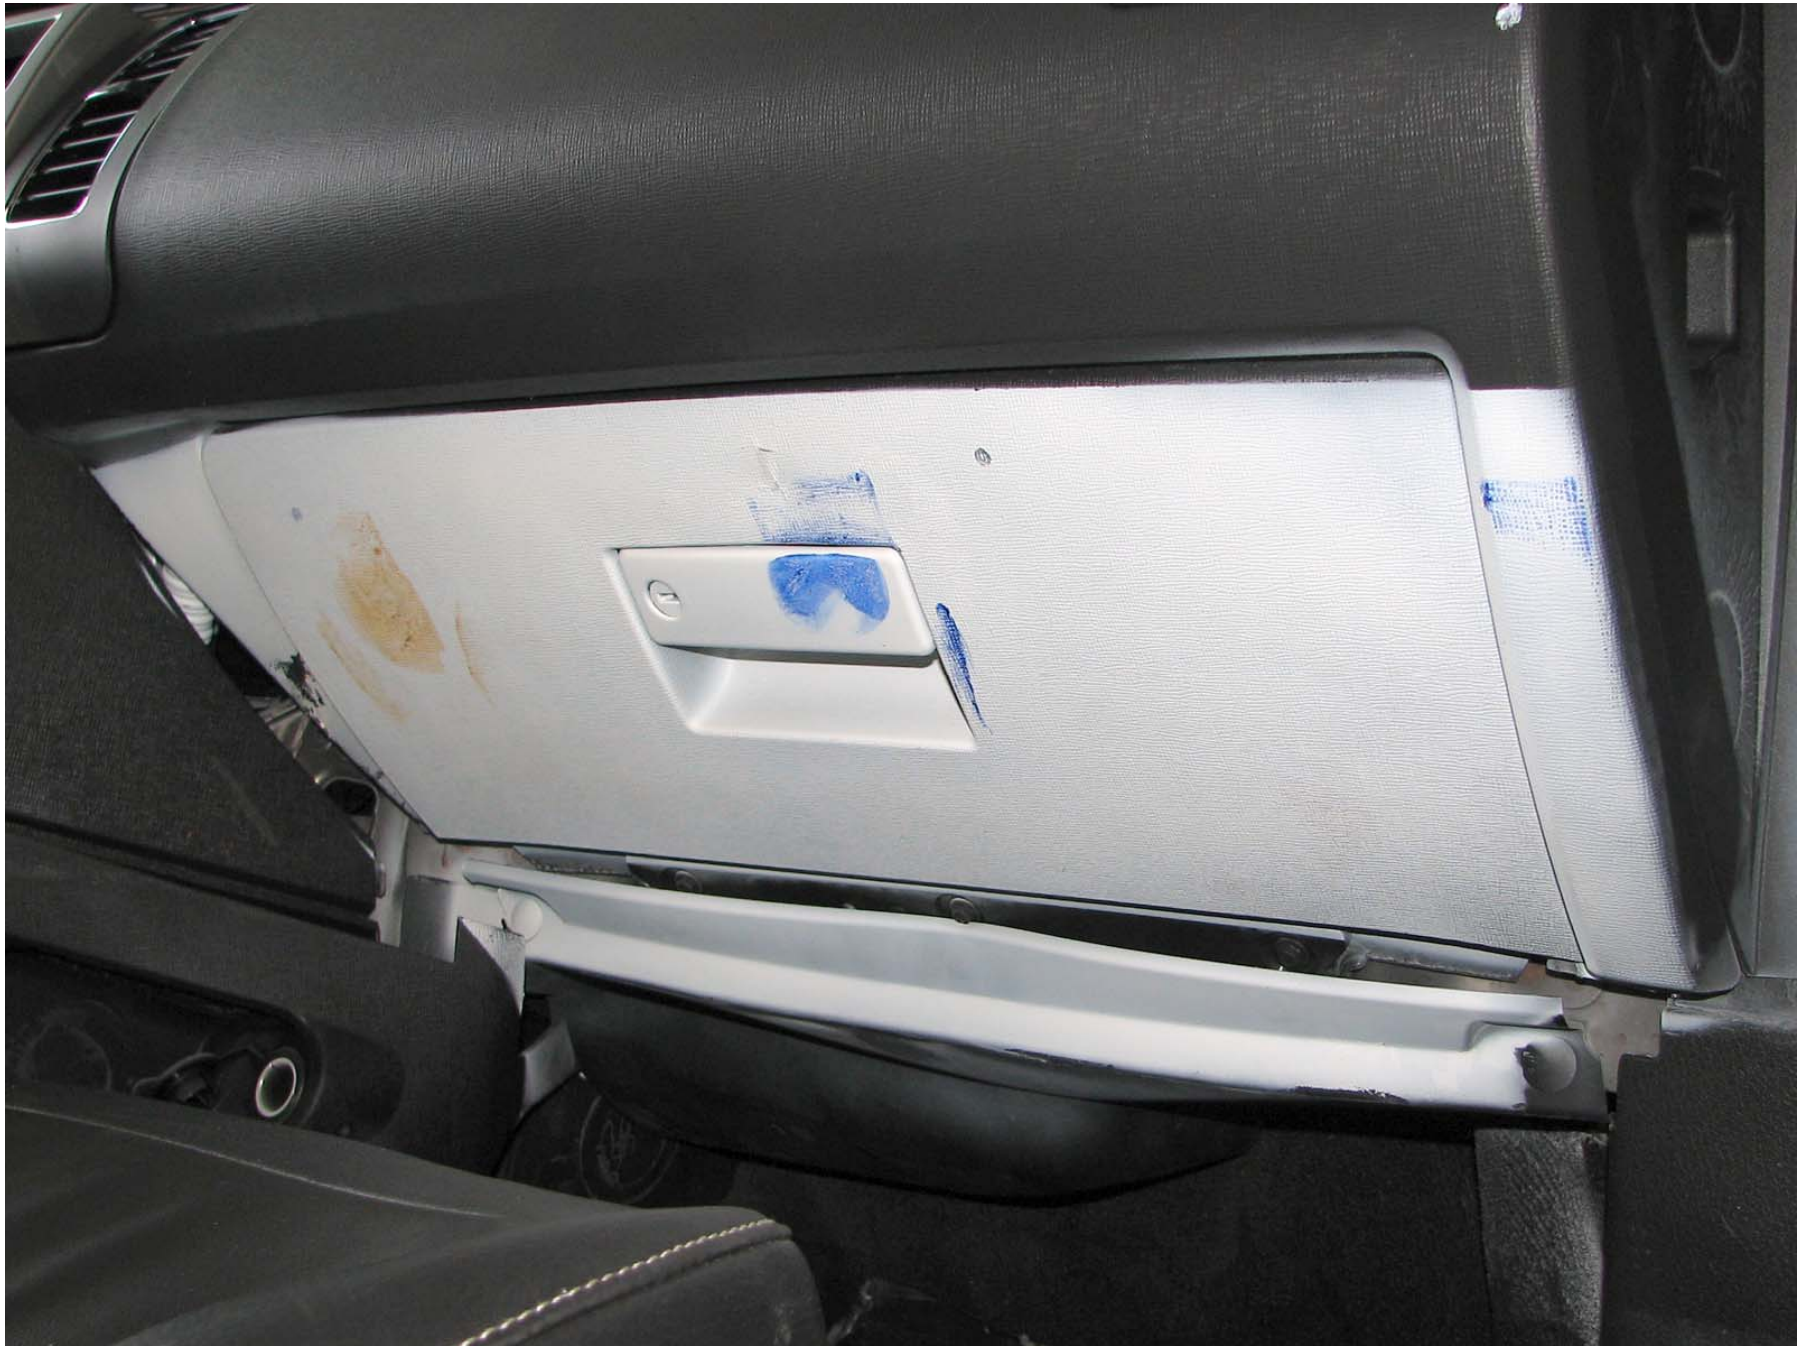
Figure A-53: Post-Test Passenger Side Glove Box

The passenger's visible contact points were as follows: The passenger ATD's head, chest, and abdomen contacted the airbag. The head also contacted the headrest. Both knees contacted the glovebox.
