REPORT NUMBER: CAL-08-19

**NEW CAR ASSESSMENT PROGRAM (NCAP)  
FRONTAL BARRIER IMPACT TEST**

NISSAN MOTOR COMPANY LTD.  
2009 NISSAN MAXIMA  
4-DOOR SEDAN

FINAL REPORT

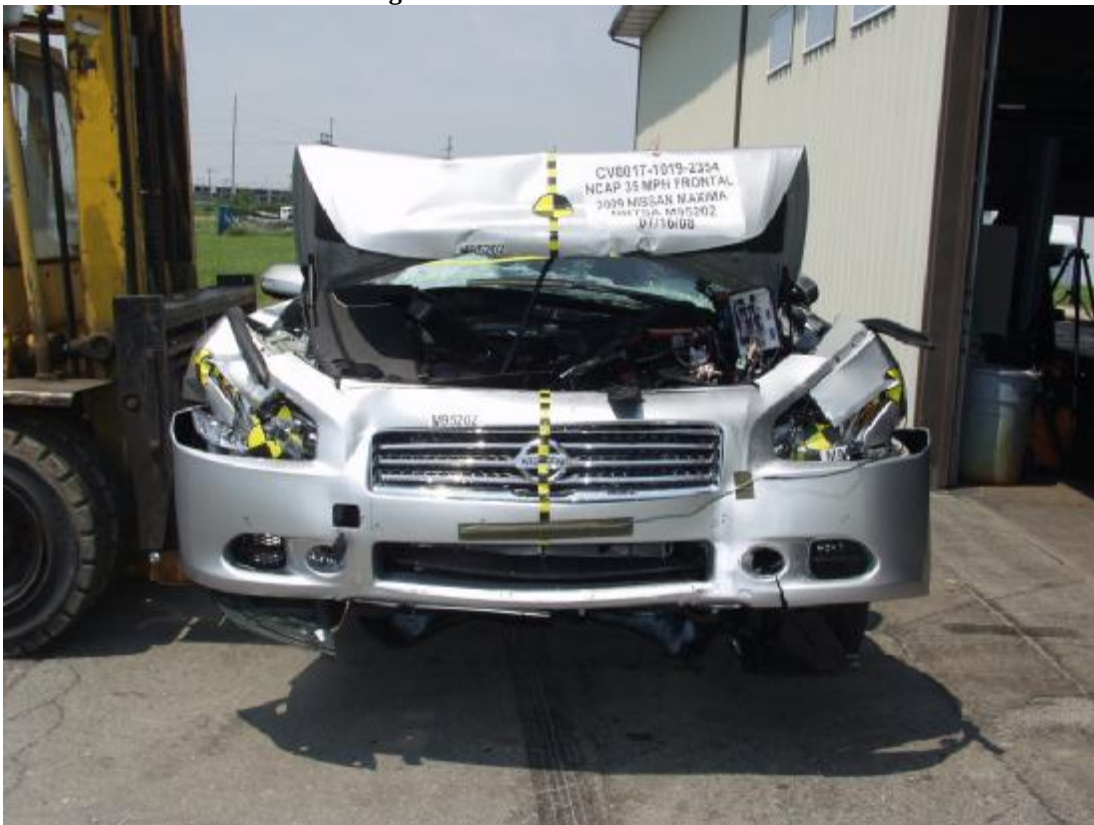
**Figure A-7: Post-Test Front View**

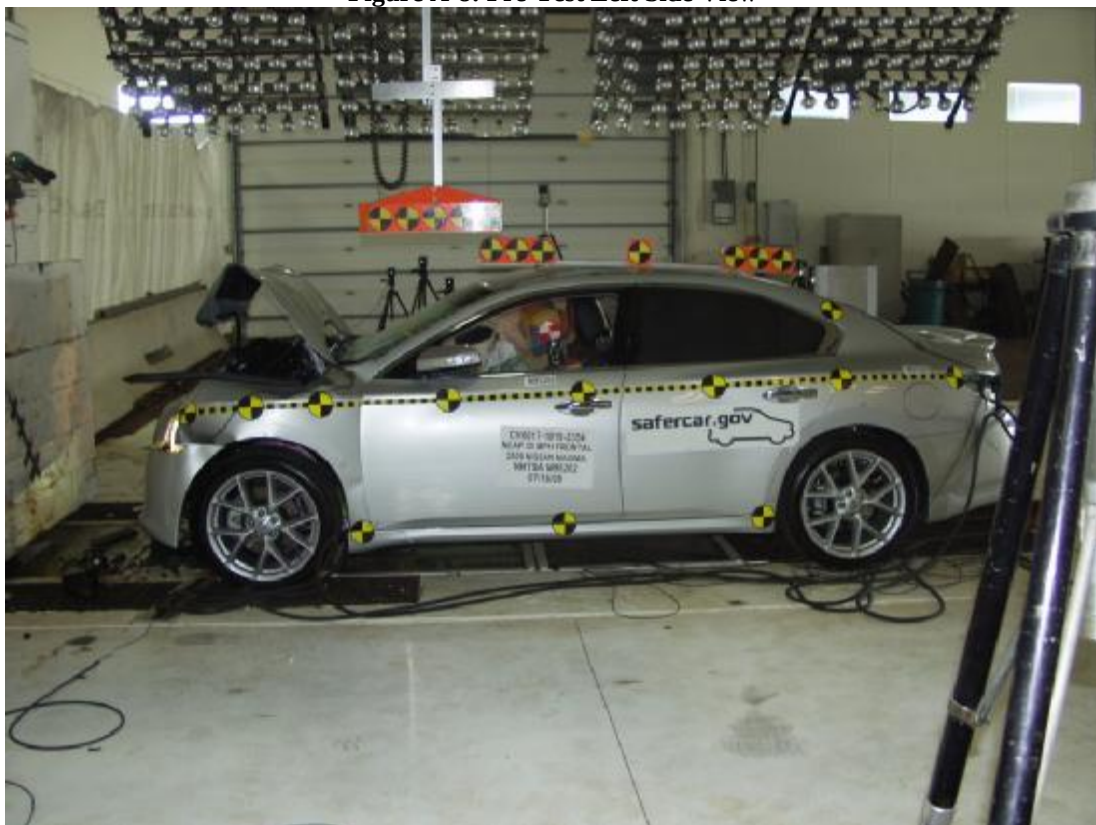
**Figure A-9: Post-Test Left Side View**

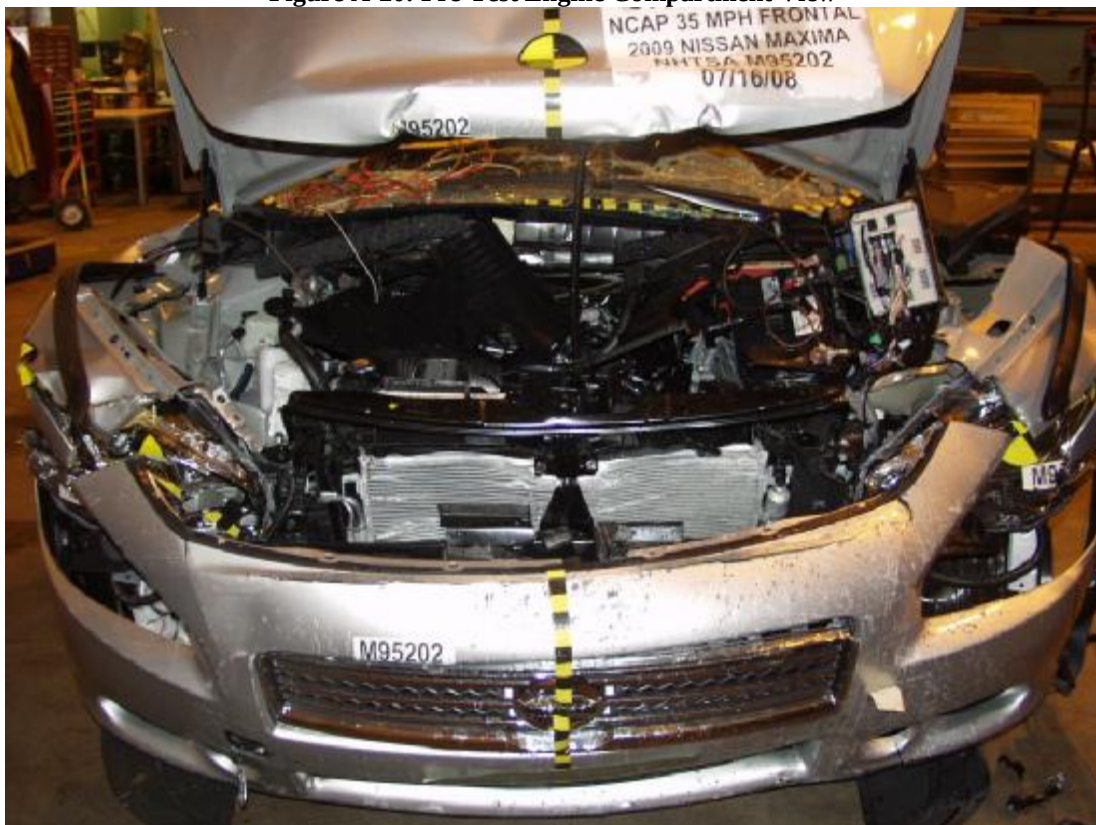
**Figure A-21: Post-Test Engine Compartment View**

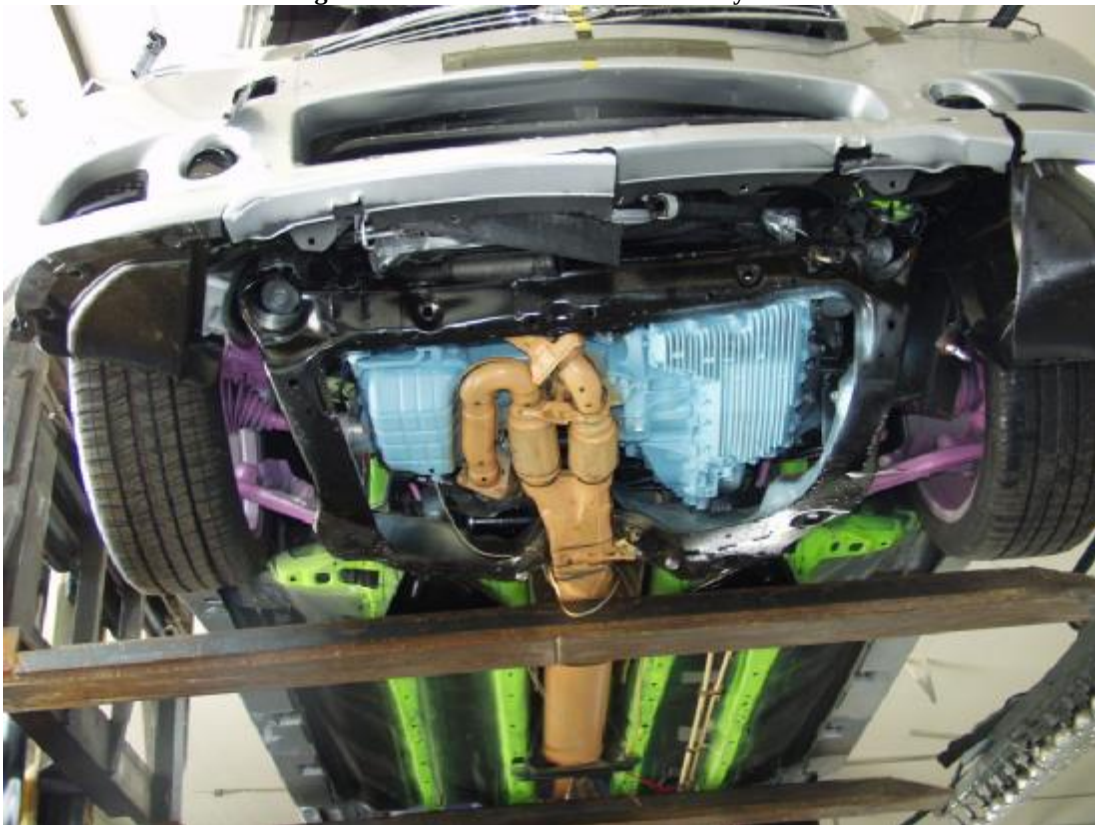
**Figure A-25: Post-Test Front Underbody View**

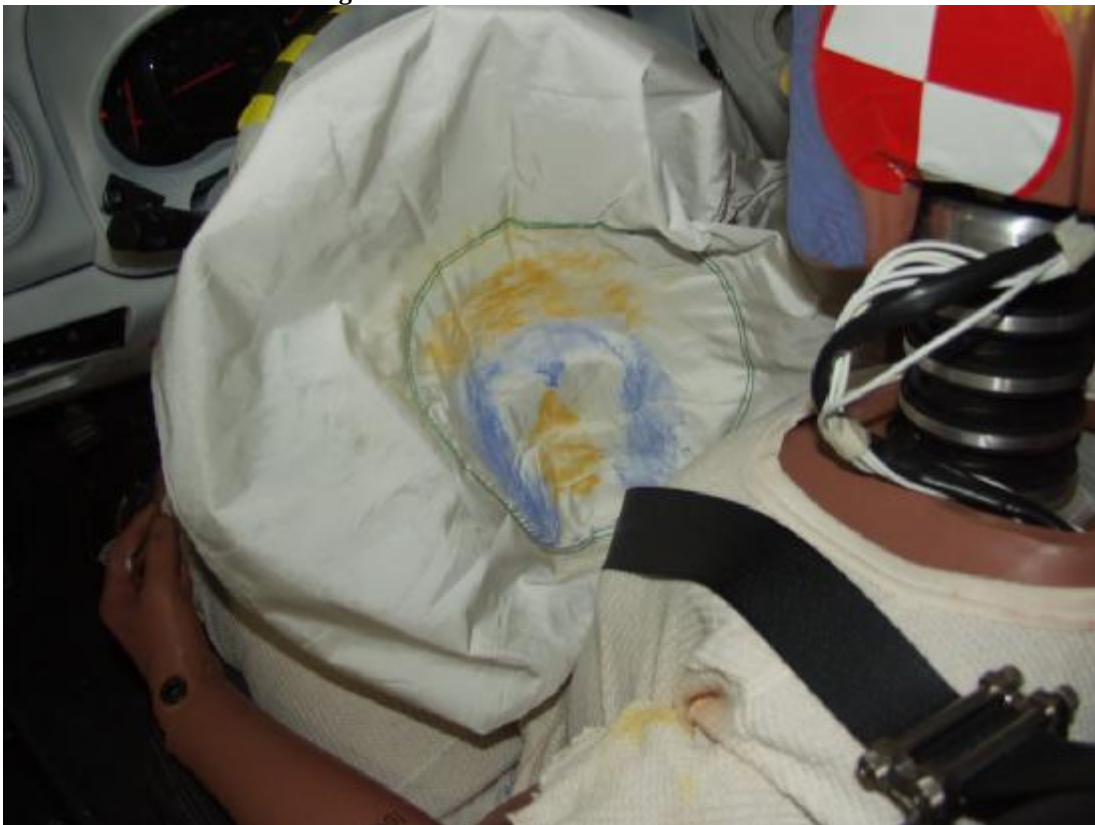
**Figure A-43: Post-Test Driver Contact to Airbag**

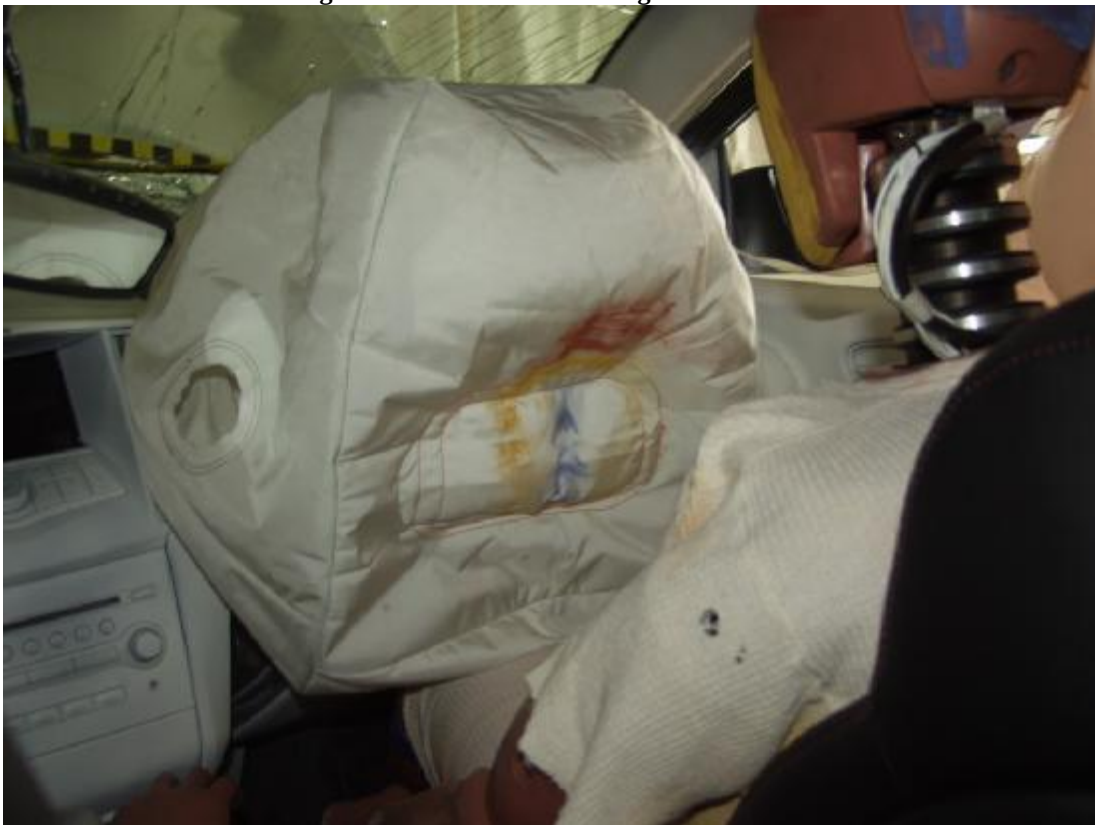
**Figure A-57: Post-Test Passenger Contact to Airbag**

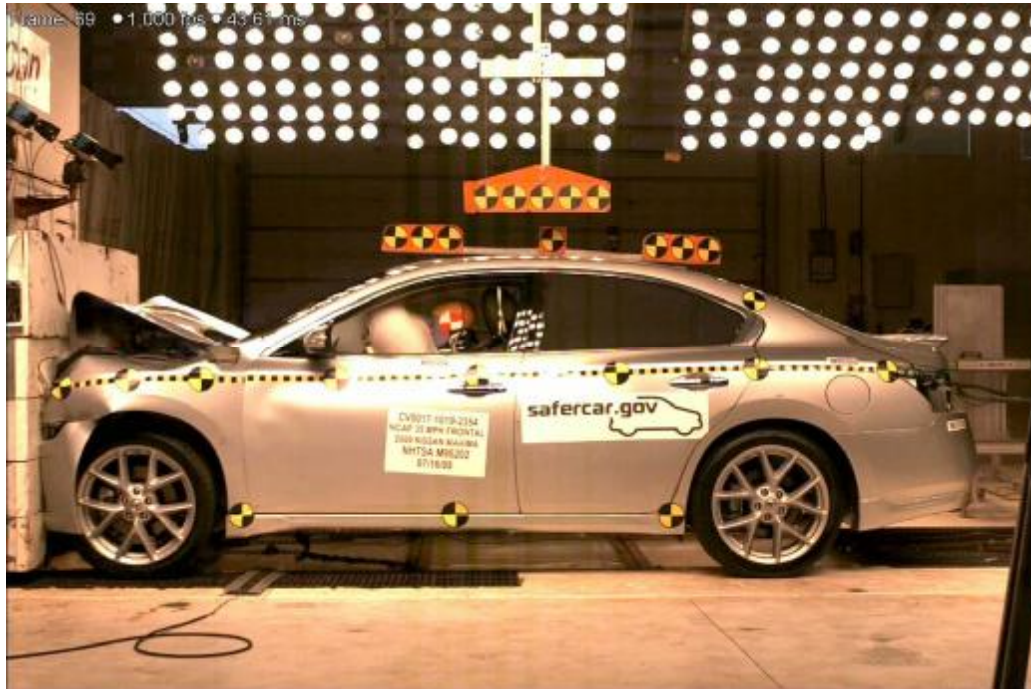
**Figure A-62: Impact View**
