**REPORT NUMBER: SNCAP-CAL-09-01**

**NEW CAR ASSESSMENT PROGRAM  
SIDE IMPACT TEST**

**NISSAN MOTOR COMPANY  
2009 NISSAN MAXIMA  
4-DOOR SEDAN**

**FINAL REPORT**

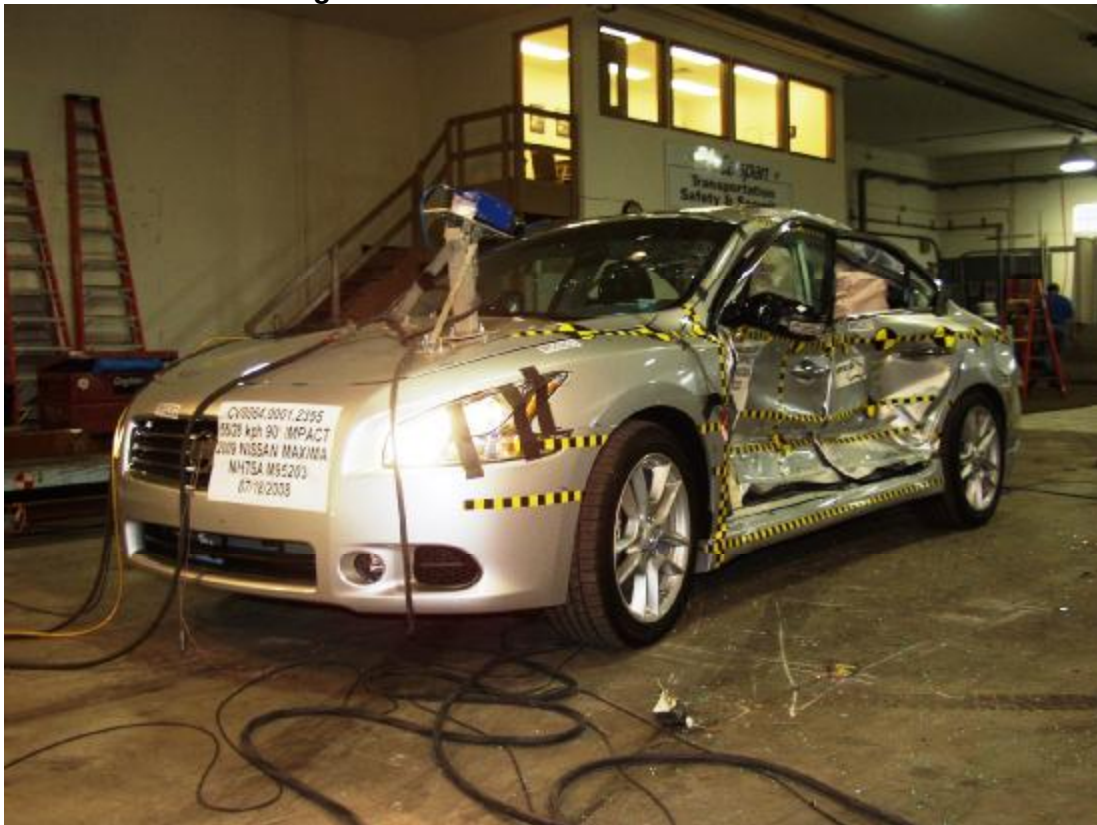
**Figure A-8: Post-Test Left Front  $\frac{3}{4}$  View**

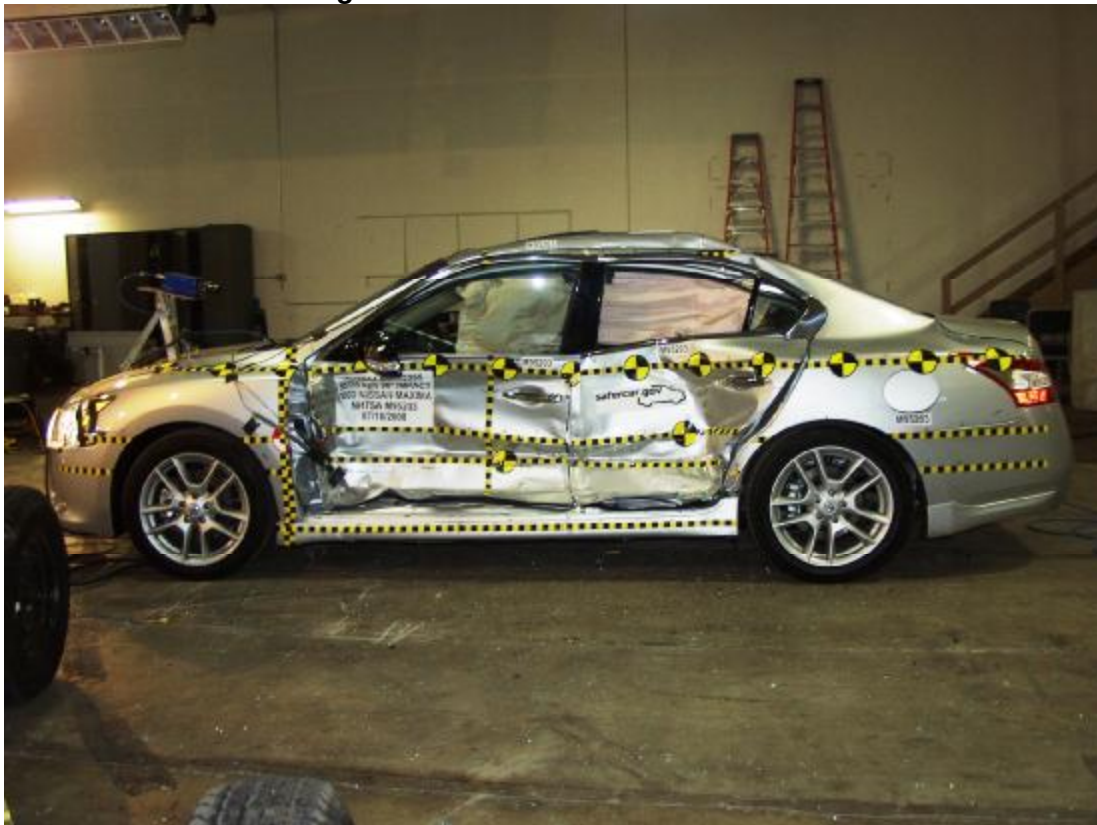
**Figure A-10: Post-Test Left Side View**

The test vehicle sustained a maximum static crush of 274 mm at level 2, 1049 mm rearward of the left vertical impact point. The driver and passenger SID/HIII's, Serial Nos. 269 and 270 respectively, were calibrated just prior to this test.

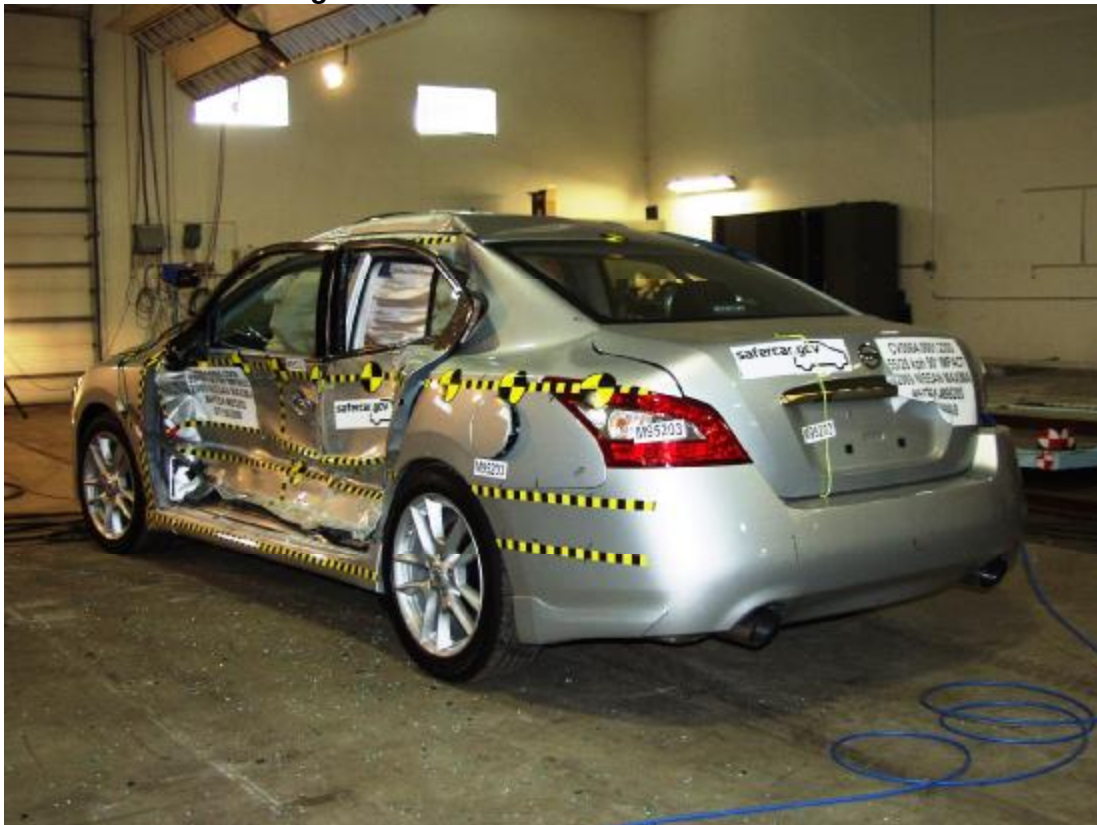
**Figure A-12: Post-Test Left Rear  $\frac{3}{4}$  View**

| Critical Areas of Performance | Observations and Conclusions |
|---|---|
| Window Damage | Left rear window shattered; Left Front window intact |

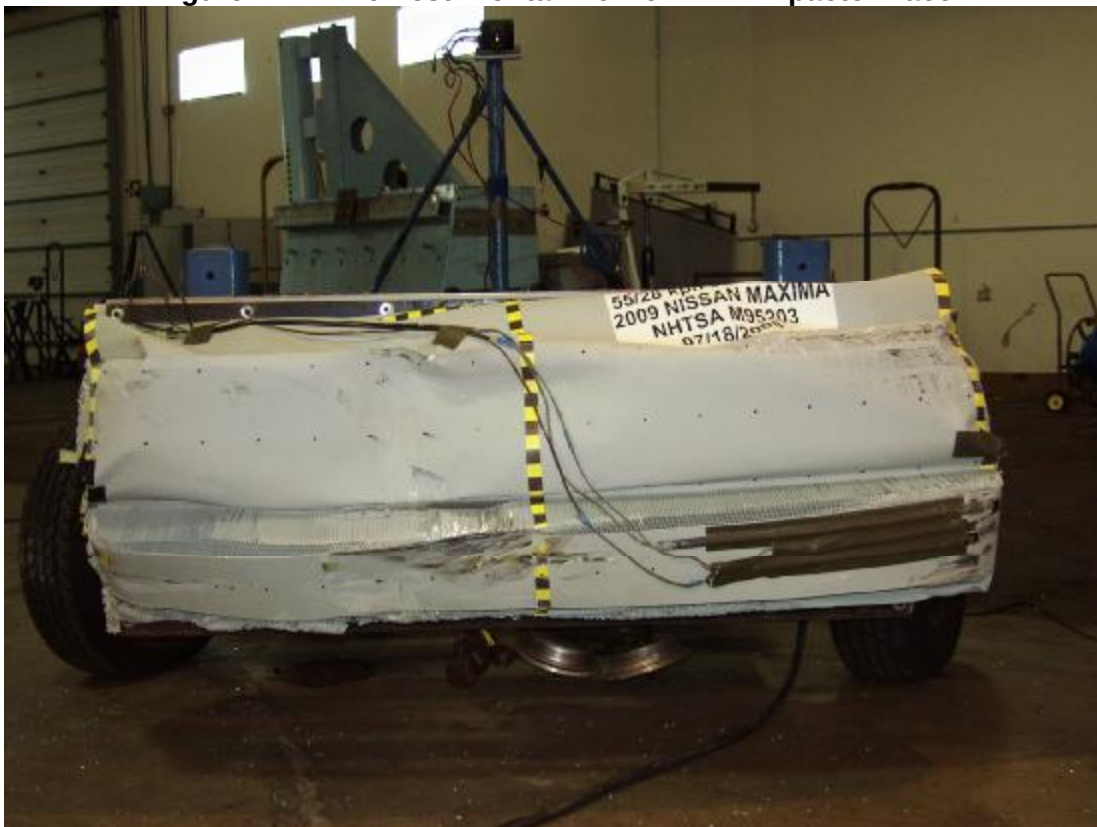
**Figure A-22: Post-Test Frontal View of MDB Impactor Face**

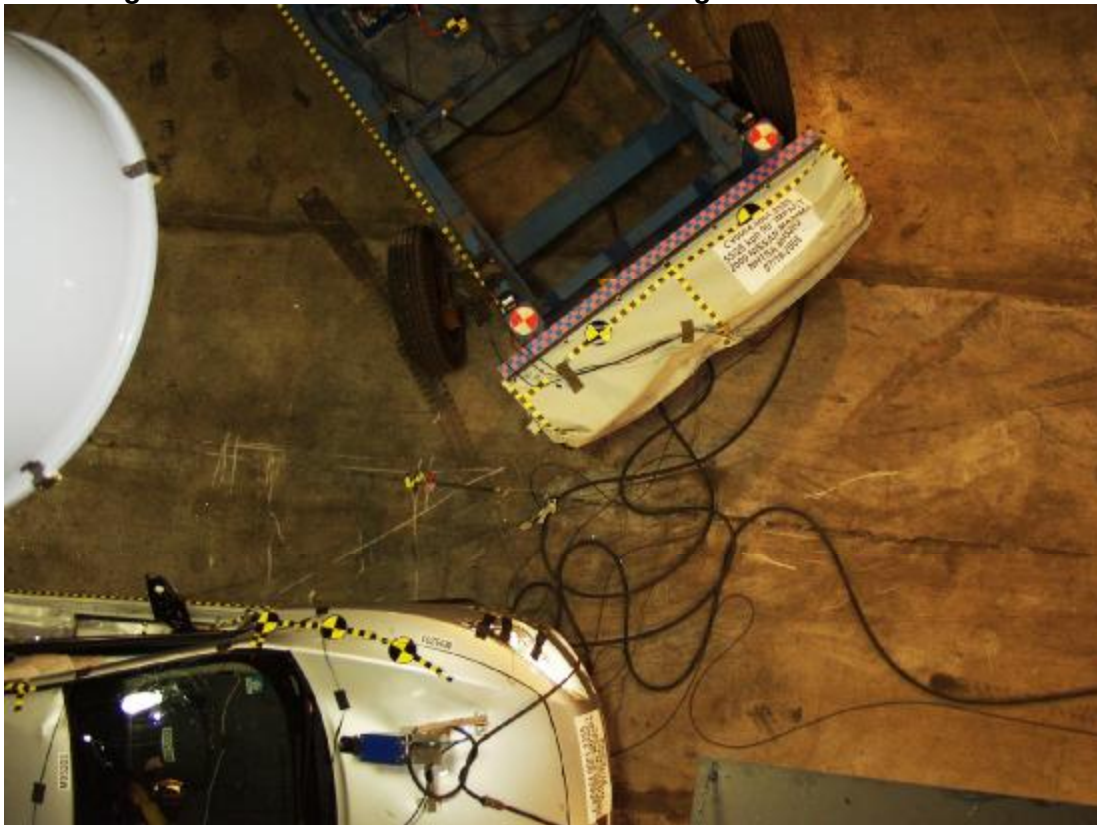
Figure A-32: Post-Test Overhead View of MDB and Vehicle

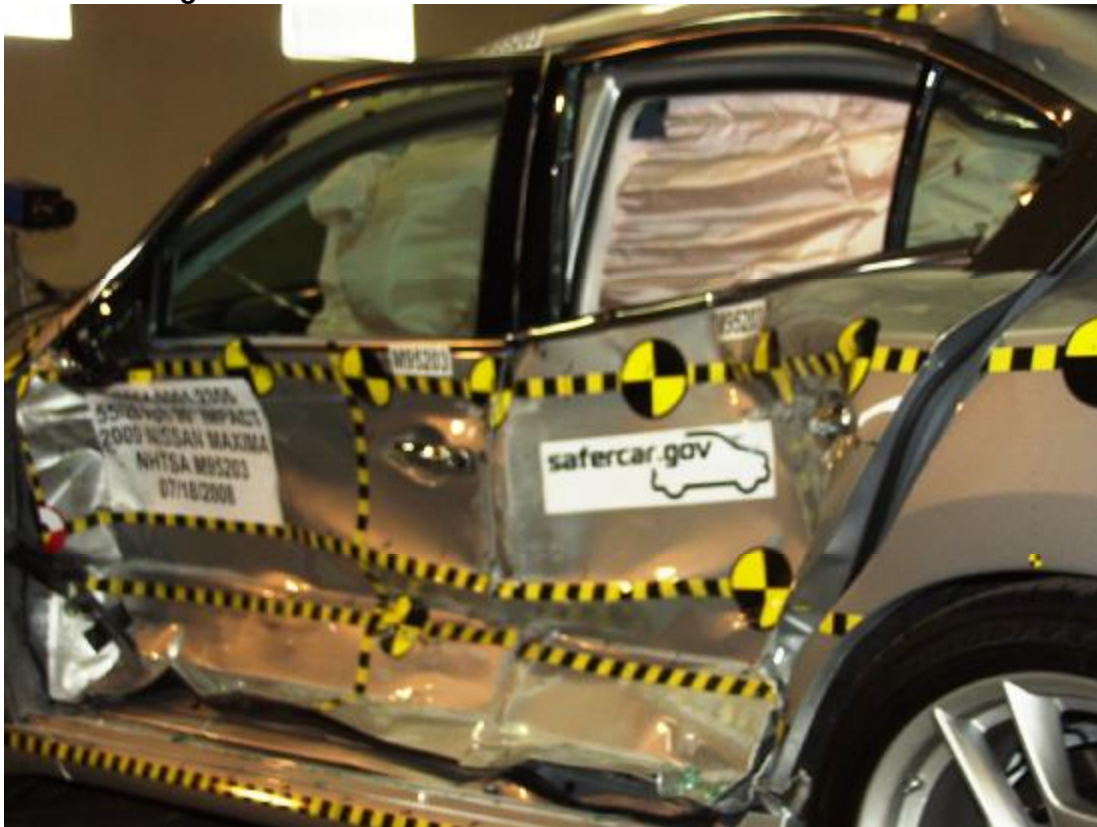
**Figure A-50: Post-Test Left Rear  $\frac{3}{4}$  View of Left Side Doors**
