**REPORT NUMBER: SNCAP-CAL-09-02**

**NEW CAR ASSESSMENT PROGRAM  
SIDE IMPACT TEST**

**FORD MOTOR COMPANY  
2009 LINCOLN MKS  
4-DOOR SEDAN**

**FINAL REPORT**

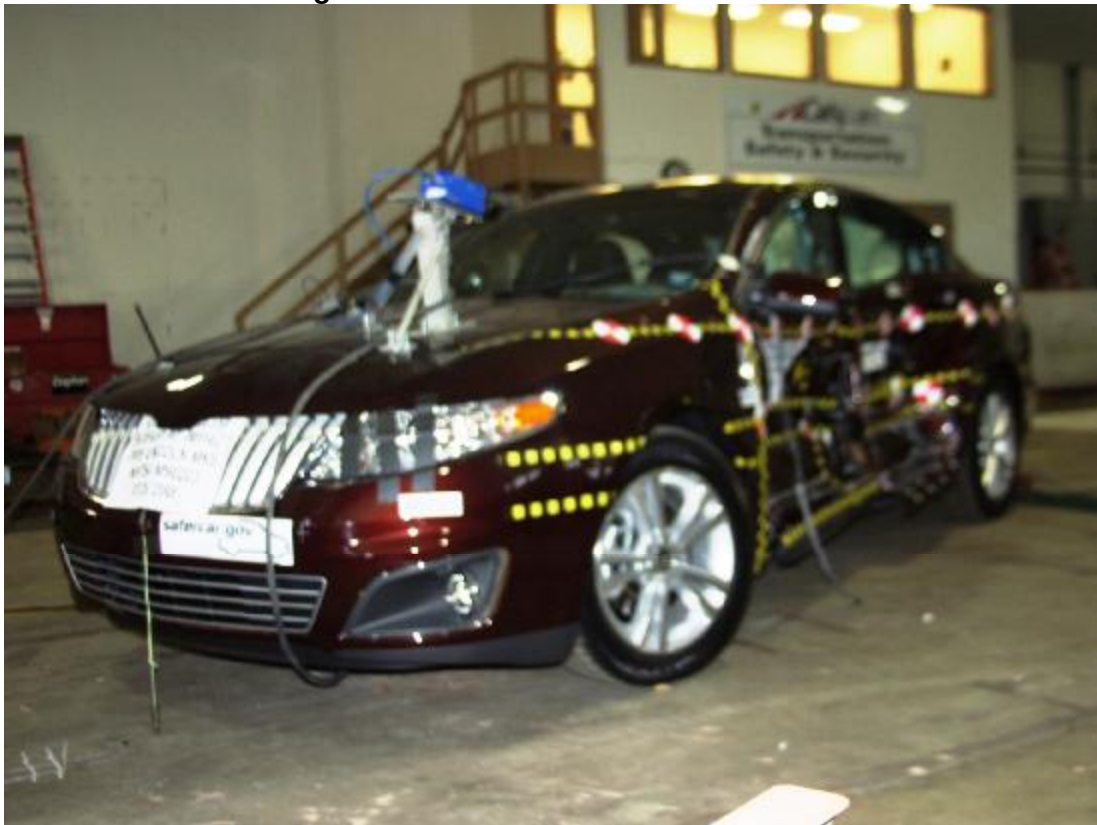
**Figure A-8: Post-Test Left Front  $\frac{3}{4}$  View**

The test vehicle sustained a maximum static crush of 238 mm at level 3, 600 mm rearward of the left vertical impact point. The driver and passenger SID/HIII's, Serial Nos. 270 and 269 respectively, were calibrated just prior to this test.

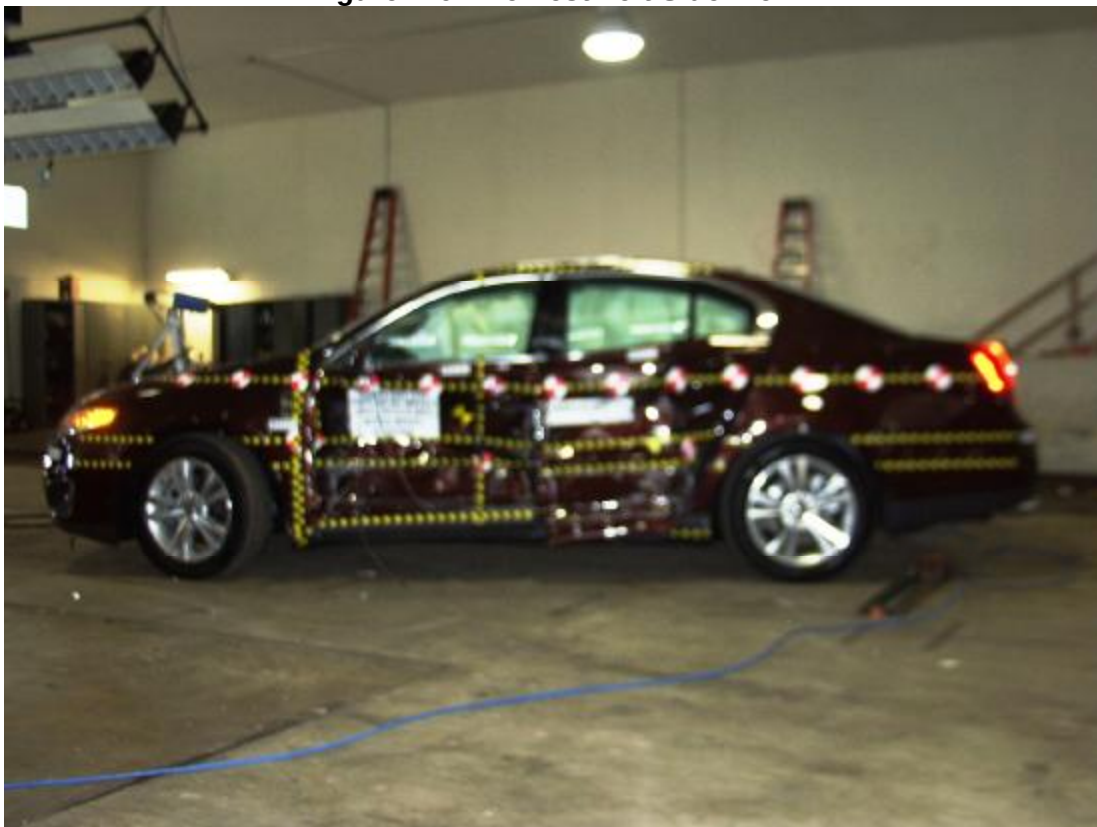
**Figure A-10: Post-Test Left Side View**

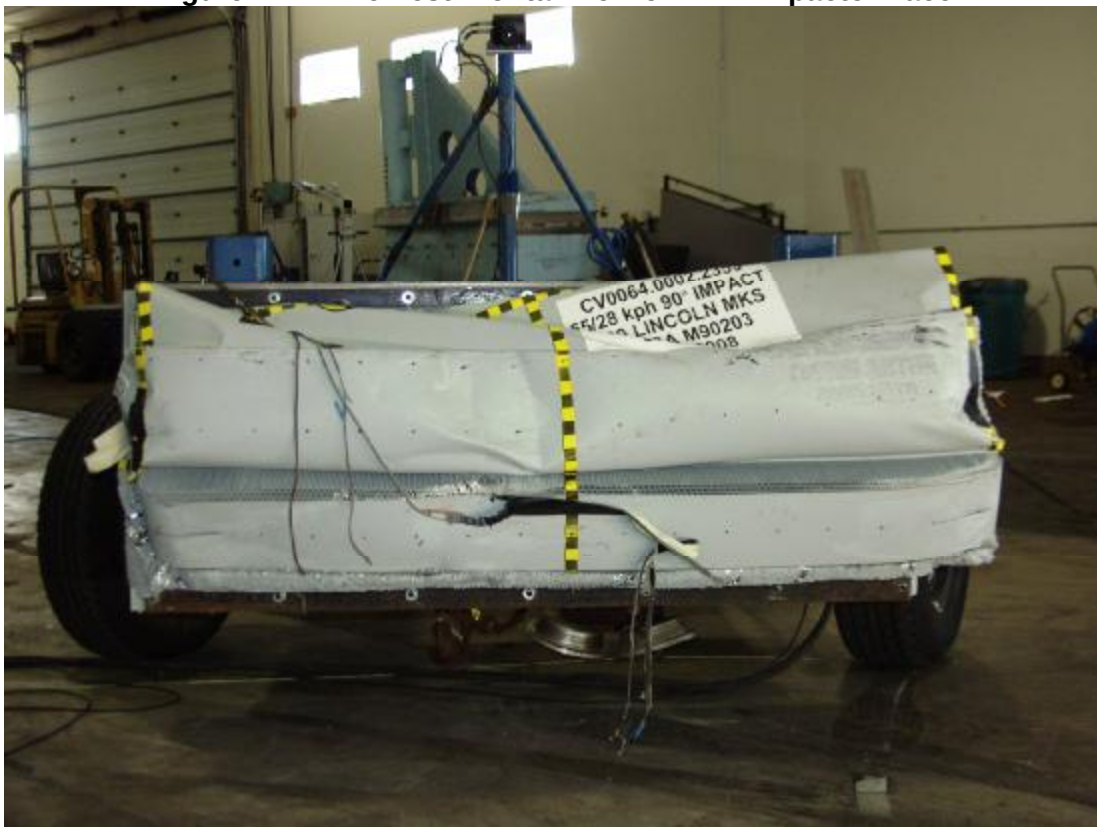
**Figure A-22: Post-Test Frontal View of MDB Impactor Face**

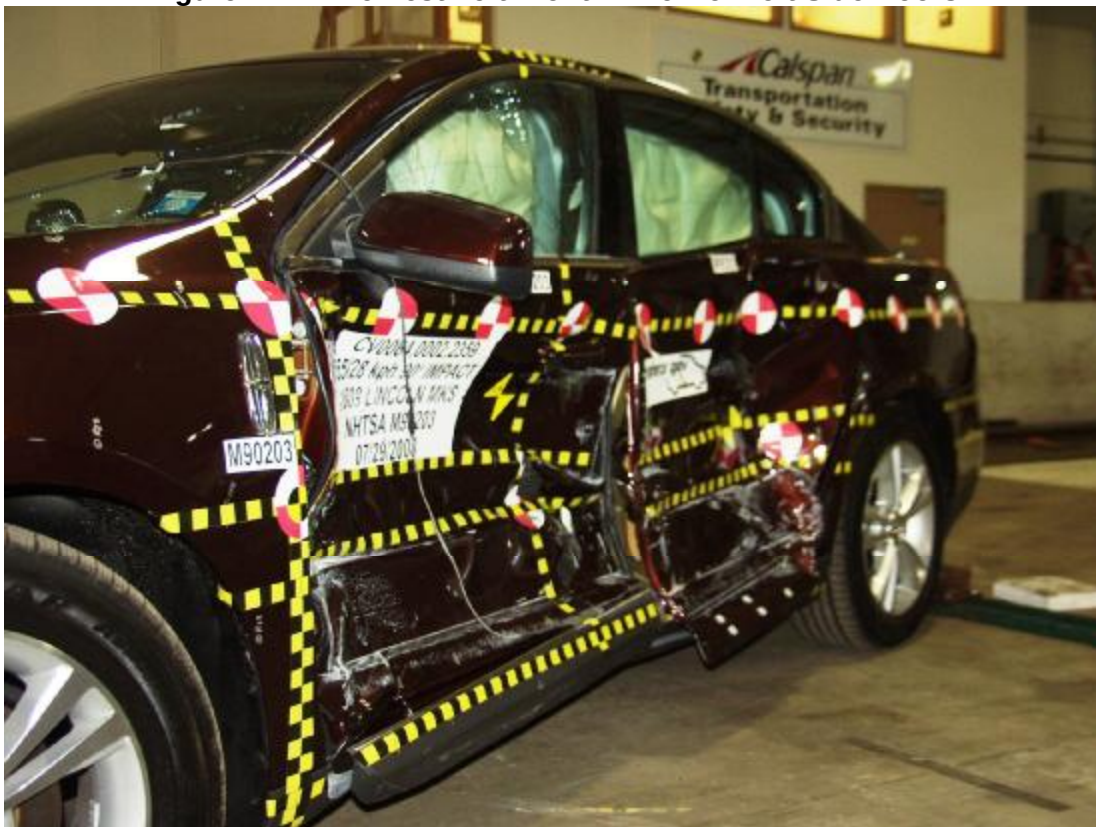
Figure A-48: Post-Test Left Front  $\frac{3}{4}$  View of Left Side Doors

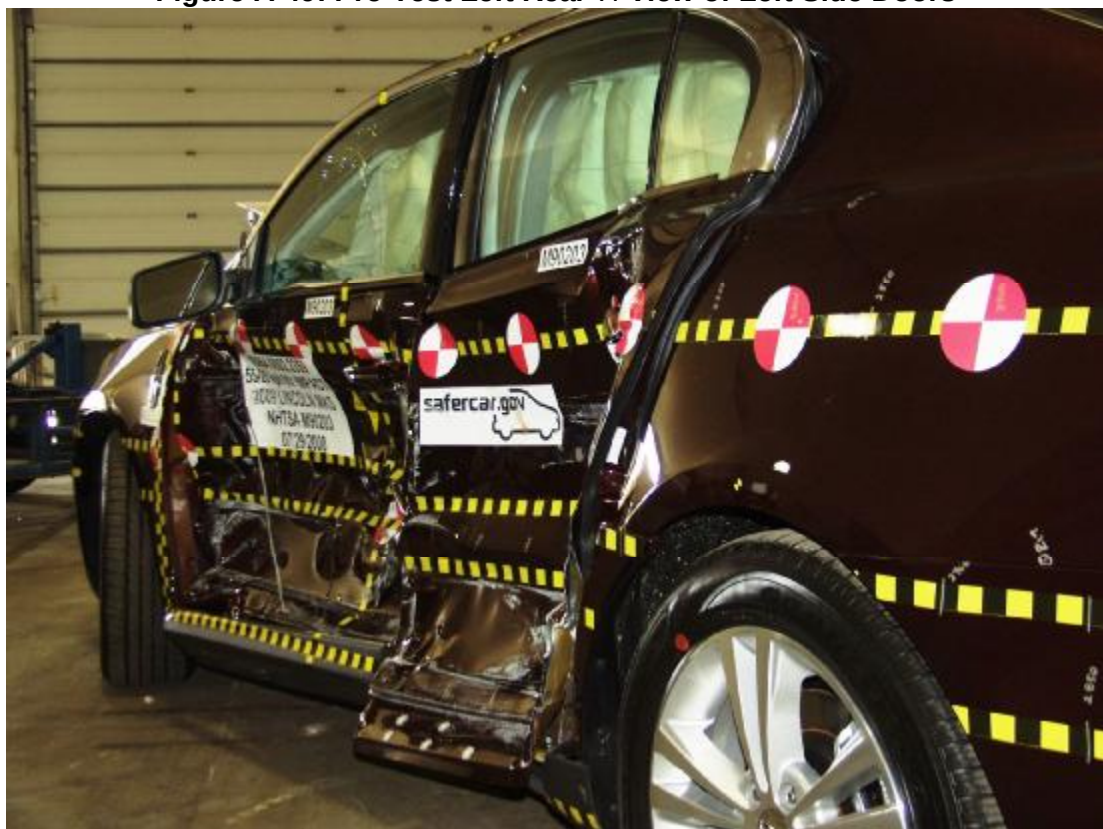
**Figure A-50: Post-Test Left Rear  $\frac{3}{4}$  View of Left Side Doors**
