REPORT NUMBER: CAL-09-01

**NEW CAR ASSESSMENT PROGRAM (NCAP)
FRONTAL BARRIER IMPACT TEST**

FORD MOTOR COMPANY
2009 LINCOLN MKS
4-DOOR SEDAN

CALSPAN TEST NUMBER: 8865-NCAP-01

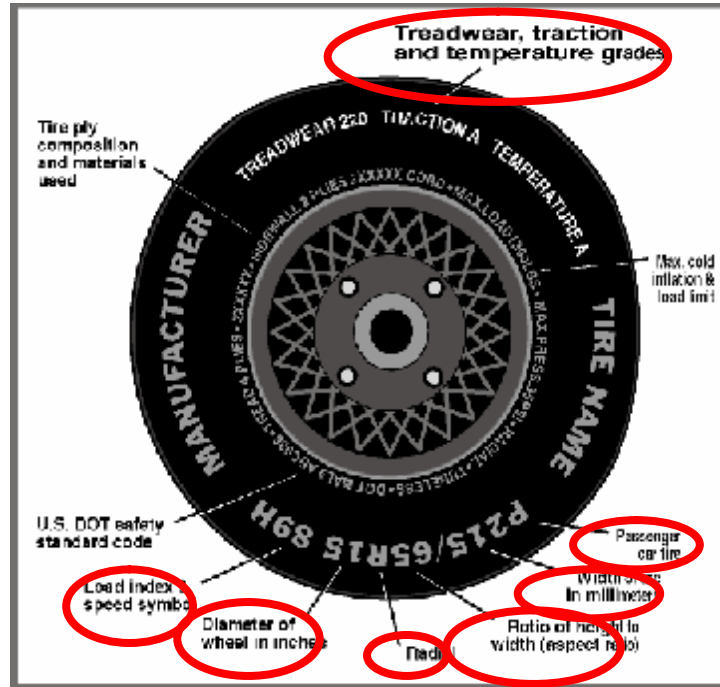
DATA SHEET NO. 3
TEST VEHICLE TIRE INFORMATION

Measured Parameter	Front	Rear
Maximum Tire Pressure (from sidewall - kPa)	350	350
Cold Pressure (from tire placard - kPa)*	220	220
Recommended Tire Size (from tire placard)	P235/55R18	P235/55R18
Tire size on Vehicle	P235/55R18	P235/55R18
Tire Manufacturer	Goodyear	Goodyear
Tire Name	Assurance	Assurance
Tire Type	P	P
Tire Width (mm)	235	235
Ratio of Height to Width (aspect ratio)	55	55
Radial	R	R
Wheel Diameter	18	18
Load Index & Speed Symbol	99T	99T
Treadwear	700	700
Traction Grade	A	A
Temperature Grade	B	B

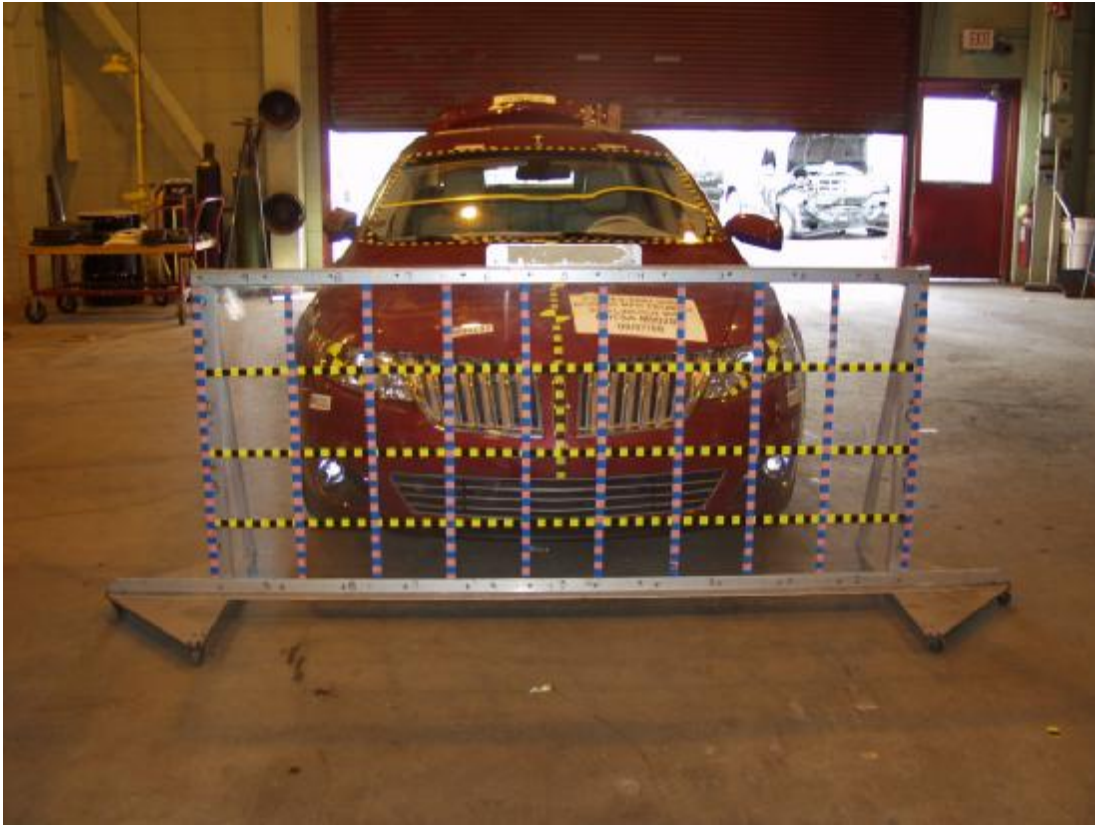
Figure A-1: Load Cell Locations

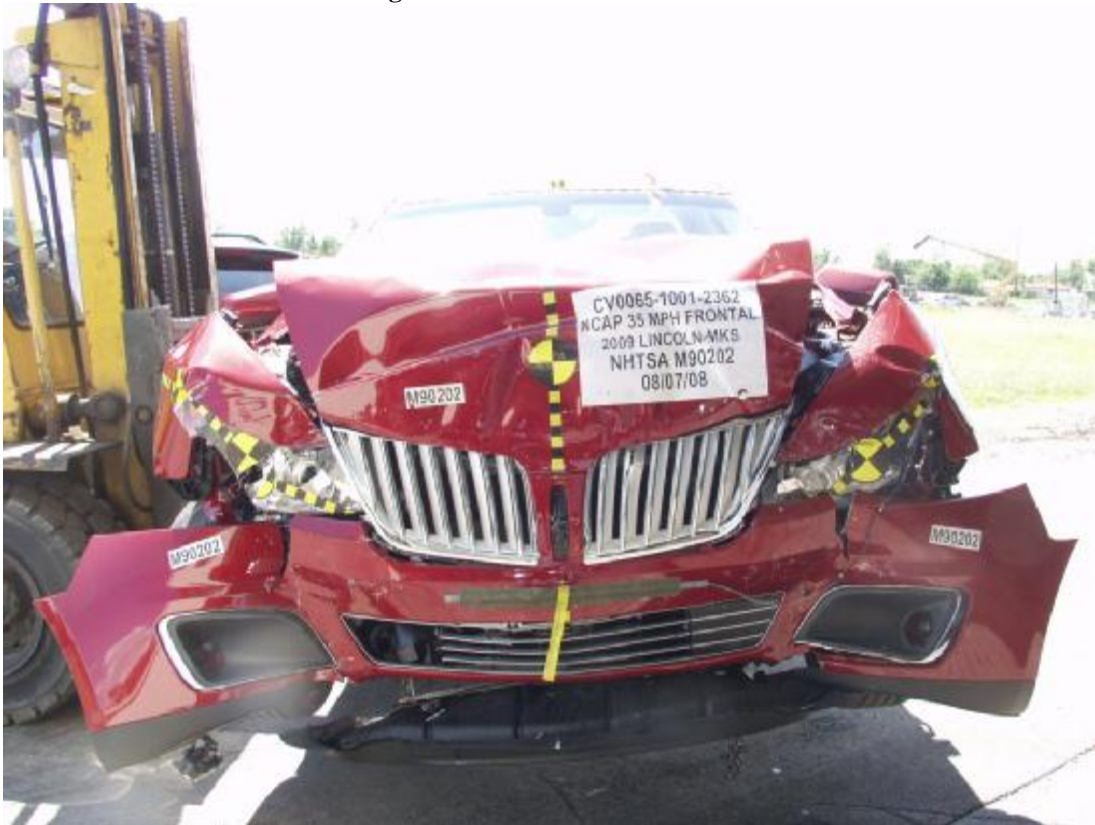
Figure A-7: Post-Test Front View

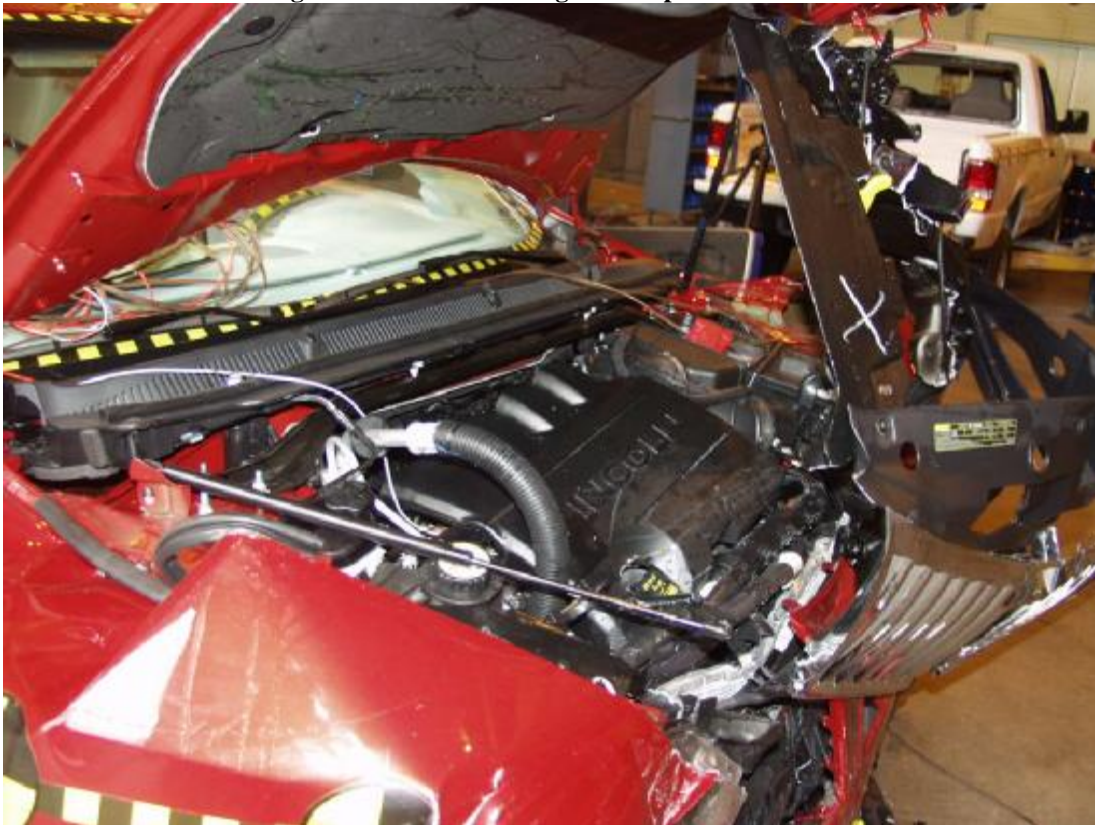
Figure A-21: Post-Test Engine Compartment View

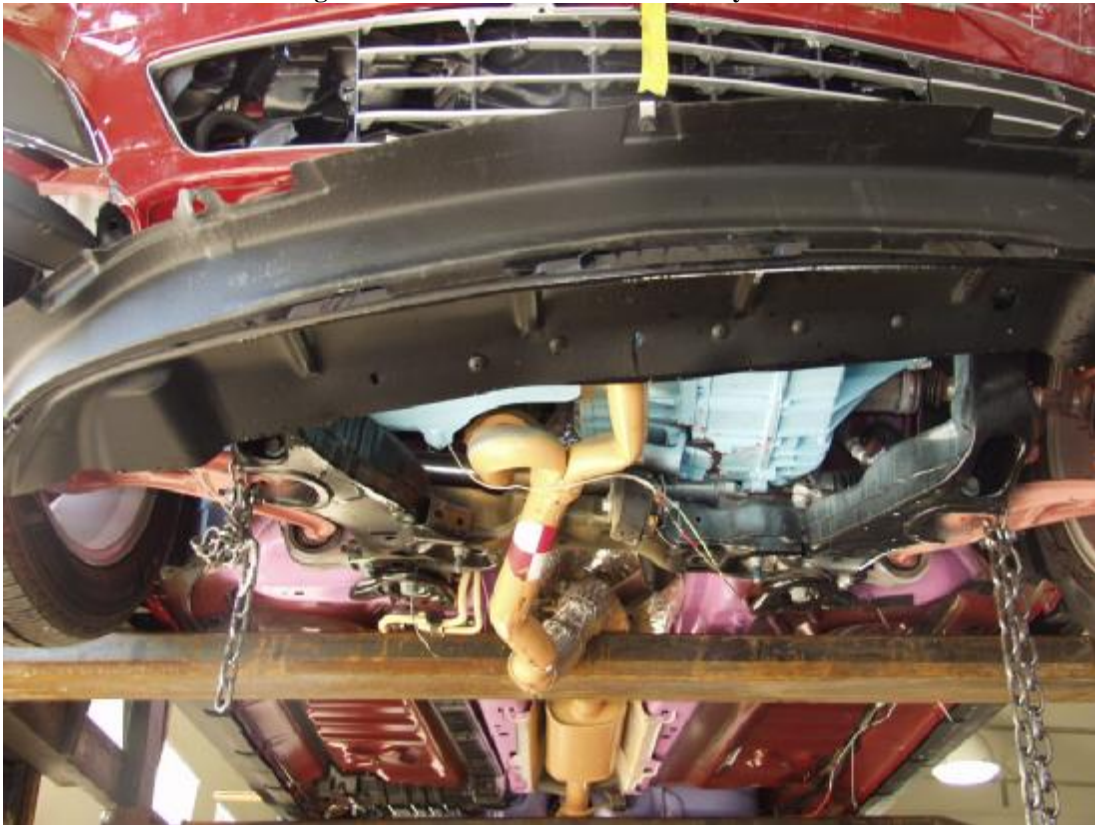
Figure A-25: Post-Test Front Underbody View

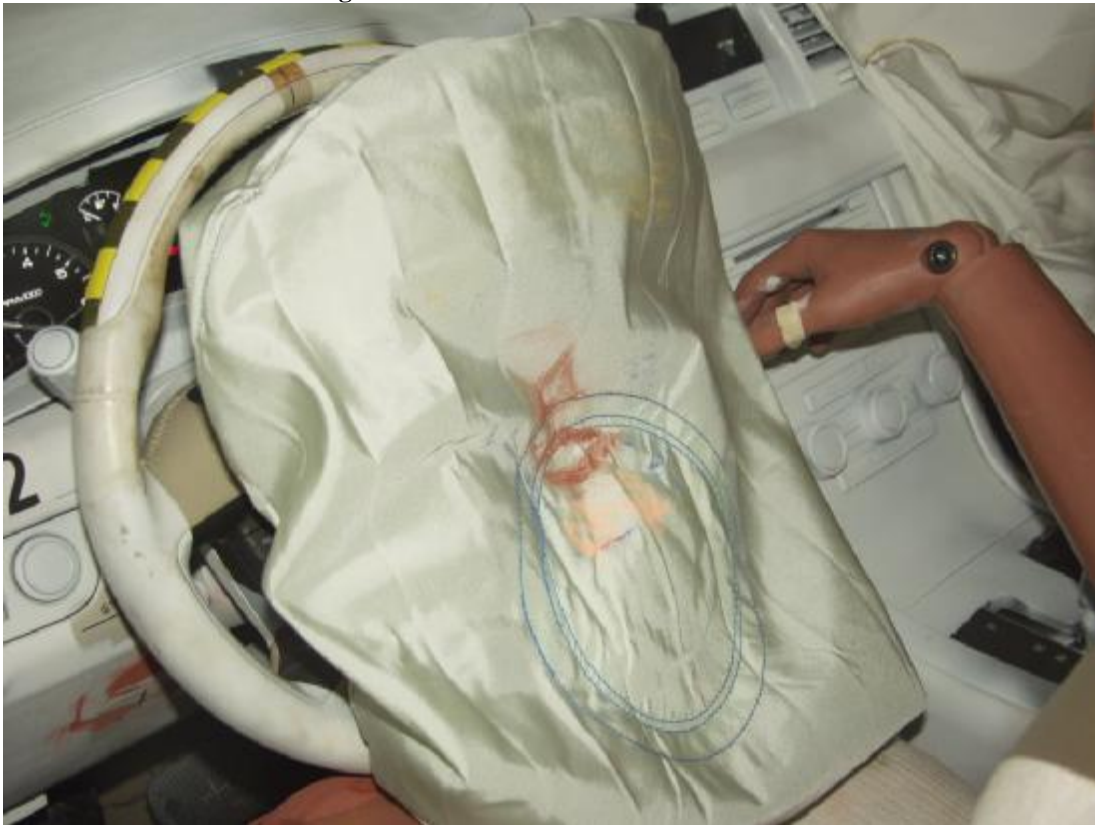
Figure A-43: Post-Test Driver Contact to Airbag

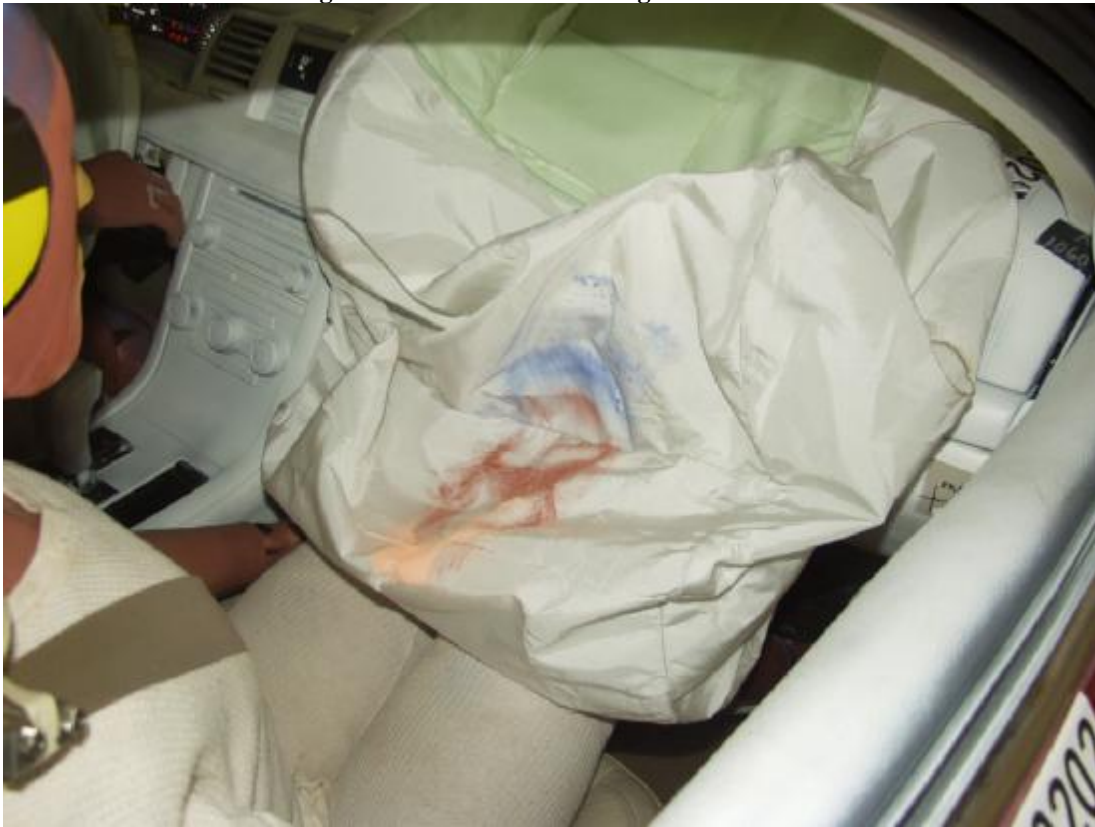
Figure A-57: Post-Test Passenger Contact to Airbag
