REPORT NUMBER: CAL-08-20

**NEW CAR ASSESSMENT PROGRAM (NCAP)  
FRONTAL BARRIER IMPACT TEST**

FORD MOTOR COMPANY  
2009 FORD ESCAPE  
4-DOOR MPV

NHTSA NUMBER: M90204

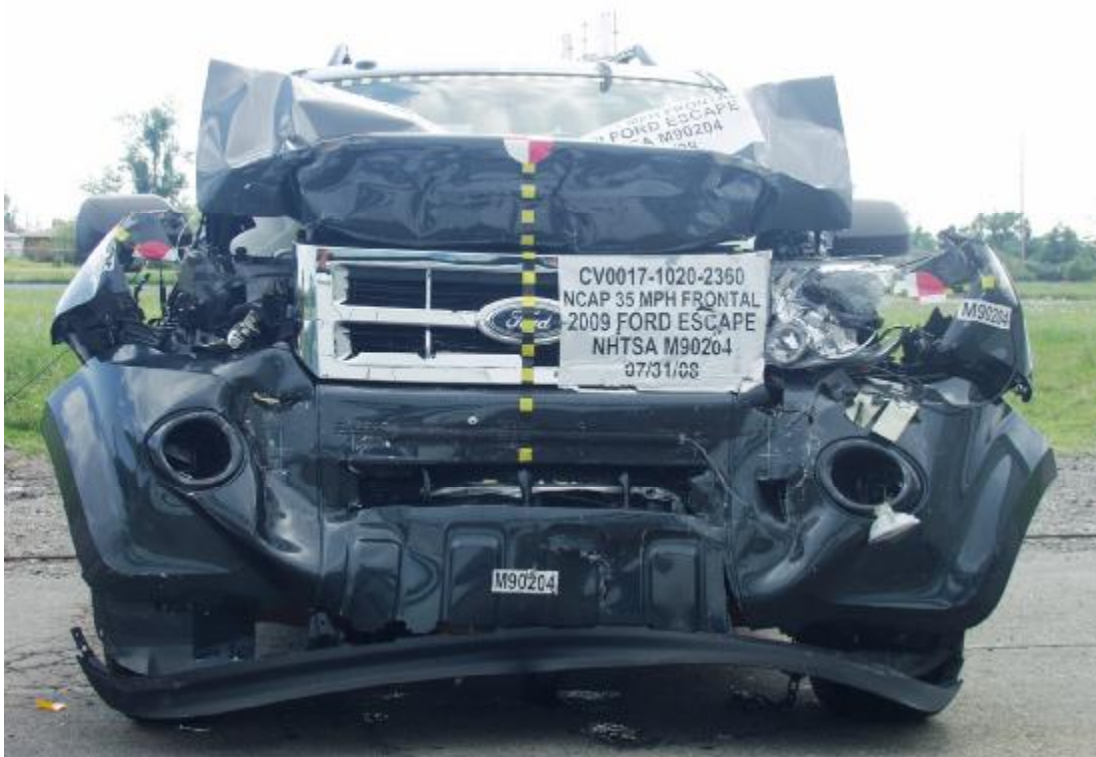
**Figure A-7: Post-Test Front View**

Vehicle NHTSA No.: M90204 Test Mode: 56.3 kph Frontal Barrier  
 Test Date: July 31, 2008 Time: 13:35 Temperature: 22 °C  
 Vehicle Make/Model/Body Style: 2009 Ford Escape 4-Door MPV  
 Vehicle Test Weight: 1904.0 kg Impact Velocity: 56.12 kph (55.5 – 57.1 kph)  
 Vehicle/Barrier Impact Angle: 0 ° Max Static Crush: 546 mm

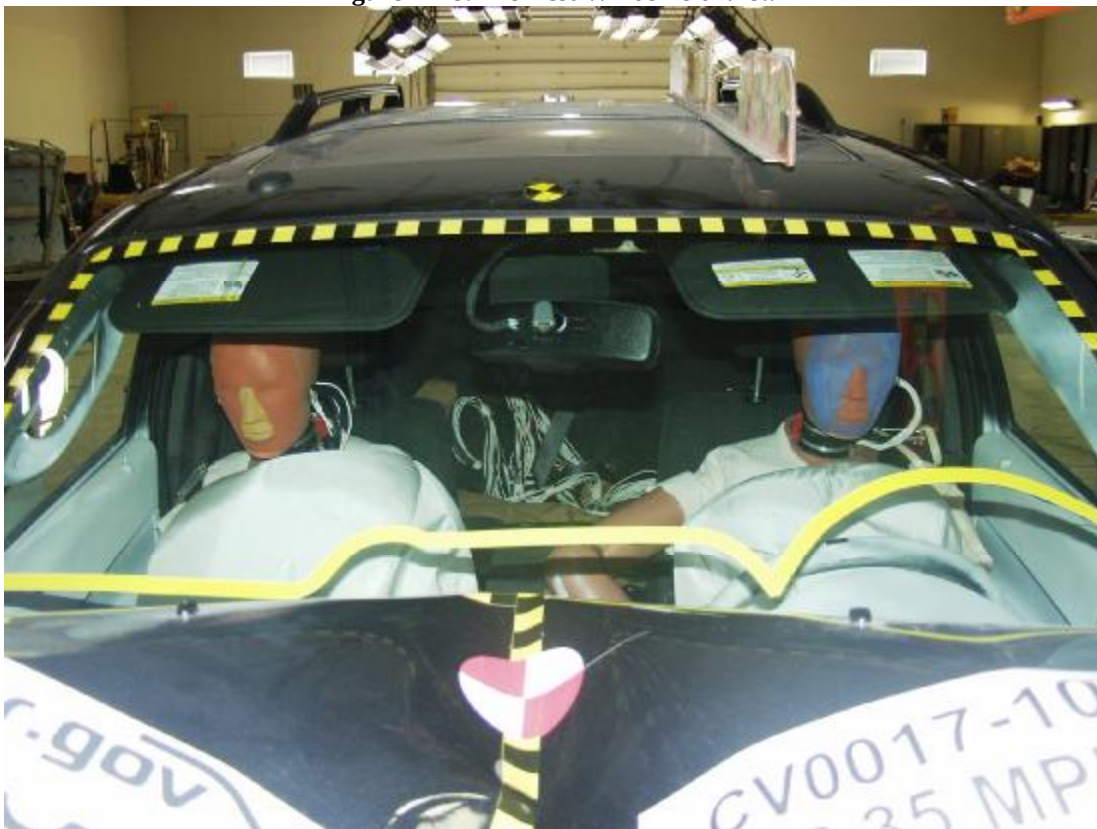
**Figure A-19: Post-Test Windshield View**

| Description | Driver Side | Passenger Side |
|---|---|---|
| Glazing Damage | None | |

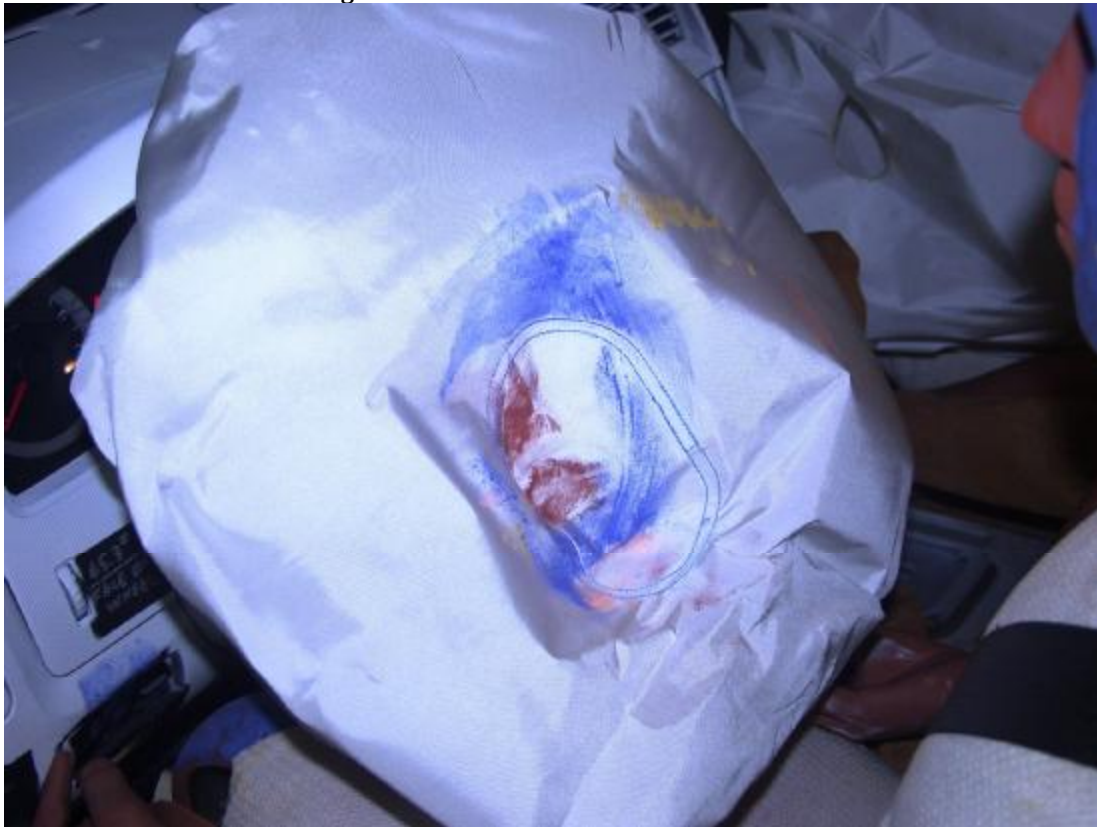
**Figure A-43: Post-Test Driver Contact to Airbag**

| | DRIVER | PASSENGER |
|---|---|---|
| Head Contact: | Face with Left Frontal Airbag<br>Back of head with left front head restraint | Face with Right Frontal Airbag<br>Back of head with right front head restraint |
| Chest Contact: | Left Frontal Airbag | Right Frontal Airbag |

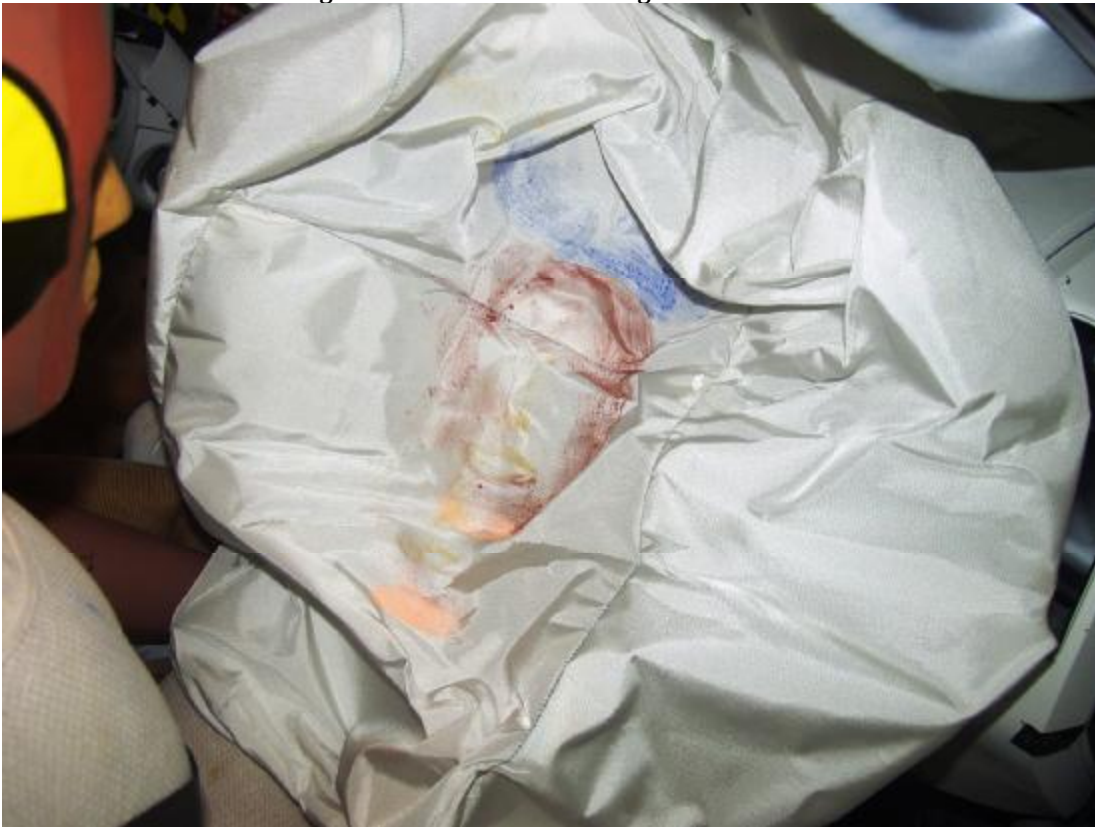
**Figure A-57: Post-Test Passenger Contact to Airbag**

| | DRIVER | PASSENGER |
|---|---|---|
| Abdomen Contact: | No Contact | Right Frontal Airbag |
