NEW CAR ASSESSMENT PROGRAM  
SIDE IMPACT TEST

CAMI AUTOMOTIVE INC.  
2009 CHEVROLET EQUINOX LS  
5-DOOR MPV

NHTSA NUMBER: M90102

FINAL REPORT

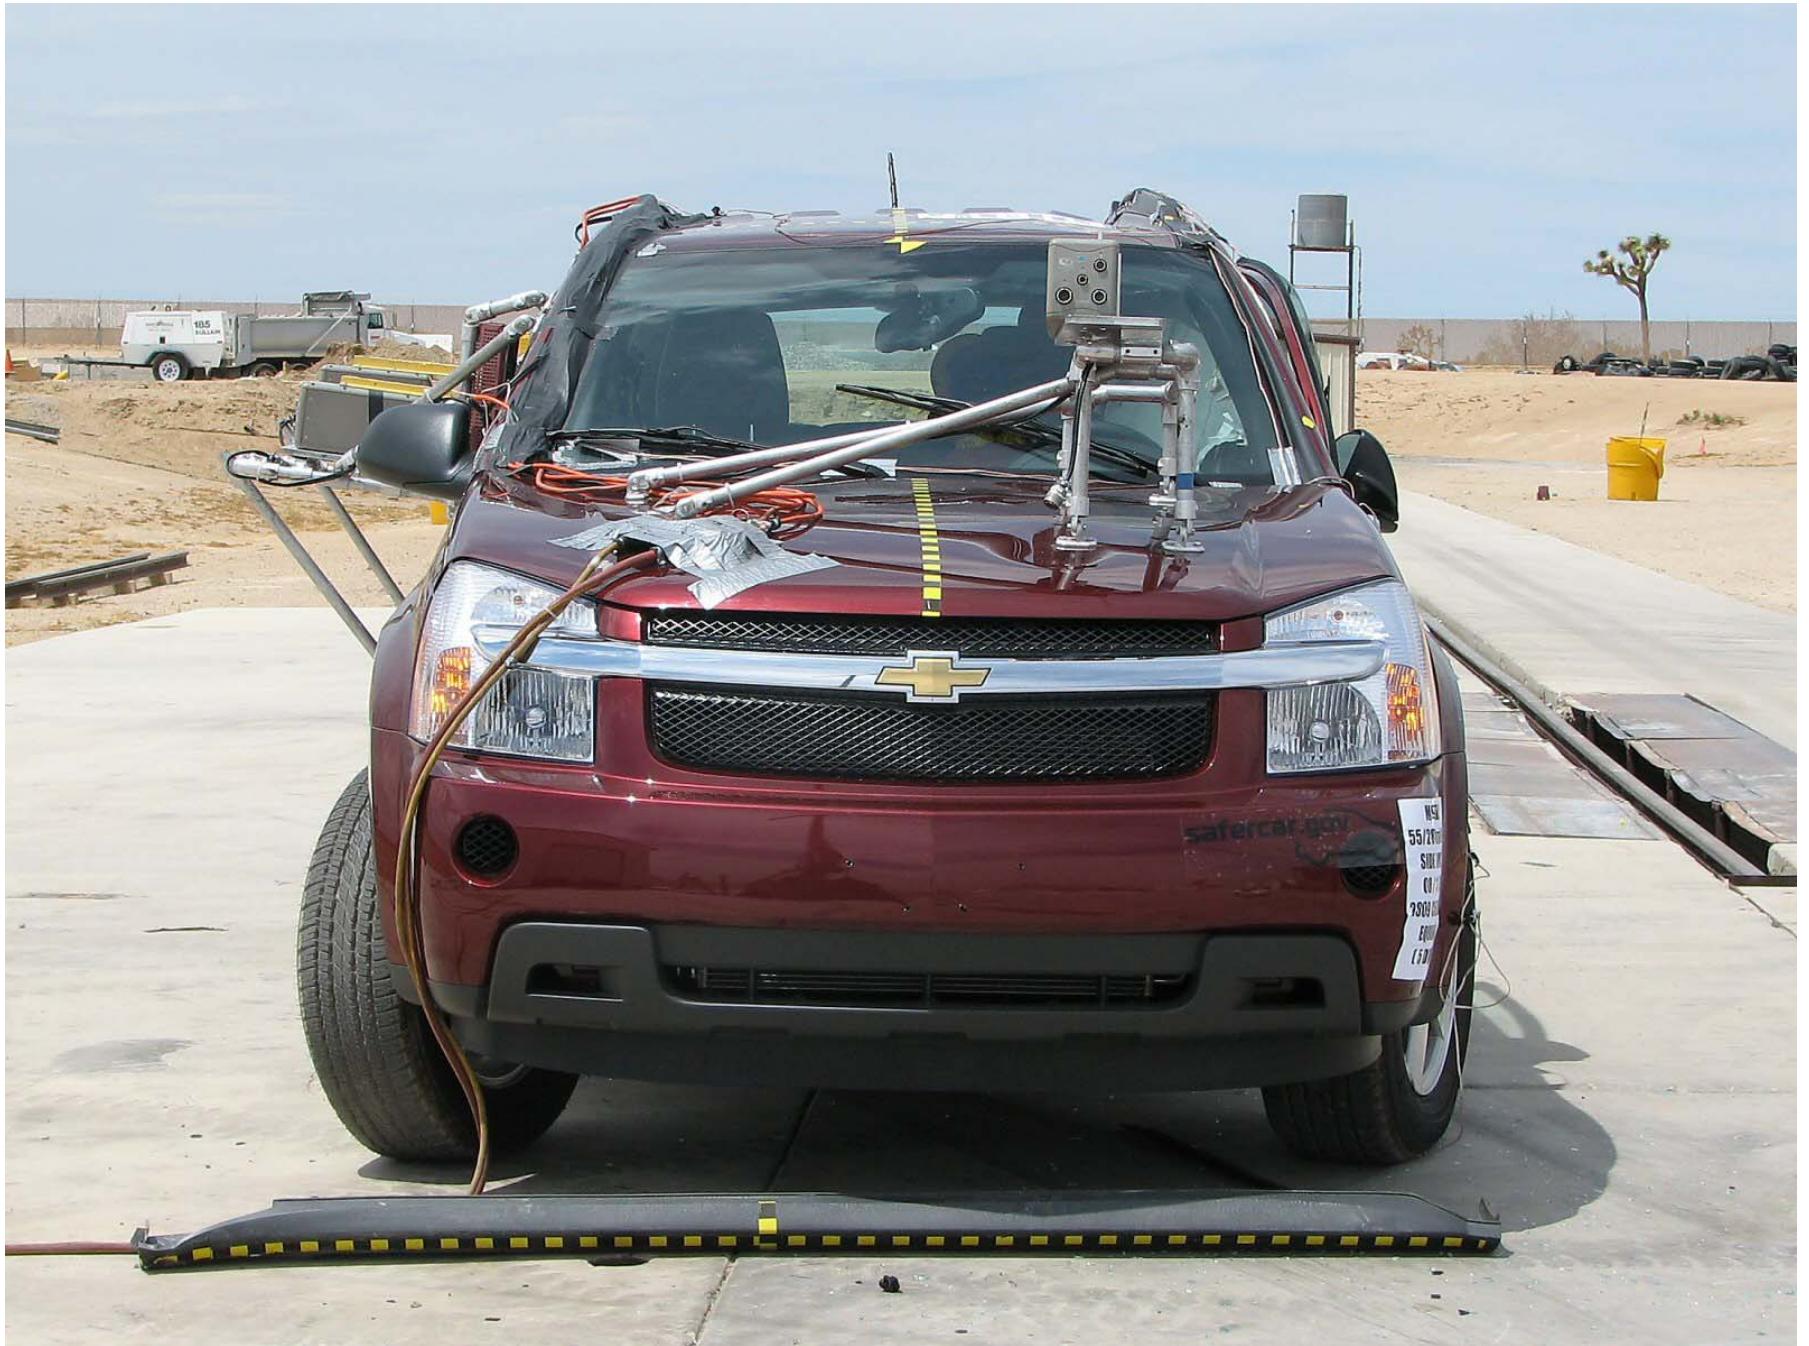
Figure A-6: Post-Test Front View

| Critical Areas of Performance | Observations and Conclusions |
|---|---|
| Windshield Damage | Cracked |

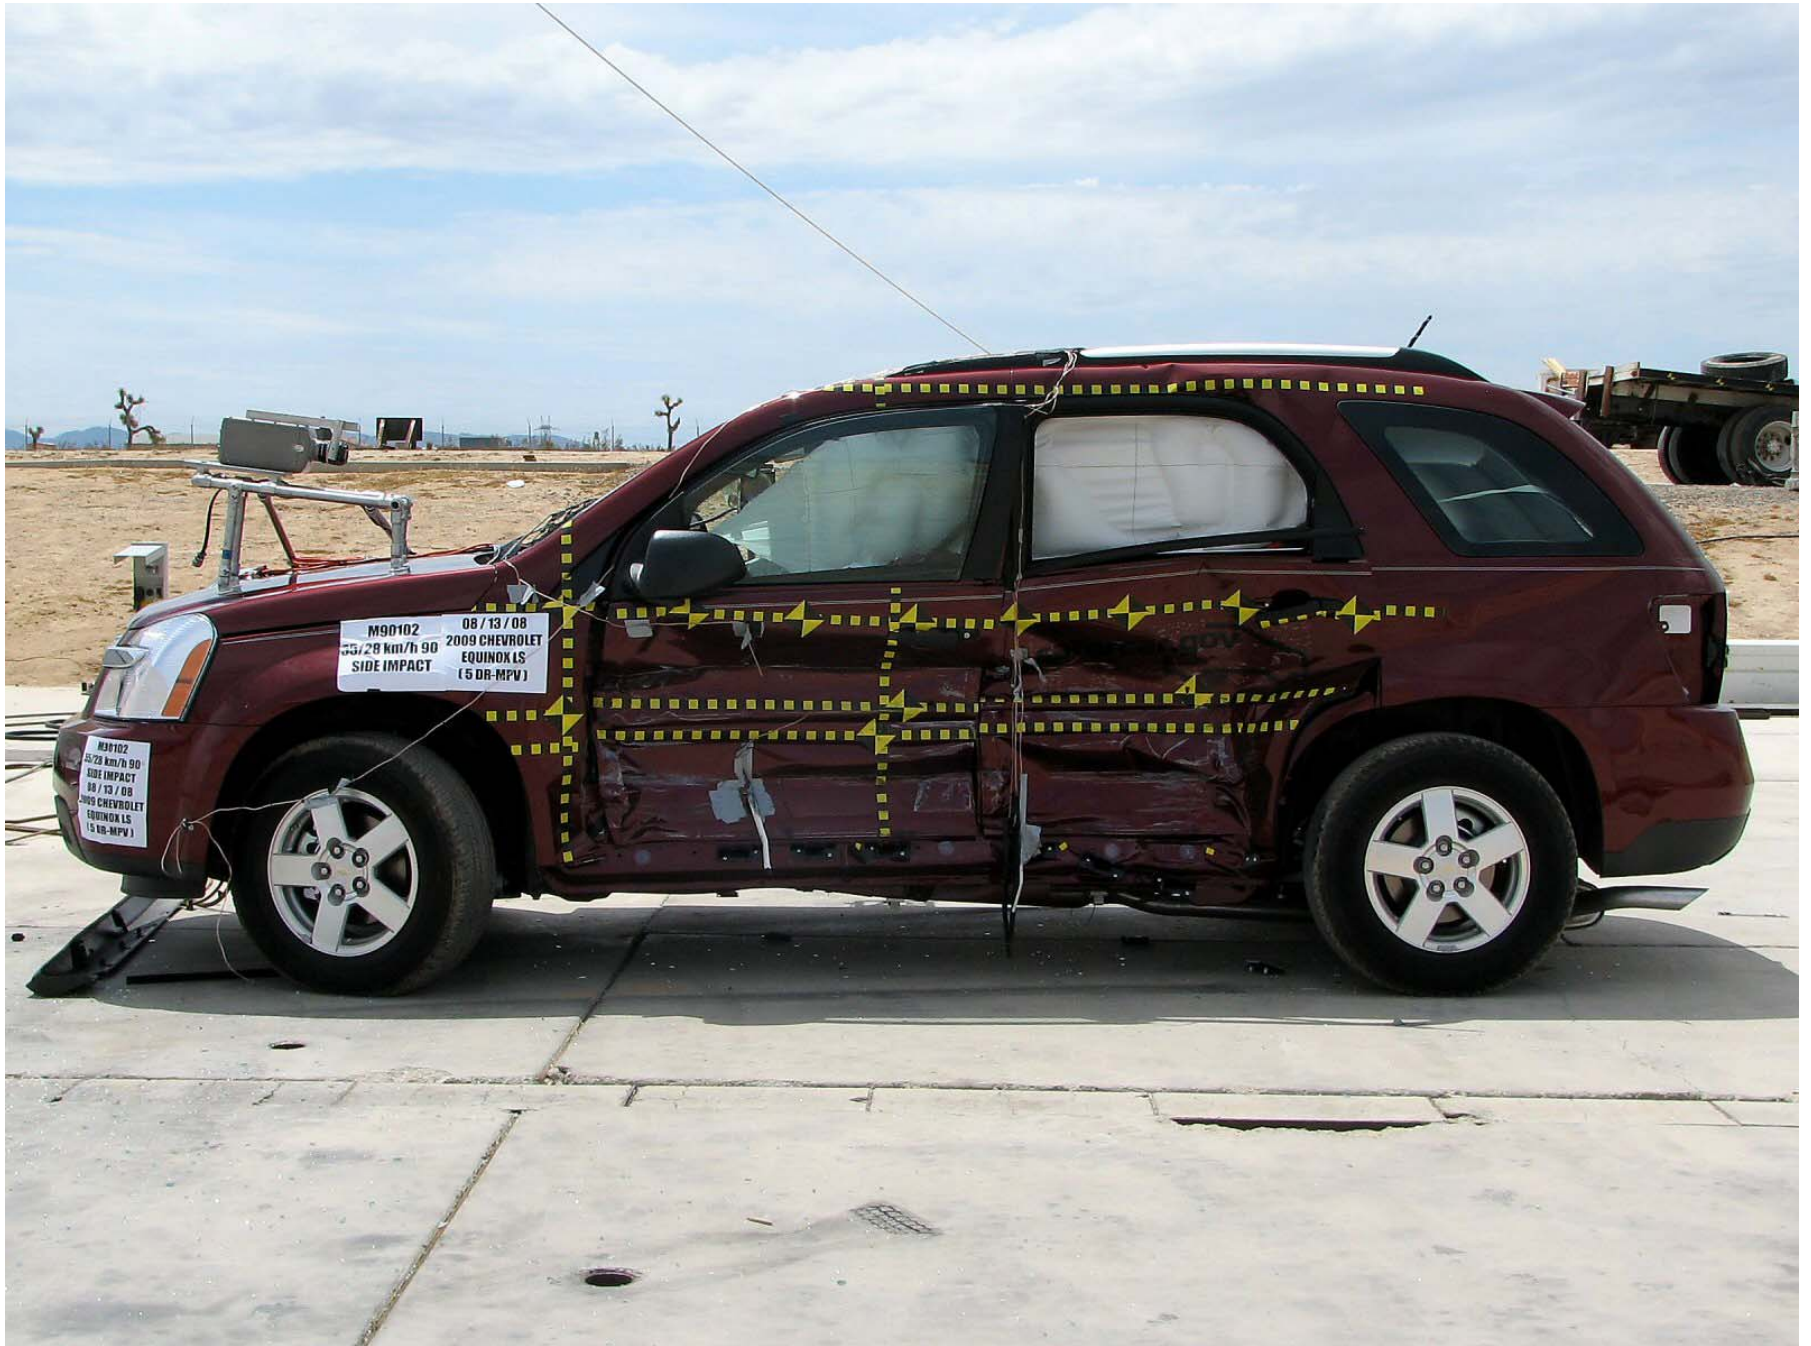
Figure A-10: Post-Test Left Side View

Both the driver and passenger doors remained closed during the impact. The test vehicle sustained a maximum static crush of 344 mm at level 3, 1500 mm rearward of the left vertical impact point. The driver SID/Hybrid III, Serial No. 275 and the passenger SID/Hybrid III, Serial No. 274 were calibrated prior to this test. The SID/Hybrid III injury criteria are summarized as follows:

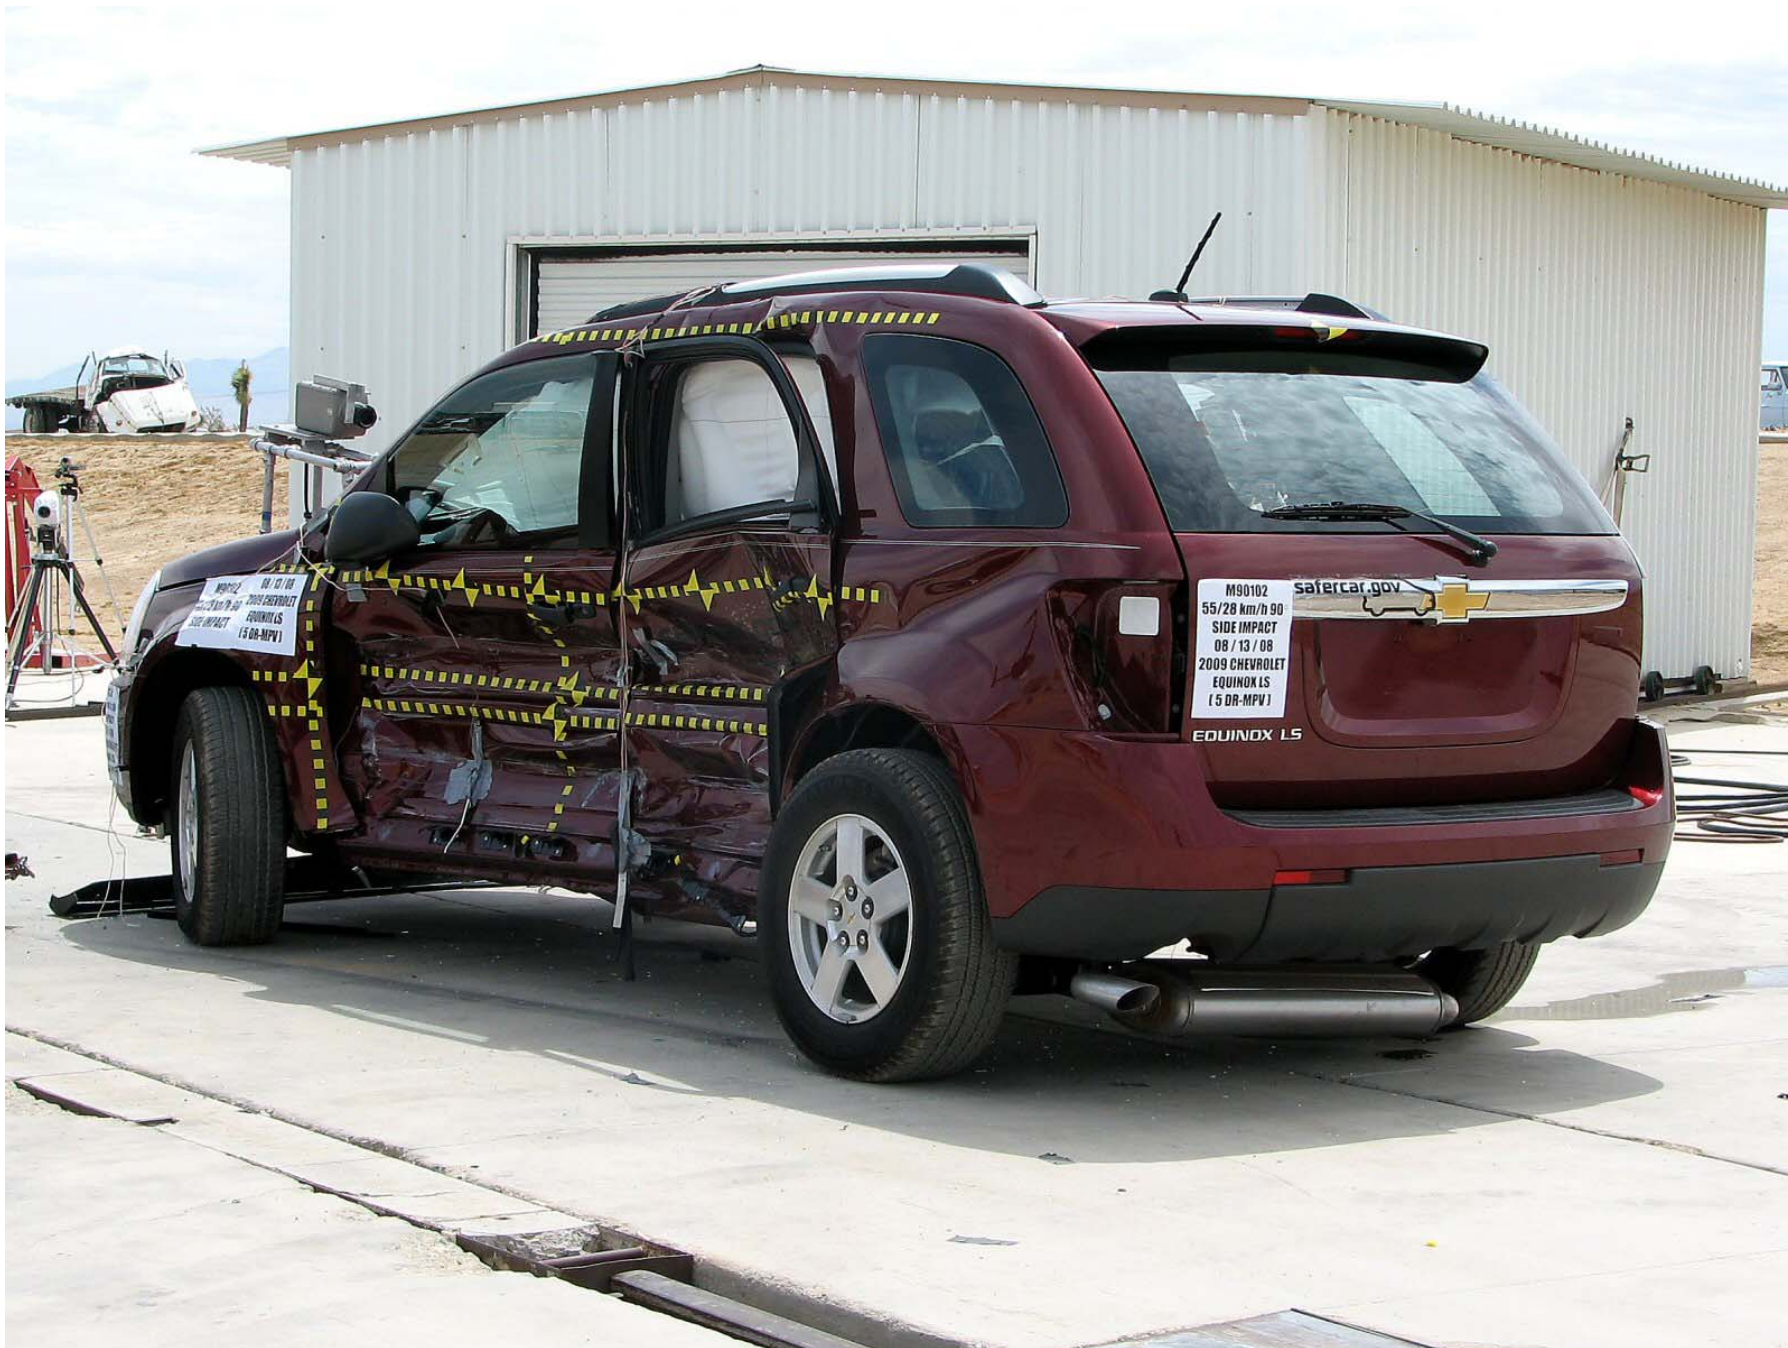
Figure A-12: Post-Test Left Rear  $\frac{3}{4}$  View

| Critical Areas of Performance | Observations and Conclusions |
|---|---|
| Window Damage | Left rear door window broken |

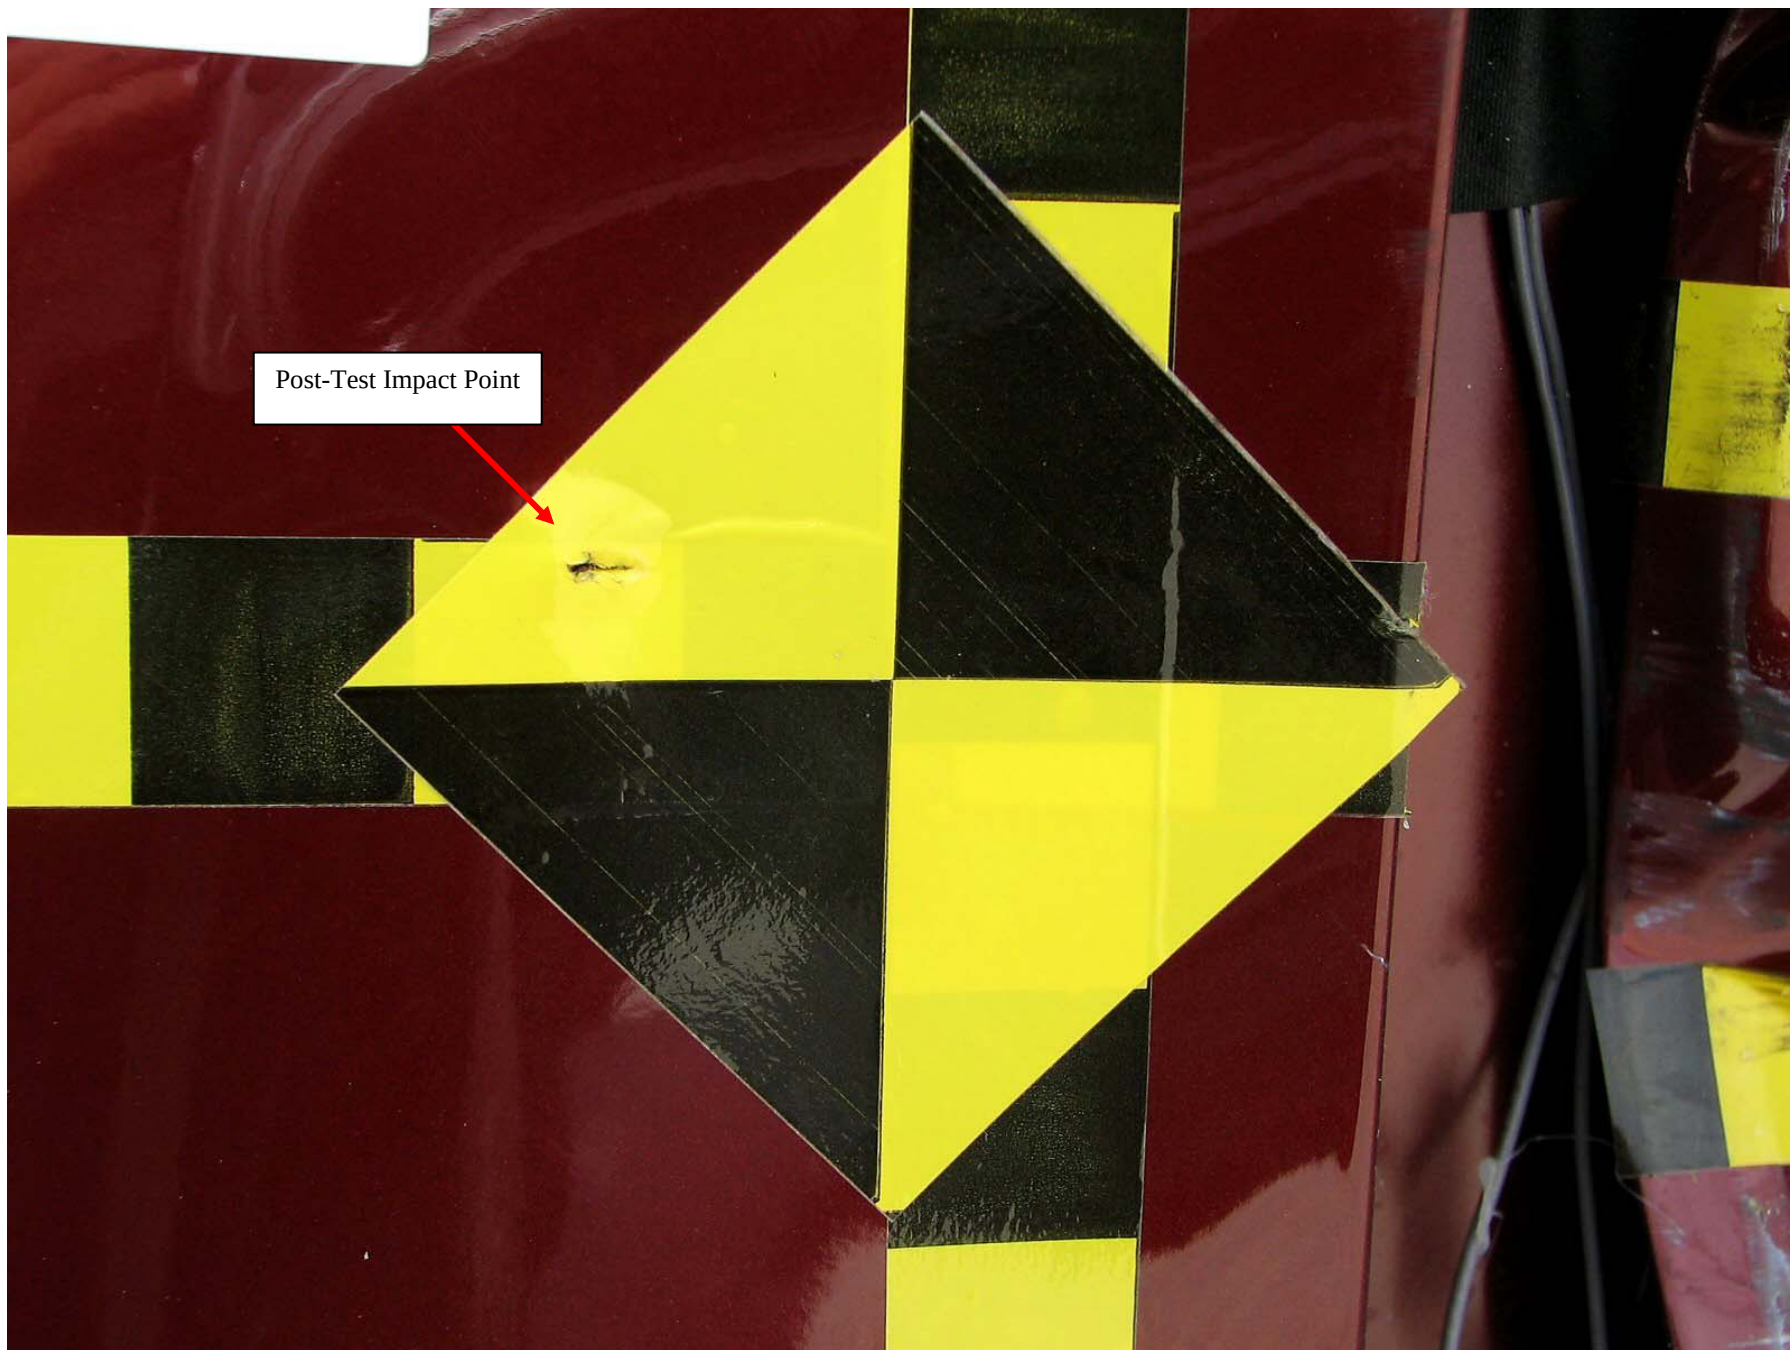
Figure A-26: Post-Test Left Impact Point

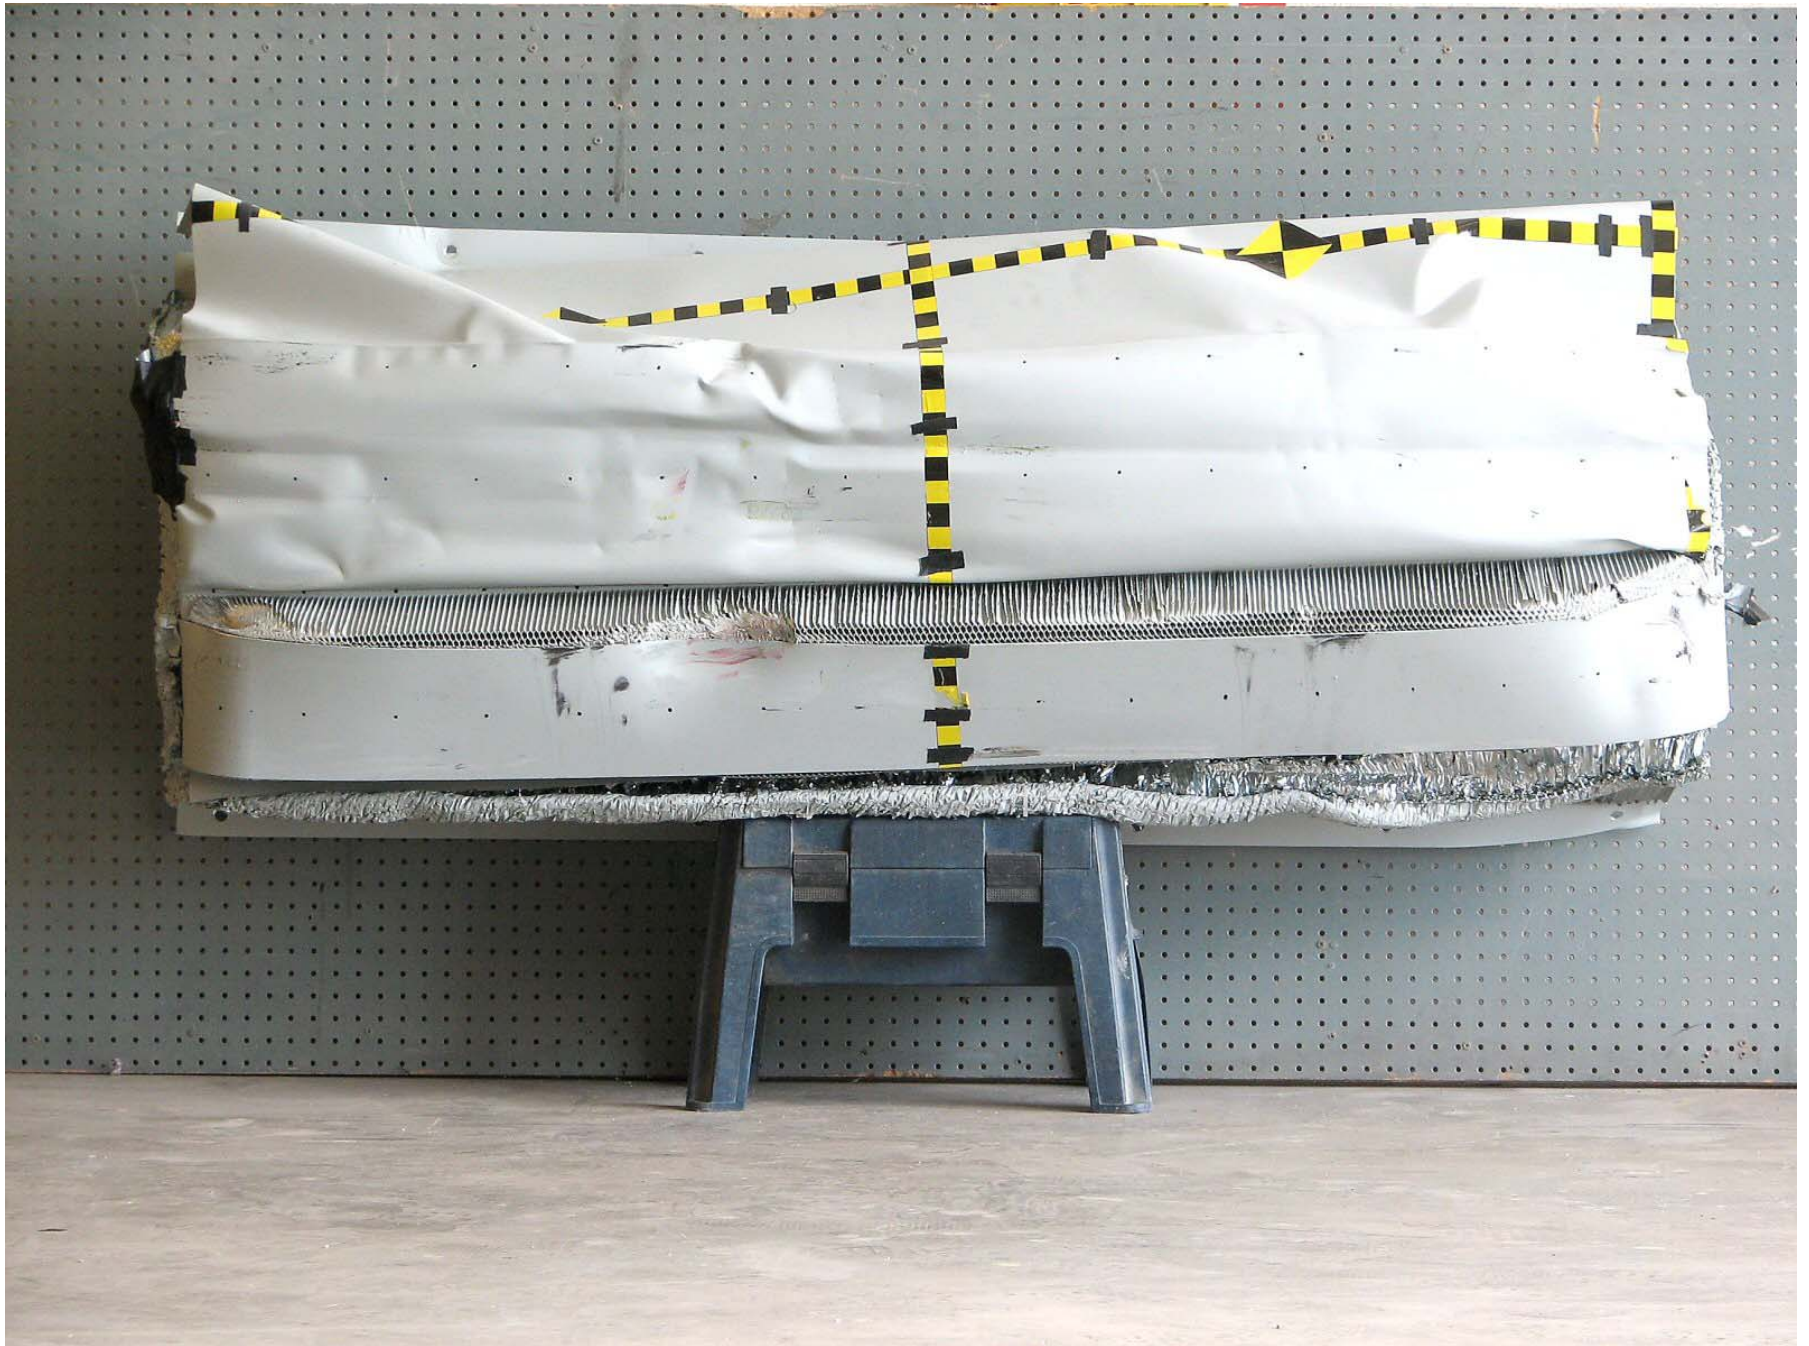
Figure A-54: Post-Test Front View of Deformable Barrier

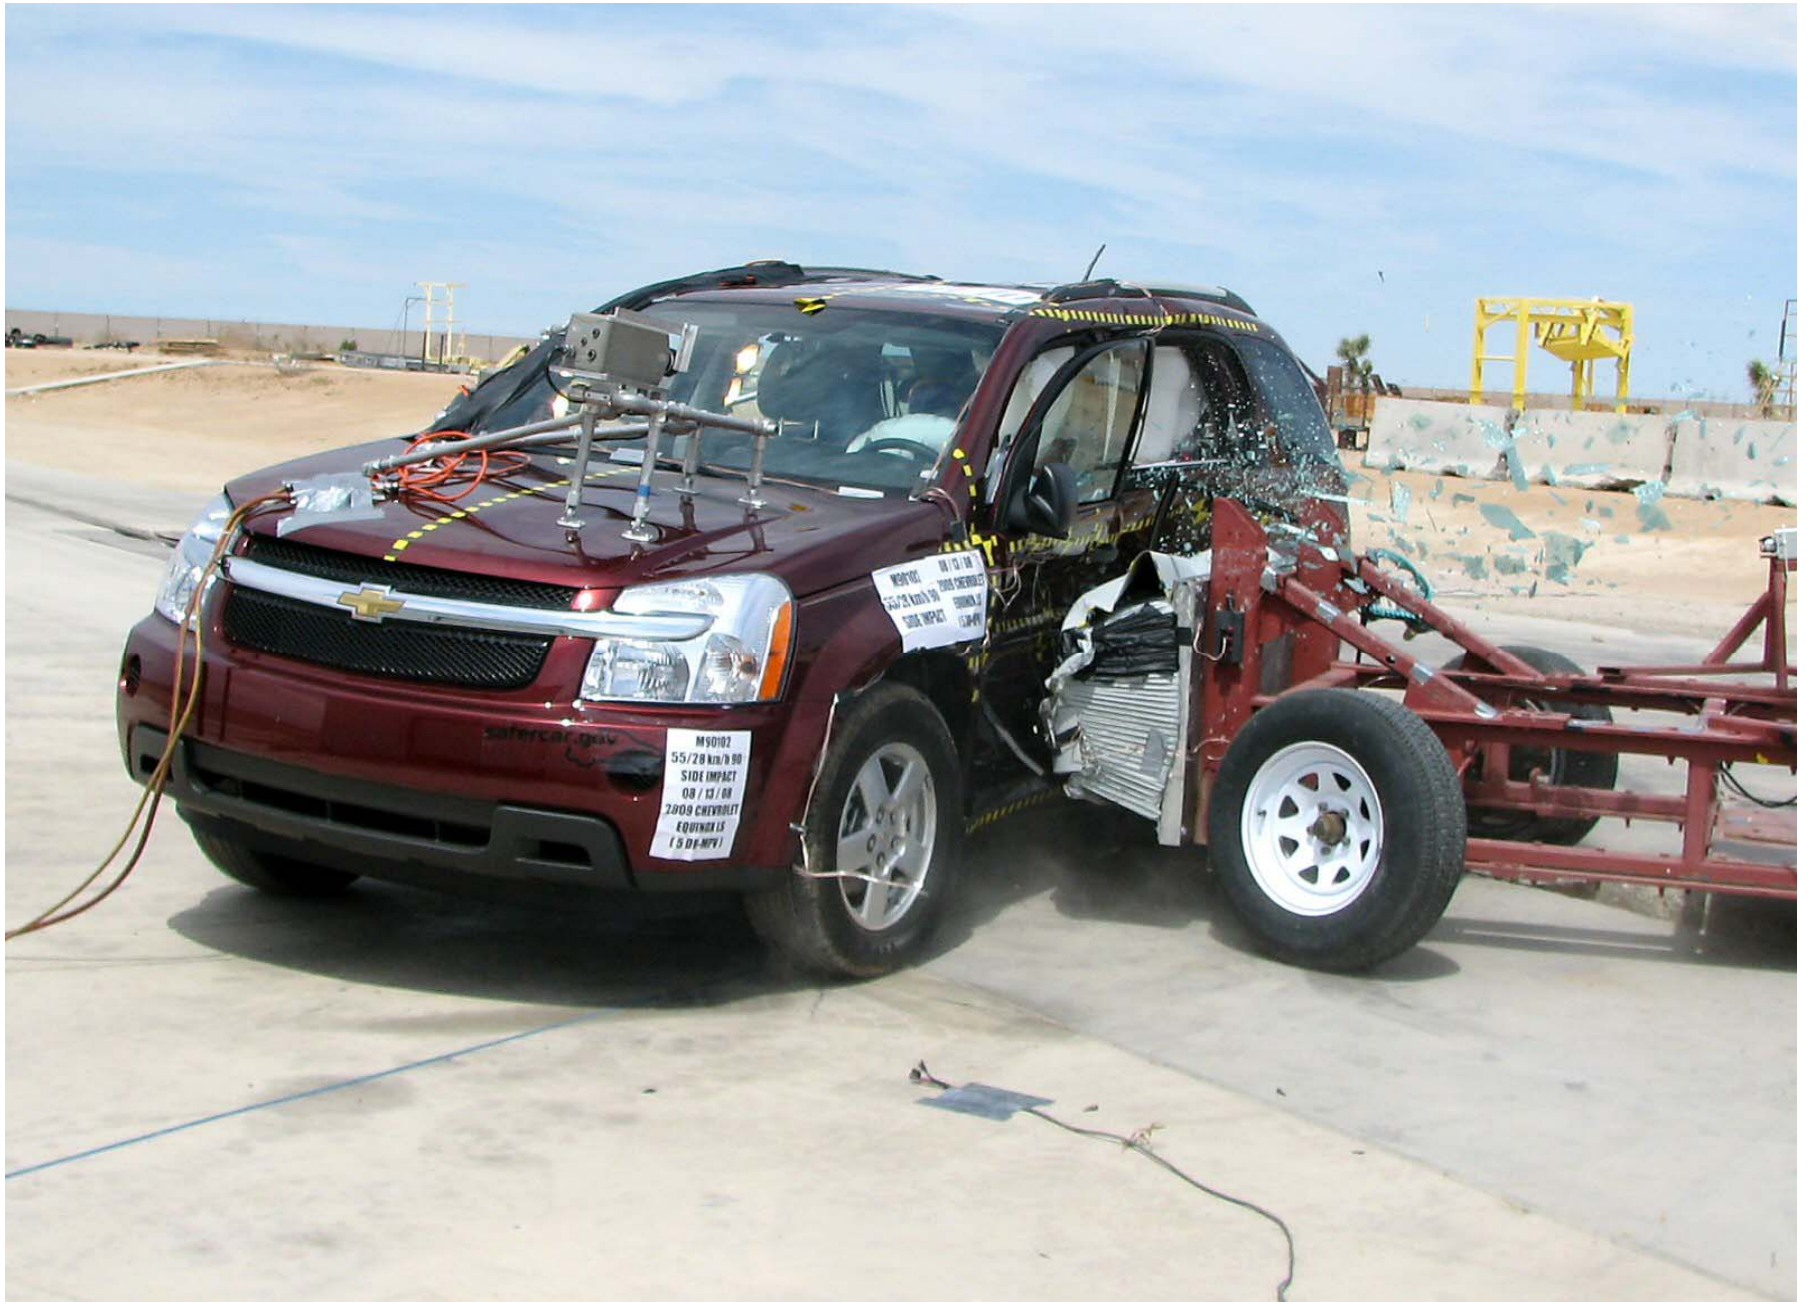
Figure A-65: Vehicle Impact

A model year 2009 Chevrolet Equinox LS 5-Door MPV was impacted on the left (driver's) side by a Moving Deformable Barrier (MDB) which was moving forward in a 27° crabbed position to the tow road guidance system at a velocity of 62.49 km/h. The specified impact velocity range is from 61.14 to 62.75 km/h. The test (target) vehicle was stationary and positioned 63° to the line of forward motion. The weight of the vehicle as tested was 1957 kg and the test weight of the MDB was 1361 kg. The test was conducted at KARCO Engineering, LLC in Adelanto, California, on August 13, 2008.
