**NEW CAR ASSESSMENT PROGRAM  
SIDE IMPACT TEST**

**HYUNDAI MOTOR COMPANY  
2009 HYUNDAI GENESIS  
NHTSA NUMBER: U90501**

**PREPARED BY:  
MGA RESEARCH CORPORATION  
5000 WARREN ROAD  
BURLINGTON, WI 53105**

**FINAL REPORT**

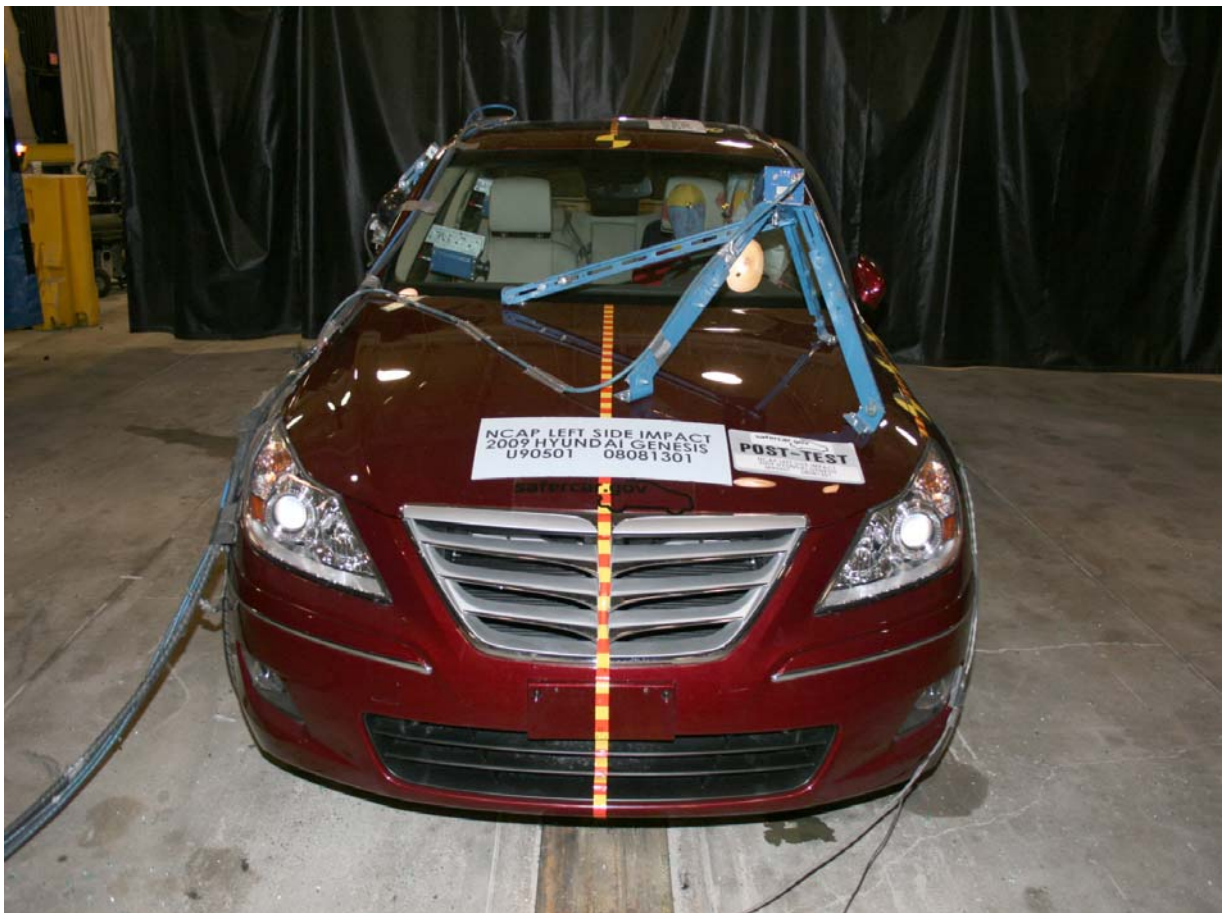
Post-Test Front View

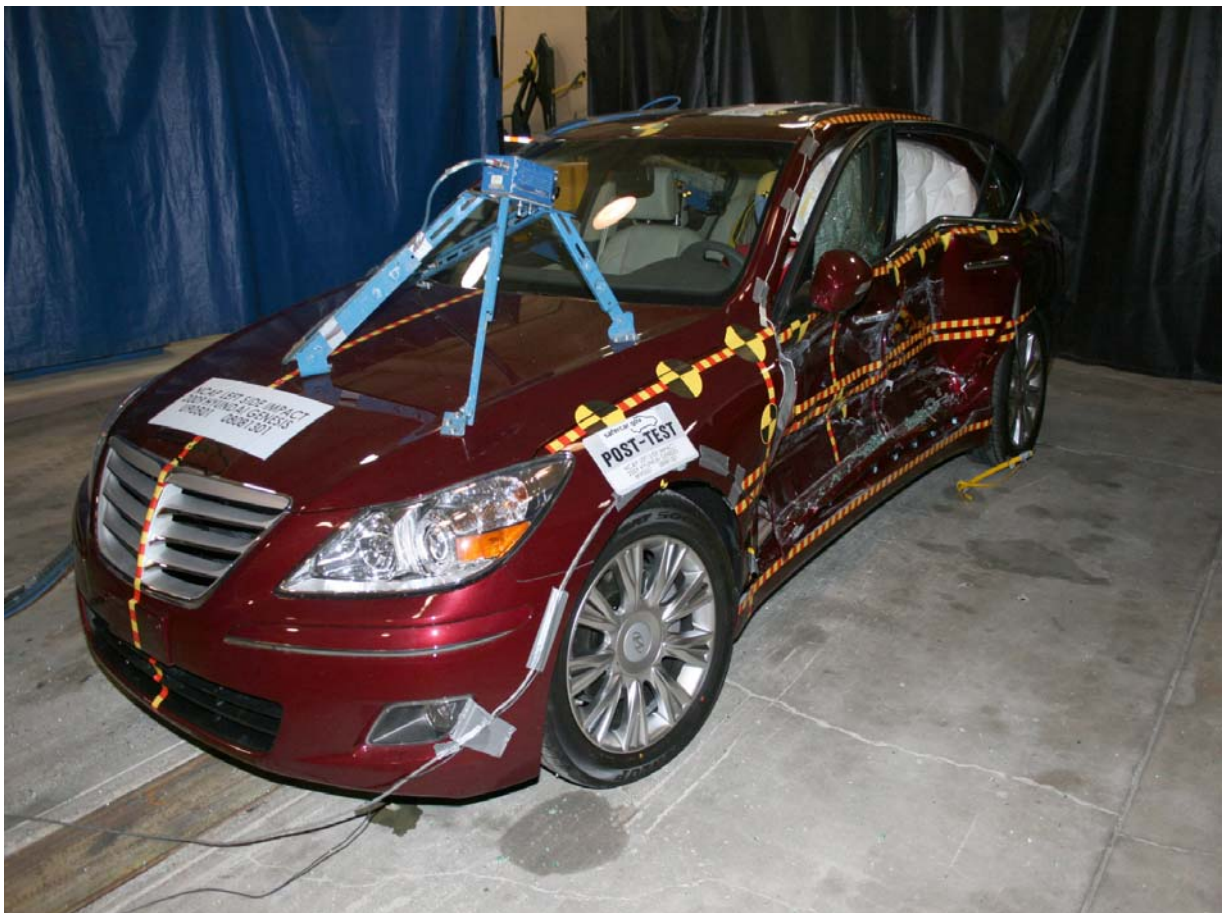
Post-Test Left Front  $\frac{3}{4}$  View

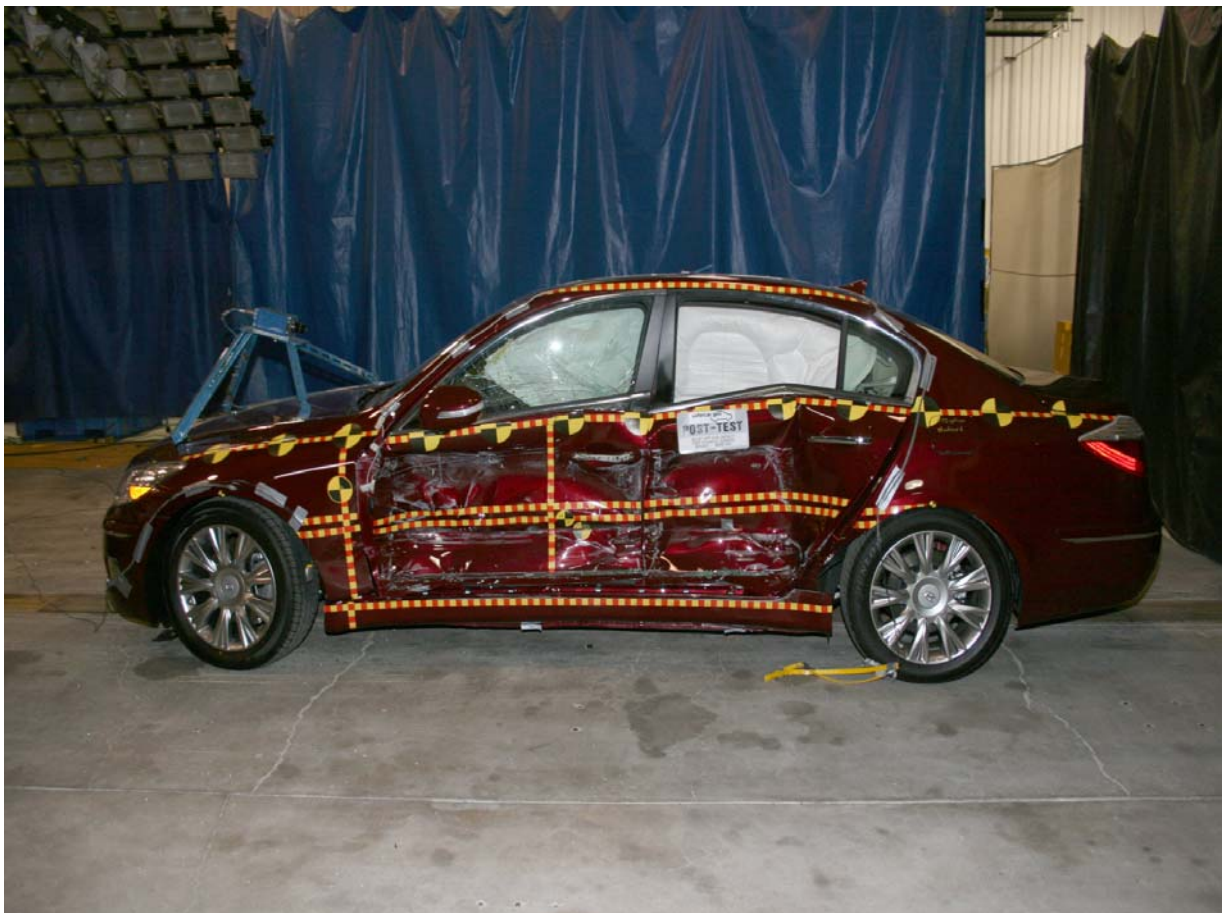
Post-Test Left Side View

The test vehicle sustained a maximum static crush of 267 mm at level 3, 1650 mm rearward of the vertical impact point. The driver and passenger SID/HIIs, Serial Nos. 271 and 272 respectively, were calibrated just prior to this test.

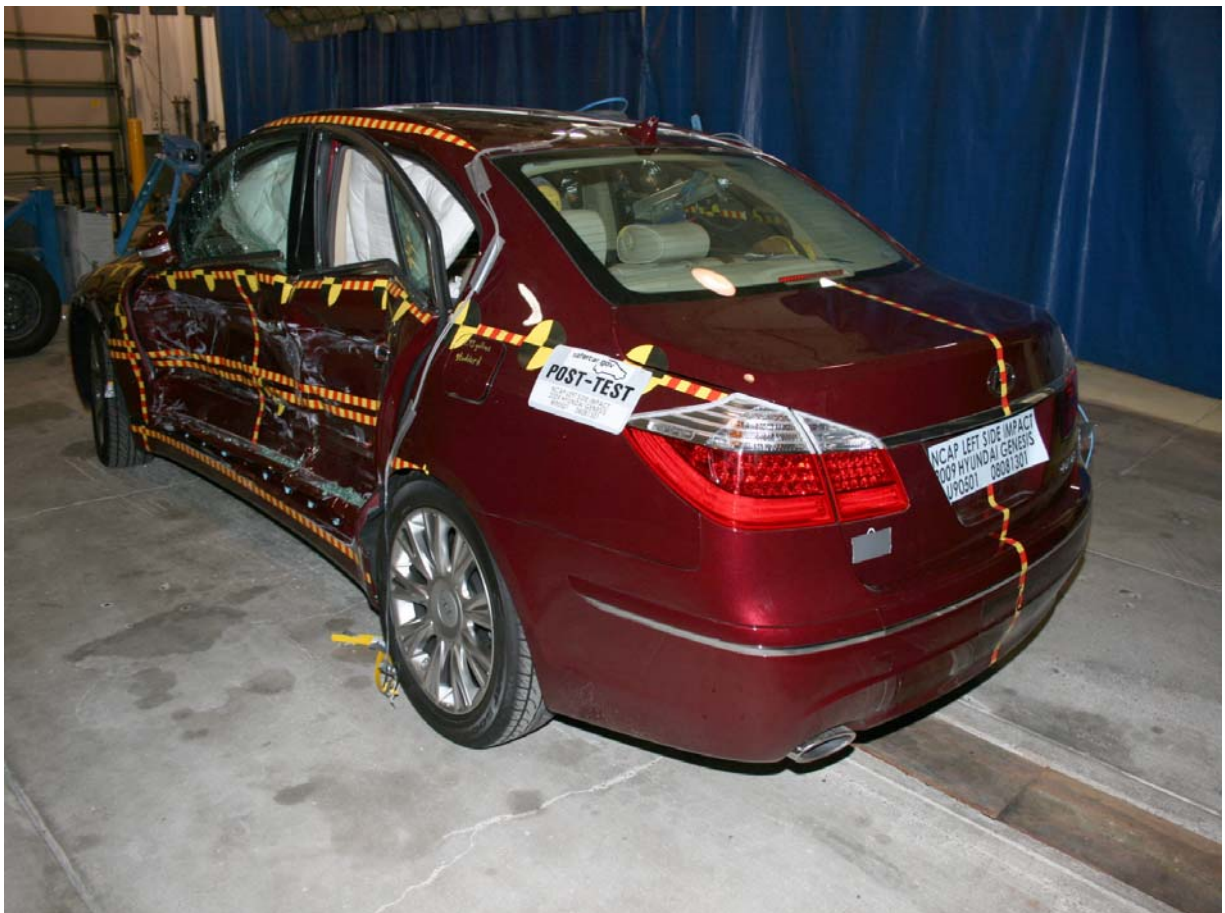
Post-Test Left Rear  $\frac{3}{4}$  View

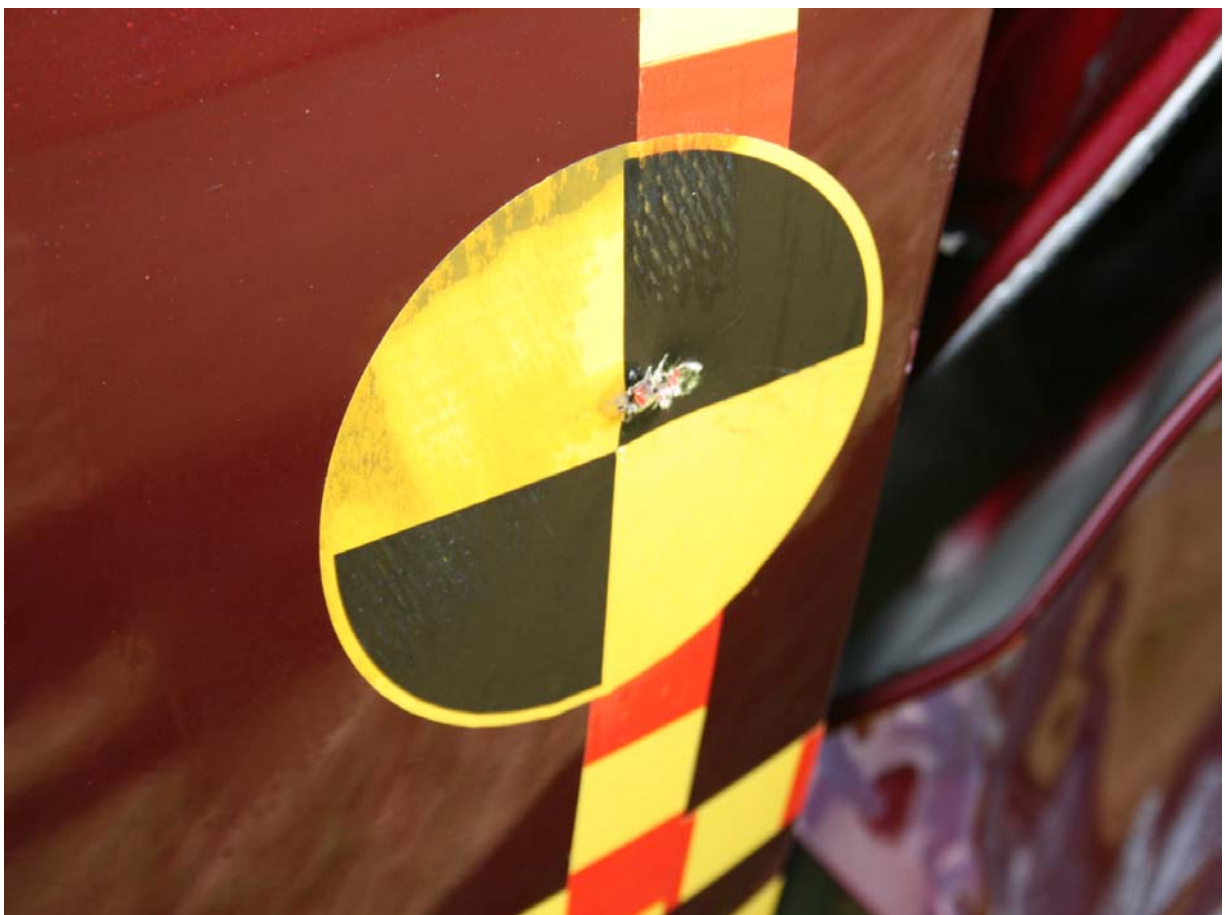
Post-Test Left Impact Point

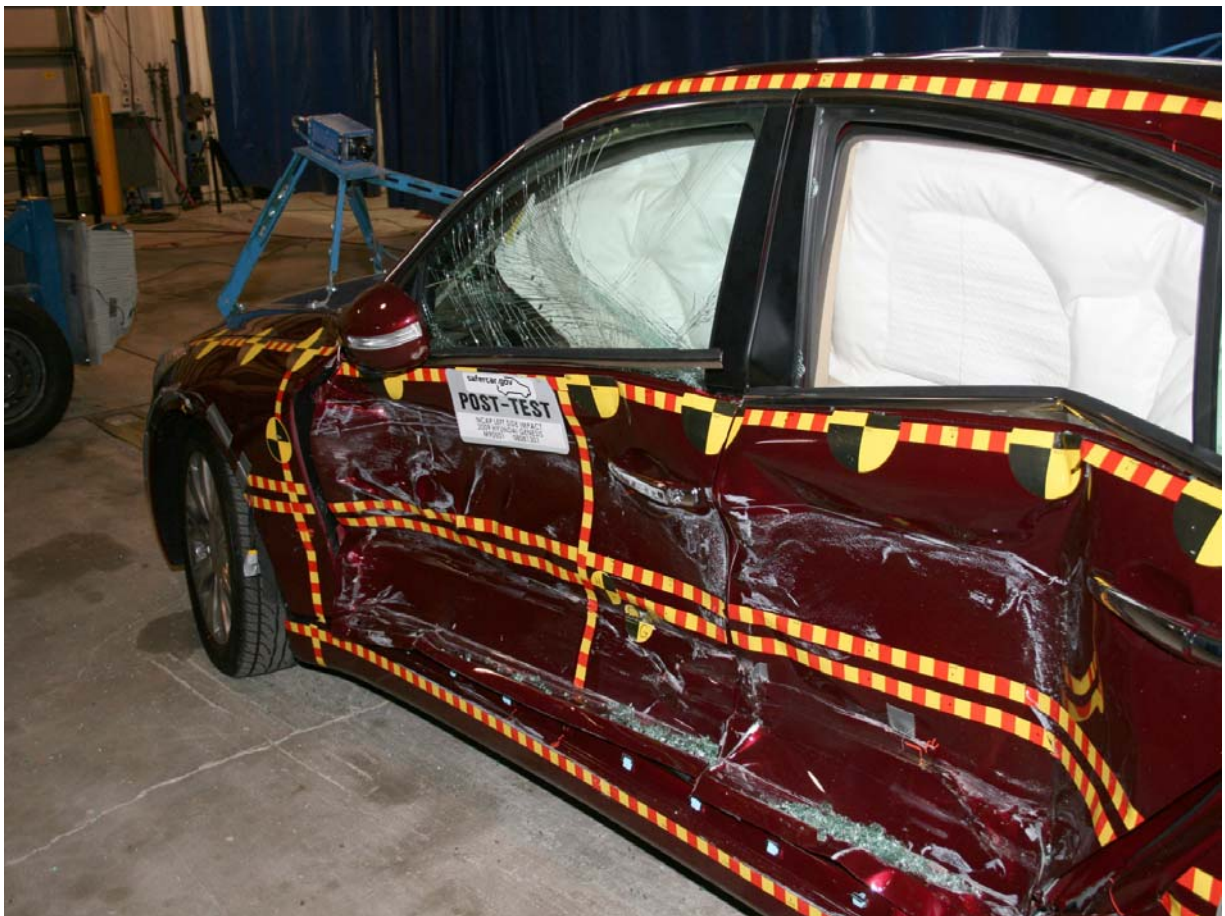
Post-Test Rear  $\frac{3}{4}$  View of Left Side Doors

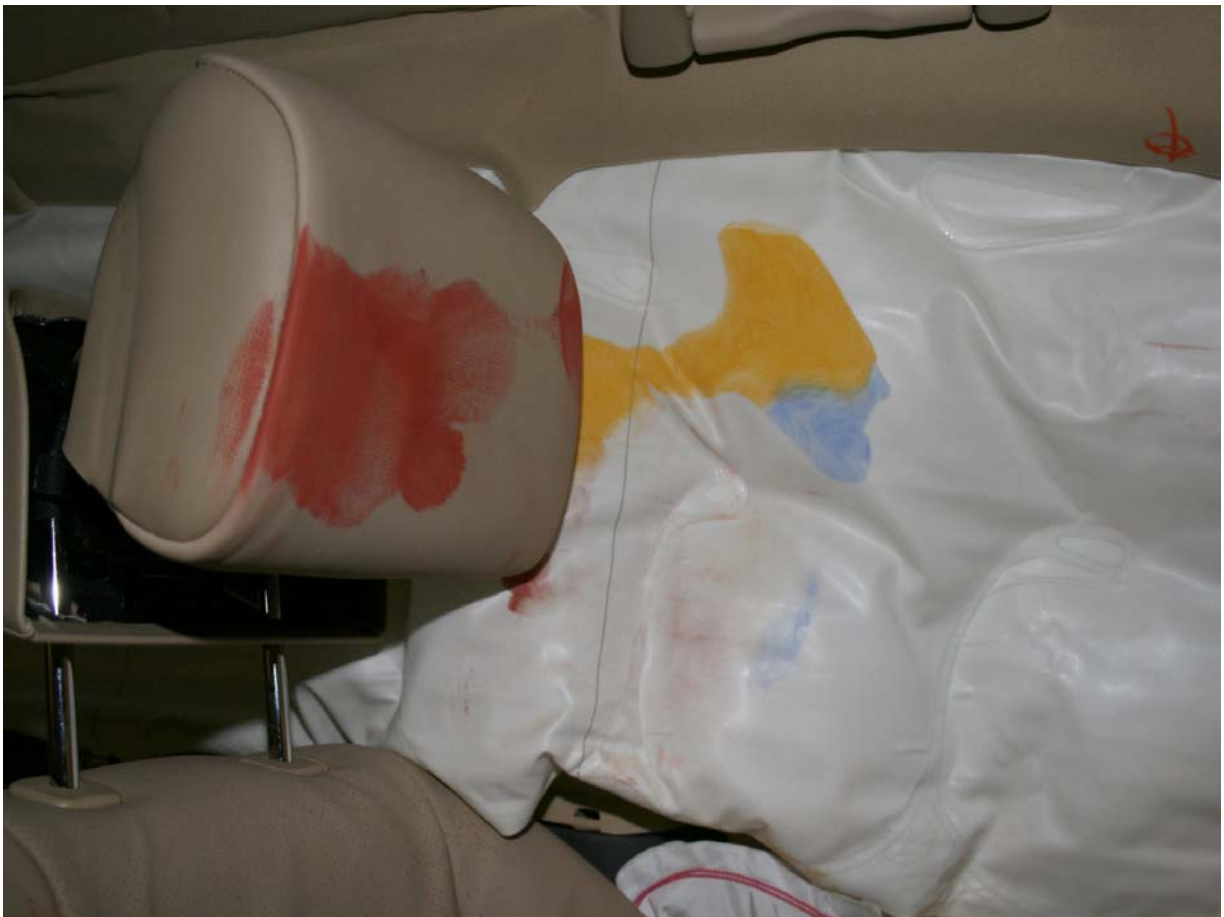
Post-Test Driver Dummy Head Contact

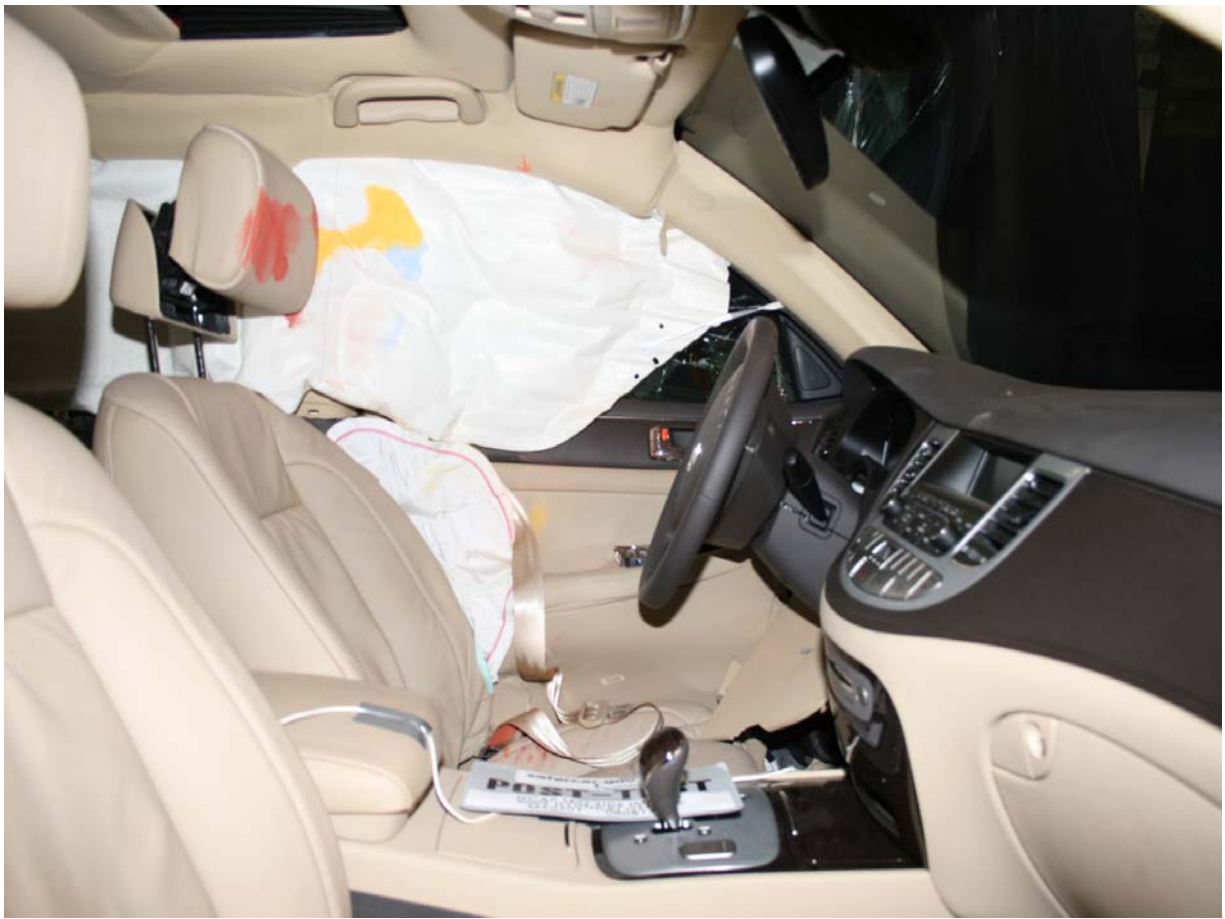
Post-Test Driver Dummy Contact

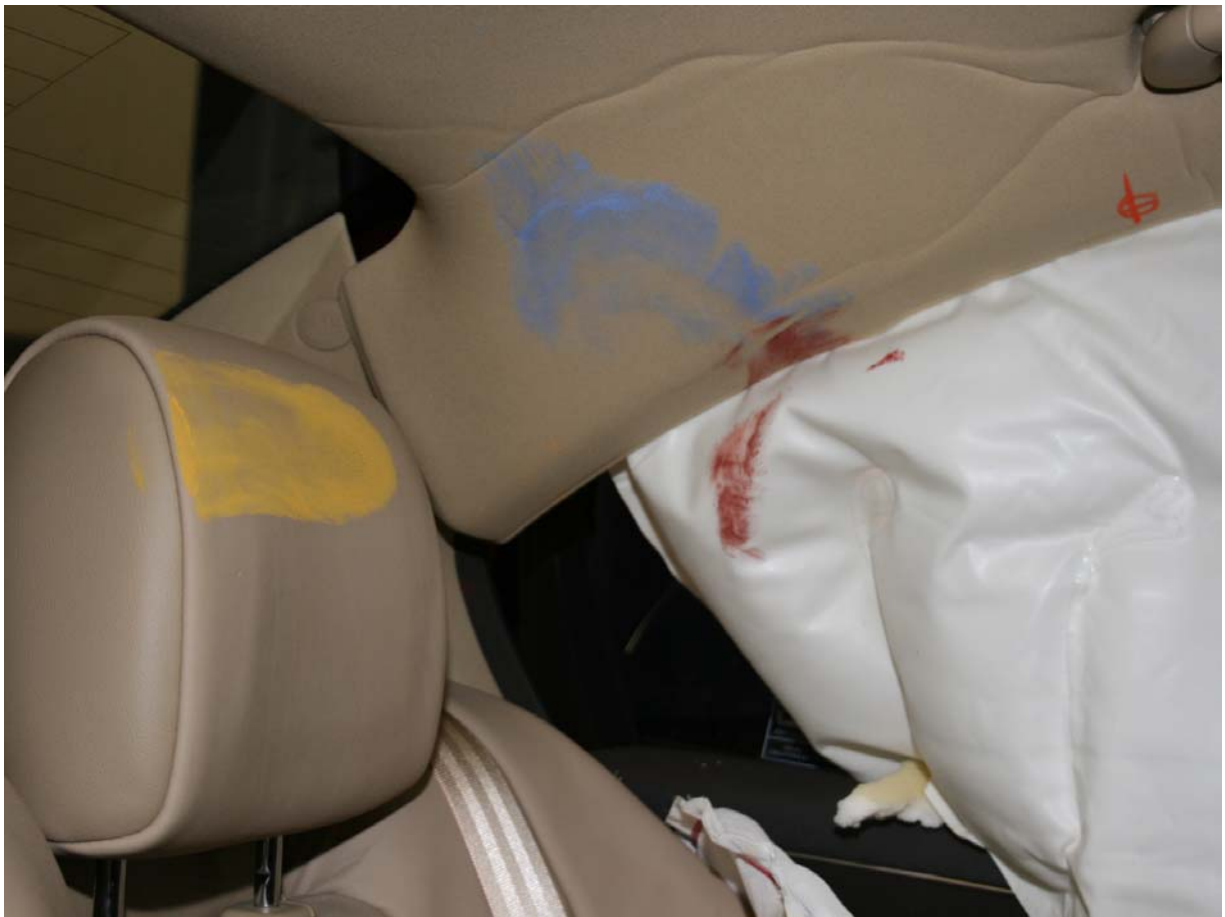
Post-Test Passenger Dummy Head Contact

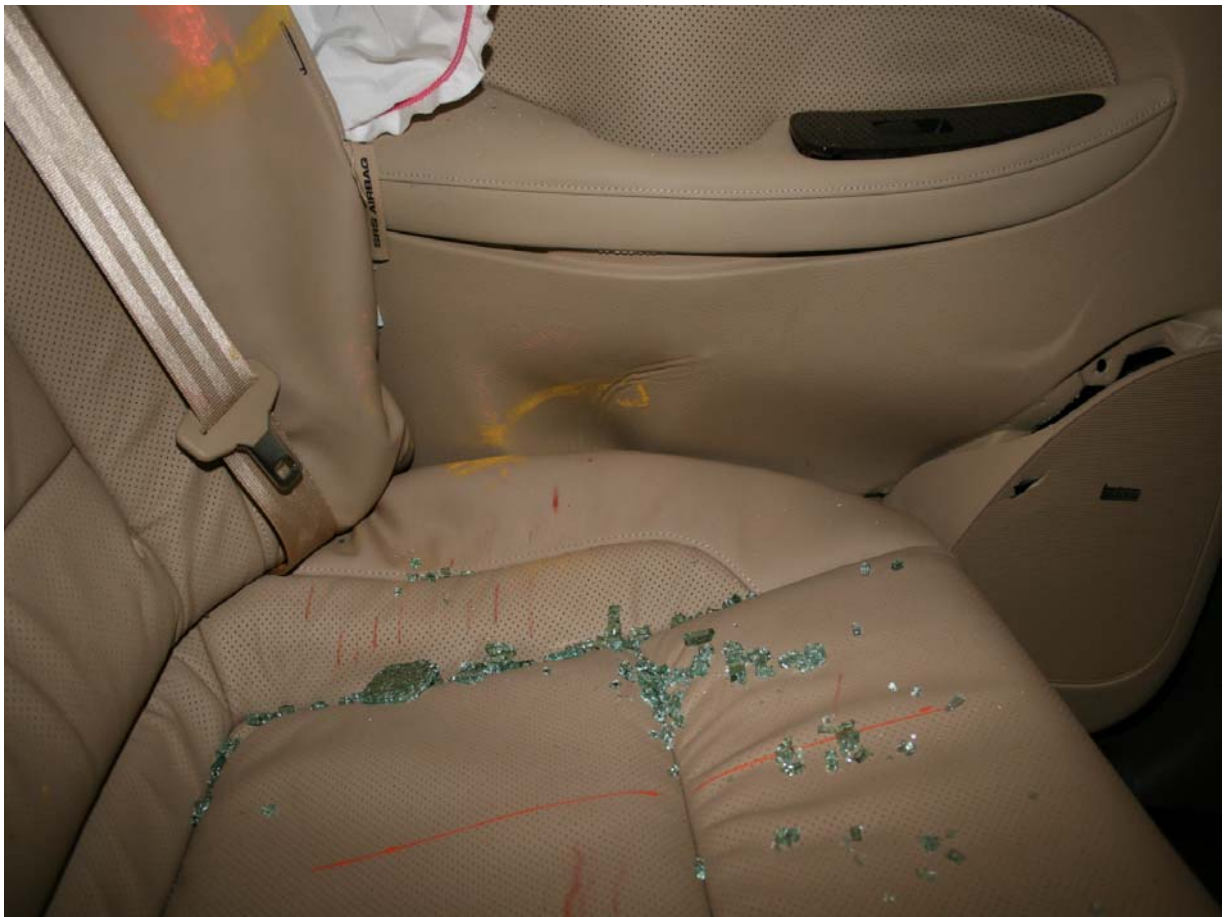
Post-Test Passenger Dummy Lower Torso Contact
