**REPORT NUMBER: NCAPSIDE-MGA-2008-017**

**NEW CAR ASSESSMENT PROGRAM  
SIDE IMPACT TEST**

**KIA MOTORS CORPORATION  
2009 KIA BORREGO EX 4X2  
NHTSA NUMBER: K90501**

**PREPARED BY:  
MGA RESEARCH CORPORATION  
5000 WARREN ROAD  
BURLINGTON, WI 53105**

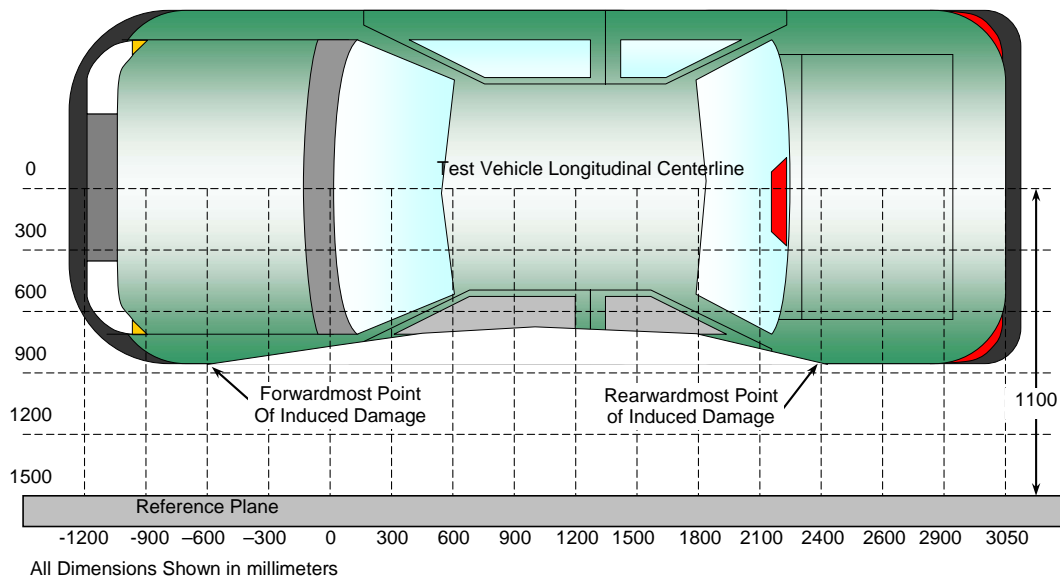
**DATA SHEET NO. 11**  
**VEHICLE DAMAGE PROFILE DISTANCES**

**TOP VIEW**

**DAMAGE PROFILE DISTANCES**

The test vehicle sustained a maximum static crush of 296 mm at level 2, 1350 mm rearward of the vertical impact point. The driver and passenger SID/HIIIs, Serial Nos. 272 and 271 respectively, were calibrated just prior to this test.

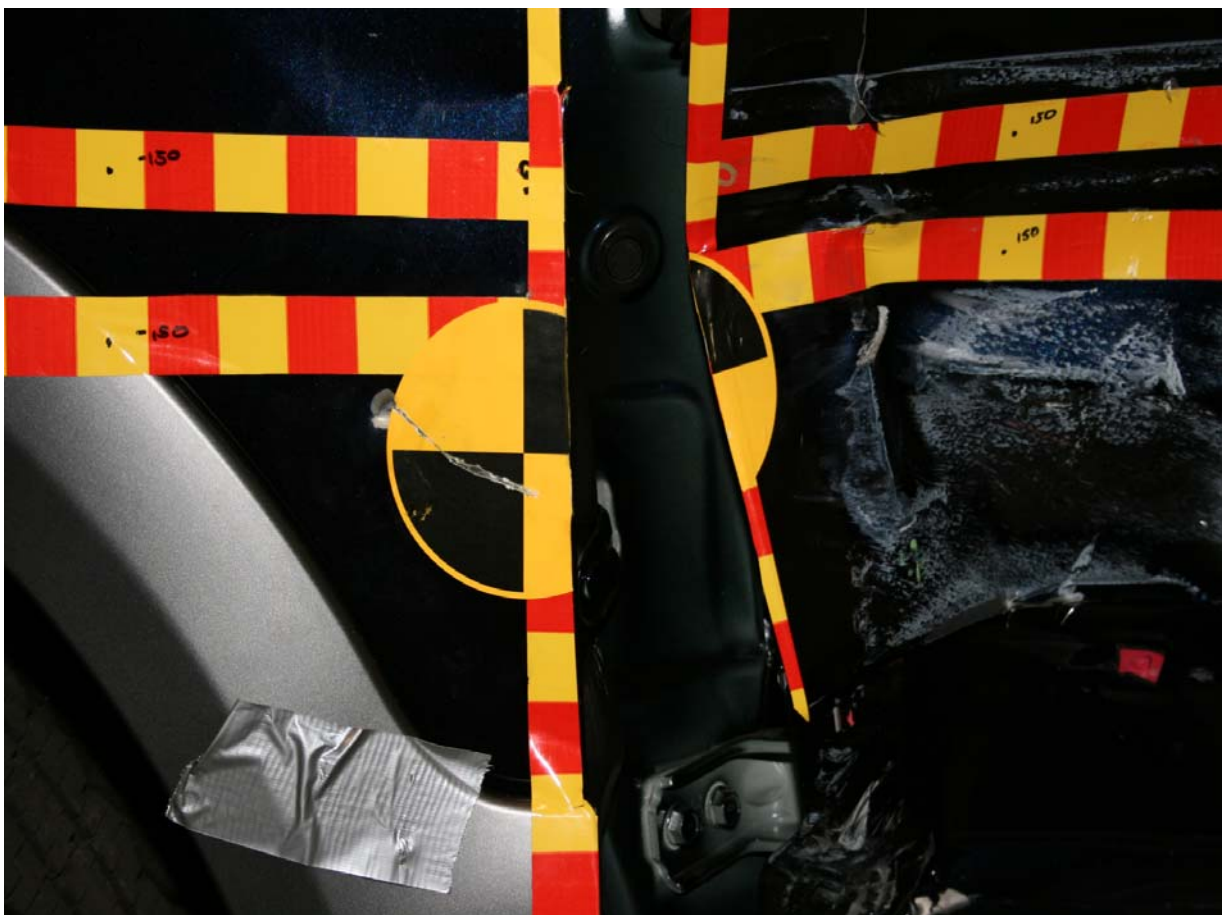
Post-Test Left Impact Point

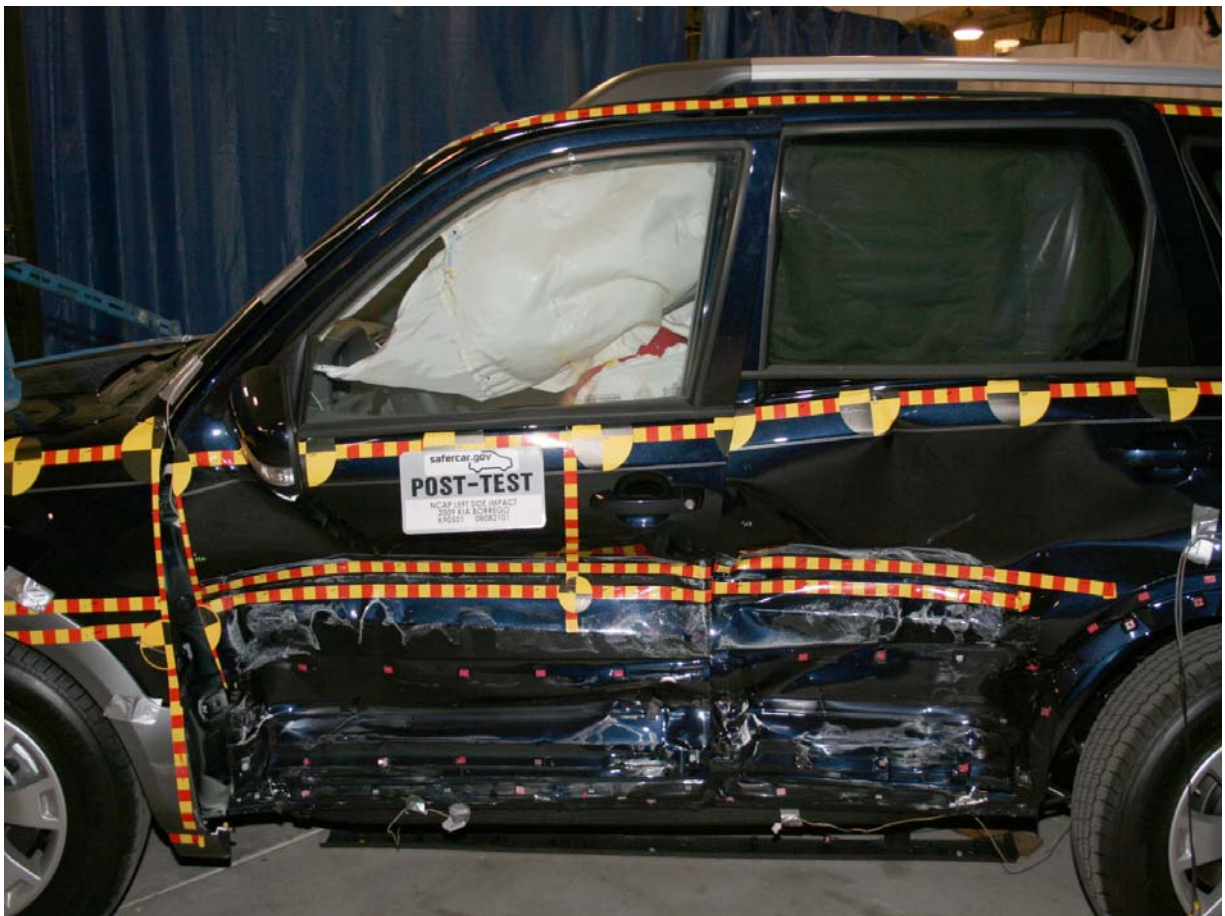
Post-Test Left Side Impact Close-up

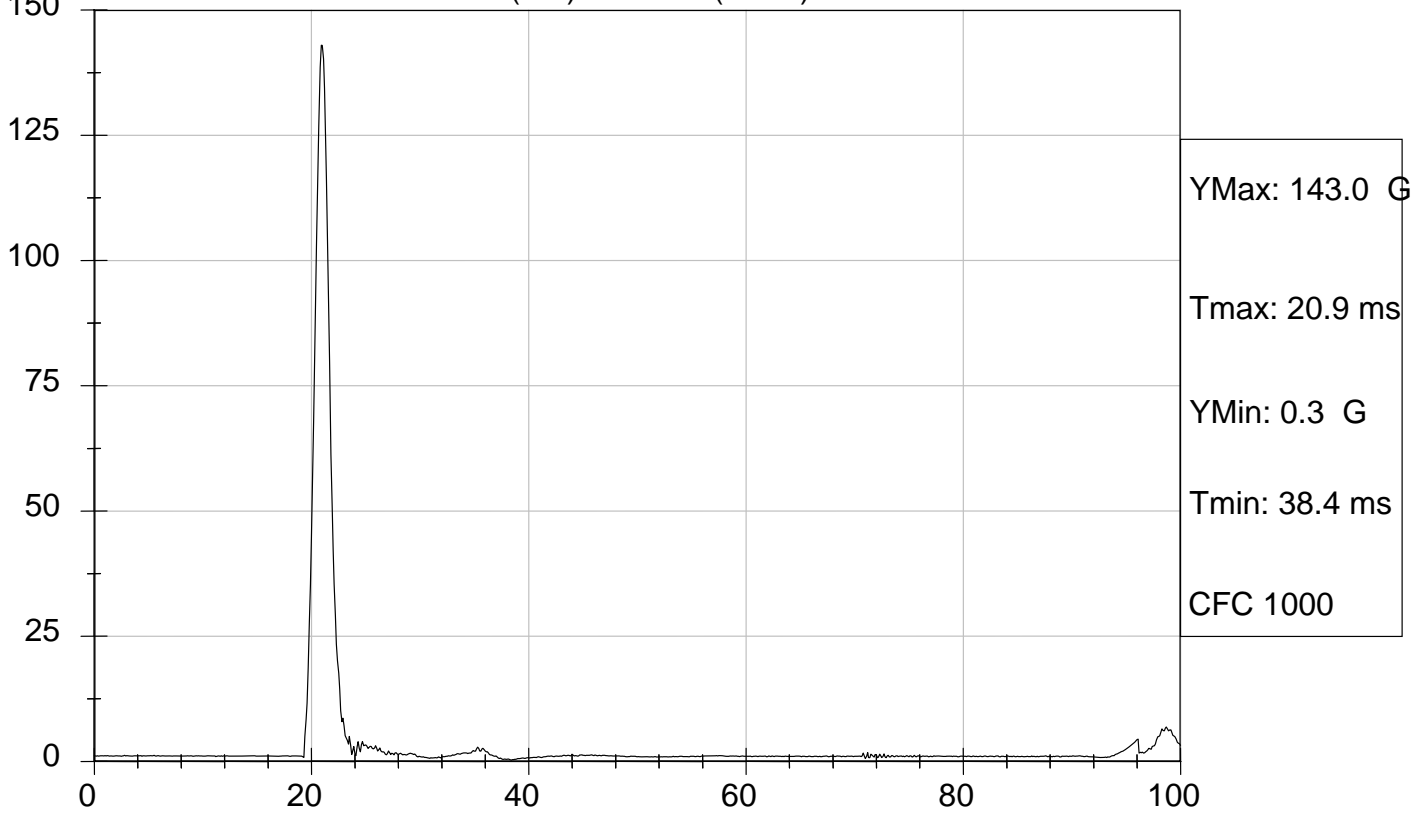
Peak Resultant Acceleration (G's) Vs Time (msec)

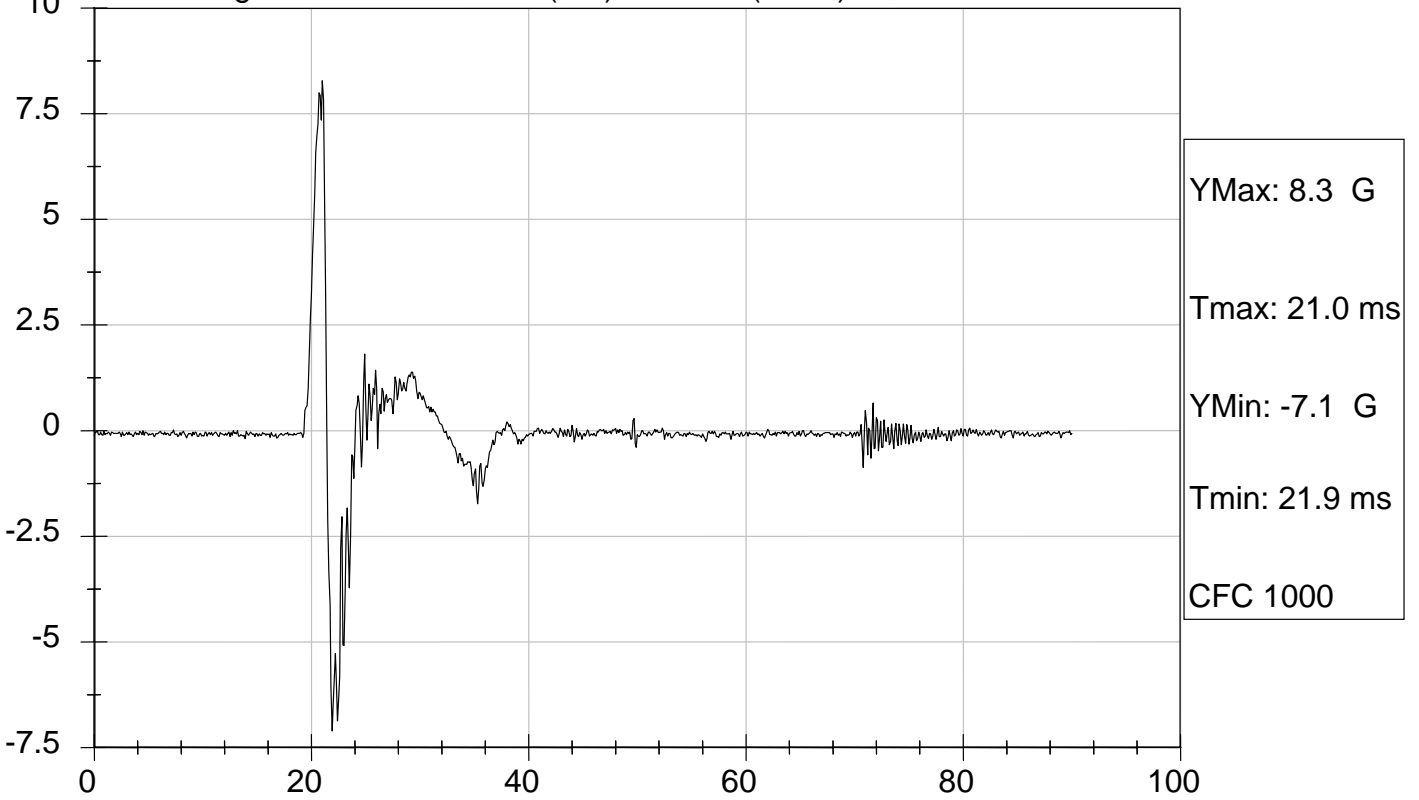
Peak Longitudinal Acceleration (G's) Vs Time (msec)

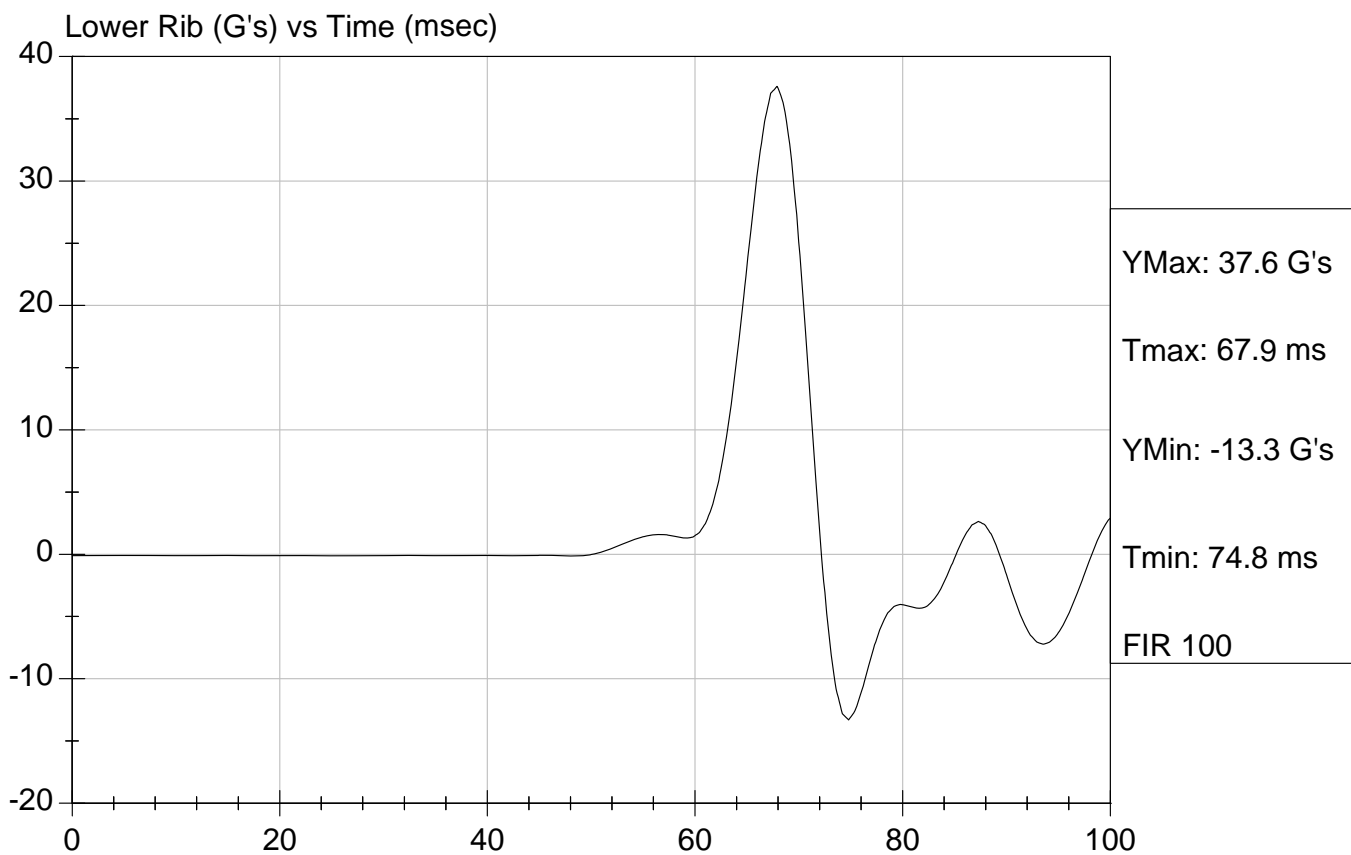
Test Desc: Thorax Impact  
Component ID: D082342

Test Date: 8/14/08  
Speed: 14.12 ft/sec, 4.30 m/sec

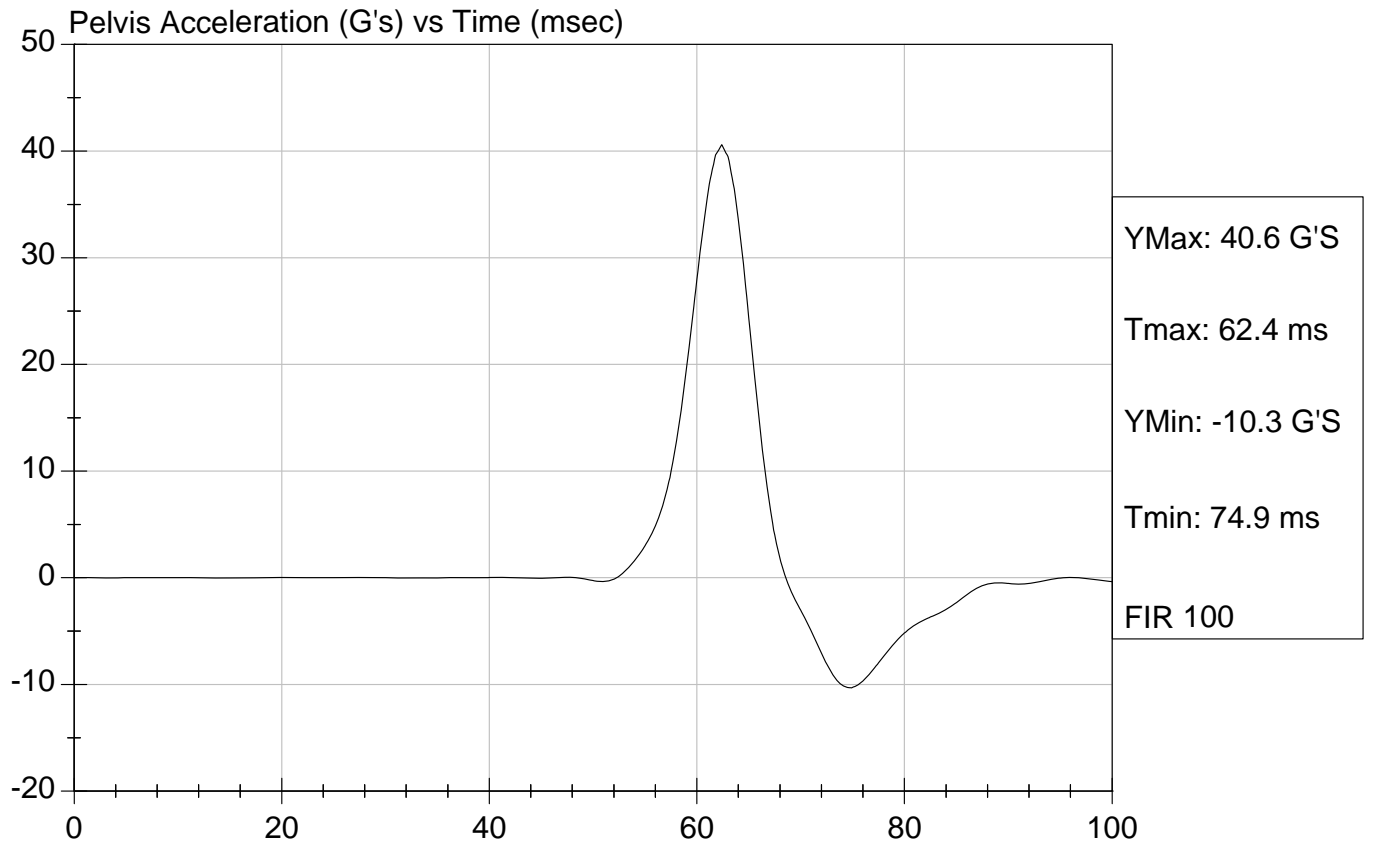
Test Desc: Pelvis Impact  
Component ID: D082343

Test Date: 8/14/08  
Speed: 14.12 ft/sec, 4.30 m/sec

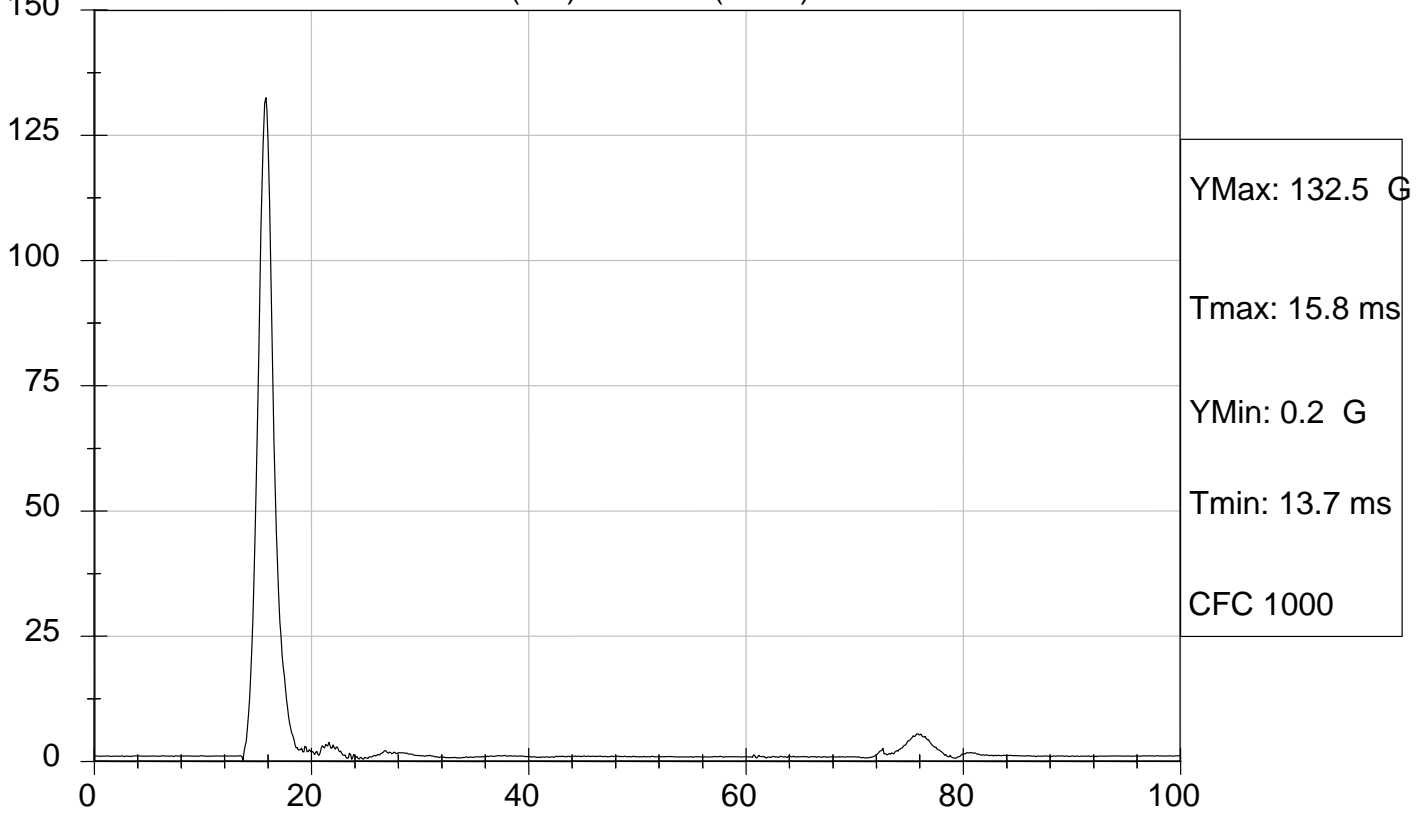
Peak Resultant Acceleration (G's) Vs Time (msec)

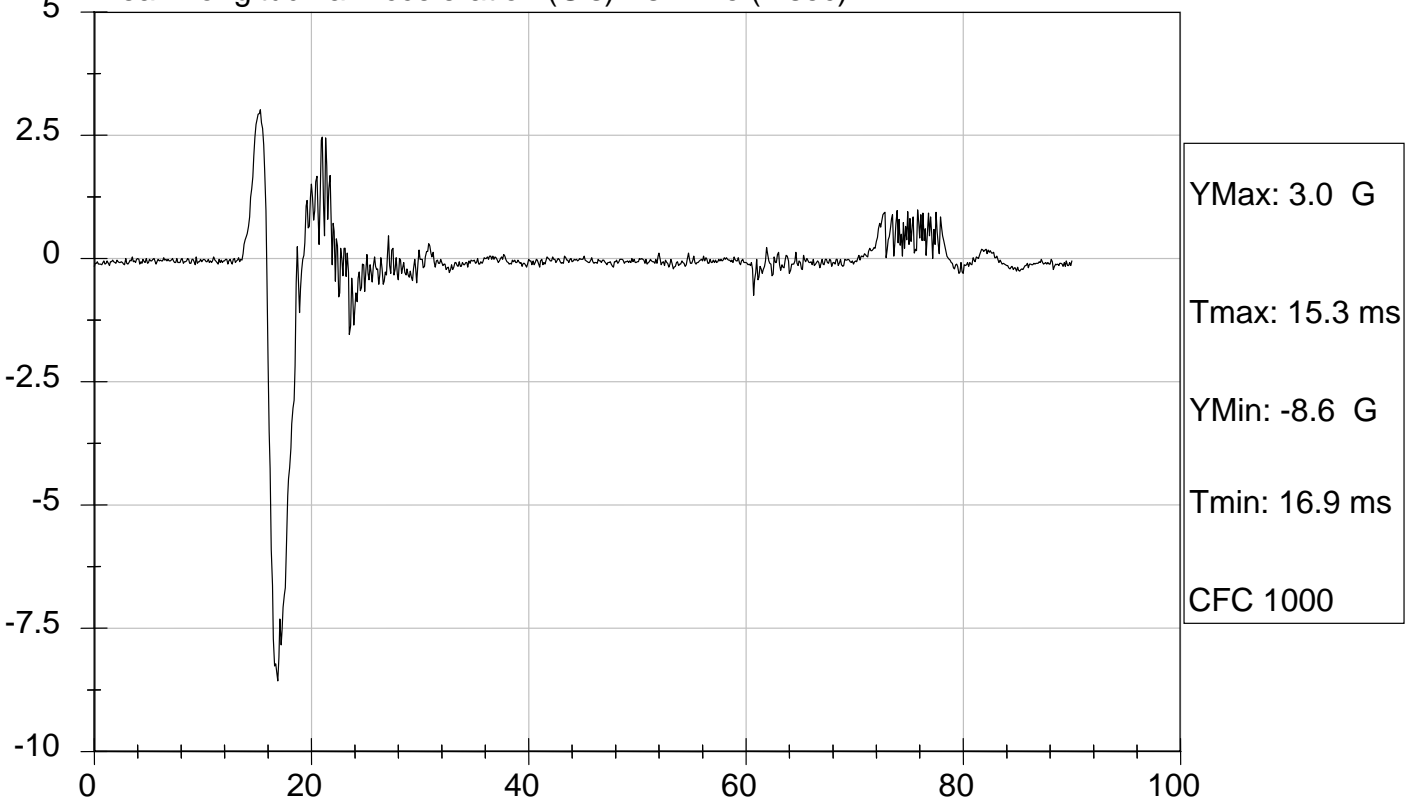
Peak Longitudinal Acceleration (G's) Vs Time (msec)

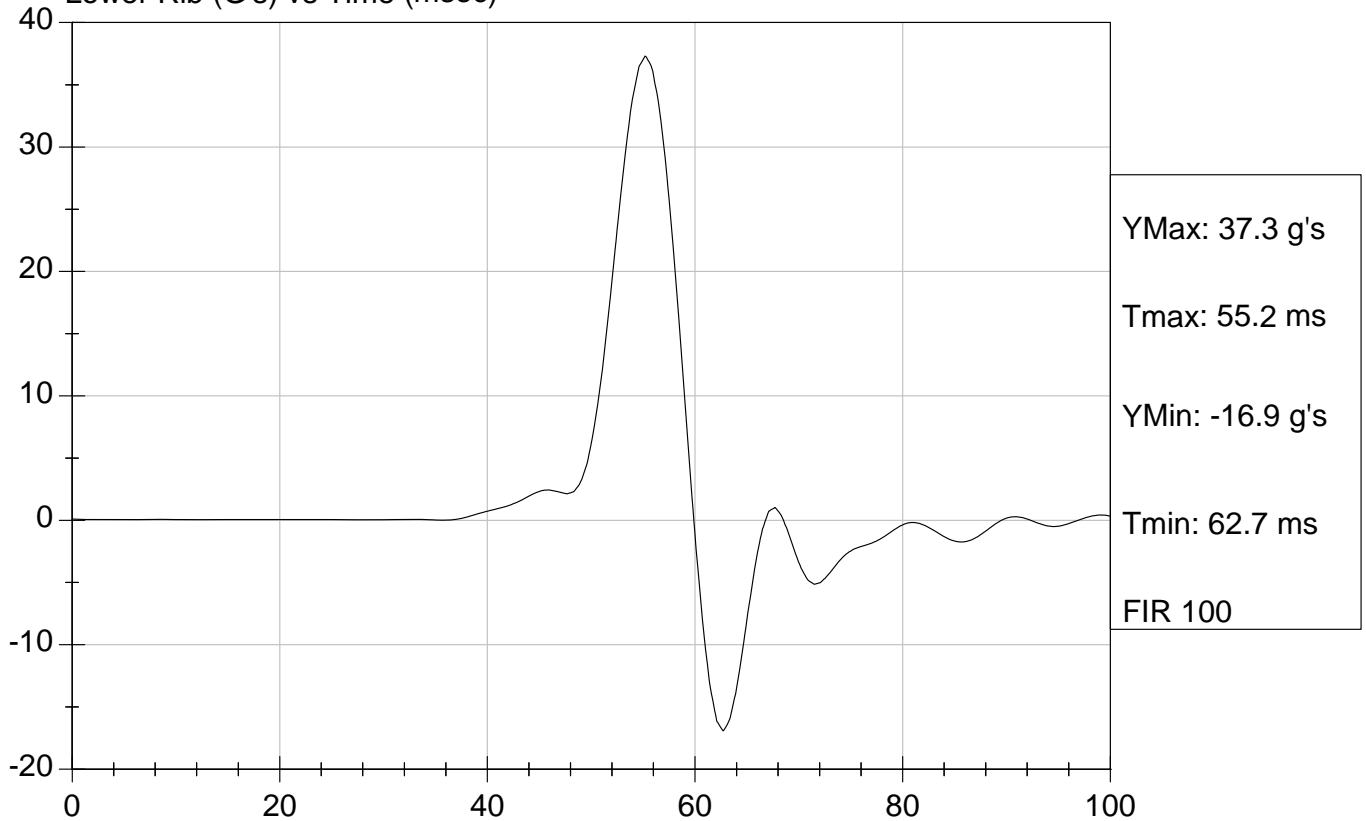
Lower Rib (G's) vs Time (msec)

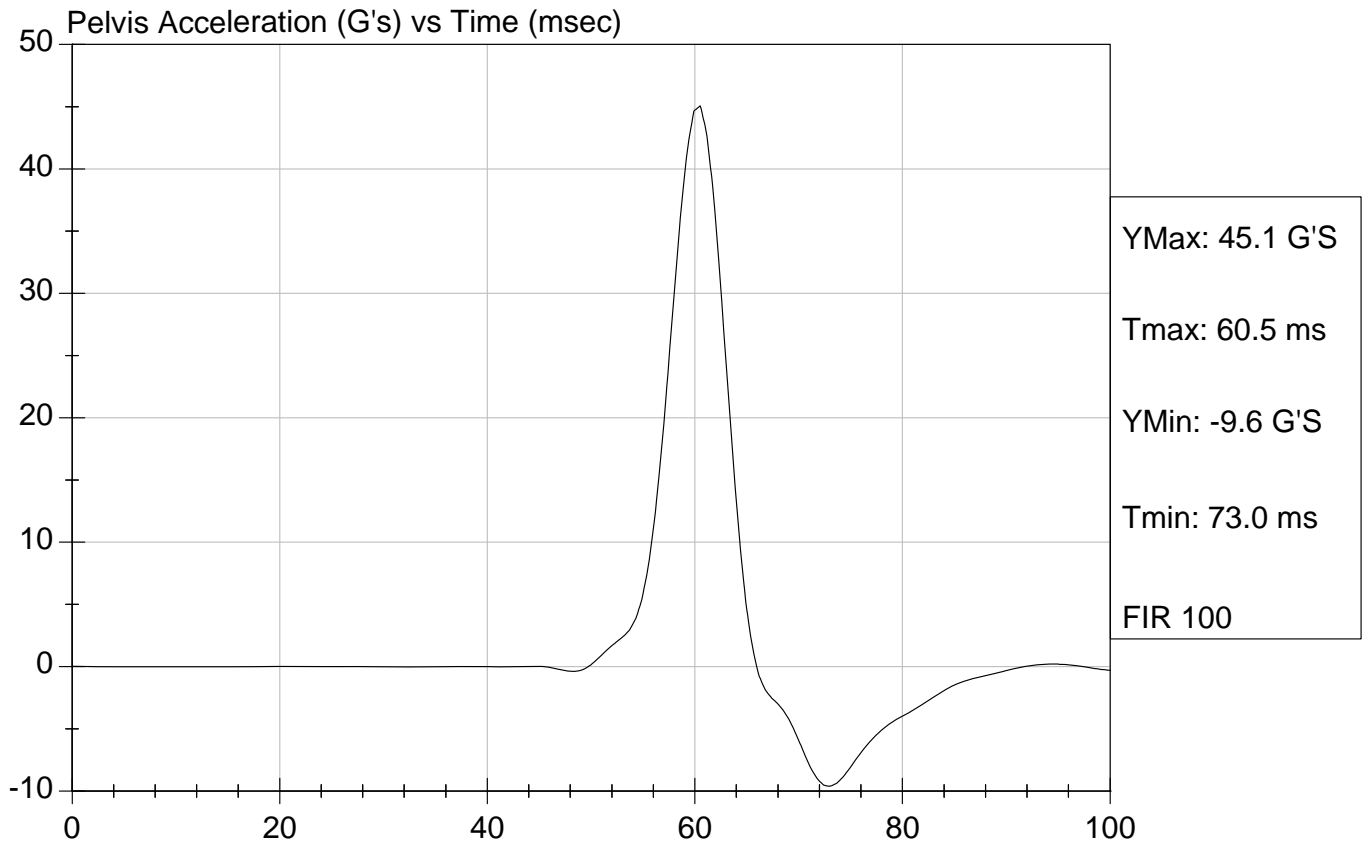
Test Desc: Pelvis Impact  
Component ID: D082433

Test Date: 8/21/08  
Speed: 14.01 ft/sec, 4.27 m/sec
