REPORT NUMBER TR-P28003-13-NC

**NEW CAR ASSESSMENT PROGRAM
SIDE IMPACT TEST**

**TOYOTA MOTOR MANUFACTURING DE BAJA CALIFORNIA
2009 TOYOTA TACOMA PRERUNNER SR5
4-DOOR TRUCK**

NHTSA NUMBER: M95105

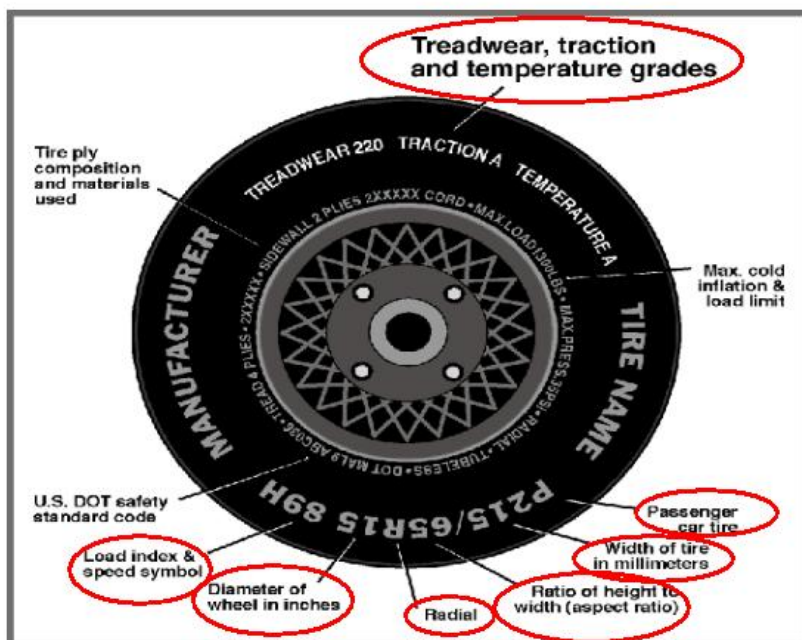
Collect year, make, model, VIN, items circled in red, and tire manufacturer and tire name.

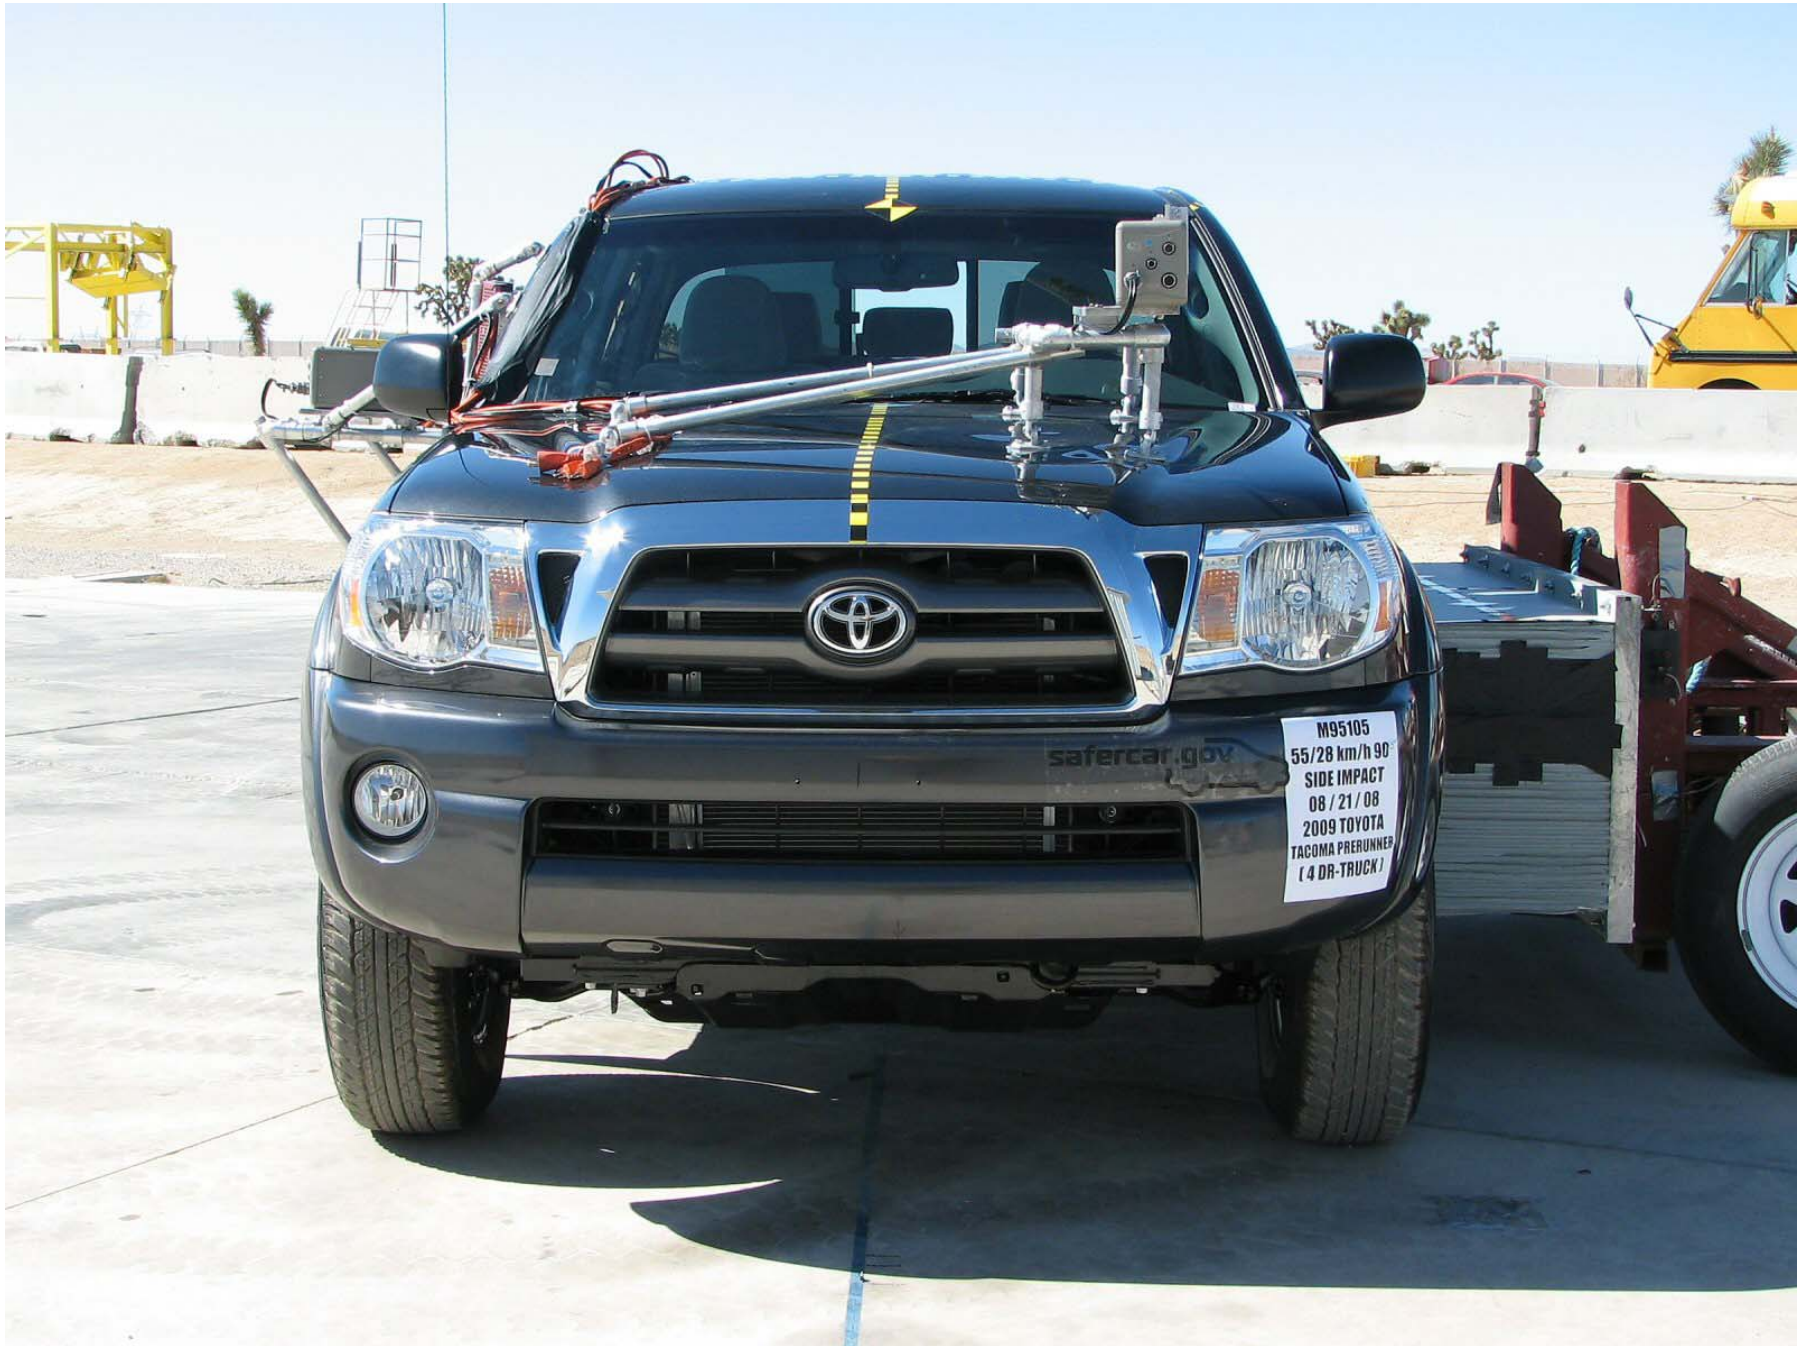
Figure A-5: Pre-Test Front View

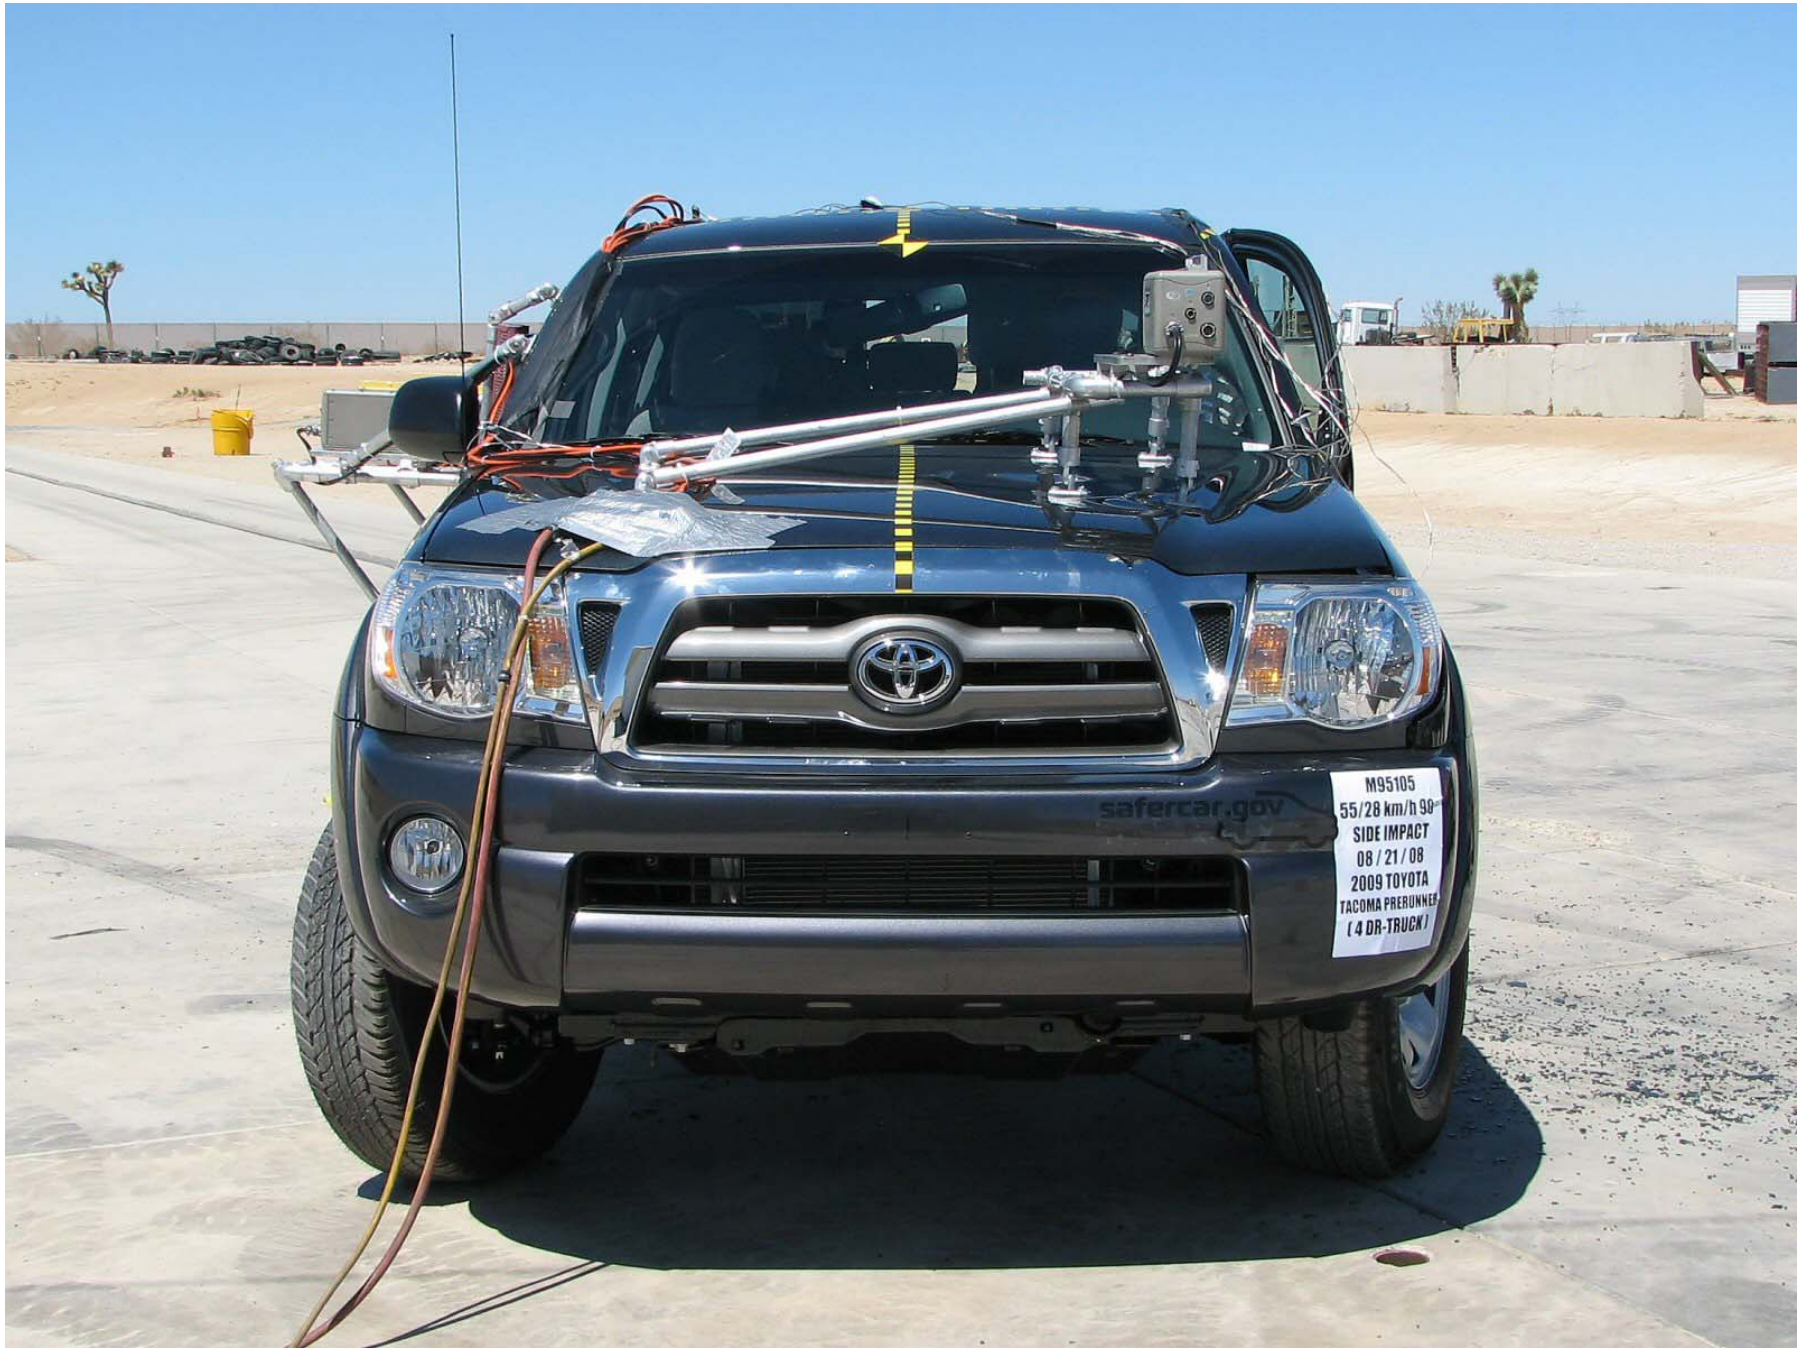
Figure A-6: Post-Test Front View

Both the driver and passenger doors remained closed during the impact. The test vehicle sustained a maximum static crush of 425 mm at level 4, 2100 mm rearward of the left vertical impact point. The driver SID/Hybrid III, Serial No. 274 and the passenger SID/Hybrid III, Serial No. 275 were calibrated prior to this test. The SID/Hybrid III injury criteria are summarized as follows:

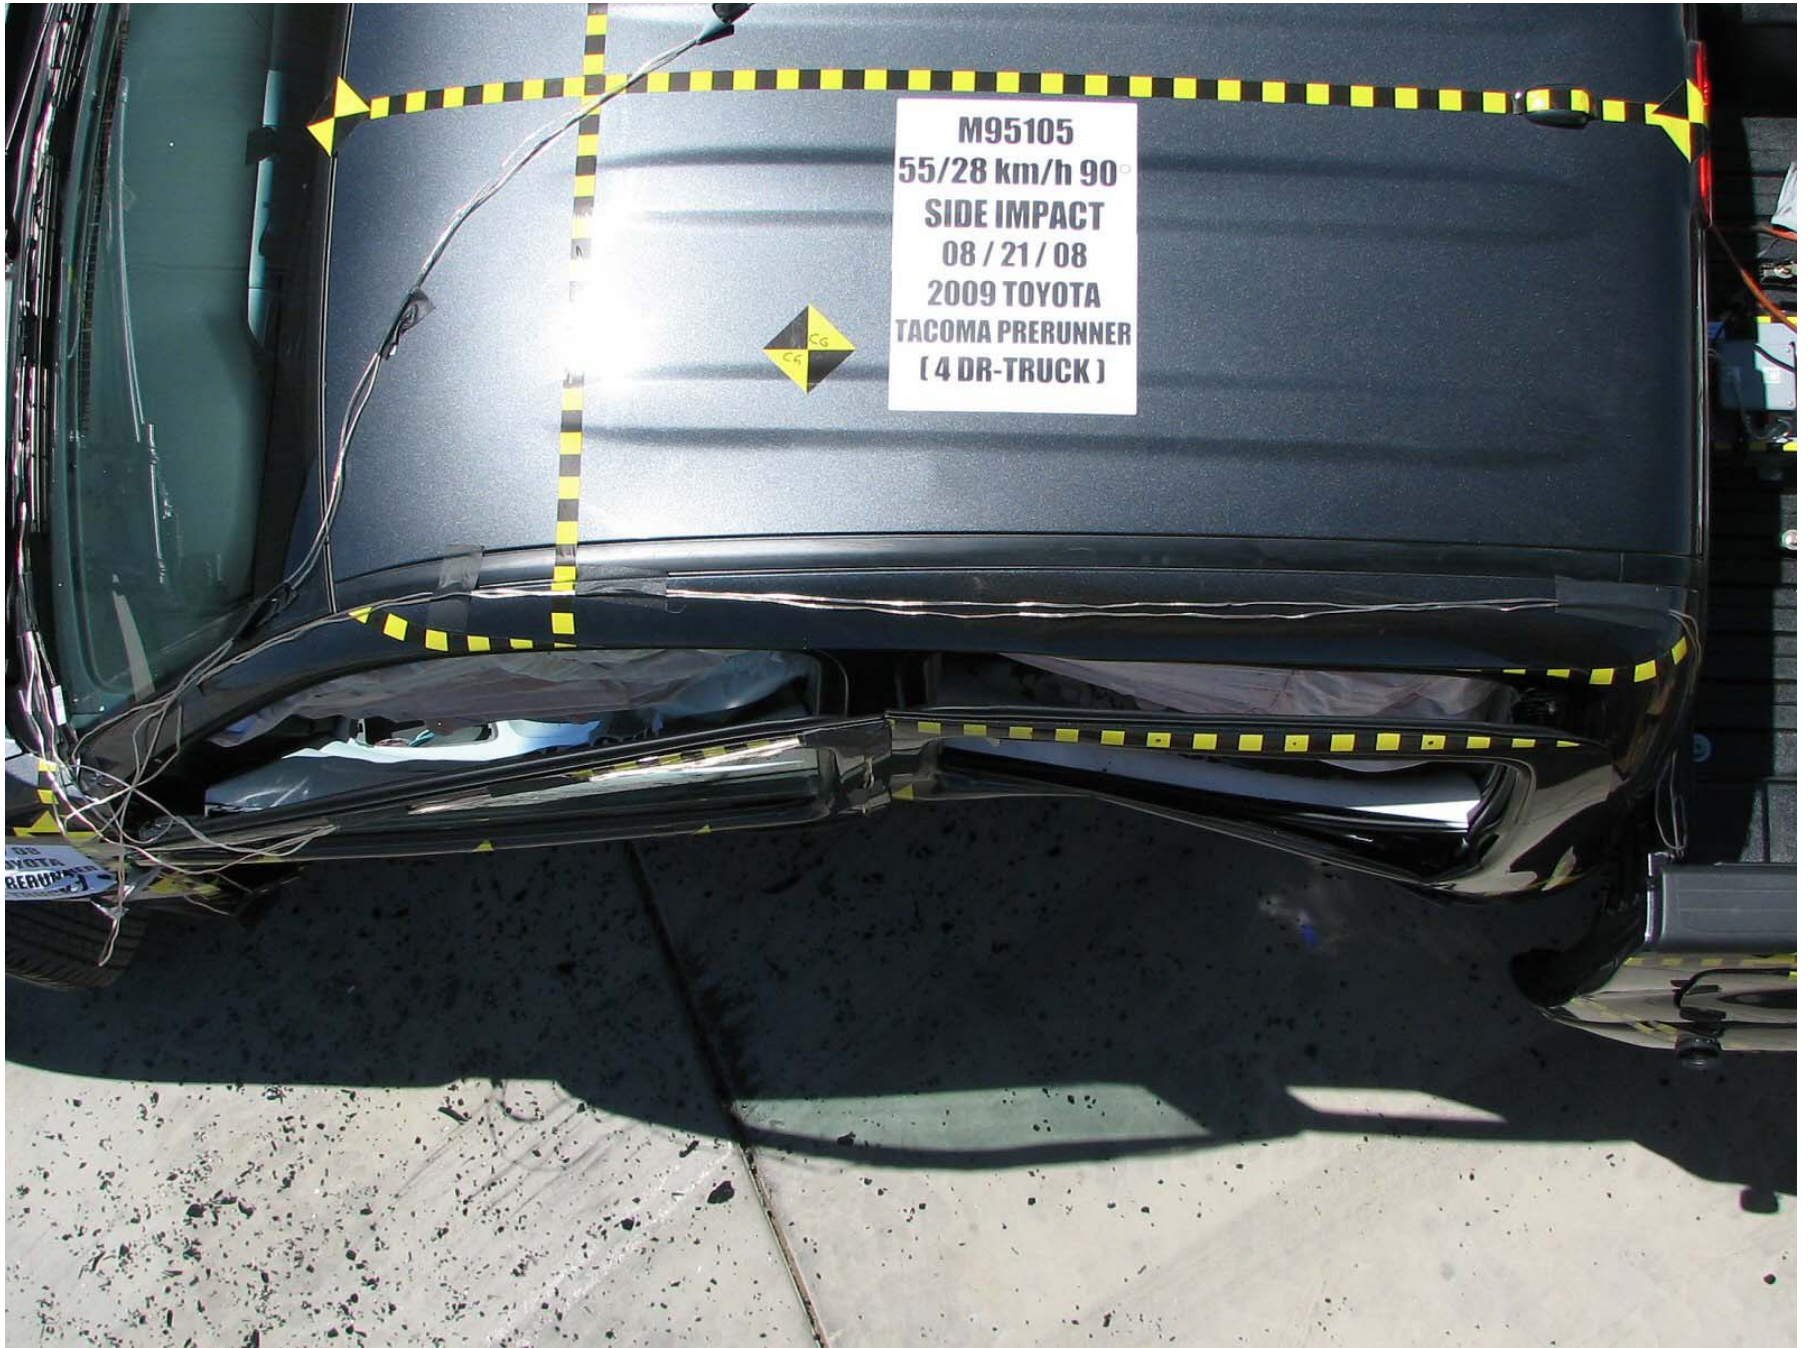
Figure A-24: Post-Test Overhead Close-up View

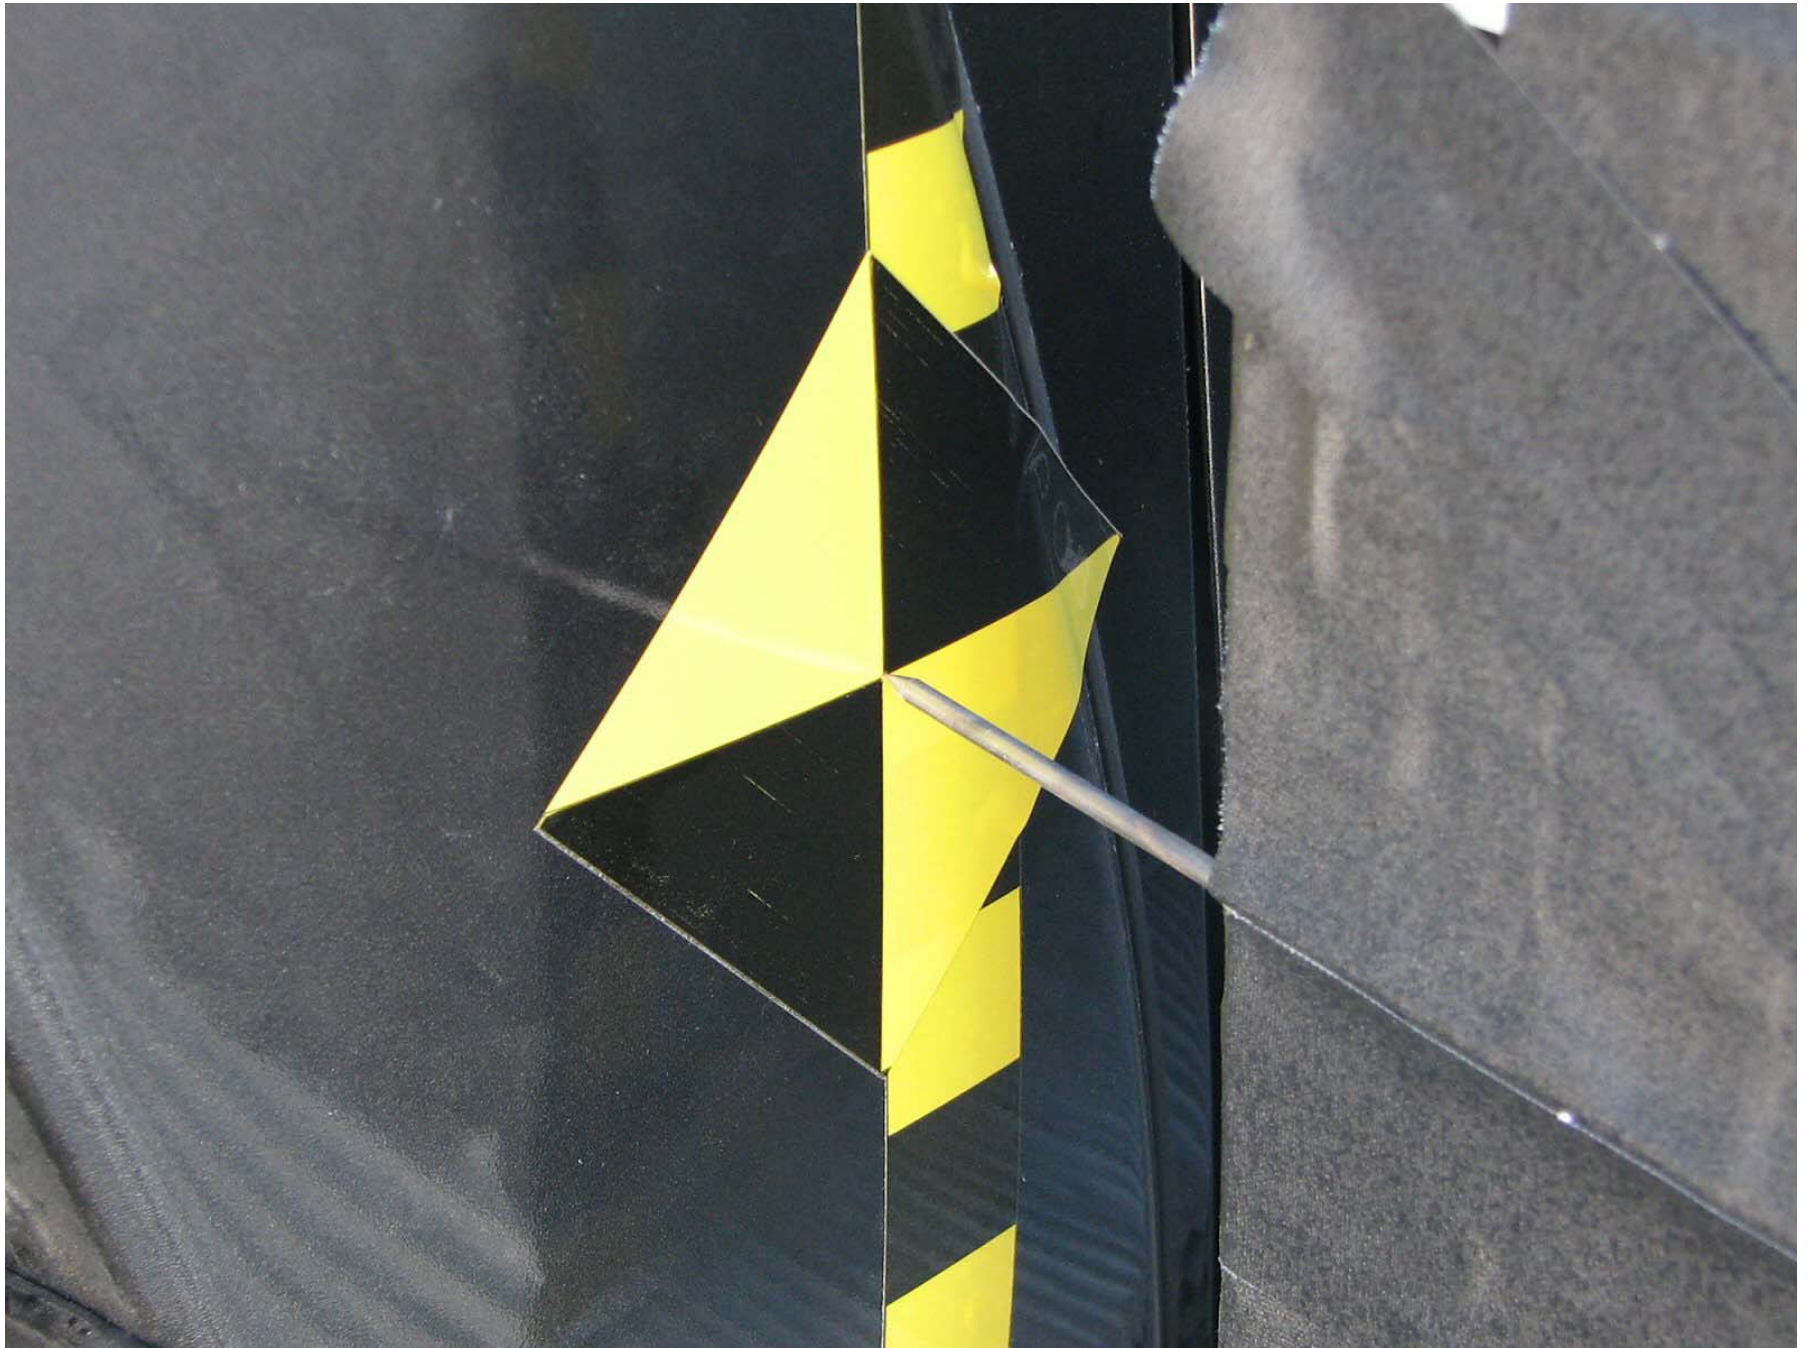
Figure A-25: Pre-Test Left Impact Point

Measurement Description	Units	Value
Test Vehicle Wheel Base	mm	3250
Target Impact Point Aft of Front Axle	mm	508
Actual Impact Point Aft of Front Axle	mm	496

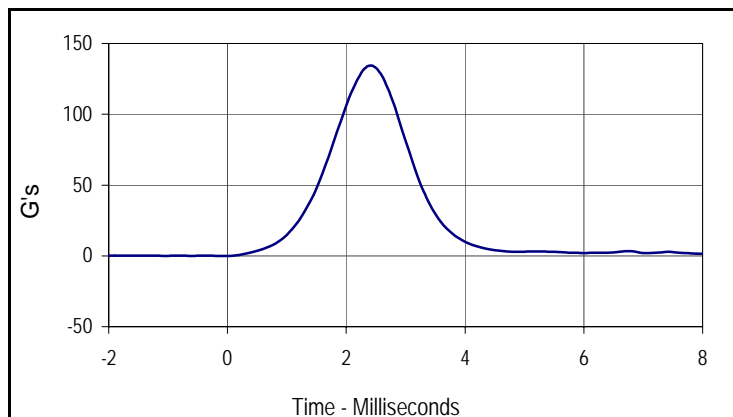
Tested Parameter	Units	Specification	Result	Pass/Fail
Laboratory Temperature	°C	18.9 to 25.6	21.7	Pass
Laboratory Relative Humidity	%	10 to 70	30	Pass
Peak Resultant Acceleration	G's	120.0 to 150.0	134.5	Pass
Peak Longitudinal Acceleration	G's	≤15.0	6.8	Pass
Is Acceleration Unimodal?	Yes/No	Yes	Yes	Pass
Oscillations After Main Pulse	%	<15	2.4	Pass
Overall Test Results				Pass

Curve Description			
Head Resultant			
CURNO	Type	SAE Class	Units
001	RES	1000	G's
Max	Time	Min	Time
134.5	2.4	0.0	-0.1
