**REPORT NUMBER: NCAP-MGA-2008-021**

**NEW CAR ASSESSMENT PROGRAM  
FRONTAL BARRIER IMPACT TEST**

**MAZDA MOTOR CORPORATION  
2009 MAZDA6 SEDAN SPORT  
NHTSA NUMBER: M95400**

**PREPARED BY:  
MGA RESEARCH CORPORATION  
5000 WARREN ROAD  
BURLINGTON, WI 53105**

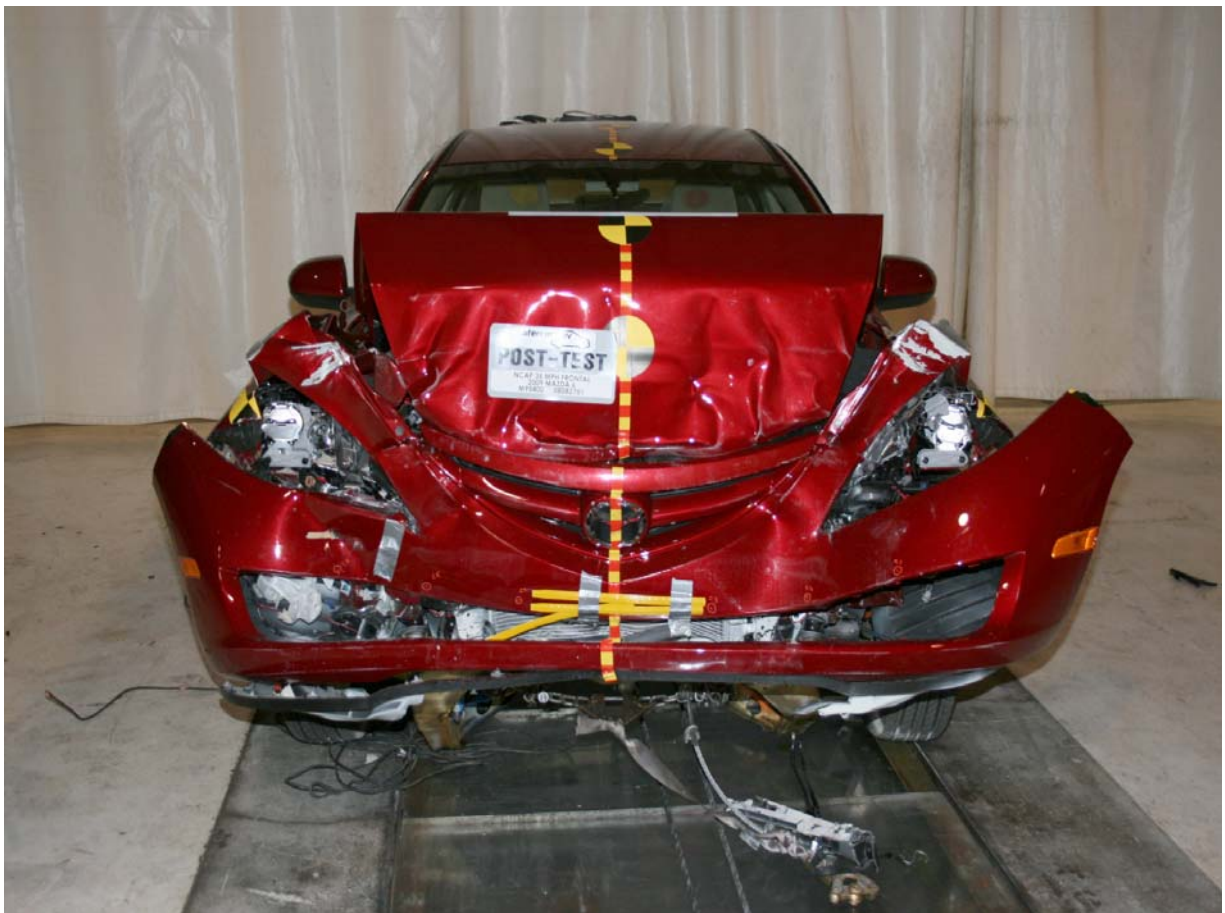
Post-Test Front View

The maximum static crush of the vehicle was 571 mm and both the driver and passenger side doors remained closed and latched during the impact event and were operable after the impact.

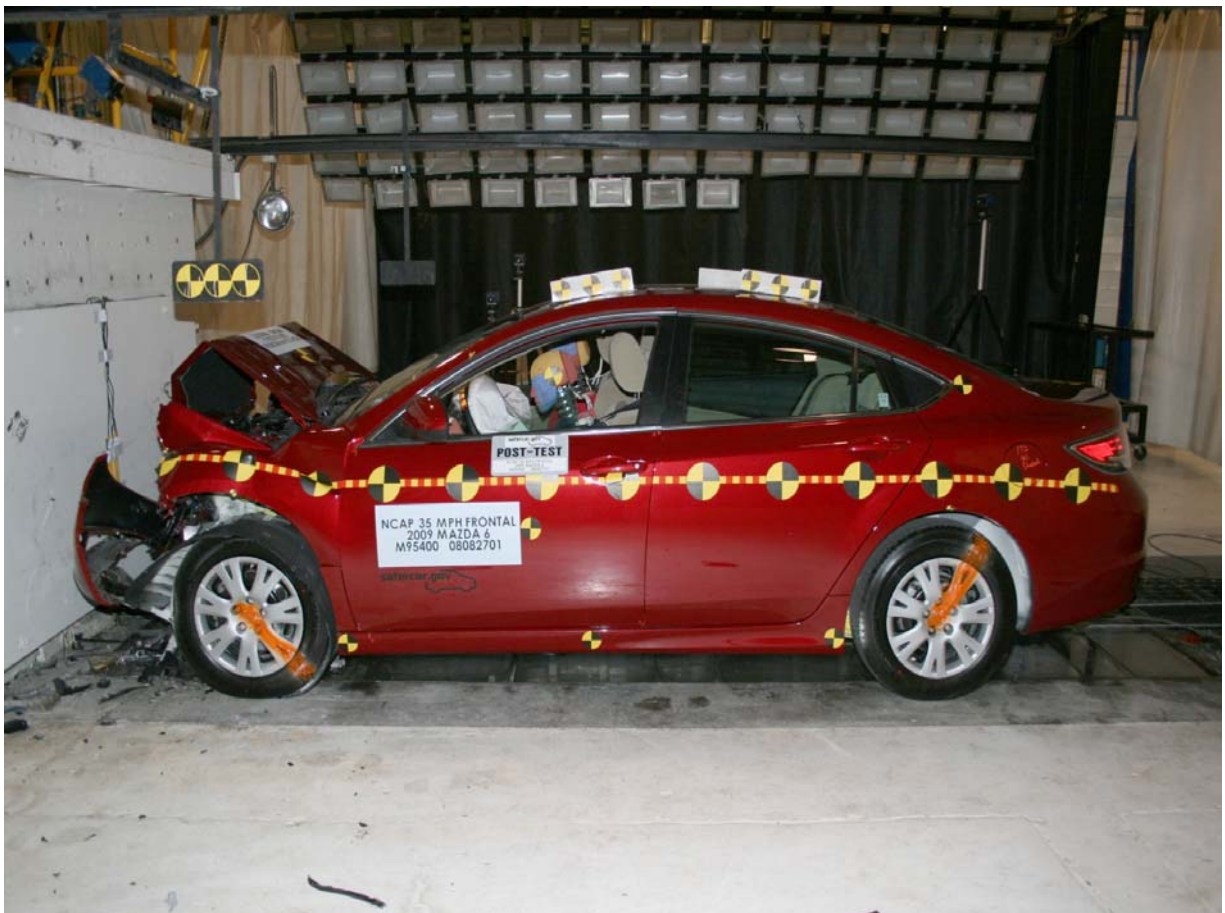
Post-Test Left Side View

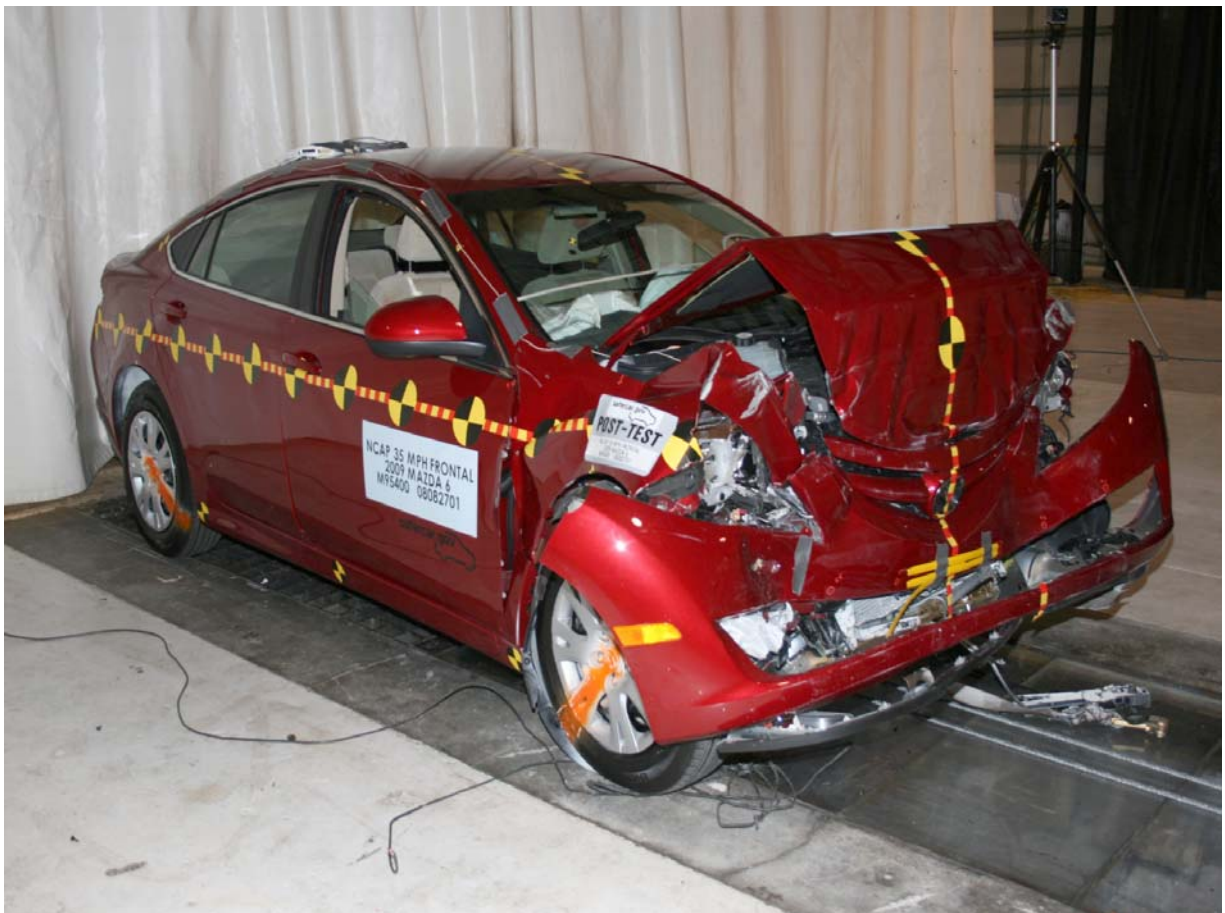
Post-Test Right Front  $\frac{3}{4}$  View

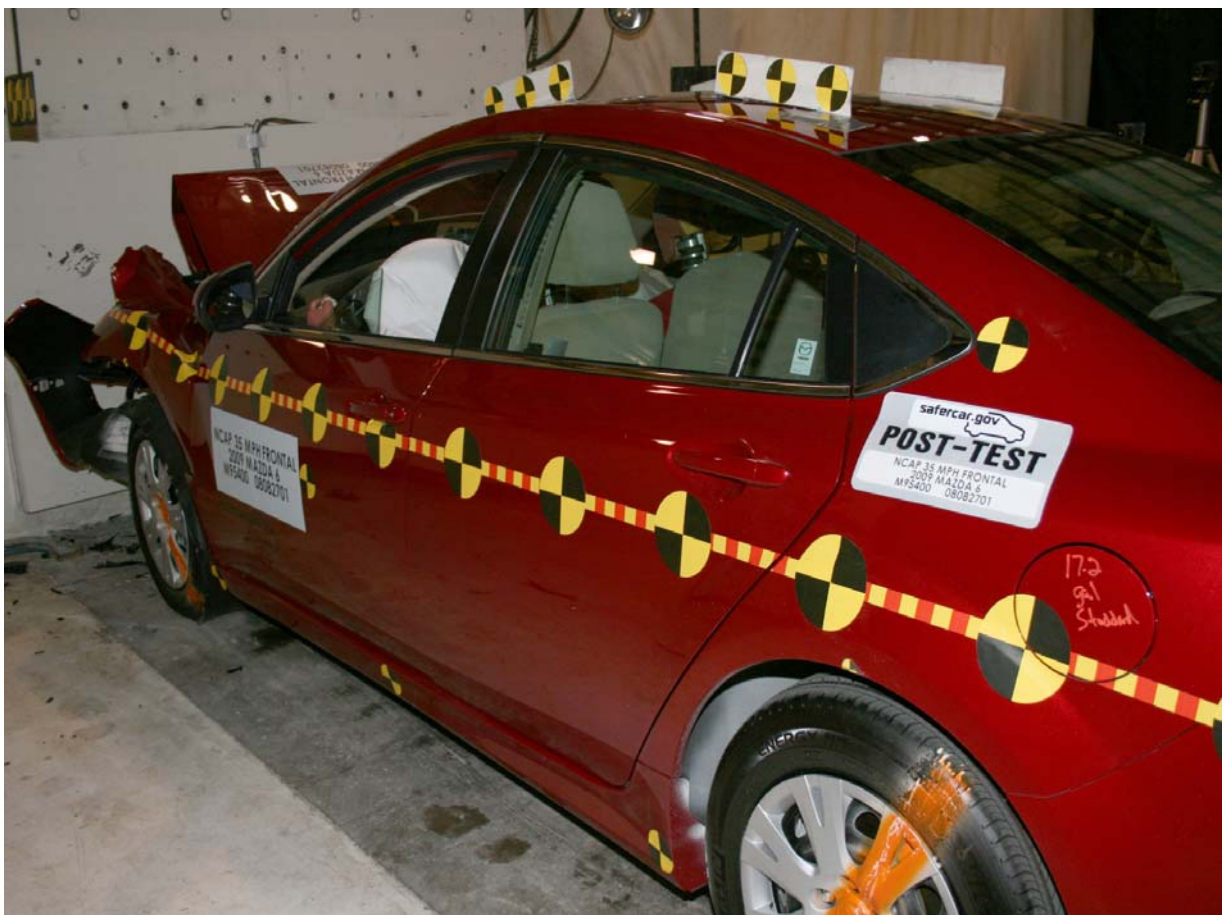
Post-Test Left Side  $\frac{3}{4}$  View of Doors After Impact

| Description | Driver | Passenger |
|---|---|---|
| Front Door Opening | Door remained closed and latched;<br>Door opened without tools | Door remained closed and latched;<br>Door opened without tools |

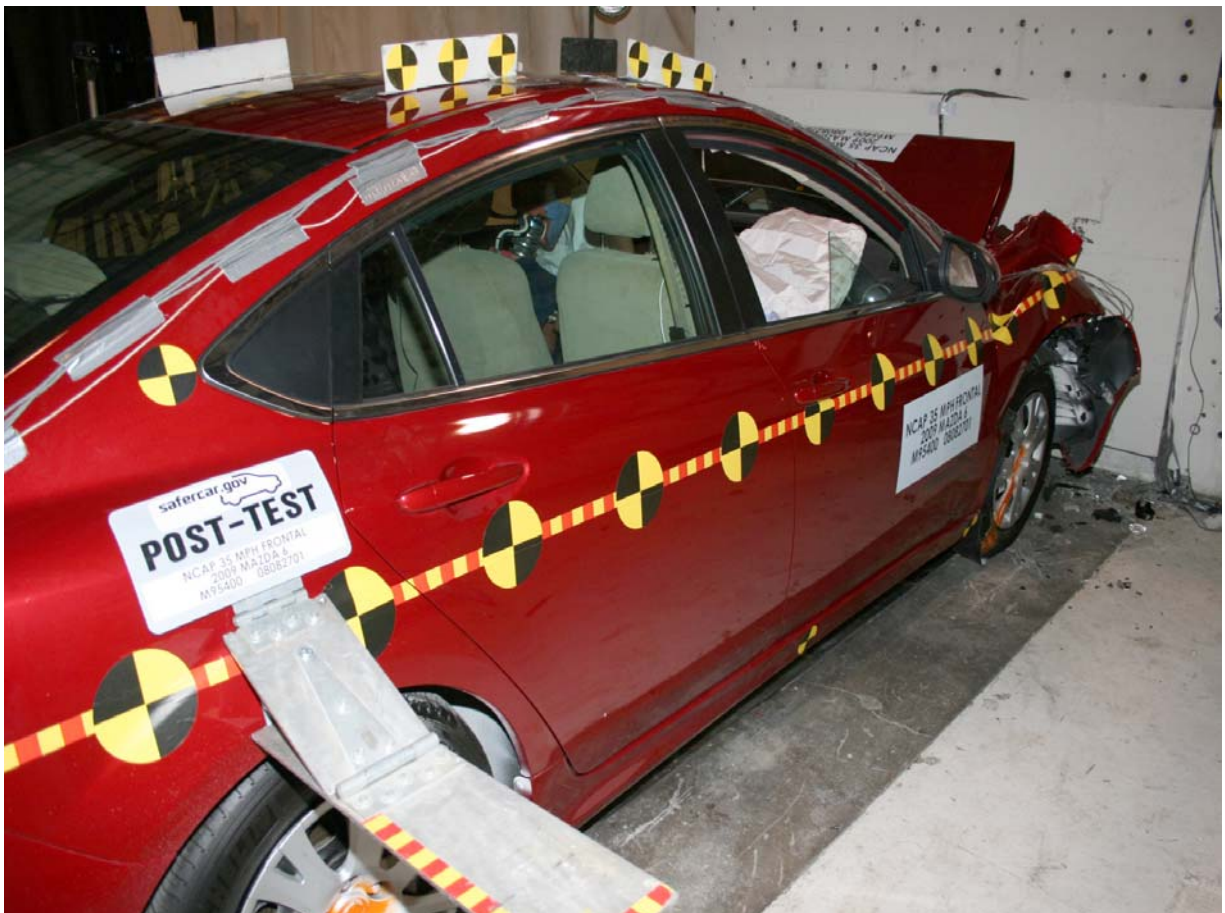
Post-Test Right Side ¾ View of Doors After Impact

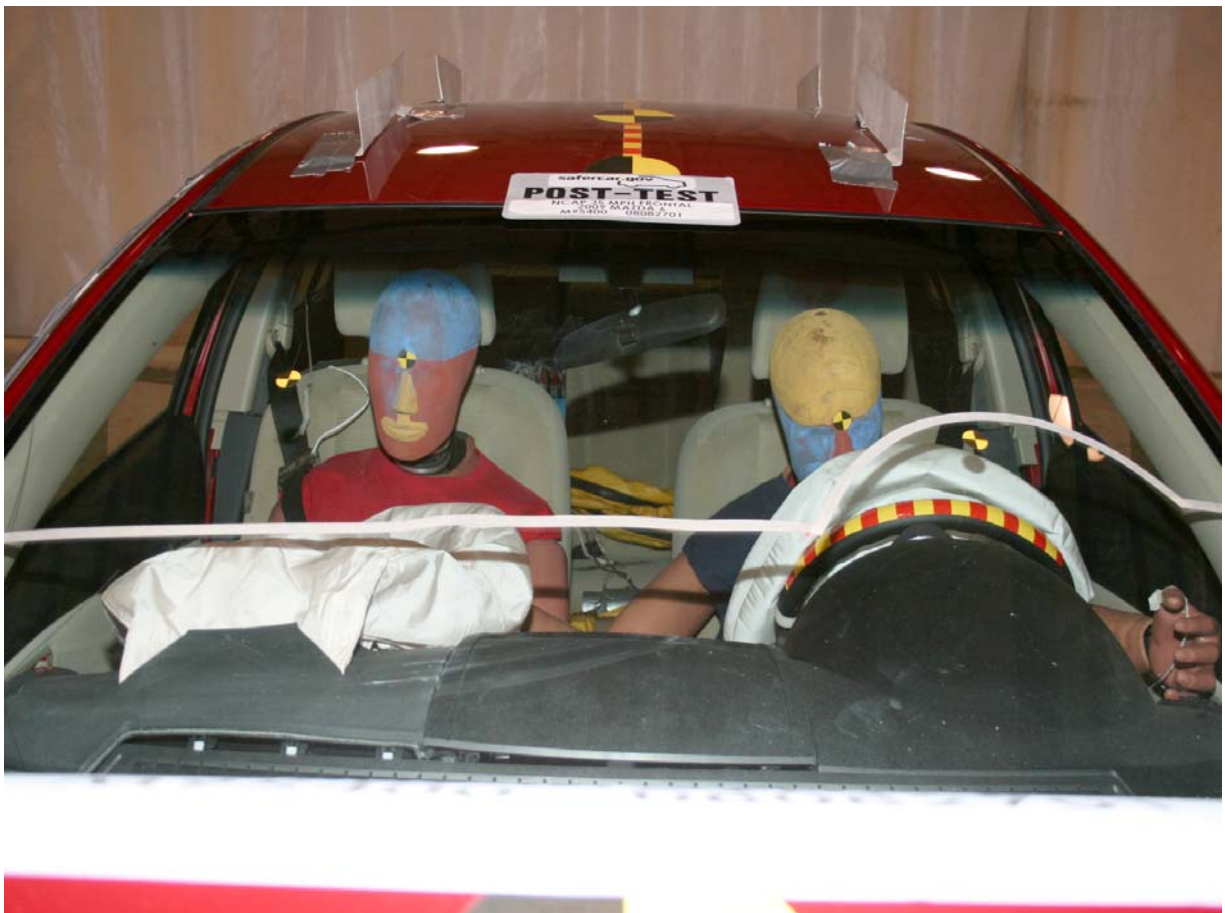
Post-Test Windshield View

There was 100 percent windshield retention and no intrusion into the protected zone of the windshield during the event. There was no Stoddard Solvent leakage after the event or during any phase of the static rollover.

| Description | Driver | Passenger |
|---|---|---|
| Glazing Damage | Windshield cracked | |

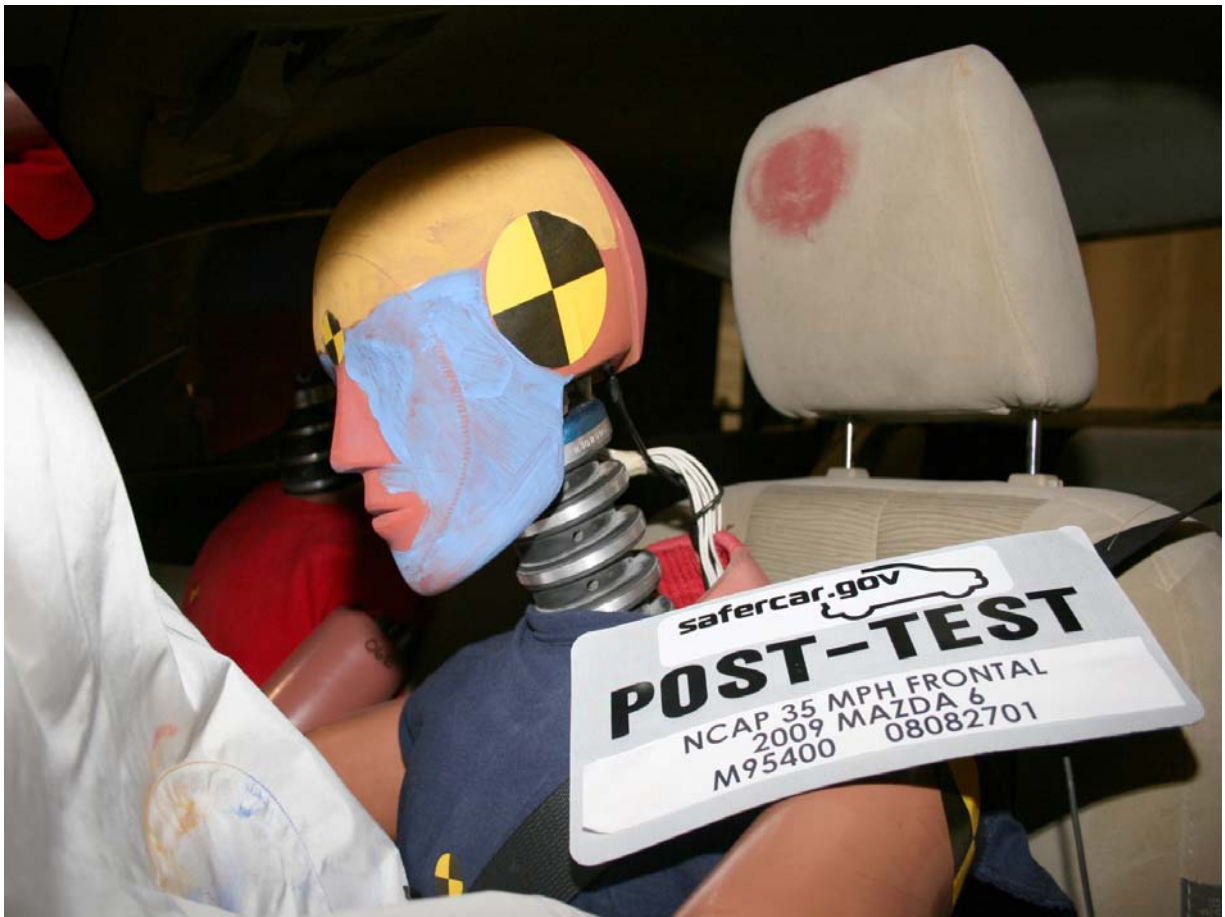
Post-Test Driver Dummy Head Contact

The driver's head and chest contacted the airbag. The driver's head also contacted the headrest. The driver's knees contacted the knee bolster. The passenger's head and chest contacted the airbag. The passenger's head also contacted the headrest. The passenger's knees contacted the glove box.

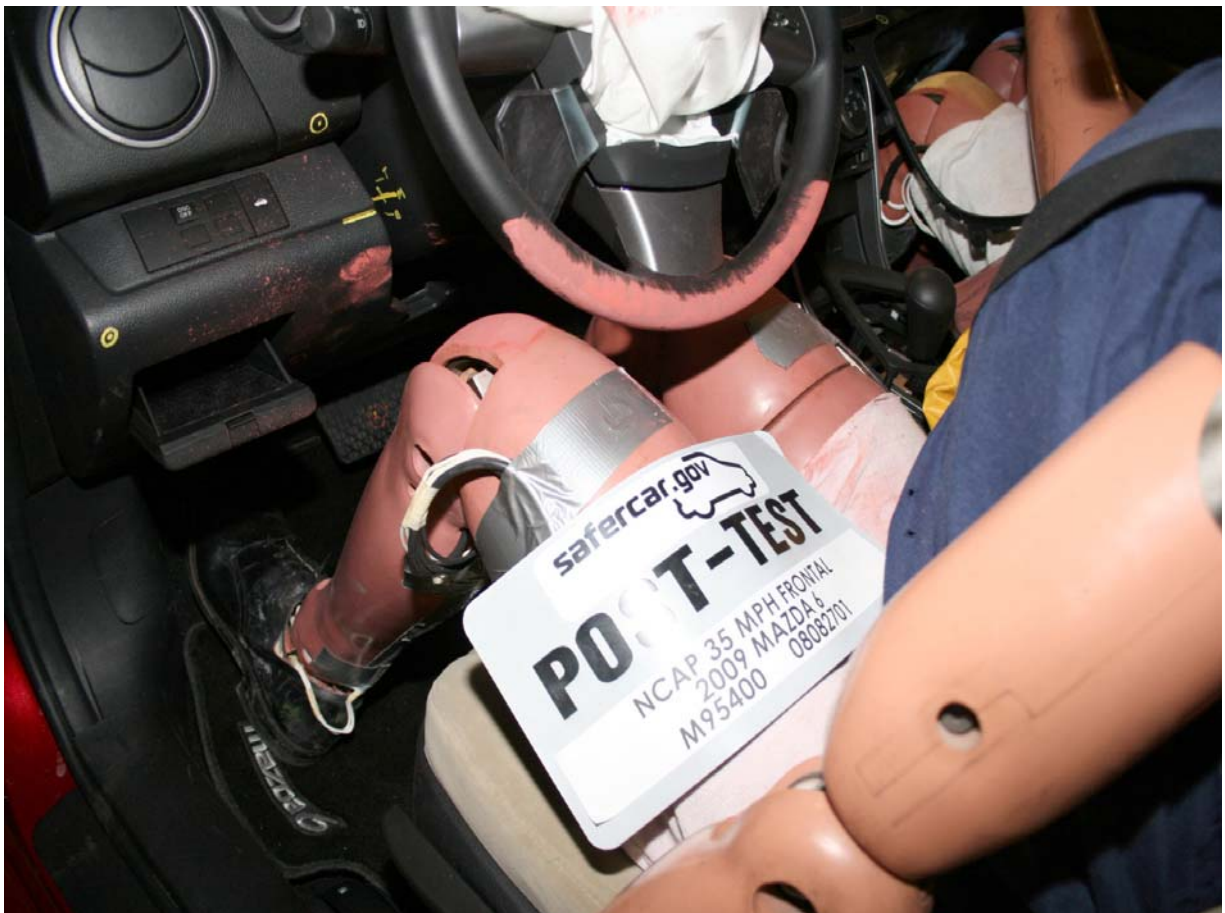
Post-Test Driver Dummy Left Knee Contact

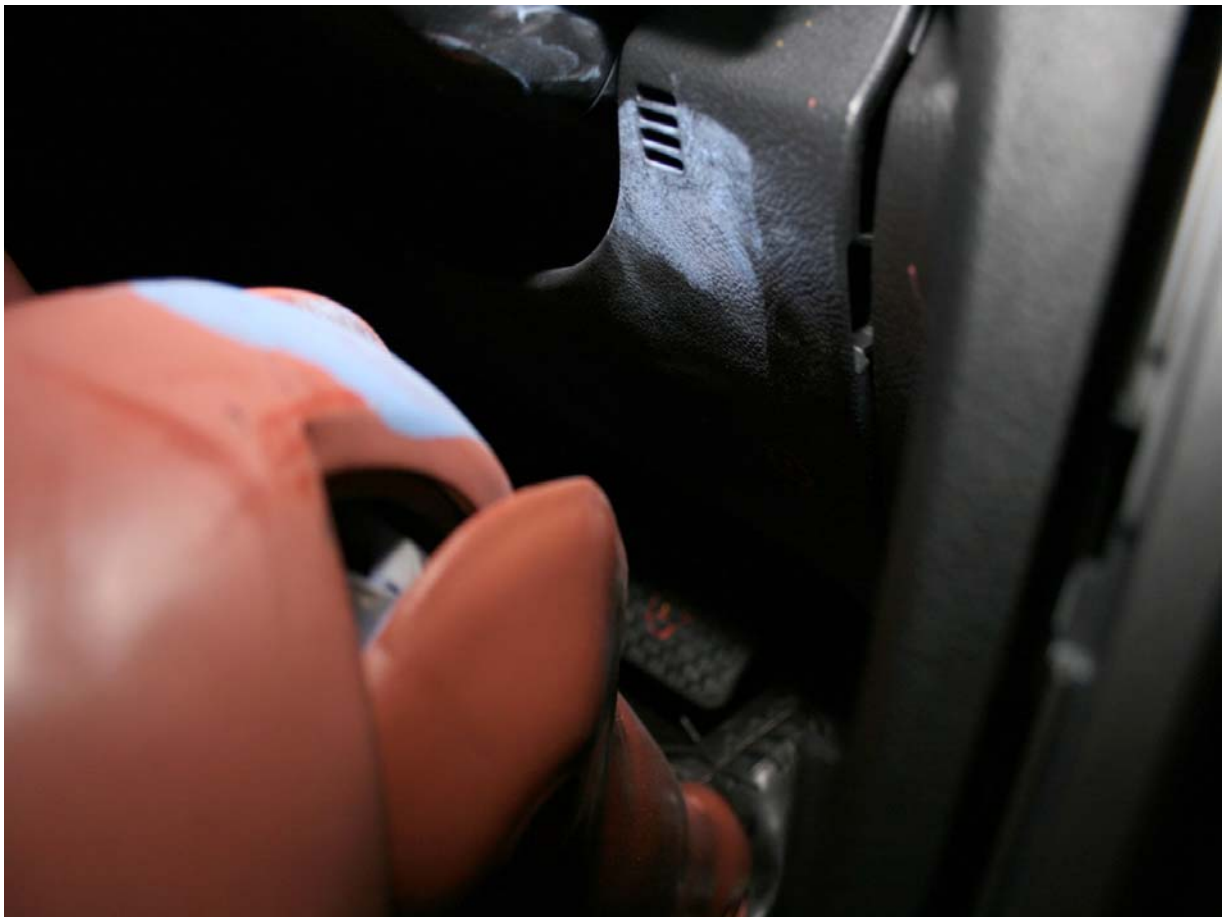
Post-Test Driver Dummy Right Knee Contact

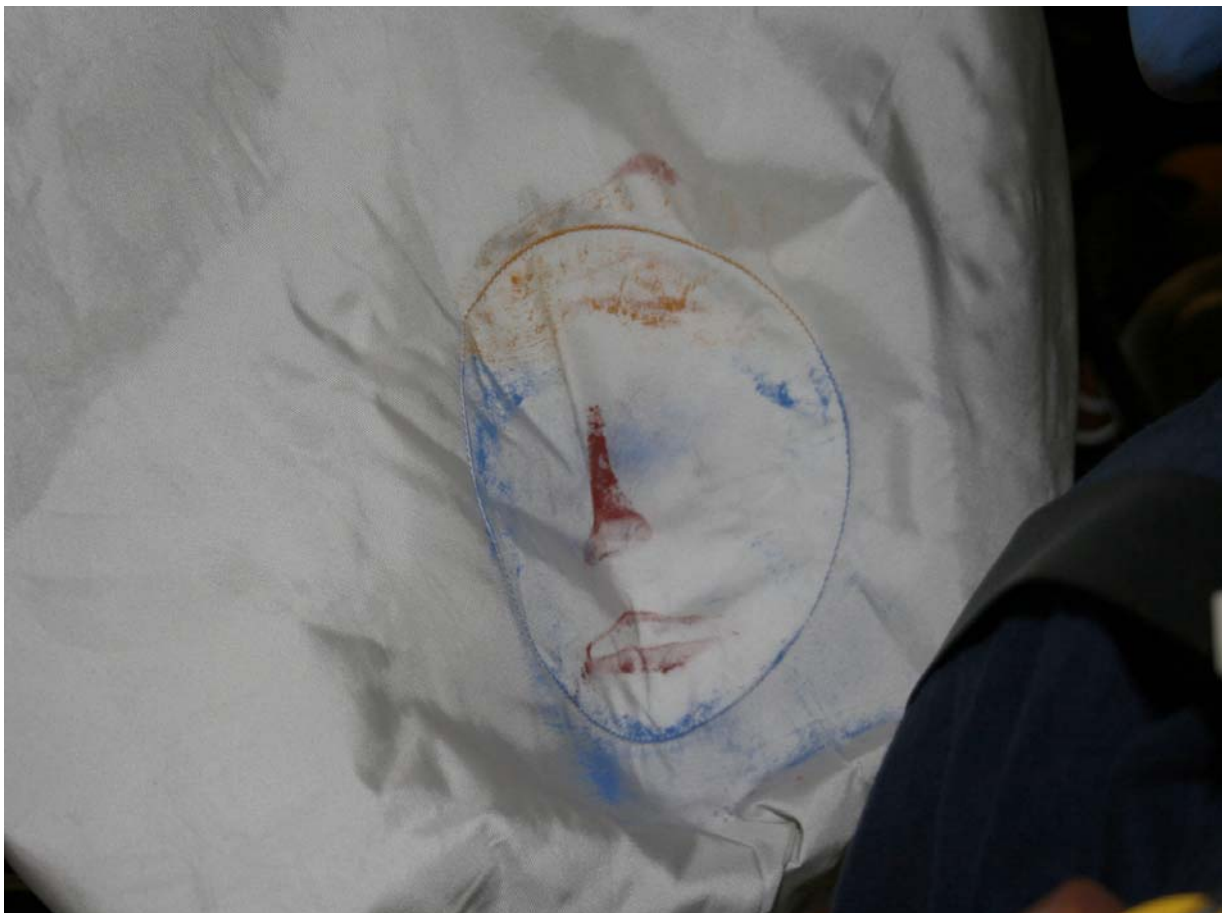
Post-Test Driver Dummy Airbag Contact

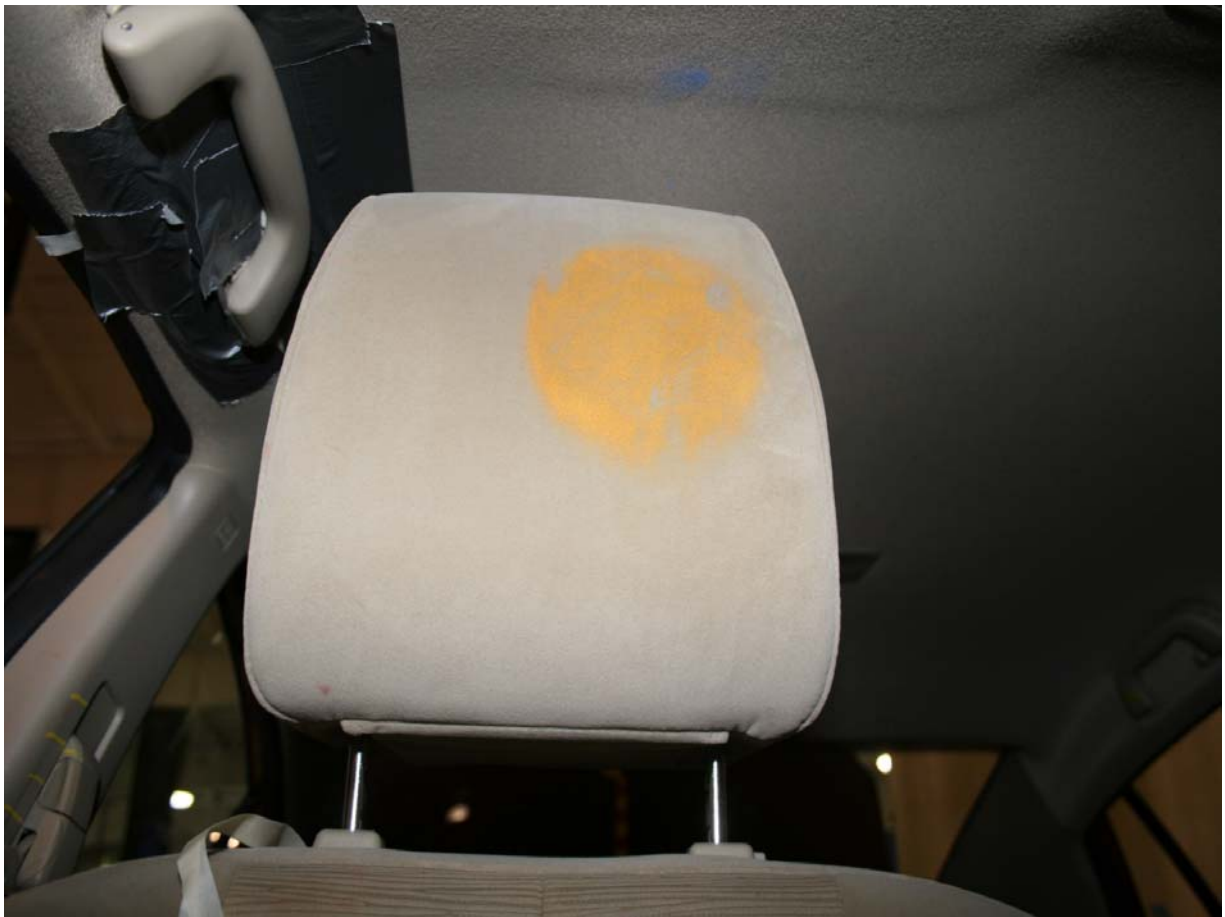
Post-Test Passenger Dummy Head Contact

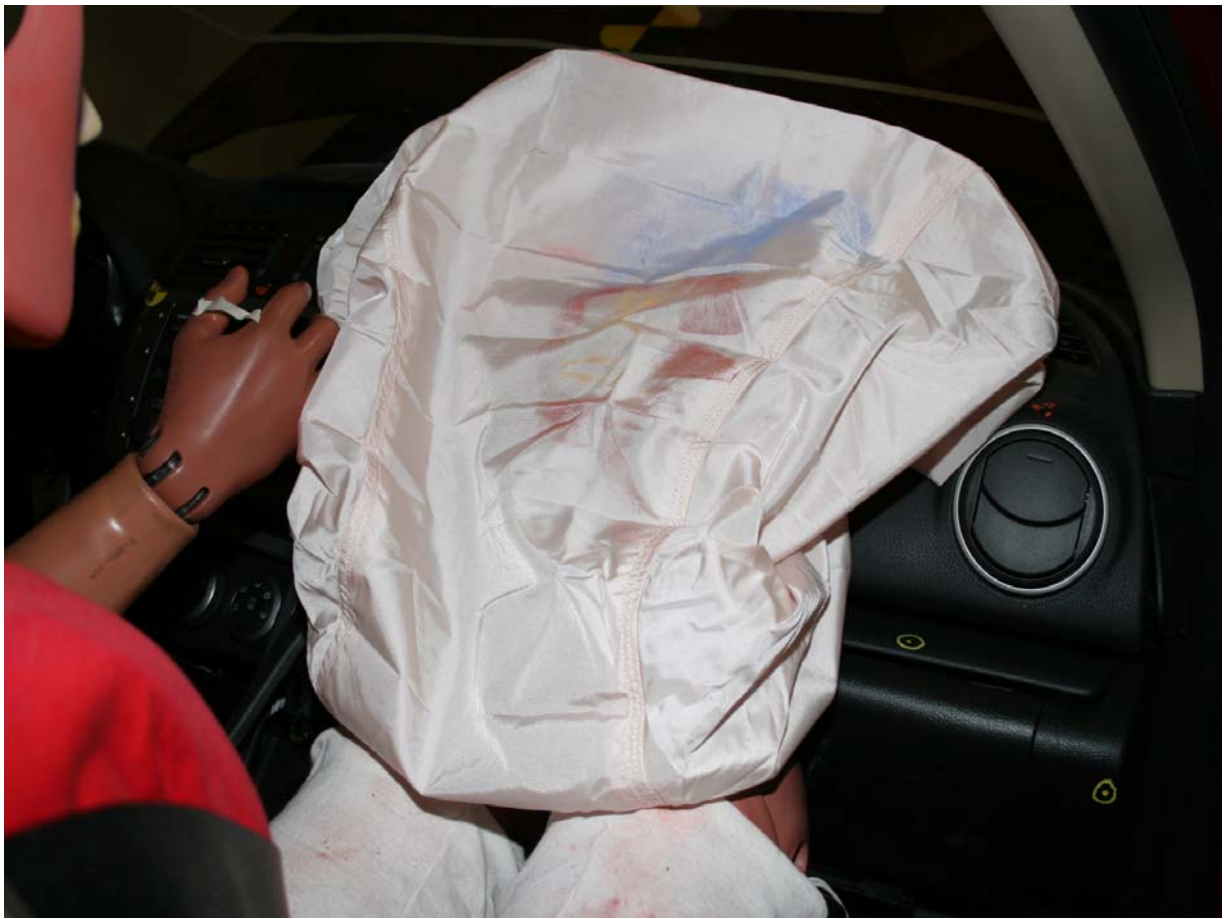
Post-Test Passenger Dummy Airbag Contact
