**REPORT NUMBER: SNCAP-CAL-09-03**

**NEW CAR ASSESSMENT PROGRAM  
SIDE IMPACT TEST**

**NISSAN MOTOR COMPANY  
2009 NISSAN XTERRA  
4-DOOR SUV**

**FINAL REPORT**

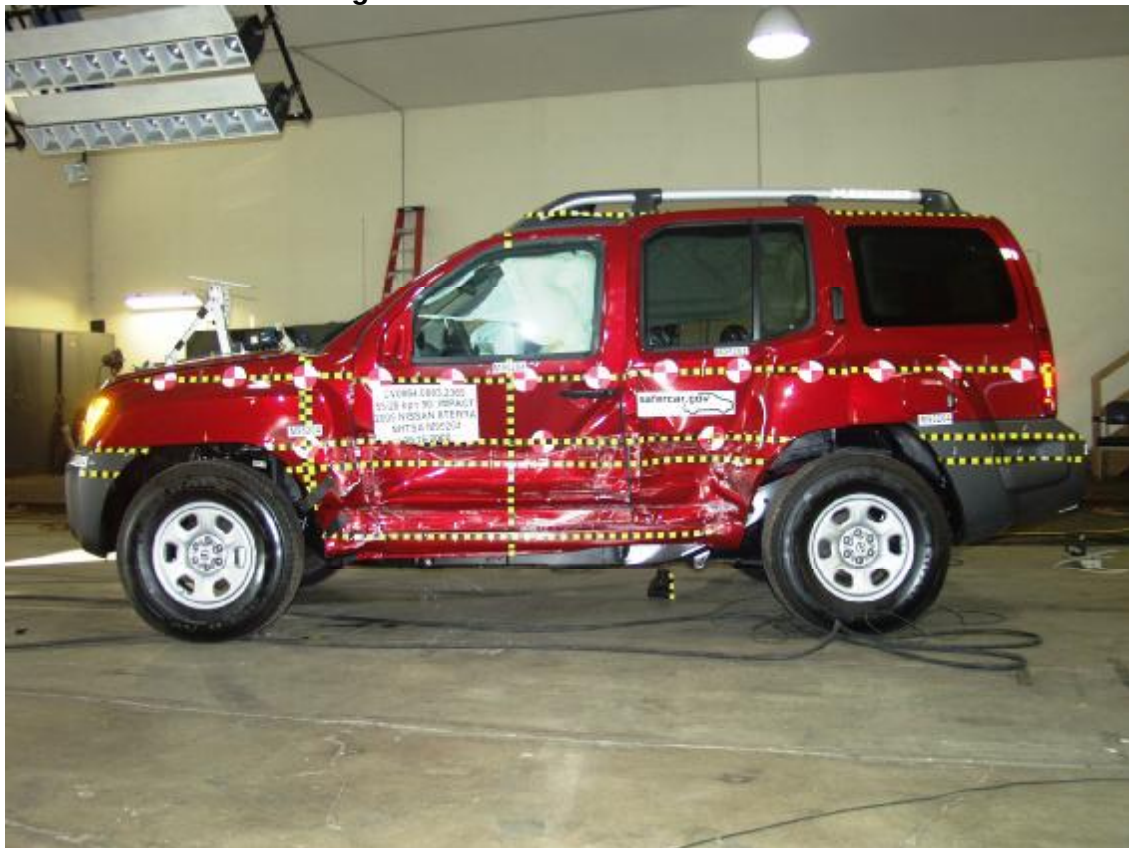
**Figure A-10: Post-Test Left Side View**

The test vehicle sustained a maximum static crush of 183 mm at level 1, 1800 mm rearward of the left vertical impact point. The driver and passenger SID/HIII's, Serial Nos. 269 and 270 respectively, were calibrated just prior to this test.
