**REPORT NUMBER: NCAP-MGA-2009-001**

**NEW CAR ASSESSMENT PROGRAM  
FRONTAL BARRIER IMPACT TEST**

**AUDI AG  
2009 AUDI A4 SEDAN  
NHTSA NUMBER: M95800**

**PREPARED BY:  
MGA RESEARCH CORPORATION  
5000 WARREN ROAD  
BURLINGTON, WI 53105**

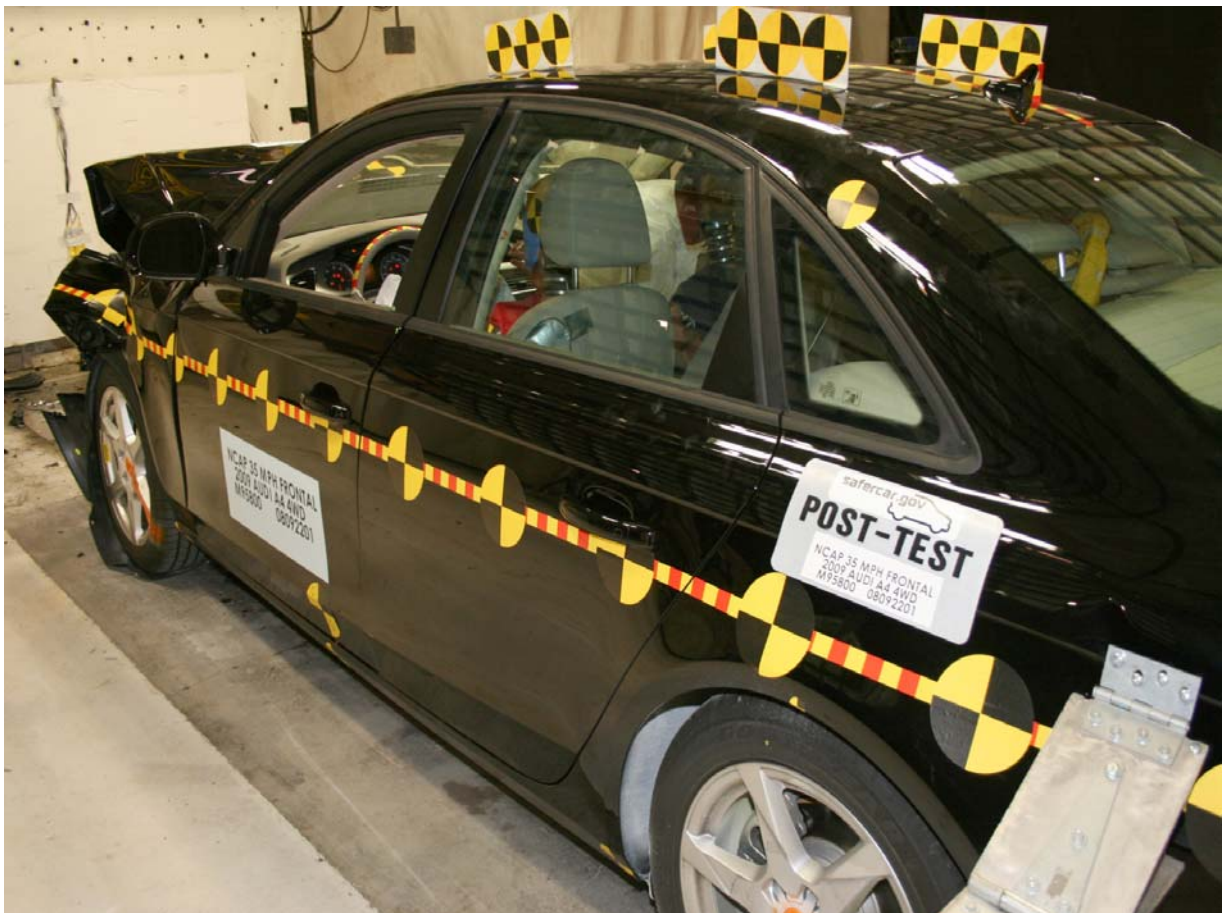
The maximum static crush of the vehicle was 658 mm and both the driver and passenger side doors remained closed and latched during the impact event and were operable after the impact.

Post-Test Left Side 3/4 View of Doors After Impact

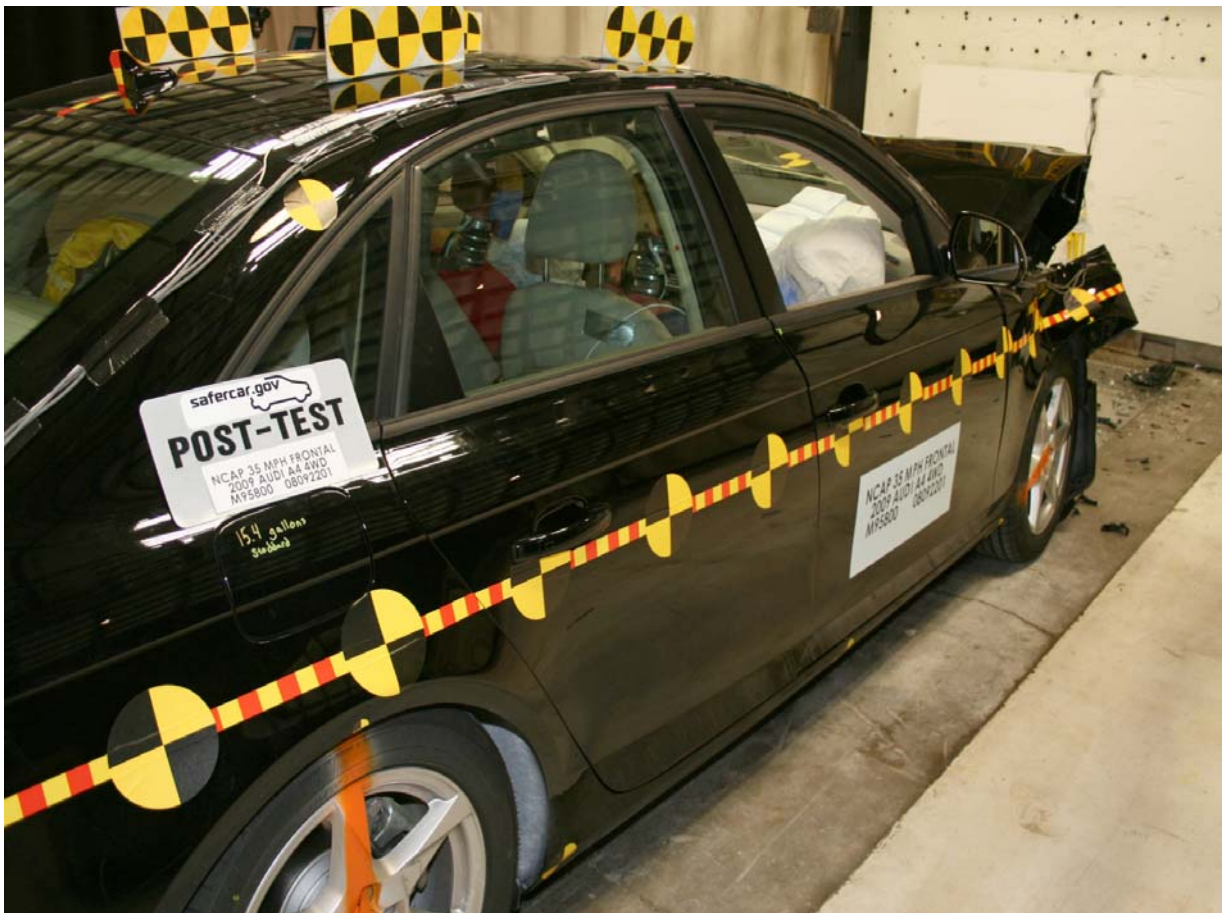
Post-Test Right Side 3/4 View of Doors After Impact

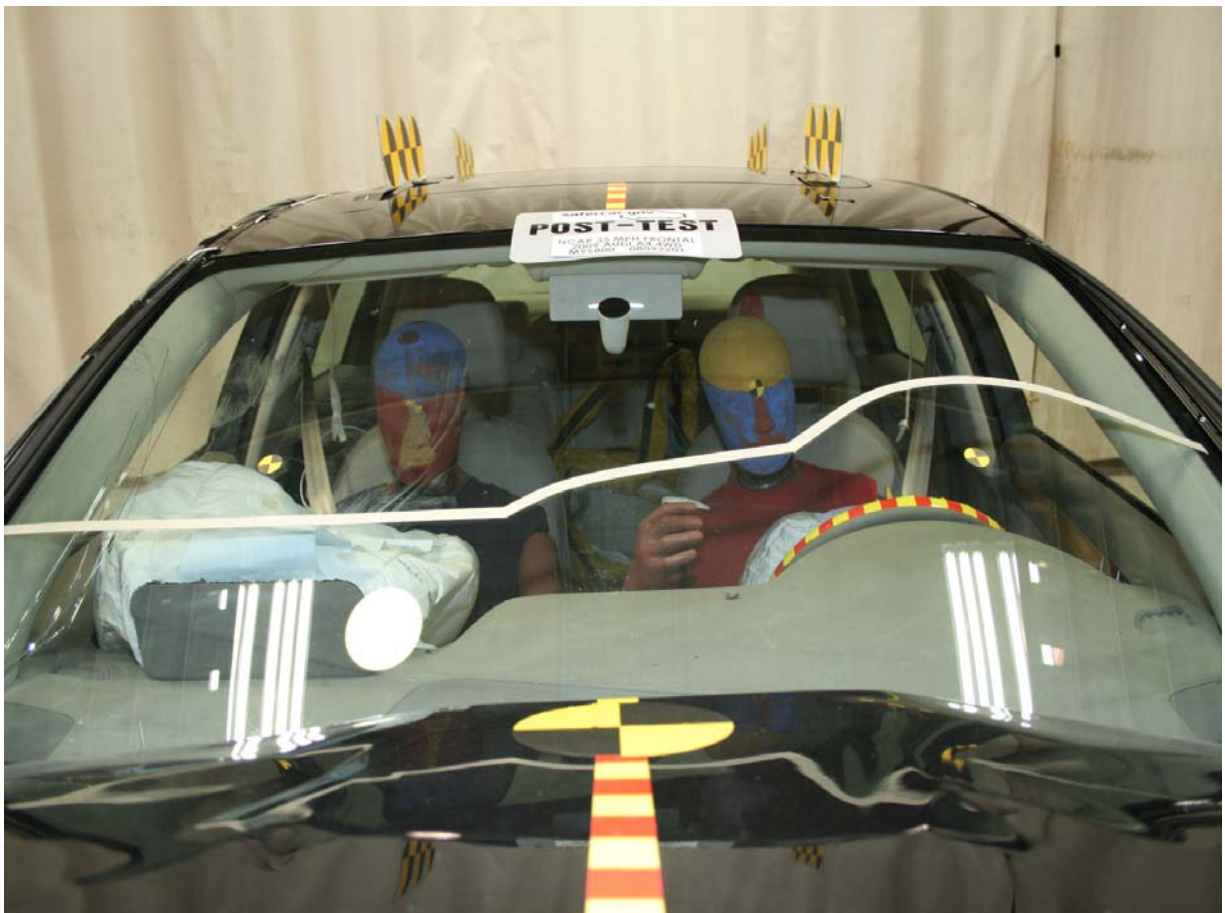
| Description | Driver | Passenger |
|---|---|---|
| Glazing Damage | Windshield cracked | |

Post-Test Windshield View

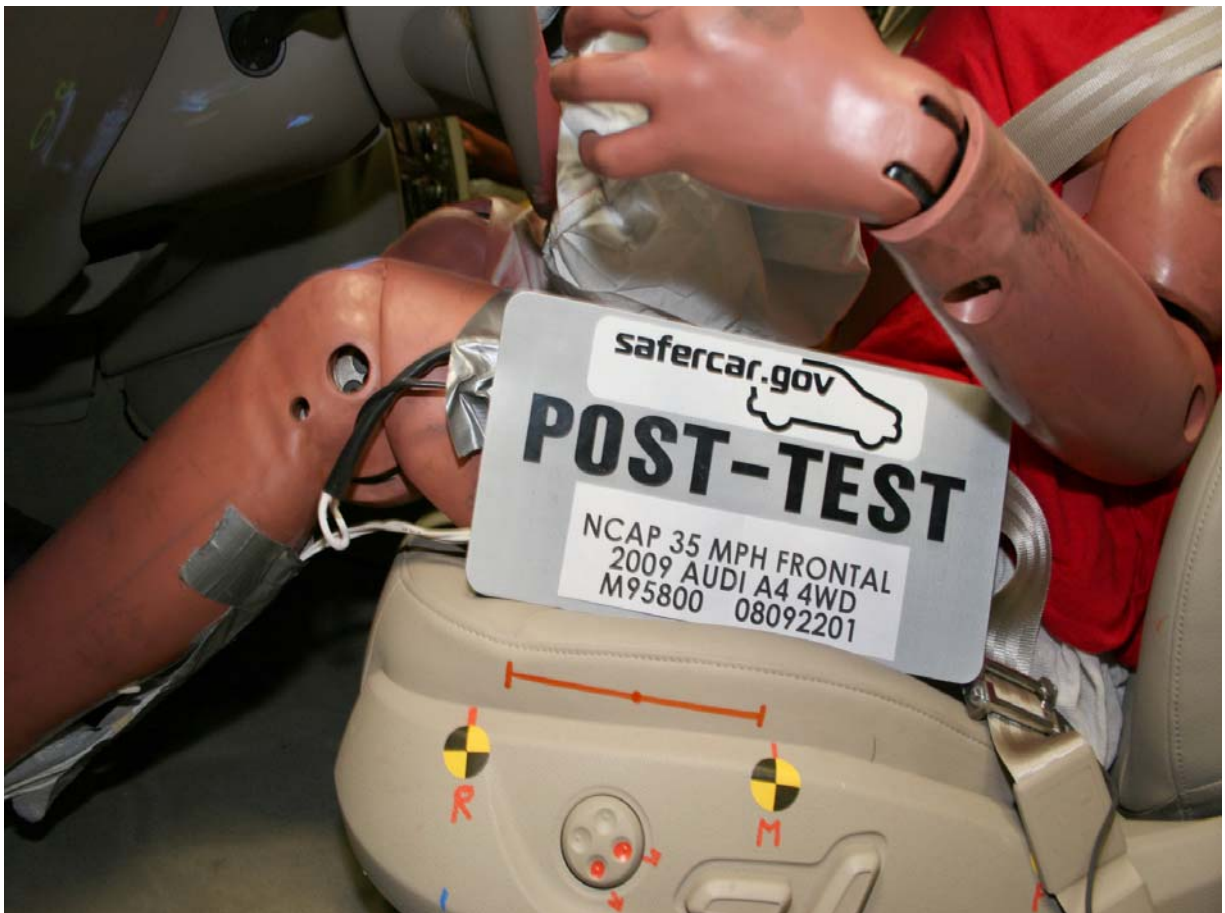
The driver's head and chest contacted the airbag. The driver's head also contacted the headrest. The driver's knees contacted the knee bolster. The passenger's head and chest contacted the airbag. The passenger's head also contacted the headrest and headliner. The passenger's knees contacted the glove box.

Post-Test Driver Side Knee Bolster

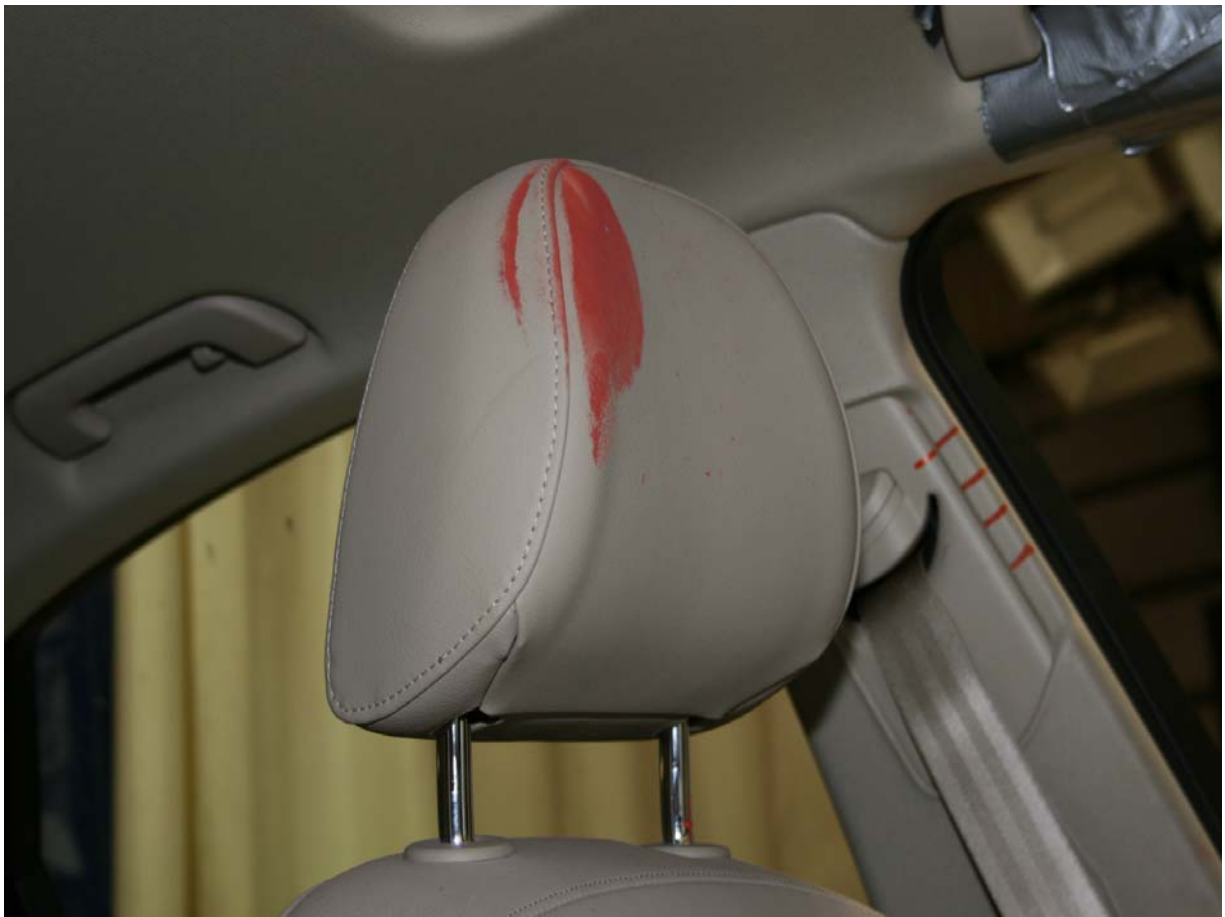
Post-Test Driver Dummy Head Contact

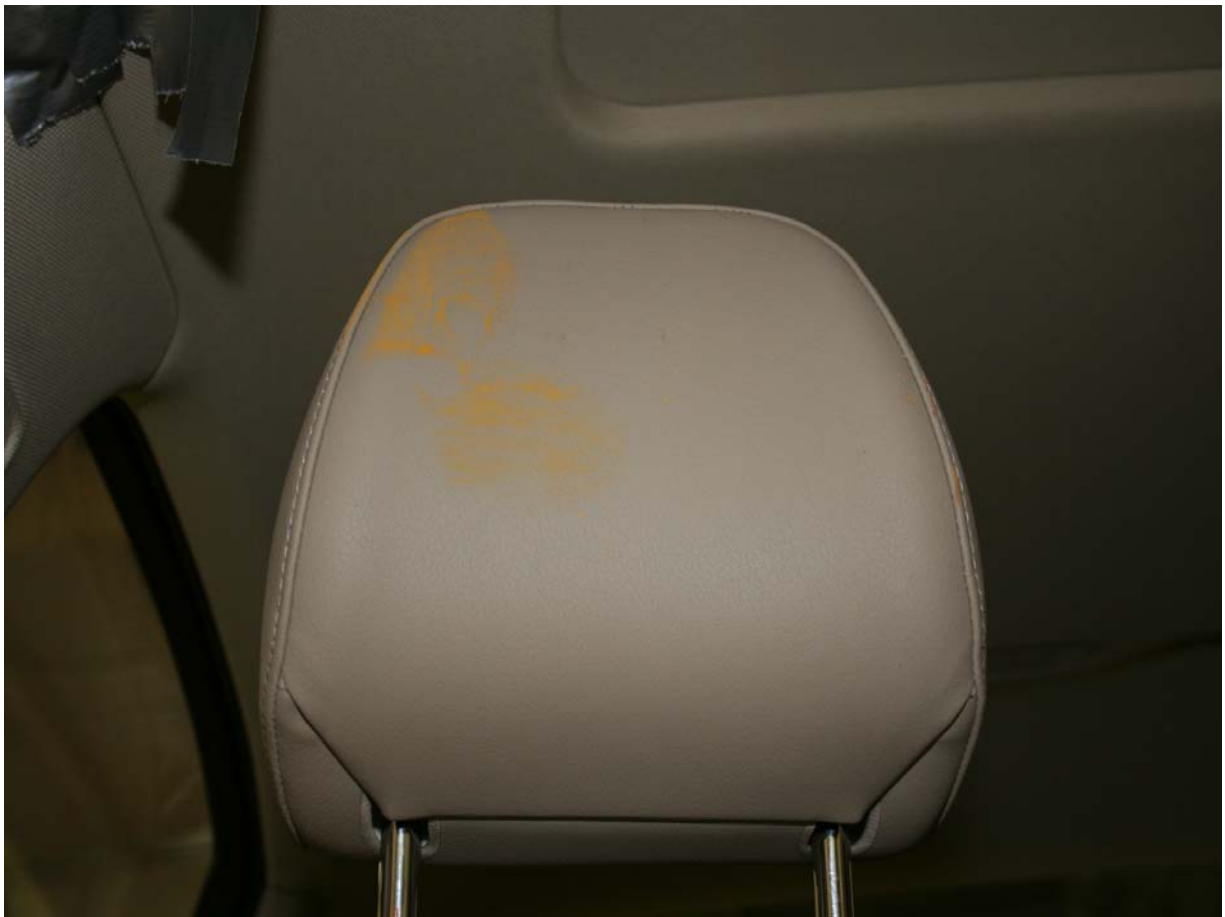
Post-Test Passenger Dummy Head Contact (headrest)

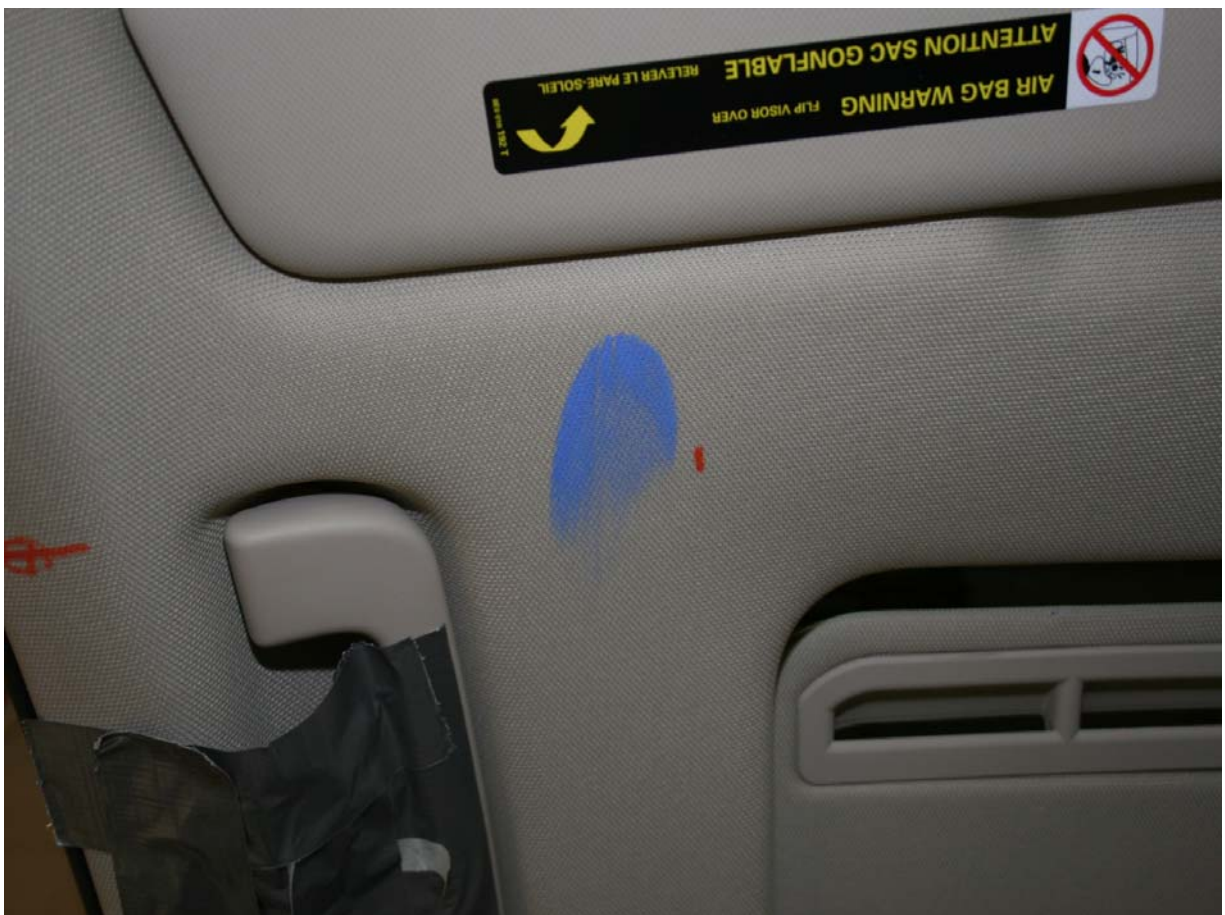
Post-Test Passenger Dummy Head Contact (headliner)

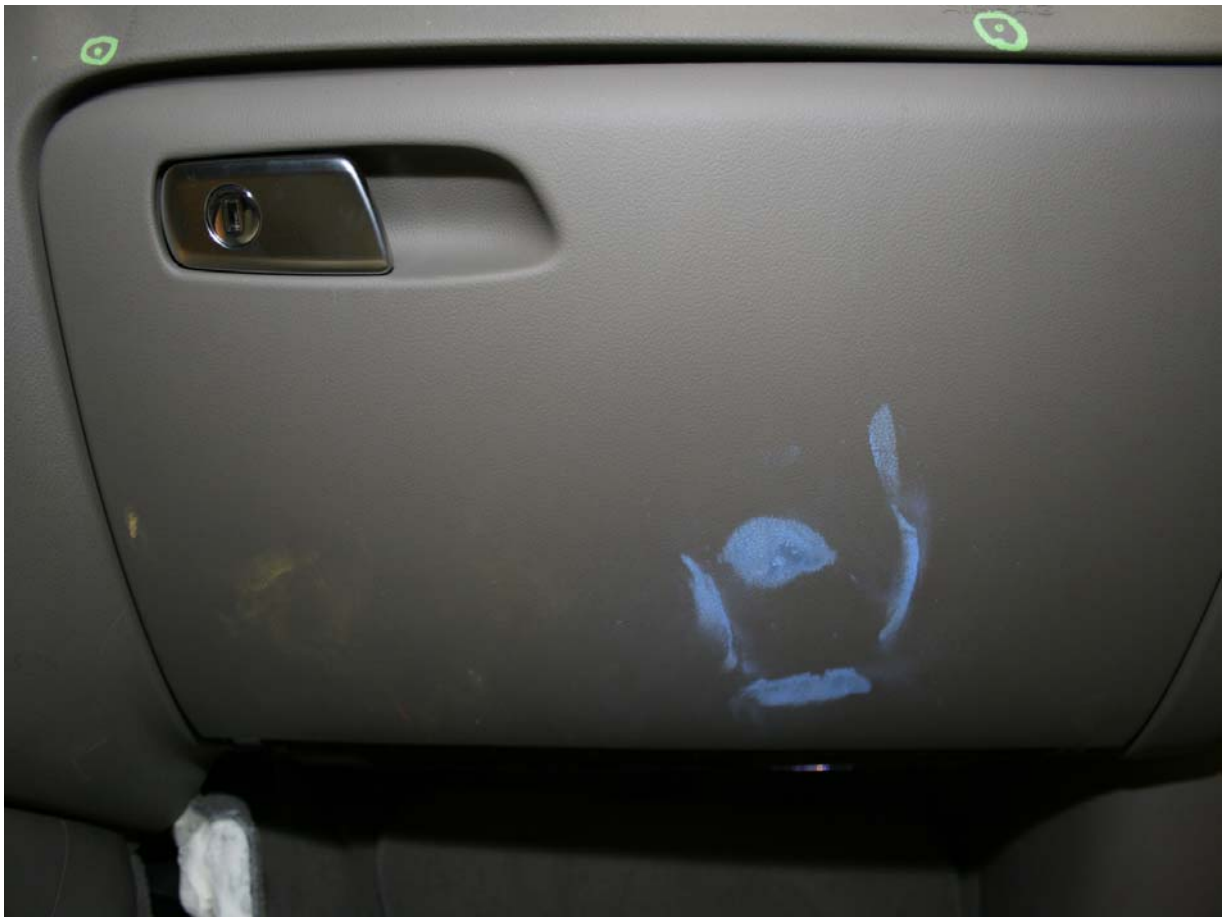
Post-Test Passenger Dummy Knee Contact
