**REPORT NUMBER: NCAPSIDE-MGA-2009-001**

**NEW CAR ASSESSMENT PROGRAM  
SIDE IMPACT TEST**

**AUDI AG  
2009 AUDI A4 SEDAN  
NHTSA NUMBER: M95801**

**PREPARED BY:  
MGA RESEARCH CORPORATION  
5000 WARREN ROAD  
BURLINGTON, WI 53105**

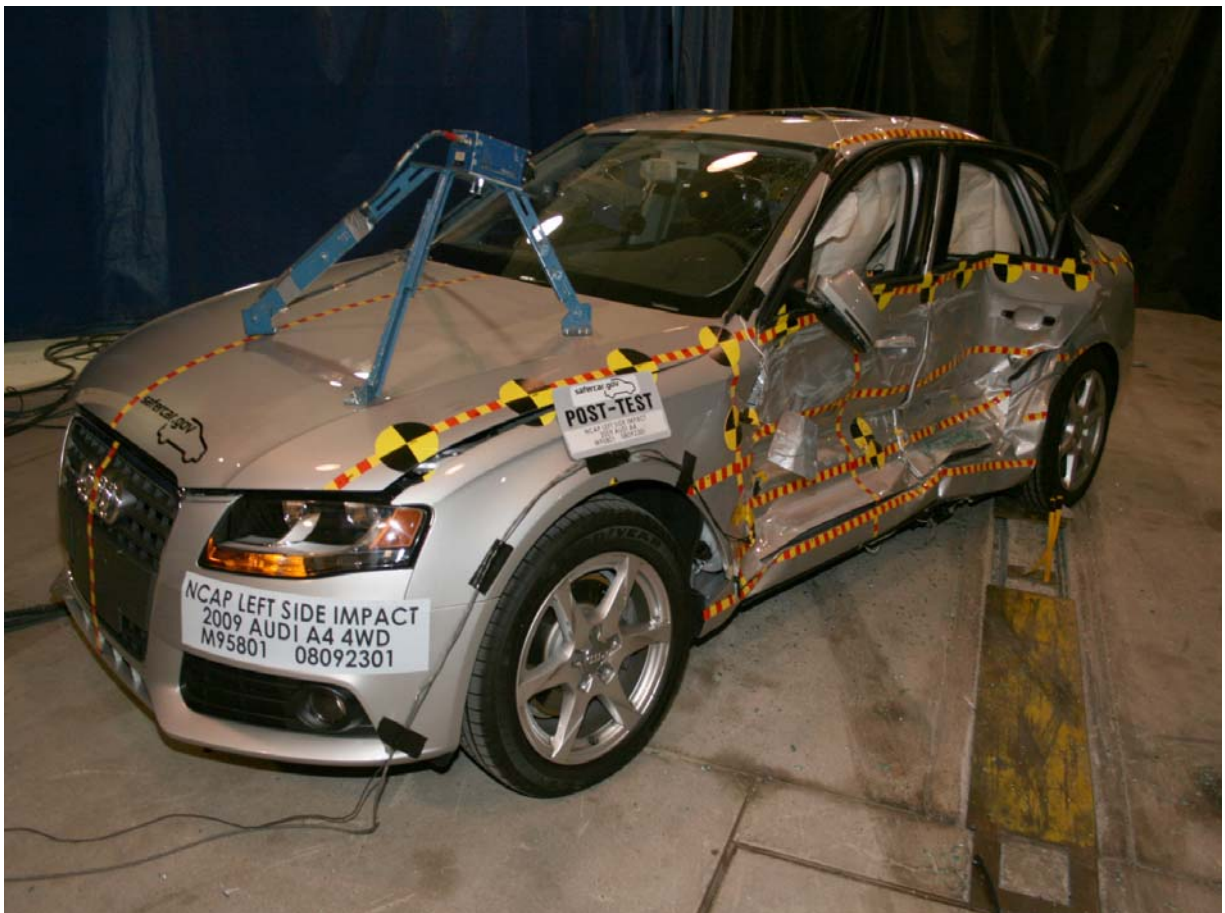
Post-Test Left Front  $\frac{3}{4}$  View

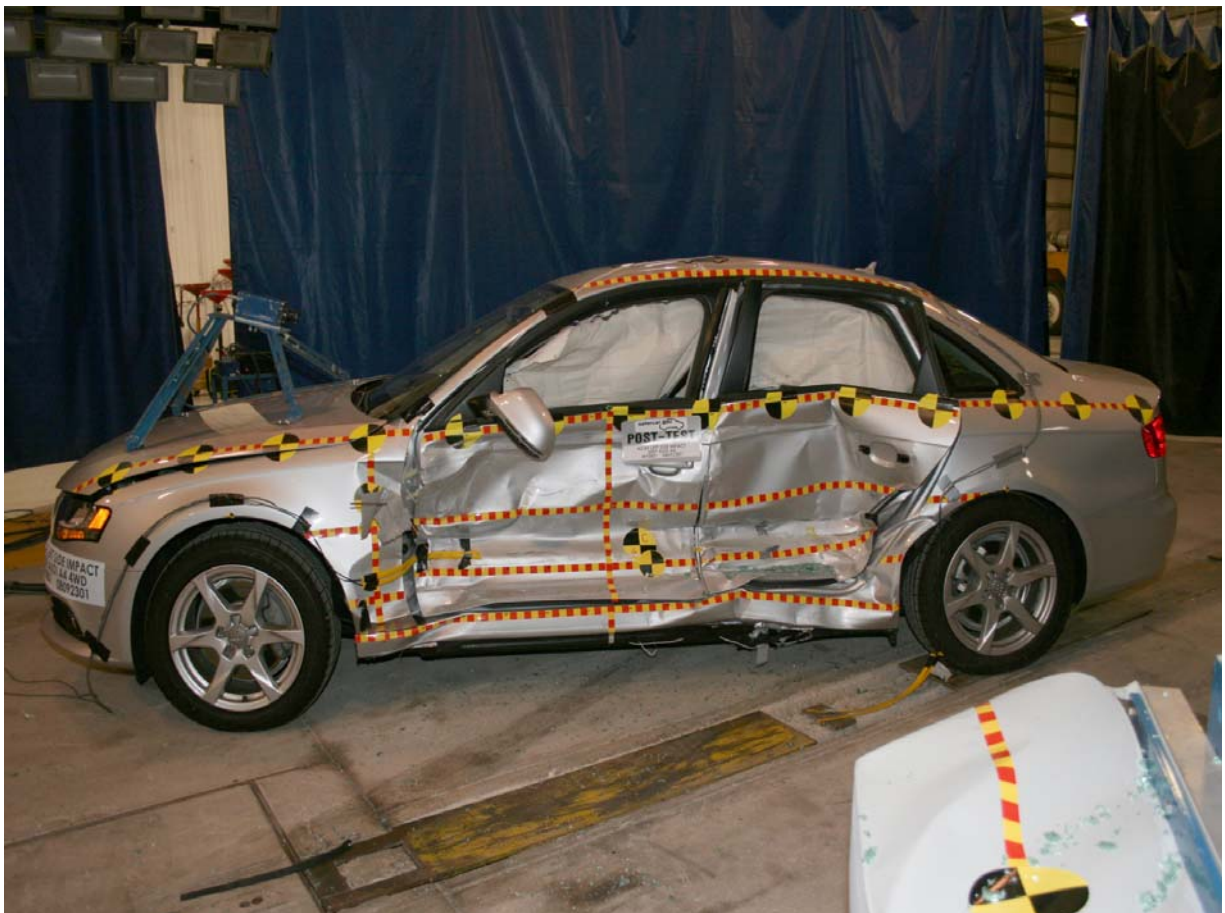
Post-Test Left Side View

The left rear passenger door separated from the body at the latch, but was measured to be less than 2 inches.

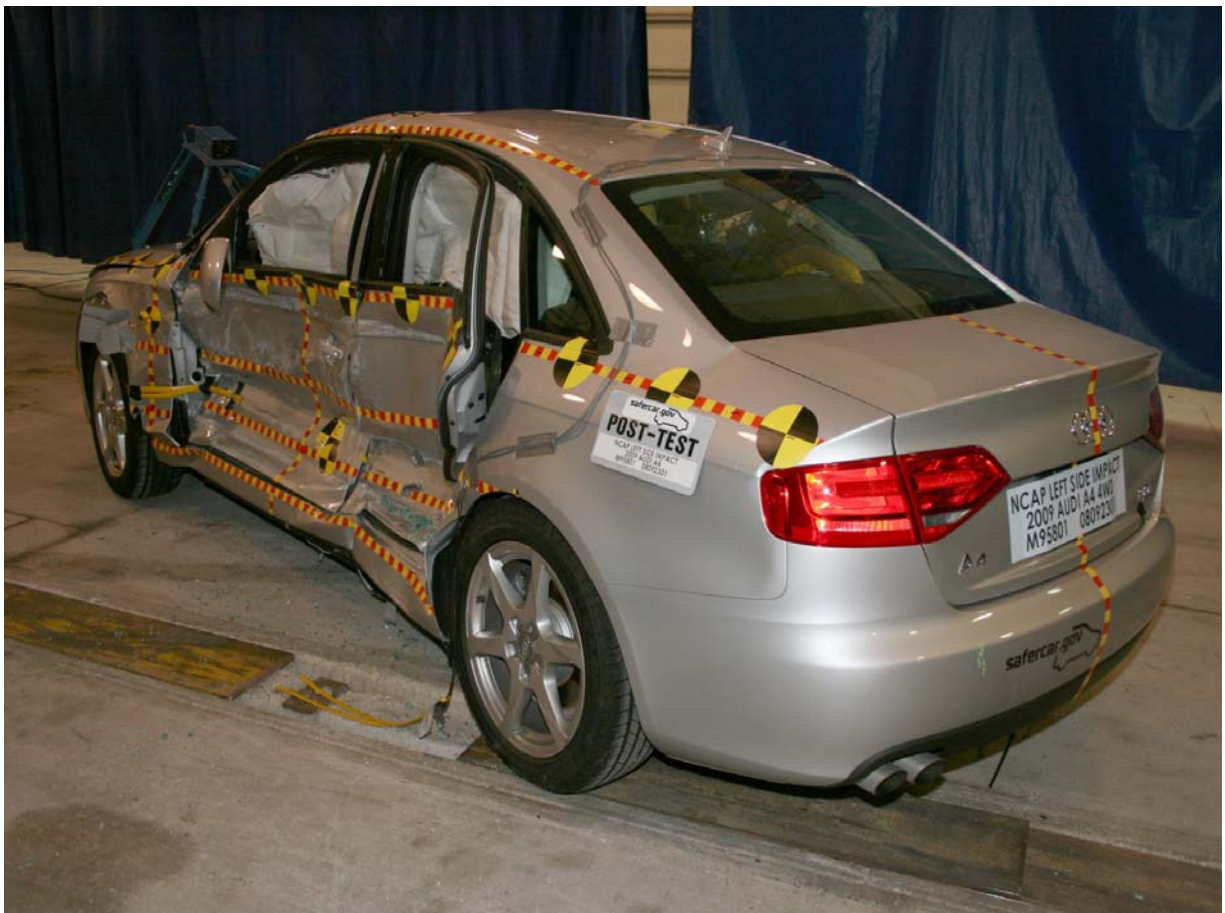
Post-Test Left Rear  $\frac{3}{4}$  View

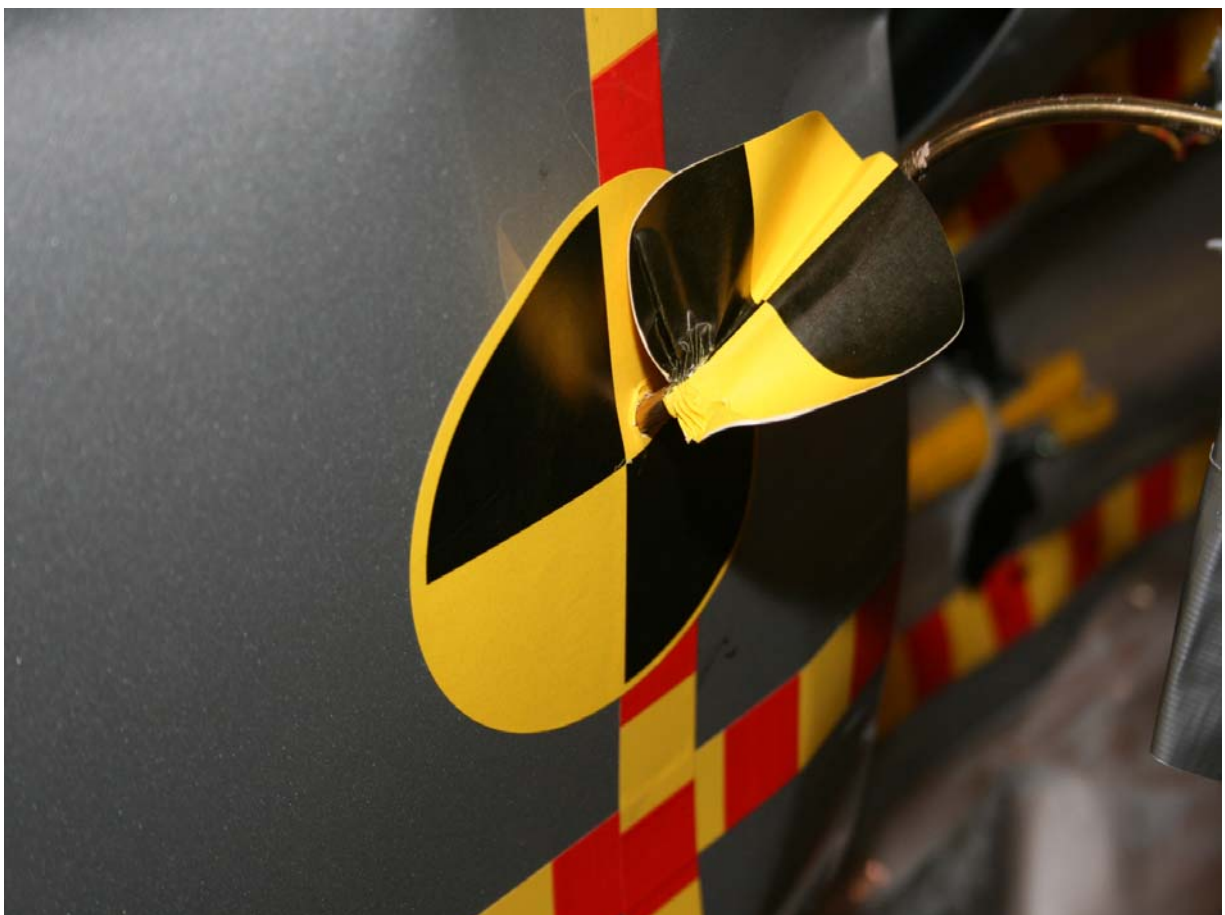
Post-Test Left Impact Point

The test vehicle sustained a maximum static crush of 286 mm at level 3, 1650 mm rearward of the vertical impact point. The driver and passenger SID/HIIIs, Serial Nos. 272 and 271 respectively, were calibrated just prior to this test.

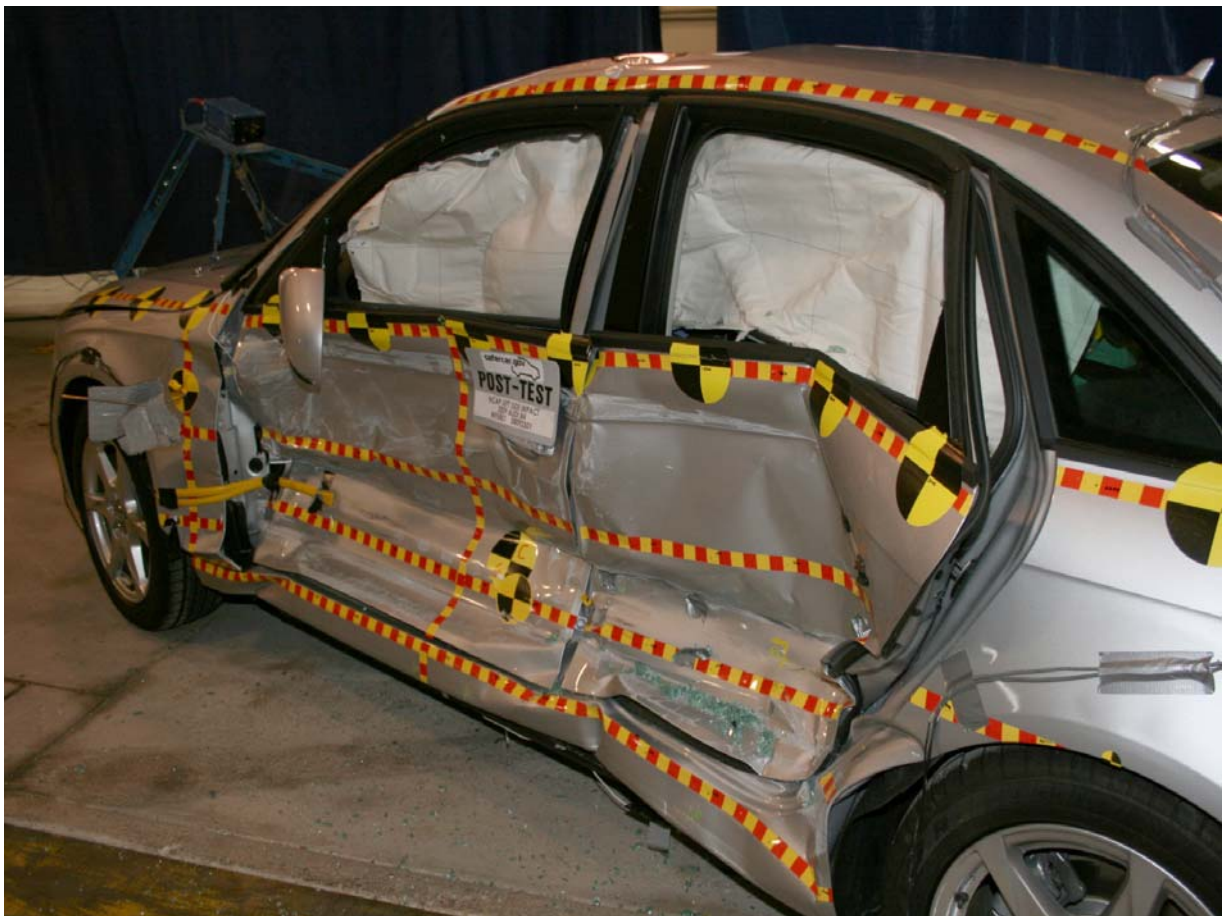
Post-Test Rear  $\frac{3}{4}$  View of Left Side Doors

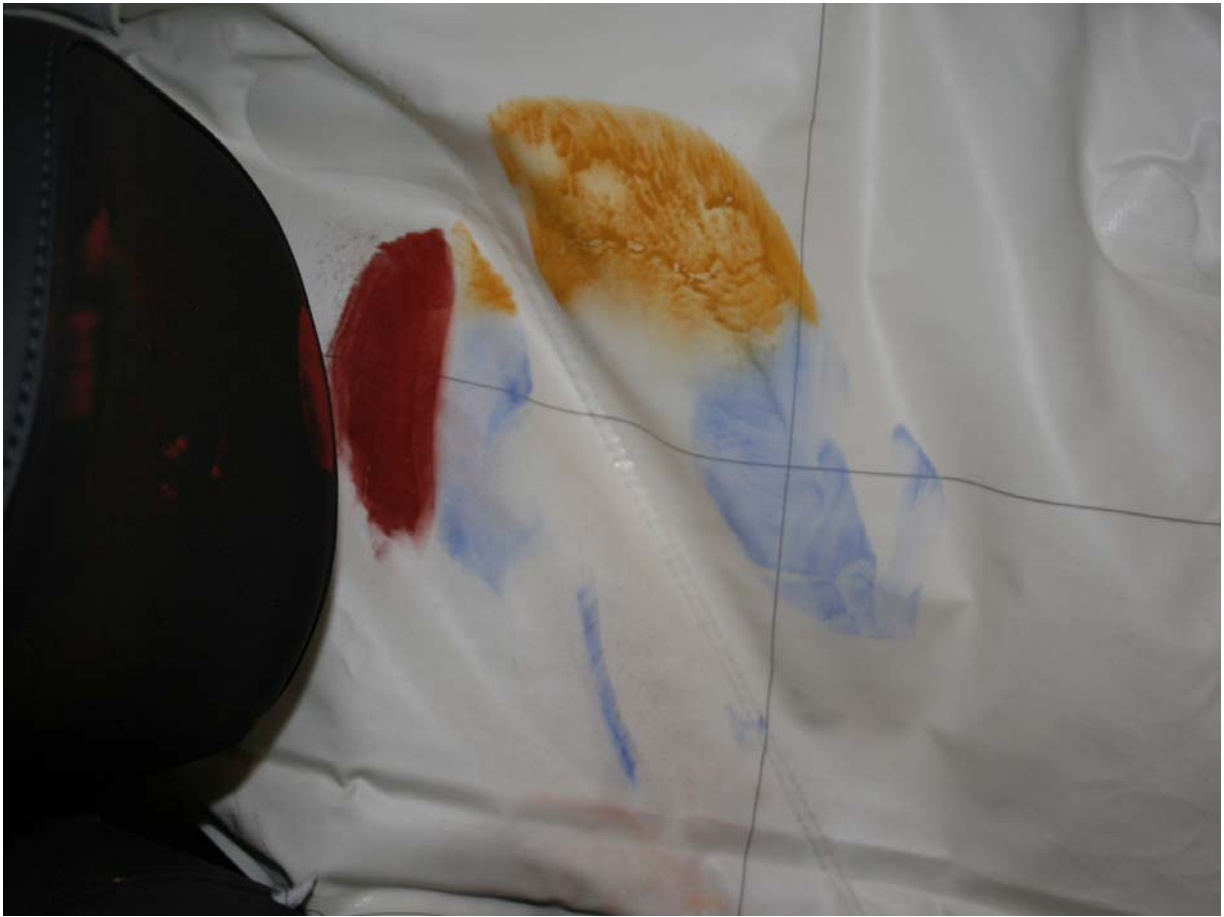
Post-Test Driver Dummy Head Contact

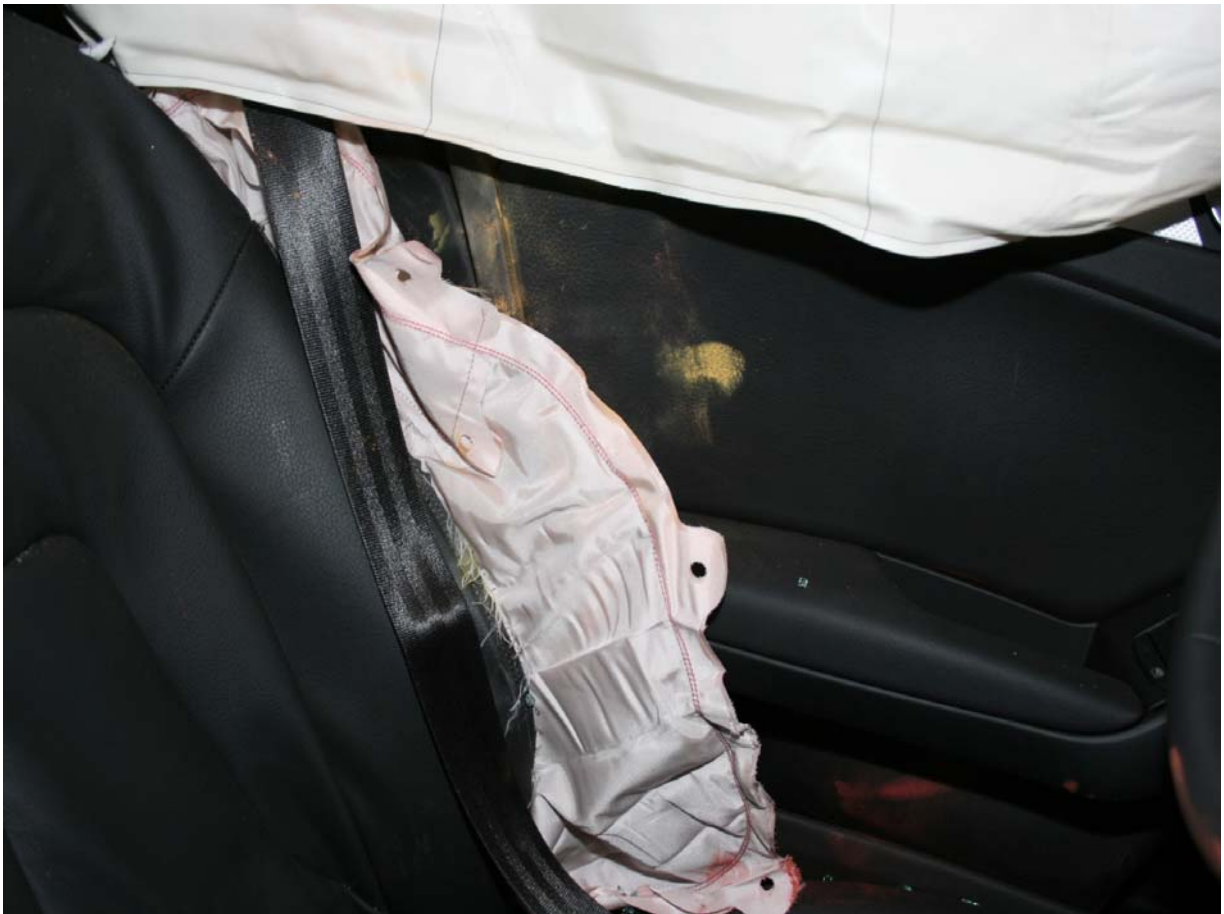
Post-Test Driver Dummy Upper Torso Contact

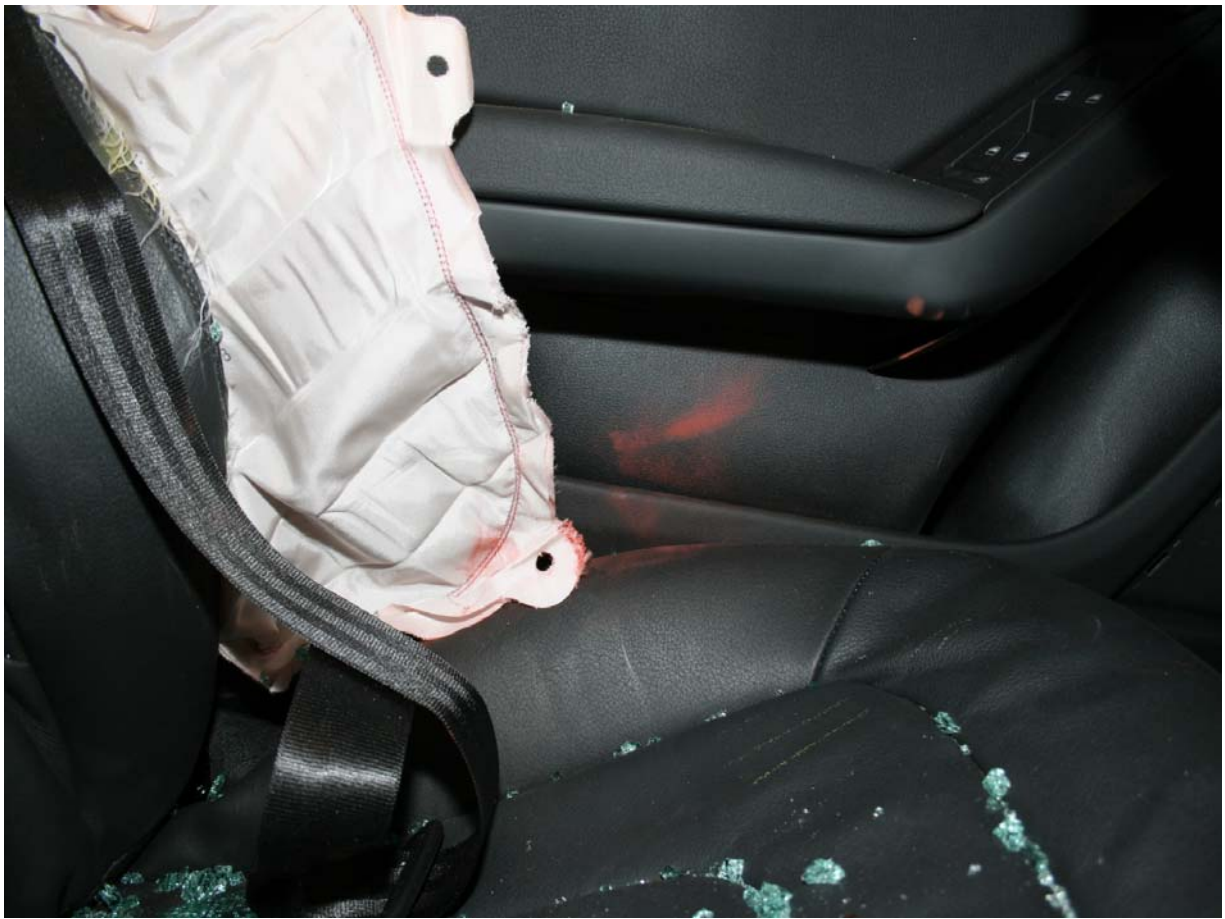
Post-Test Driver Dummy Lower Torso Contact

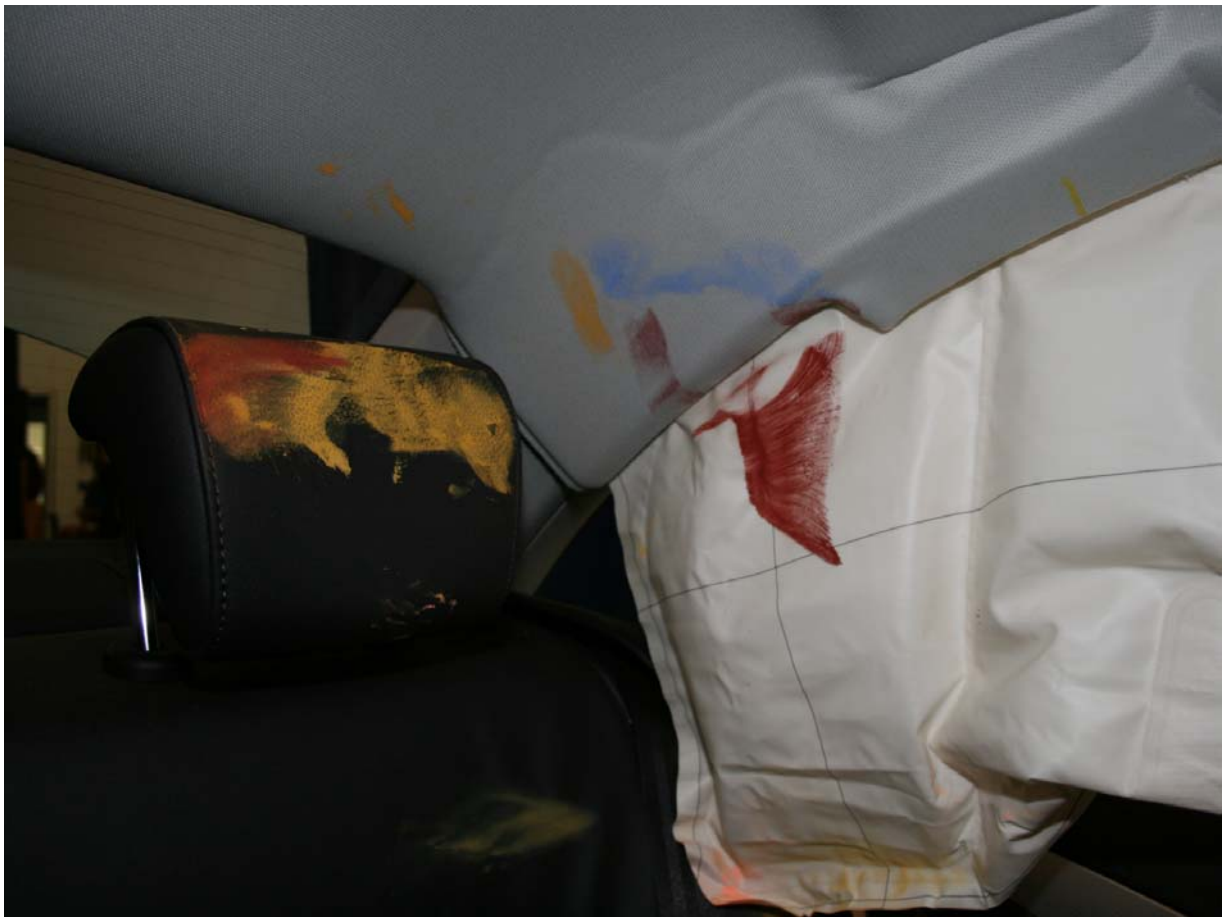
Post-Test Passenger Dummy Head Contact
