**REPORT NUMBER: NCAP-MGA-2009-002**

**NEW CAR ASSESSMENT PROGRAM  
FRONTAL BARRIER IMPACT TEST**

**CHRYSLER LLC  
2009 DODGE CHALLENGER SE 2-DOOR SEDAN  
NHTSA NUMBER: M90303**

**PREPARED BY:  
MGA RESEARCH CORPORATION  
5000 WARREN ROAD  
BURLINGTON, WI 53105**

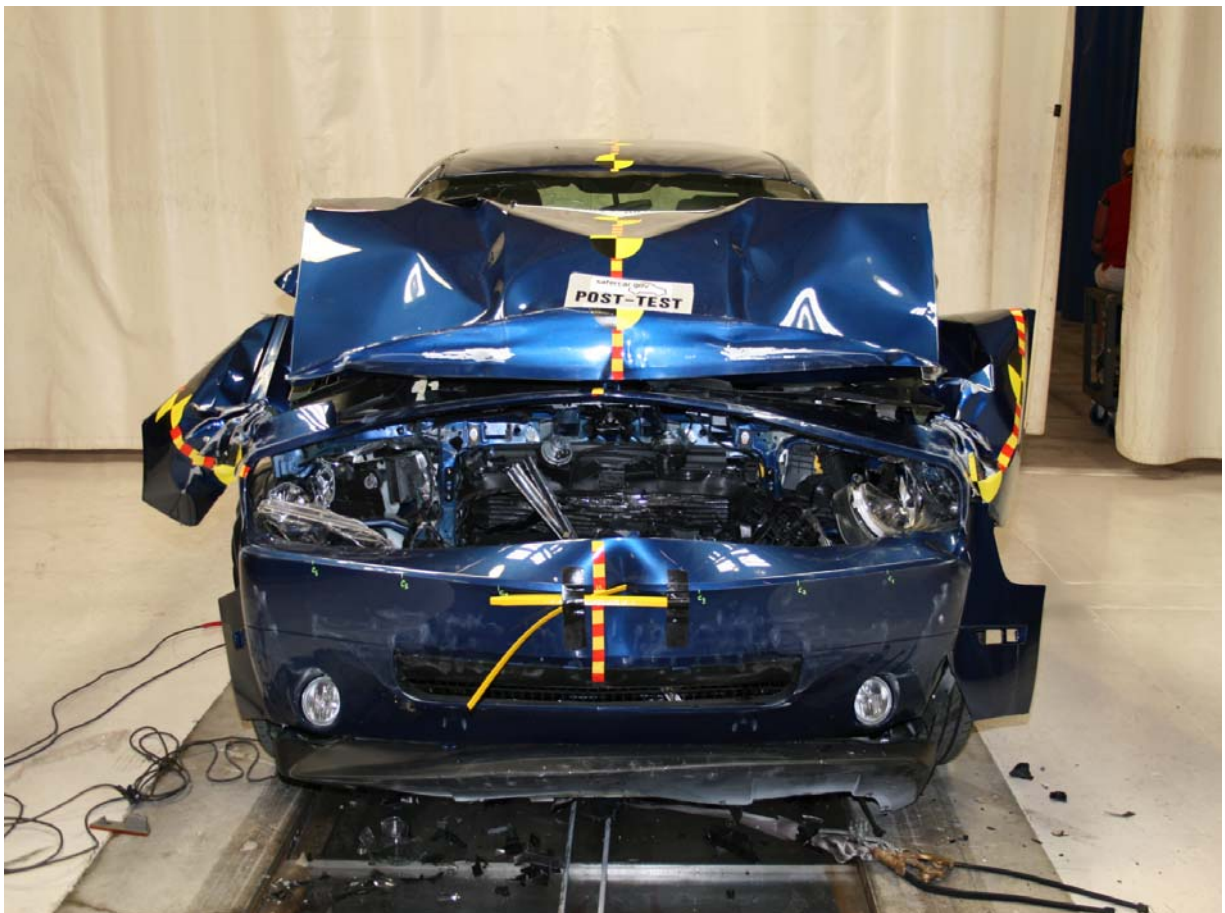
Post-Test Front View

The maximum static crush of the vehicle was 632 mm and both the driver and passenger side doors remained closed and latched during the impact event and were operable after the impact.

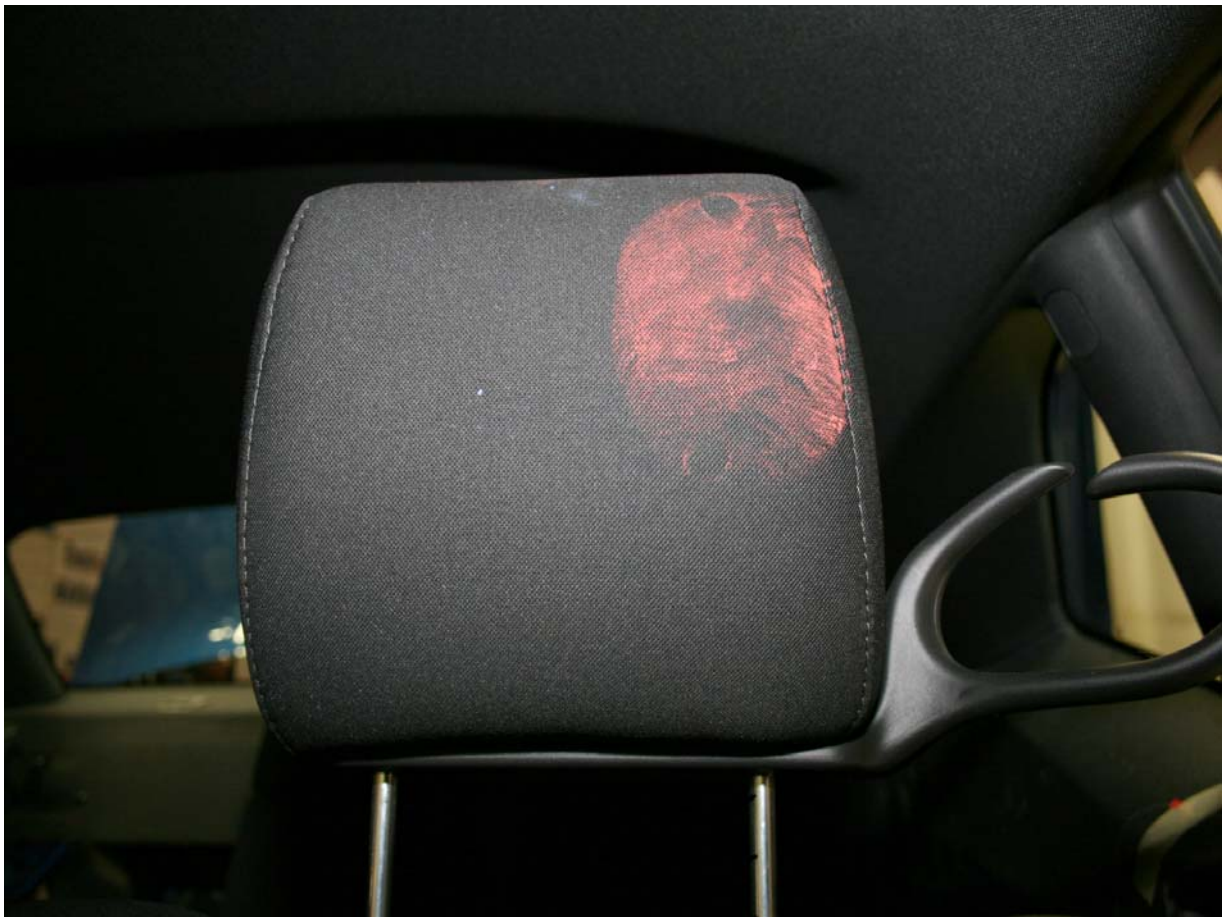
Post-Test Driver Dummy Head Contact

The driver's head and chest contacted the airbag. The driver's head also contacted the headrest. The driver's knees contacted the knee bolster. The passenger's head and chest contacted the airbag. The passenger's head also contacted the headrest. The passenger's knees contacted the glove box.

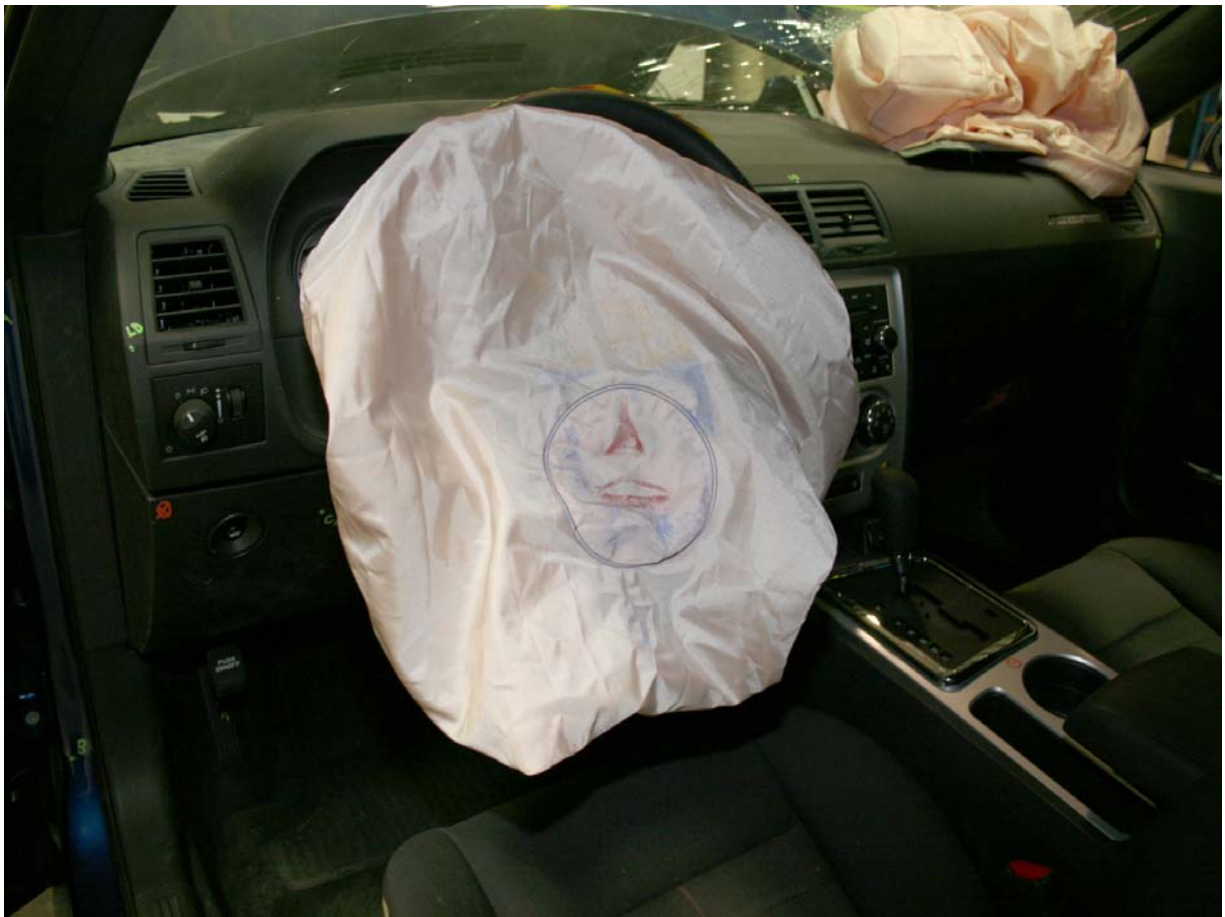
Post-Test Driver Dummy Airbag Contact

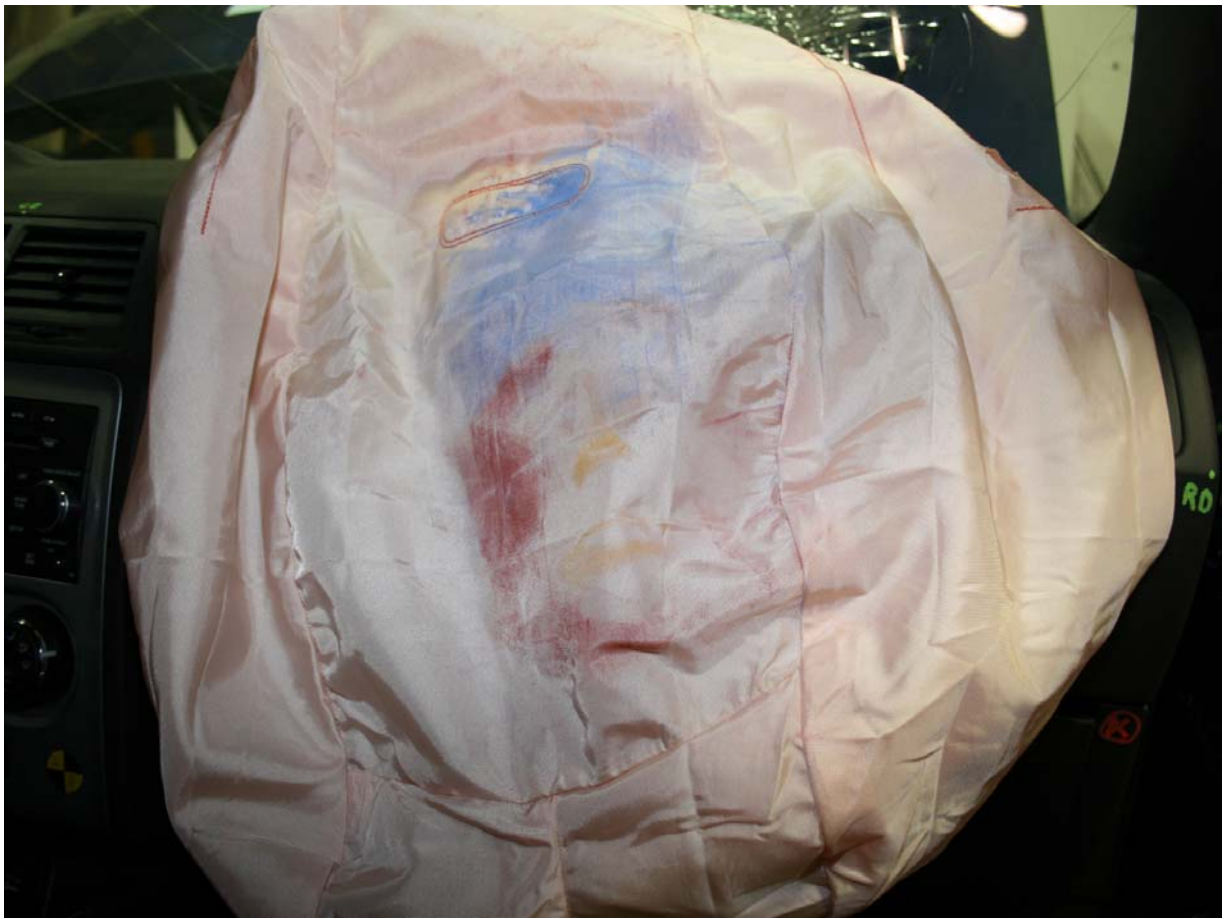
Post-Test Passenger Dummy Airbag Contact
