**REPORT NUMBER: MCW-DOT-09SN02**

**NEW CAR ASSESSMENT PROGRAM  
SIDE IMPACT TEST**

**2009 TOYOTA YARIS 3-DOOR LIFTBACK**

**FINAL REPORT**

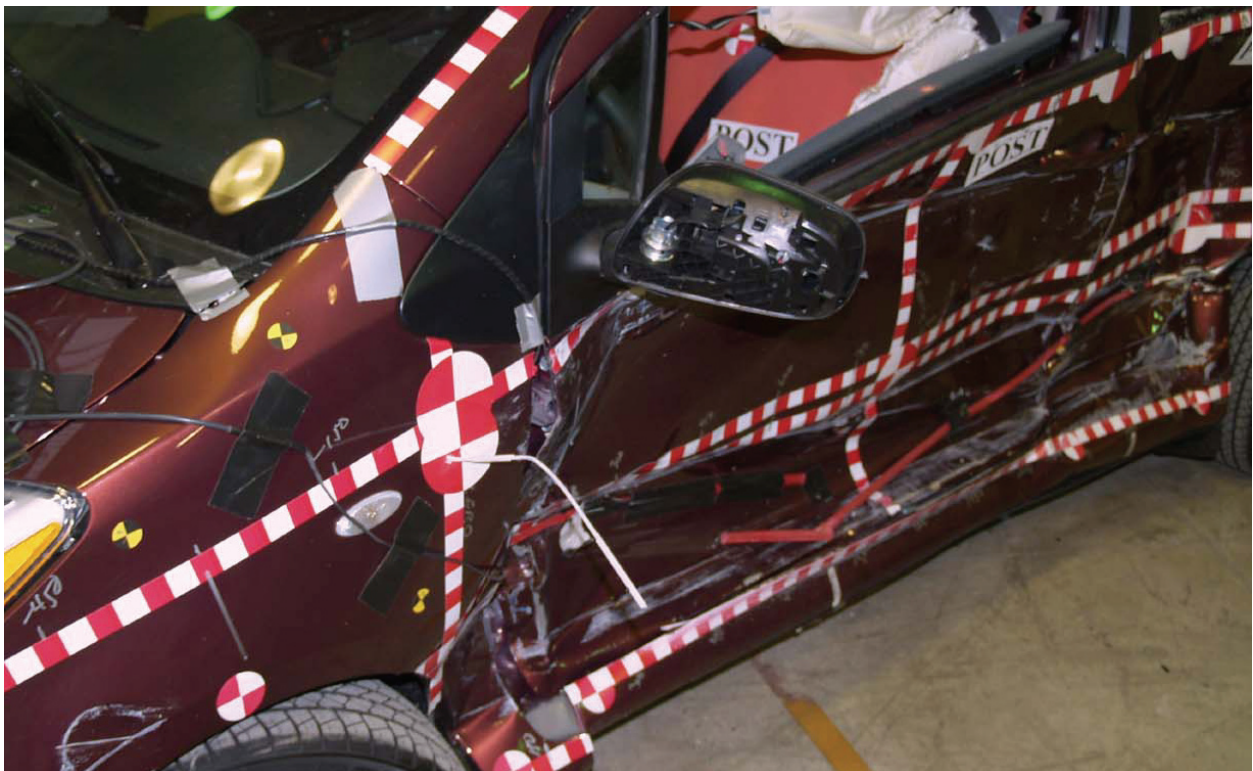
Figure A-28: Post test front 3/4 view of left side door

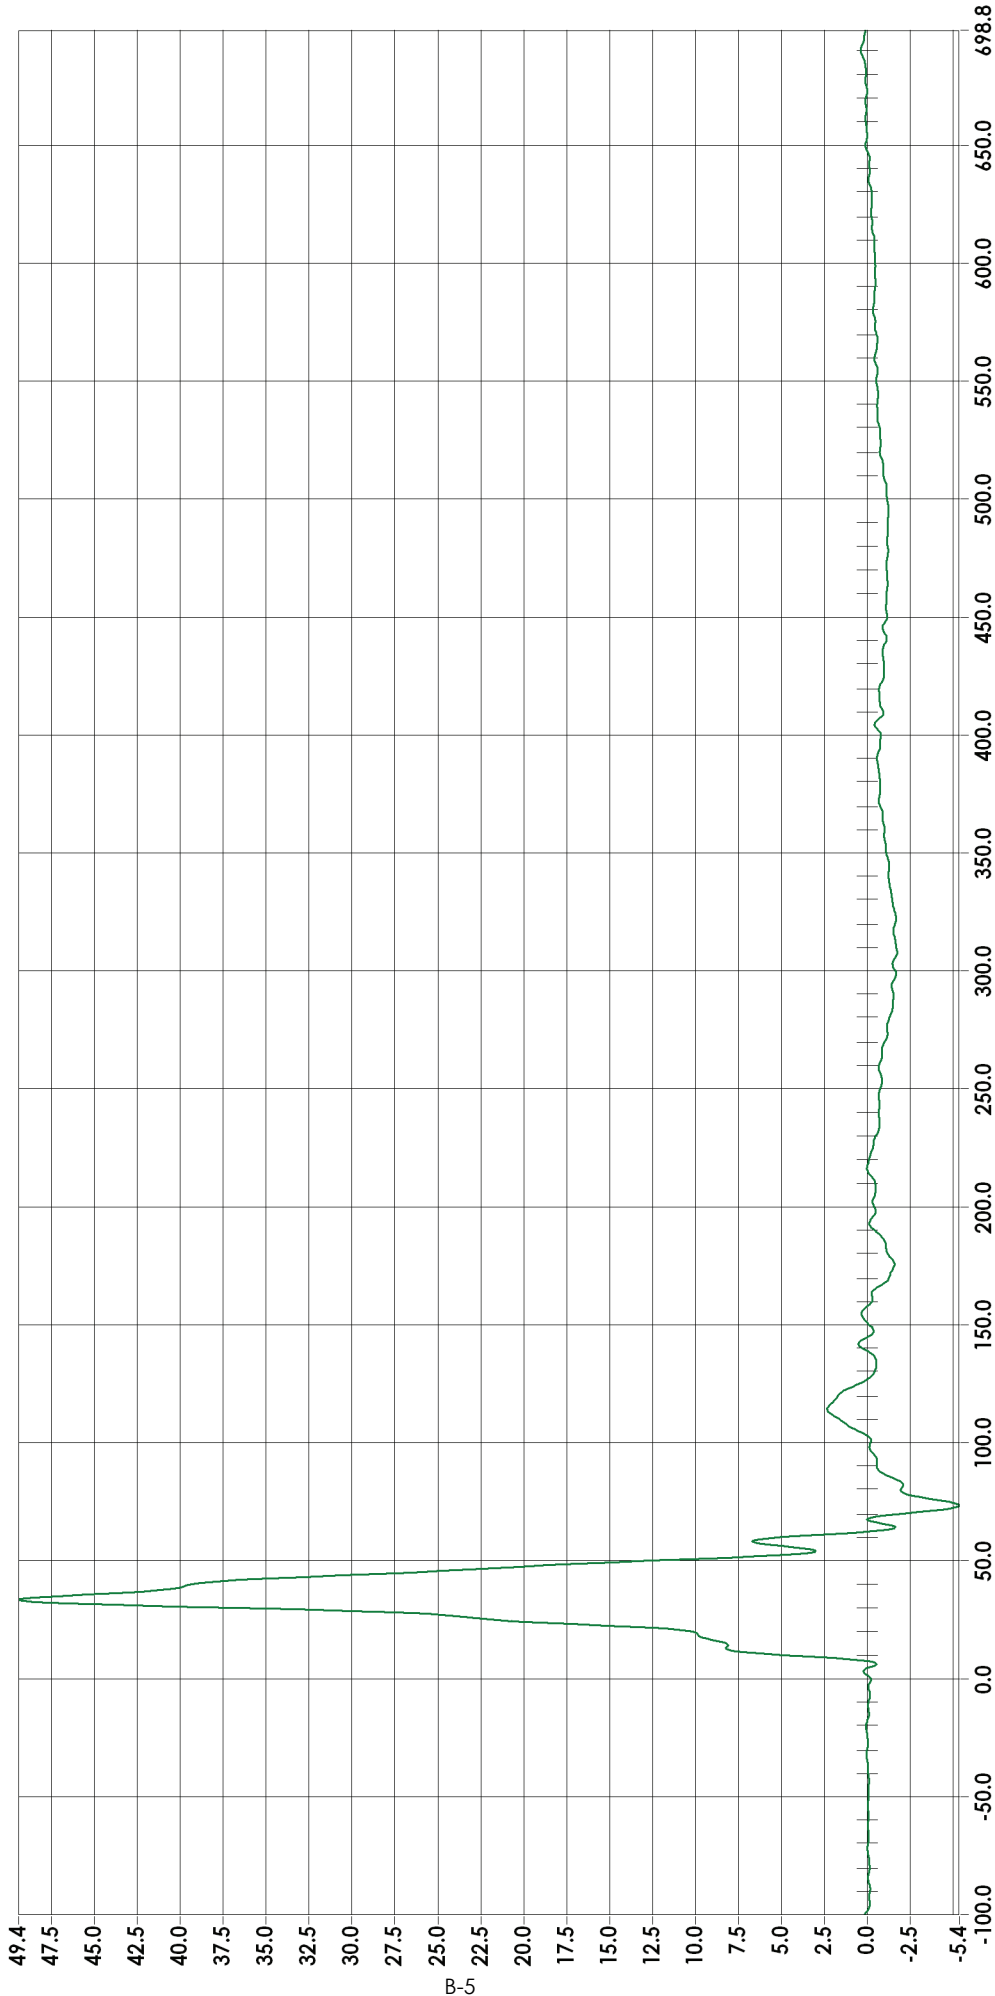
Driver lower rib acceleration (P) - FIR100 YL

| Max | 49.39 | G's | at | 33.12 | msec |
| Min | -5.35 | G's | at | 73.12 | msec |

<table><tr> <th></th> <th><u>Units</u></th> <th><u>DRIVER</u></th> <th><u>PASS.</u></th> </tr><tr> <td>Left lower rib (LLR) acceleration</td> <td>G</td> <td>49.5</td> <td>86.6</td> </tr></table>

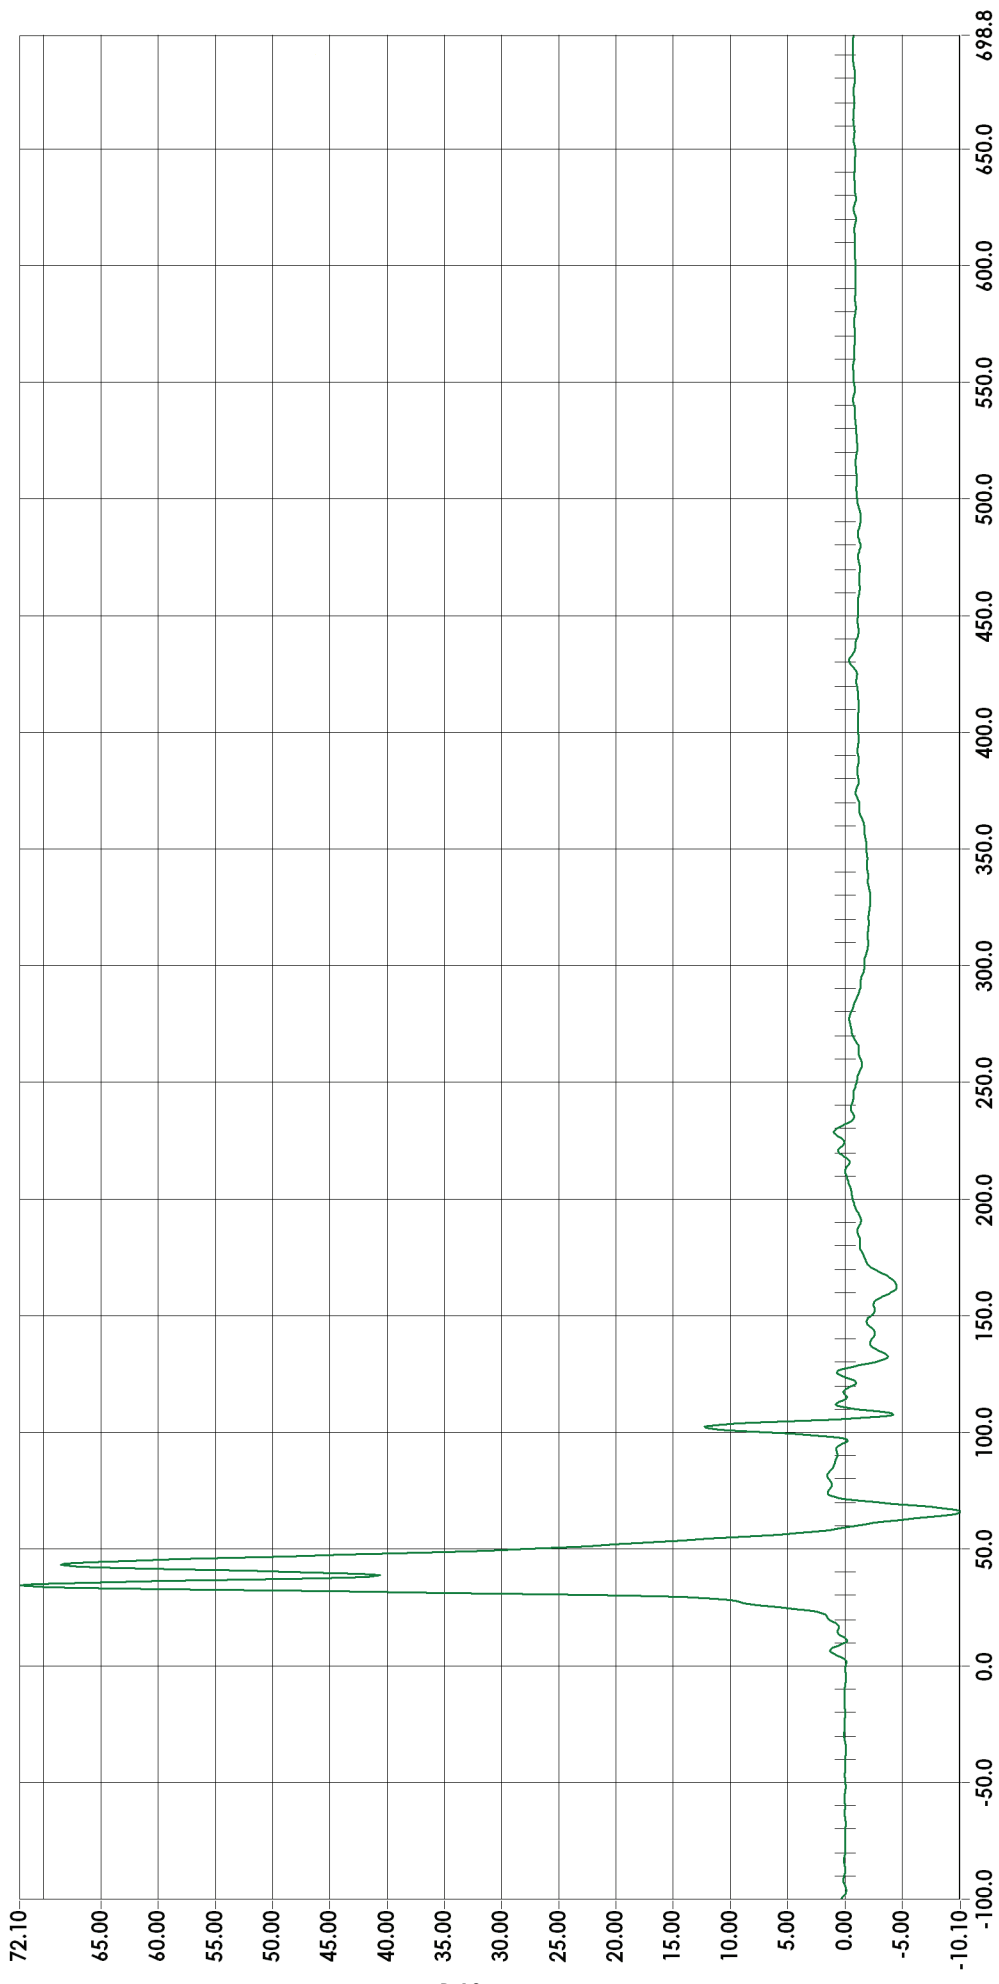
Passenger lower spine acceleration (P) - FIR100 YL

| Max | 72.10 | G's | at | 34.38 | msec |

<table><tr> <th></th> <th><u>Units</u></th> <th><u>DRIVER</u></th> <th><u>PASS.</u></th> </tr><tr> <td>Lower spine (T<sub>12</sub>) acceleration</td> <td>G</td> <td>52.0</td> <td>72.4</td> </tr></table>
