REPORT NUMBER: CAL-09-01A

**NEW CAR ASSESSMENT PROGRAM (NCAP)  
FRONTAL BARRIER IMPACT TEST**

FORD MOTOR COMPANY  
2009 LINCOLN MKS  
4-DOOR SEDAN

FINAL REPORT

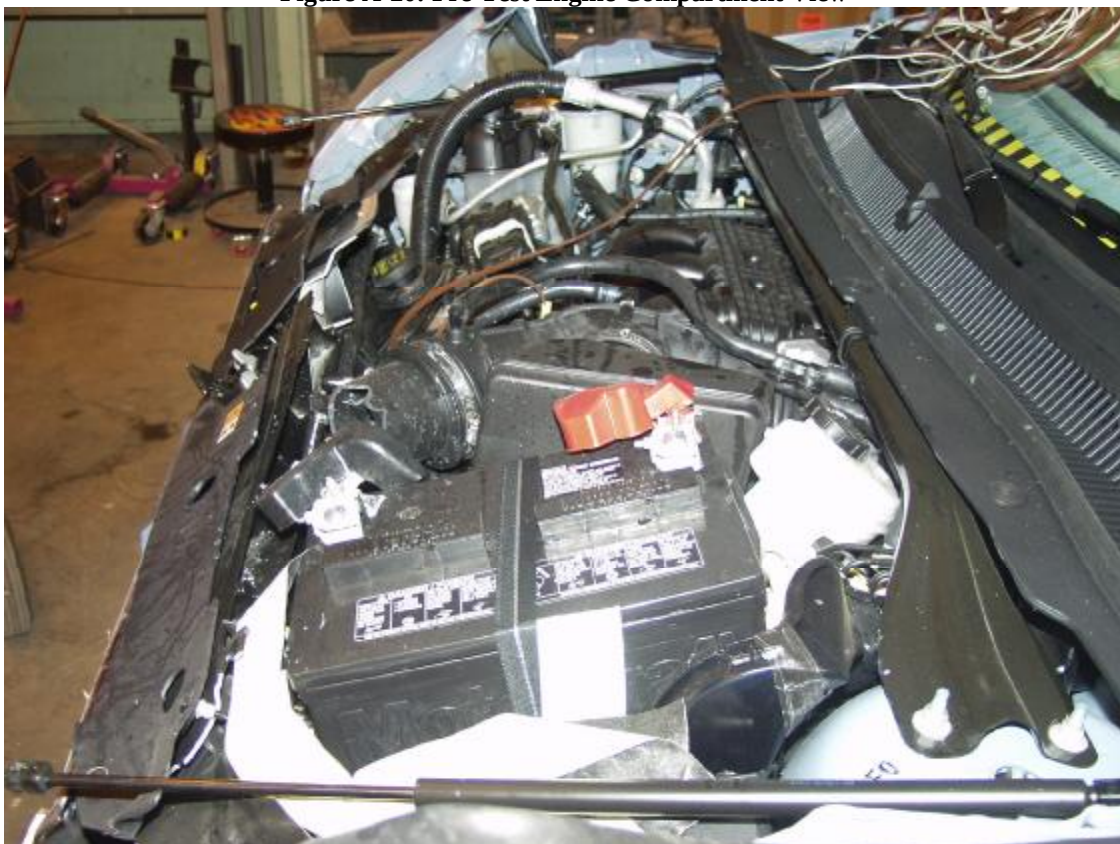
**Figure A-21: Post-Test Engine Compartment View**

| TEST NOTES | |
|---|---|
| V1 Engine Bottom #4x | Cut sensor cable after 54 msec |

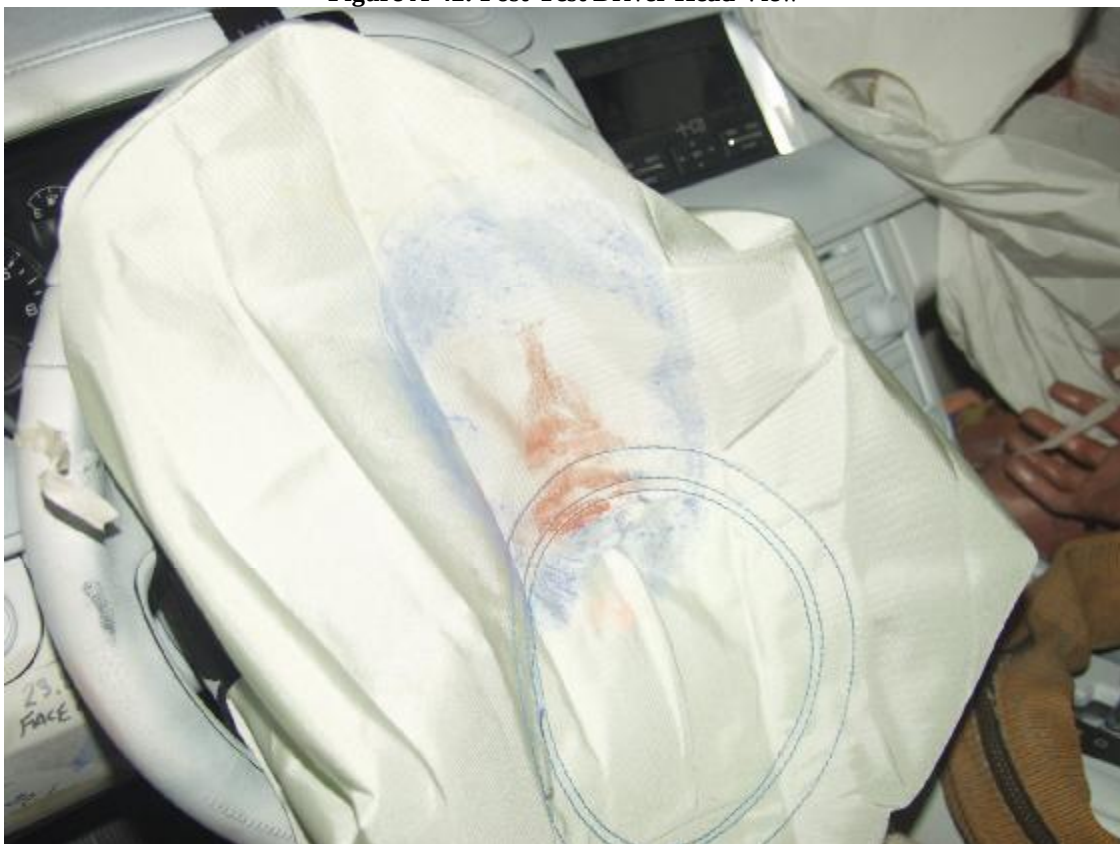
**Figure A-43: Post-Test Driver Contact to Airbag**

| | DRIVER | PASSENGER |
|---|---|---|
| Head Contact: | Airbag, Back of head to head restraint | Airbag, Top of head to sunvisor |
| Chest Contact: | Airbag | Airbag |

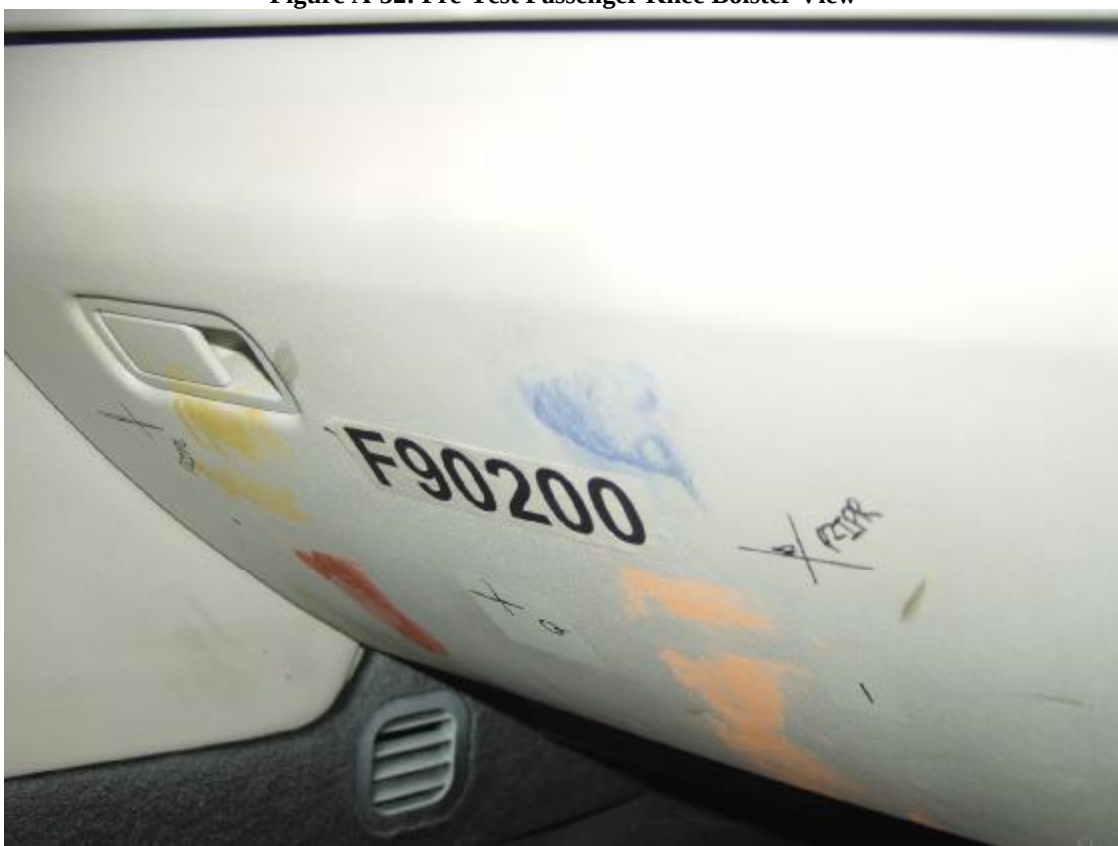
**Figure A-53: Post-Test Passenger Knee Bolster View**

| | DRIVER | PASSENGER |
|---|---|---|
| Left Knee Contact: | Knee Bolster | Glove Box |
| Right Knee Contact: | Knee Bolster | Glove Box |
