**REPORT NUMBER: NCAPSIDE-MGA-2009-002**

**NEW CAR ASSESSMENT PROGRAM  
SIDE IMPACT TEST**

**TOYOTA MOTOR CORPORATION  
2009 TOYOTA YARIS 4-DOOR SEDAN  
NHTSA NUMBER: M95108**

**PREPARED BY:  
MGA RESEARCH CORPORATION  
5000 WARREN ROAD  
BURLINGTON, WI 53105**

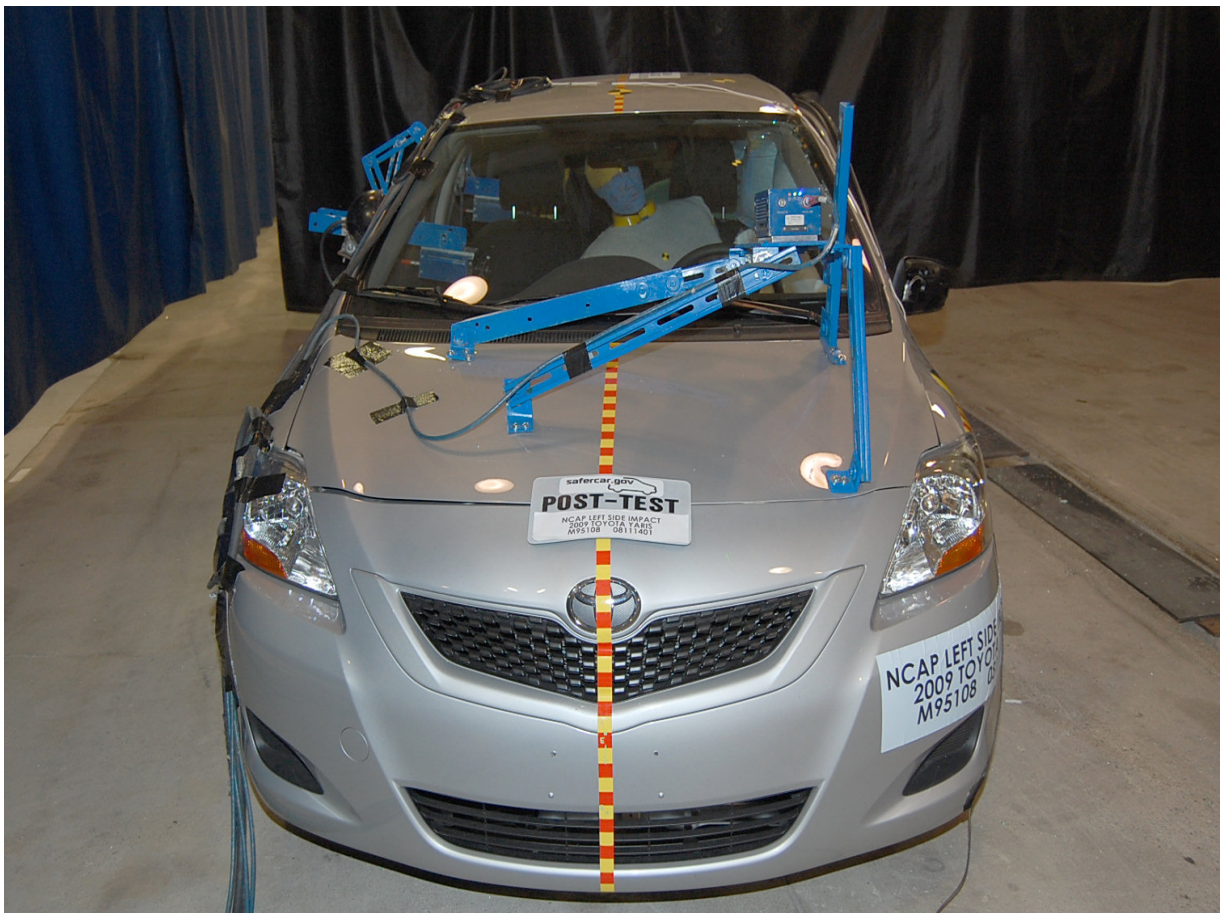
Post-Test Front View

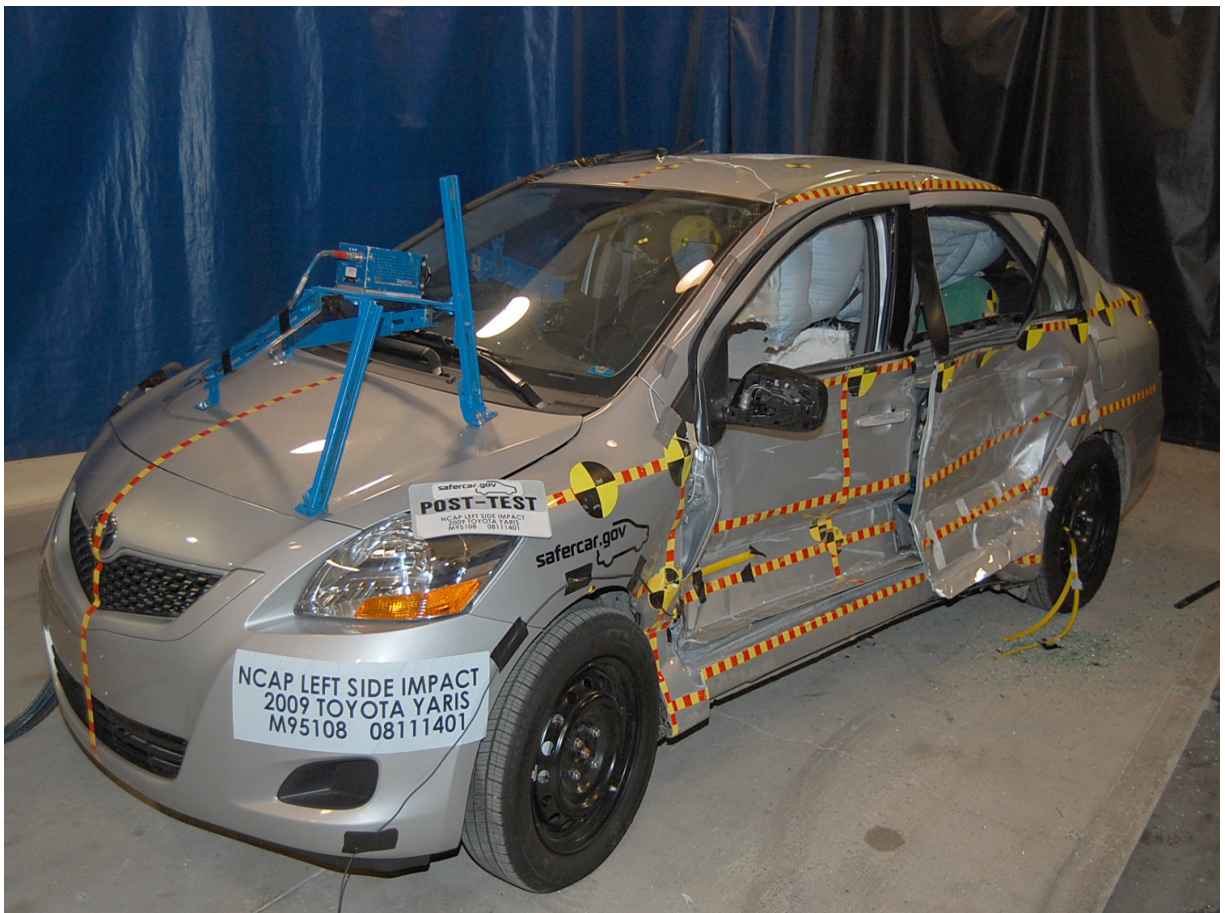
Post-Test Left Front  $\frac{3}{4}$  View

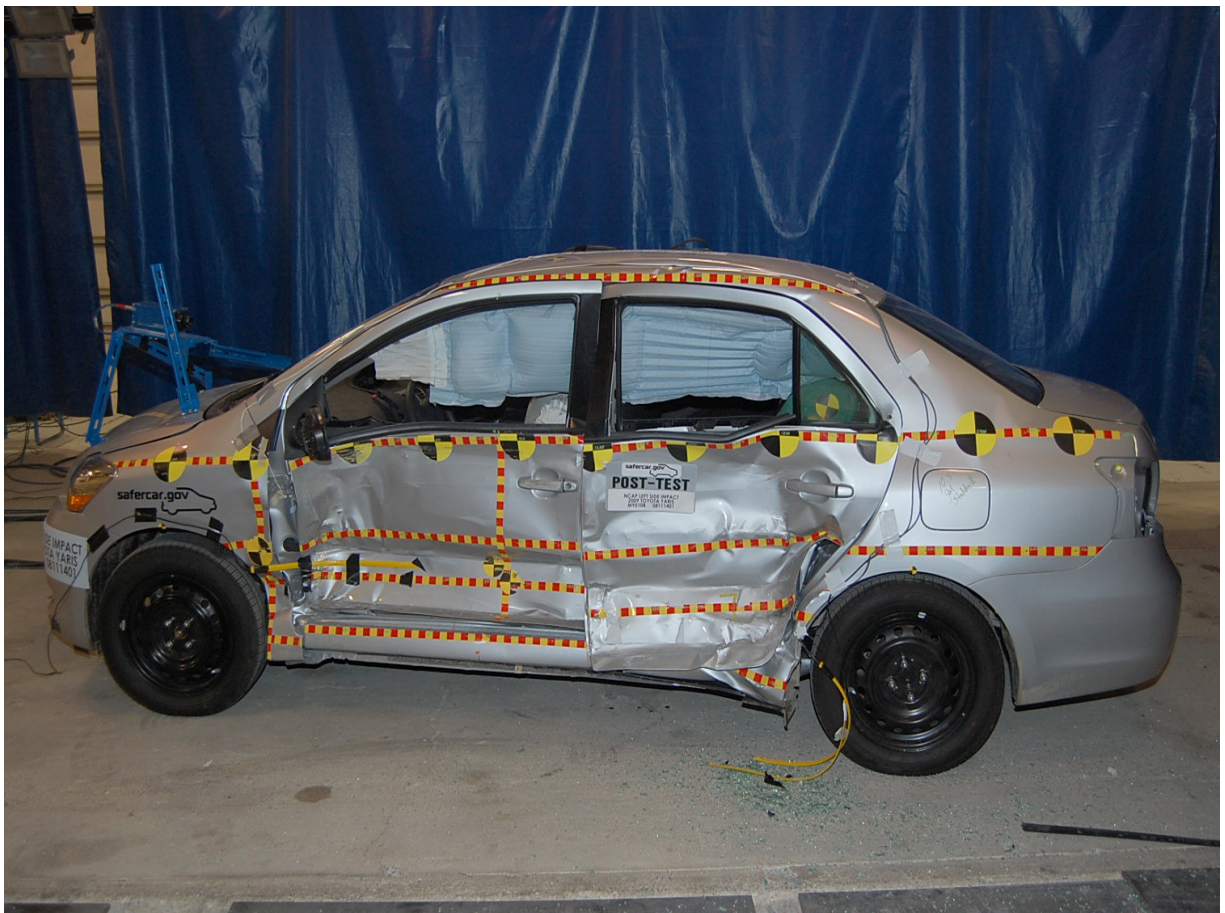
Post-Test Left Side View

The test vehicle sustained a maximum static crush of 242 mm at level 3, 300 mm rearward of the vertical impact point. The driver and passenger SID/HIIIs, Serial Nos. 272 and 271 respectively, were calibrated just prior to this test.

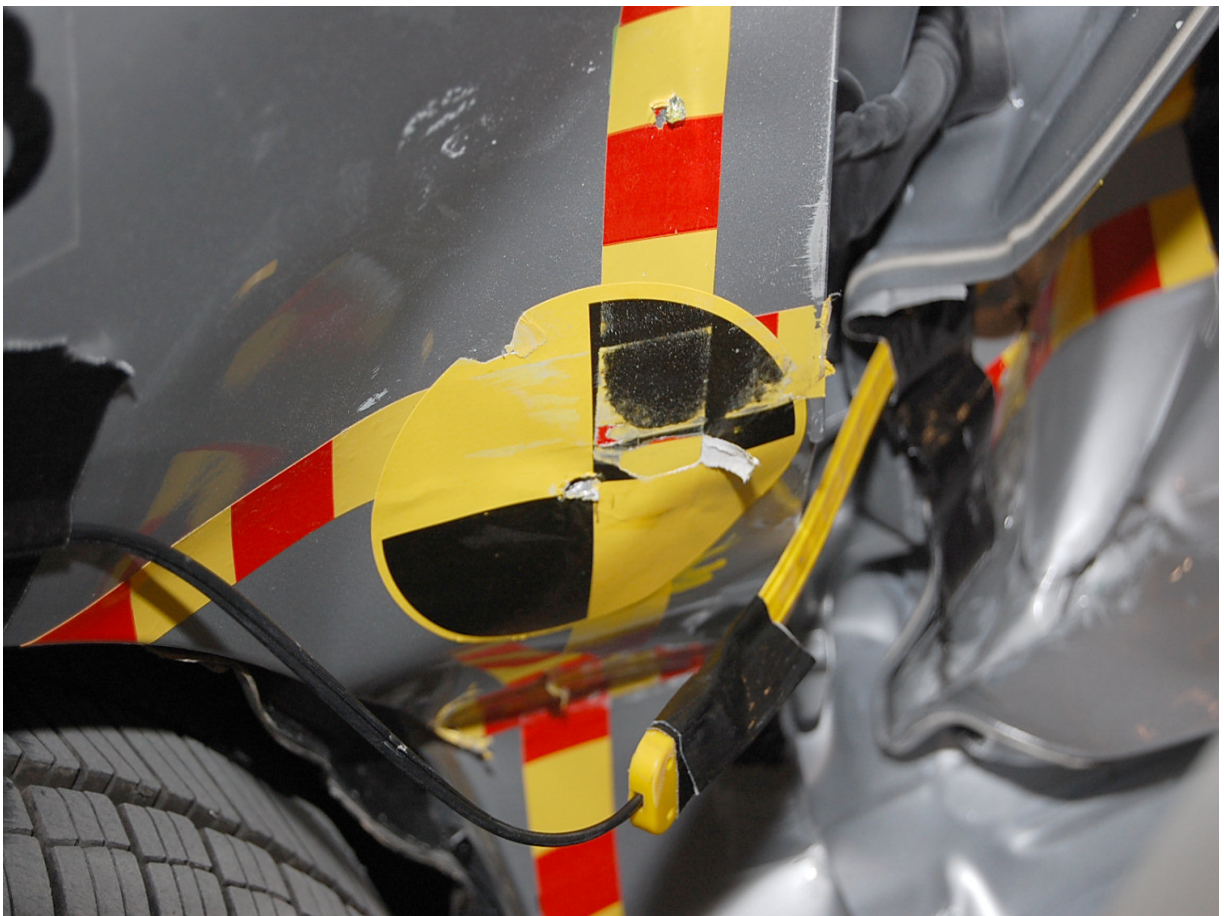
Post-Test Left Impact Point

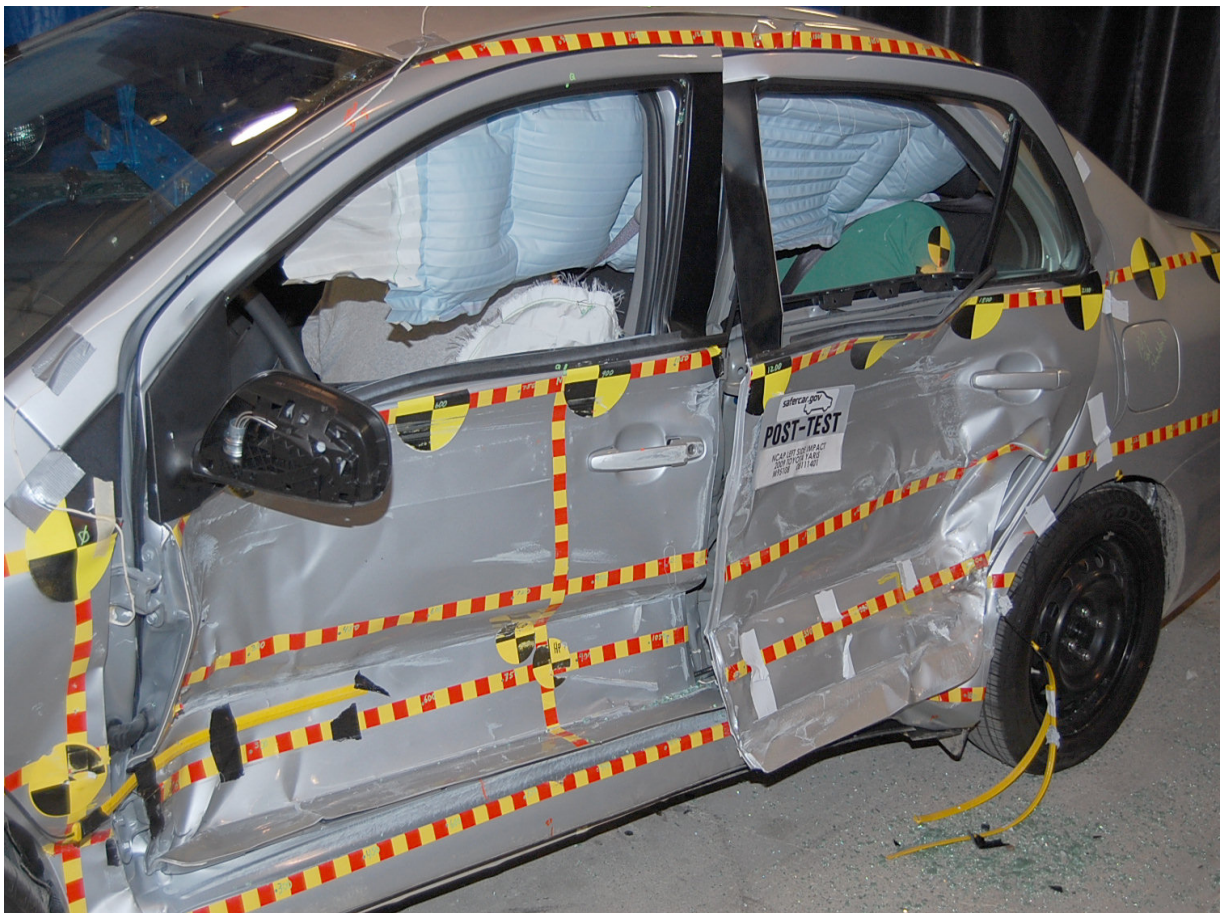
Post-Test Front  $\frac{3}{4}$  View of Left Side Doors

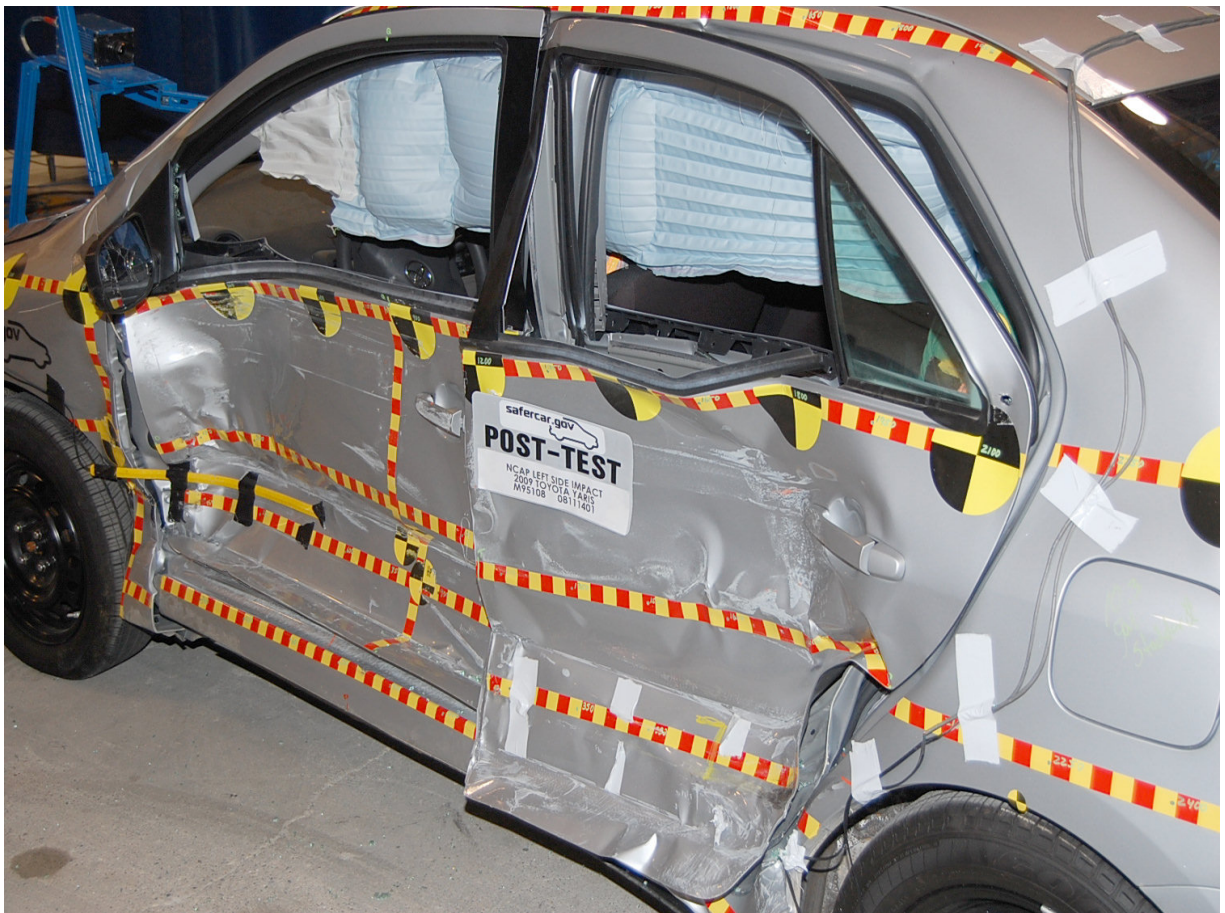
Post-Test Rear  $\frac{3}{4}$  View of Left Side Doors

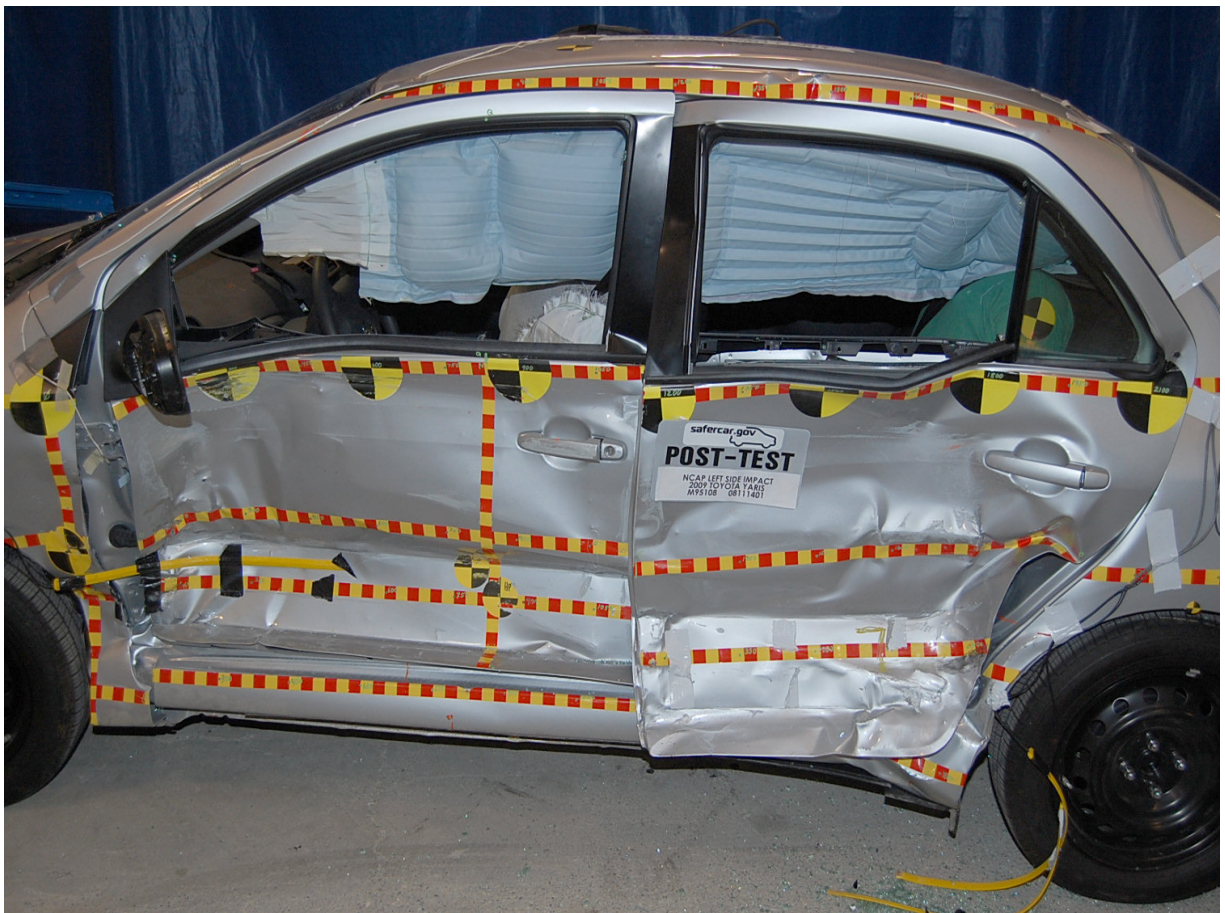
Post-Test Left Side Impact Close-up

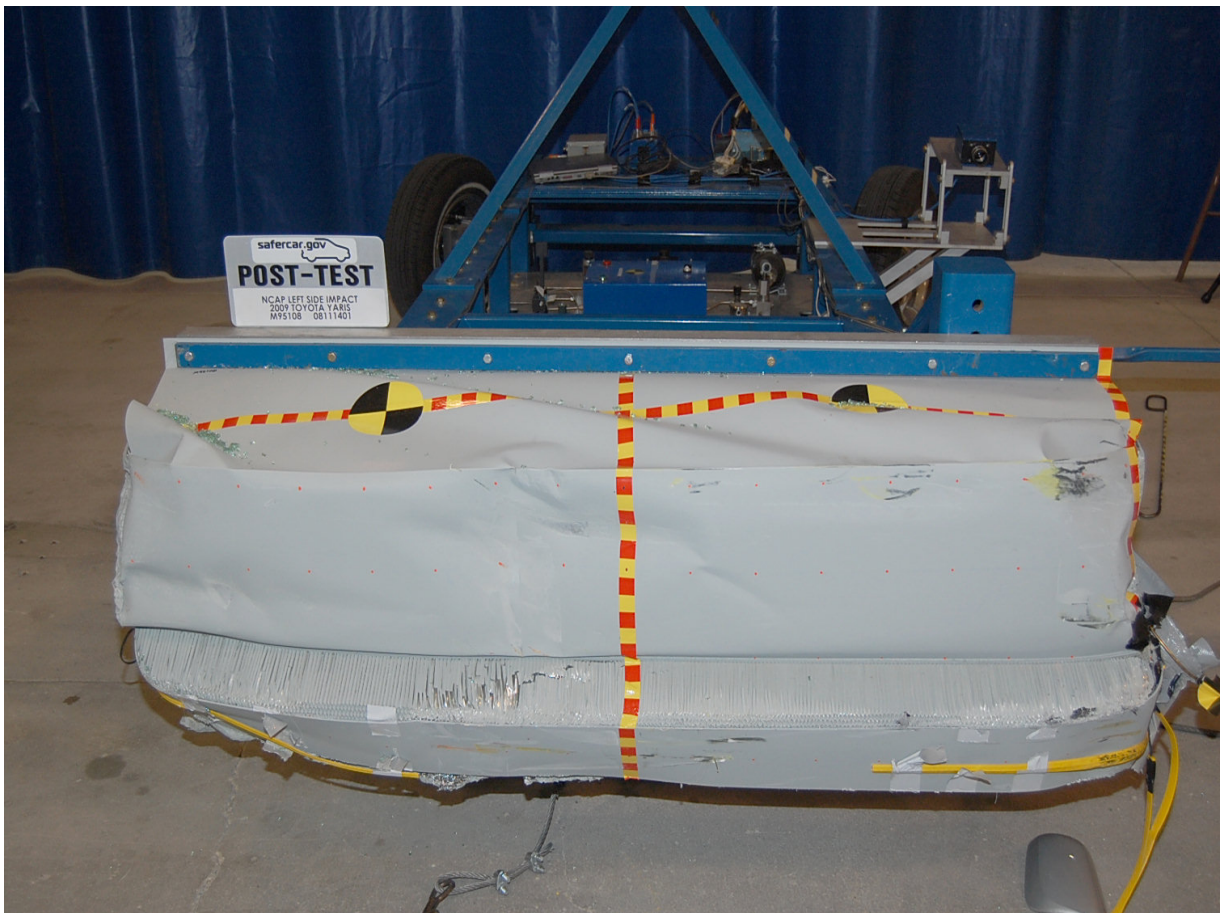
Post-Test Front View of Deformable Barrier

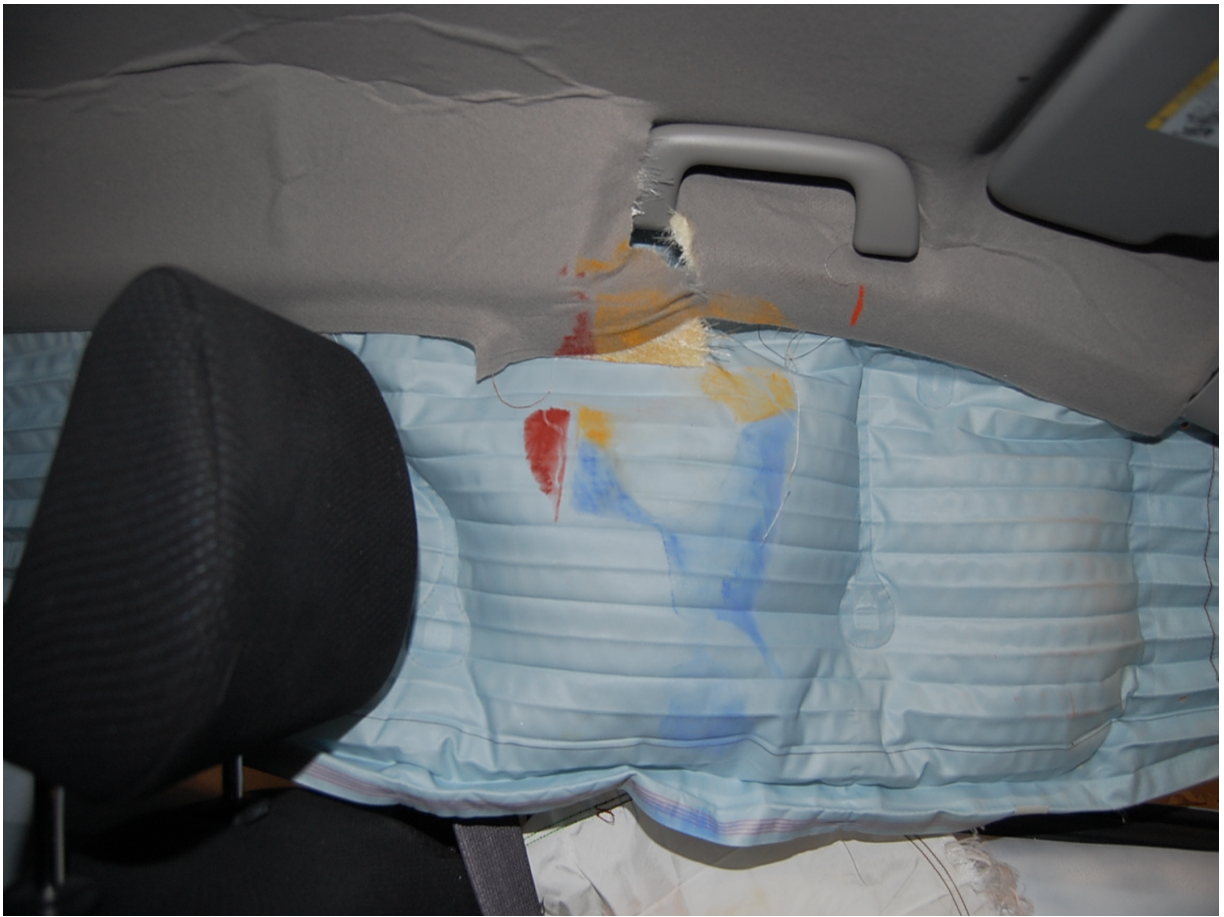
Post-Test Driver Dummy Head Contact

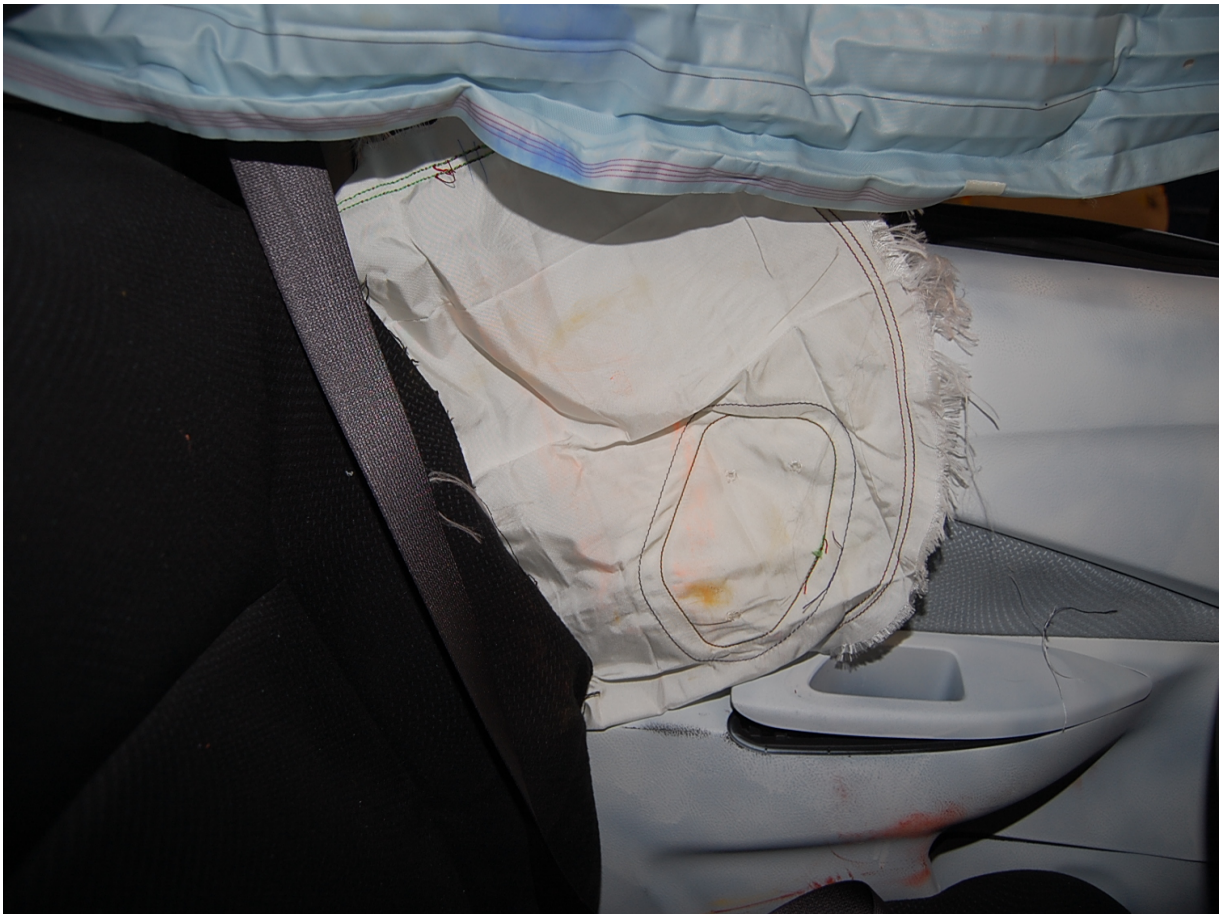
Post-Test Driver Dummy Upper Torso Contact

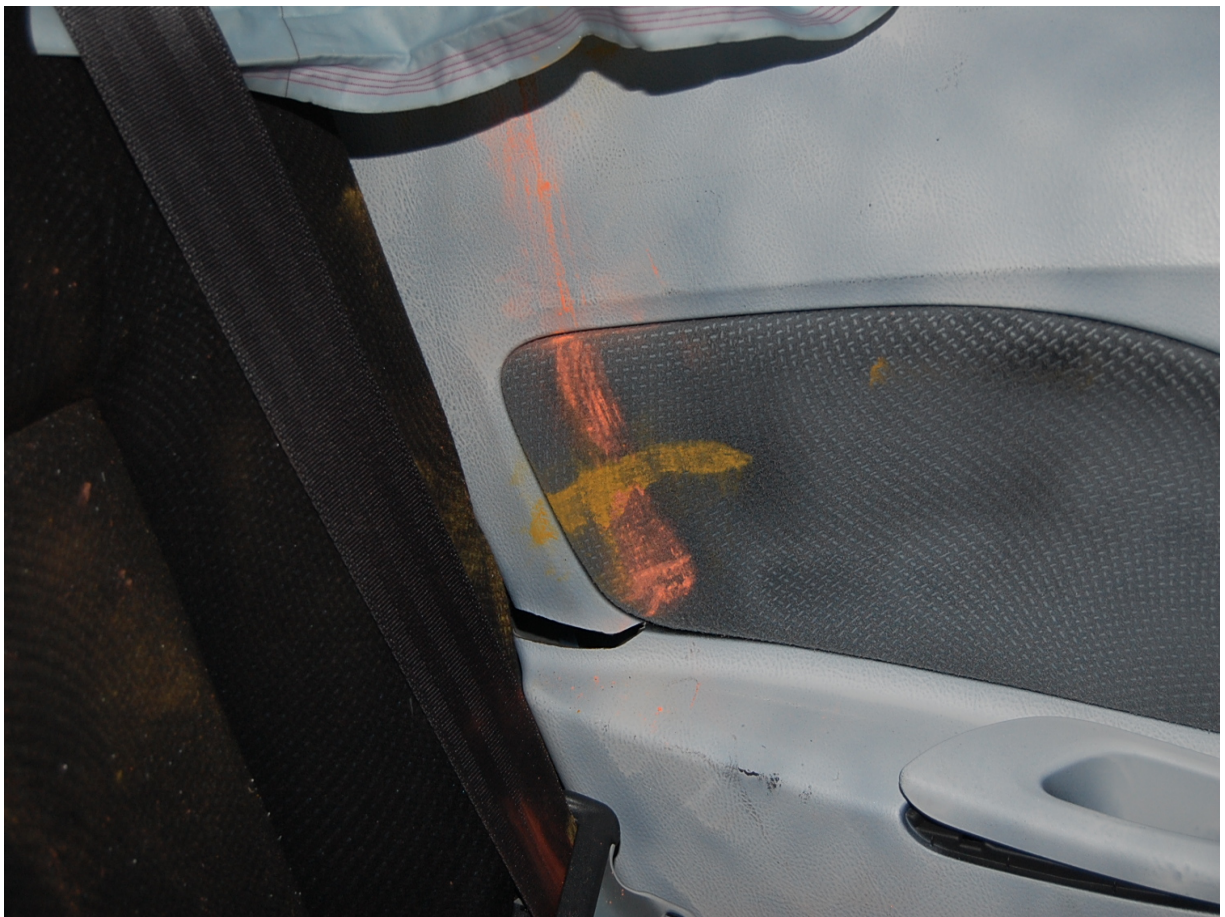
Post-Test Passenger Dummy Upper Torso Contact
