**REPORT NUMBER TR-P28181-01-NC**

**NEW CAR ASSESSMENT PROGRAM  
SIDE IMPACT TEST**

**FORD MOTOR CO.  
2009 FORD F-150 XLT SUPERCAB  
2-DOOR TRUCK**

**FINAL REPORT**

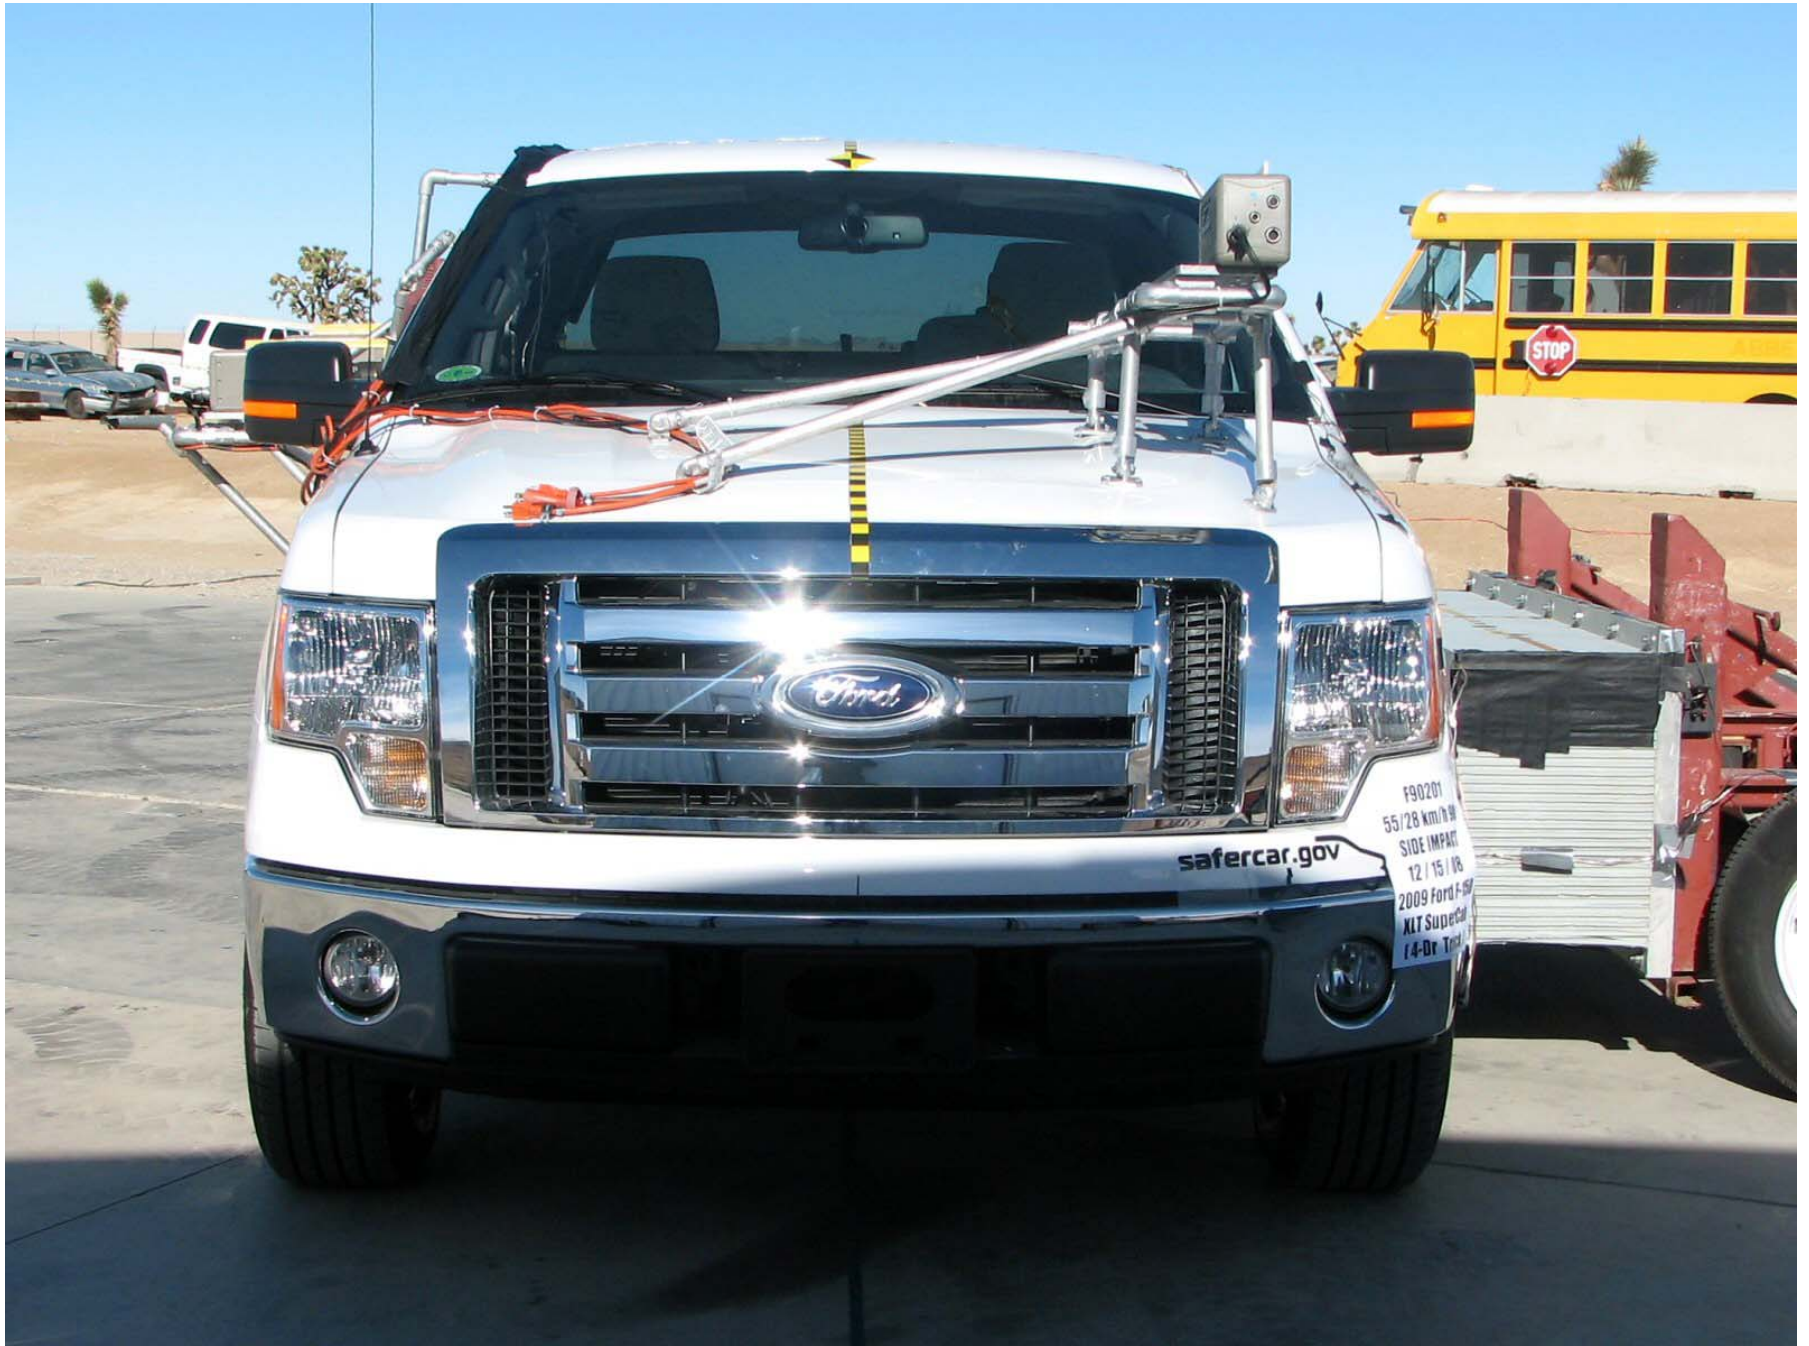
Figure A-5: Pre-Test Front View

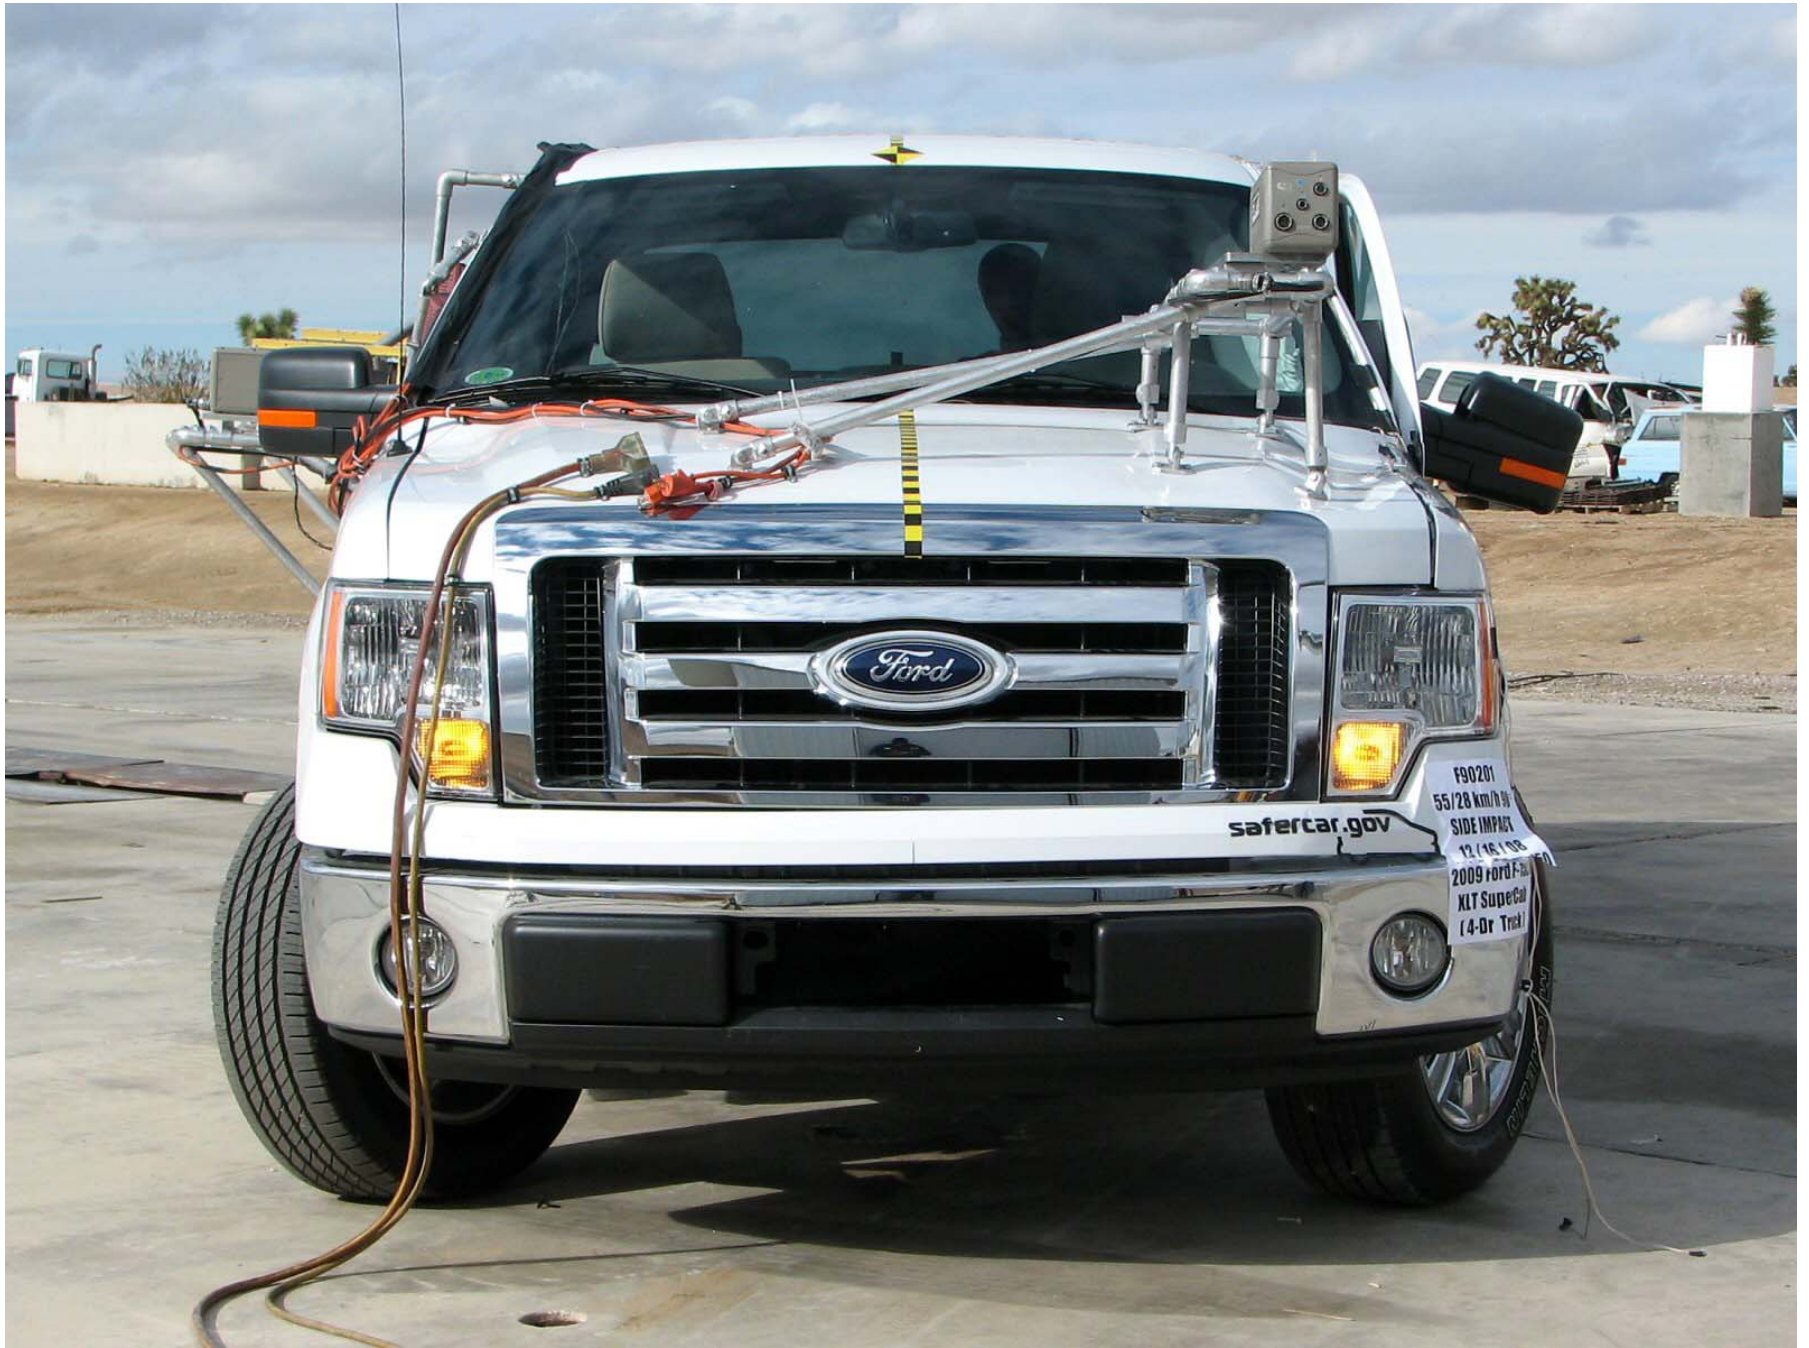
Figure A-6: Post-Test Front View

Both the driver and passenger doors remained closed during the impact. The test vehicle sustained a maximum static crush of 282 mm at level 1, 1650 mm rearward of the left vertical impact point. The driver SID/Hybrid III, Serial No. 275 and the passenger SID/Hybrid III, Serial No. 274 were calibrated prior to this test. The SID/Hybrid III injury criteria are summarized as follows:

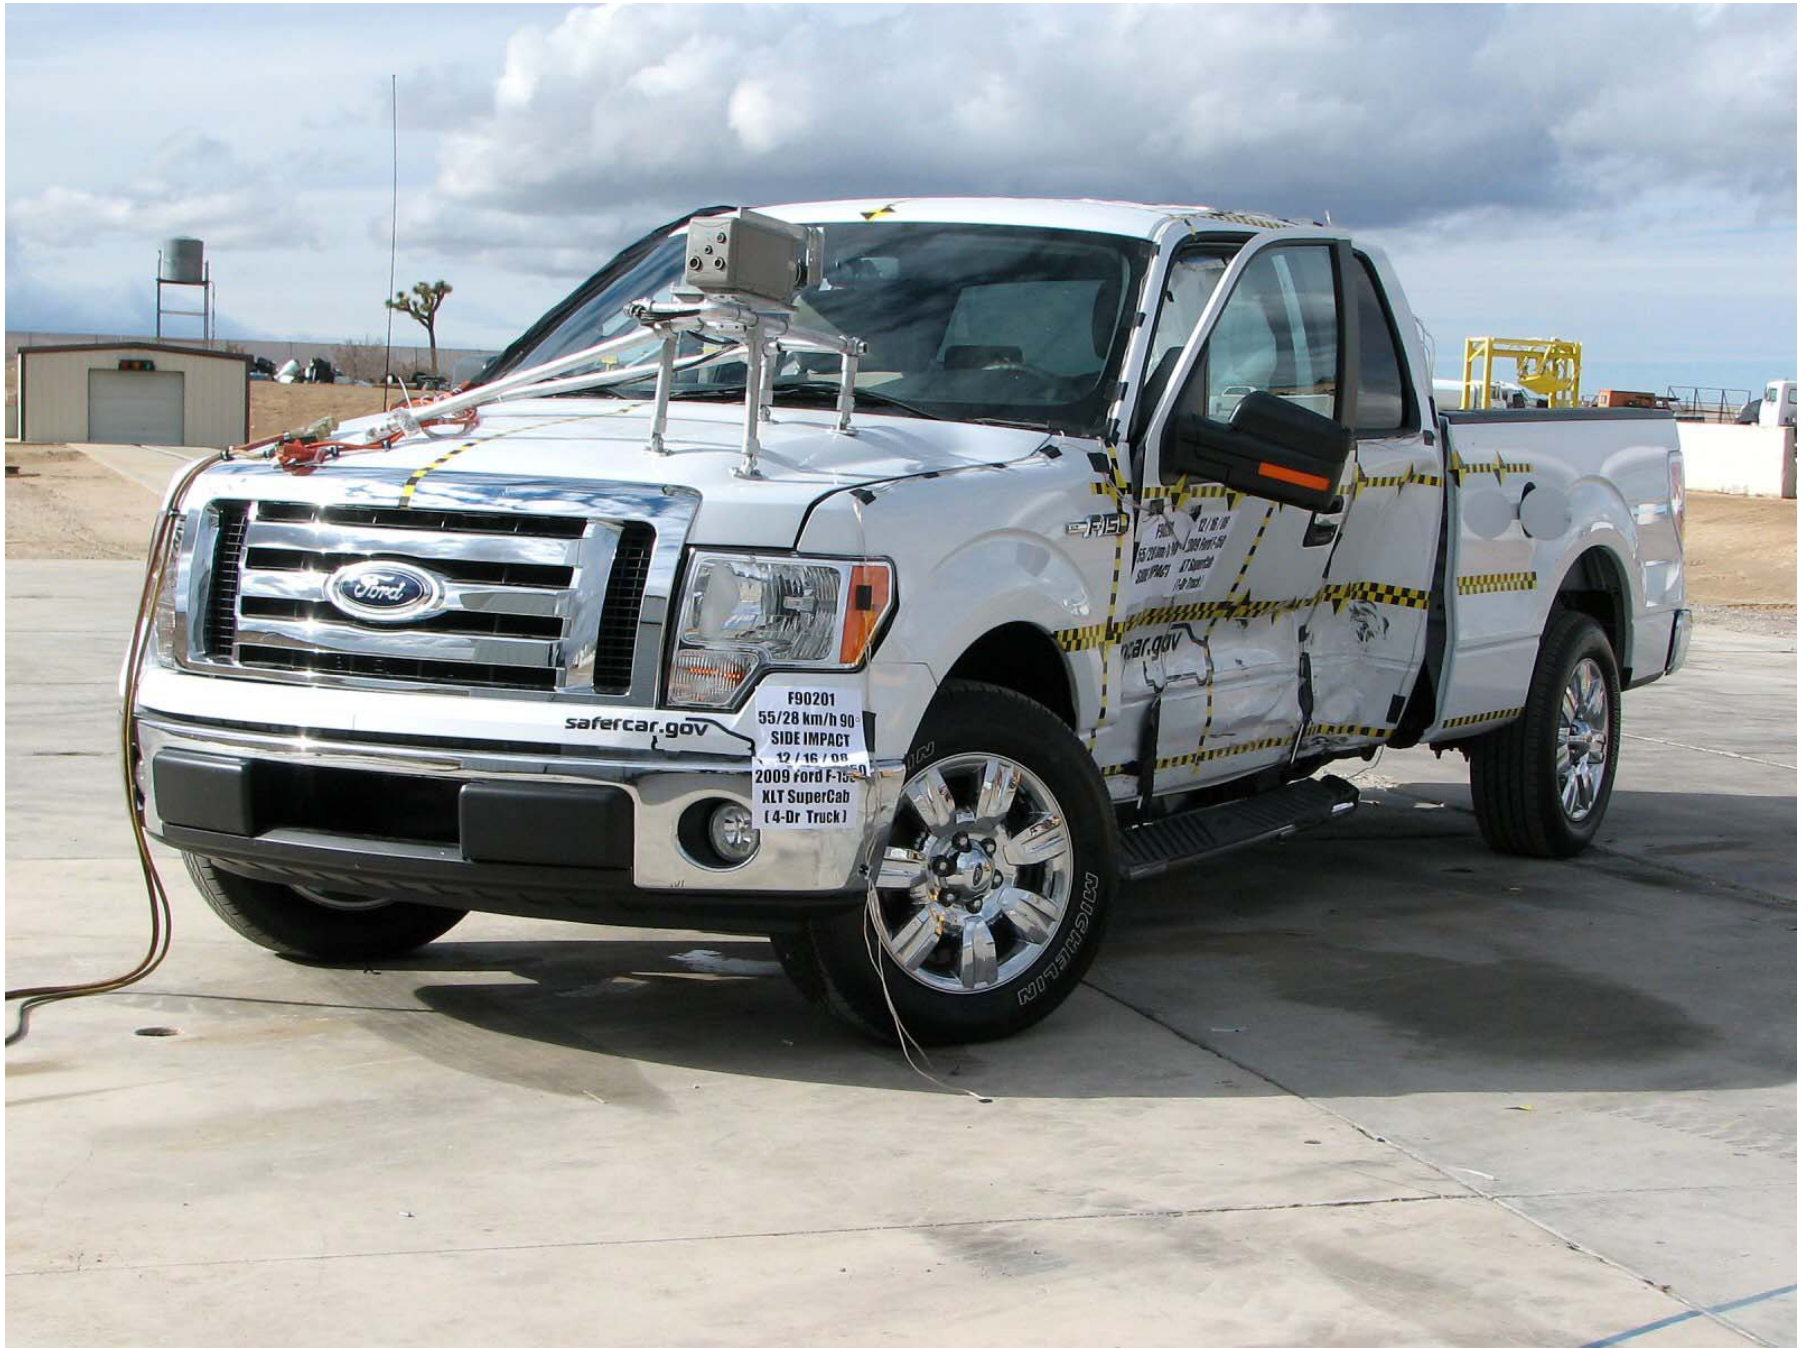
Figure A-8: Post-Test Left Front 3/4 View

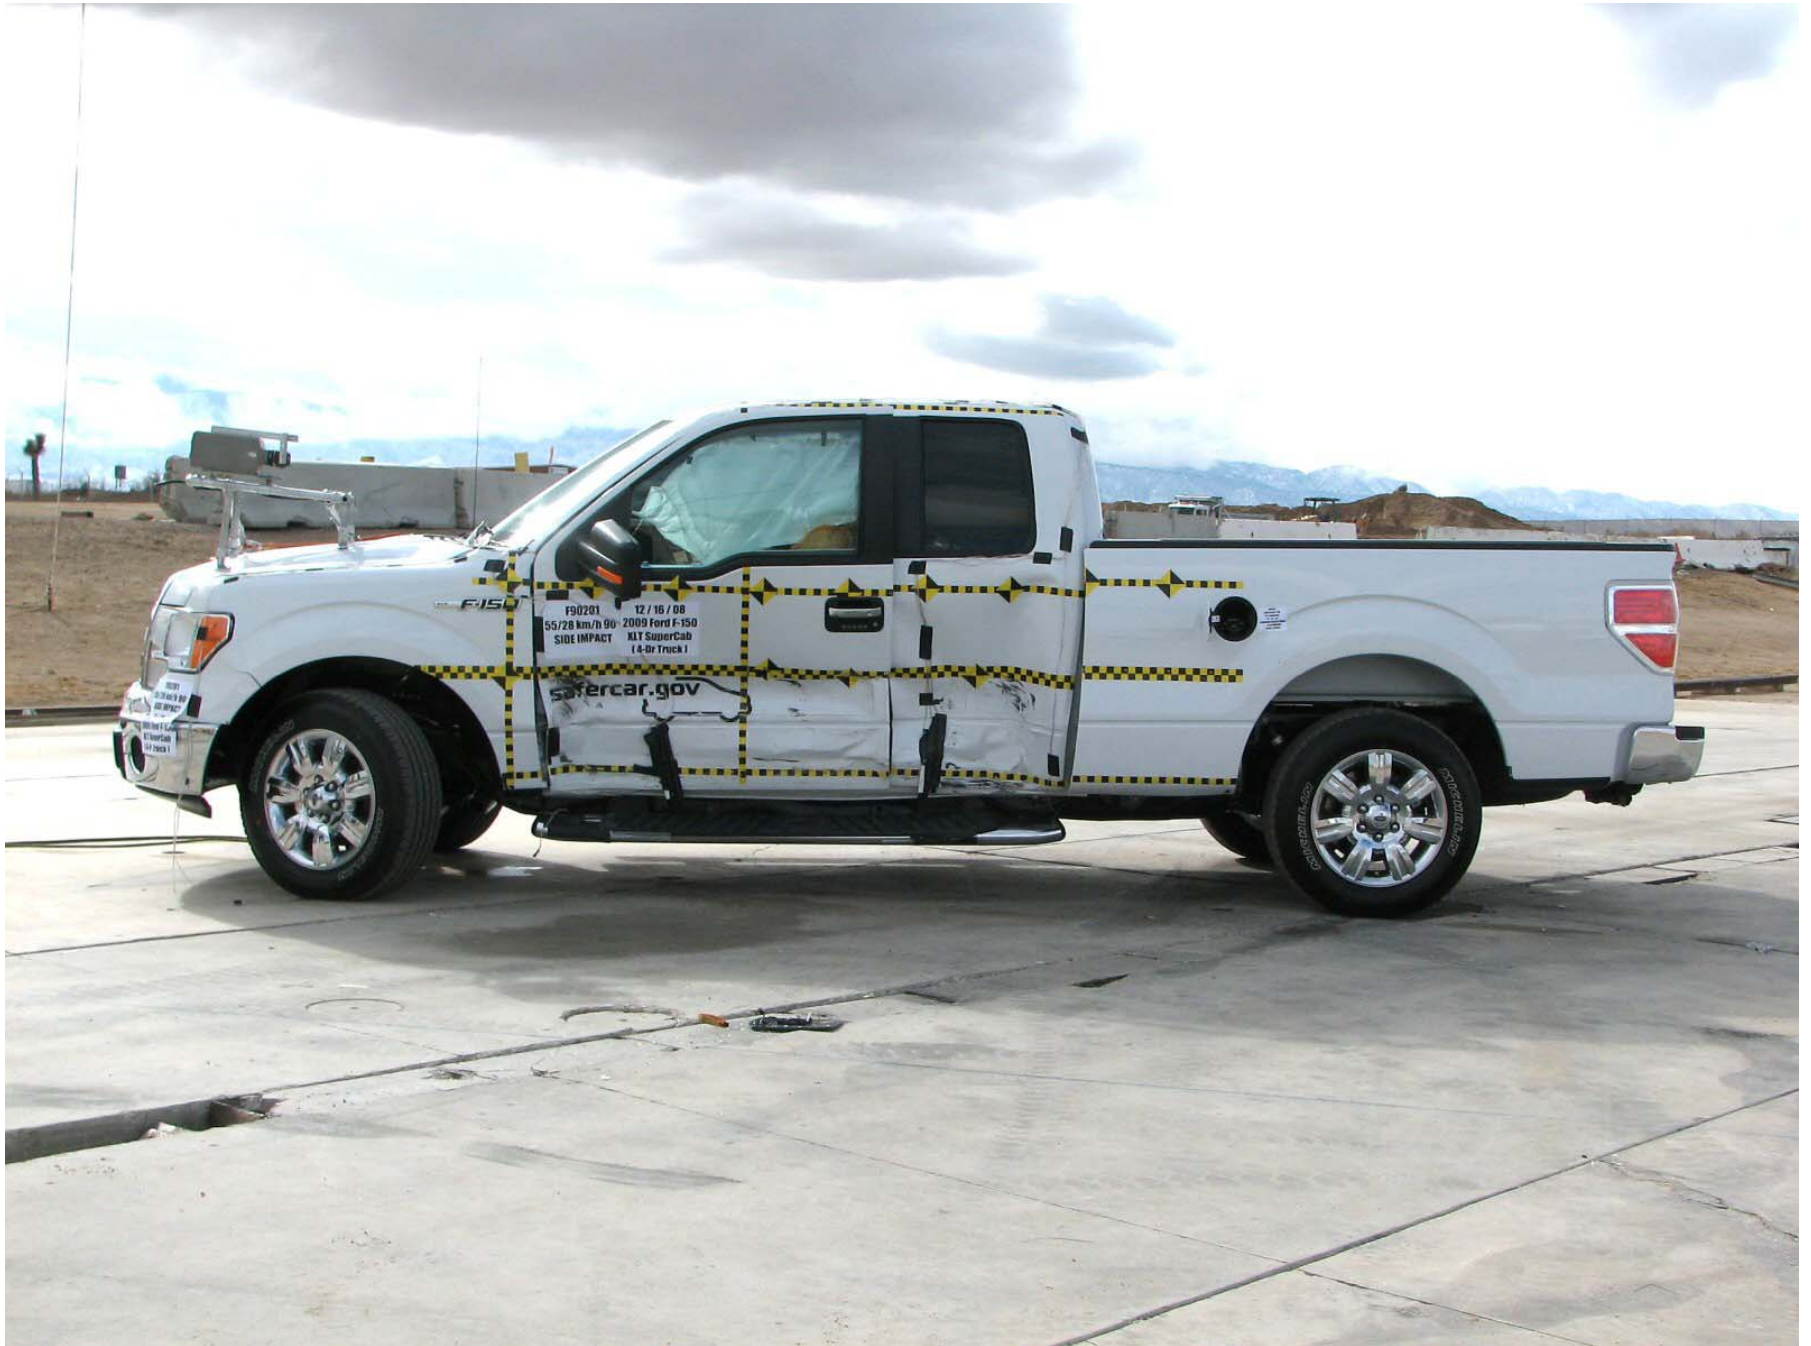
Figure A-10: Post-Test Left Side View

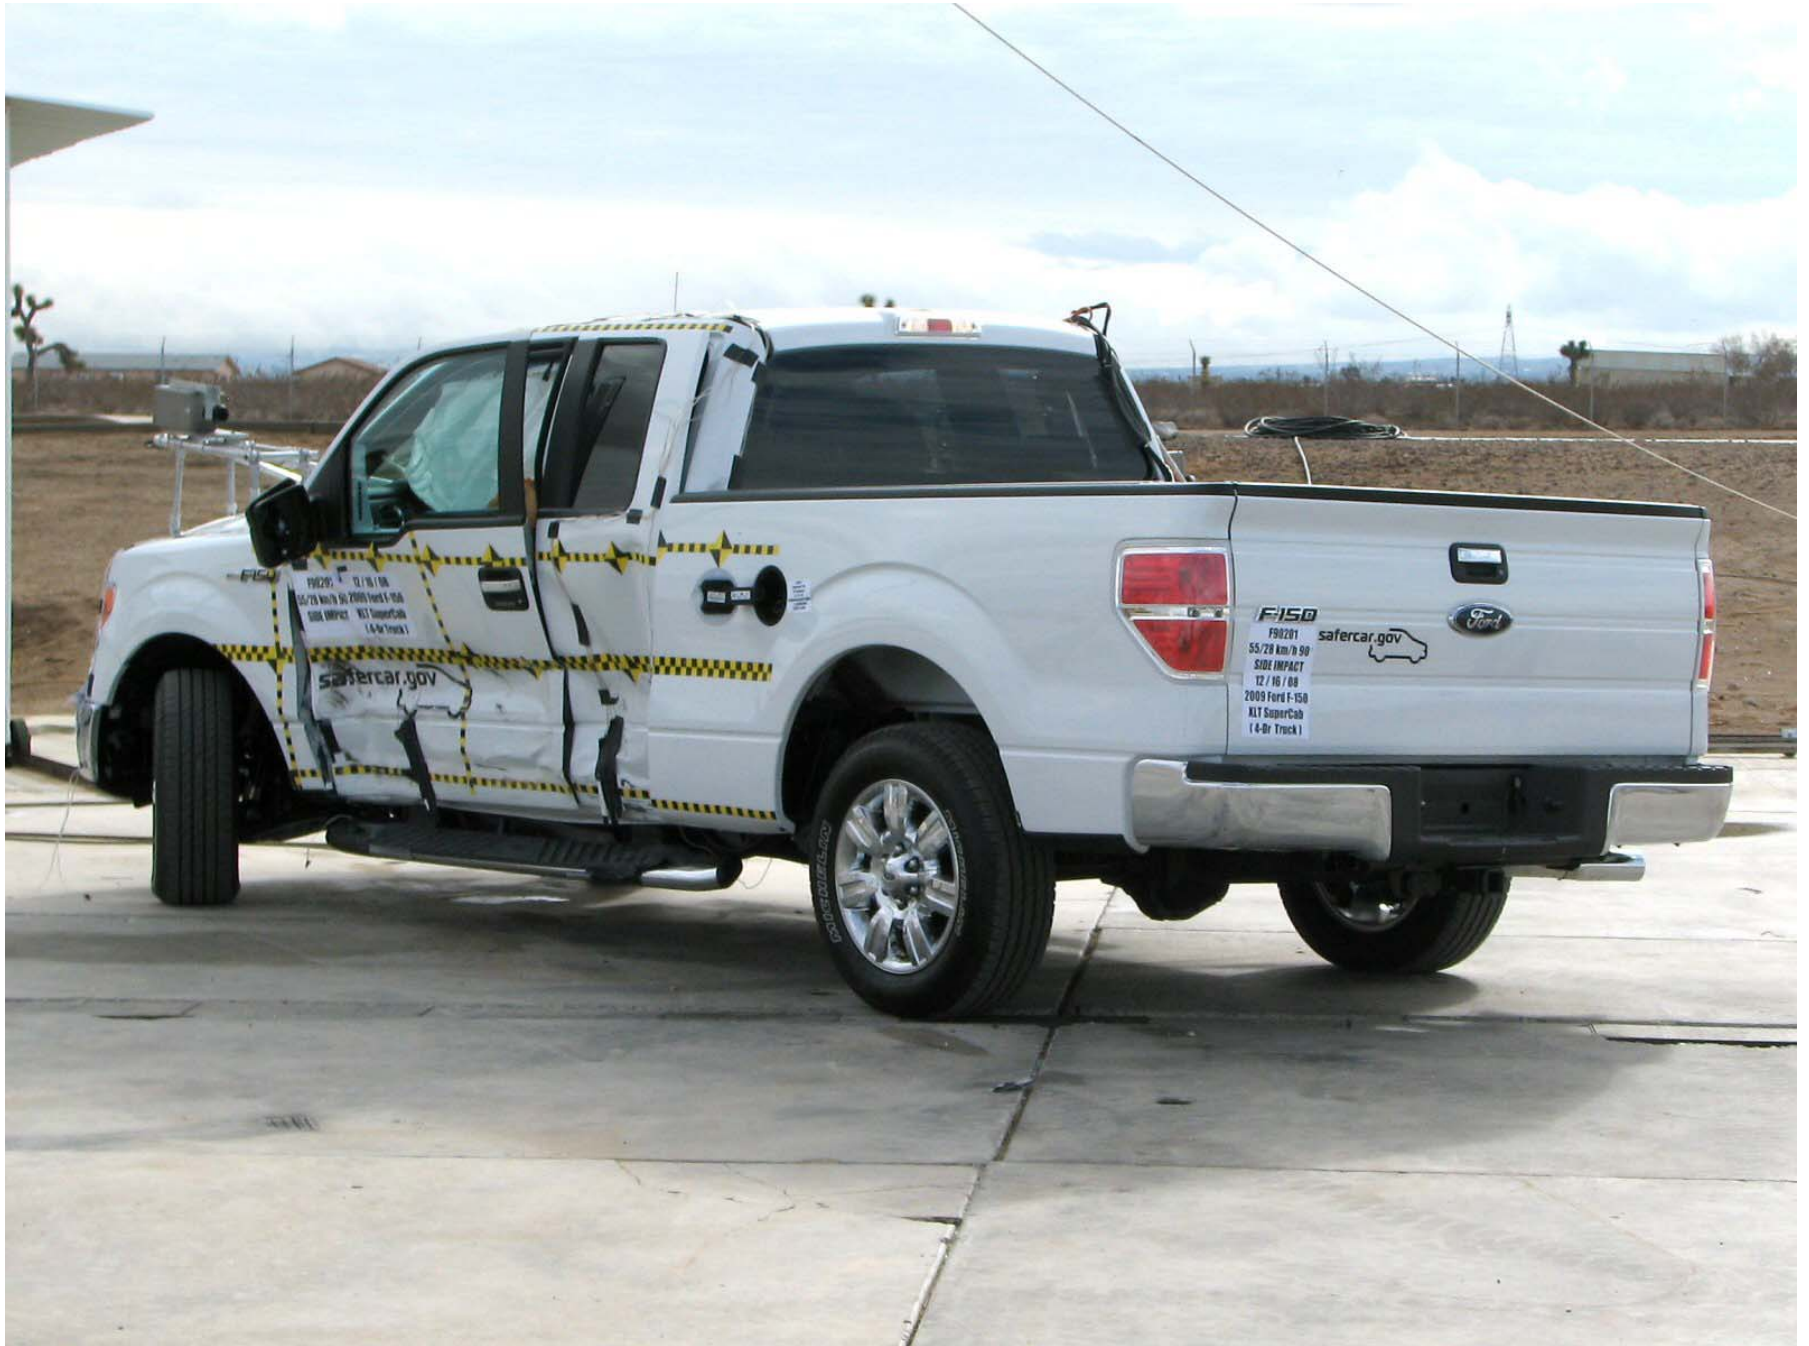
Figure A-12: Post-Test Left Rear ¾ View

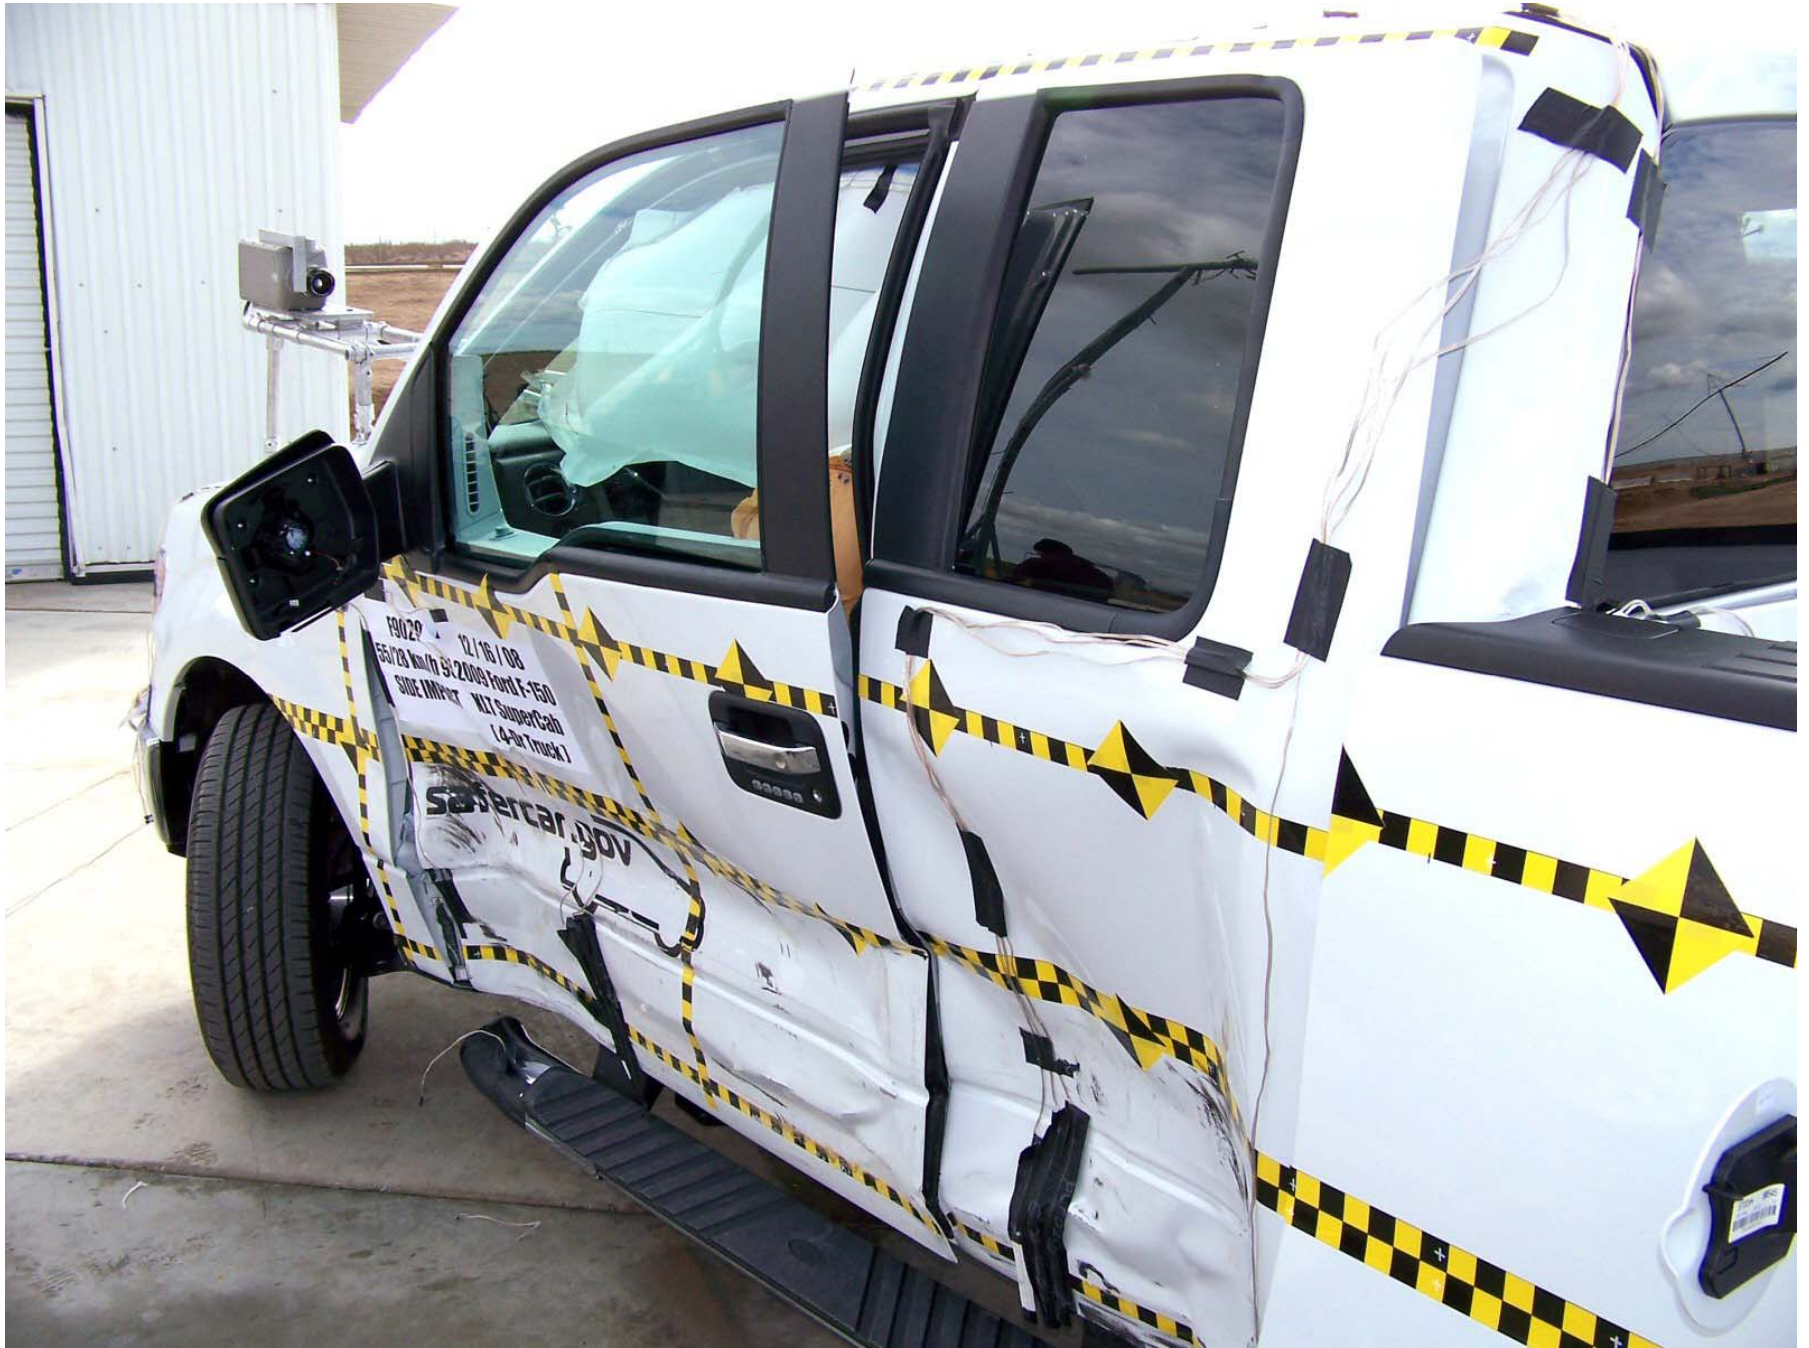
Figure A-30: Post-Test Rear 3/4 View of Left Side Door

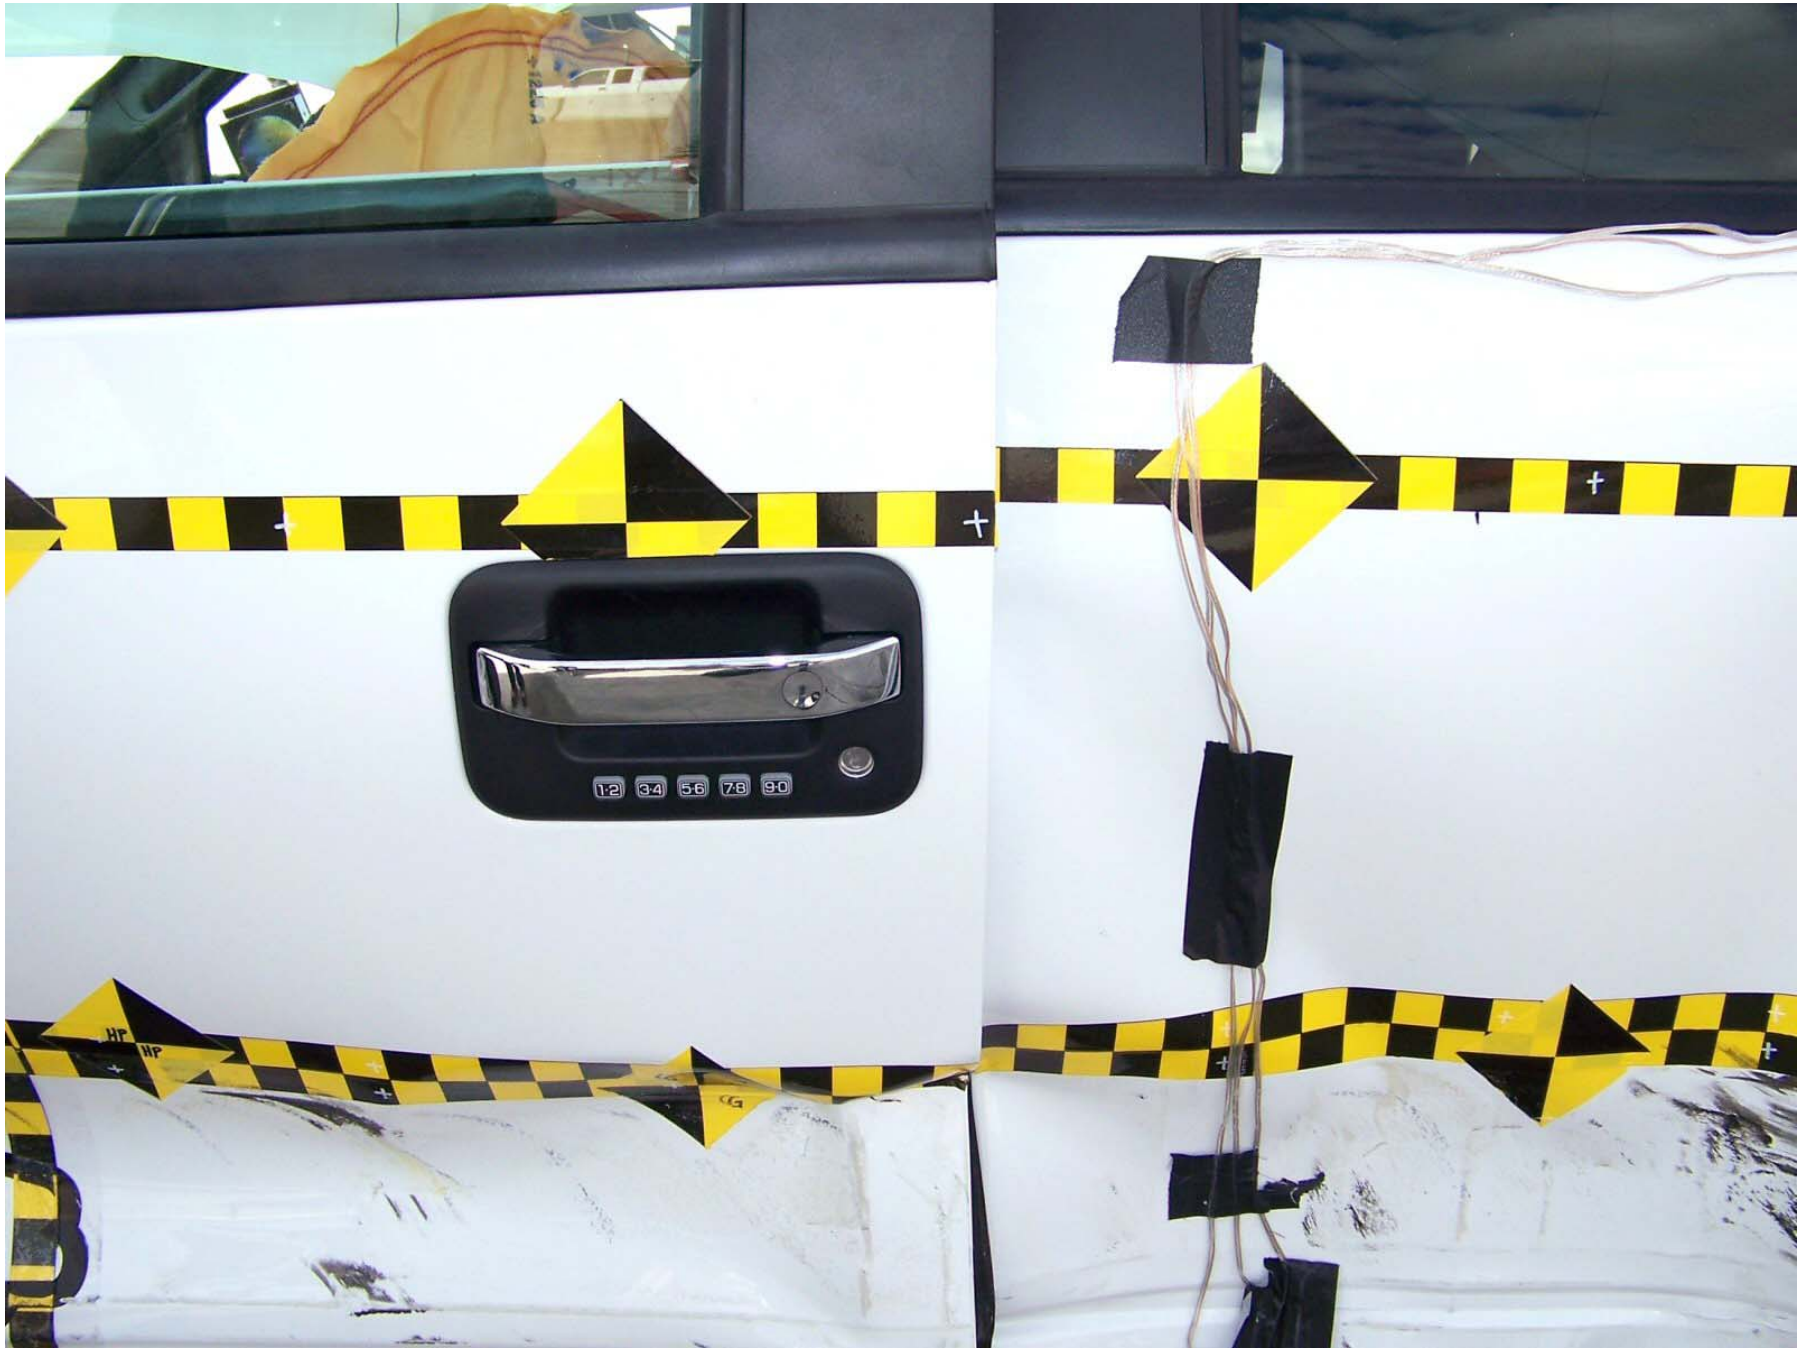
Figure A-32: Post-Test Left Front Door

Description	Front	Rear
Left Side Door Opening	Remained closed and latched, jammed	Remained closed and latched, jammed
Right Side Door Opening	Remained closed and latched, operational.	Remained closed and latched, operational.
Seat Movement	None	None
Seatback Failure	None	None

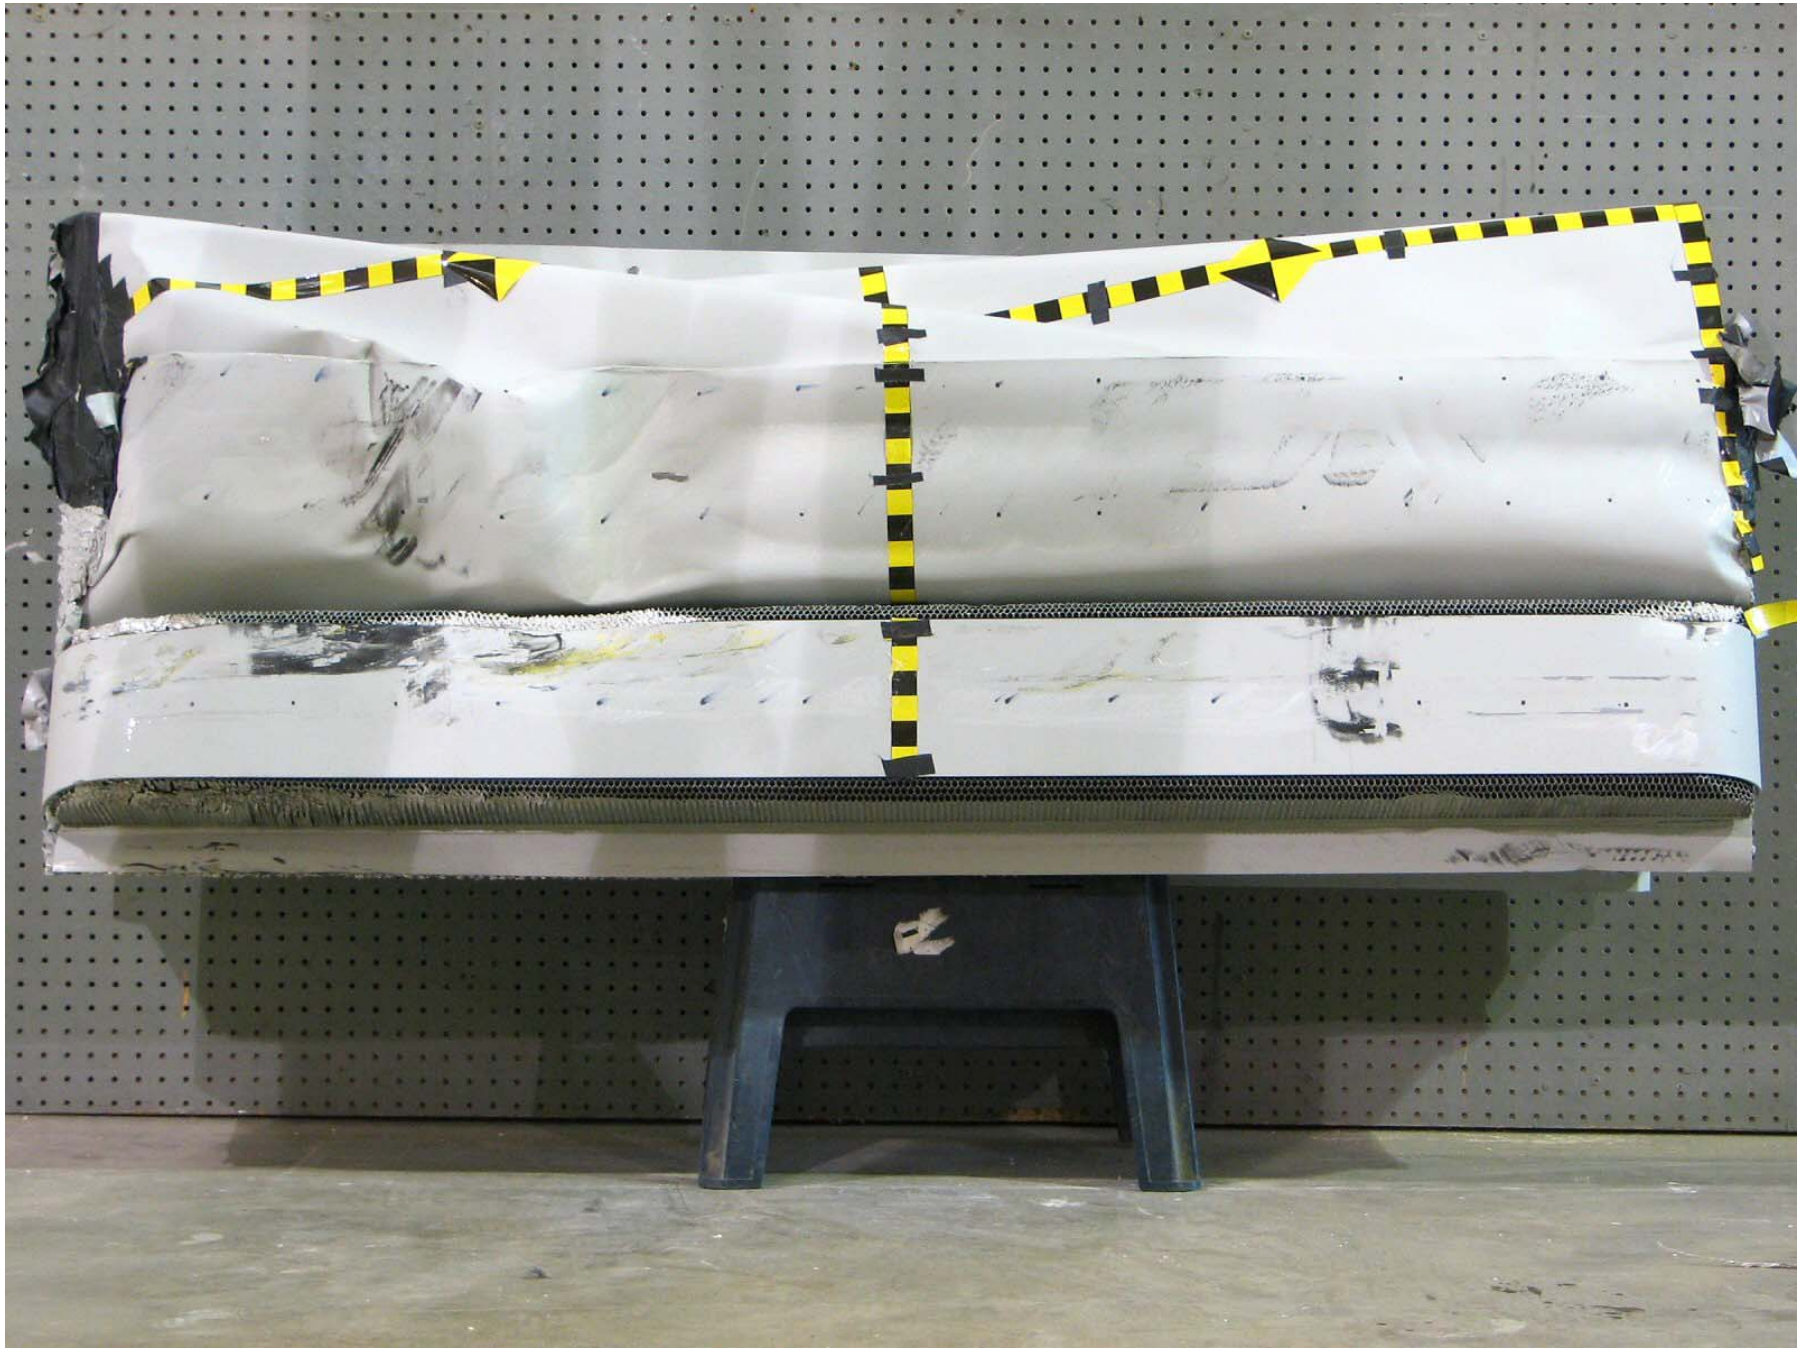
Figure A-54: Post-Test Front View of Deformable Barrier

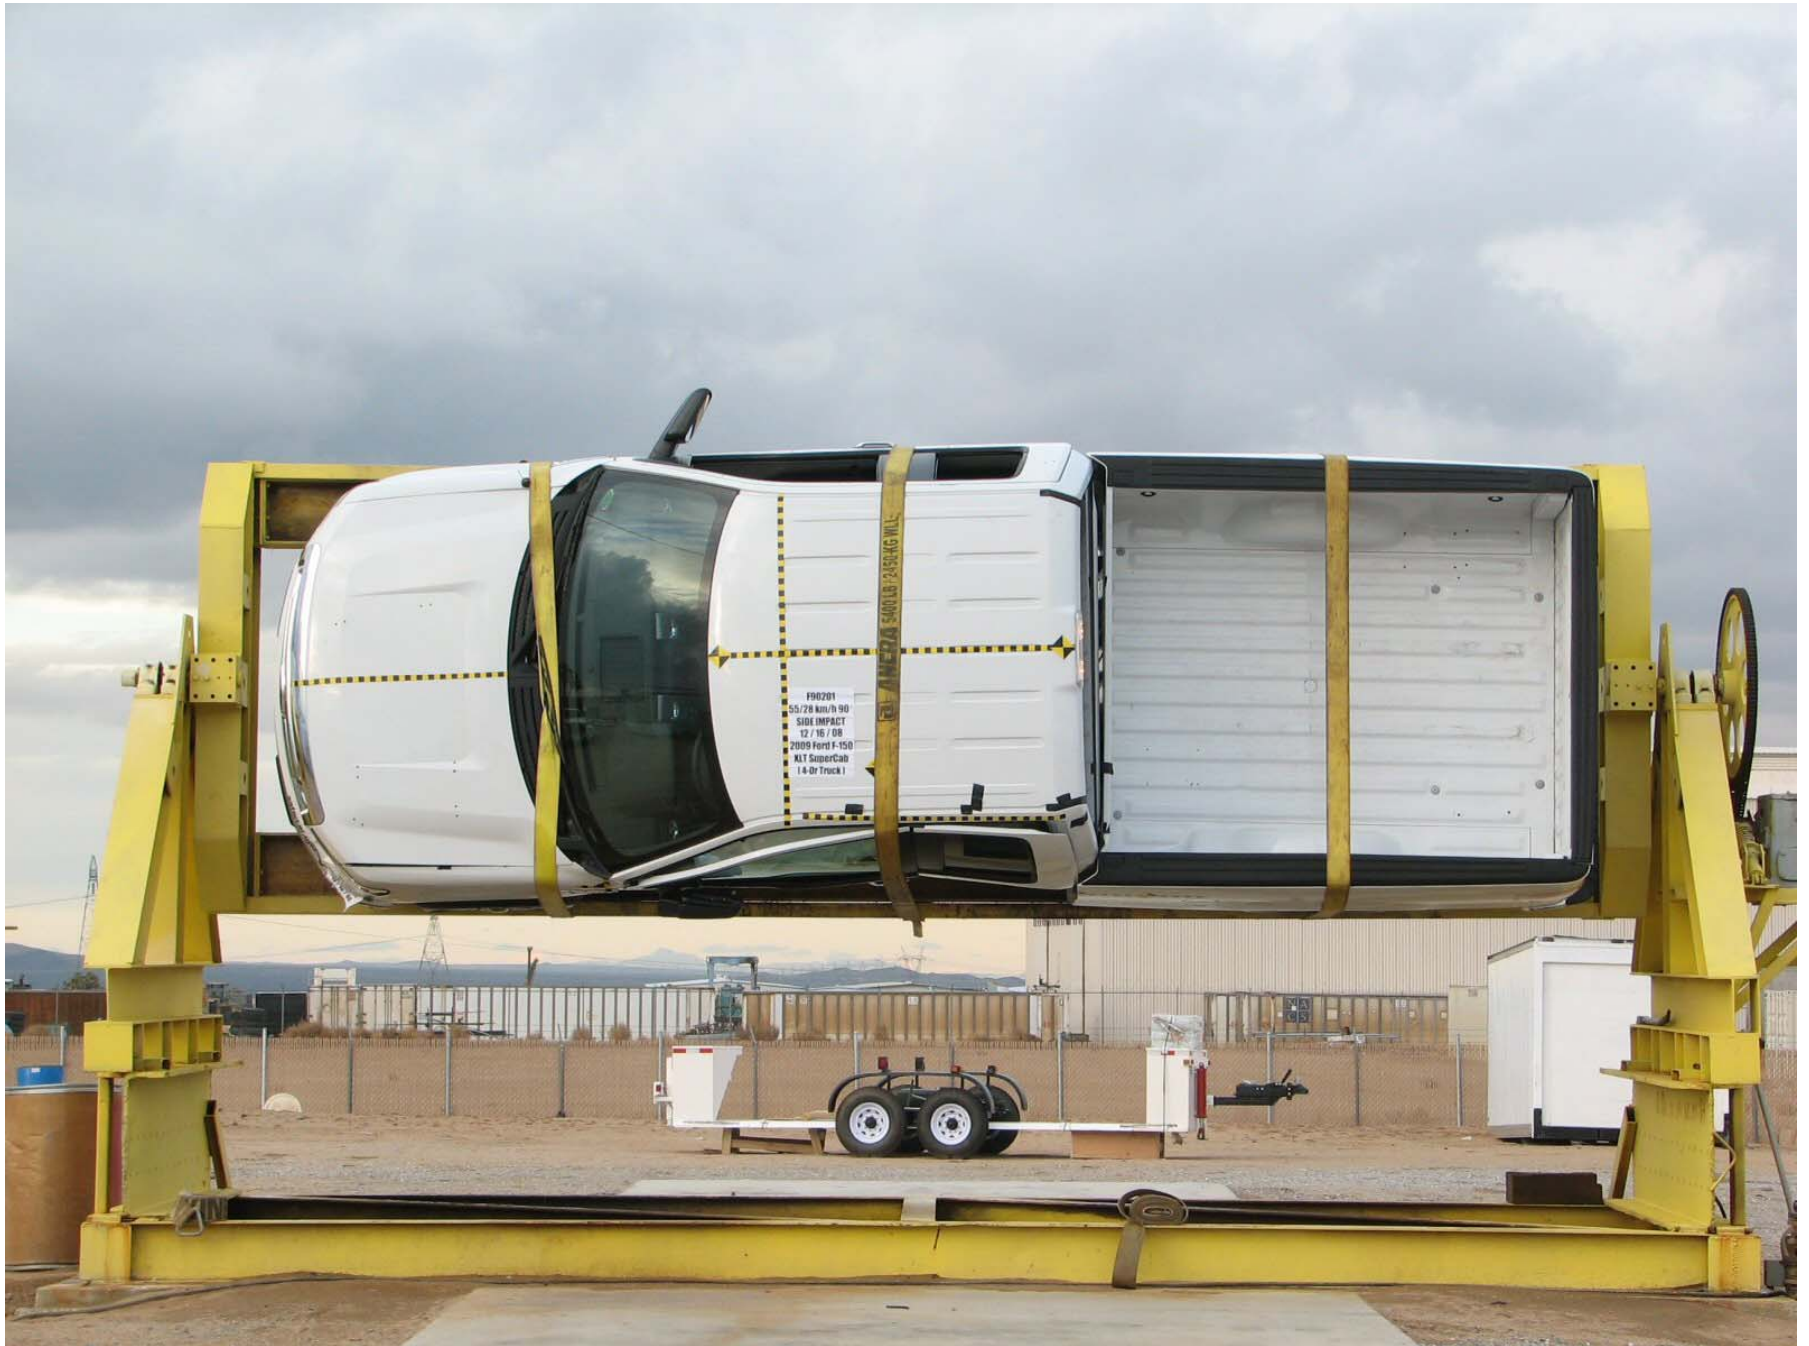
Figure A-61: Vehicle on Rollover Device (90°)

1. The specified fixture rollover rate for each 90° of rotation is 60 to 120 seconds.
  2. The position hold time at each position is 300 seconds (minimum).
  3. Details of Stoddard Solvent spillage locations.
- No solvent leakage occurred during static rollover testing.
