REPORT NUMBER TR-P28182-01-NC

**NEW CAR ASSESSMENT PROGRAM
SIDE IMPACT TEST**

**FORD MOTOR CO.
2009 FORD F-150 XL SUPERCREW
4-DOOR TRUCK**

NHTSA NUMBER: F90202

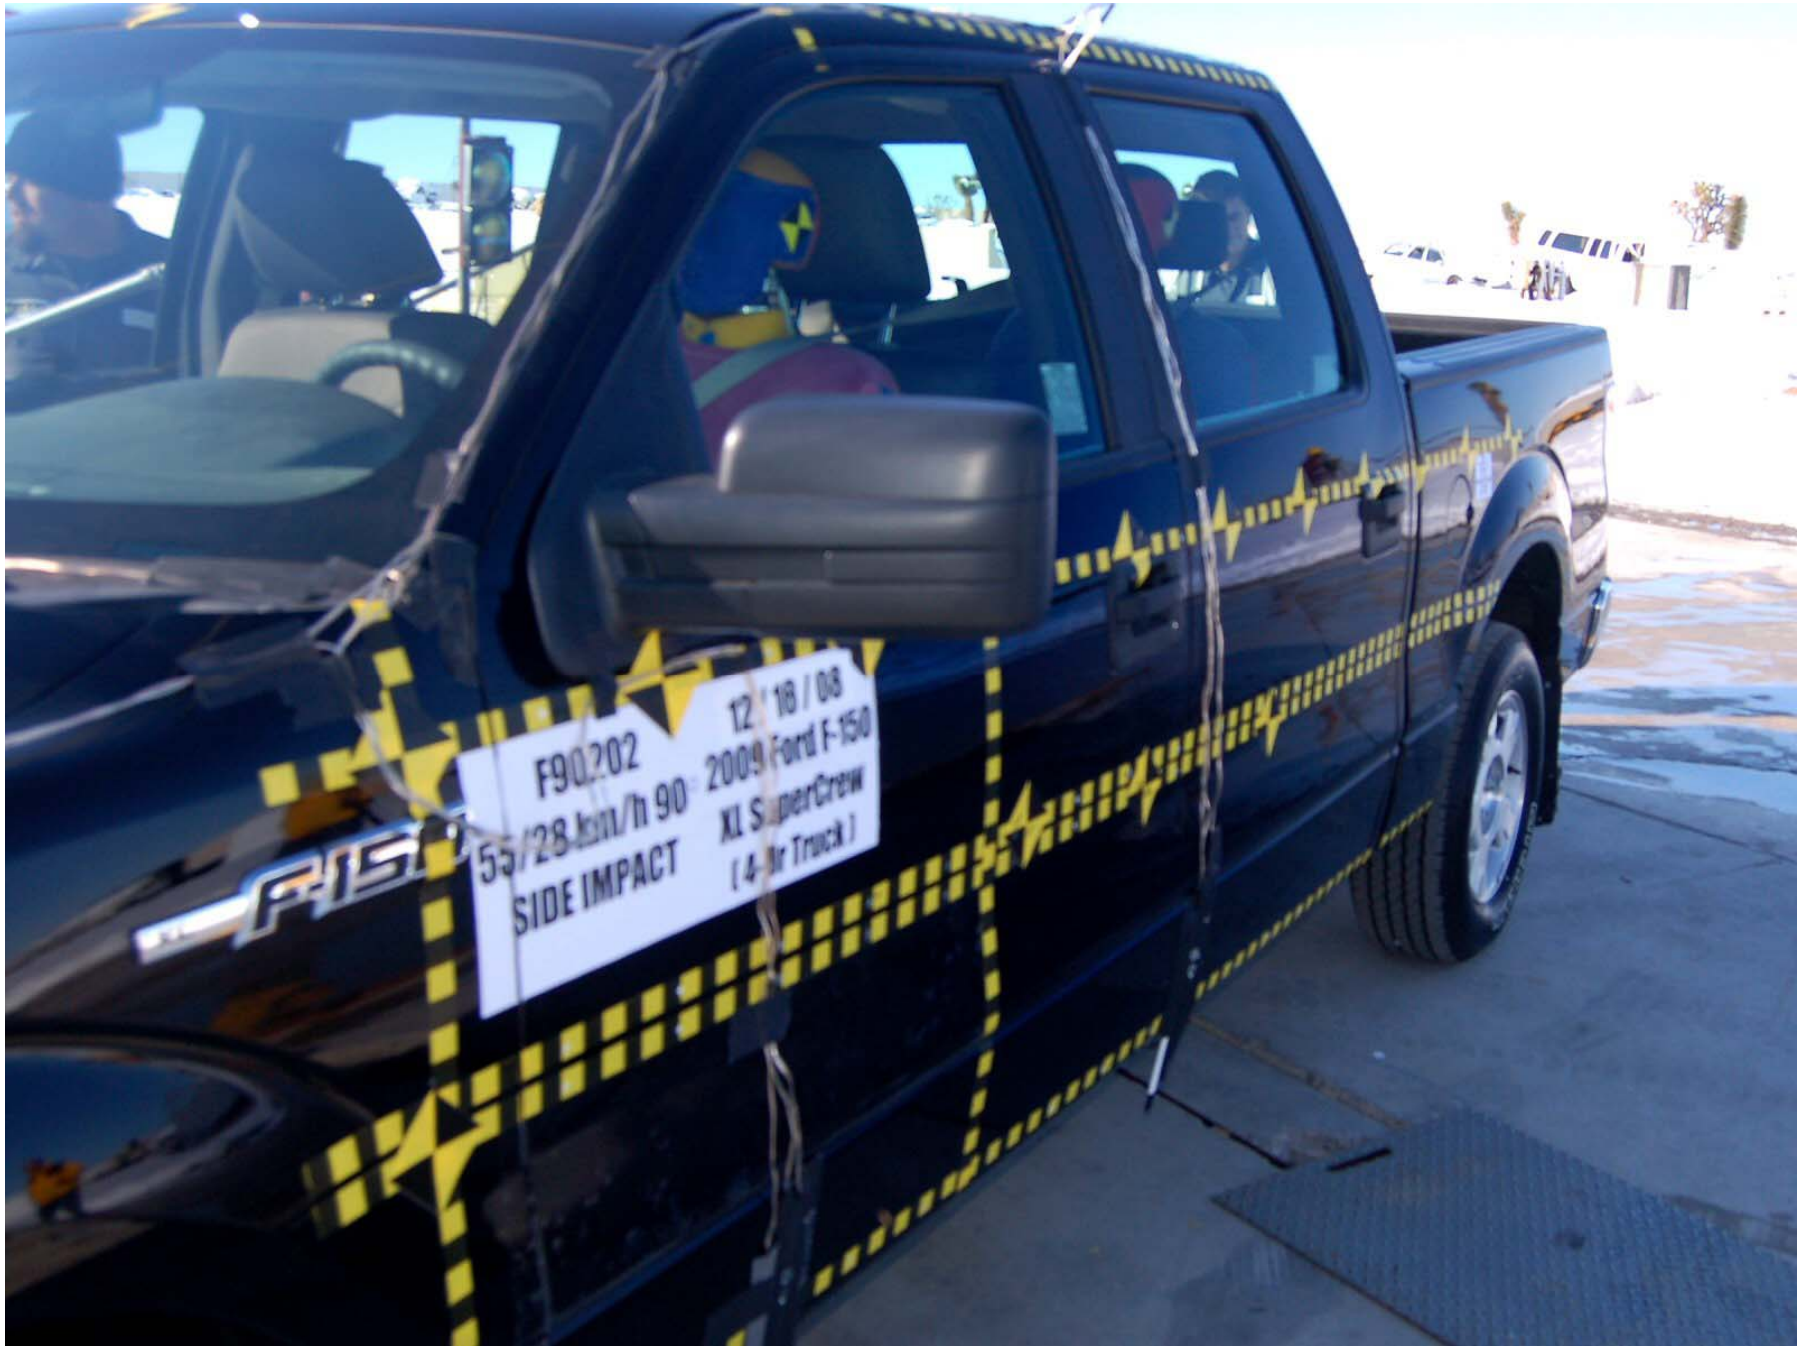
Figure A-26: Post-Test Left Impact Point

Both the driver and passenger doors remained closed during the impact. The test vehicle sustained a maximum static crush of 325 mm at level 1, 1650 mm rearward of the left vertical impact point. The driver SID/Hybrid III, Serial No. 275 and the passenger SID/Hybrid III, Serial No. 274 were calibrated prior to this test. The SID/Hybrid III injury criteria are summarized as follows:

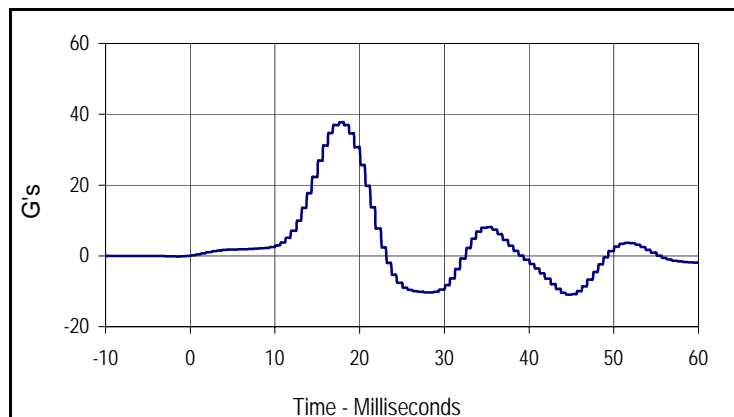
Tested Parameter	Units	Specification	Result	Pass/Fail
Laboratory Temperature	°C	18.9 to 25.6	21.1	Pass
Laboratory Relative Humidity	%	10 to 70	30	Pass
Probe Velocity	m/s	4.21 to 4.33	4.32	Pass
Upper Rib Acceleration	G's	37.0 to 46.0	37.8	Pass
Lower Rib Acceleration	G's	37.0 to 46.0	37.8	Pass
Thoracic Spine Acceleration	G's	15.0 to 22.0	16.4	Pass
Overall Test Results				Pass

Curve Description			
Upper Rib Y Primary			
CURNO	Type	SAE Class	Units
001	FIL	FIR100	G's
Max	Time	Min	Time
37.8	17.6	-10.9	44.4

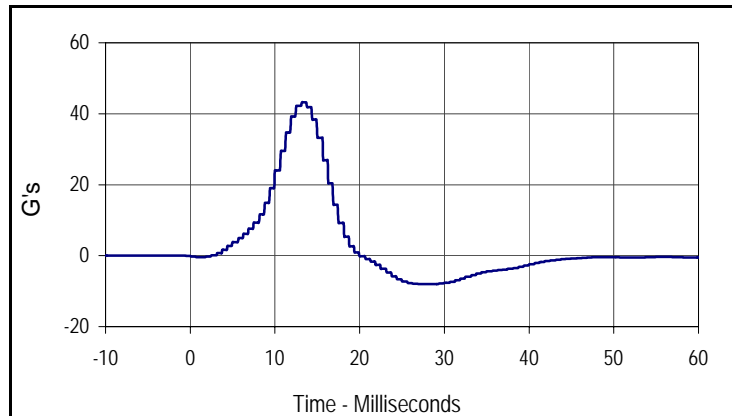
Tested Parameter	Units	Specification	Result	Pass/Fail
Laboratory Temperature	°C	18.9 to 25.6	21.1	Pass
Laboratory Relative Humidity	%	10 to 70	30	Pass
Probe Velocity	m/s	4.21 to 4.33	4.32	Pass
Peak Pelvis Acceleration	G's	40.0 to 60.0	43.2	Pass
Acceleration Time Above 20 G's	Msec.	3.0 to 7.0	4.90	Pass
Overall Test Results				Pass

Curve Description			
Pelvis Y Primary			
CURNO	Type	SAE Class	Units
001	FIL	FIR100	G's
Max	Time	Min	Time
43.2	13.2	-8.0	27.5

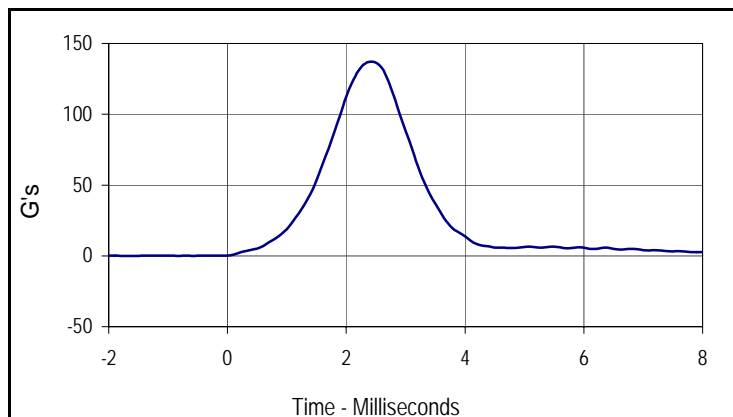
Test Program: SID / HIII Head Drop Lateral Impact Test
 ATD Serial No.: 274

Tested Parameter	Units	Specification	Result	Pass/Fail
Laboratory Temperature	°C	18.9 to 25.6	21.1	Pass
Laboratory Relative Humidity	%	10 to 70	30	Pass
Peak Resultant Acceleration	G's	120.0 to 150.0	137.2	Pass
Peak Longitudinal Acceleration	G's	≤15.0	5.5	Pass
Is Acceleration Unimodal?	Yes/No	Yes	Yes	Pass
Oscillations After Main Pulse	%	<15	4.7	Pass
Overall Test Results				Pass

Curve Description			
Head Resultant			
CURNO	Type	SAE Class	Units
001	RES	1000	G's
Max	Time	Min	Time
137.2	2.4	0.0	-1.7

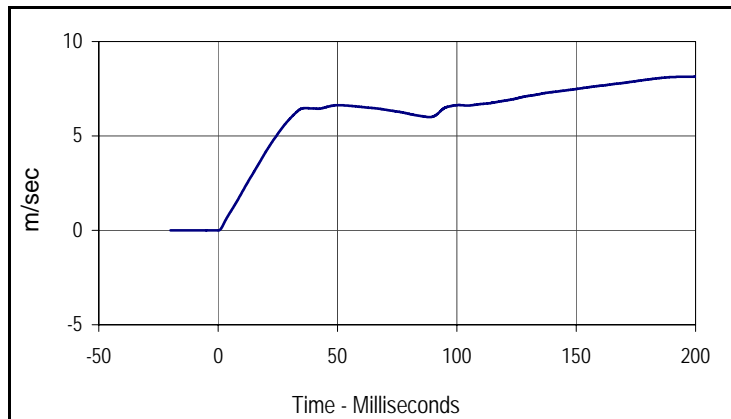
Tested Parameter	Units	Specification	Result	Pass/Fail	
Laboratory Temperature	°C	20.6 to 22.2	21.1	Pass	
Laboratory Relative Humidity	%	10 to 70	30	Pass	
Pendulum Velocity	m/sec	6.89 to 7.13	7.07	Pass	
Pendulum Deceleration	10 Msec.	m/sec	1.96 to 2.55	2.02	Pass
	20 Msec.	m/sec	4.12 to 5.10	4.17	Pass
	30 Msec.	m/sec	5.73 to 7.01	5.91	Pass
	40 to 70	m/sec	6.27 to 7.64	6.63	Pass
"D" Plane Rotation	Max	Degrees	66.0 to 82.0	71.9	Pass
Max Rotation Time After Peak Moment	Msec.	2.0 to 16.0	15.4	Pass	
Rotation Time From Peak to Zero Angle	Msec.	58.0 to 67.0	61.9	Pass	
Moment About Occipital Condyle	Nm	73.0 to 88.0	73.8	Pass	
Positive Moment Decay, Time To 0 Nm	Msec.	49.0 to 64.0	50.4	Pass	
Overall Test Results				Pass

Curve Description			
Pendulum Velocity			
CURNO	Type	SAE Class	Units
001	FIL	180	m/sec
Max	Time	Min	Time
8.1	196.6	0.0	-0.1

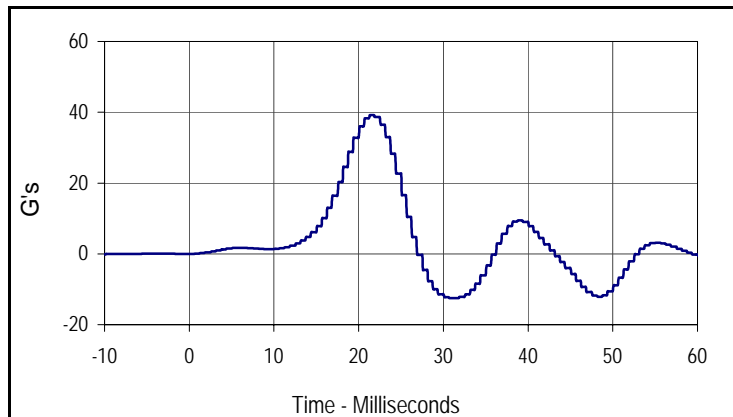
Tested Parameter	Units	Specification	Result	Pass/Fail
Laboratory Temperature	°C	18.9 to 25.6	21.1	Pass
Laboratory Relative Humidity	%	10 to 70	30	Pass
Probe Velocity	m/s	4.21 to 4.33	4.30	Pass
Upper Rib Acceleration	G's	37.0 to 46.0	39.2	Pass
Lower Rib Acceleration	G's	37.0 to 46.0	39.1	Pass
Thoracic Spine Acceleration	G's	15.0 to 22.0	15.8	Pass
Overall Test Results			Pass

Curve Description			
Upper Rib Y Primary			
CURNO	Type	SAE Class	Units
001	FIL	FIR100	G's
Max	Time	Min	Time
39.2	21.3	-12.5	30.7

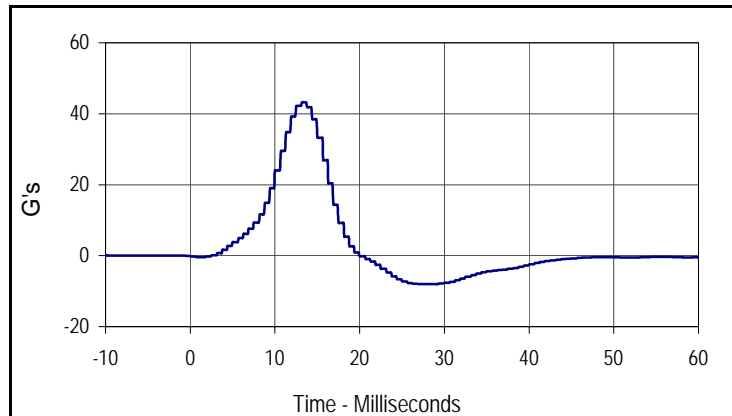
Tested Parameter	Units	Specification	Result	Pass/Fail
Laboratory Temperature	°C	18.9 to 25.6	21.1	Pass
Laboratory Relative Humidity	%	10 to 70	30	Pass
Probe Velocity	m/s	4.21 to 4.33	4.31	Pass
Peak Pelvis Acceleration	G's	40.0 to 60.0	43.2	Pass
Acceleration Time Above 20 G's	Msec.	3.0 to 7.0	4.90	Pass
Overall Test Results				Pass

Curve Description			
Pelvis Y Primary			
CURNO	Type	SAE Class	Units
001	FIL	FIR100	G's
Max	Time	Min	Time
43.2	13.2	-8.0	27.5

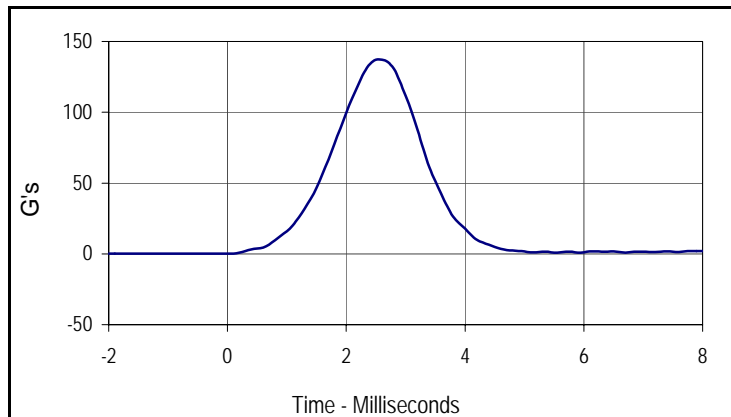
Test Program: SID / HIII Head Drop Lateral Impact Test
 ATD Serial No.: 275

Tested Parameter	Units	Specification	Result	Pass/Fail
Laboratory Temperature	°C	18.9 to 25.6	21.1	Pass
Laboratory Relative Humidity	%	10 to 70	30	Pass
Peak Resultant Acceleration	G's	120.0 to 150.0	137.2	Pass
Peak Longitudinal Acceleration	G's	≤15.0	8.8	Pass
Is Acceleration Unimodal?	Yes/No	Yes	Yes	Pass
Oscillations After Main Pulse	%	<15	1.3	Pass
Overall Test Results			Pass

Curve Description			
Head Resultant			
CURNO	Type	SAE Class	Units
001	RES	1000	G's
Max	Time	Min	Time
137.2	2.6	0.2	-1.5

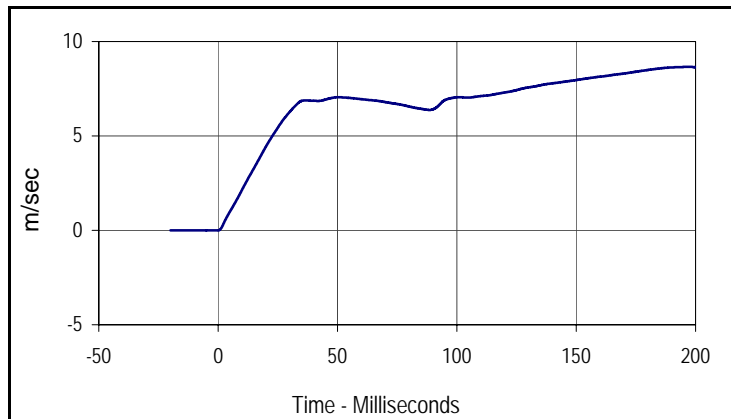
Tested Parameter	Units	Specification	Result	Pass/Fail	
Laboratory Temperature	°C	20.6 to 22.2	21.1	Pass	
Laboratory Relative Humidity	%	10 to 70	30	Pass	
Pendulum Velocity	m/sec	6.89 to 7.13	7.07	Pass	
Pendulum Deceleration	10 Msec.	m/sec	1.96 to 2.55	2.15	Pass
	20 Msec.	m/sec	4.12 to 5.10	4.43	Pass
	30 Msec.	m/sec	5.73 to 7.01	6.28	Pass
	40 to 70	m/sec	6.27 to 7.64	7.05	Pass
"D" Plane Rotation	Max	Degrees	66.0 to 82.0	81.0	Pass
Max Rotation Time After Peak Moment	Msec.	2.0 to 16.0	15.5	Pass	
Rotation Time From Peak to Zero Angle	Msec.	58.0 to 67.0	61.5	Pass	
Moment About Occipital Condyle	Nm	73.0 to 88.0	77.4	Pass	
Positive Moment Decay, Time To 0 Nm	Msec.	49.0 to 64.0	50.4	Pass	
Overall Test Results				Pass

Curve Description			
Pendulum Velocity			
CURNO	Type	SAE Class	Units
001	FIL	180	m/sec
Max	Time	Min	Time
8.7	196.6	0.0	-0.1

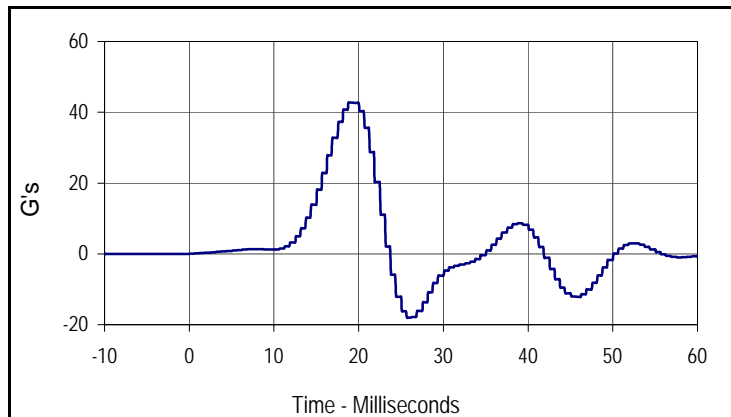
Tested Parameter	Units	Specification	Result	Pass/Fail
Laboratory Temperature	°C	18.9 to 25.6	21.1	Pass
Laboratory Relative Humidity	%	10 to 70	30	Pass
Probe Velocity	m/s	4.21 to 4.33	4.24	Pass
Upper Rib Acceleration	G's	37.0 to 46.0	42.7	Pass
Lower Rib Acceleration	G's	37.0 to 46.0	41.8	Pass
Thoracic Spine Acceleration	G's	15.0 to 22.0	17.8	Pass
Overall Test Results				Pass

Curve Description			
Upper Rib Y Primary			
CURNO	Type	SAE Class	Units
001	FIL	FIR100	G's
Max	Time	Min	Time
42.7	18.8	-18.0	25.7

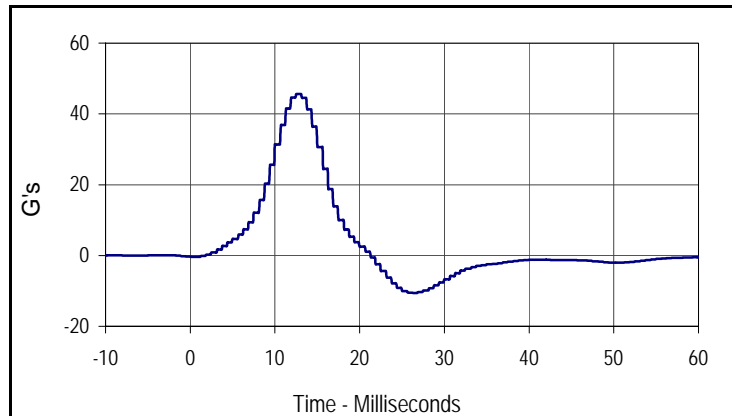
Tested Parameter	Units	Specification	Result	Pass/Fail
Laboratory Temperature	°C	18.9 to 25.6	21.1	Pass
Laboratory Relative Humidity	%	10 to 70	30	Pass
Probe Velocity	m/s	4.21 to 4.33	4.28	Pass
Peak Pelvis Acceleration	G's	40.0 to 60.0	45.7	Pass
Acceleration Time Above 20 G's	Msec.	3.0 to 7.0	6.10	Pass
Overall Test Results				Pass

Curve Description			
Pelvis Y Primary			
CURNO	Type	SAE Class	Units
001	FIL	FIR100	G's
Max	Time	Min	Time
45.7	12.5	-10.6	26.3

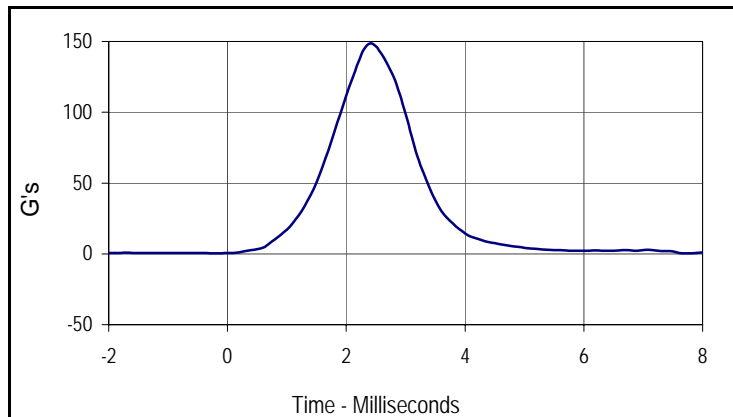
Test Program: SID / HIII Head Drop Lateral Impact Test
 ATD Serial No.: 274

Tested Parameter	Units	Specification	Result	Pass/Fail
Laboratory Temperature	°C	18.9 to 25.6	21.7	Pass
Laboratory Relative Humidity	%	10 to 70	30	Pass
Peak Resultant Acceleration	G's	120.0 to 150.0	148.6	Pass
Peak Longitudinal Acceleration	G's	≤15.0	6.4	Pass
Is Acceleration Unimodal?	Yes/No	Yes	Yes	Pass
Oscillations After Main Pulse	%	<15	2.9	Pass
Overall Test Results			Pass

Curve Description			
Head Resultant			
CURNO	Type	SAE Class	Units
001	RES	1000	G's
Max	Time	Min	Time
148.6	2.4	0.5	-0.2

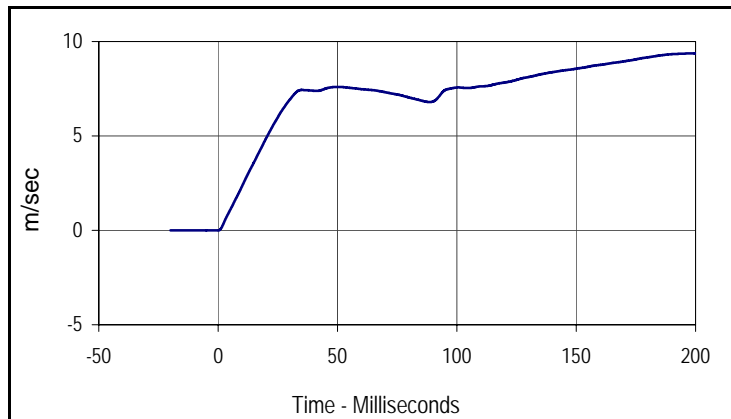
Tested Parameter	Units	Specification	Result	Pass/Fail	
Laboratory Temperature	°C	20.6 to 22.2	21.1	Pass	
Laboratory Relative Humidity	%	10 to 70	30	Pass	
Pendulum Velocity	m/sec	6.89 to 7.13	7.09	Pass	
Pendulum Deceleration	10 Msec.	m/sec	1.96 to 2.55	2.34	Pass
	20 Msec.	m/sec	4.12 to 5.10	4.85	Pass
	30 Msec.	m/sec	5.73 to 7.01	6.92	Pass
	40 to 70	m/sec	6.27 to 7.64	7.60	Pass
"D" Plane Rotation	Max	Degrees	66.0 to 82.0	79.2	Pass
Max Rotation Time After Peak Moment	Msec.	2.0 to 16.0	10.0	Pass	
Rotation Time From Peak to Zero Angle	Msec.	58.0 to 67.0	59.9	Pass	
Moment About Occipital Condyle	Nm	73.0 to 88.0	86.3	Pass	
Positive Moment Decay, Time To 0 Nm	Msec.	49.0 to 64.0	49.7	Pass	
Overall Test Results				Pass

Curve Description			
Pendulum Velocity			
CURNO	Type	SAE Class	Units
001	FIL	180	m/sec
Max	Time	Min	Time
9.4	198.6	0.0	-0.1

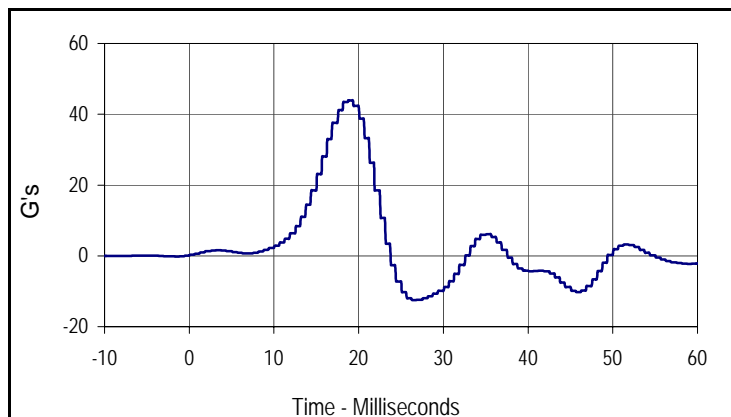
Tested Parameter	Units	Specification	Result	Pass/Fail
Laboratory Temperature	°C	18.9 to 25.6	21.1	Pass
Laboratory Relative Humidity	%	10 to 70	30	Pass
Probe Velocity	m/s	4.21 to 4.33	4.24	Pass
Upper Rib Acceleration	G's	37.0 to 46.0	43.9	Pass
Lower Rib Acceleration	G's	37.0 to 46.0	43.5	Pass
Thoracic Spine Acceleration	G's	15.0 to 22.0	19.8	Pass
Overall Test Results			Pass

Curve Description			
Upper Rib Y Primary			
CURNO	Type	SAE Class	Units
001	FIL	FIR100	G's
Max	Time	Min	Time
43.9	18.8	-12.5	26.3

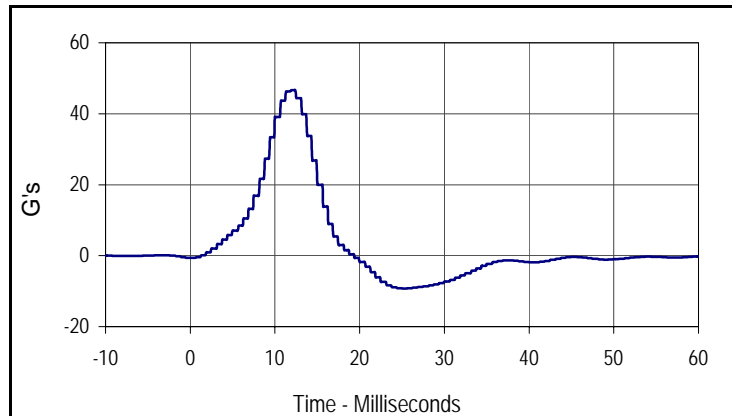
Tested Parameter	Units	Specification	Result	Pass/Fail
Laboratory Temperature	°C	18.9 to 25.6	21.1	Pass
Laboratory Relative Humidity	%	10 to 70	30	Pass
Probe Velocity	m/s	4.21 to 4.33	4.30	Pass
Peak Pelvis Acceleration	G's	40.0 to 60.0	46.6	Pass
Acceleration Time Above 20 G's	Msec.	3.0 to 7.0	6.70	Pass
Overall Test Results				Pass

Curve Description			
Pelvis Y Primary			
CURNO	Type	SAE Class	Units
001	FIL	FIR100	G's
Max	Time	Min	Time
46.6	11.9	-9.3	25.0

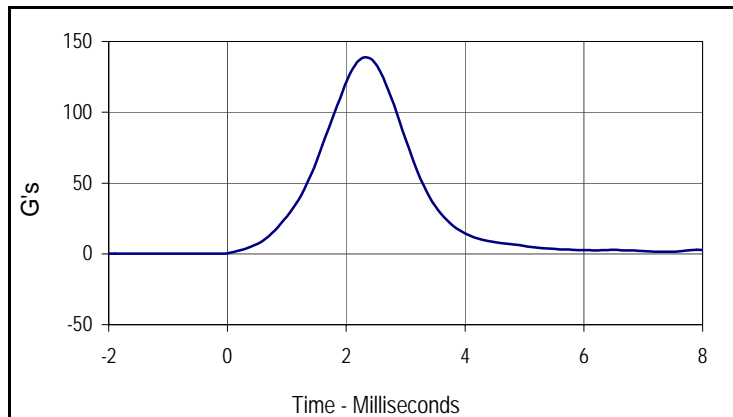
Test Program: SID / HIII Head Drop Lateral Impact Test

Tested Parameter	Units	Specification	Result	Pass/Fail
Laboratory Temperature	°C	18.9 to 25.6	21.7	Pass
Laboratory Relative Humidity	%	10 to 70	30	Pass
Peak Resultant Acceleration	G's	120.0 to 150.0	138.8	Pass
Peak Longitudinal Acceleration	G's	≤15.0	8.0	Pass
Is Acceleration Unimodal?	Yes/No	Yes	Yes	Pass
Oscillations After Main Pulse	%	<15	4.0	Pass
Overall Test Results				Pass

Curve Description			
Head Resultant			
CURNO	Type	SAE Class	Units
001	RES	1000	G's
Max	Time	Min	Time
138.8	2.3	0.1	-0.9

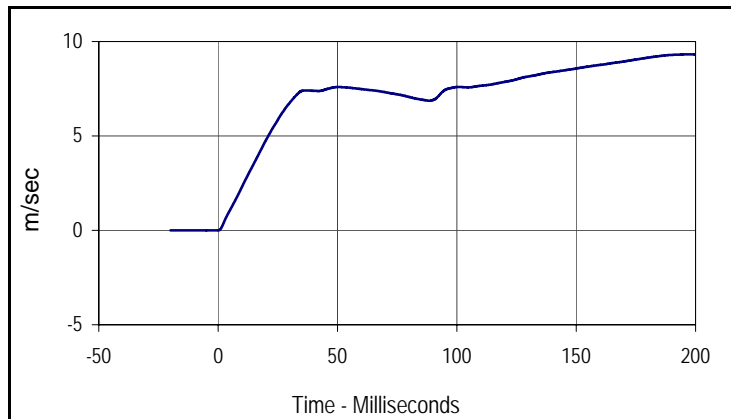
Tested Parameter	Units	Specification	Result	Pass/Fail	
Laboratory Temperature	°C	20.6 to 22.2	21.1	Pass	
Laboratory Relative Humidity	%	10 to 70	30	Pass	
Pendulum Velocity	m/sec	6.89 to 7.13	7.09	Pass	
Pendulum Deceleration	10 Msec.	m/sec	1.96 to 2.55	2.31	Pass
	20 Msec.	m/sec	4.12 to 5.10	4.77	Pass
	30 Msec.	m/sec	5.73 to 7.01	6.76	Pass
	40 to 70	m/sec	6.27 to 7.64	7.59	Pass
"D" Plane Rotation	Max	Degrees	66.0 to 82.0	81.3	Pass
Max Rotation Time After Peak Moment	Msec.	2.0 to 16.0	15.4	Pass	
Rotation Time From Peak to Zero Angle	Msec.	58.0 to 67.0	61.9	Pass	
Moment About Occipital Condyle	Nm	73.0 to 88.0	76.8	Pass	
Positive Moment Decay, Time To 0 Nm	Msec.	49.0 to 64.0	50.4	Pass	
Overall Test Results				Pass

Curve Description			
Pendulum Velocity			
CURNO	Type	SAE Class	Units
001	FIL	180	m/sec
Max	Time	Min	Time
9.3	196.6	0.0	-0.1
