**REPORT NUMBER: 201-MGA-2008-001**

**SAFETY COMPLIANCE TESTING FOR FMVSS 201  
RIGID POLE SIDE IMPACT TEST**

**FUJI HEAVY INDUSTRIES LTD.  
2008 SUBARU IMPREZA 4-DOOR  
NHTSA NUMBER: C85501**

**FINAL REPORT**

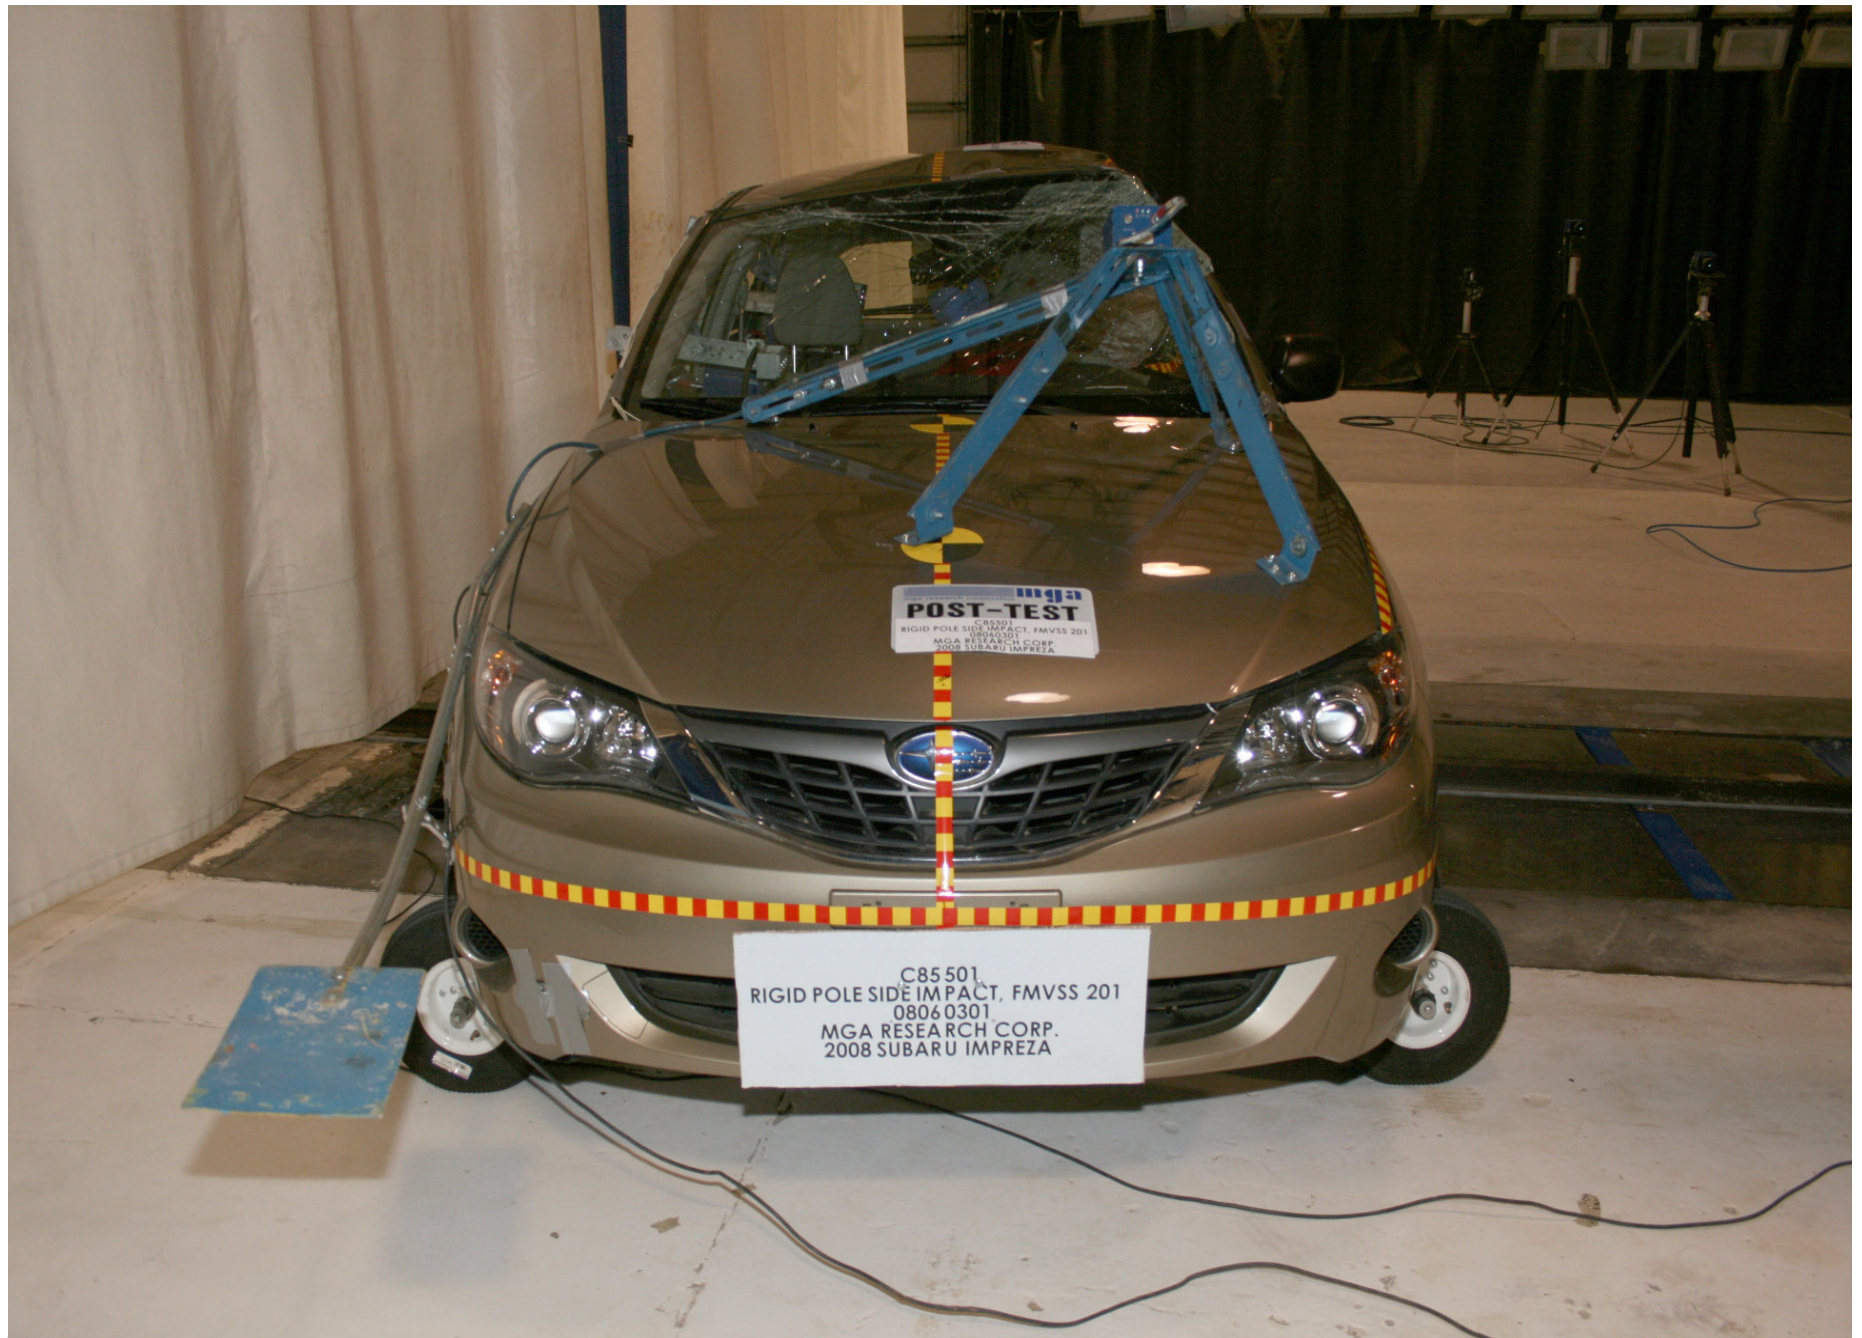
Post-Test Front View of Test Vehicle

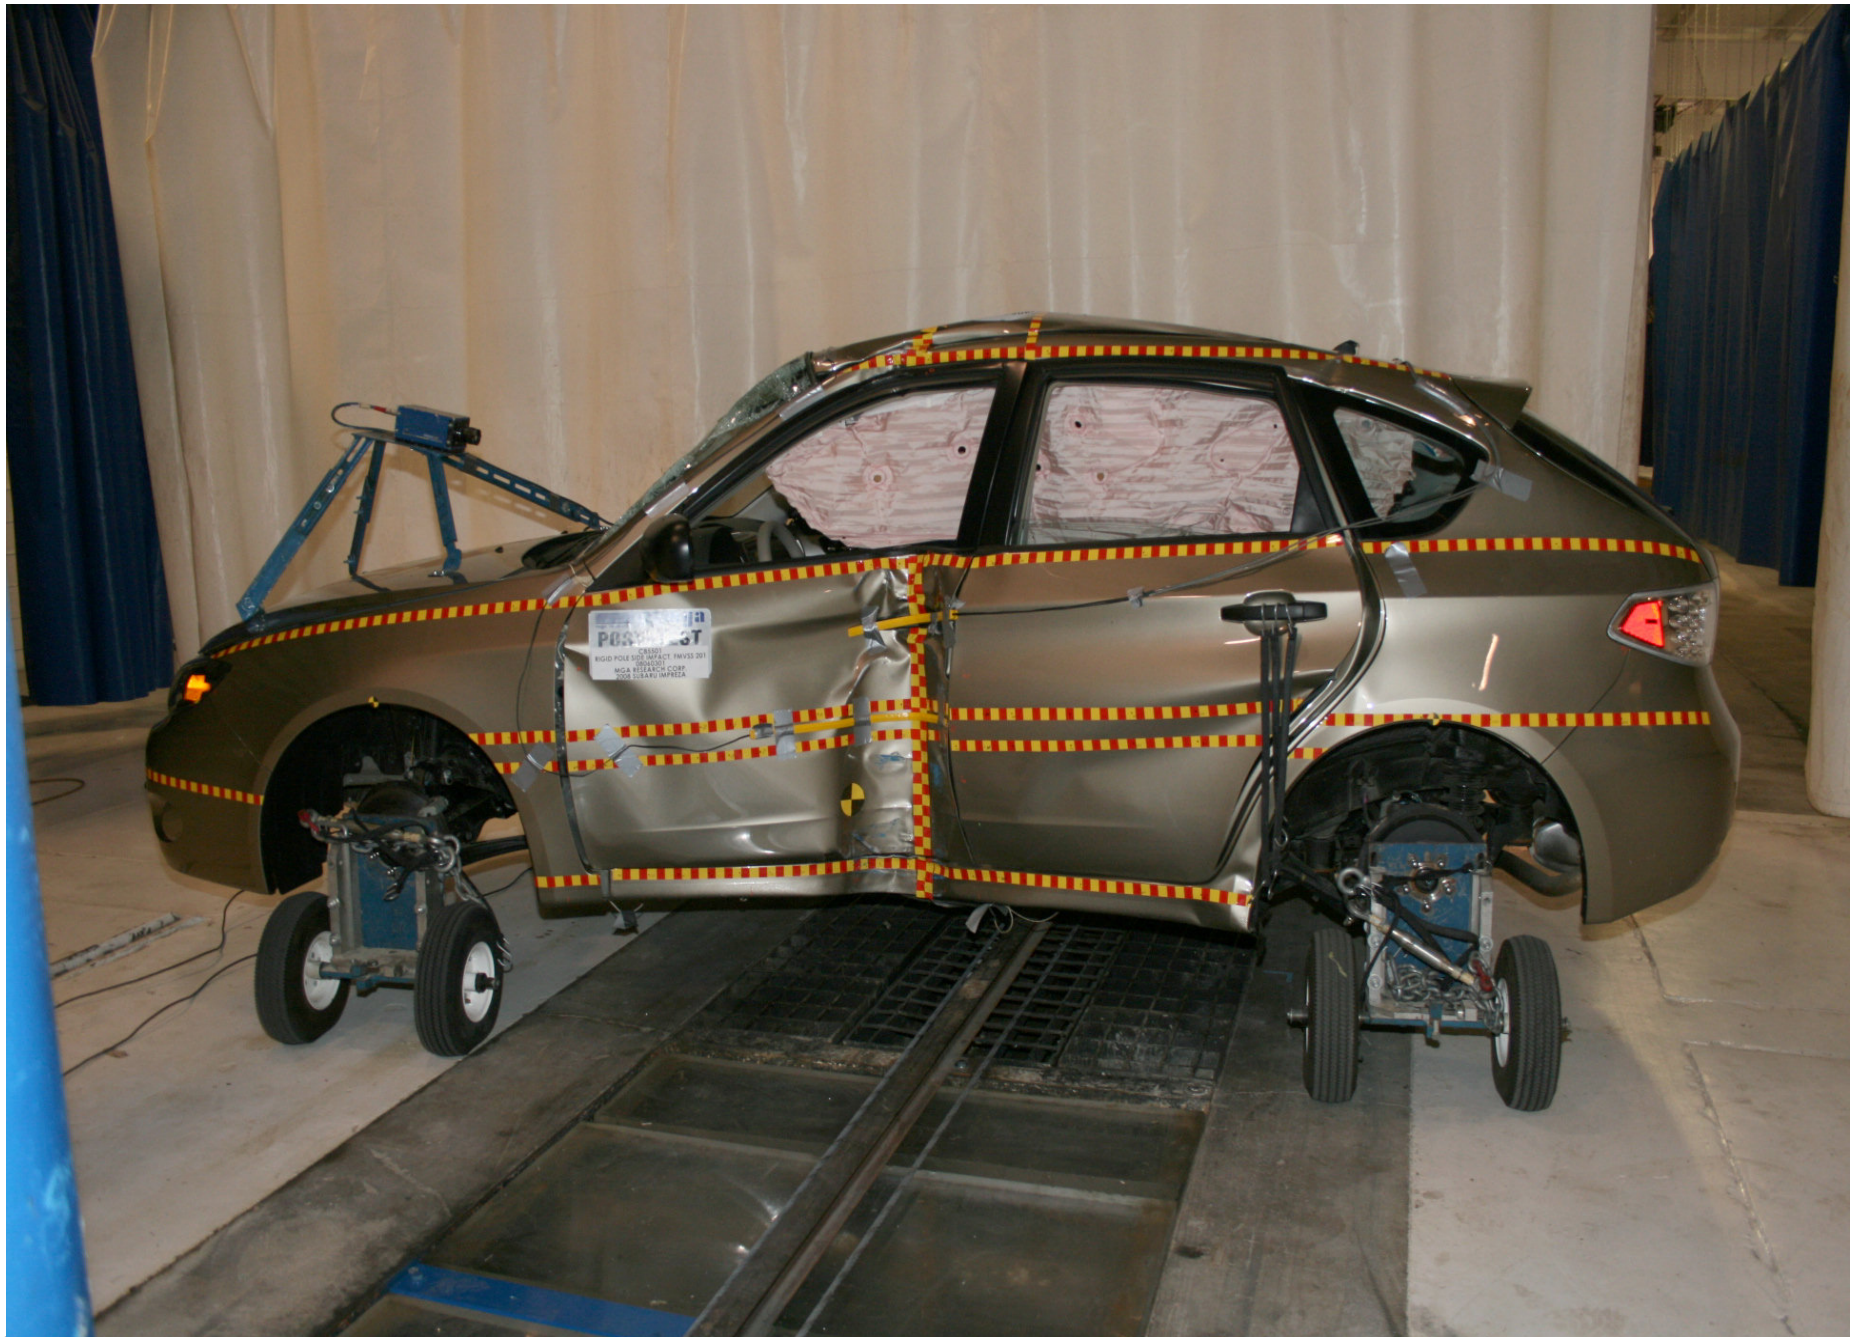
Post-Test Left Side View of Test Vehicle

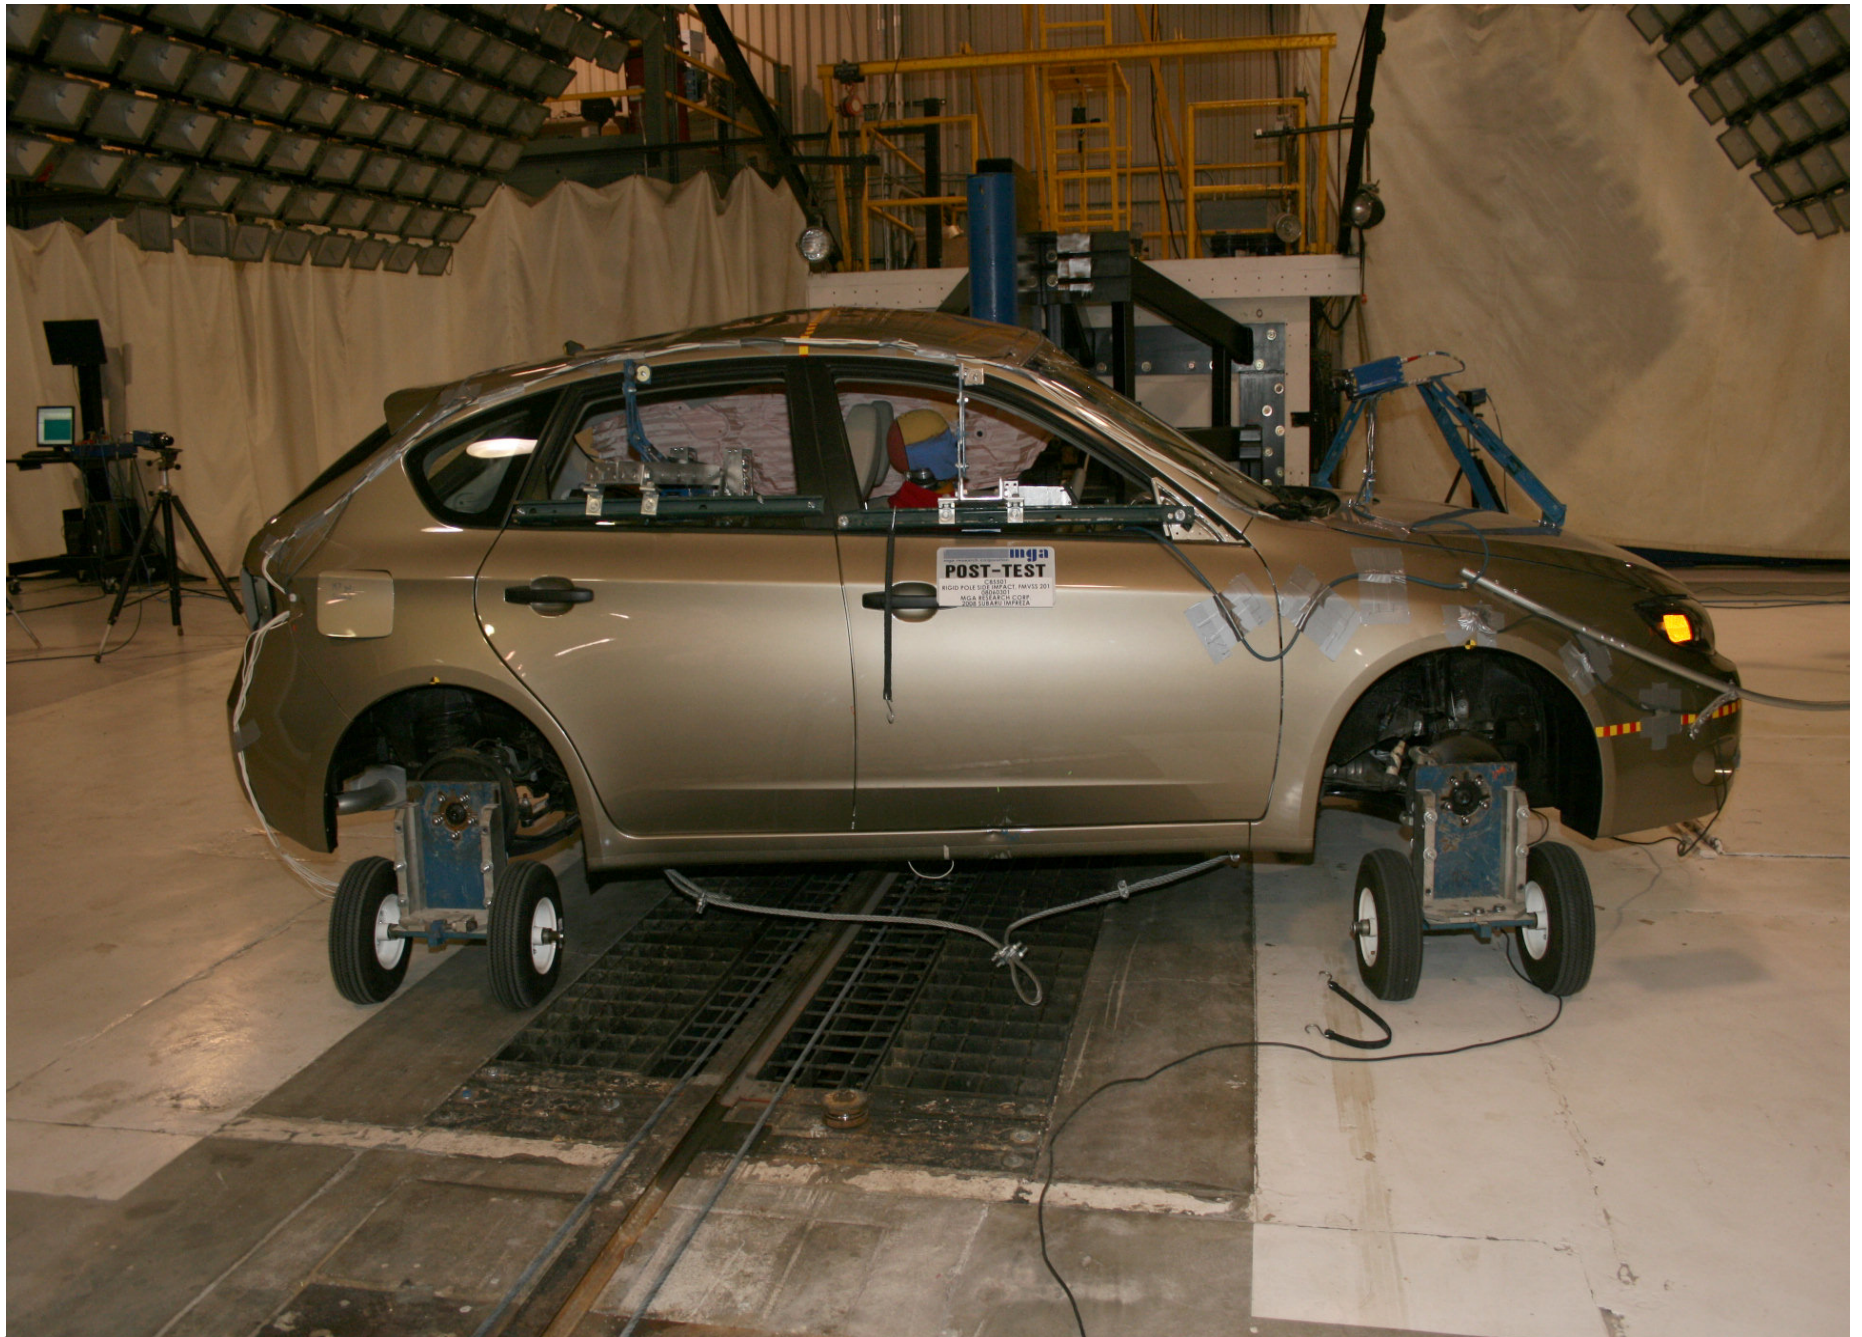
Post-Test Right Side View of Test Vehicle

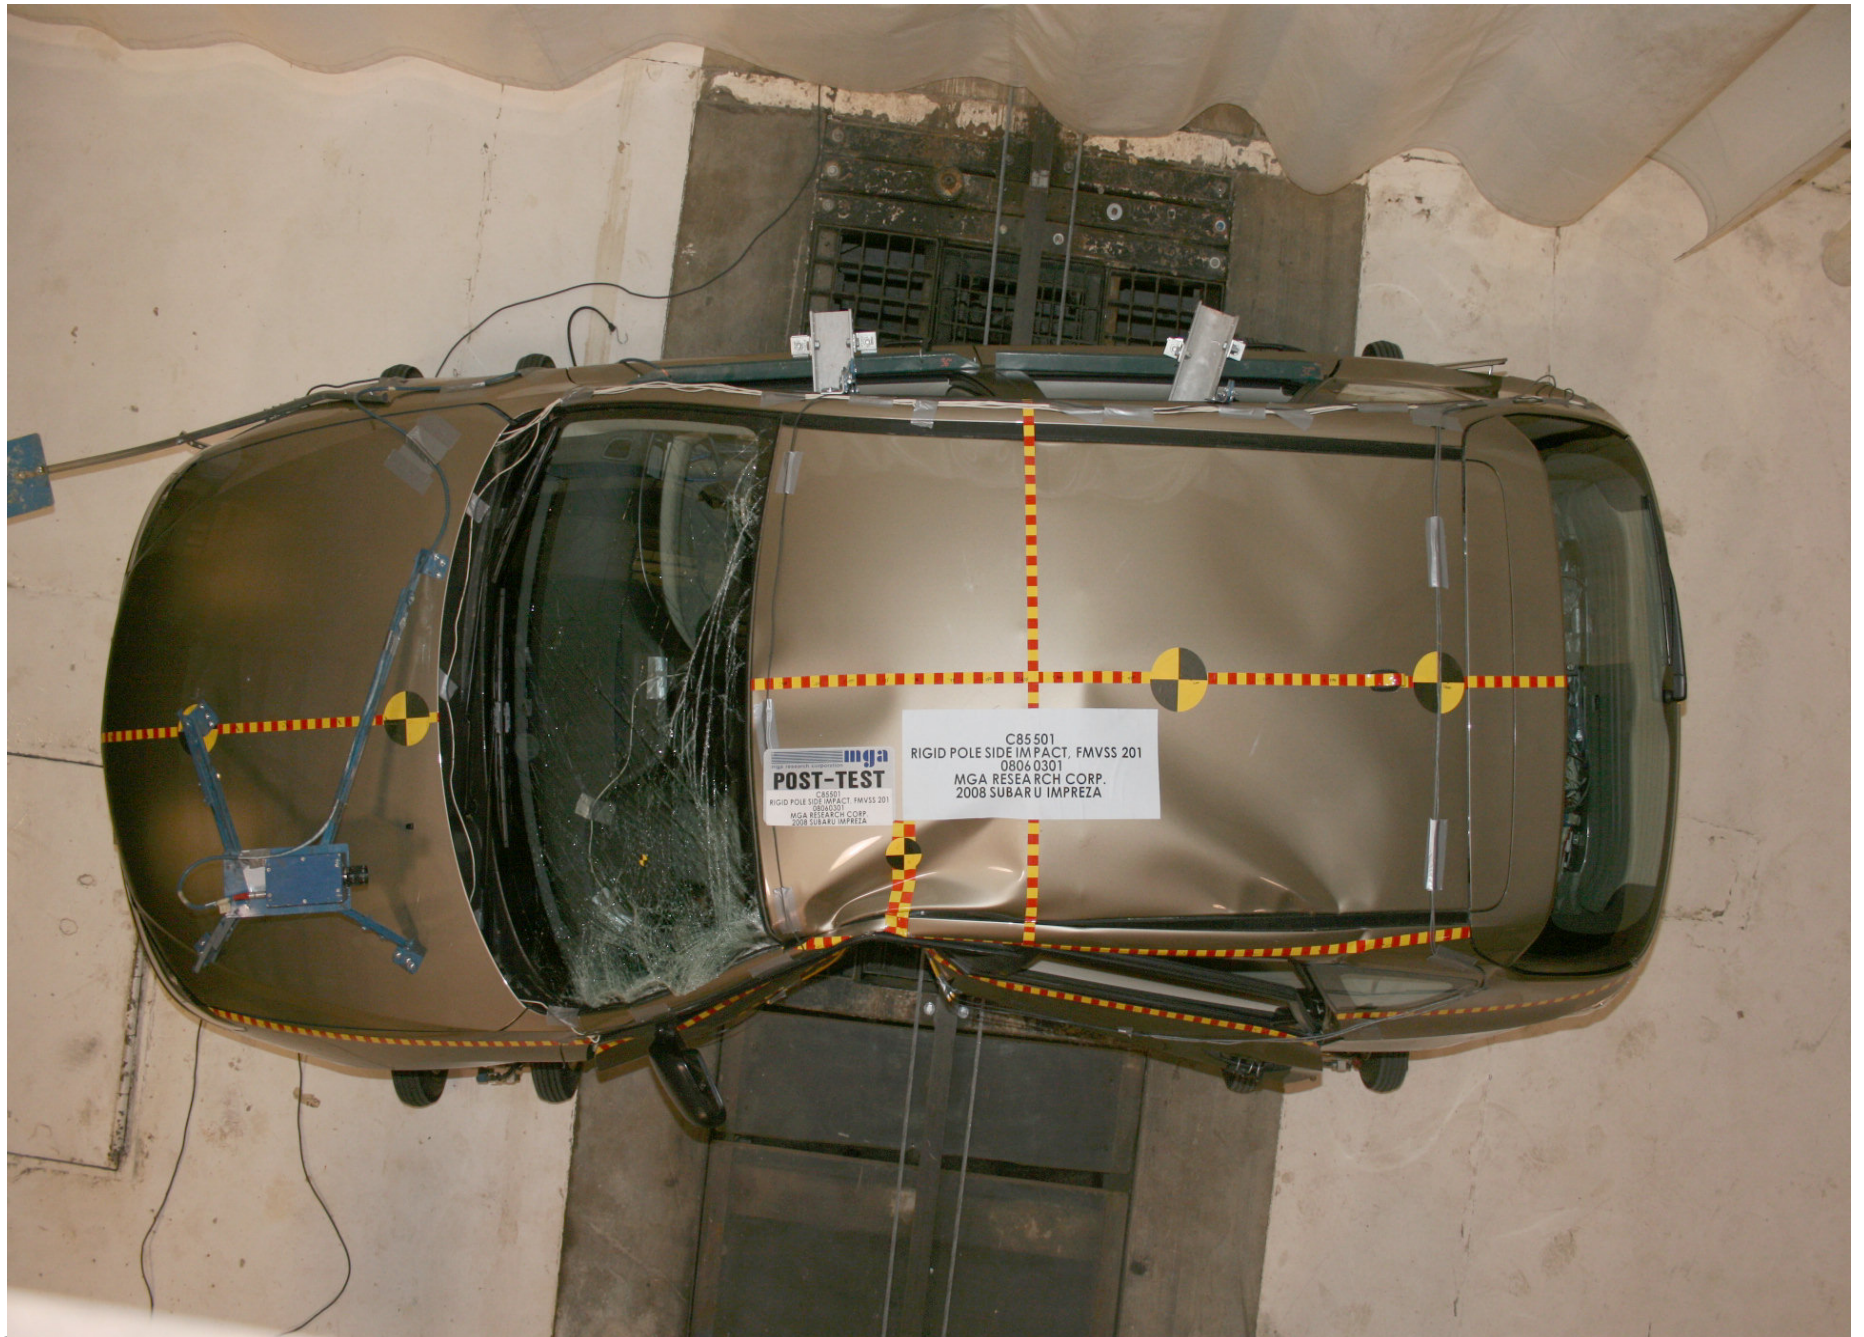
Post-Test Overhead View of Test Vehicle

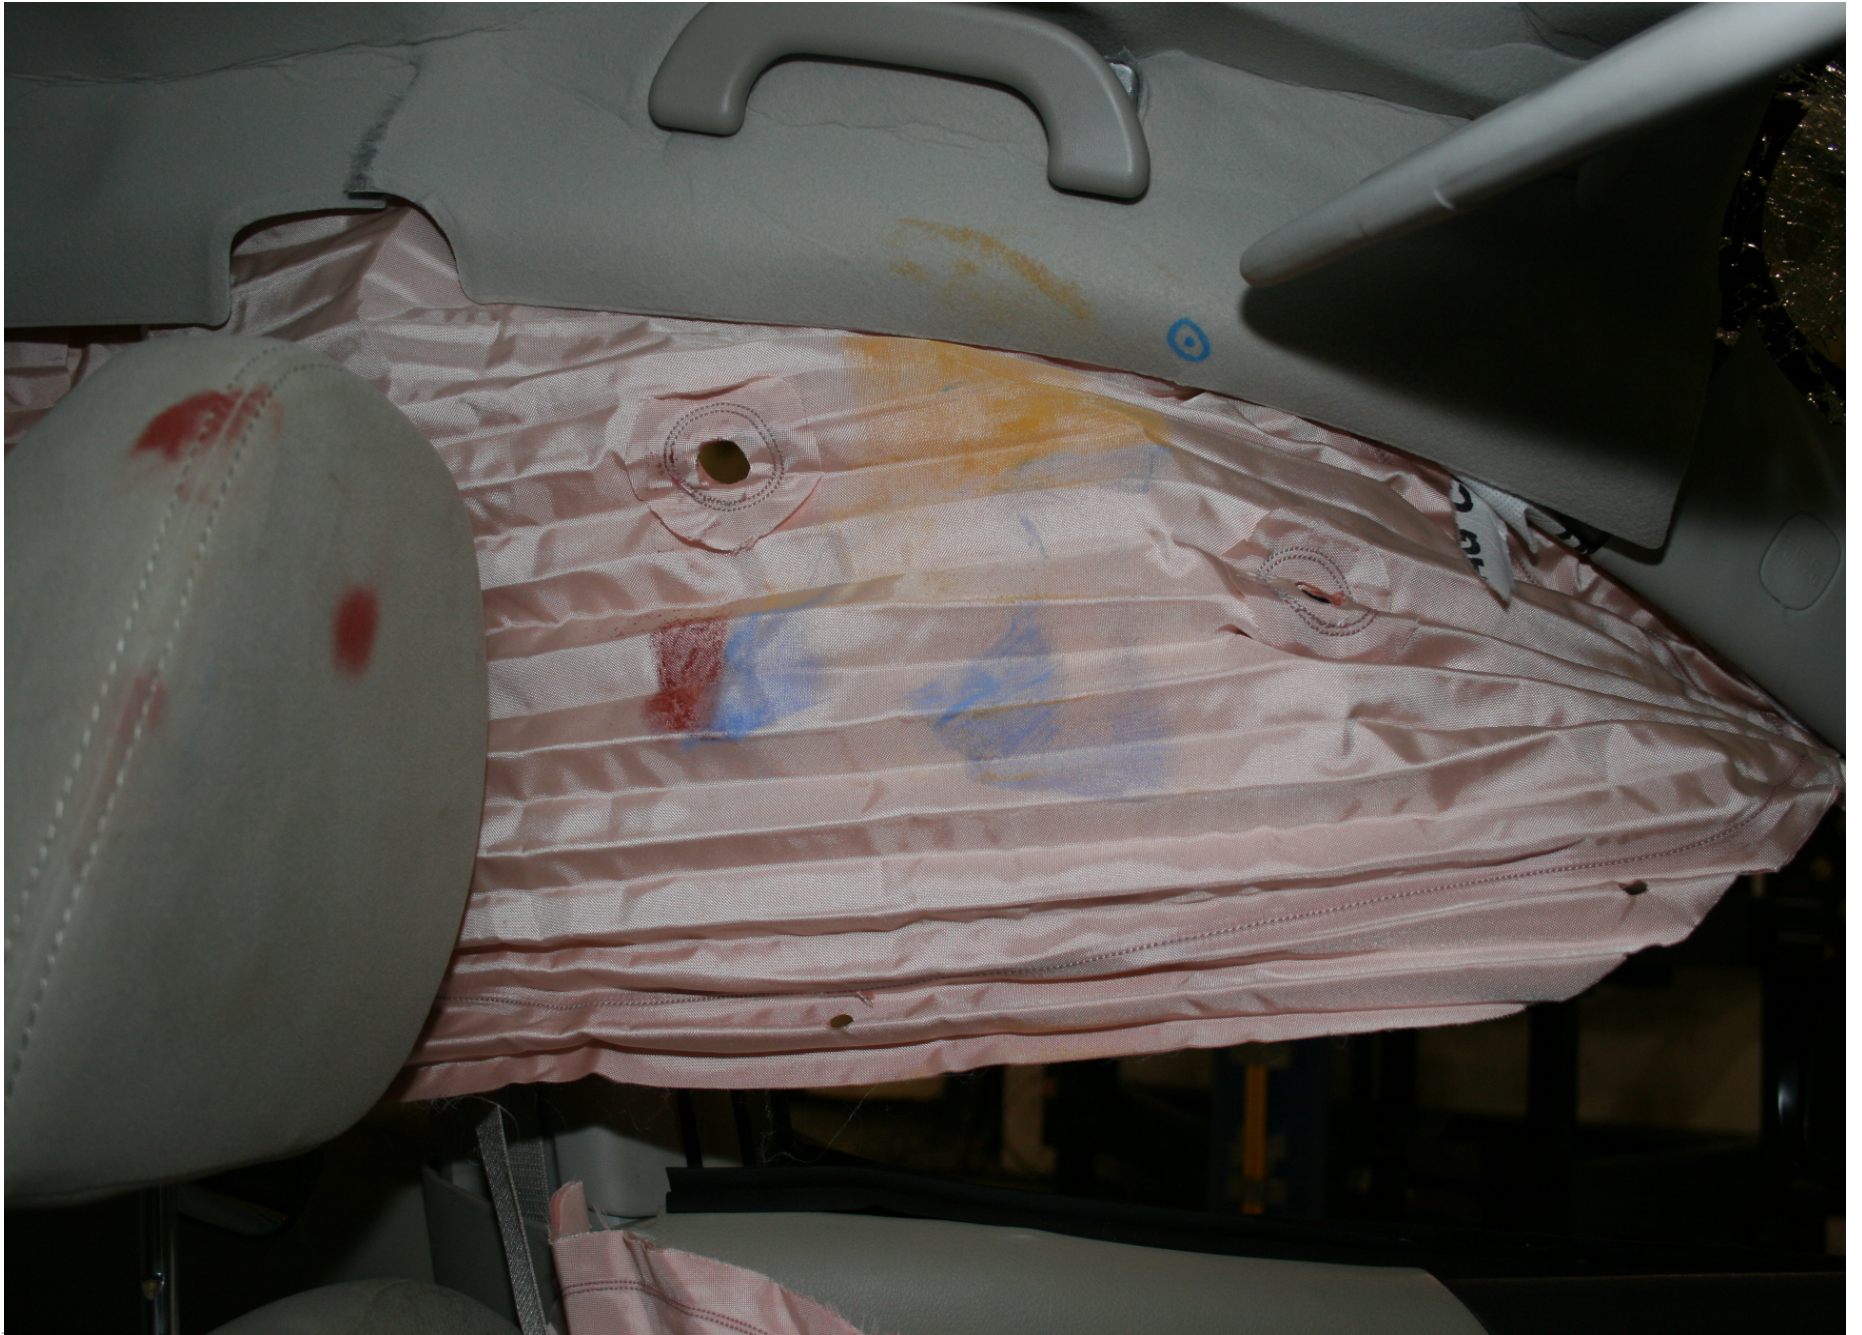
Post-Test Driver Dummy Head Contact (CAB & Headrest)

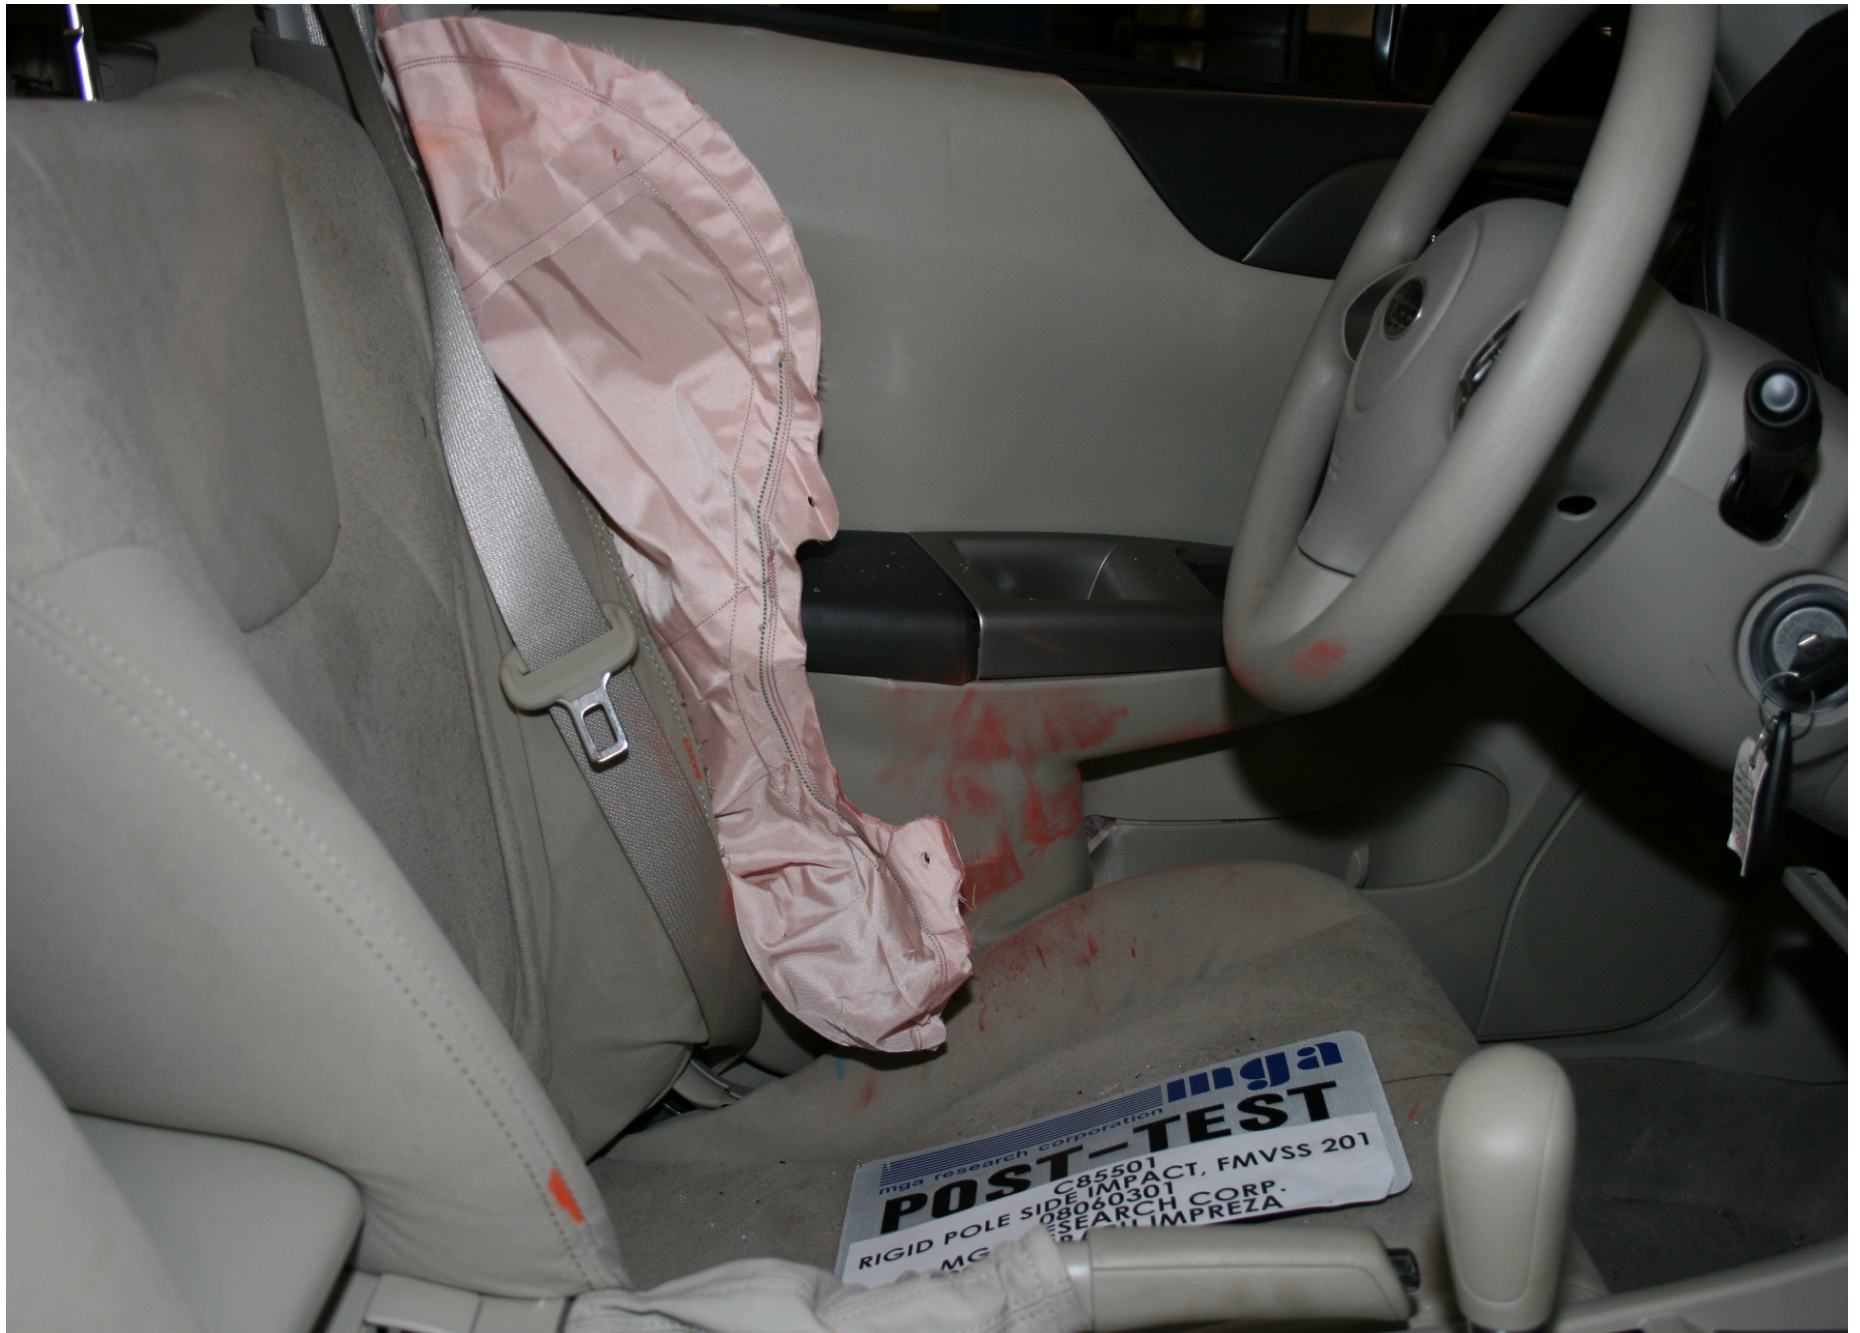
Post-Test Driver Dummy Upper Thorax Contact

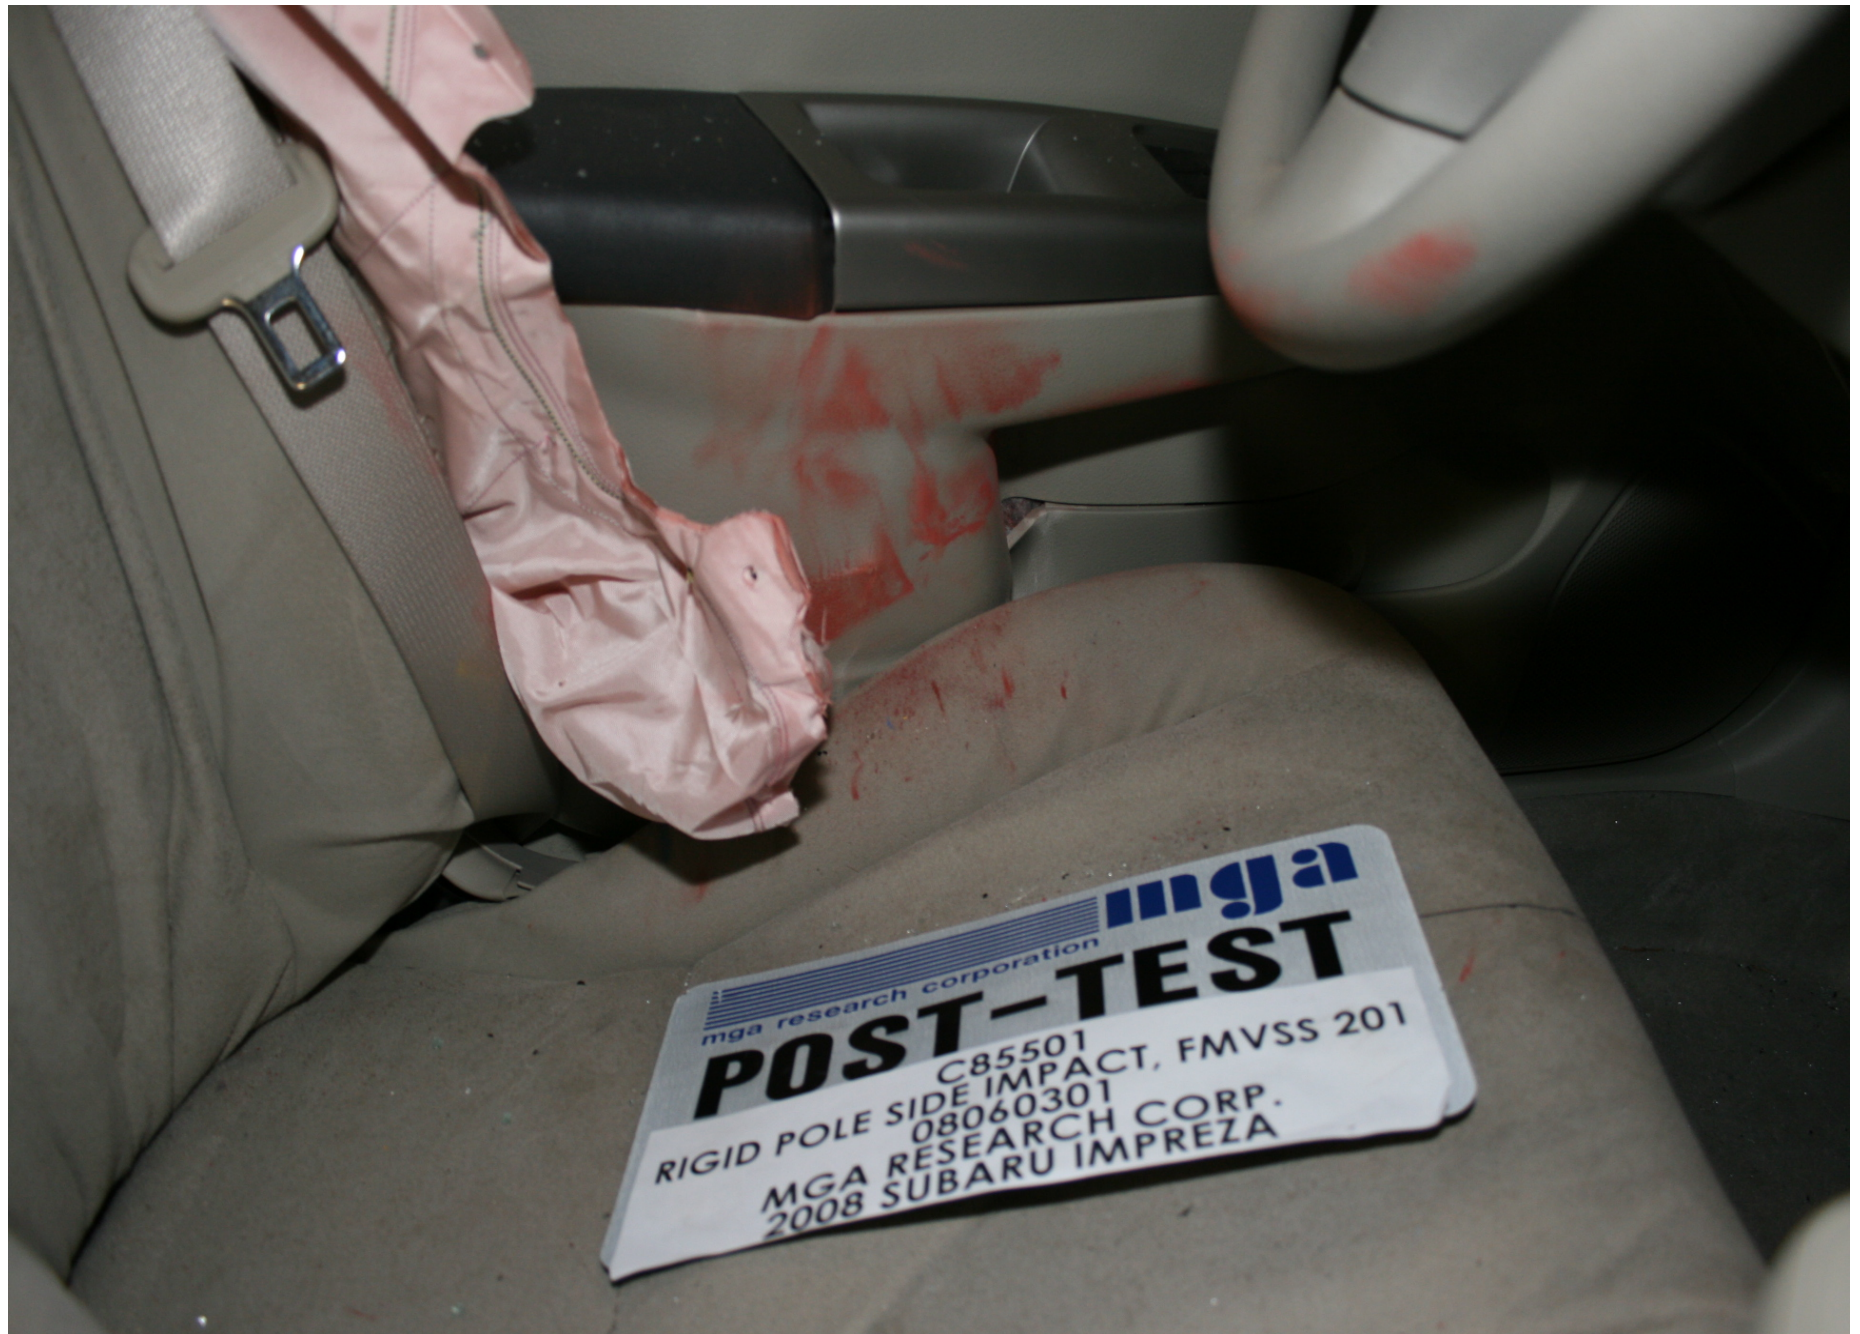
Post-Test Driver Dummy Lower Thorax Contact

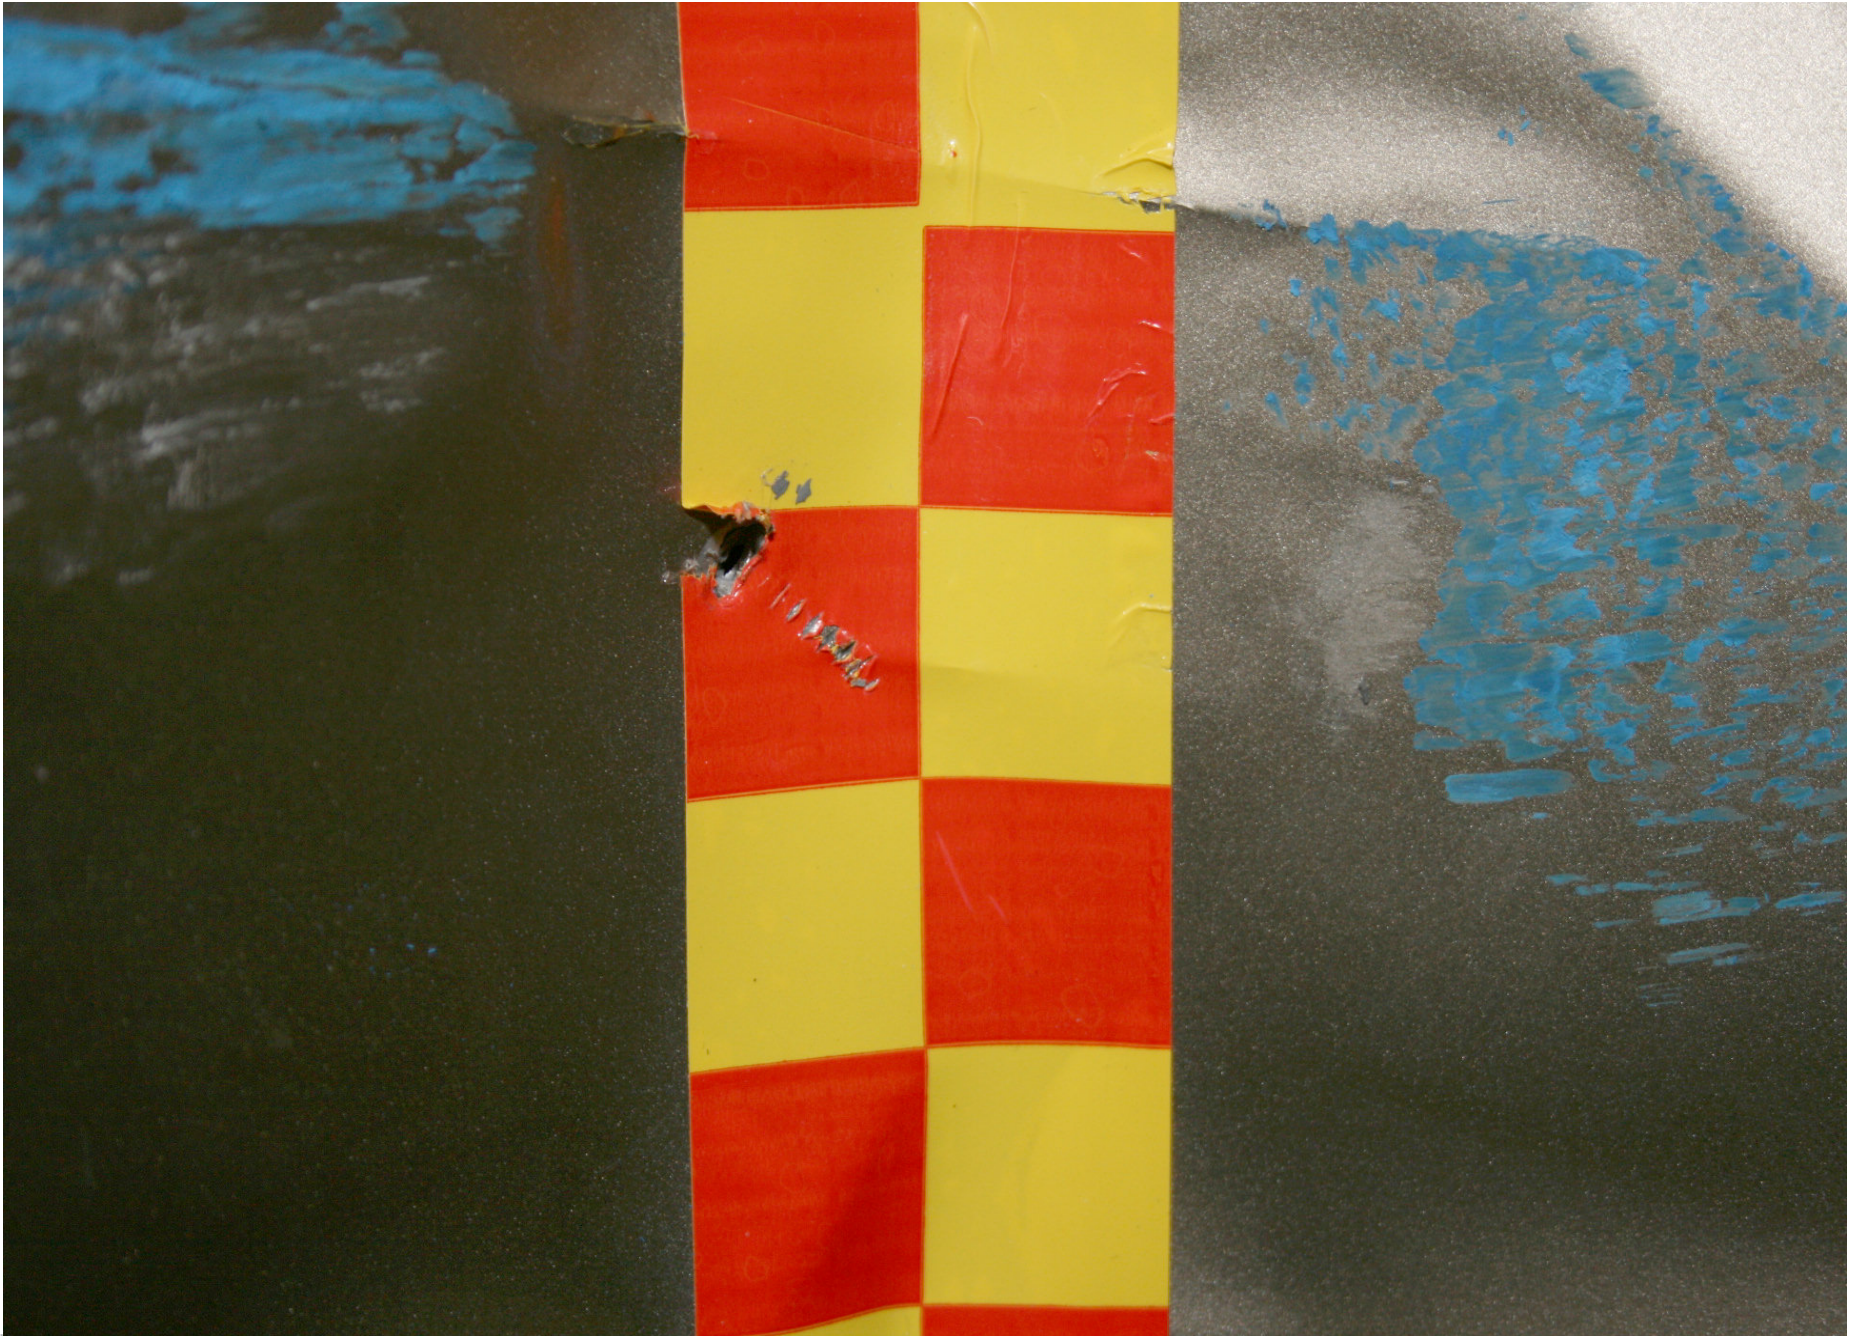
Post-Test Impact Point on Vehicle

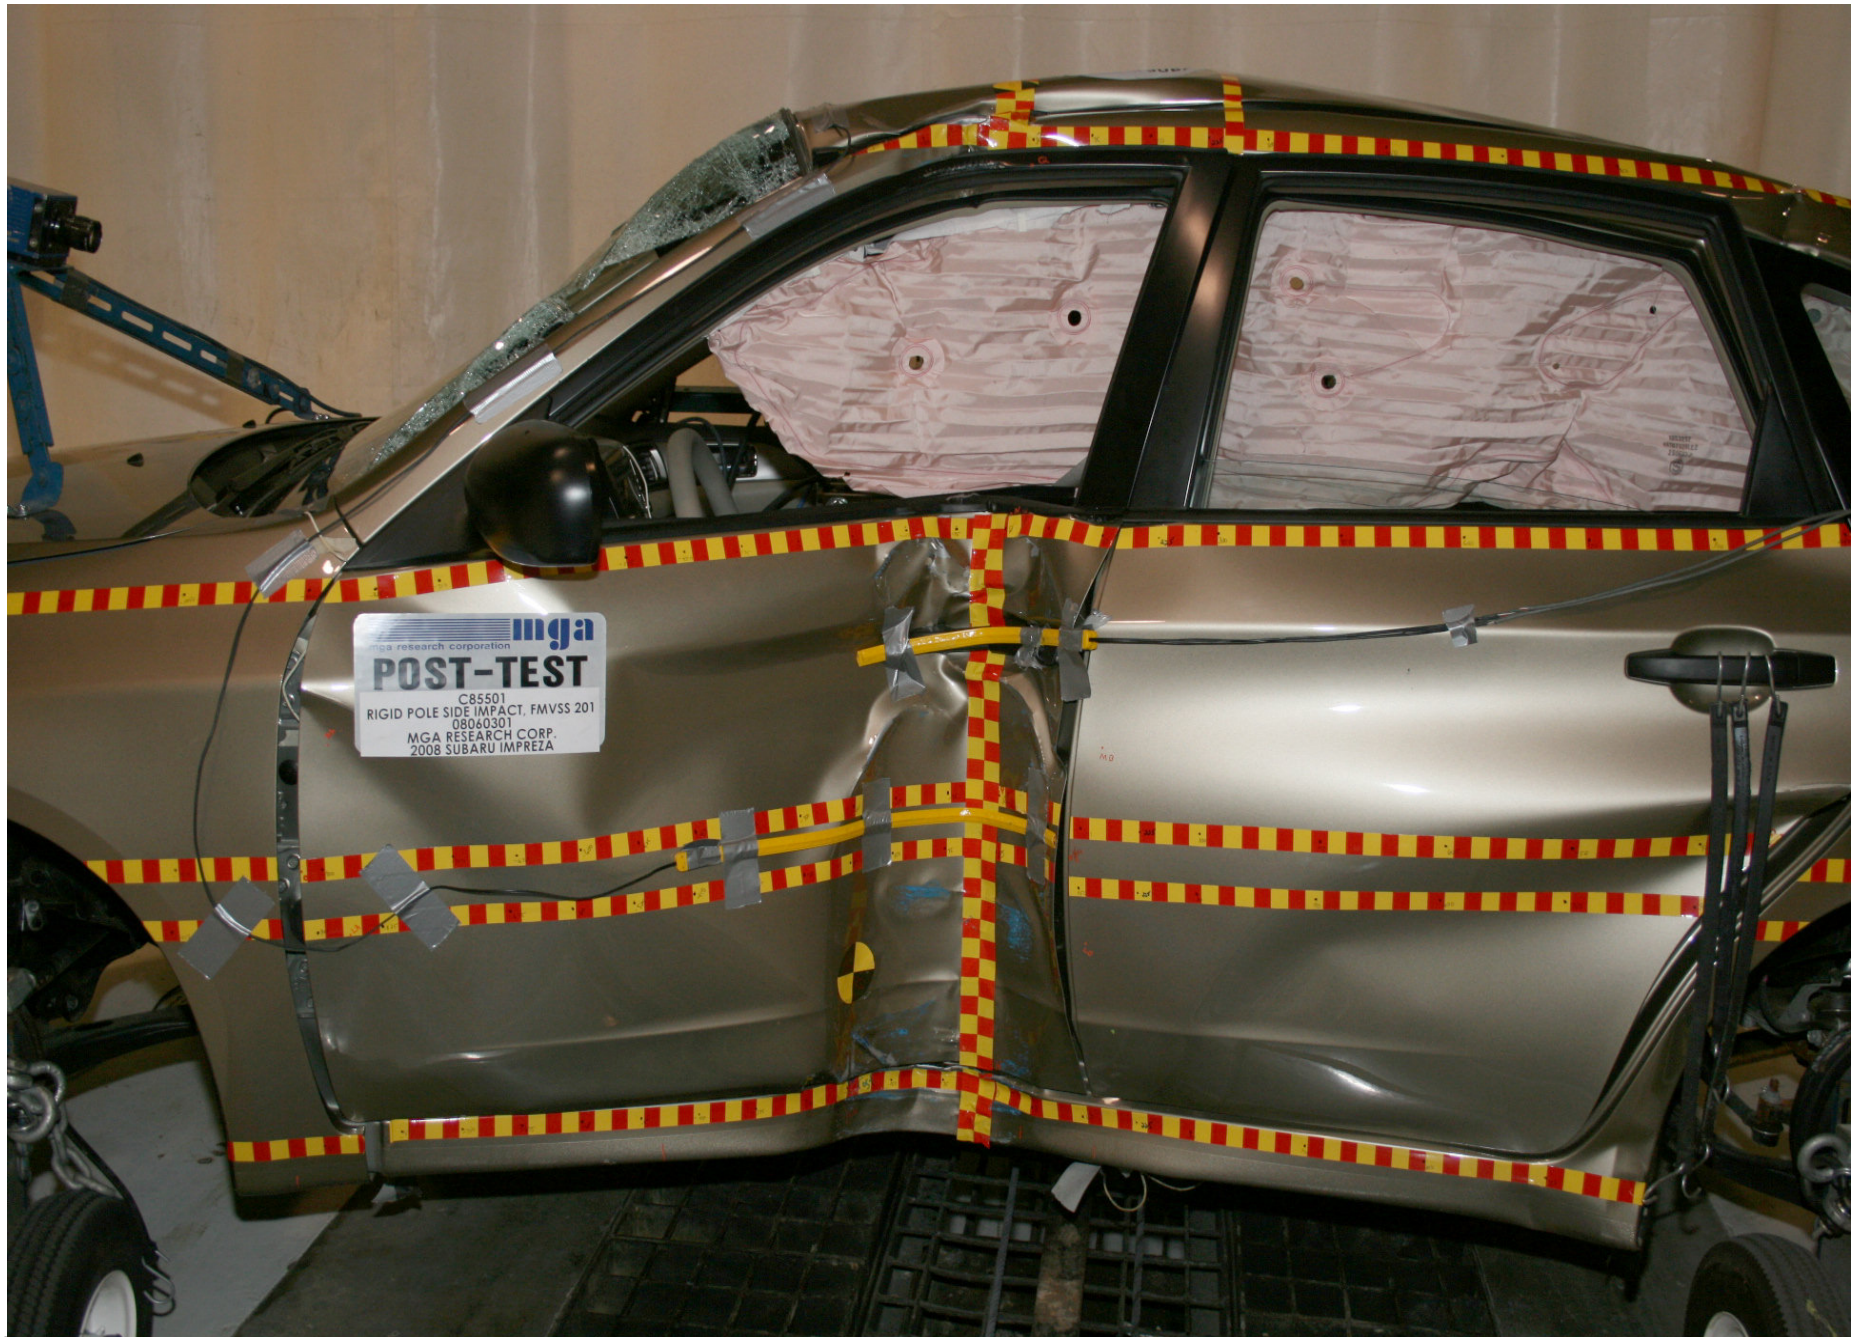
Post-Test Impact Zone Close-up View

The test vehicle sustained a maximum static crush of 314 mm at level 3, at the vertical impact line. The driver SID/HIII, Serial No. 036, was calibrated just prior to this test. The SID/HIII's injury criteria are summarized as follows:
