REPORT NUMBER: 201P-CAL-08-02

**SAFETY COMPLIANCE TESTING FOR FMVSS 201  
RIGID POLE SIDE IMPACT TEST**

GENERAL MOTORS CORPORATION  
2008 CHEVROLET IMPALA  
4-DOOR SEDAN

CALSPAN TEST NUMBER: 8863-F201P-02

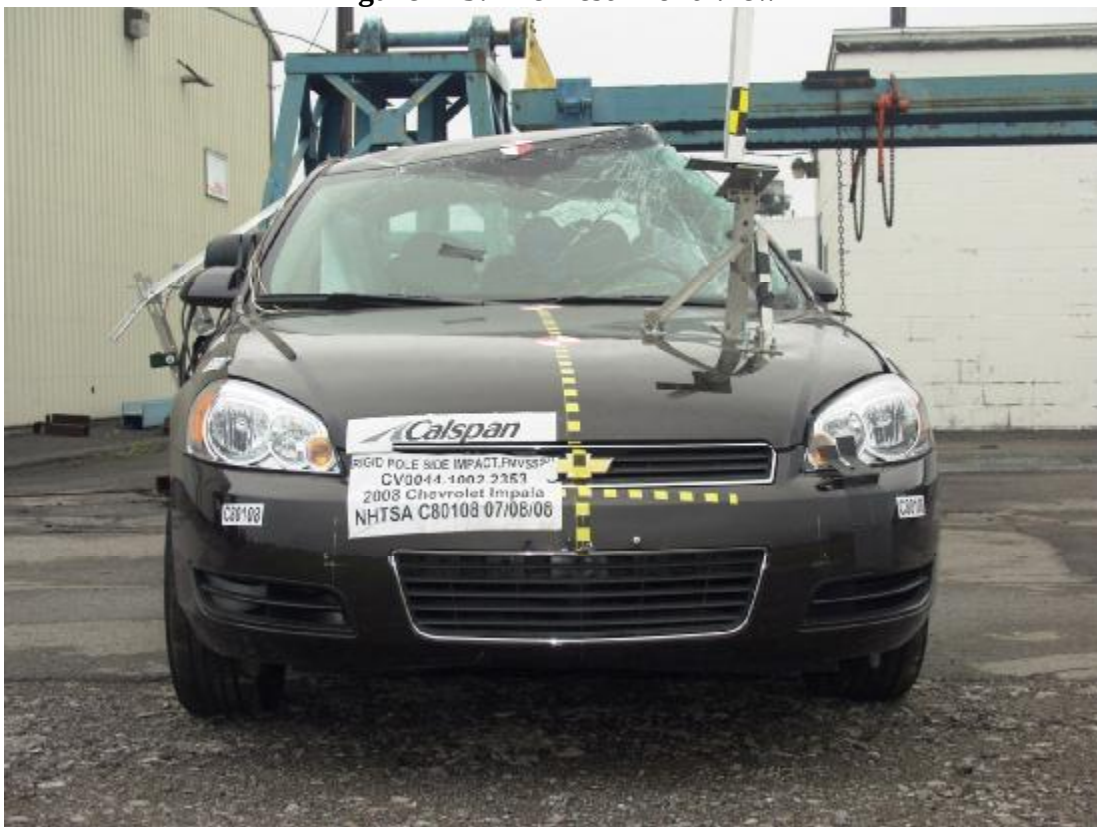
**Figure A-6: Post-Test Front View**

| Windshield: | Severe cracking on left side |

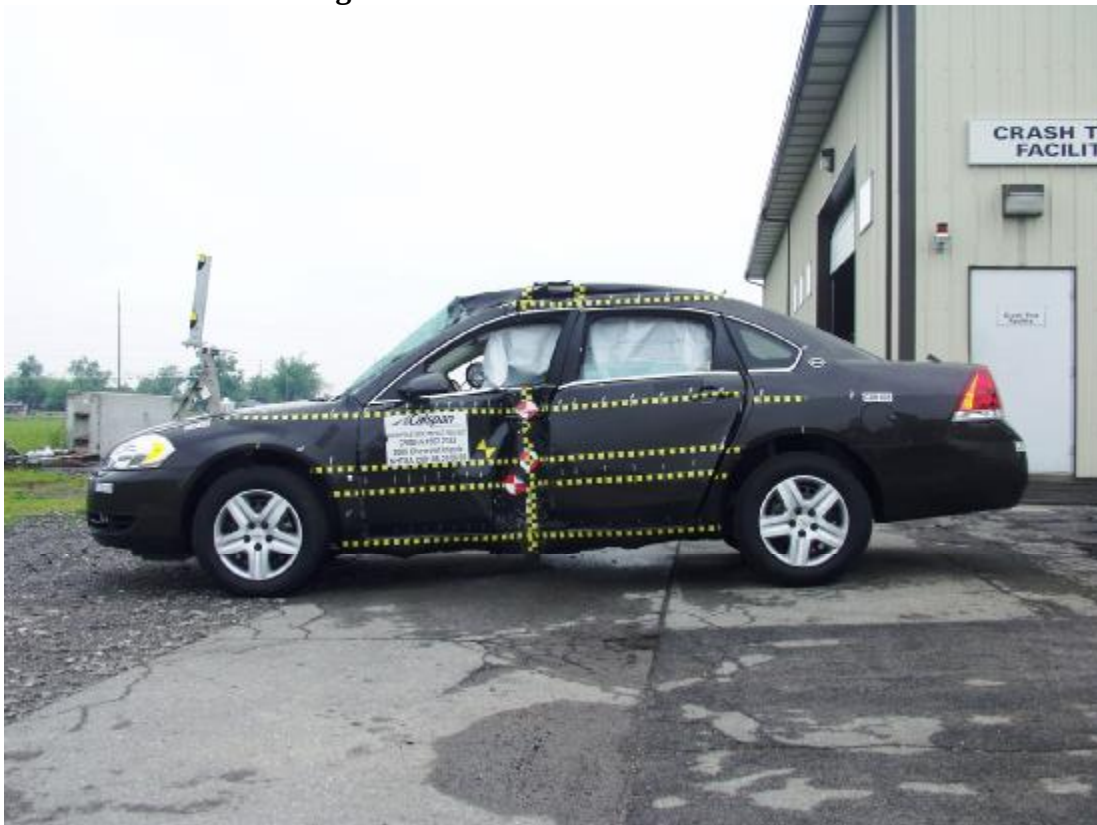
**Figure A-10: Post-Test Left Side View**

MAXIMUM EXTERIOR STATIC CRUSH:

1. LEVEL 1 ( 250 mm above ground) = 267 millimeters

2. LEVEL 2 ( 501 mm above ground) = 337 millimeters

3. LEVEL 3 ( 620 mm above ground) = 351 millimeters

4. LEVEL 4 ( 875 mm above ground) = 330 millimeters

5. LEVEL 5 ( 1398 mm above ground) = 134 millimeters

Maximum Post-Test Intrusion = 351 millimeters

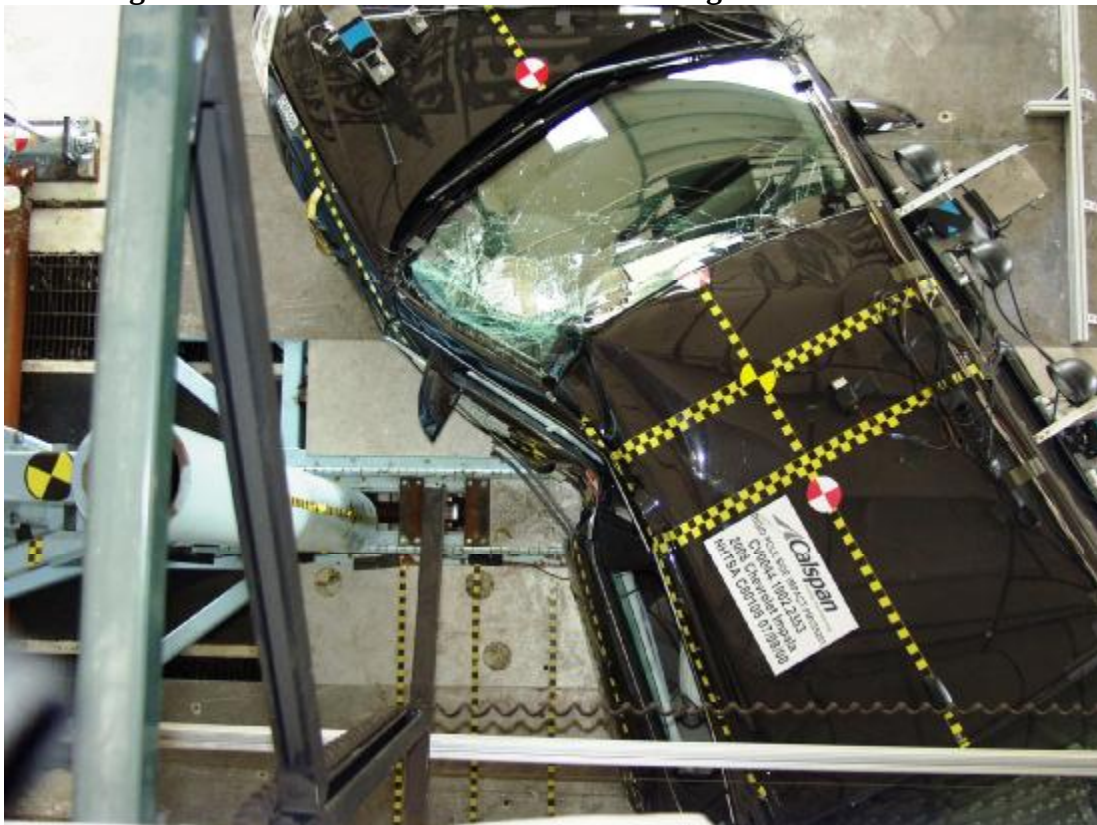
**Figure A-24: Post-Test Overhead View of Vehicle and Pole**

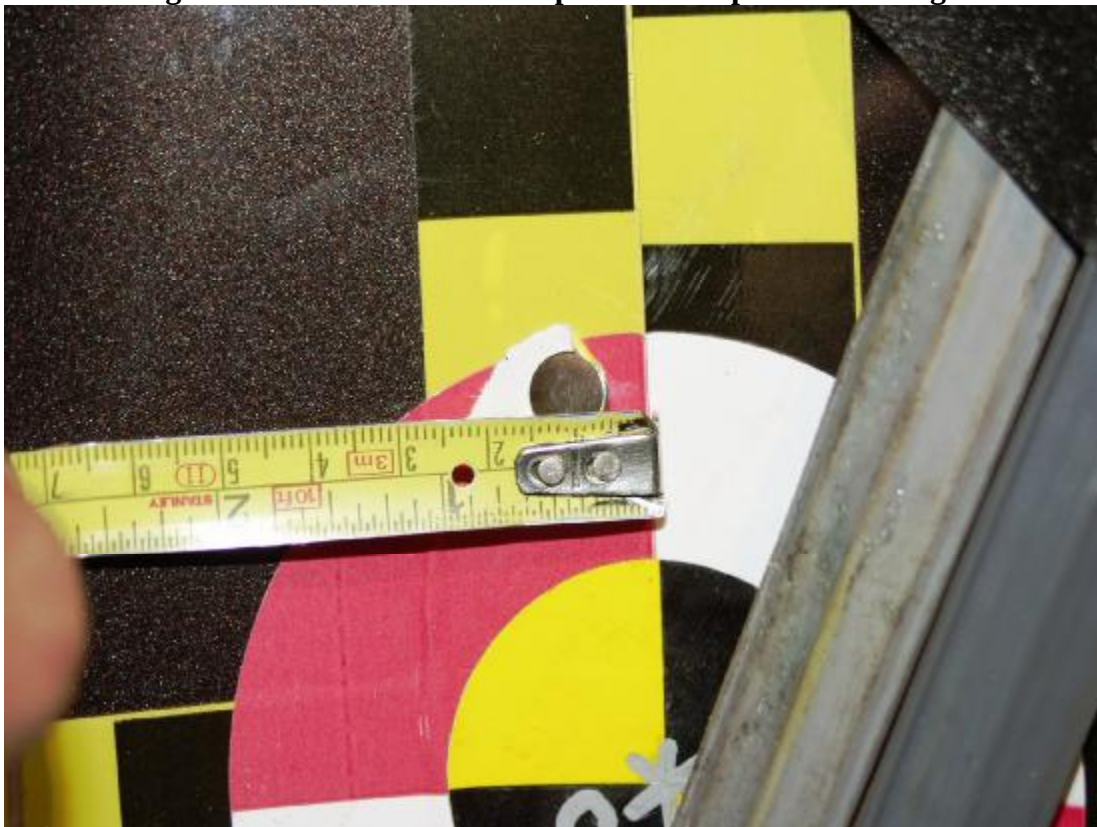
**Figure A-26: Post-Test Close-Up View of Impact Point Target**

Actual Impact Point is 10 mm forward of nominal impact ref. line (Lateral)

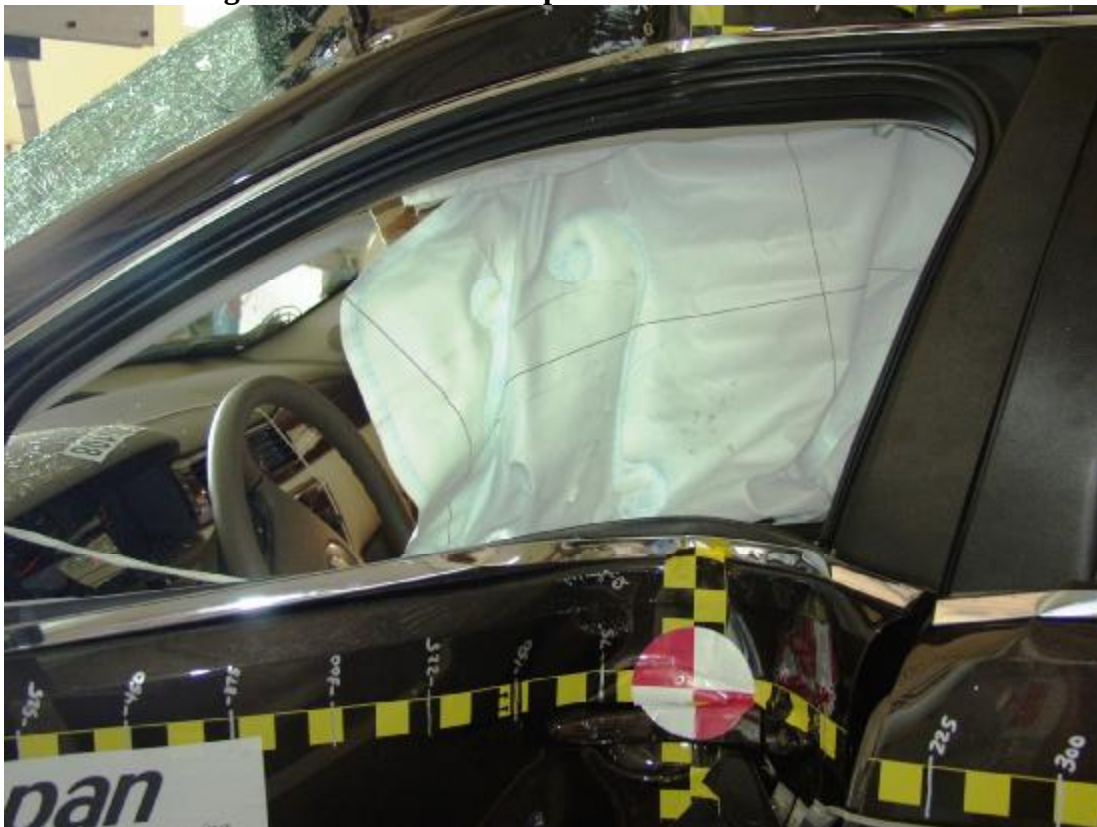
**Figure A-31: Post-Test Impact Side View of SID HIII**

VISIBLE DUMMY CONTACT POINTS:

SID HIII

| Head: | Side Curtain Airbag |
| Upper Torso: | Seat Torso Airbag / Left Side Door |
| Lower Torso: | Seat Torso Airbag / Left Side Door |
| Left Knee: | Left Side Door / Armrest |
| Right Knee: | Left Knee |

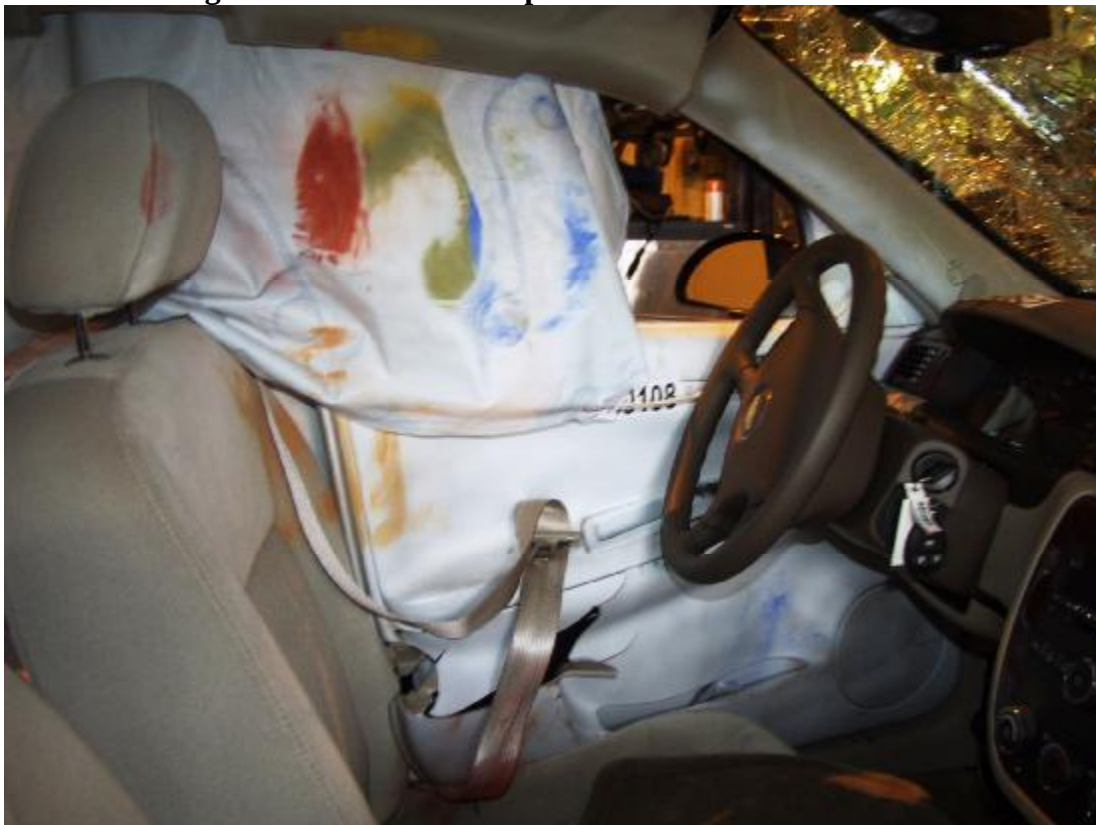
**Figure A-35: Post-Test Impact Side Front Interior Trim**

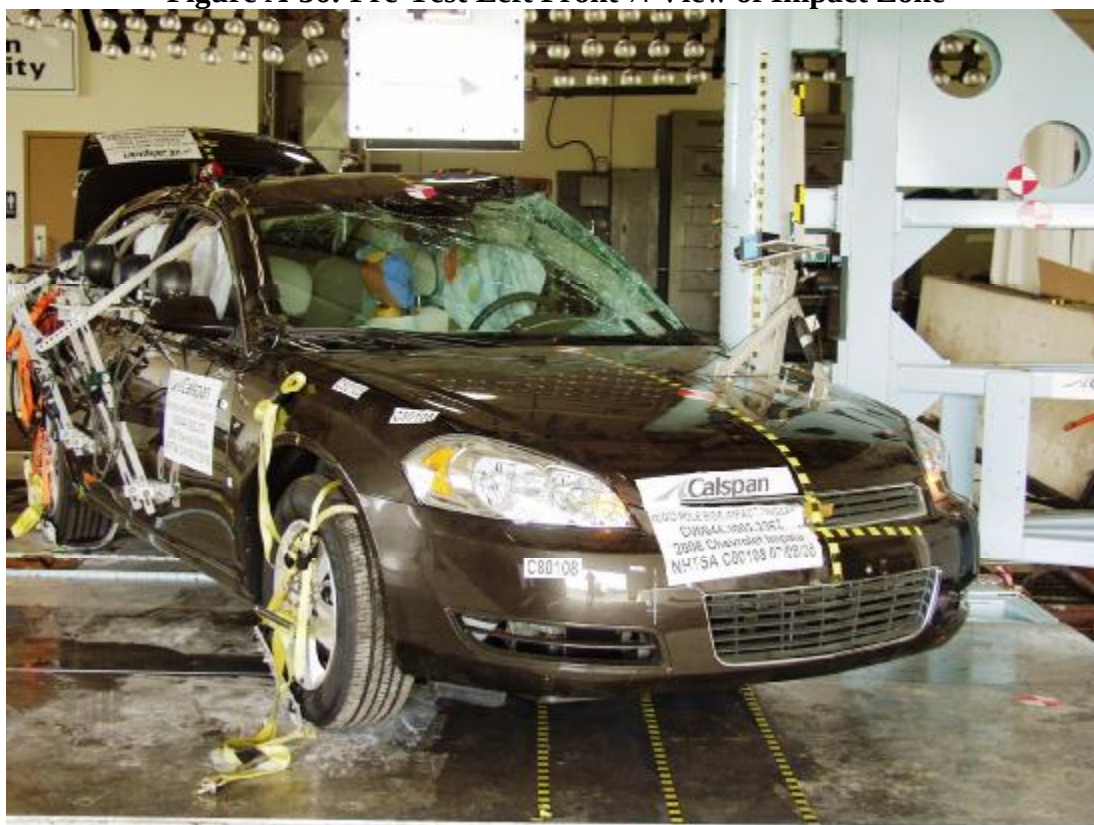
**Figure A-37: Post-Test Left Front  $\frac{3}{4}$  View of Impact Zone**

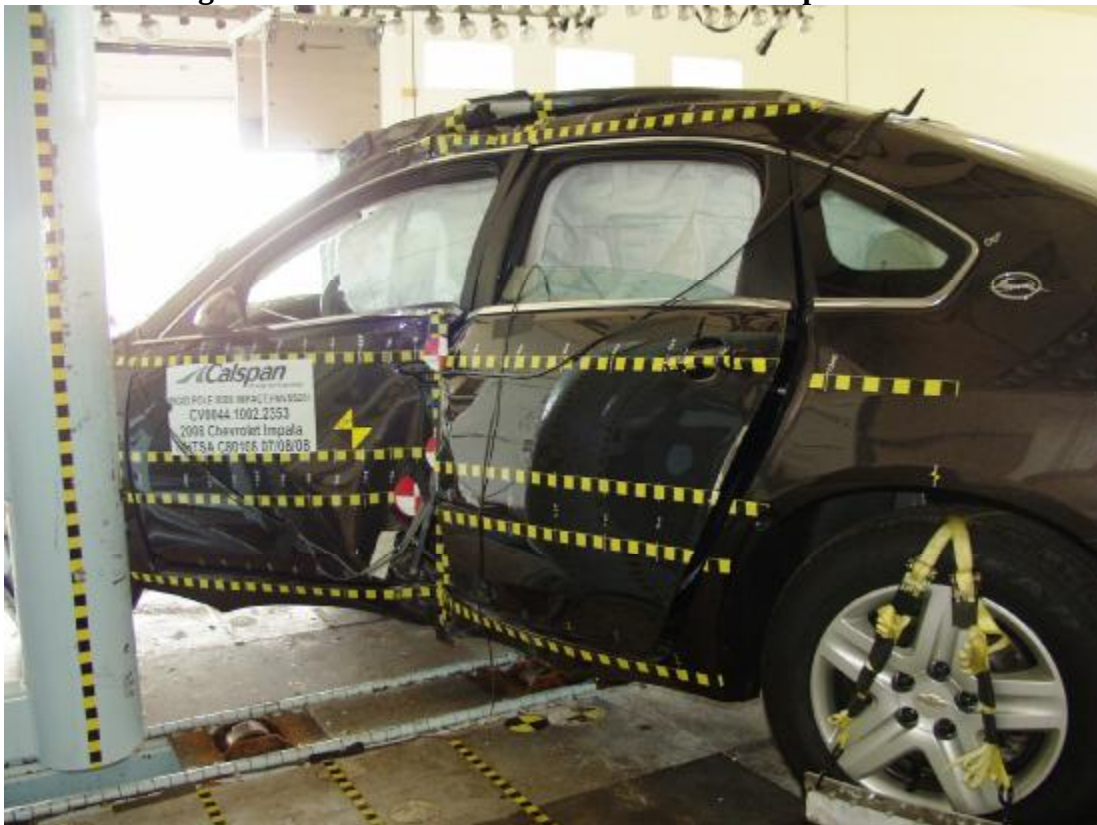
**Figure A-39: Post-Test Left Rear  $\frac{3}{4}$  View of Impact Zone**
